ASIA TURBOMACHINERY & PUMP SYMPOSIUM  
MARCH 2018 | SUNTEC SINGAPORE

# Base plate corrosion and Premature Bearing failure in RO Pump

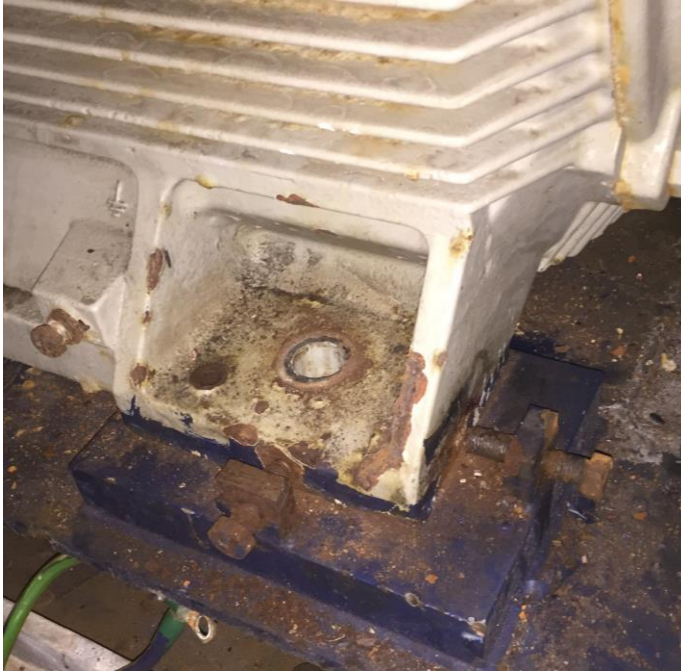
Motor Front Feet

There was thick layer of rust sludge built-up underneath the motor foot which rises the motor to 0.6 mm.

The rust sludges have tendency to grow up between the gap and will increase the gap and even crack the structure.

- ✓ Motor vertical offset due to rust sludge built up in the foot
- ✓ Coupling misalignment leads to overload the Pump radial bearing.

- ✓ The primary source of the premature failure of the bearing was identified as the rust sludge formed in the motor foot.
- ✓ As there is no shim available to correct the vertical offset that leads to further investigation.
- ✓ The vertical offset corrected after removal of rust sludges with 0.7 mm shims.

- ✓ Extra care need to be given for the Pump base plate to prevent any Rust/corrosion.
- ✓ Stainless steel laminated shims size need to match with the base plate contact surface and custom design if required.
