# ***Gearbox Misalignment on Combustion Gas Turbine Generator***

*Mohammed Al-Hajri*

**Abqaiq Plants-Saudi Aramco**

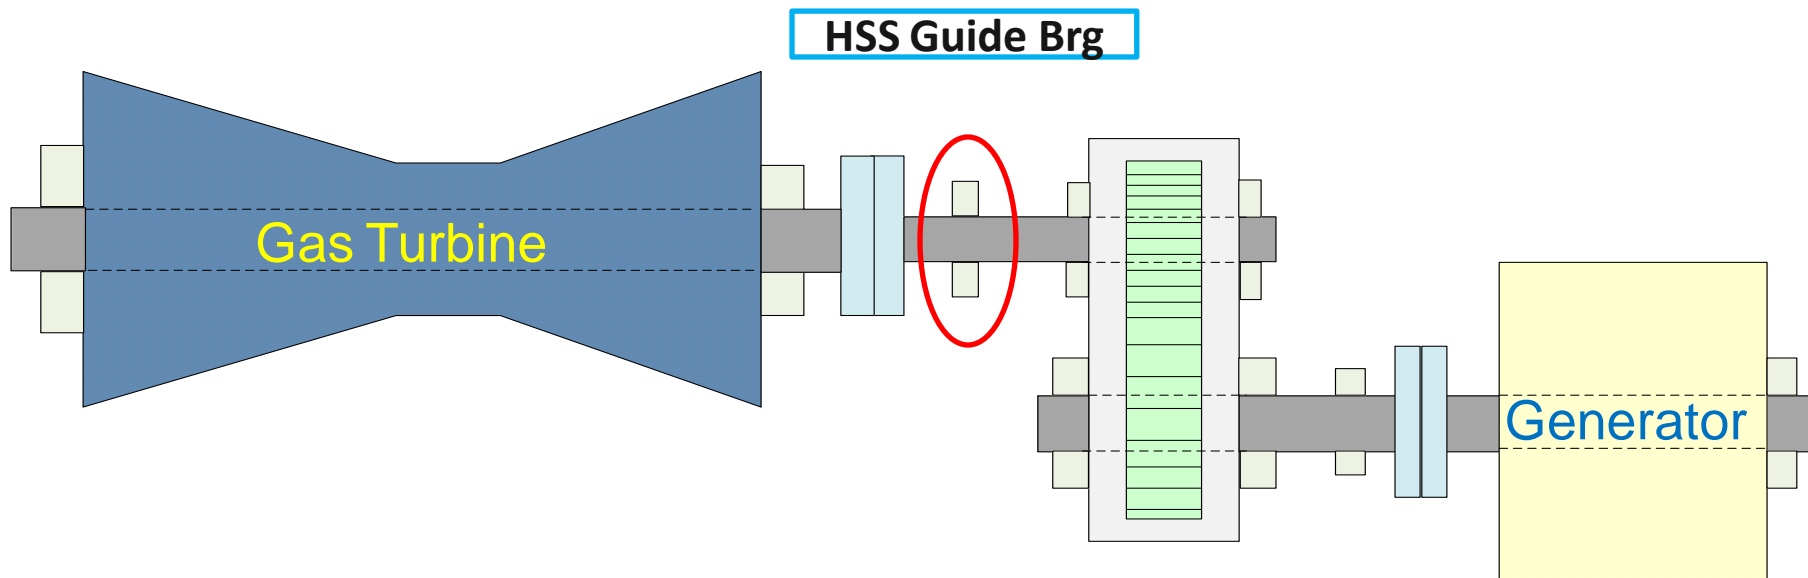
- High vibration at the Gearbox HSS guide bearing reached 5.2 mils Pk-Pk (alarm is 4.9)

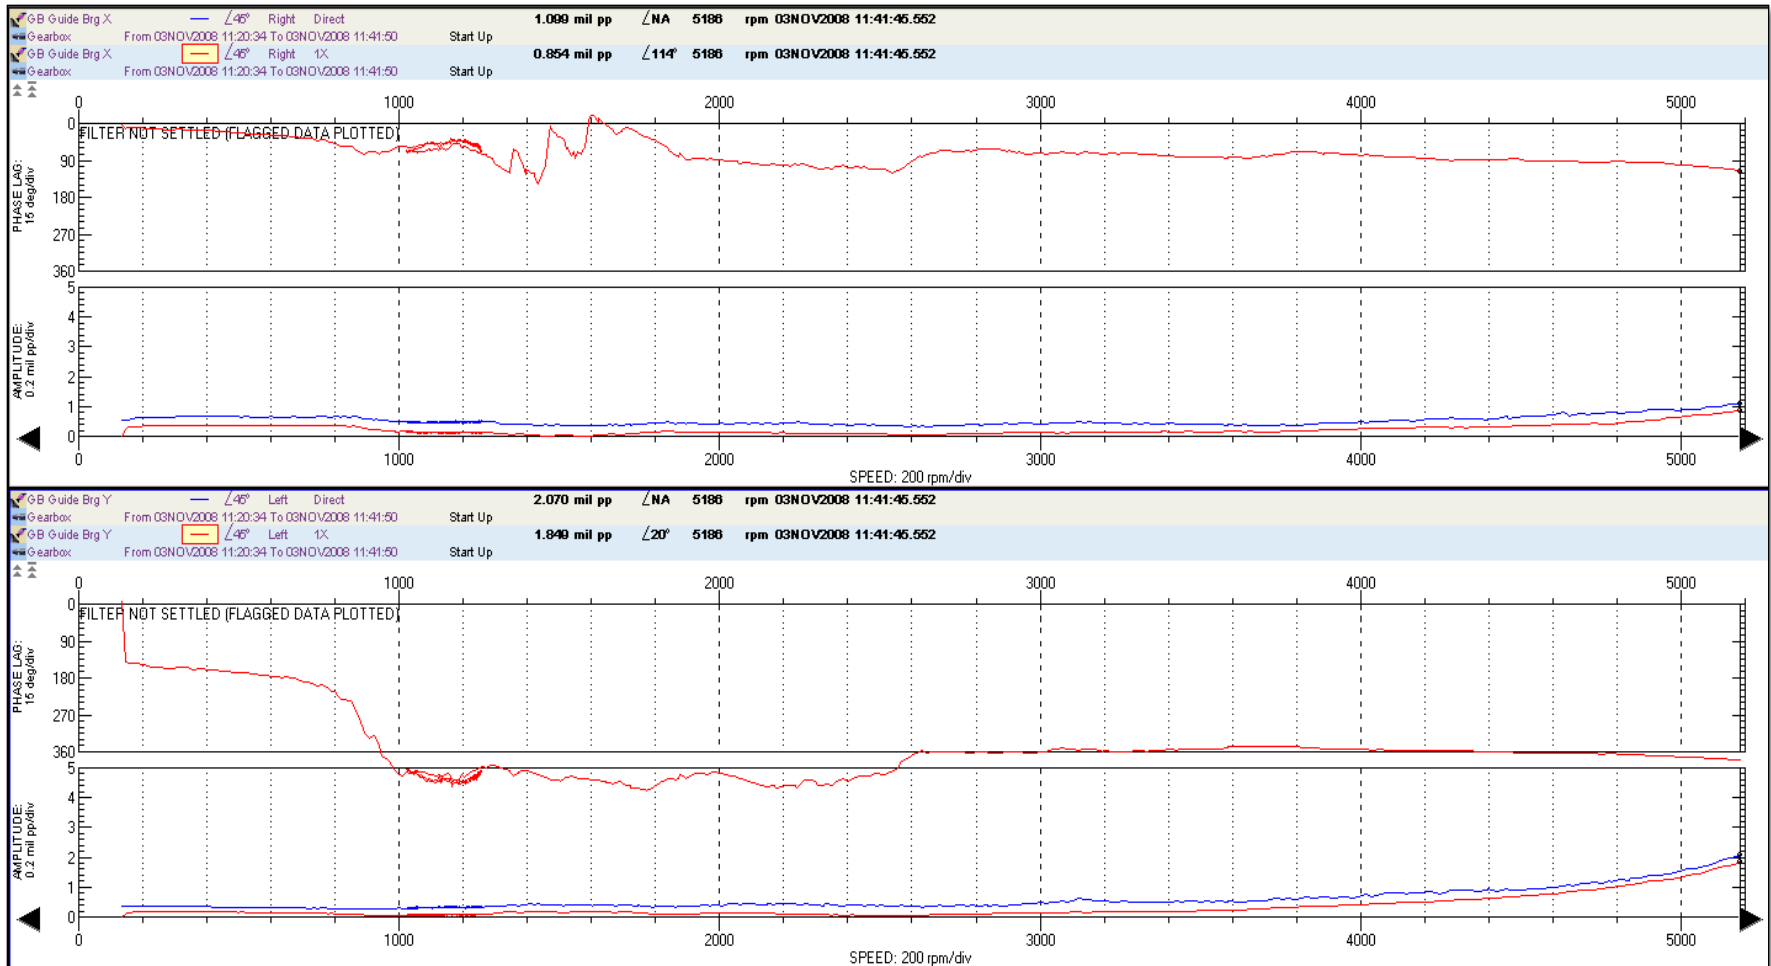
## 1) Bode Plot

- The thermal behavior observed on the Gearbox HSS guide bearing, the heavy multiple preloaded orbit and the presence of 2/3 X component could be due to hot misalignment to the turbine
- The gearbox acceleration vibration signature indicated high frequency components related to gear mesh frequency and its harmonics. This signature is most likely due to teeth wear or misalignment

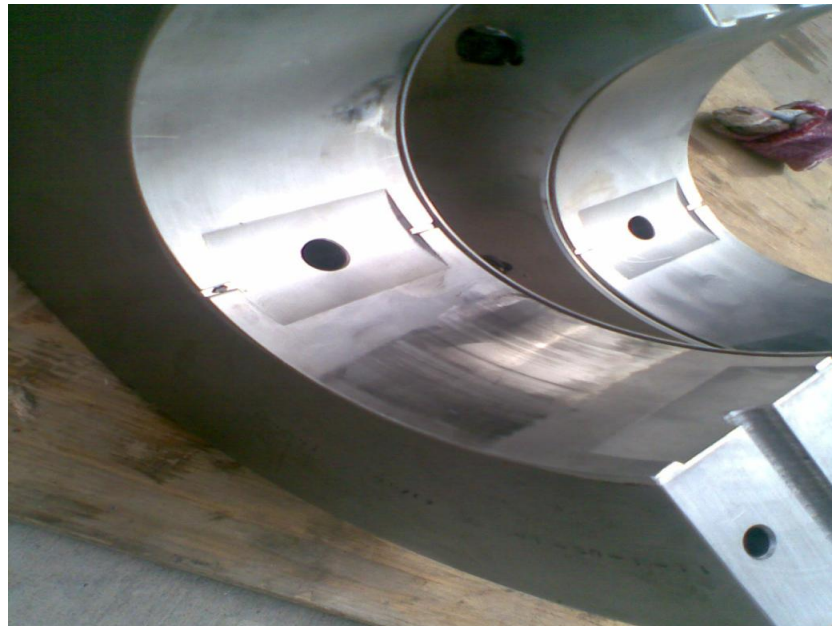
- The Bearing clearance was found above the limit with 17 mils.  
( Required: 11-to-12.9 mils)
- The bearing was found worn out with Babbitt metal loss

- HSS guide bearing was replaced
- Alignment between the turbine and load gearbox was corrected
- The right side turbine support leg was Repaired

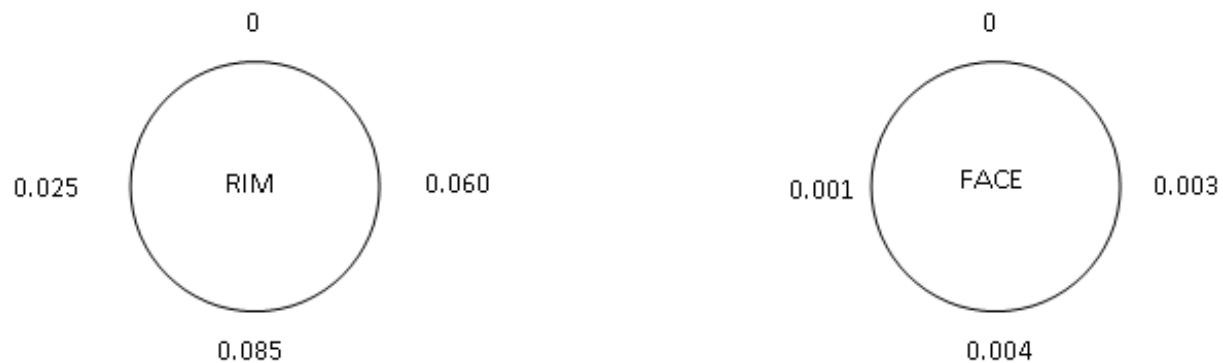
**Load Gear Box to Turbine Findings Before Correction (All Dimensions are in inches)**

- The bearing failure was attributed to unit misalignment; however, this amount of misalignment is unusual for a machine, which has been running smoothly for years
- Therefore, the cause of this problem was investigated in order to prevent future failures

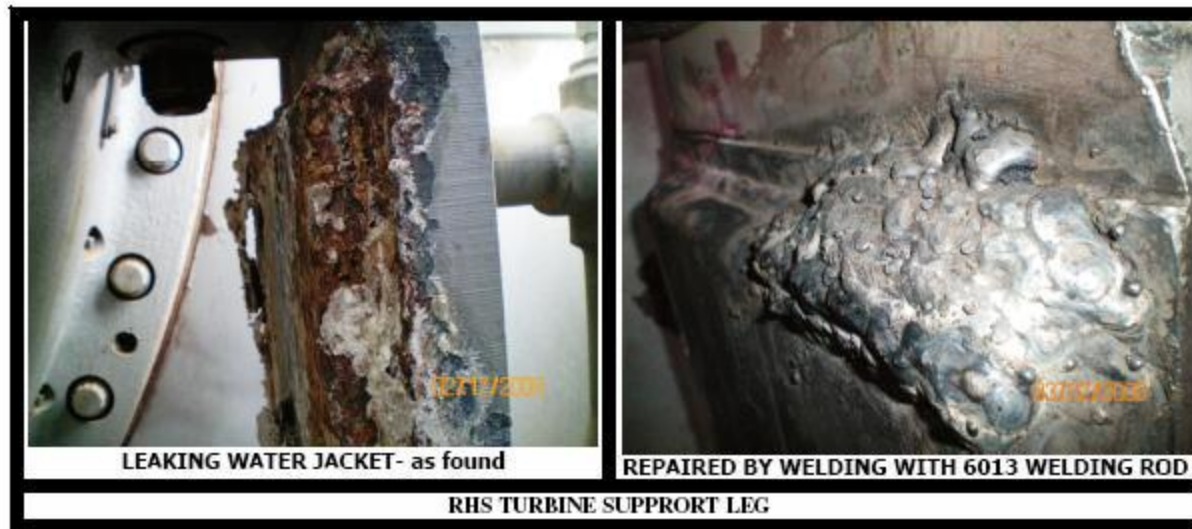
- The main root cause of the misalignment was pointed out as a turbine exhaust frame support leg failure
