# “Beating” Effect Caused by Two Closely Spaced Mechanical Frequencies Observed on Two-Shaft, Gas Turbine Drive

By Robert X. Perez, machinery engineer working for a midstream energy company in the USA,

Andrew Conkey PhD, Assistant Professor of Mechanical Engineering, Texas A&M University at Qatar

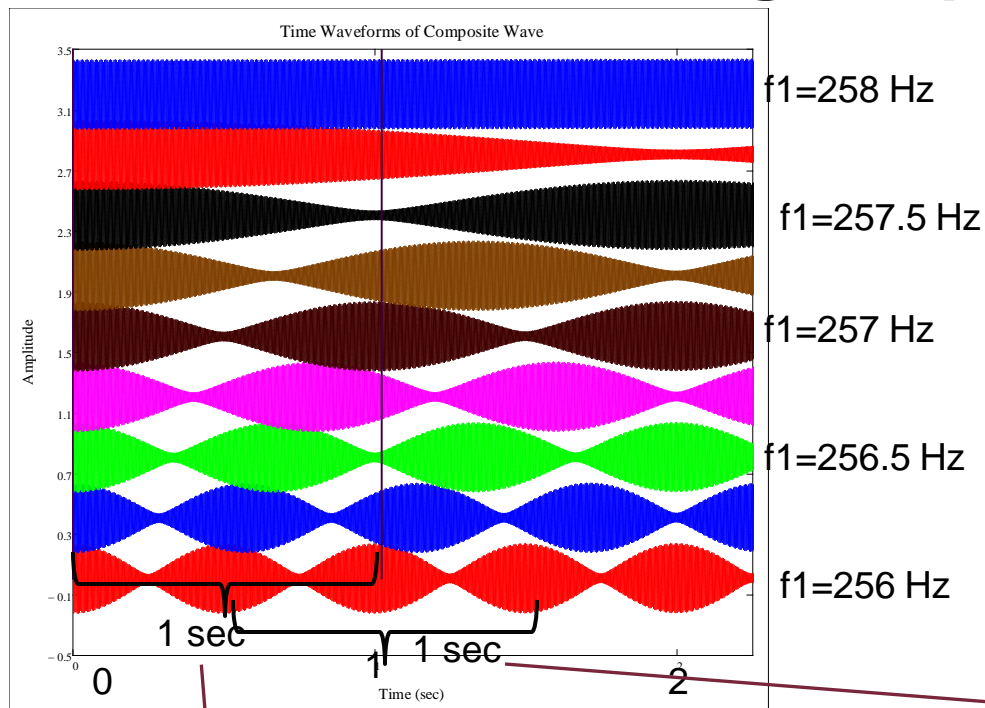
# Resulting Graphs: Set 1

The time waveforms on the left are the composite wave as the first waves' frequency changes.

The four figures on the bottom are the spectrums if the start time of the 1 sec. sampling shifts to the right. This is essentially a phase change. No 1X pick up on PT-GP system.

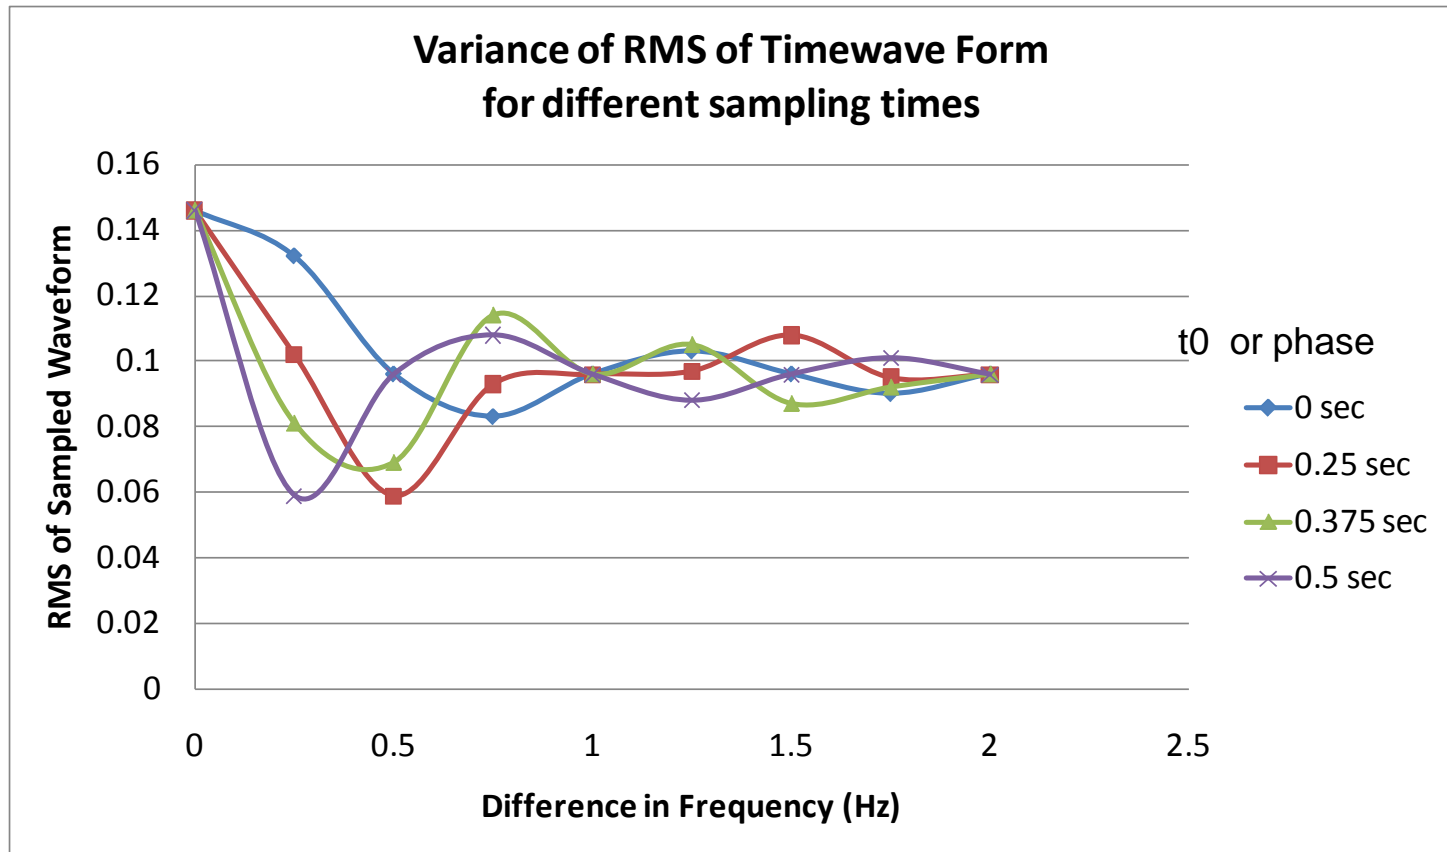
# Resulting RMS Graphs: Set 2

If the rms of a 1 second time waveform sample is examined, and the time as to when the sample is measured is changed, there can arise a wide swing of the rms value when the difference between the two signals is less than 1 Hz.

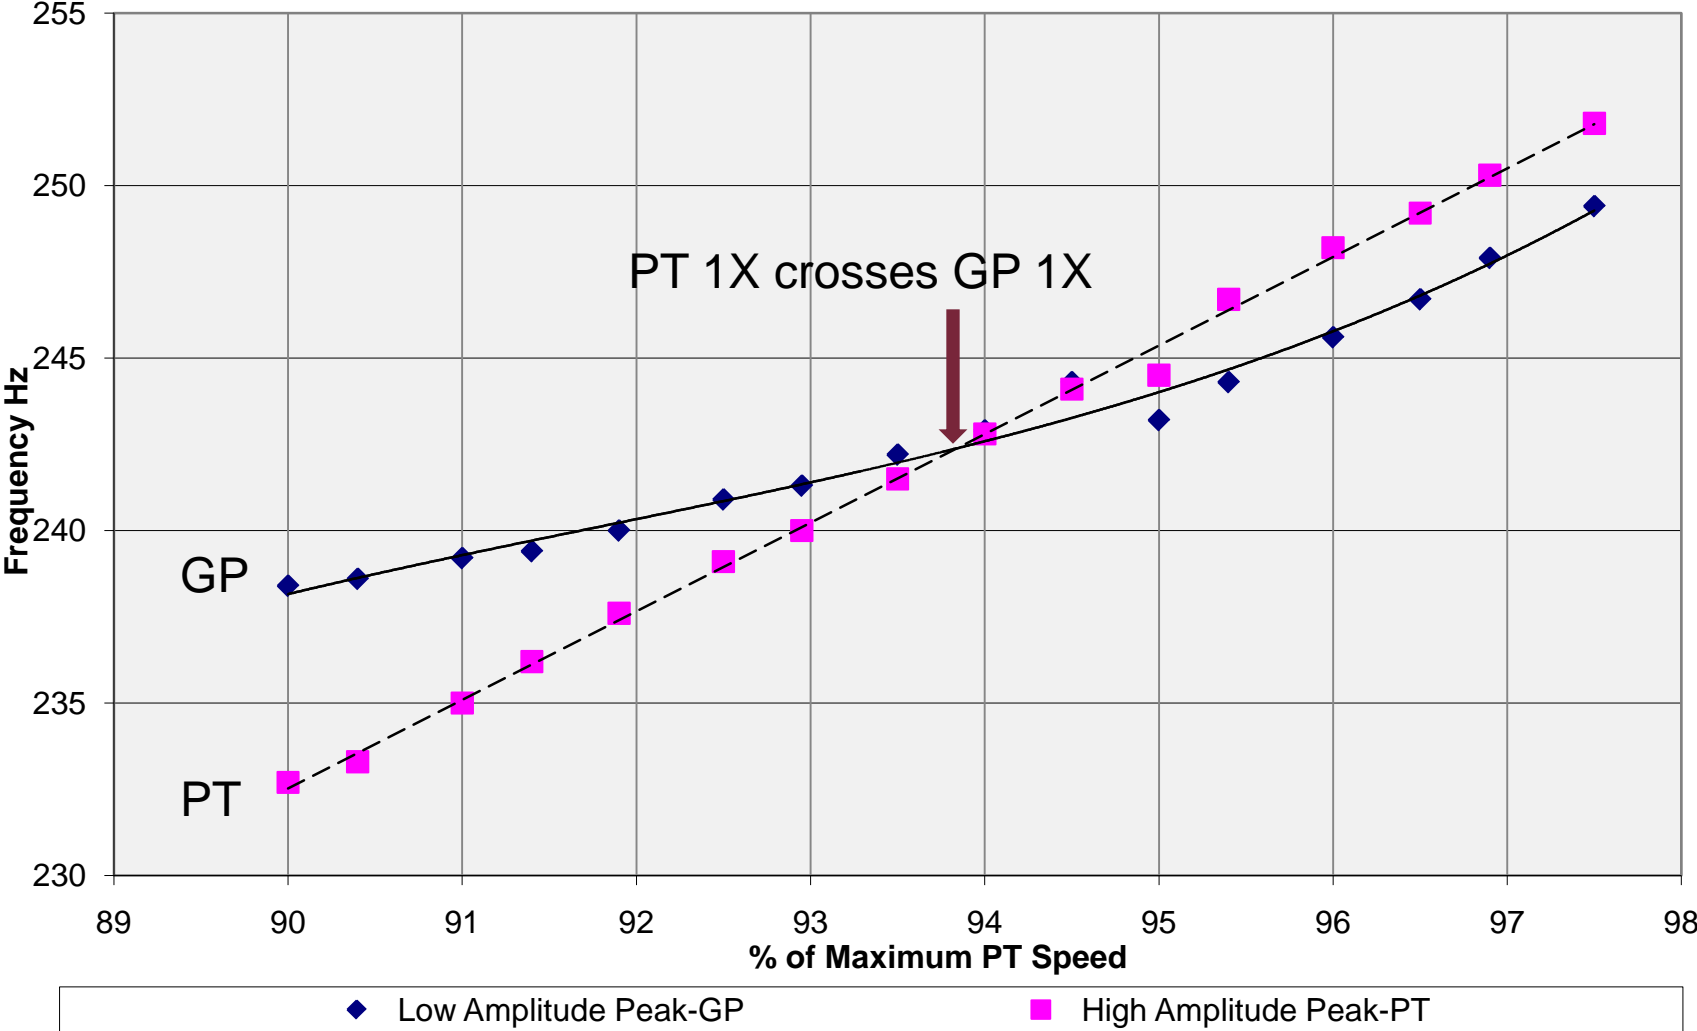
# Zoom Analysis Results from PT Speed Sweep

To better understand the phenomenon occurring between the GP and the PT, two curves were generated by varying the PT speed from 90% to 97.5% of the PT rated speed and recording the spectral characteristics of the two predominant peaks in the 230 to 250 Hz range.

These curves were created by collecting and then plotting the amplitudes and frequencies of the larger component and the smaller sideband with the frequency analyzer set at a 230 to 250 Hz frequency span with 1600 lines of resolution.

It was soon discovered that the larger of the two peaks related to the PT 1x frequency and the smaller sideband peak corresponded to the GP 1x frequency.

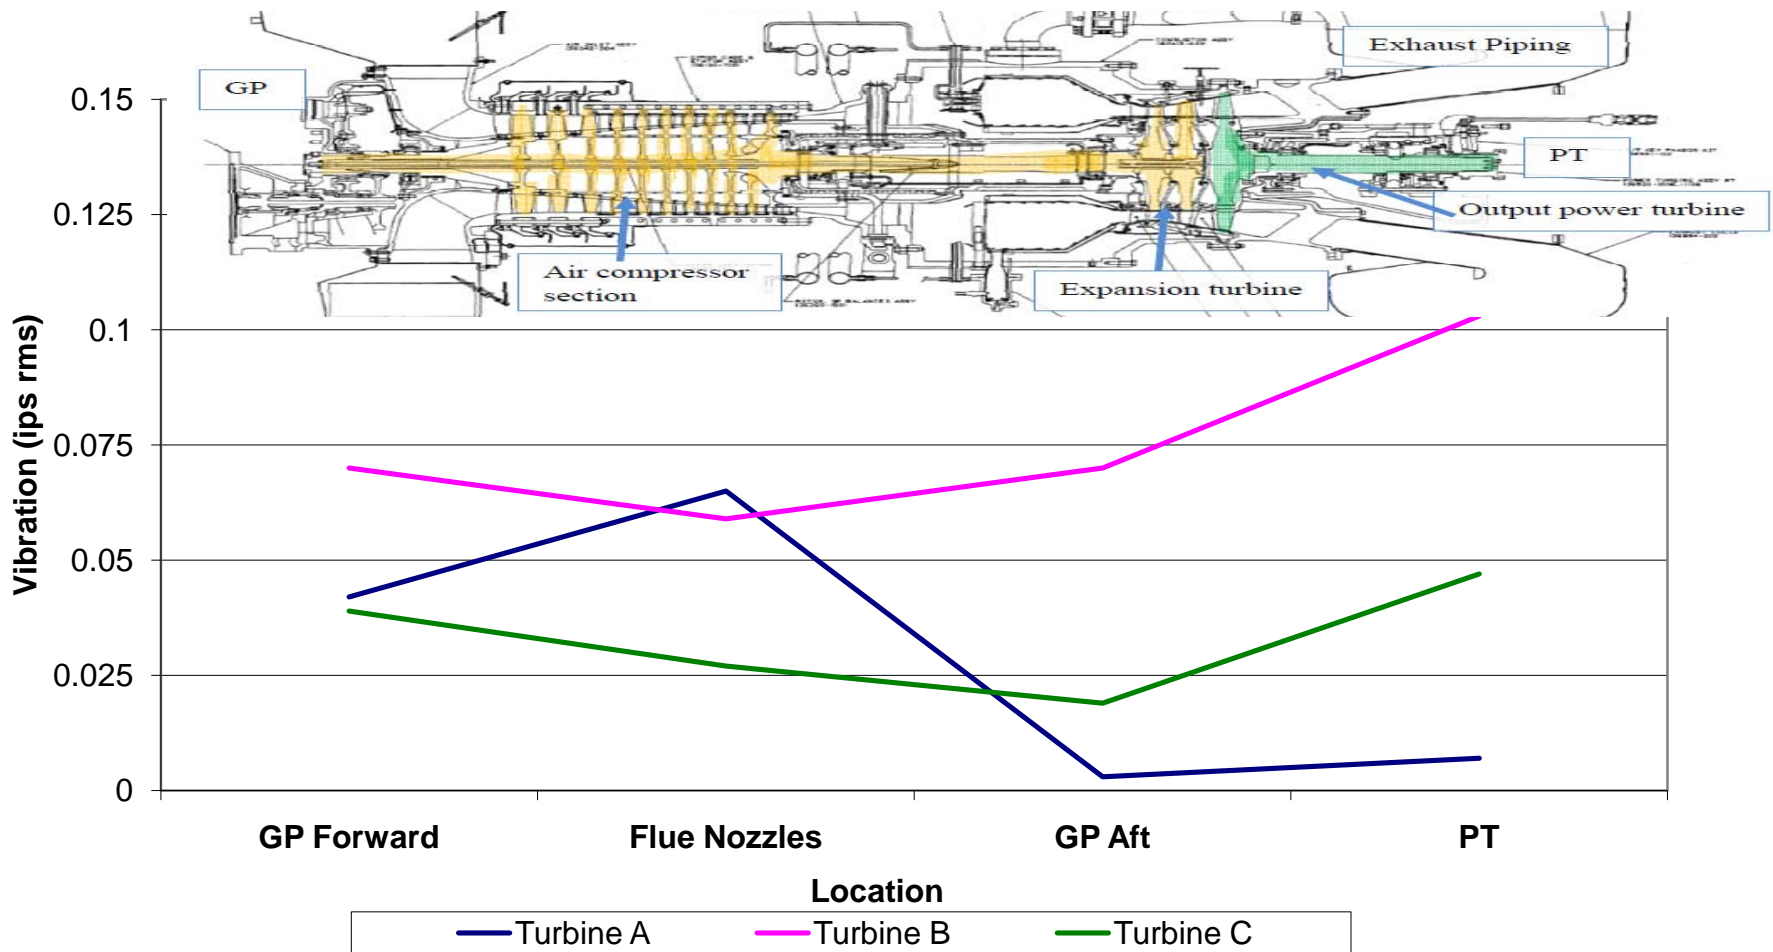
## Gas Producer Vertical Vibration Levels at Different Train Locations

Three (3) similar gas turbines at the site were running at the time of this comparative analysis. Here is a plot showing GP vibration at various locations along the three engines analyzed. Note: Turbine B below is the engine described in the case study. Notice that for some unknown reason it transmits the highest level of GP vibration to the power turbine end.

Turbine B is the gas turbine in the case study
