Turbo-Expander Compressor Active Magnetic Bearing Trips Reduction - A Case Study

RasGas

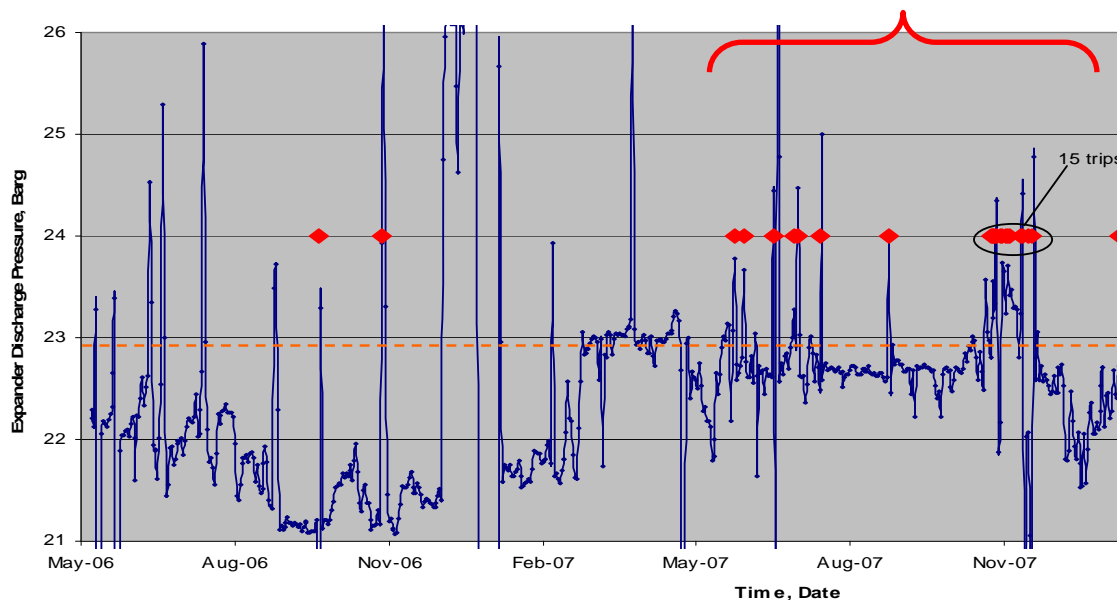
- Failures were initially one-off's & electronic components related
 - sensor rings, detector boards, battery, etc
- High rate operations of Unit #1 caused 32 trips in several months in mid-late 2007
 - Extensive Root Cause Failure Analysis (RCFA) efforts including engagement of TEC OEM, AMB supplier & Operator team

— Expander Discharge Pressure — Trip Point

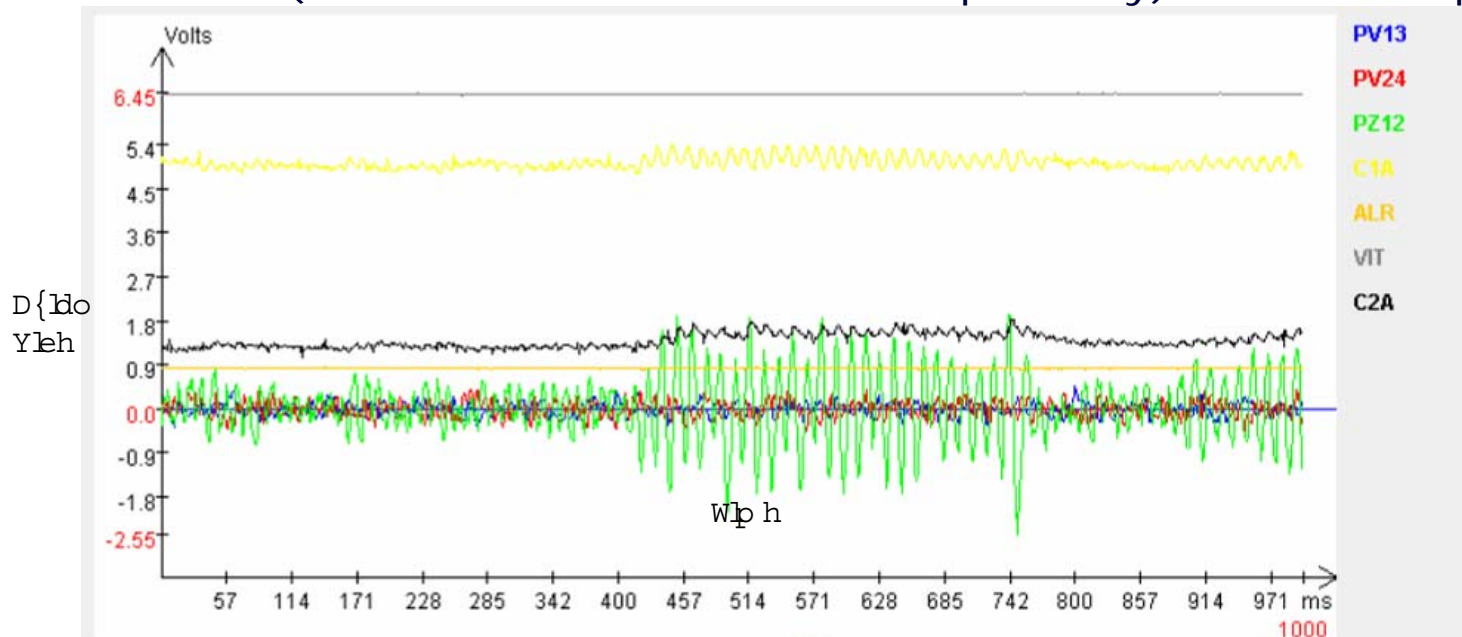
- Axial Shuttling (Surge Failure Z12) – Spurious Trips
 - Some radial vibration at 1st natural frequency (~80Hz) and but thru certain conditions axial 240 Hz. Picks up exceeded the trip limit – affected only Unit #1
 - Trip generated by AMB control system when it detects at least 5 peaks of vibration amplitude higher than alarm and trip threshold values (default 87 um and 105 um respectively) in a 7s time period

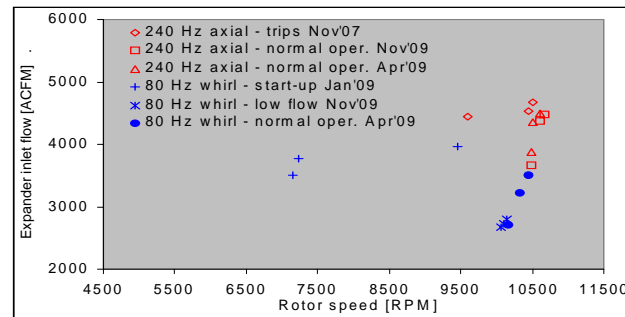
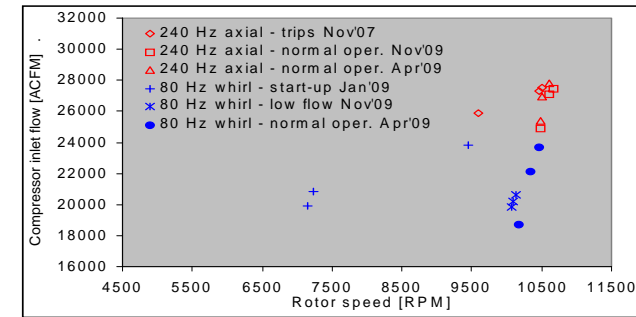
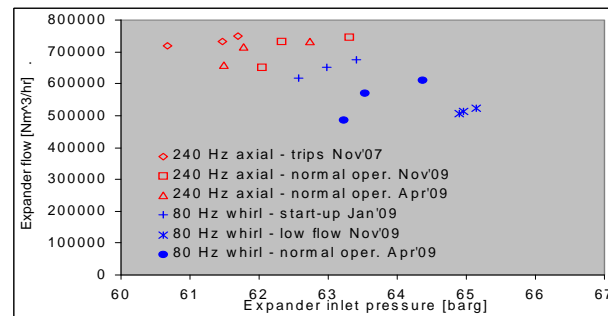
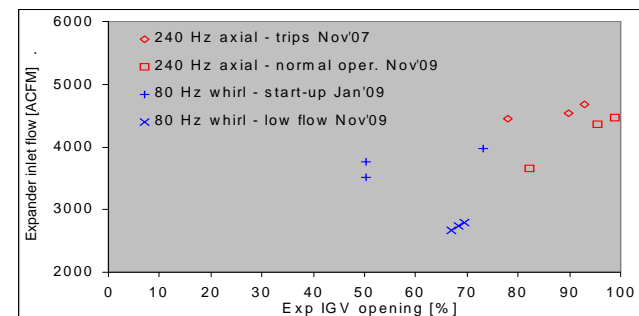
- RCFA Found Combination of Factors
 - ATB was initially not functioning correctly (logic, stroke & setting)
 - Off-design condition due to high rate operations creating low back wheel pressure (high axial thrust load)
 - Unknown high frequency (240Hz) vibration used up dynamic capability of AMB – only seen at specific low pressure/ high flow/ speed settings

- Automatic Thrust Balance logic, stroke & setting corrected
- Increased Thrust Bias Current (12A → 15A) to improve Dynamic Capability of AMB (by 60%)
- Better thrust balance after change of TEC Machine Center Section in Jan. 2009
- Stability check performed unloaded/ 50% neg. stiffness
- Extensive review confirmed ATB design (valve and piping), but measured pressure drop higher than expected
- Rotor dynamic analysis confirmed 80Hz natural frequency ... but could not detect any 240Hz cross-coupling

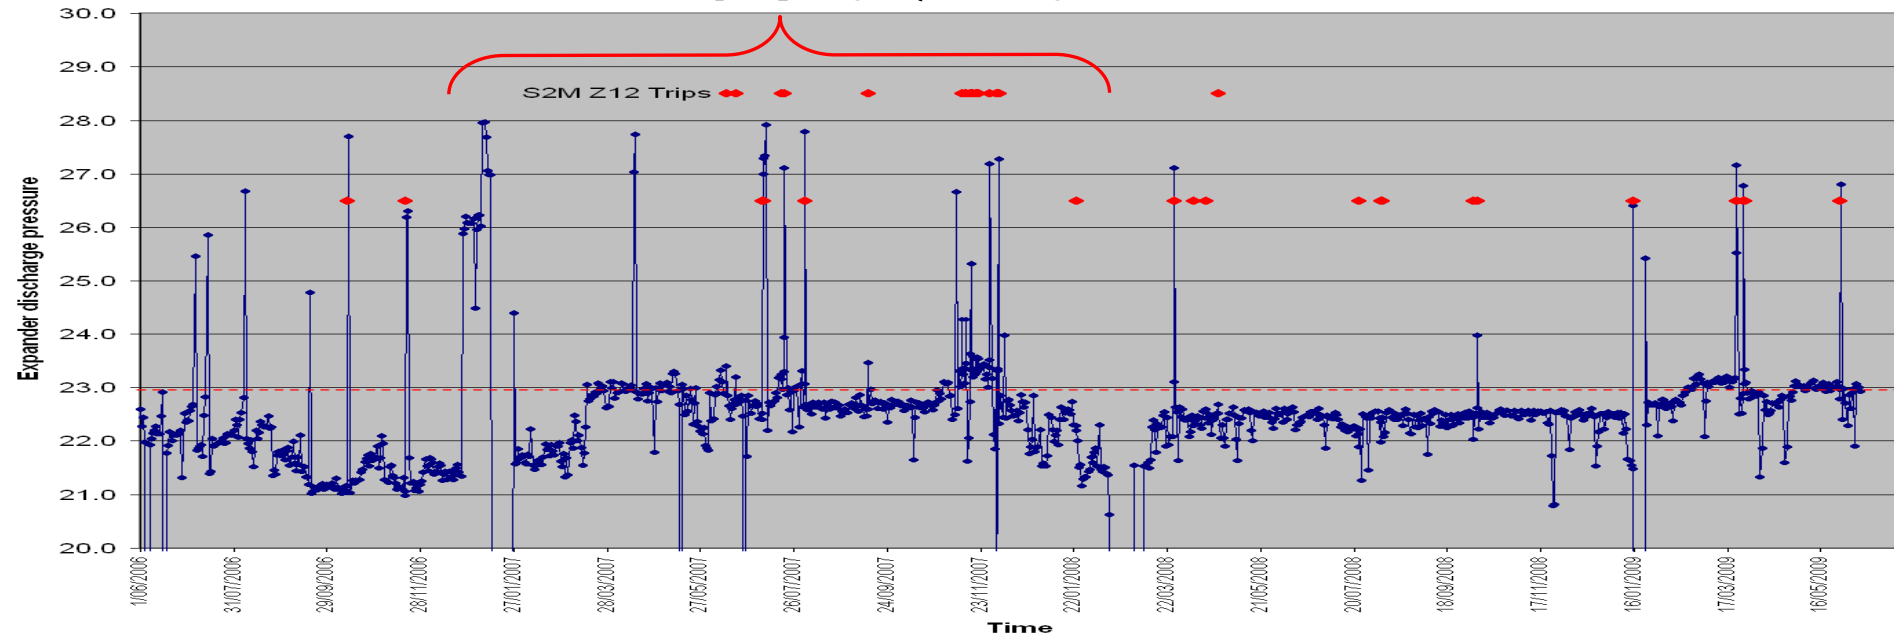
S2M Z12 Trips

- No AMB/ Z12 Trips since April 2008

- Outstanding Works
 - Source of high frequency (240Hz) vibration is still to be determined, though
 - ATB valve and piping to be inspected and if necessary upgraded to reduce pressure drop

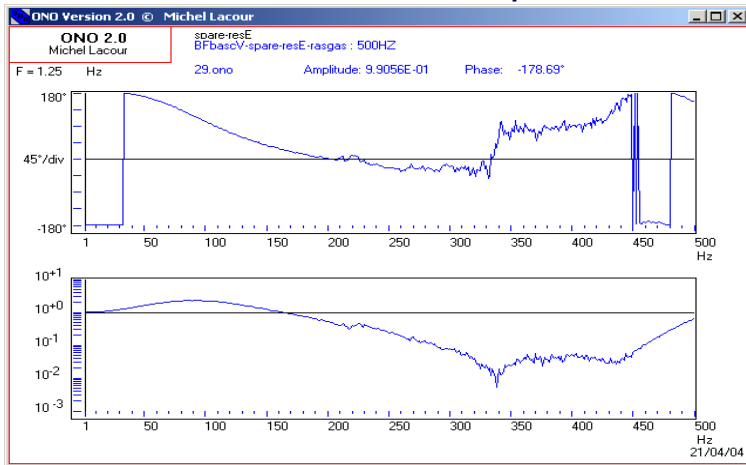
Translation Closed Loop TF

- Closed Loop TF on Translation and Tilting mode controllers (measured at standstill) appear to be very flat in the 70-120 Hz frequency range. This is a good indicator of system stability.

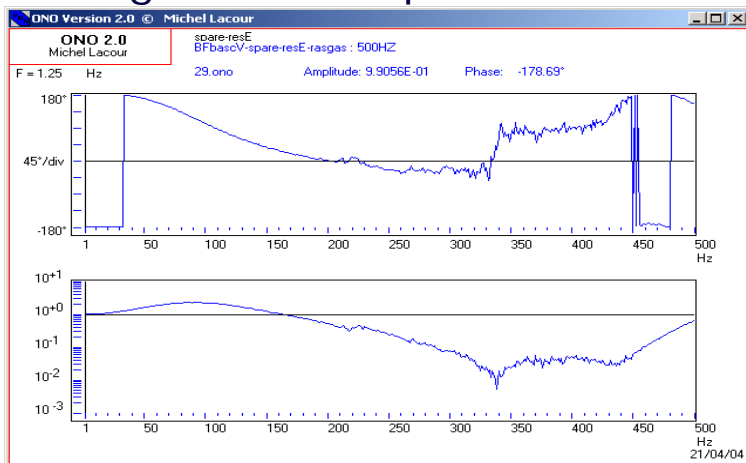
Tilting Closed Loop TF

- Closed Loop TF should be measured with machine in operation to have confirmation on stability margins.

The standard S2M Amplification factor criteria on a close loop transfer function is < 2.5

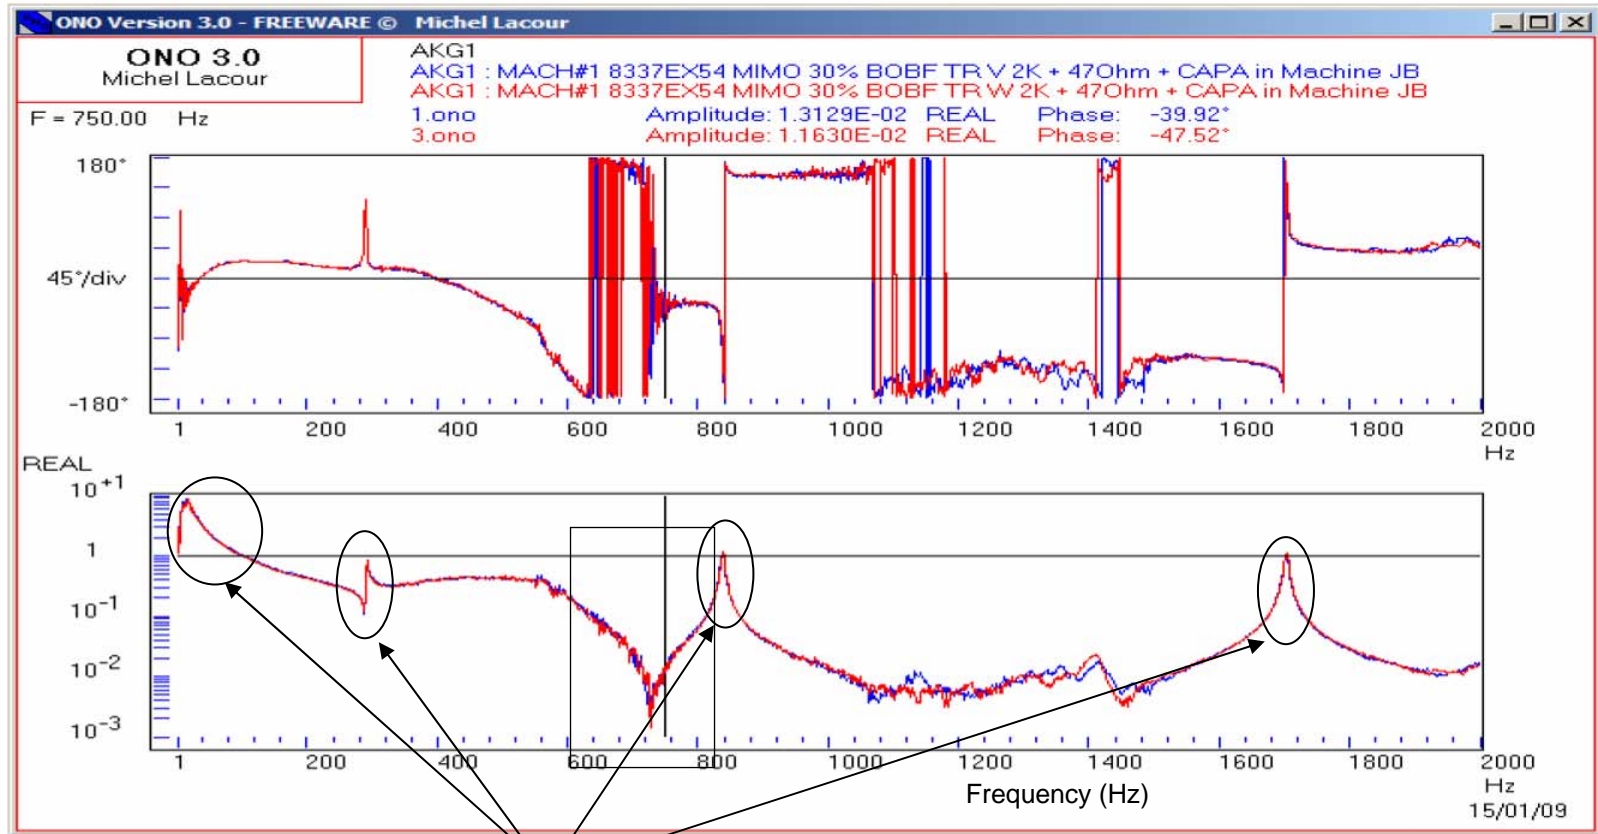
A1 - Typical Transfer Function Plots

- Natural frequencies as per design
- Compared with previous reading – good to go

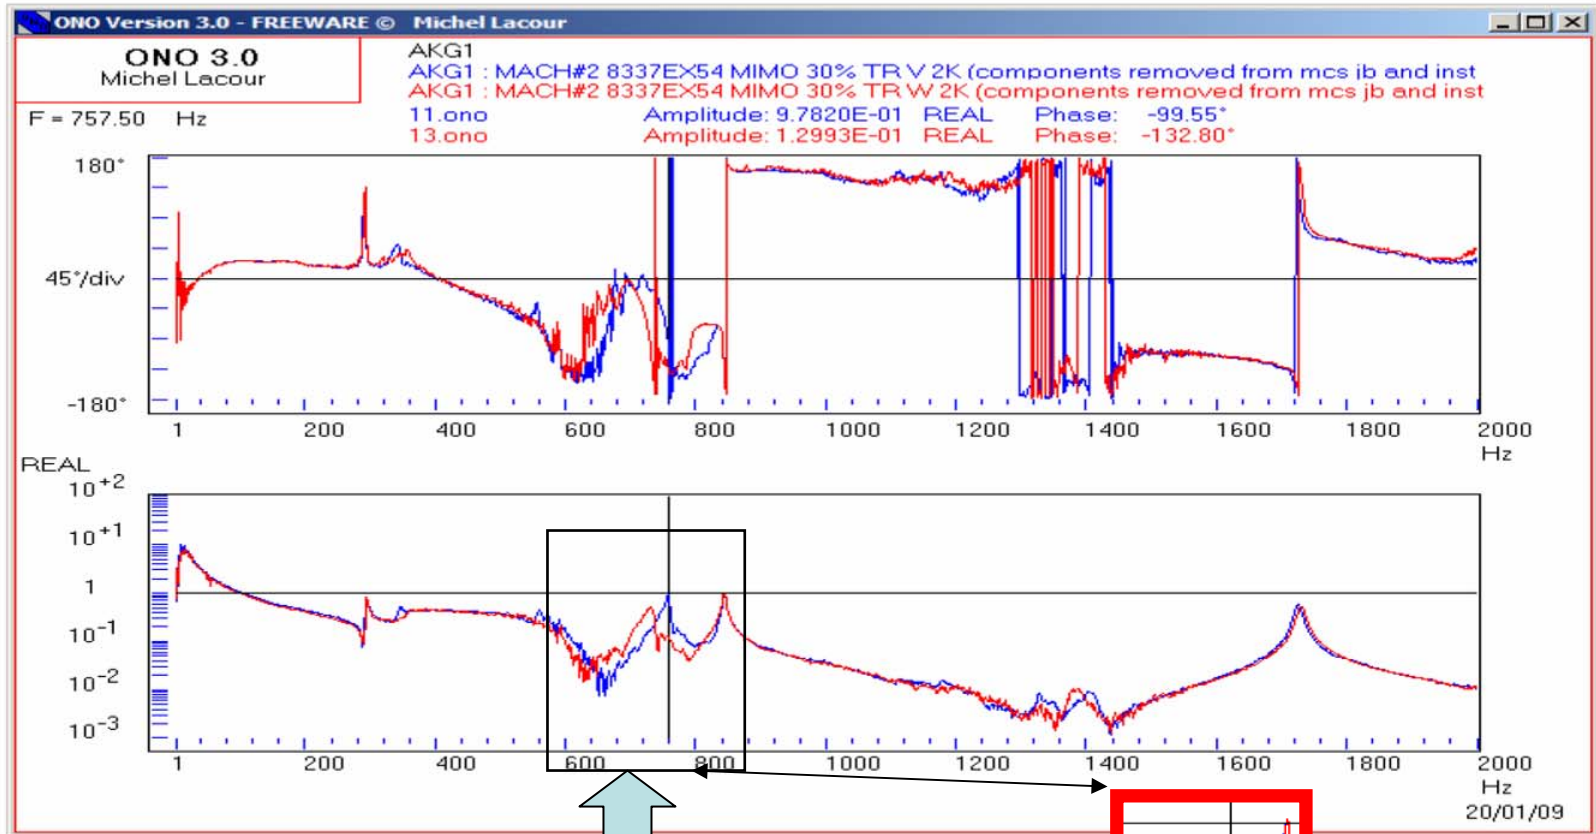
A2 – Unit #1 TF Change at High Frequency

High frequency TF change measured

TF curve before the replacement of the MCS (this is the expected curve).

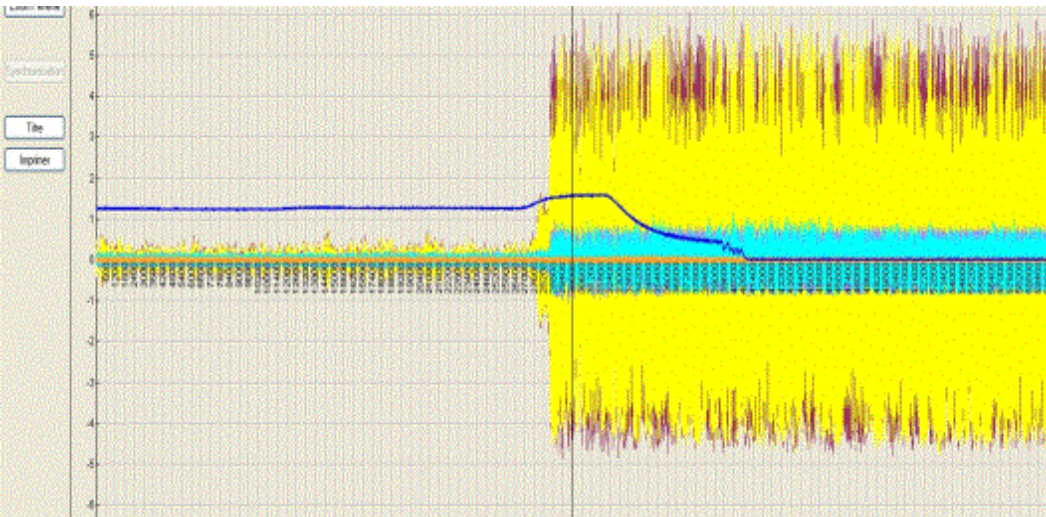
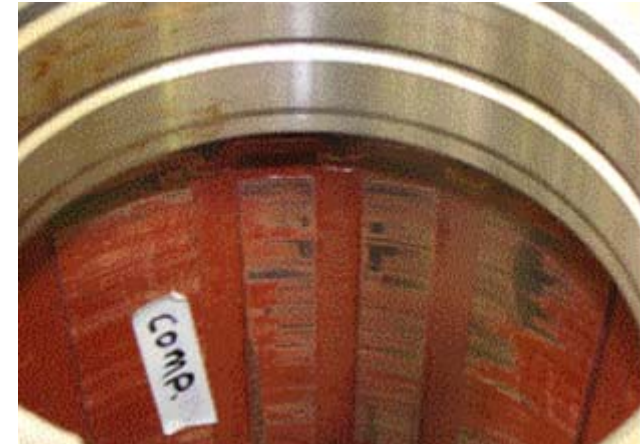
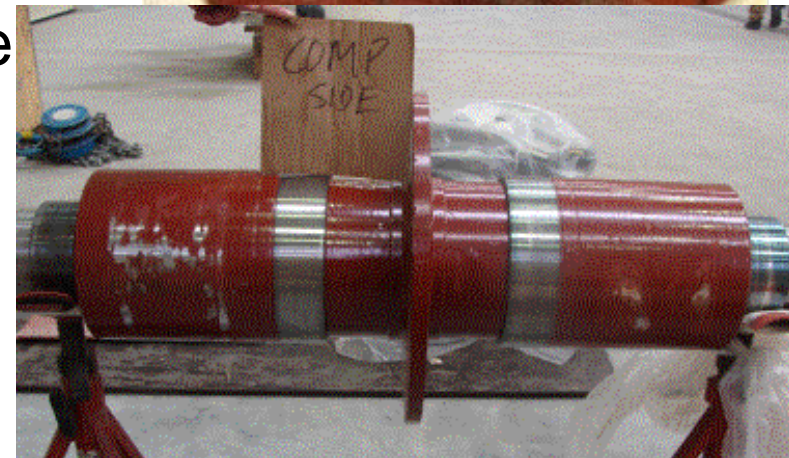
B1 – Unit #2 TEC Unstable Vibration following TF Change

Rubs on shaft and varnish

- Unstable vibration when ramp up the machine
- Cannot restart, reinstall old unit
- Severe rubs of stator and rotor (photos)

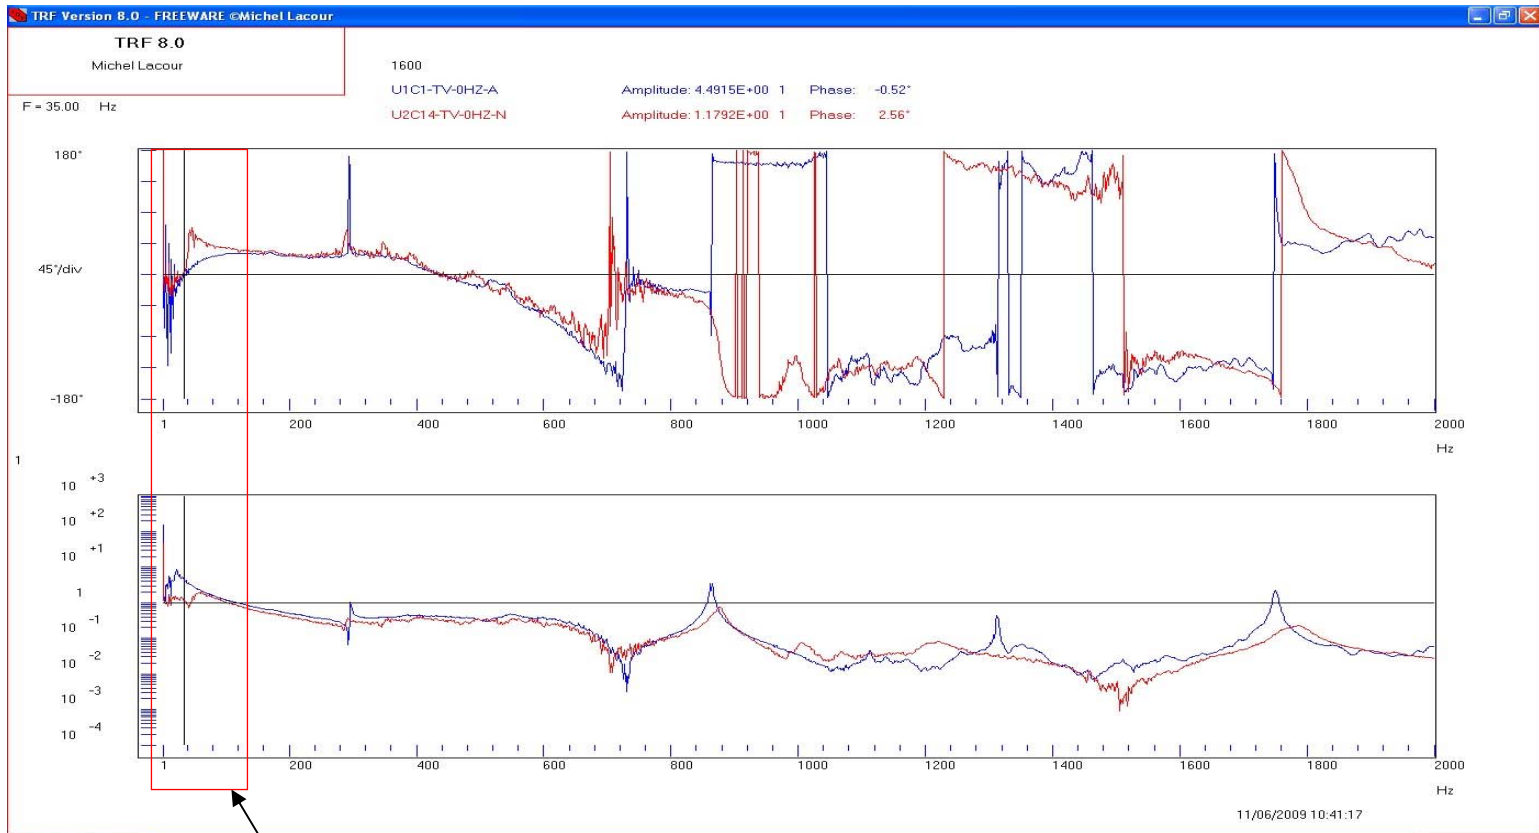
B2 – Unit #2 TF Changed at Low Frequency

- Low frequency response changed
- Indicating instability

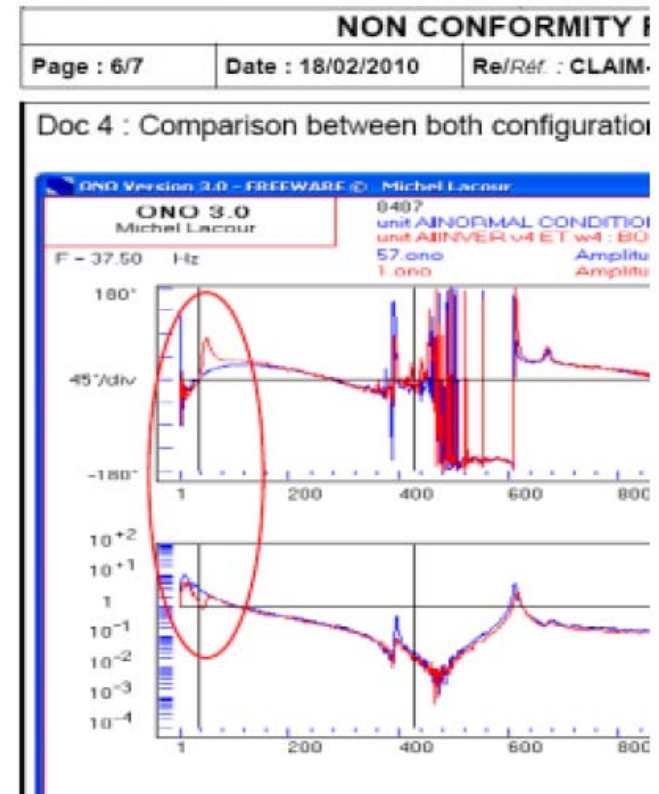
B3 – Unit #2 Machine Center Section Root Cause

- Axis identification on compressor side was wrong (signals cables)
 - Wiring was also crossed inside MCS
 - Wiring was crossed at JB during replacement
- Static levitation can be performed even if lower radial coils crossed and appeared to be stable, but in dynamic mode unit is unstable
- Field error replicated in the vendor facility

- Spare AMB cabinet to test all MCS before installation
