Steam Turbine Blade Failure

Qatar Chemical Company, QATAR

MIDDLE EAST TURBO MACHINERY SYMPOSIUM - 2011

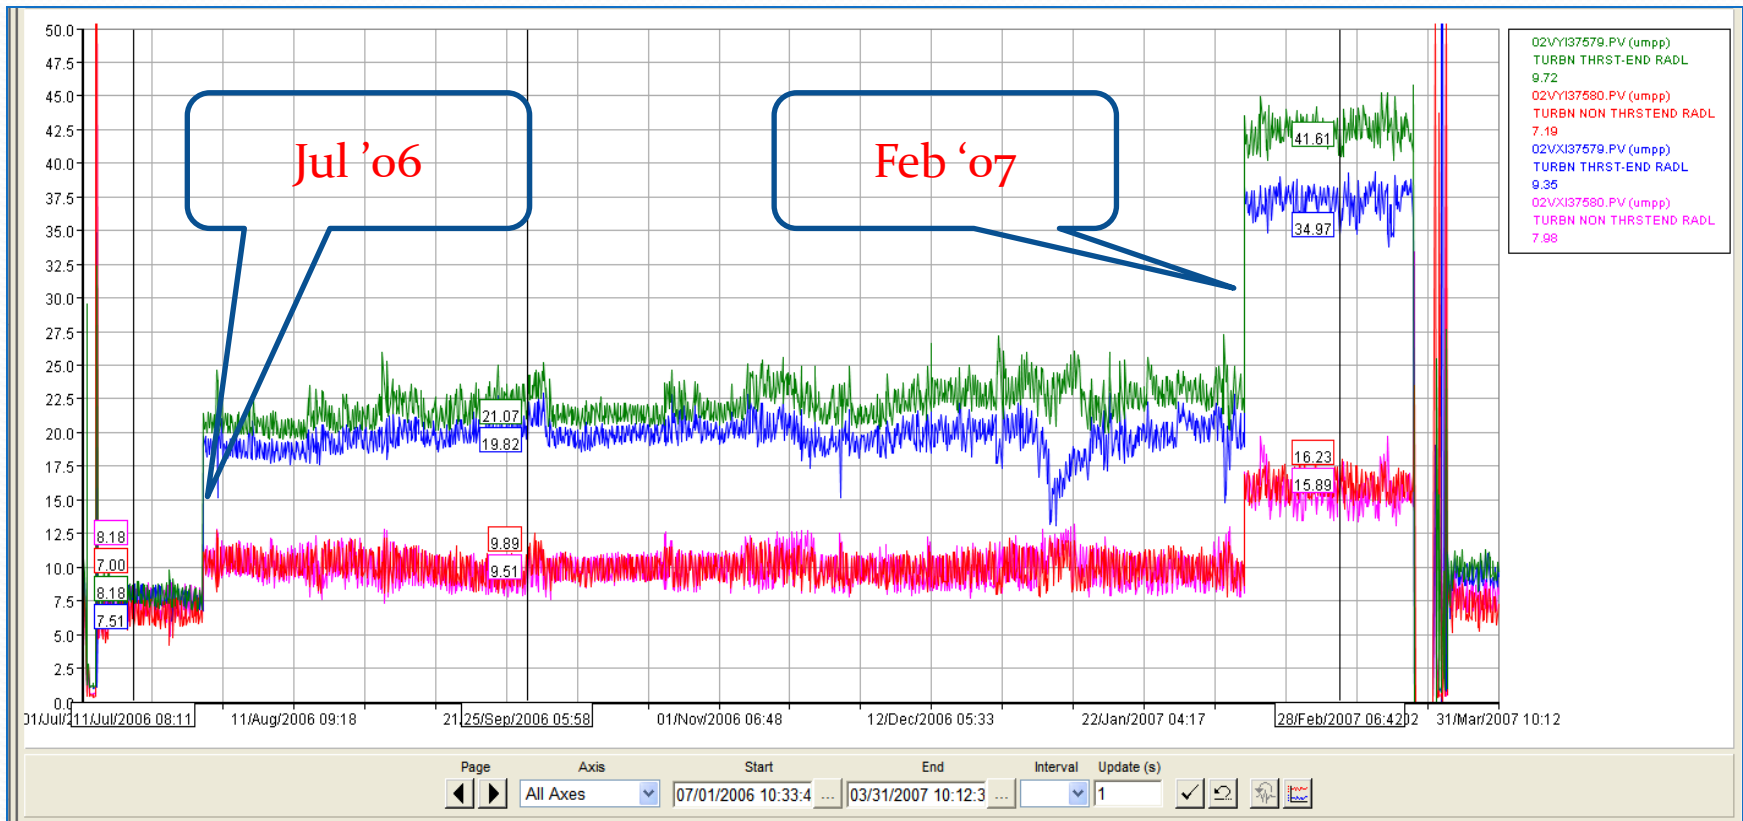
Event Timeline – Vibration Trends

July 2006 – First Step Change, Suspected Blade Failure.

Feb 2007 – Second Step change, Vibration reach 70% Alarm.

March 2007 – Planned shutdown and rotor replaced.

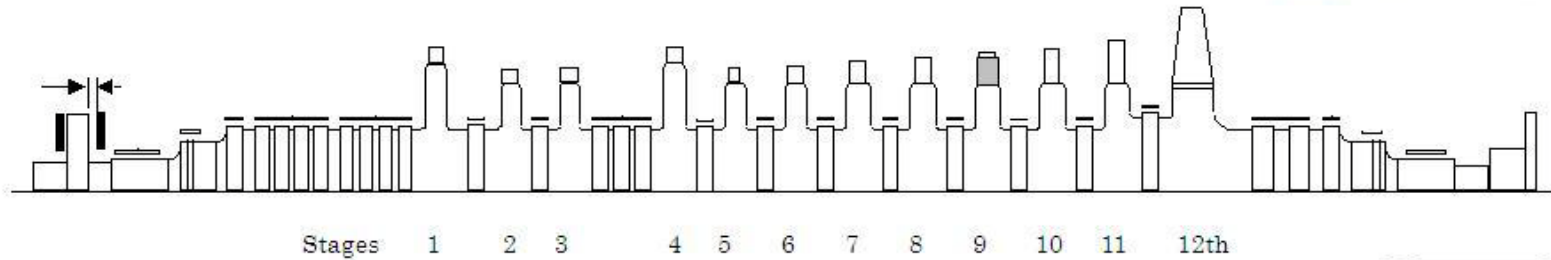
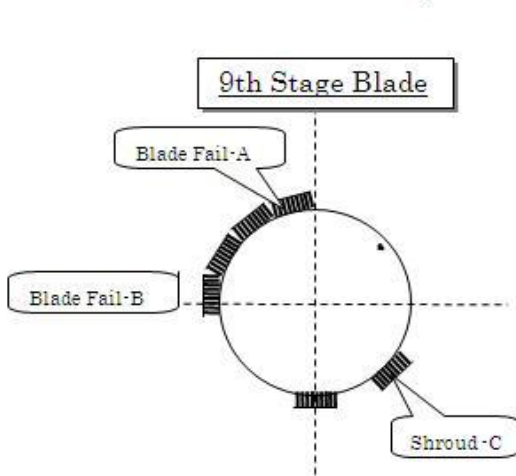
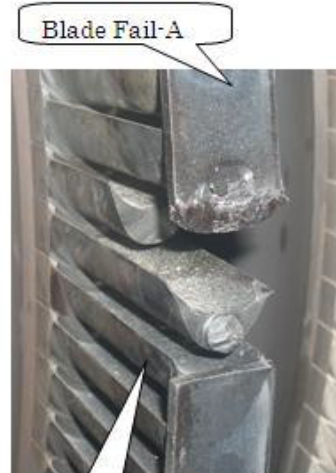
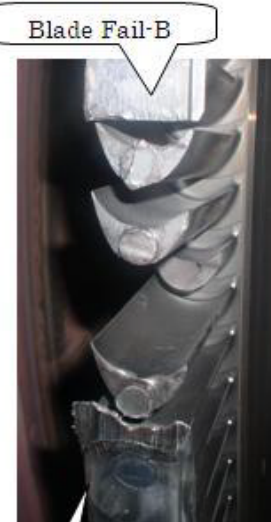
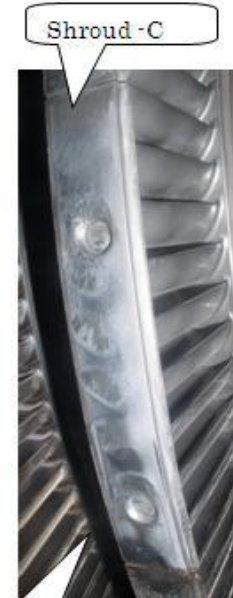
Visual Inspection of failed rotor

- Failure limited to 9th stage blades.
- 9th stage blades failed at 3 locations. Blade no 30~38, 68~77, 96~104.
- Surface and fracture surface of blades found black.
- Tenons found broken at 31,36,76,96
- Profile found broken at 75,97
- Shrouds were lost at 74,77,98
- Rub marks on blades 76, 96
- Some red deposits found on 2nd ~6th Stage blades
- Some white deposits found on 7th ~12th Stage blades.
- Inlet side of 10th stage blades show many dents.

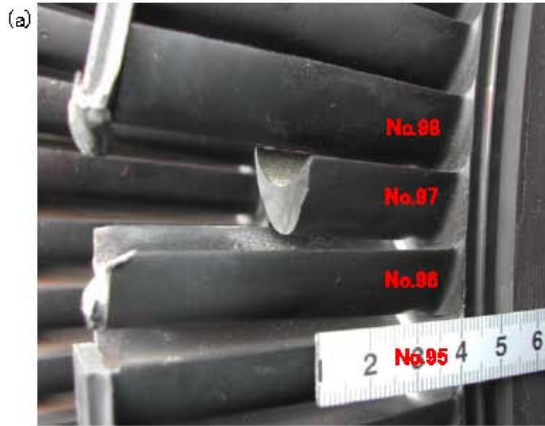
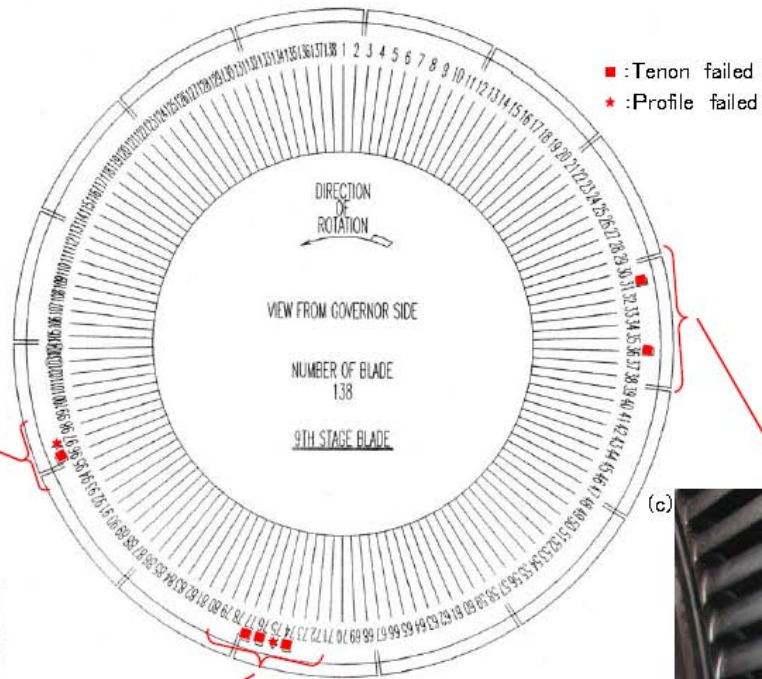
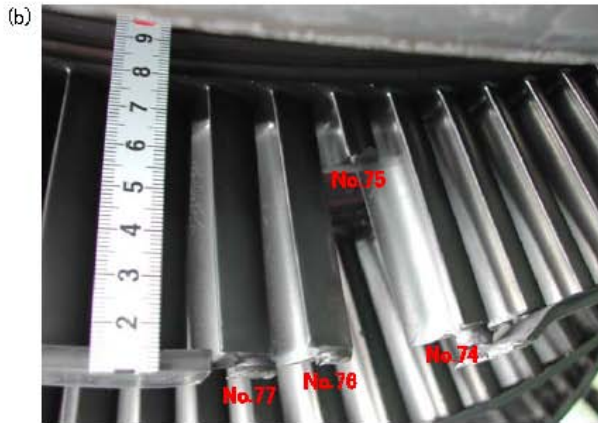
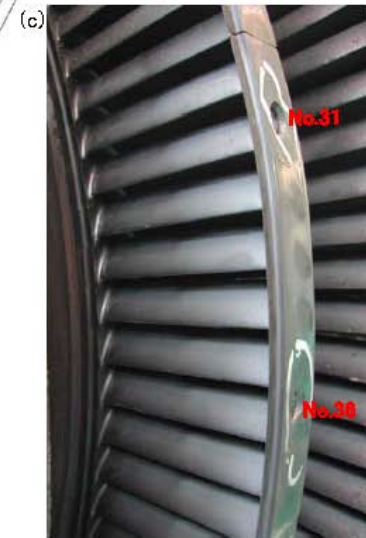
STAGE 9 - BLADE FAILURE LOCATIONS

Failure condition of 9th stage blades

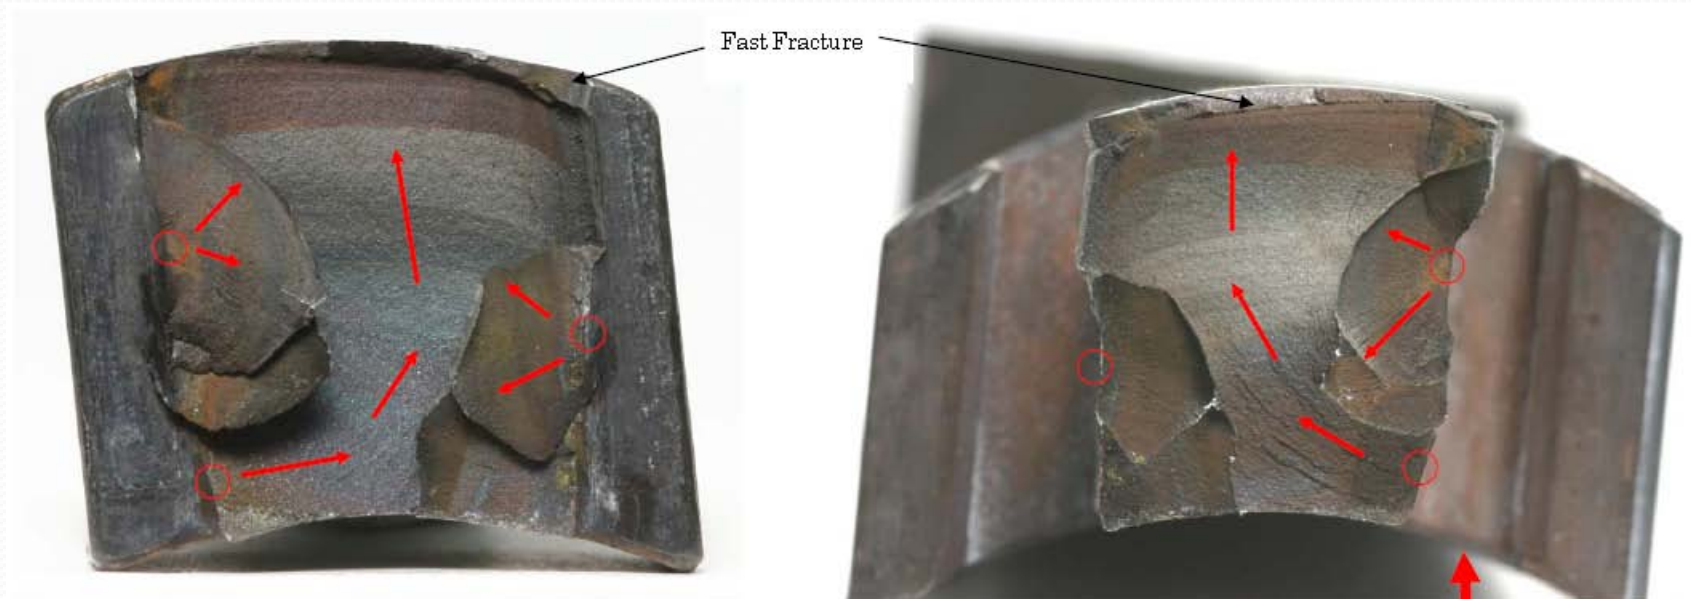
Blade Roots

- Magnetic particle tests were carried out at all 9th stage blade roots and cracks were observed at roots of blade Numbers 24,26,32 and 65.
- Beach mark pattern indicating fatigue fracture is seen in the fracture surfaces.

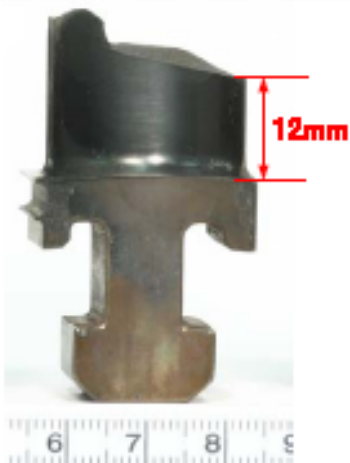
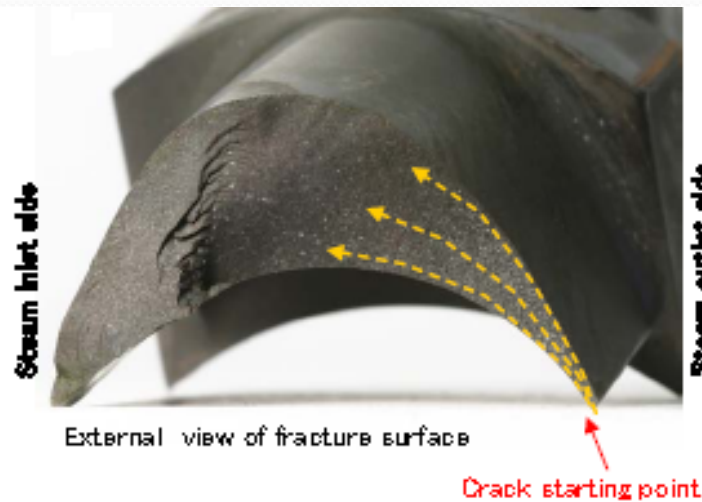
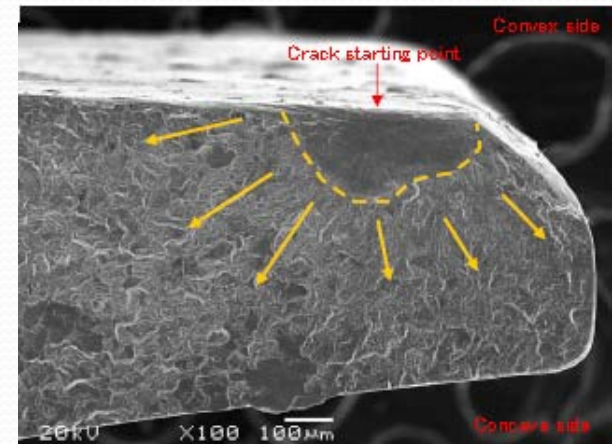
Profiles

- Sub surface cracks and corrosion pits are seen on tenons
- Fatigue crack initiated in the tenons at corrosion pits.
- Striation patterns of fatigue crack characteristic are observed at propagated area.

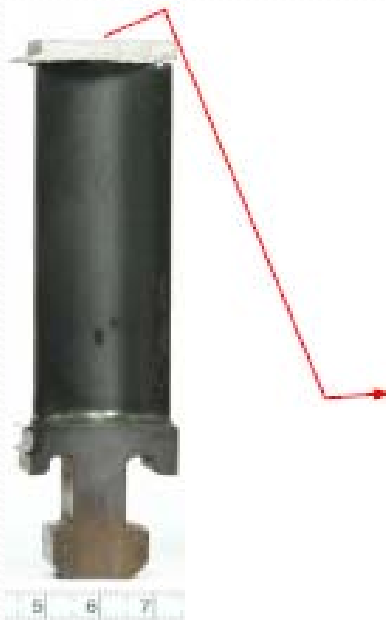
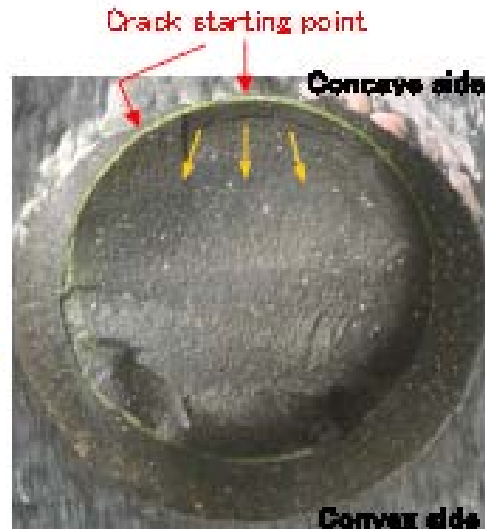
Tenons

- Sub surface cracks and corrosion pits are seen on tenons
- Fatigue crack initiated in the tenons at corrosion pits.
- Striation patterns of fatigue crack characteristic are observed at propagated area.

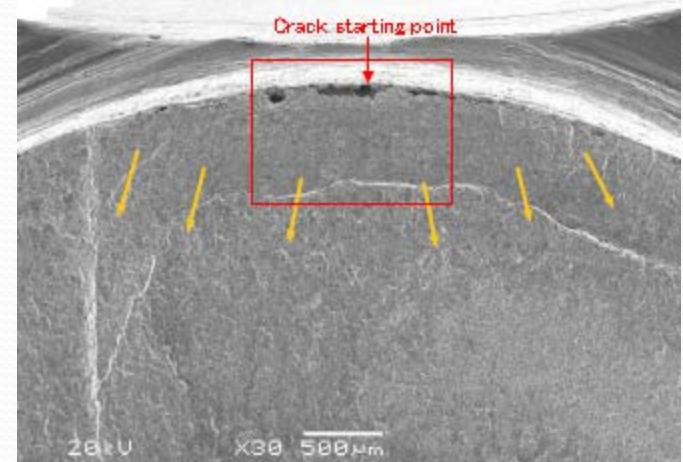
External view of fracture surface

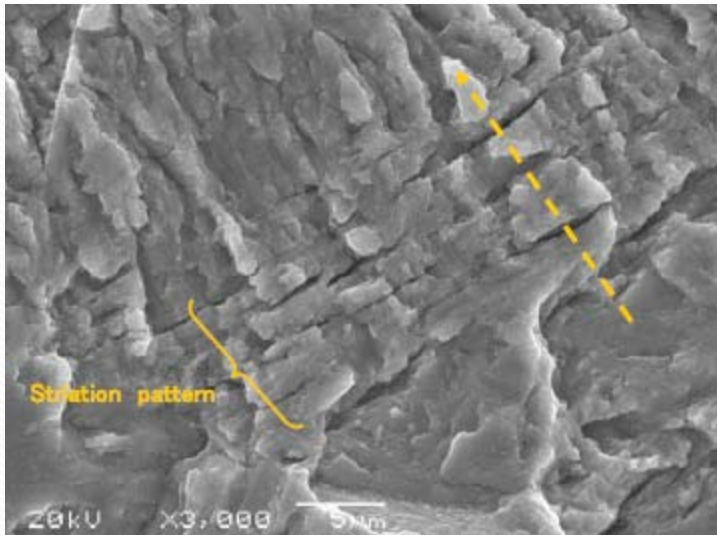
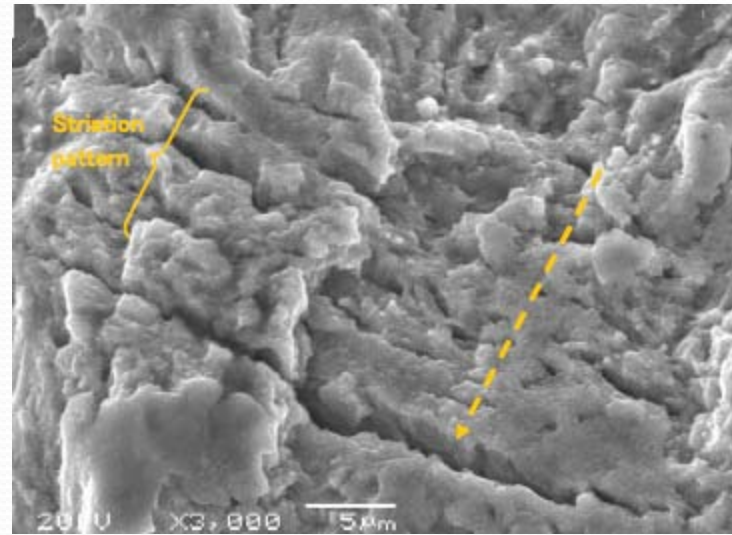
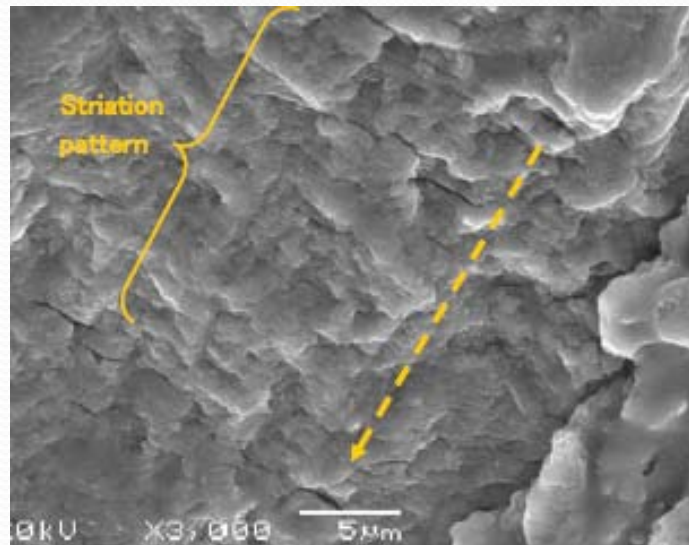
Striations associated with fatigue failure

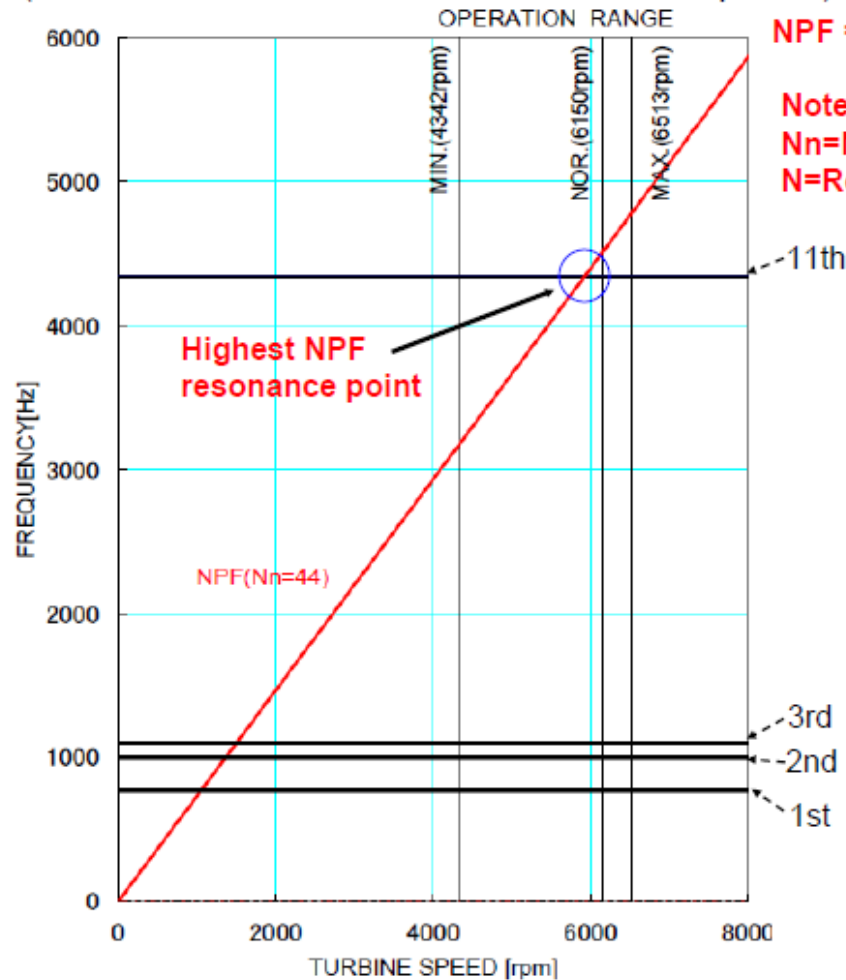
Campbell diagram

- The blade pack and rotor disk were modelled to evaluate Natural frequency of blades.
- 11th mode of blade natural frequency has the highest resonance among all modes
- 11th mode of blade natural frequency (4334Hz) is in resonance with Nozzle pass frequency in the Operating range. (See Campbell Diagram)
- Highest resonant stresses at tenon 2.5 kgf/mm², profile 0.33 kgf/mm² and blade root 3.2 kgf/mm².
- Above resonant stresses are within design limit, but close to their boundaries.
- Corrosive environment lowered the fatigue limit of the material, causing the stresses to exceed the limits.

(NPF Resonance check of blade natural frequency)

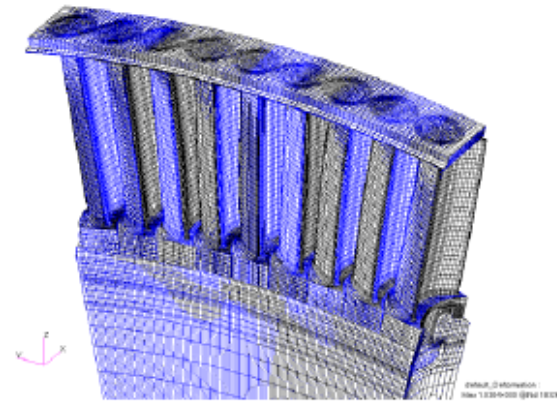
11th blade natural frequency mode (4334Hz)

Resonance check of 9th stage blade by 3-D model analysis

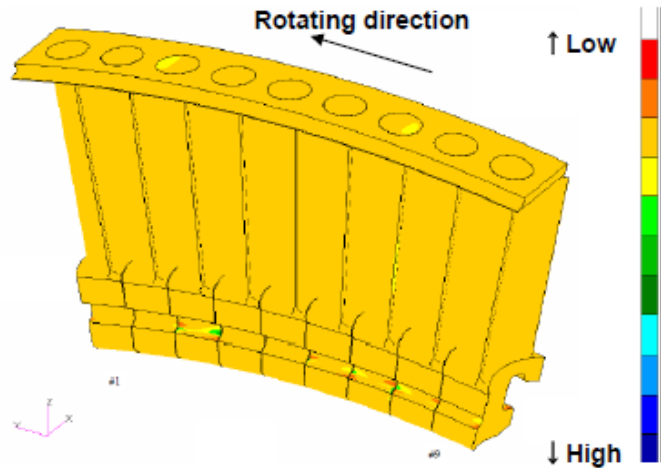
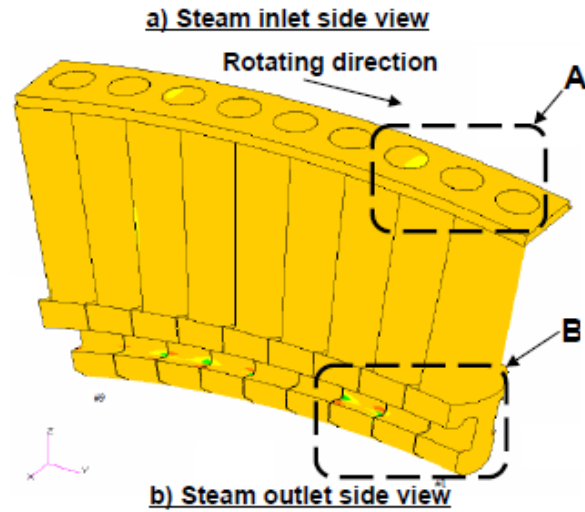
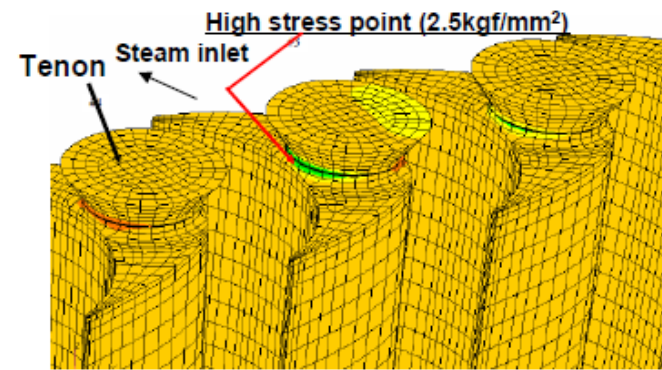
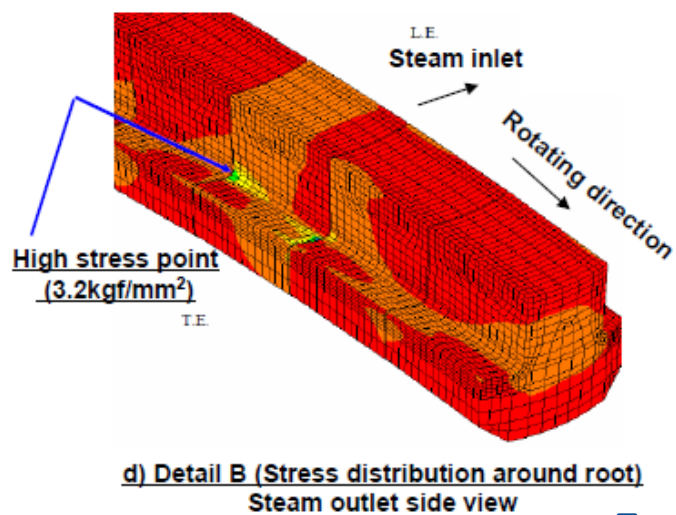
NPF resonant stress distribution of 11th mode

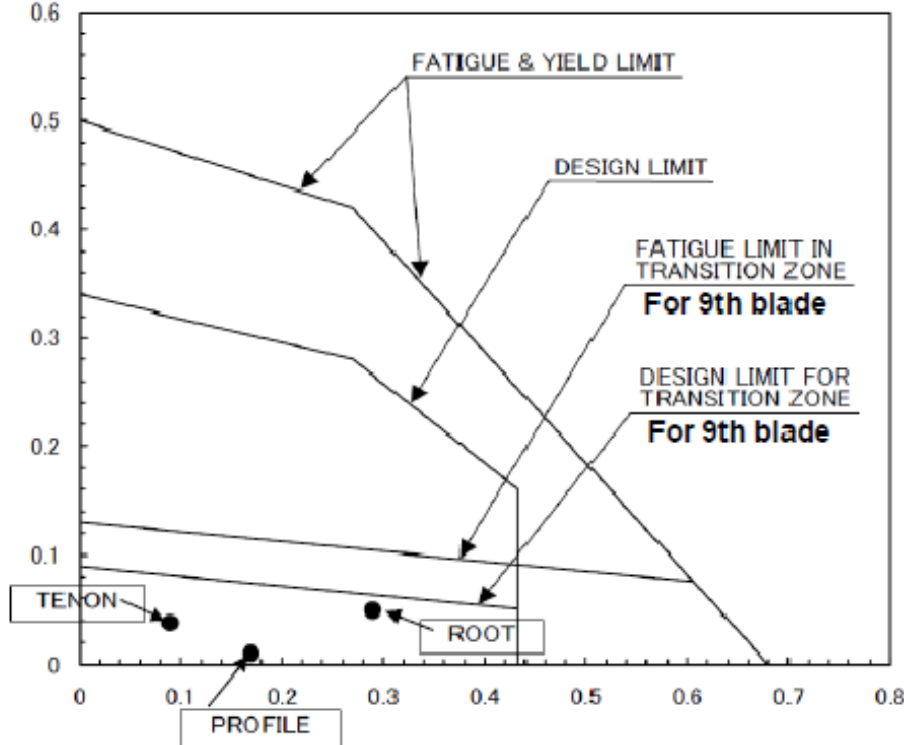
Goodman diagram on 9th stage blade

Highest resonant stress level
→ Within design limit

- Corrosion and pitting caused by presence of Chlorides .
- Higher stress due to existence of blade resonance at its 11th mode of natural frequency, excited by Nozzle Pass frequency in the operating range.
