HIGH FLOW PROTECTION FOR VARIABLE SPEED PUMPS

This paper presents detailed analysis of major failures that occurred in three 27,000 HP variable speed water injection pumps in which high flow operation was a major contributor to the failures. It includes the evaluation of the impeller hydraulics and material in addition to impeller modal analysis.

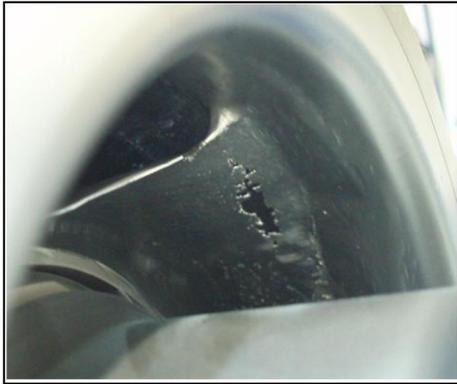
- Cavitation damage on the vanes back side (pressure side) of all the second stage impellers and some of the third stage impellers as shown in figure 1. It should be highlighted that no cavitation damage was found on the first stage which is a double suction impeller.
- Cracks on some of the second and third stage impellers vane inlets and vane outlets and breakage of some of the second stage impellers vane inlets as shown in figures 2, 3 and 4.
- Cracks on some of the second stage impeller shrouds and breakage of some of the impeller shrouds as shown in figures 5 and 6.

Figure 1: G-3001 2nd stage impeller cavitation

As the NPSHA for the second stage is a result of summing the pump NPSHA and the first stage differential pressure, the high flow operation of these pumps while running the pumps at lower speeds than rated caused a significant reduction in the NPSHA for the second stage. This reduction is mainly due to the decrease in the pump NPSHA as the flow increases, in addition to the reduction of the first stage differential head due to high flow and low speed operation which also cause an increase in the NPSHR. To illustrate the last point, the NPSHR requirement for G-2001 new rotor actual operating condition, which was running at 14,400 GPM and 87% of rated speed, was added in figure 11. As can be seen in this figure, for any high flow operation above 11,500 GPM, the NPSHR requirement for the 87% rated speed curve is higher than that for rated speed. For G-2001 actual operating condition, the NPSHR requirement is much higher than 700 FT. This reduction in NPSHA and increase in NPSHR is believed to be the reason for the observed cavitation damage on the second stage impellers for all the four failed rotors.

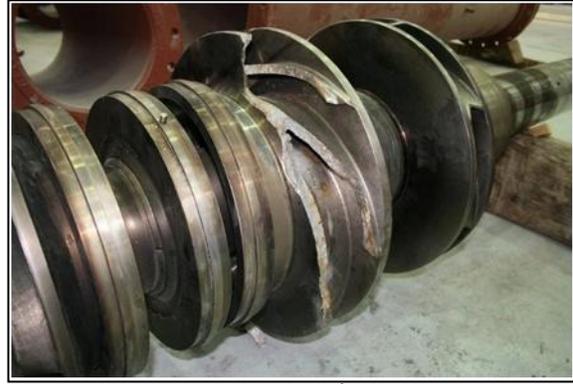
Figure 5: G-2001 new rotor 2nd stage shroud breakage

- The impeller material was upgraded from duplex to super duplex stainless steel (ASTM A 890 Grade 5A), which has higher fatigue and corrosion resistance than the original duplex stainless steel material.
- Implemented better control on the new impellers casting and casting repair quality.

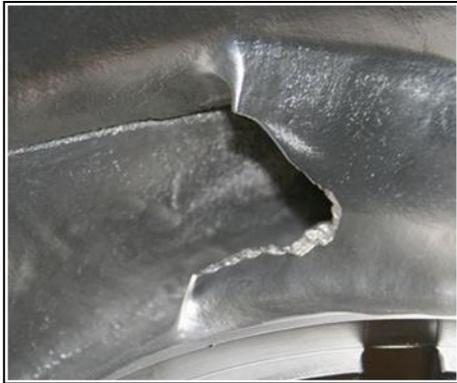
Figure 2: G-2001 old rotor 2nd stage vane inlet

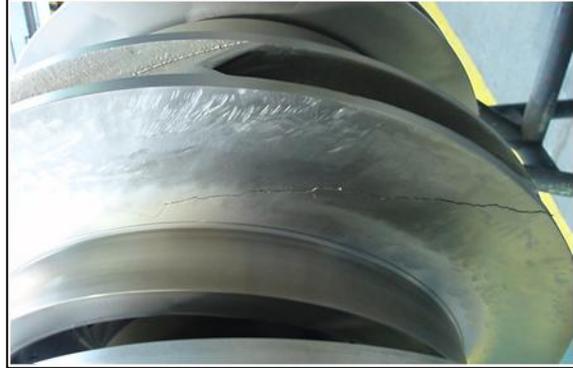
Figure 6: G-3001 2nd stage shroud crack

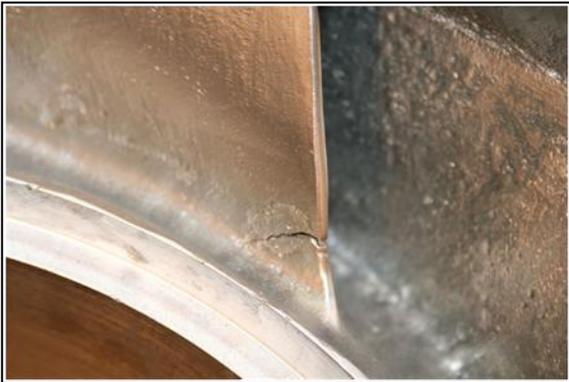
Figure 3: G-2001 old rotor 3rd stage vane inlet

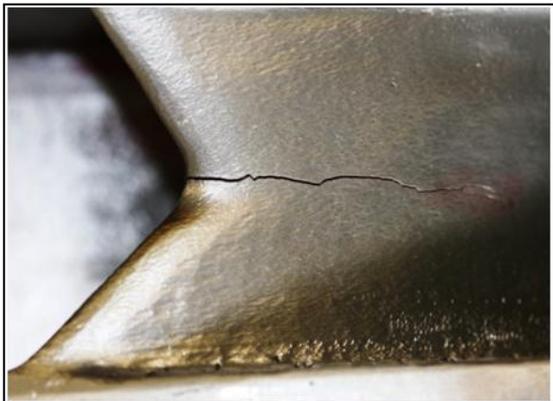
Figure 4: G-1001 2nd stage vane outlet

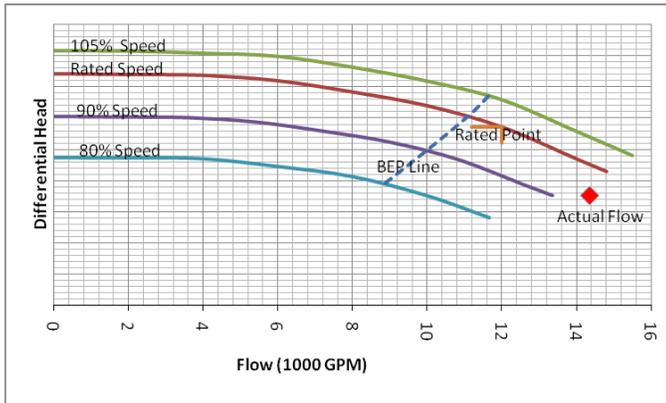
Figure 7: Operating Condition for G-2001 New Rotor

To illustrate the above point, let's take a look at the operating parameters for G-2001 new rotor shown in figure 7. The pump was designed to have a normal flow of 12,000 GPM at rated speed and to be capable of achieving 15,000 GPM by increasing its speed to 105%. The actual time averaged flow for this pump was 14350 GPM, which was achieved while operating at 87% of rated speed. Due to the low process back pressure, the pump was able to achieve high flow than rated while operating at lower than the rated speed. This actual flow is approximately 148% of the BEP flow which falls outside the allowable operating region for this pump at that reduced speed.

The pump allowable operating region is typically limited to a maximum of 120% of BEP flow. Operating at higher flow rates than this limit, such as in this case, is not recommended since it will reduce the life of the pump significantly in addition to the deterioration of the pump performance. The high flow operation for these pumps is believed to be the main contributing factor to the four failures. This conclusion is supported by the operating data, which showed that shorter life and higher damage was found on the pumps that were operated for longer portion of their life at high flow rates.

- A monitoring system was added to the Distributed Control System (DCS) to show the pump operator whether the pump is operating within or outside its allowable operating range at the running speed.

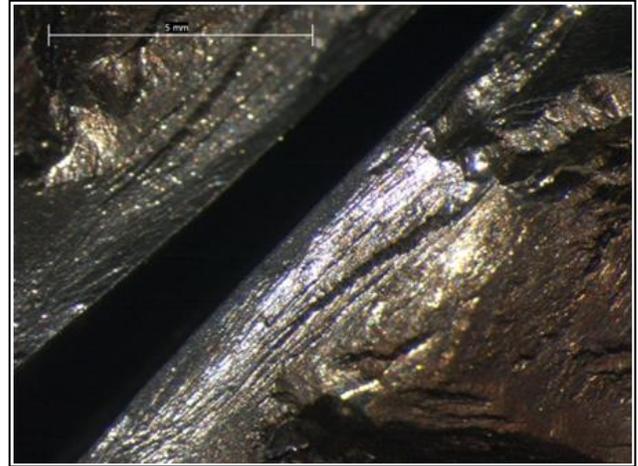
The material failure analysis was conducted on the two rotors that were used in G-2001. The first rotor lasted for 623 days of operation while the second rotor lasted for only 97 days. The analysis showed that many of the impeller cracks were caused by a combination of stress corrosion and fatigue cracking (see figure 8), which are believed to be influenced by high dynamic loading. It also showed some impeller casting and machining defects such as casting weld repairs and

reduction of vane wall thickness by grinding. These deficiencies have contributed to these failures.

Figure 8: Beach marks on the fracture surface indicative of fatigue

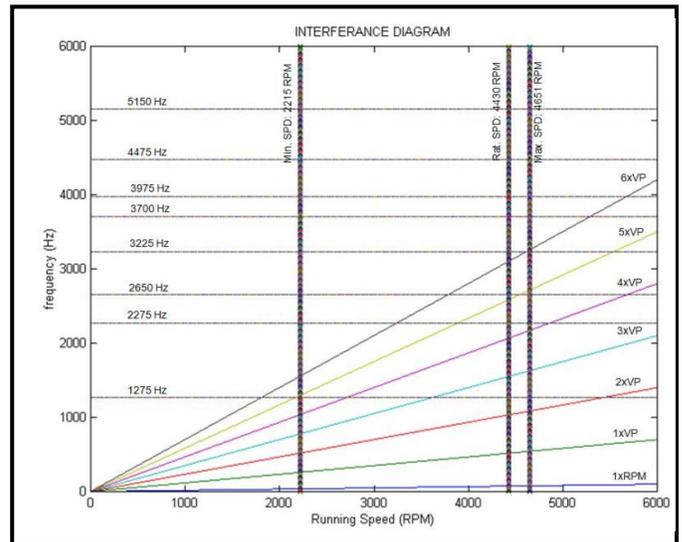
Figure 9: 2nd and 3rd Stage Impeller Interference Diagram

The interference diagram shows that there are many possible high frequency excitations that can meet the impeller natural frequencies due to the wide pump operating speeds. The diagram shows that the nearest excitation mode is much higher than the vane pass frequency. Although there are possible excitations at some of the natural frequencies, these frequencies are considered very high, which reduces the possibility for their contribution to the second stage impeller failures.

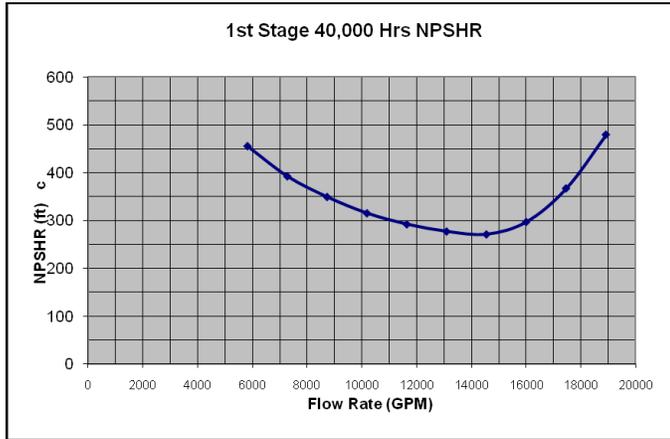
Figure 10: Predicted First Stage Impeller 40,000 Hours NPSHR Curves

When looking at figure-10 and figure-11, it becomes clear why the high flow operation caused the cavitation damage on the second stage and not at the first stage. As was stated previously, the subject pumps were operated at high flow rates exceeding their 12,000 GPM rated flow. Figure-10 shows that the NPSHR for the first stage impeller reduces as the flow exceeds the rated flow until it reaches the shockless entrances capacity which is 14,550 GPM. For the second stage impeller, the shockless entrance capacity (10,570 GPM) is low, which causes exponential increase in the NPSHR as the flow increases above the 12,000 GPM, as shown in figure 11.

If the pumps were operated at their design condition then the first stage impeller will see a Net Positive Suction Head Available (NPSHA) of more than 900 ft while it requires an NPSHR of approximately 270 ft. Even at higher flow rates, the NPSHA is higher than the NPSHR. Having a higher NPSHA than NPSHR will help in preventing many cavitation modes. The second stage impeller has an NPSHA of approximately 2400 ft at the rated flow and speed due to the added head by the first stage impeller. During normal operation, the second stage impeller should not have cavitation even if the pump was to operate at 120% of rated design flow rate since the NPSHA significantly exceeds the NPSHR.

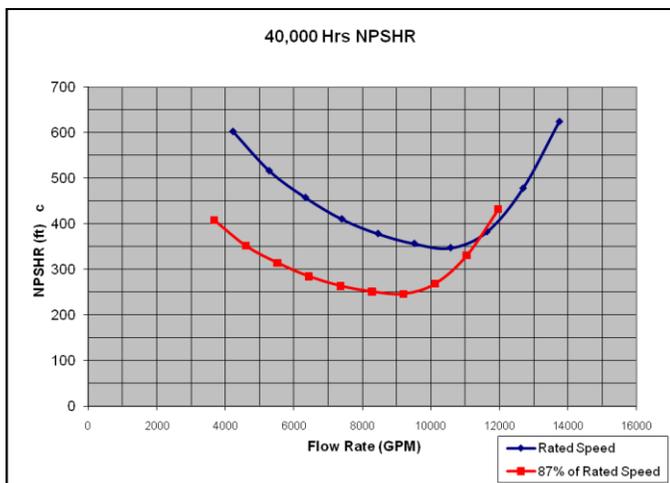
Figure 11: Predicted Second Stage Impeller 40,000 Hours
