Pitting Corrosion on Fr6B Gas Turbine Axial Compressor Blades: Investigation and Preventive Measures

Authors:

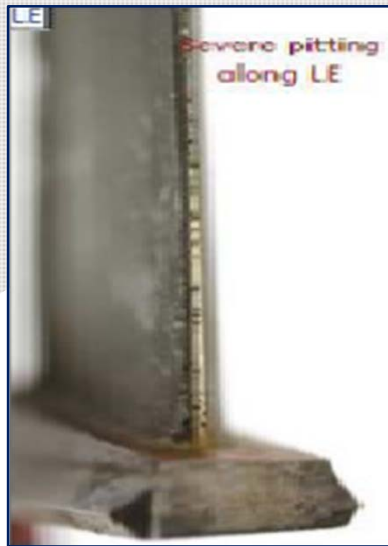
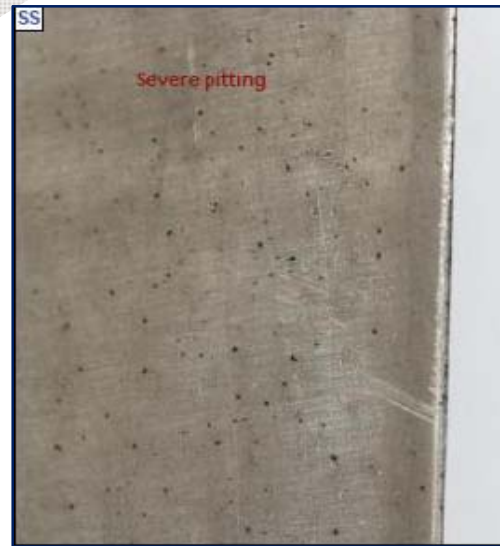
During rotor inspection in MI of Fr6B turbines, mild to severe pitting corrosion observed on axial compressor rotating and stationary blades. The extent of damage was severe on first 4 rows of both stationary and rotating blades .

- Severity of damage was above acceptance criteria.
- Liberation of affected blade during operation can result in catastrophic failure of downstream compressor stages.
- Premature refurbishment of rotors was therefore carried out to ensure reliability of gas turbines.

- Premature replacement of affected rotors was therefore carried out with refurbished ones. Also impaired stationary vanes (S1-S4) were replaced with new ones.
- Thorough checks and cleaning of filter house carried out and filter cartridges replaced.
- Sample rotor blades (R1-R4) and stationary vanes (S1-S4) removed from affected turbines as well as dirty filter cartridges were thoroughly investigated at OEM laboratory to find out root cause of pitting corrosion failure.

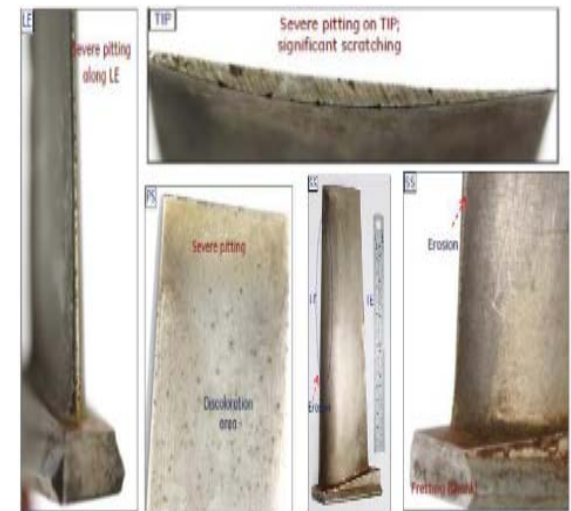
- The stationary vanes and rotating blades were visually inspected.
- The most significant damage observed is related to severe pitting corrosion and erosion – mostly along leading edge (LE) and on pressure side (PS).

Vane	Findings	Blade	Findings
S1	Corrosion pits along LE, TE, TIP, PS, SS; shank fretting; erosion (discoloration) at LE; discoloration close to TIP; dents within 20-60% span TE	R1	Corrosion pits along LE, SS; Erosion (discoloration) of airfoil PS; shank fretting; disassembly dents
S2	Corrosion pits SS, PS, TIP, whole LE; shank fretting; discoloration at TIP; erosion at LE; dents at 30% span TE	R2	Corrosion pits LE, PS (low span); Erosion (discoloration) at LE, SS (low span); shank fretting; disassembly dent
S3	Corrosion pits along LE, PS, SS (low span); erosion at LE; shank fretting	R3	Corrosion pits LE, PS; discoloration at LE SS, airfoil PS; shank fretting; disassembly dents
S4	Corrosion pits along LE, PS (upper span), SS; erosion (discoloration) at LE; shank fretting	R4	Corrosion pits LE (upper span); discoloration at LE, airfoil PS, SS; disassembly dents

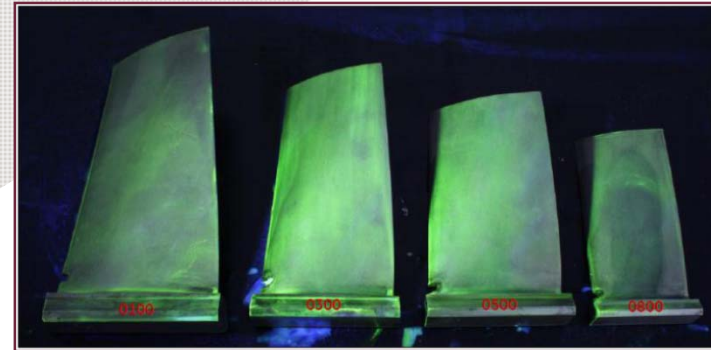
- Magnetic Particle Testing of sample vanes and blades carried out by using wet fluorescent method.
- The test revealed no indication other than corrosion pits on the airfoil surface.

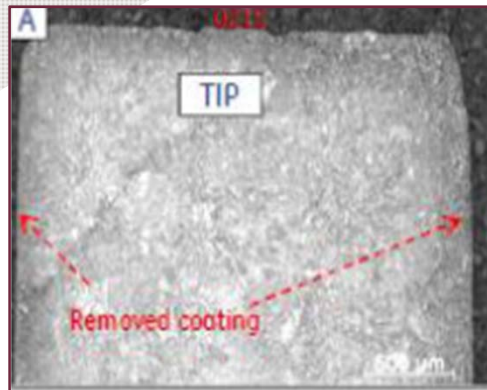
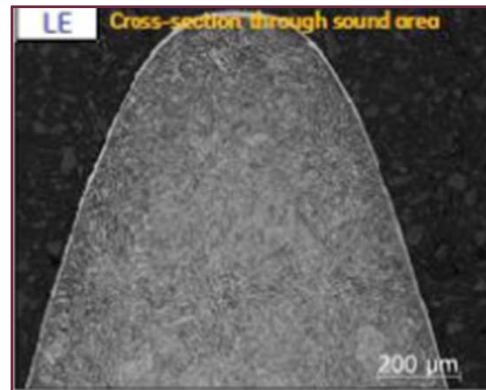
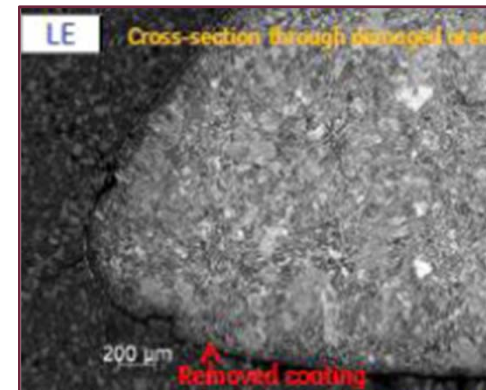
- Ni-Cd diffusion coating is applied on vanes.
- In sound areas, coating thickness was in range of 5-8 μm .
- Coating was found partially or totally removed at LE and close to Tip on all vanes.

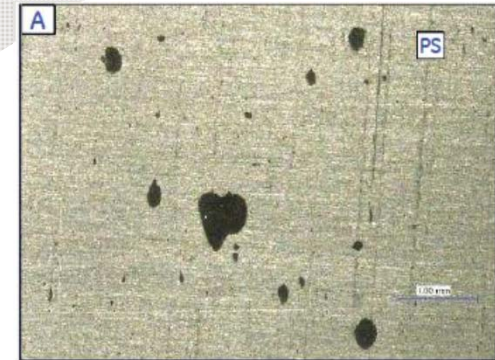
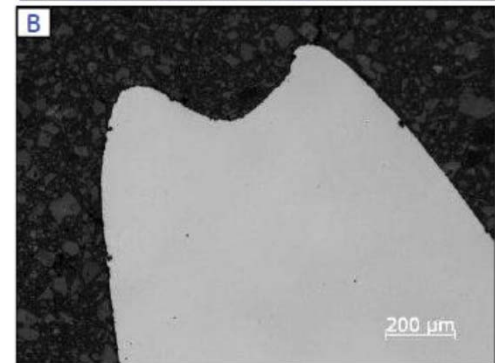
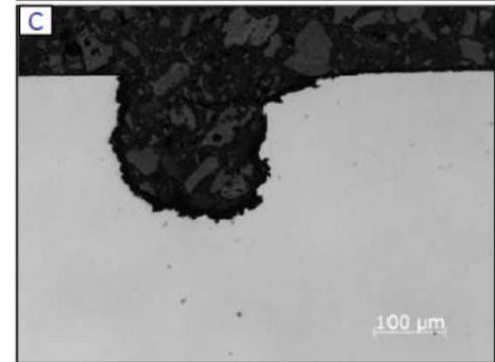
(A) Image used for Analysis
 (B, C) Cross-sections through pits

- Pitting Corrosion was assessed on representative stationary vanes (S1-S4) and Rotating blades (R1-R2)
- Pits were analyzed according to ASTM-G46 for density, size, depth and shape

Sample Vane #	Pitting evaluation				
	Density (pits/mm ²)	Max size (mm ²)	Average size (mm ²)	Max depth (μm)	Shape
S1	2.8	0.29	0.012	300	Elliptical, undercut, subsurface
S2	3.4	0.15	0.004	90	Elliptical, undercut, subsurface
S3	1.6	0.11	0.008	460	Elliptical, undercut, subsurface
S4	2.4	0.04	0.008	260	Elliptical, undercut, subsurface
R1	0.42	0.097	0.014	207	Standard elliptical
R2	0.35	0.23	0.031	524	Standard elliptical
R3	0.26	0.16	0.022	384	Narrow deep elliptical
R4	-	-	-	428	Narrow elliptical

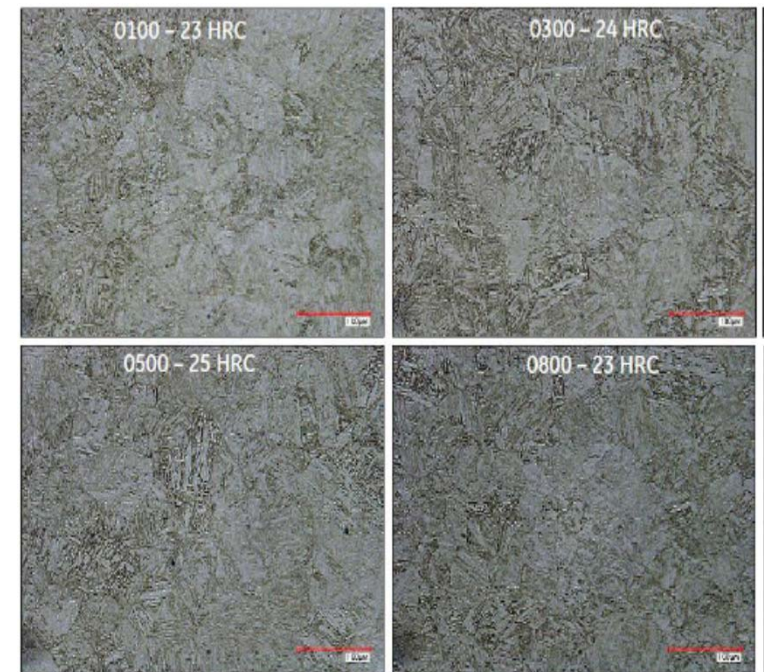
R1-R4 Base material microstructure and hardness

- Base material verification performed on representative vanes and blades (original material: Martensitic SS type 403Cb)
- Microstructure was uniform throughout cross section of blades and in line with martensitic stainless steel of specified type (SS403Cb)
- Vanes/blades base material hardness measured and found in accordance with material specification.
- Chemical composition of base material verified and found in adherence to requirement
- No abnormalities observed

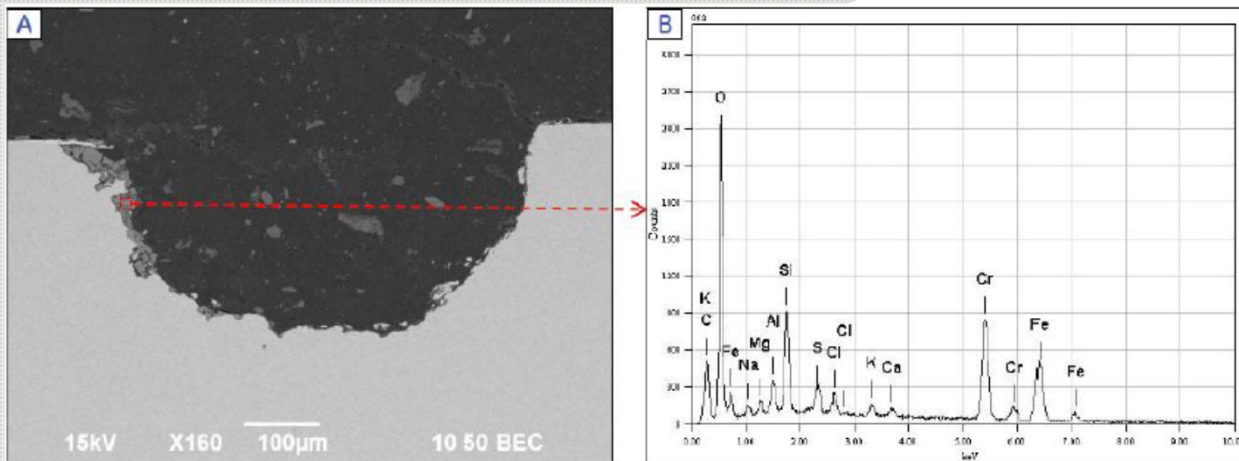
Rotating Blades
(A) Analyzed region within pit
(B) Spectrum of corrosion products

- Corrosion products in the pits were analyzed for both rotating and stationary blades
- Apart from base material elements, presence of chlorine (Cl) and sulfur (S) found. Presence of chlorine and sulfur (especially Cl) is cause of pitting corrosion
- Traces of potassium, sodium and calcium were detected

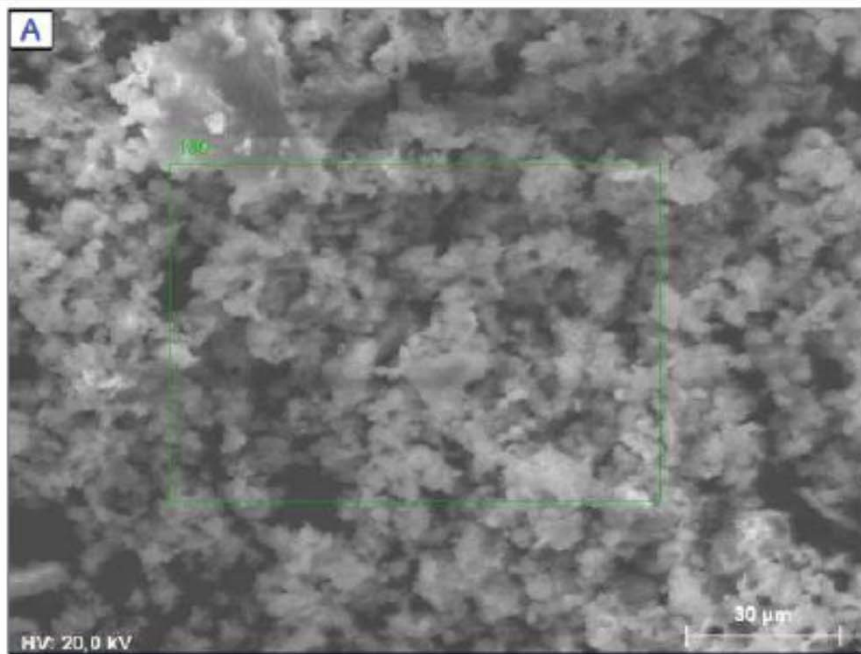
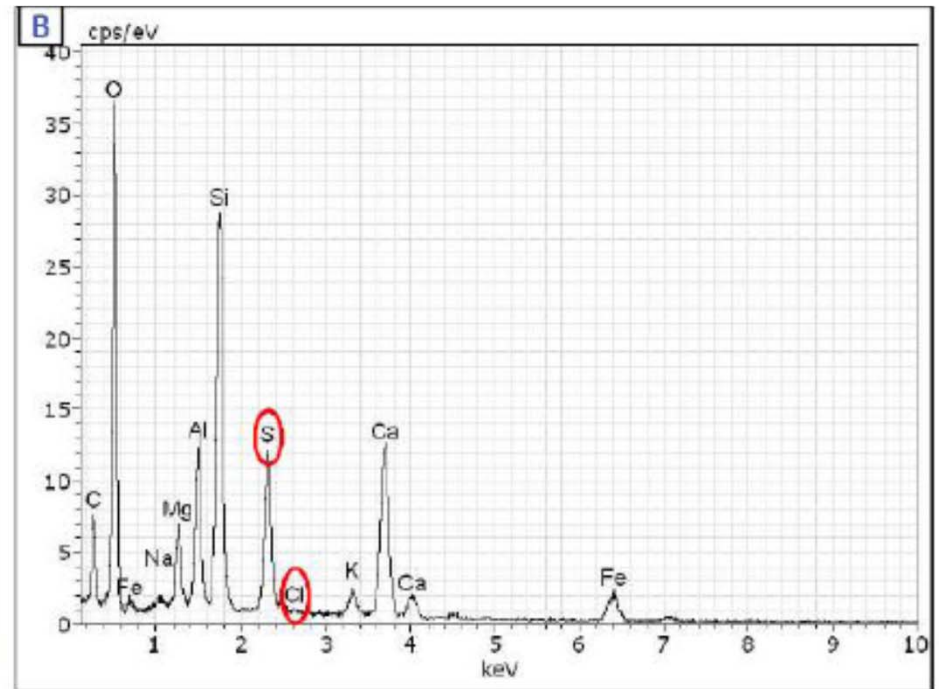
(A) Morphology of examined powder; (B) ED spectrum

- Powder collected from air filter analyzed
- Main elements detected were: Oxygen, Carbon, Potassium, Magnesium, Calcium, Sulfur, Chlorine and Iron
- Sulfur and chlorine are well known as a primary cause of pitting corrosion

- Pitting Corrosion observed on rotating/stationary blades was result of presence of corrosive elements (mainly chlorine and sulfur) in aqueous environment.
- The origin of chlorine and sulfur is from the turbine working environment, as confirmed by the analysis of powder from the filter cartridge.
- Low efficiency of filters and incorrect maintenance strategies are the most probable causes of contamination found on axial compressor blades.
- A contributor to severe pitting corrosion of axial compressor blades can be to the lack of optimal water wash strategy.

- Recommended to replace existing F7 filter cartridges with H12 membrane type (ePTFE) filters.

- Recommended to proceed for modified filter cartridges (F7 to H12) to improve filtration efficiency and prevent ingress of corrosive elements and moisture particles into axial compressor section (H12 filter cartridges are on order).
