# Head-flange O-rings on Barrel Type Centrifugal Compressor Units at RasGas: issues & resolutions

Quraisy Shatri, Rajeshkumar Rajani, Dr. Basel Wakileh (RasGas)  
Leonardo Baldassarre, Andrea Cianti, Alberto Armenzani (GEO&G)

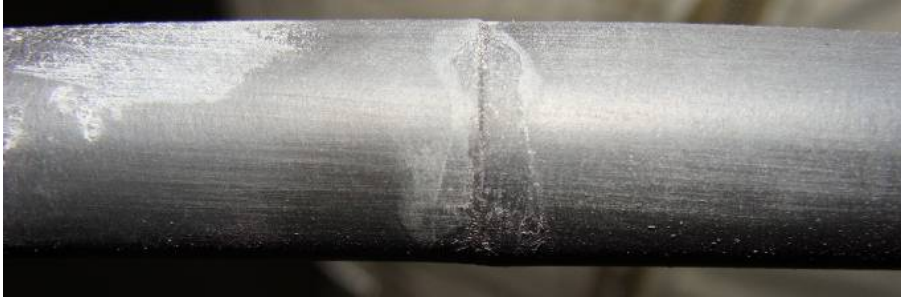
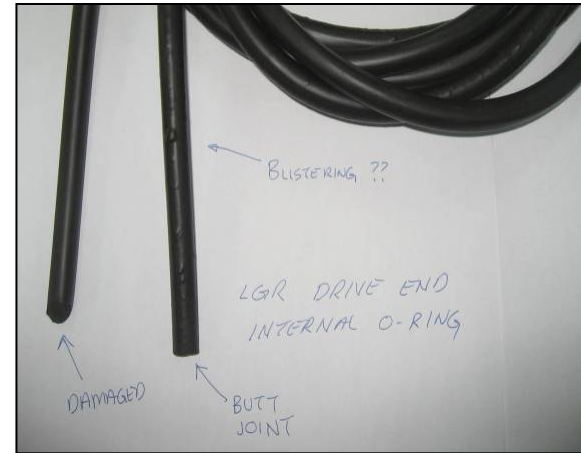
# Failure analyses: spare O-rings condition in warehouse, stored for few years

- Preservation condition acceptable, however, defects (cracks) on joints were visible.
- Spare O-rings presented evidence of cracks without any bending and failed by bending @ the bonded joint.
- No evidence of vulcanization except adhesion.

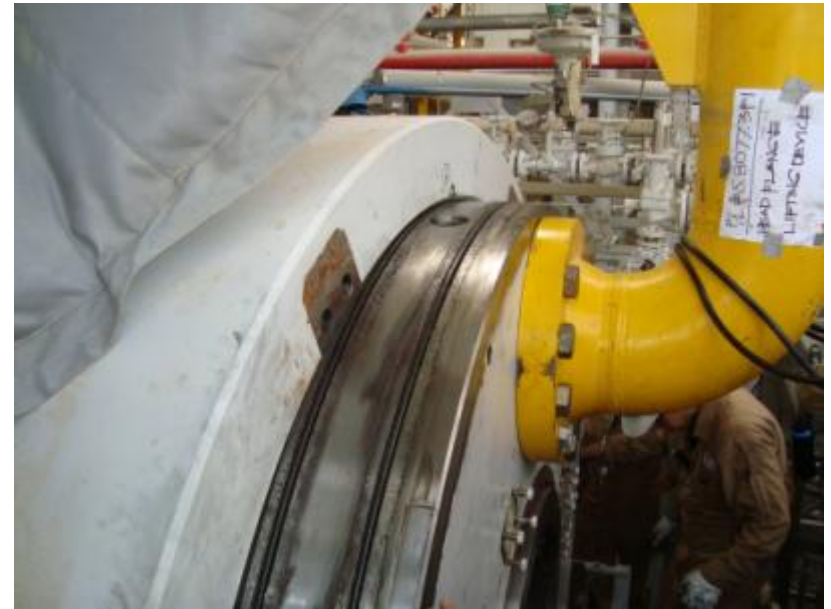
Shop test was at 66.8 bar G / 30-min / with N<sub>2</sub> per API 617. No leaks observed. Spliced O-ring might pass 30-min leak check, but fail once in service at operating temperature (100+C) and pressure pulsations.

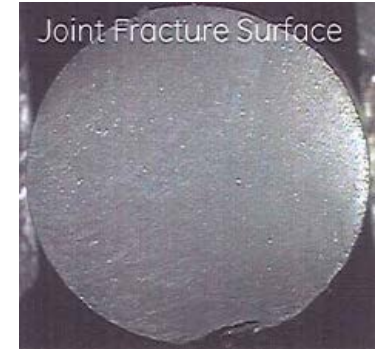
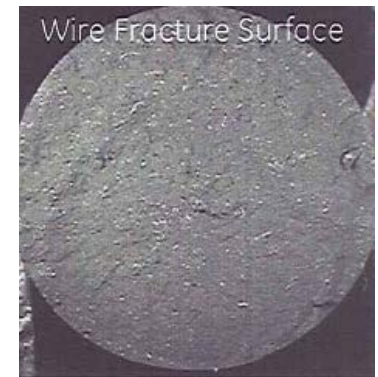
- Joint resistance Test: Rupture at 35 kgf and 55 kgf for NDE side O Rings and that is 18 and 35 % of specified base material strengths.
- Wire Resistance test : failure produced with 120 kgf that is 61 % of expected strength.
- FTIR analysis : Sample spectrum compared with library and material confirmed to be Fluoroelastomer (FKM or Viton).

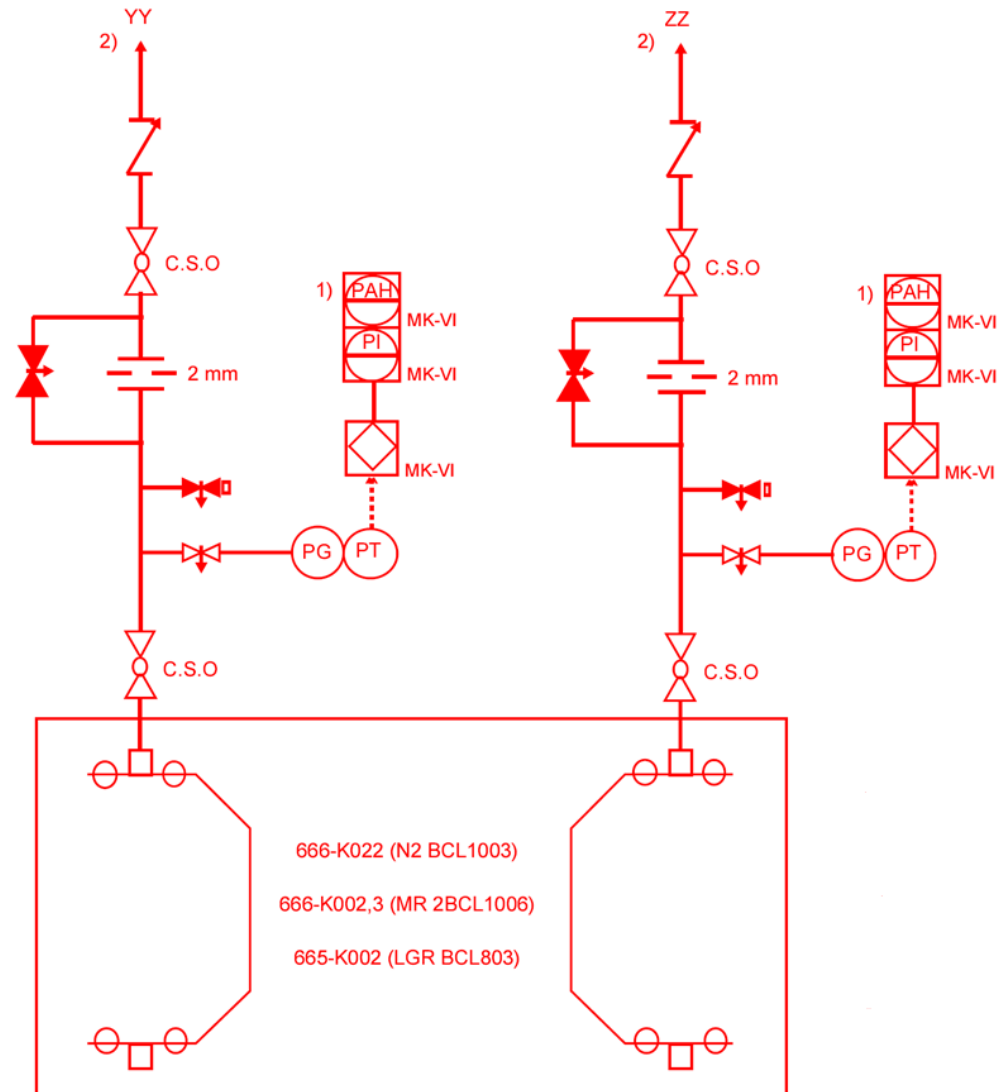
- The gas from the recovery system routed directly to flare line.
- Remote monitoring provided for cavity pressure (space between two O-rings).
