Advancement in Vibration Monitoring Techniques to Identify and Prevent Motor Failures on MOL Pumps at QP Offshore

Isham Sudardjat
Reliability Engineer
QP Offshore Operations

Sankar Ganesh
Lead MDS Engineer
GE-Bently Nevada

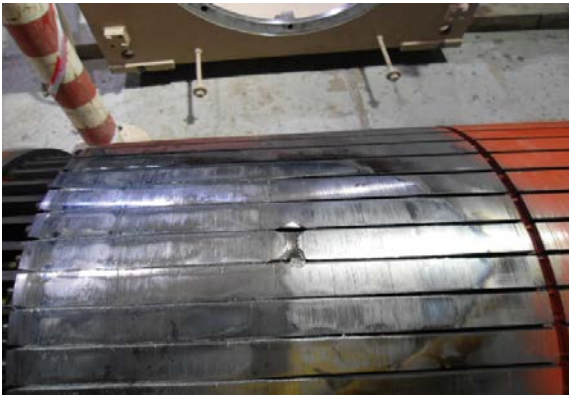
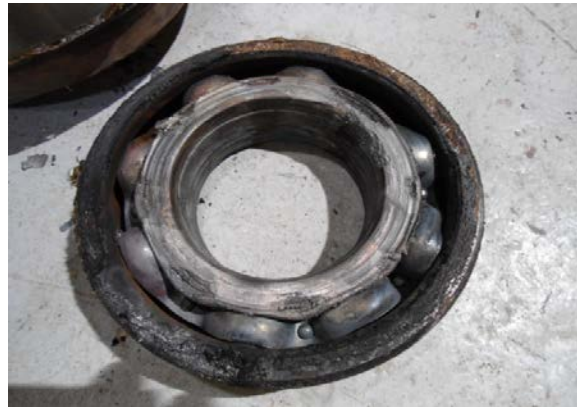
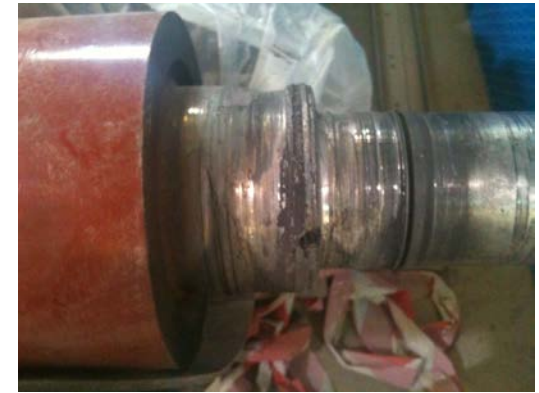
- Qatar Petroleum (QP) Offshore Operations is comprised of two production platforms, PS-2 & PS-3
- Each platform includes three Main Oil Pumps (A, B, and S)
- Main Oil Pumps critical to oil production
- Two motors failed within a span of less than one year.
- Motor X tripped on overload during start. After inspection, failures were found on coupling, Motor DE bearing, motor rotor and stator. No damage to the pump.

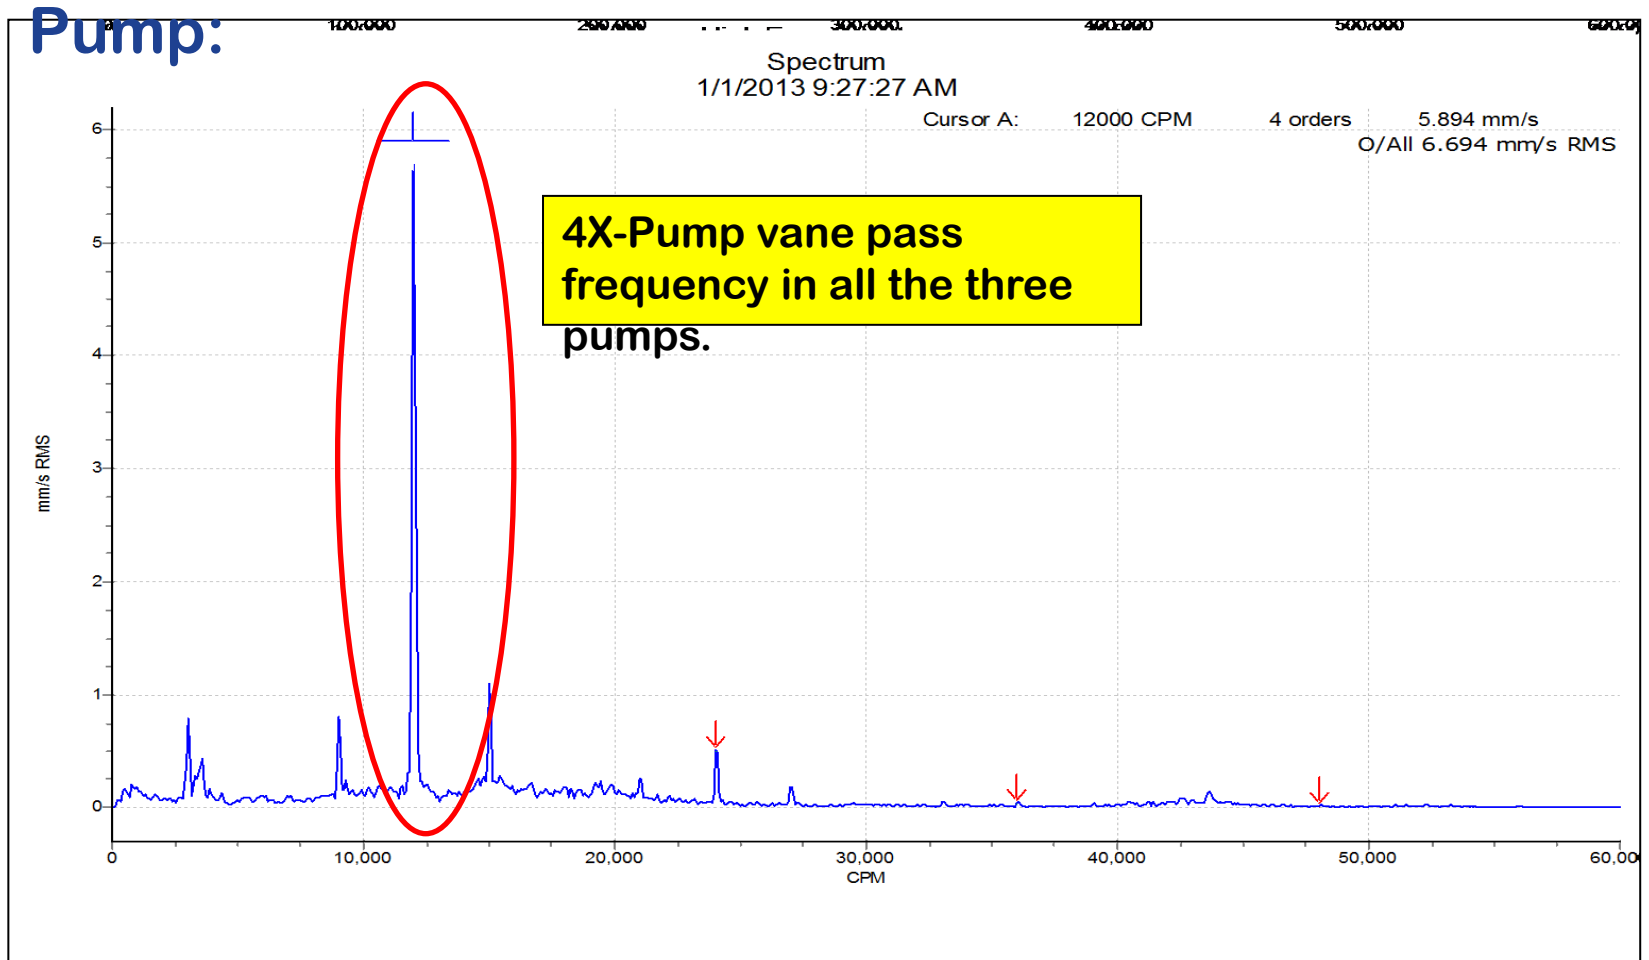
Abnormal Behavior – High amplitude of pump vane pass frequency observed since commissioning, but not damaging.

- Corroded plate replaced and base frame rectified for Pump-S in PS2 – Measurement pending due to pump non availability.
- Correction of rotor centering reduced the vane pass frequency amplitude on pumps at PS-3 platform.
- Motor online condition monitoring technologies being explored.
- Vibration Monitoring program modified to capture and trend the Motor Rotor Bar Pass Frequency.
- Coupling replacement for pump-A & S in PS3 reduced the startup vibration significantly.

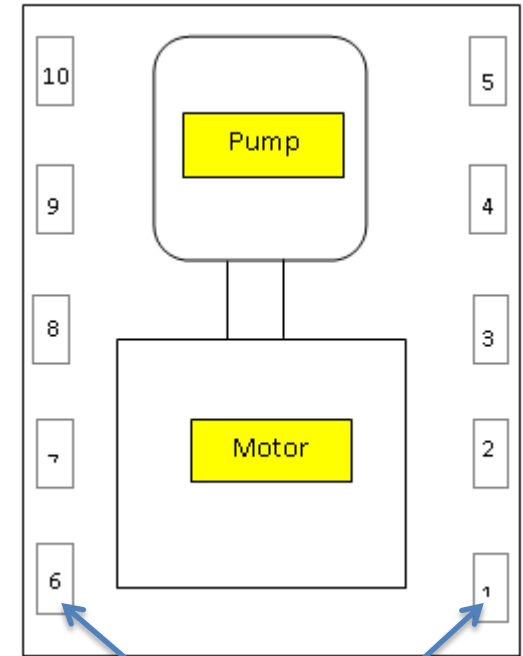
Pads

Abnormal Behavior:
Base frame vibration out of phase on PS2 Pump S and PS3 Pump B.

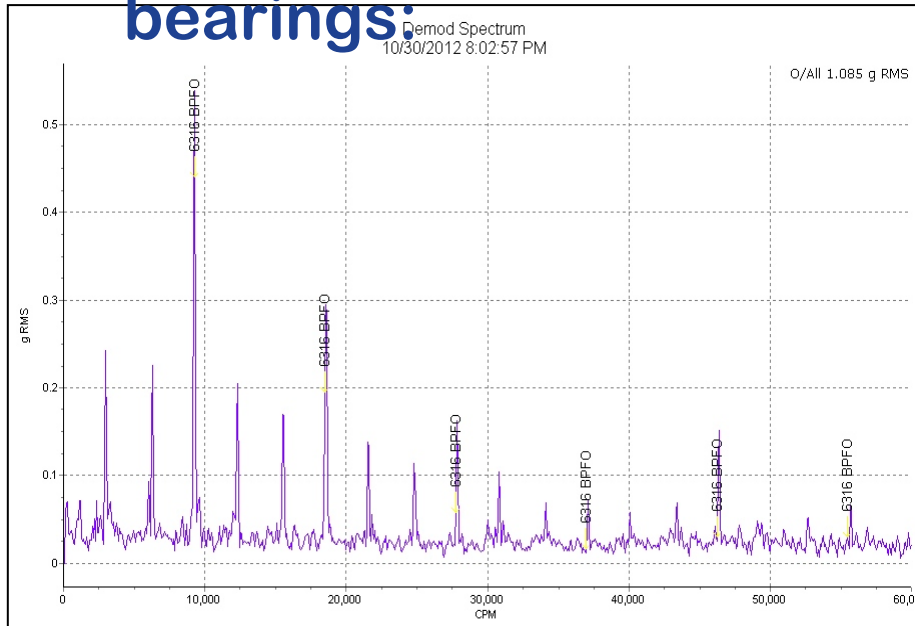
PS 2 Pump - S

- ✓ Bearing defect frequencies observed on two motors even though overall amplitudes were well within limits.
- ✓ Coincidentally, these two motors' base frames showed out-of phase behavior.

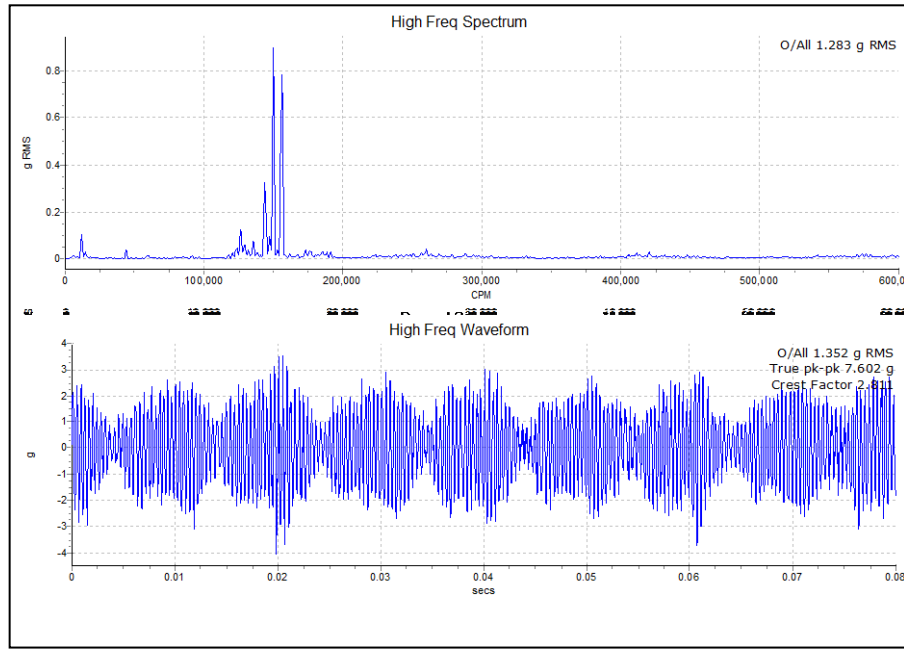
PS 2 Pump - S

- ✓ High frequency peak at 50X with 2 times line-frequency side bands, attributed to rotor bar pass frequency
- ✓ Suspected to be inherent since commissioning
- ✓ Found on all motors.

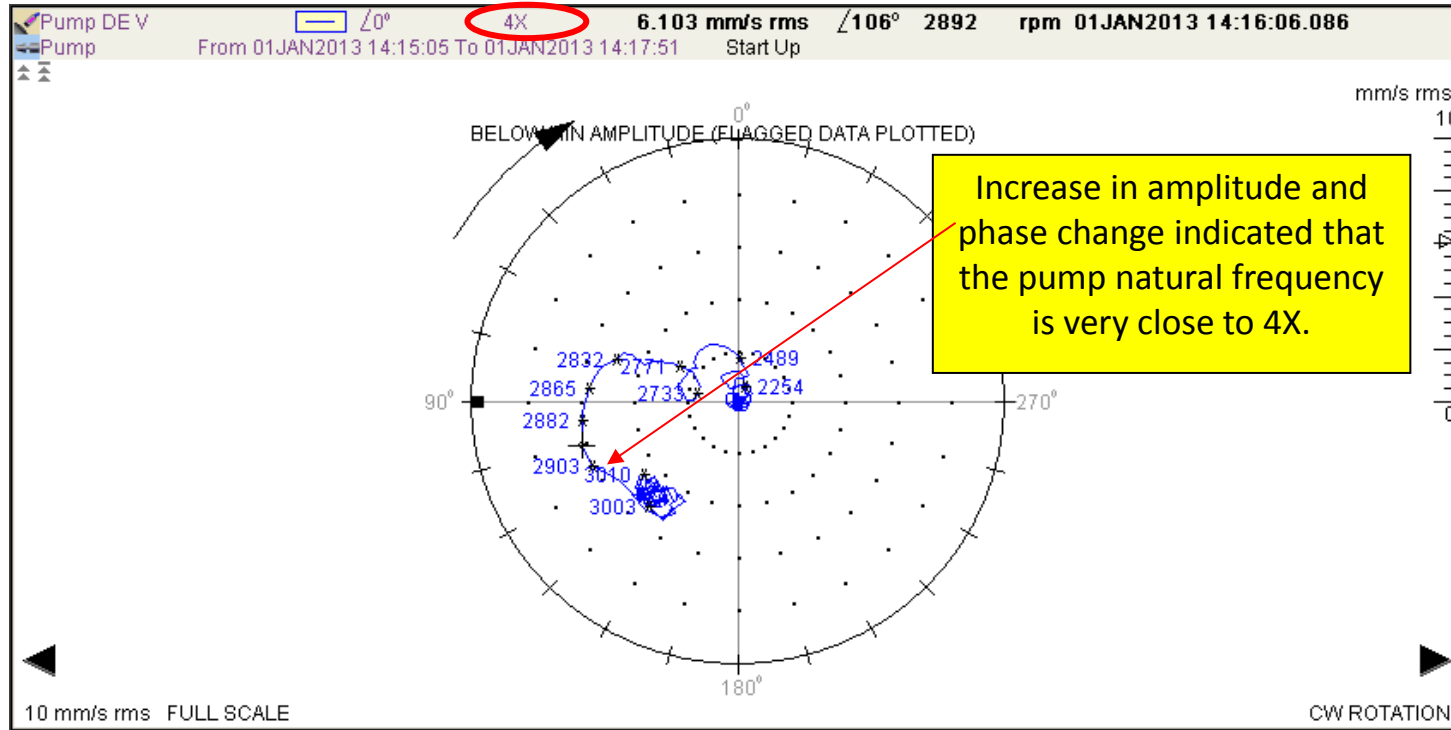
- 4X variable (vane pass frequency) spectral bands configured for all pumps.
- Coast down test conducted on pumps.
- 4X polar plot clearly indicated second natural frequency very close to the 12000 cpm.

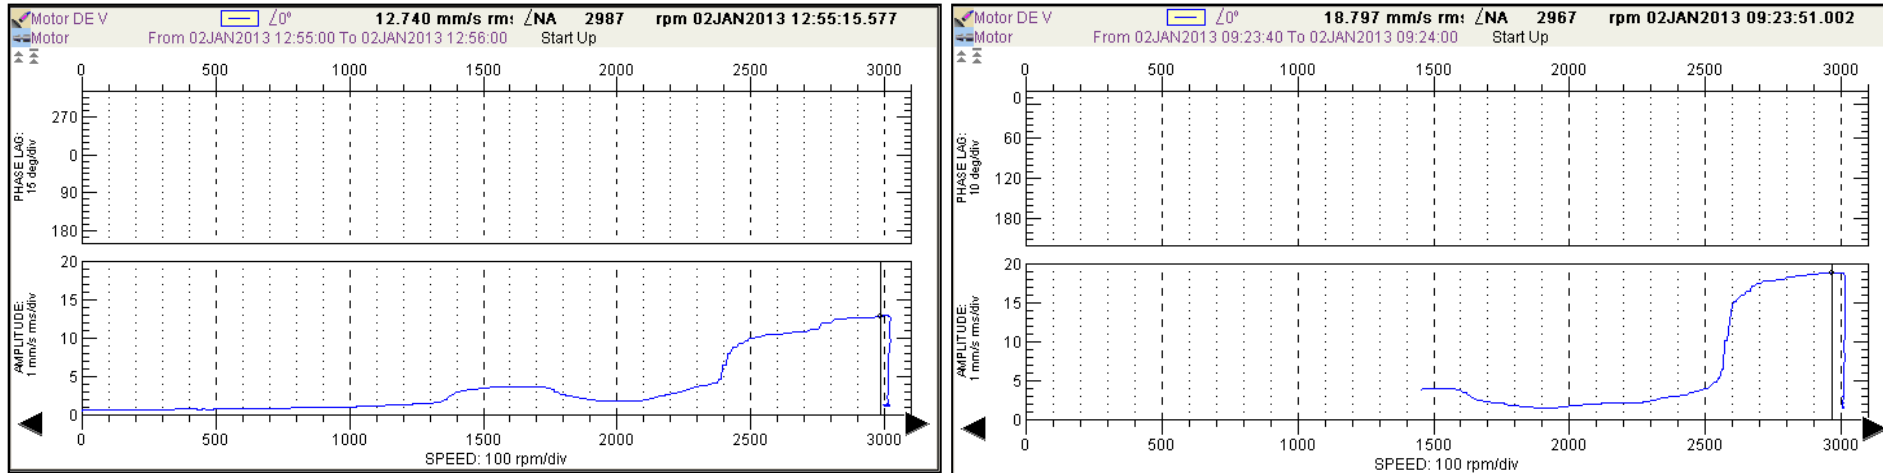
**Note: Phase data is not plotted since the high amplitude of overall vibration was due to sub synchronous component at 6Hz (not 1X).*

- 4 Velomiters on base locations 1,4 & 9 – Vertical direction
- 1 Velomitor on both Motor DE V and Pump DE V locations.
- High vibration (18 mm/s) was observed on Motor DE

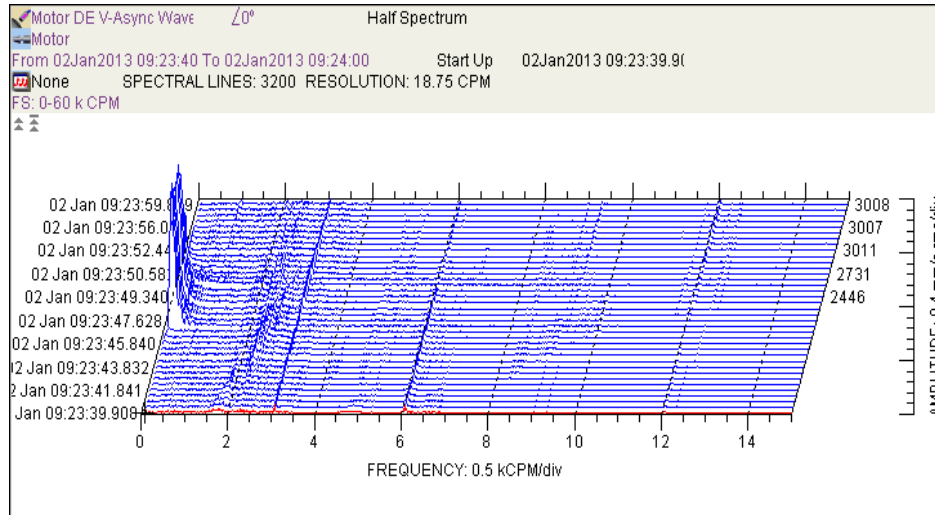
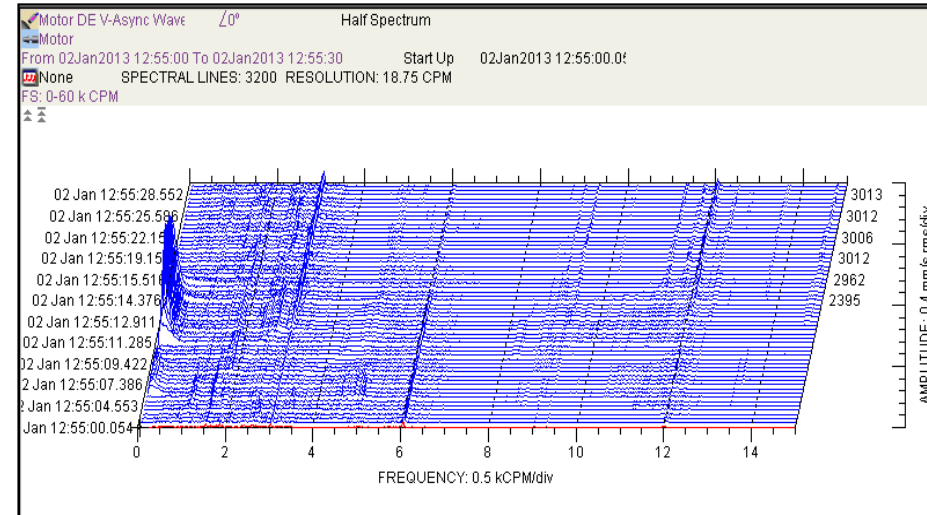
- Startup spectrum waterfall indicated very low frequency components, close to 6Hz.
- Low frequency component appear at speed between 2500 to 3000 rpm, disappearing at 3000 rpm.
- Expert Analysts concluded that the low frequency sub-synchronous component was due to torsional vibration from the coupling.

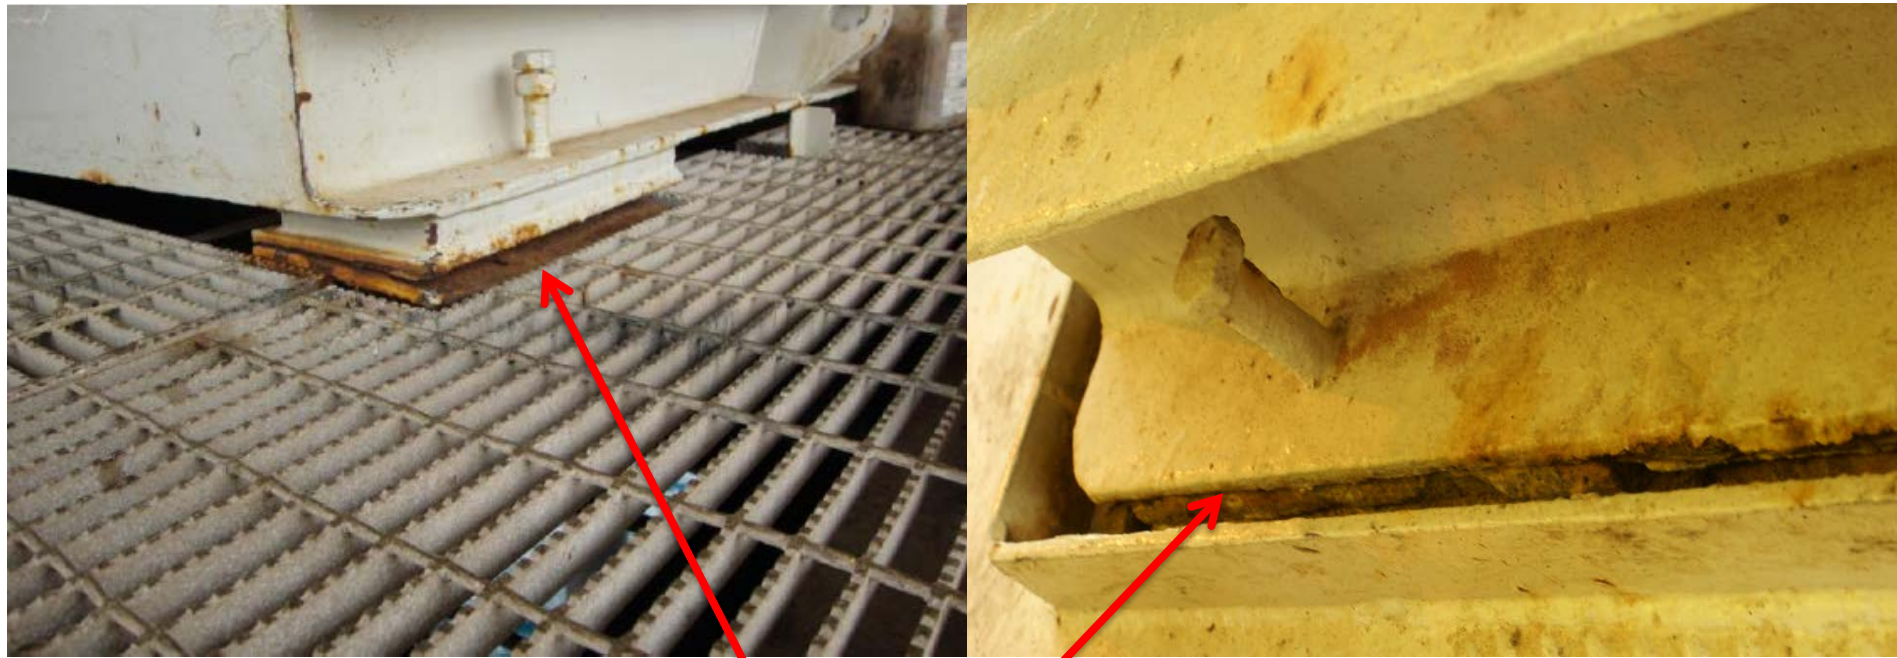
The plates welded between base plate and the structural beam found corroded

- Corroded plate between motor base frame and structural beam
 - ✓ Baseplate looseness caused motor bearing to fail prematurely, damaging the motor internals.
