RIVER RESTORATION OF THE UPPER REACH OF THE SAN MIGUEL RIVER,  
COLORADO: A POST APPRAISAL GEOMORPHOLOGICAL ANALYSIS

A Thesis

JAMES A. S. HOOTSMANS

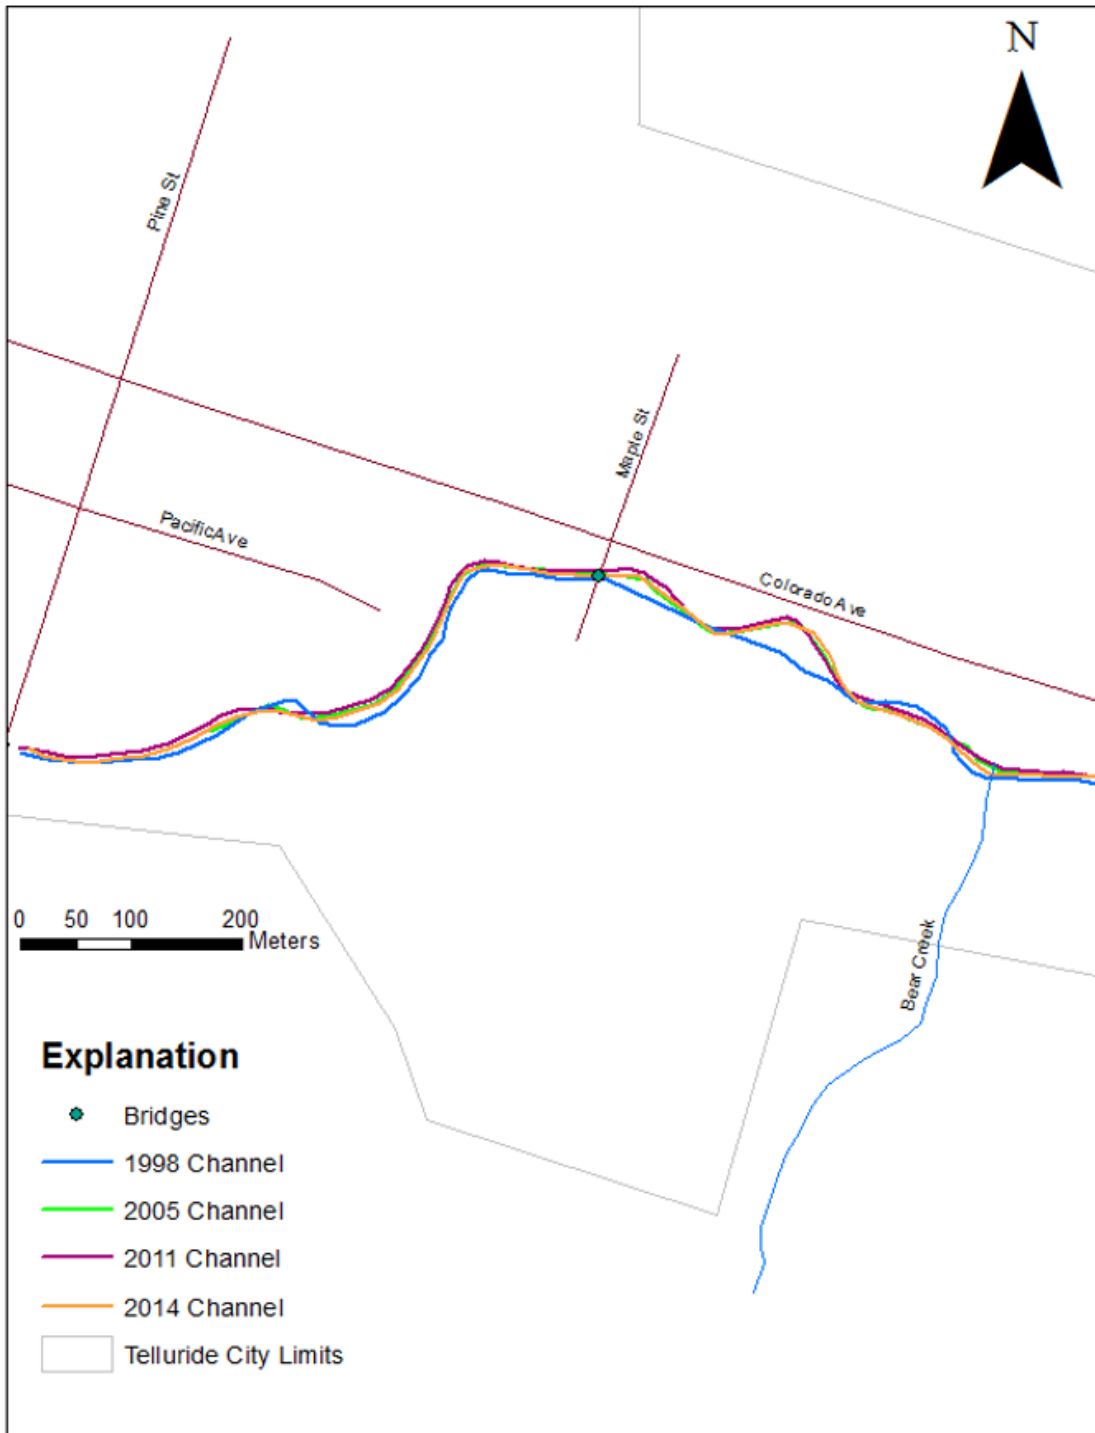
**Figure 15: Thalweg (main channel) movement of the San Miguel River, Telluride, Phase I of restoration. The 1998 channel is pre-restoration, 2005 is 1 year after completion of phase I and II. Movement is minimal between 2005 and 2011.**

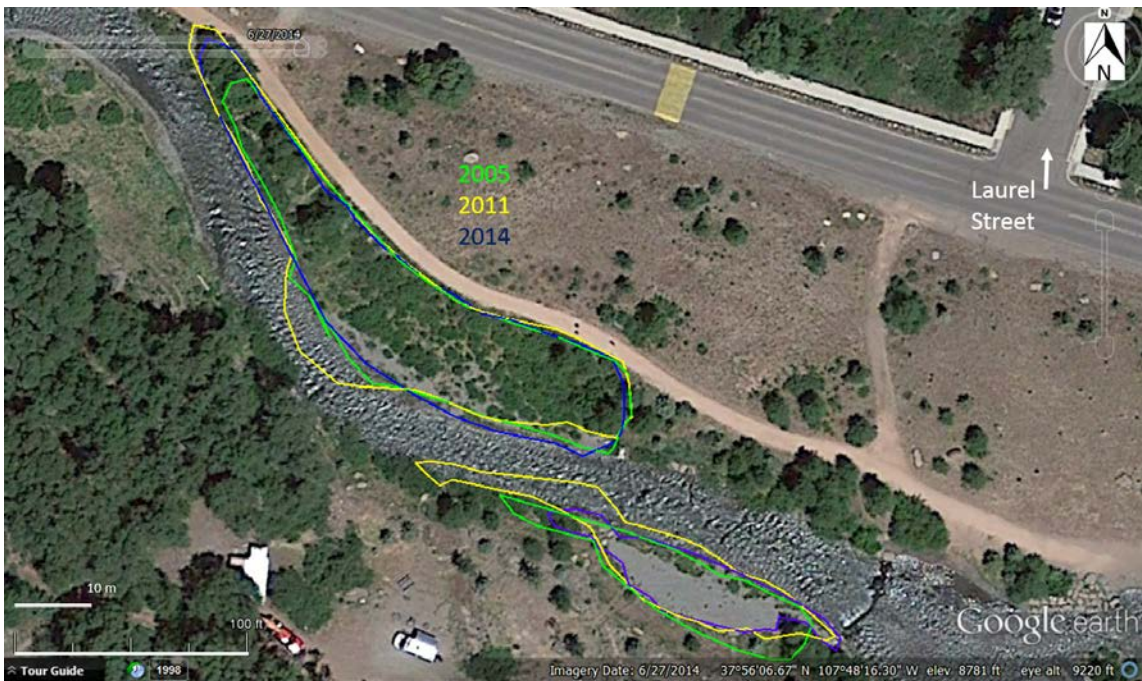
Table 3 highlights increases and decreases in perimeter up to 30% and up to about 50% in area of the various point bars in the 1 km priority reach. These changes in size for point bars in between Laurel Street and Pinion Street, ~ 15 meters upstream of Pacific Avenue Bridge, and just south of Willow Street are displayed in Figures 16, 17, and 18 (Google Earth 2014). The various polygons represent the different years: Green is 2005, Yellow is 2011, and blue is 2014.

**Figure 16: Changes in point bar sizes along the San Miguel River, between Laurel Street and Pinion Street. Point bar outlines from 2005, 2011 and 2014 are shown in green, yellow and blue respectively. Base is Google Earth® Image from 06/27/2014**

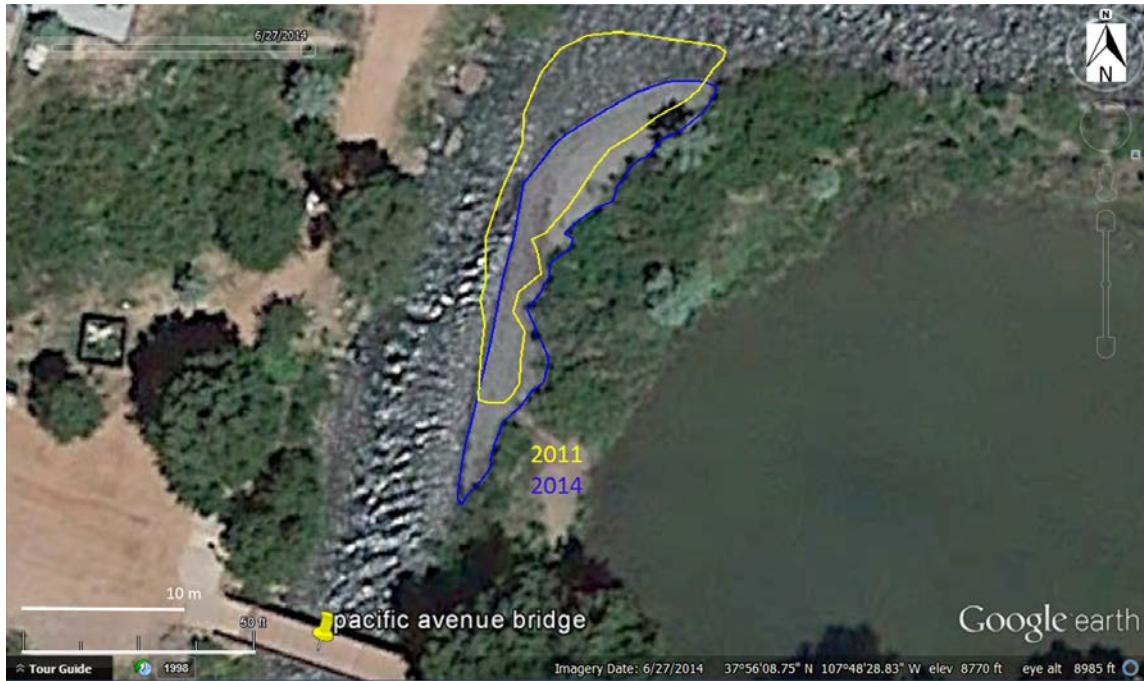
**Figure 17: Changes in point bar sizes along the San Miguel River, upstream of Pacific Avenue Bridge. Point bar outlines from 2011 and 2014 are shown in yellow and blue respectively. Base is Google Earth® Image from 06/27/2014**

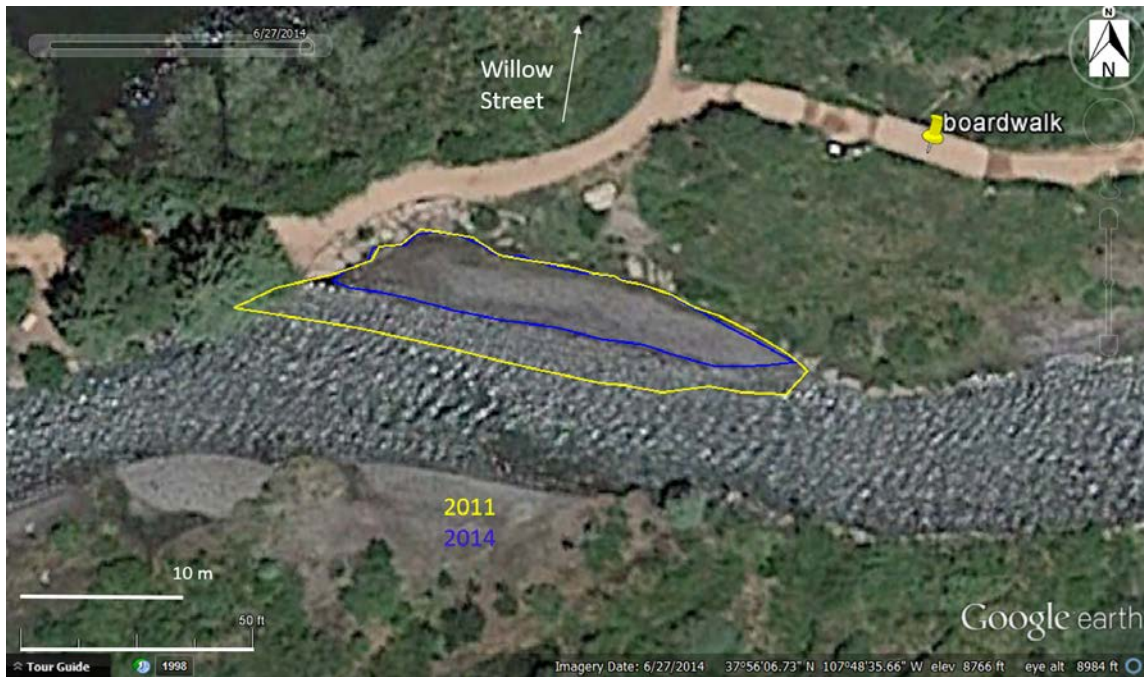
**Figure 18: Changes in point bar sizes along the San Miguel River, upstream of Pacific Avenue Bridge. Point bar outlines from 2011 and 2014 are shown in yellow and blue respectively. Base is Google Earth® Image from 06/27/2014**

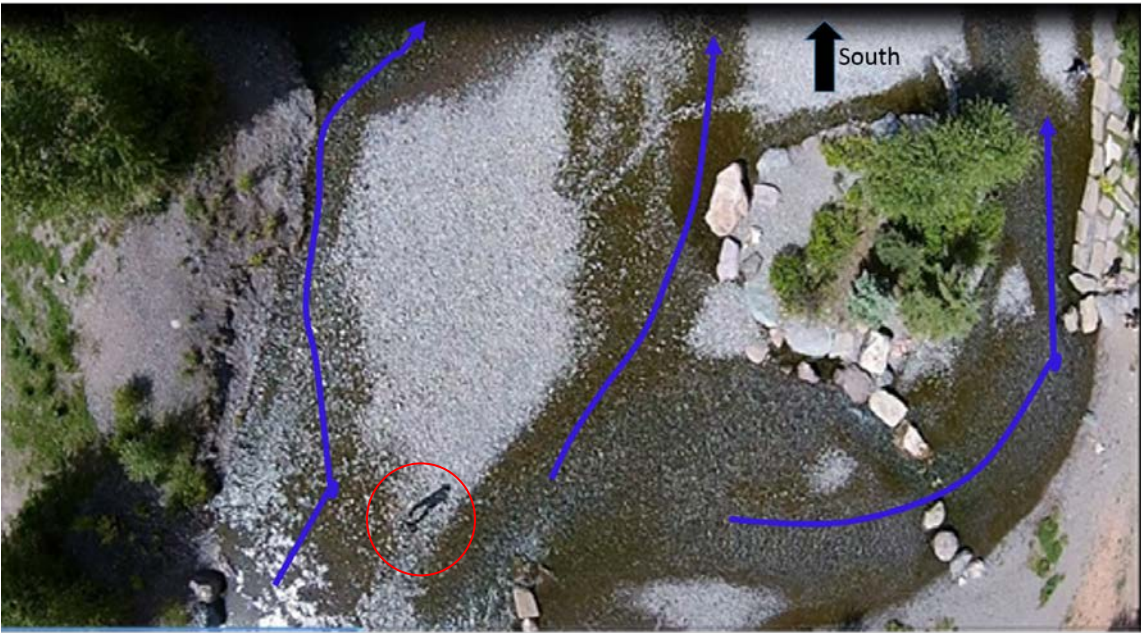
**Figure 22: Flow paths in Instream Sedimentation Basin, 2014: Screenshot from UAV video, 6-foot shadow of field assistant for scale.**

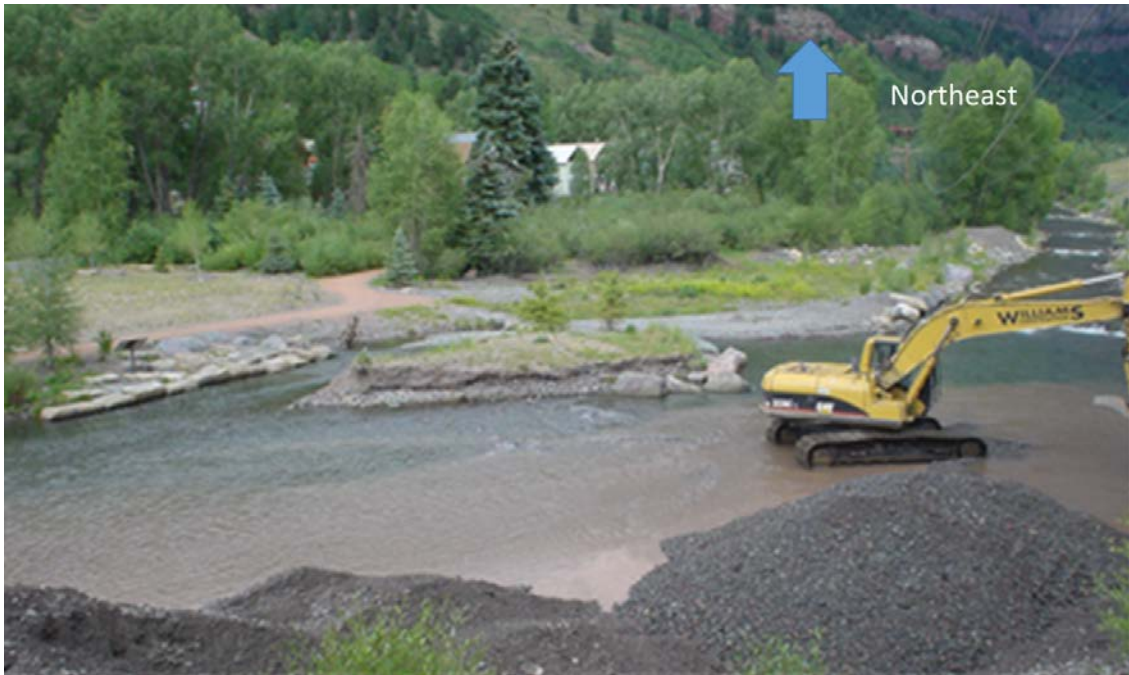
**Figure 23: Excavation and maintenance of Instream Sedimentation Basin, 2003.**

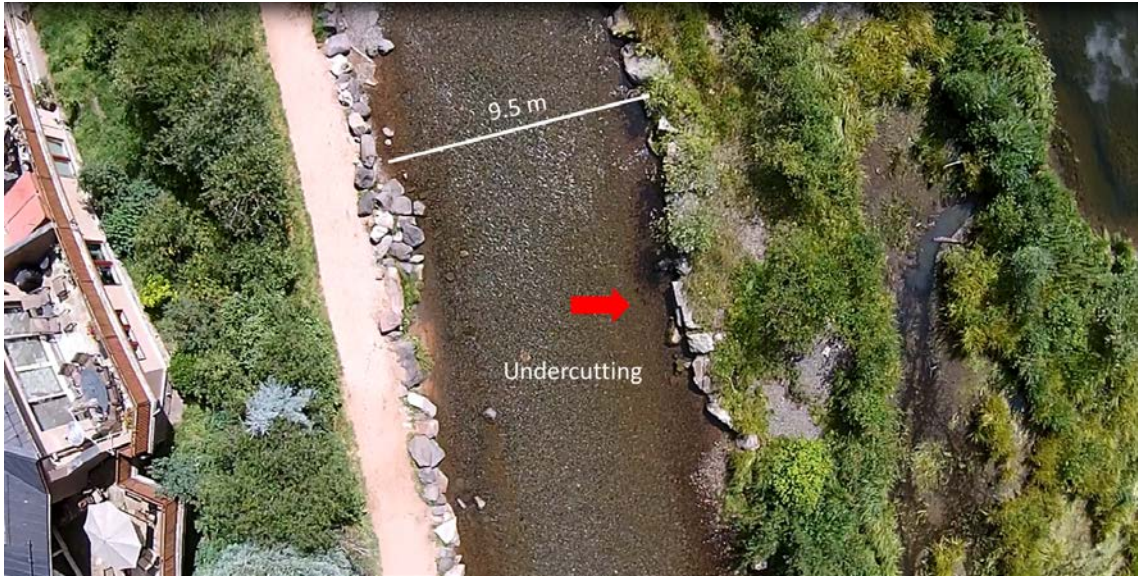
**Figure 24: UAV video (screenshot) (2014) depicting undercutting banks.**

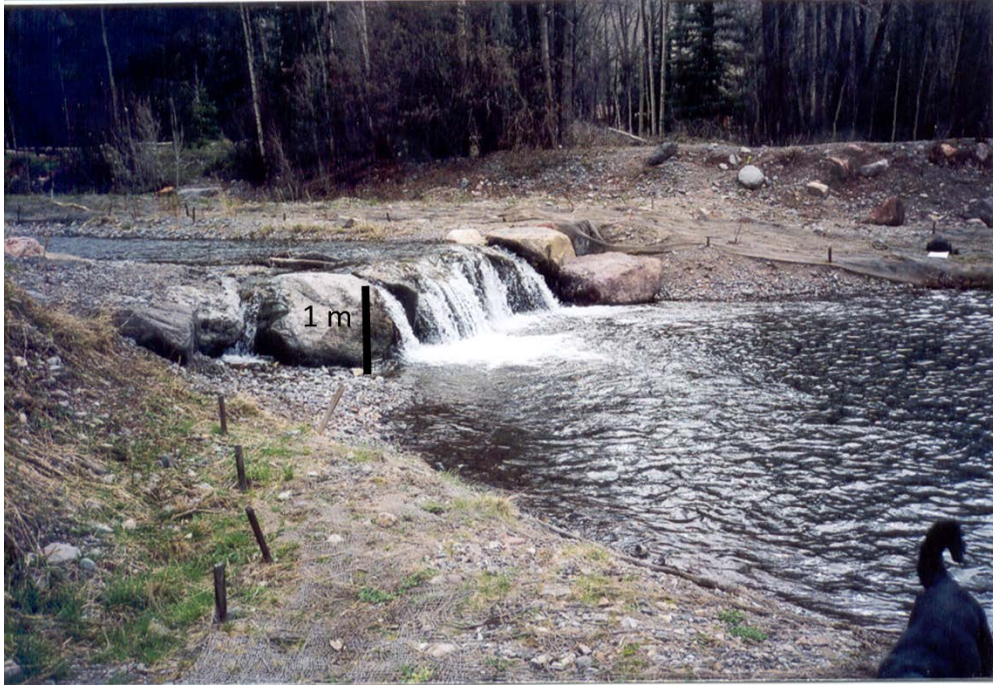
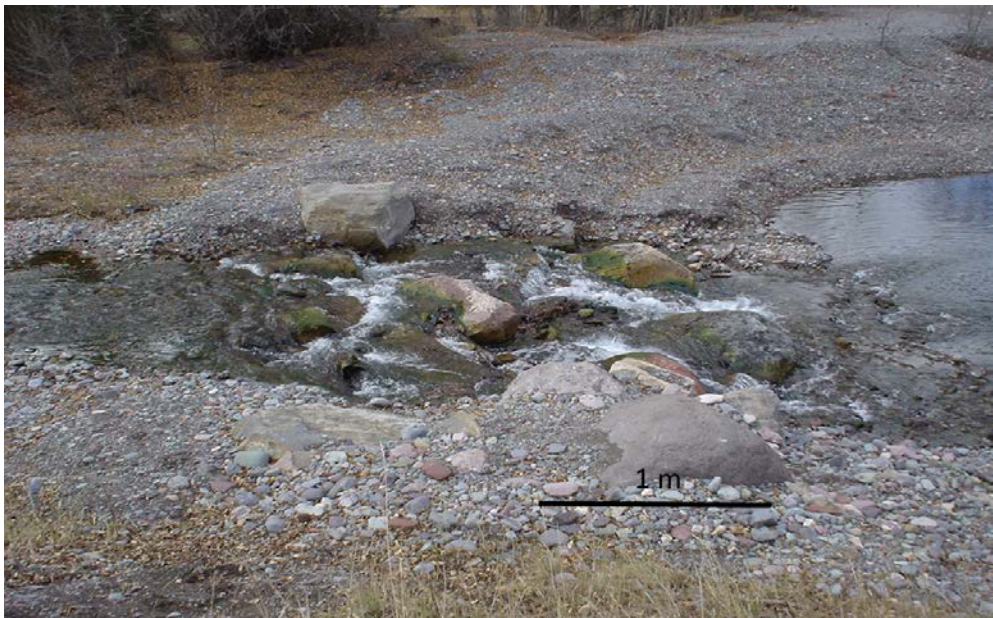
**Figure 25: Bear Creek Drop Structure re-engineered: a) original structure in 2001; b) new design in 2004.**

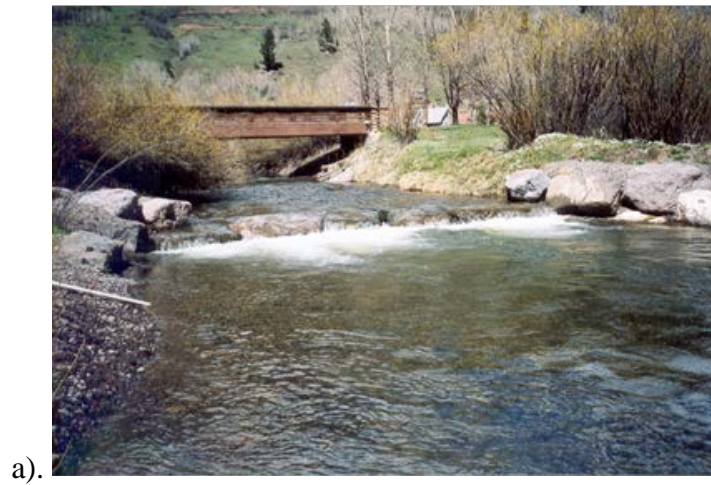
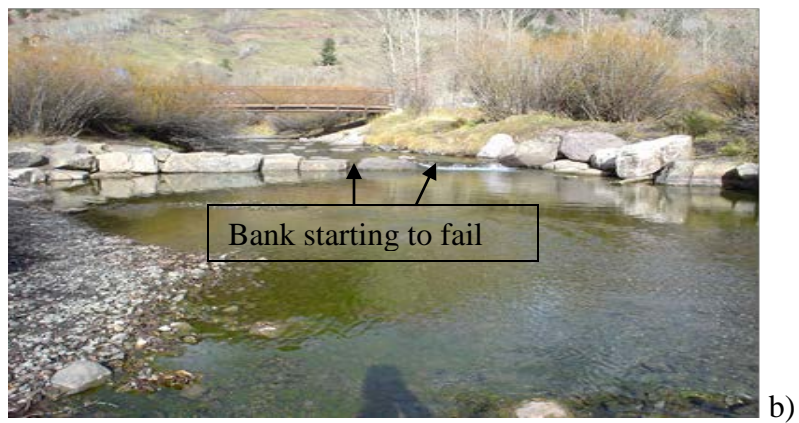
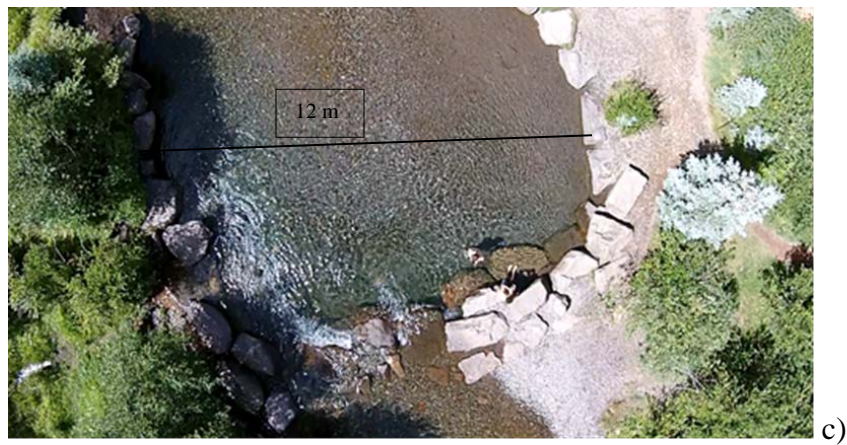
**Figure 26: Drop Structure directly downstream of Pacific Avenue Bridge: a) 2002 a year after construction; b) Eastern side starting to fail in 2004; c) Grade control has minimal effect, Screenshot of UAV video, 2014.**

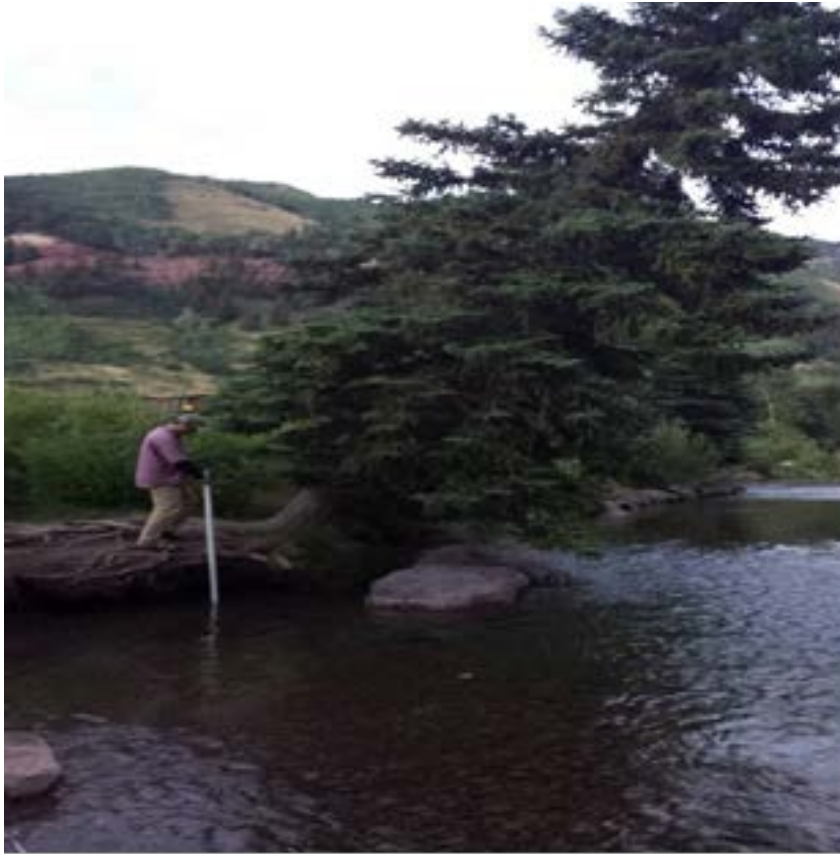
erosion by the river, the tree now leans at a 45° angle, with the roots holding the bank in place (Figure 27).

**Figure 27: Image of falling tree and undercut bank in between Willow and Spruce Streets; Photograph taken August 2014. Field assistant used for scale, about 1.75 m tall.**
