THE HISTORY OF GALVESTON'S CONCRETE SHIPS

A Thesis

DOROTHY ANNE ROWLAND

December 2018

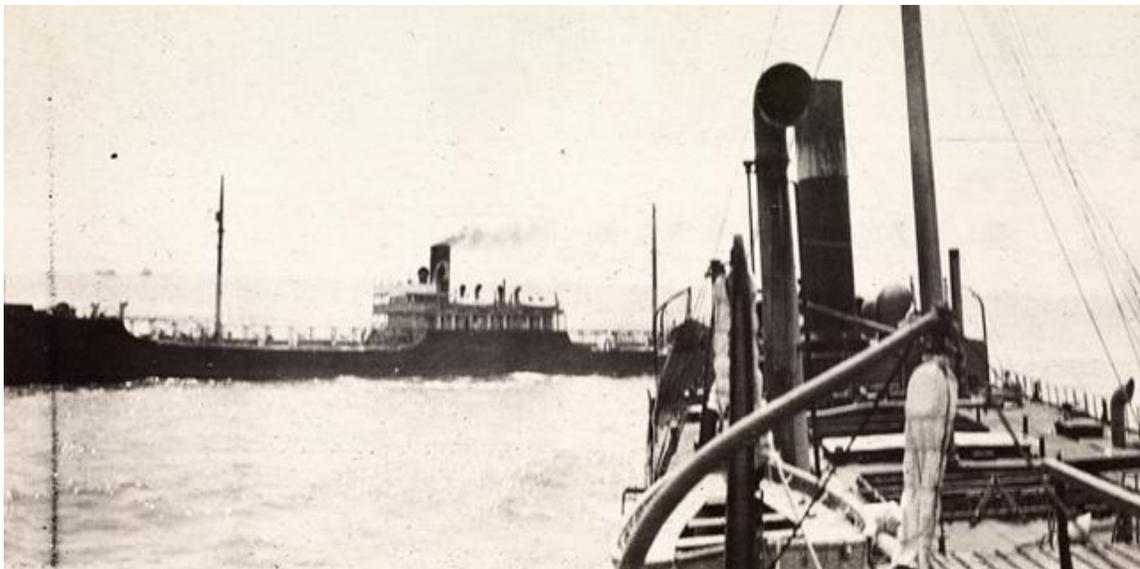
Figure 4. View of *Selma* stranded on the Tampico jetty from the deck of the SS *John D. Rockefeller*. Reprinted with permission from The Mariners' Museum.²²

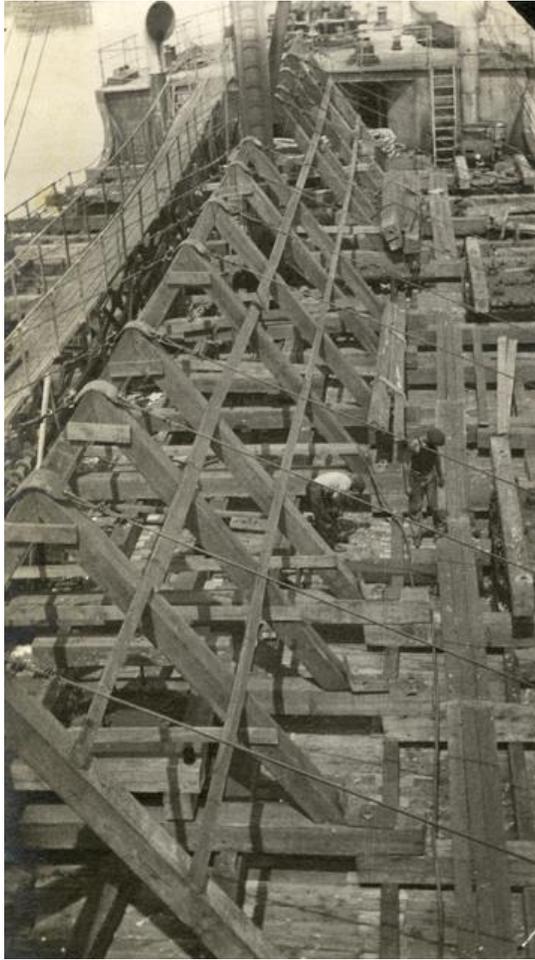
To get *Selma* back to the United States, compressed air was continuously pumped into the forward cargo space. Since the bottom of the hull in this area was missing, heavy timbers were attached to side of the vessel. “Immense A frames of heavy wooden spars were built, and these were placed at about fifteen-foot [4.57 meter] intervals along the top of the deck [Figure 5].²⁵

Figure 5. Reinforcing timbers on *Selma* to allow it to be sailed to Galveston. Reprinted with permission from The Mariners' Museum.²⁶

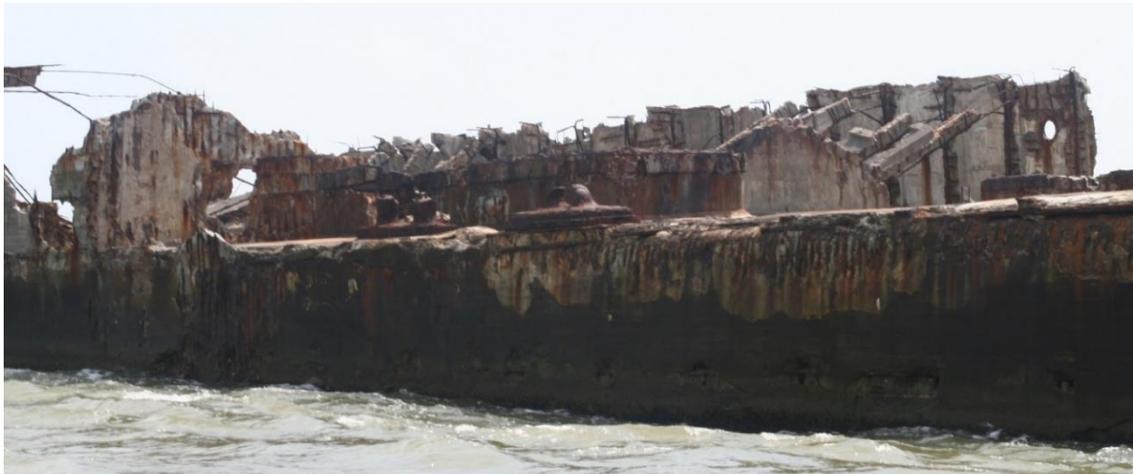
Figure 18. View of *Selma* amidships from starboard with partial view of lower foredeck, 2007. Reprinted with permission of Amy Borgens.¹⁰⁷

Figures 18, 19, and 20 show the amidships superstructure. In the earlier photos, this section of *Selma* had fully standing walls with missing sections of concrete. Here, the upper supports have fallen with the fore and aft bulkheads mostly gone. The port and starboard sides still survive with small pieces missing. The side of the ship is stained by rust a discoloration by the seawater and is further deteriorating from where the deck meets the side of the hull.

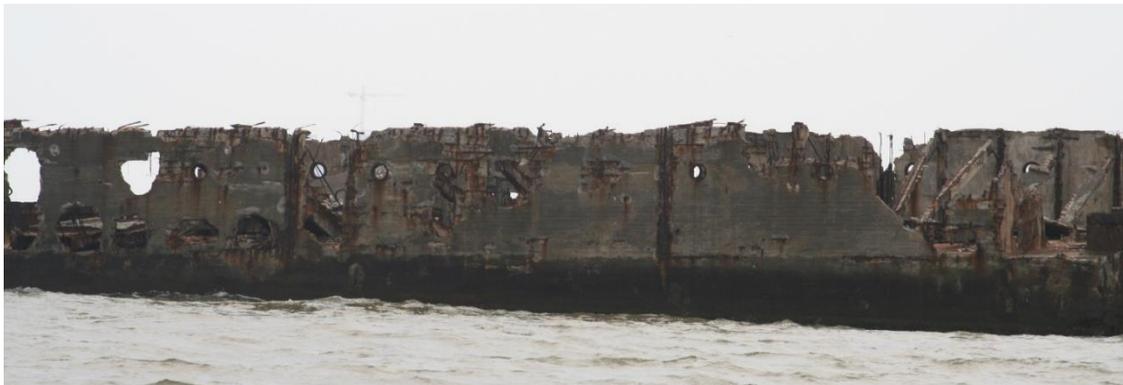
Figure 19. View of *Selma* amidships from starboard, 2007. Reprinted with permission of Amy Borgens.¹⁰⁸

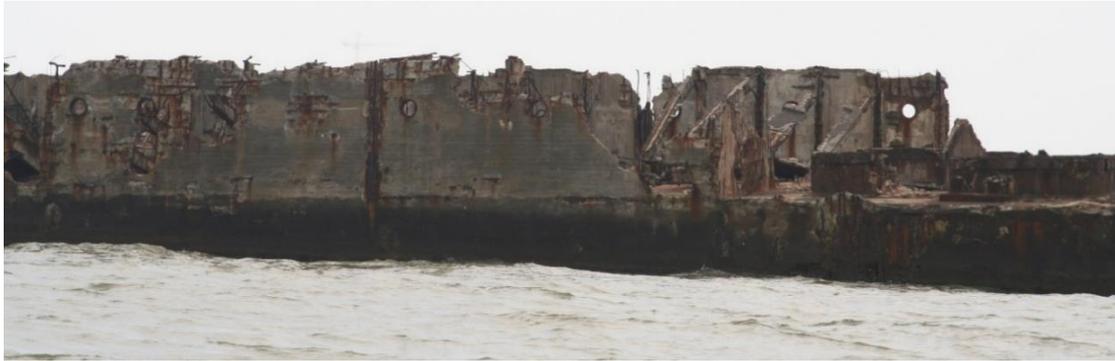
Figure 20. *Selma* amidships, view aft, 2007. Reprinted with permission of Amy Borgens.¹⁰⁹

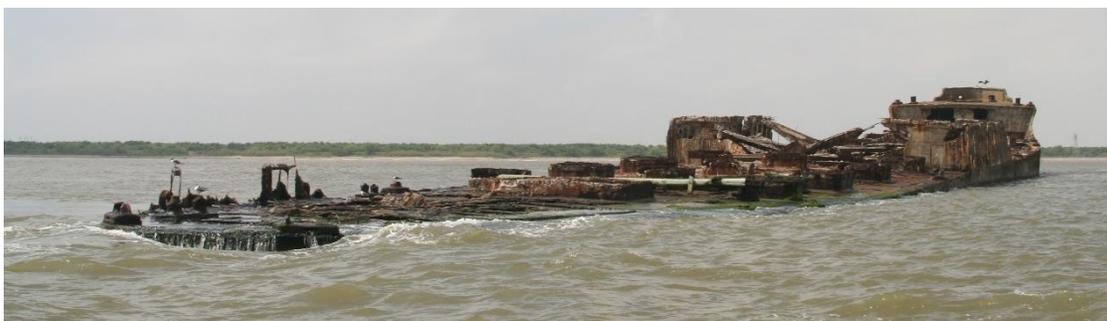
Figure 21. View of *Selma* from starboard stern, 2007. Reprinted with permission of Amy Borgens.¹¹⁰

Figure 21 shows definite wear as compared to the 1940s-60s photos. The railing feature on the stern port side has only one support standing with the rest reduced to short stumps. The chock on the starboard side is damaged with only one small portion attached to the base. The bollards seen in Figures 14 and 15 on the starboard side are no longer there.

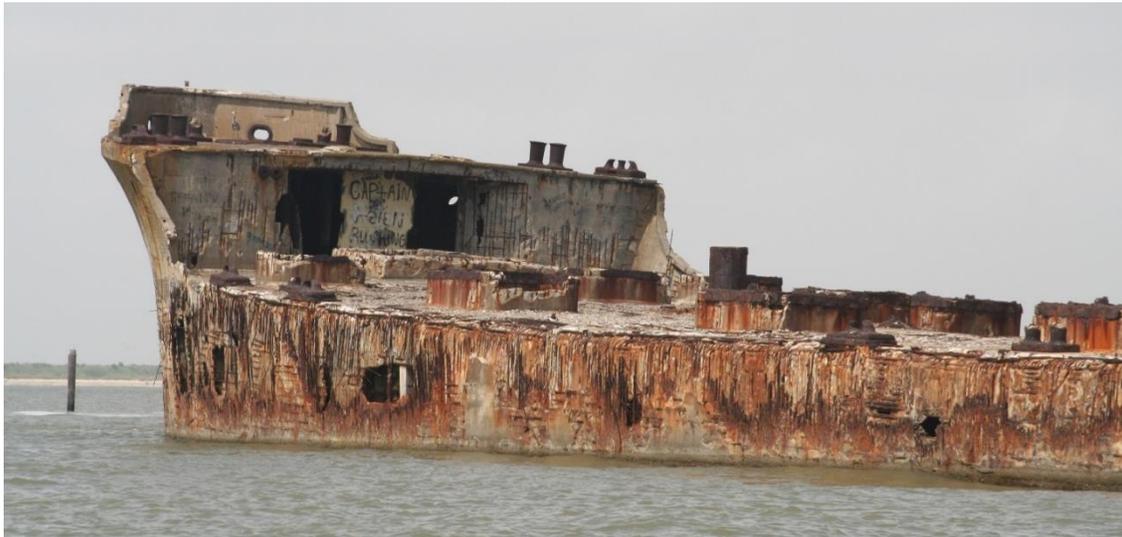
Figure 23. *Selma* from port side, 2007. Reprinted with permission of Amy Borgens.¹¹²

condition of the deck is hard to gauge, but reinforcing steel is exposed. The hatches in Figure 23 look more deteriorated than the aft hatches that can be seen in Figure 23. The metal bands are missing sections and some of the hatches have concrete missing on their sides. The concrete and metal pieces of the raised foredeck appear to be in better condition than those on the main deck.

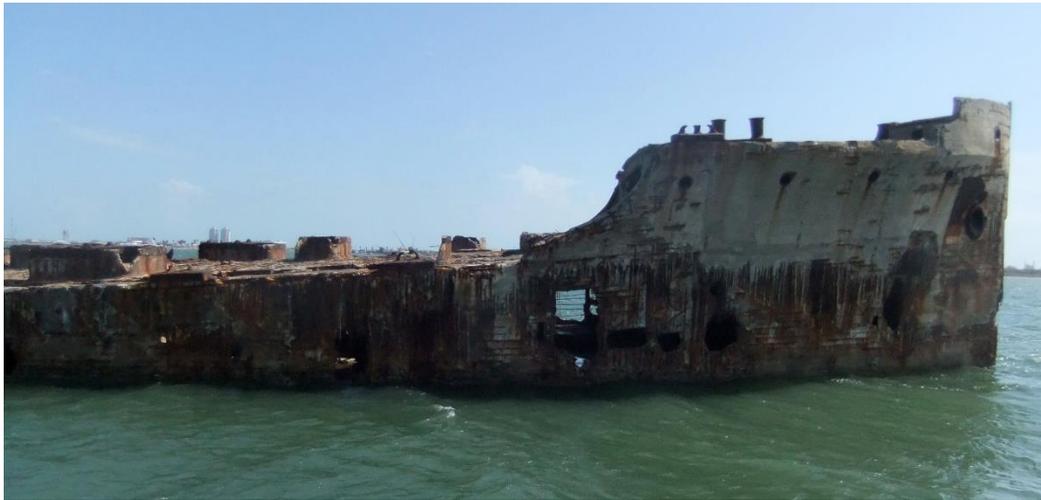
Figure 30. View of *Selma* bow from port side, 2012.¹¹⁹

There is no direct comparison photo from 2007, but Figure 30 shows the significant deterioration of the concrete on the starboard side with many large holes visible. It is noteworthy that there is a hole extending through the entire ship.

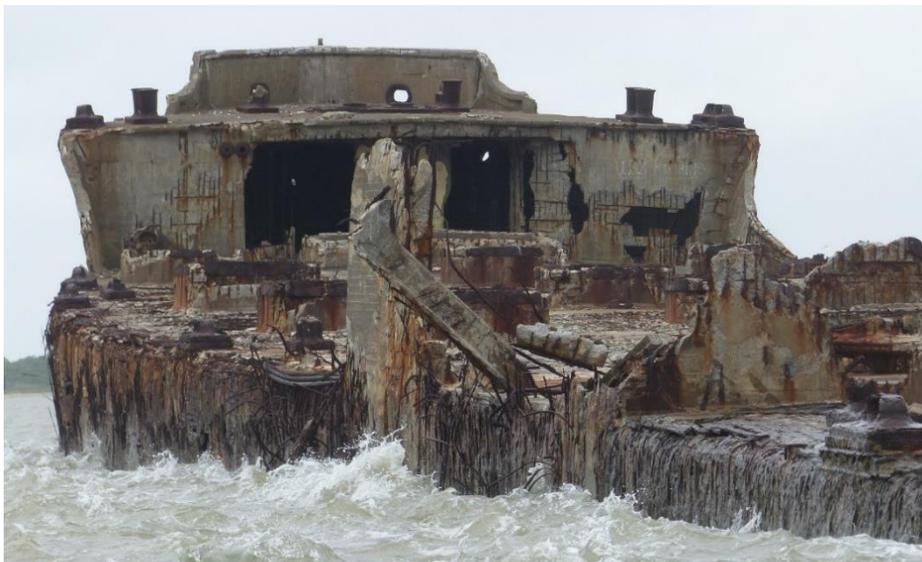
Figure 35. View of *Selma* just forward of amidships looking to the bow, 2018.¹²⁴

Figure 35 shows the port side concrete erosion and the extent to which the steel reinforcing rods are becoming exposed to the elements. The few sections of the superstructure still standing are beginning to fall and the holes in the raised foredeck bulkhead are expanding.

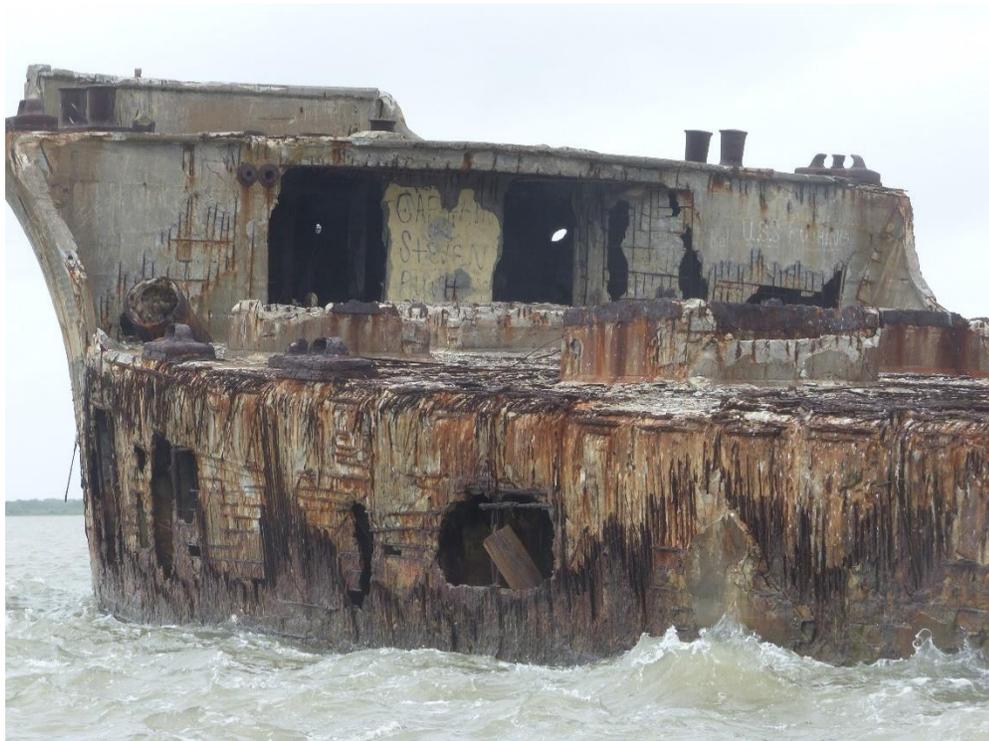
Figure 36. View of the bow of *Selma* from the port, 2018.¹²⁵

Figure 36 shows how, from 2012 to 2018, the holes in the port side of *Selma*'s bow have become much larger. The metal insert for the fore-mast, which in Figures 22 and 23 was in the middle of the deck just forward of the superstructure, is now located on the port side abaft the foredeck bulkhead. It seems unlikely that wave action could have moved the metal piece up the deck, and it is more likely that this was done by humans rather than waves.

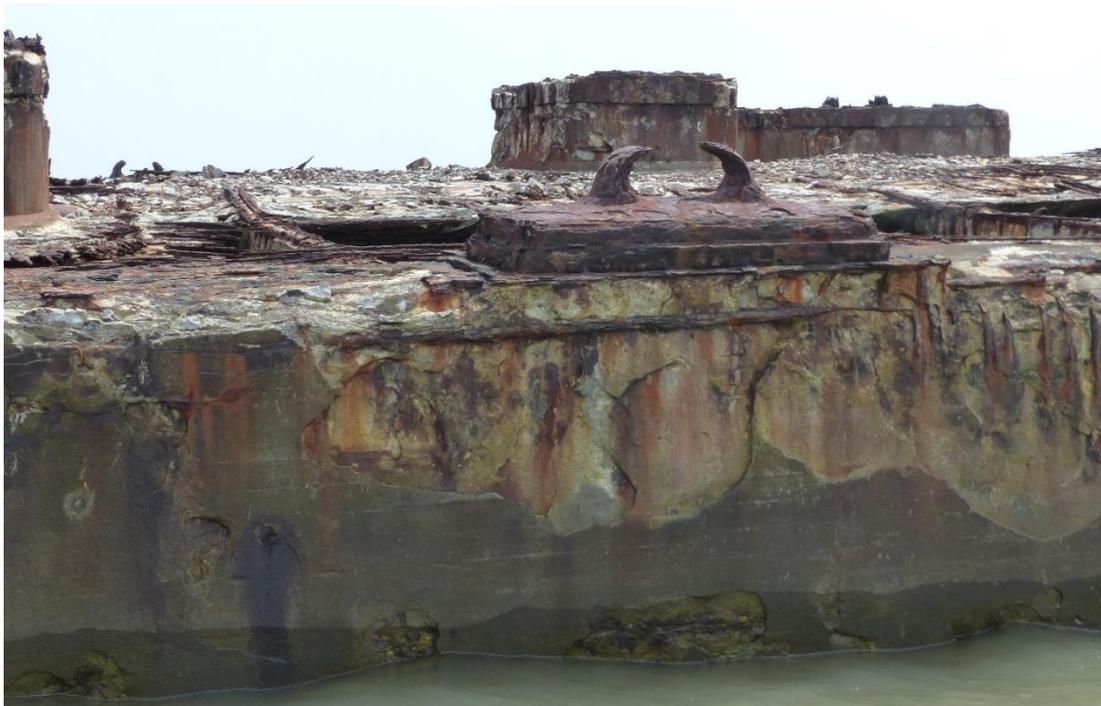
Figure 37. Close up a chock and section of the port side hull on *Selma*, 2018.¹²⁶

Figure 37 shows how the steel reinforcement is damaging the concrete from the inside due to expansive forces of iron corrosion causing the concrete to spall off the sides and deck. The outside of the concrete that still has the outer layer looks like it is in fairly good condition, but there is staining from the steel rods deteriorating underneath the surface.
