47TH TURBOMACHINERY & 34TH PUMP SYMPOSIA
HOUSTON, TEXAS | SEPTEMBER 17-20, 2018
GEORGE R. BROWN CONVENTION CENTER

Vertical Turbine Pump Reliability Improvement

Yve L. Zhao

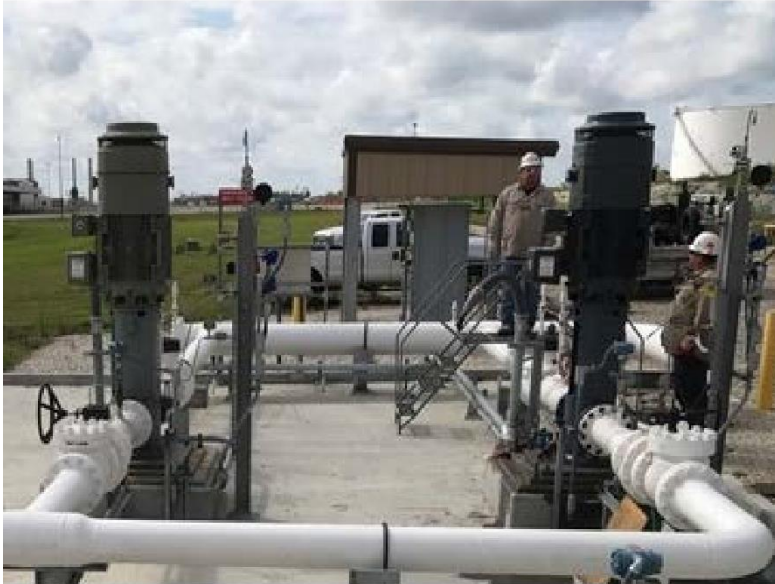
Pump System Configuration

Two (10 stage) pumps for on-stream backup.

Back pressure control valve.

VFD for speed control.

One pump with slightly higher system resistance – on the right.

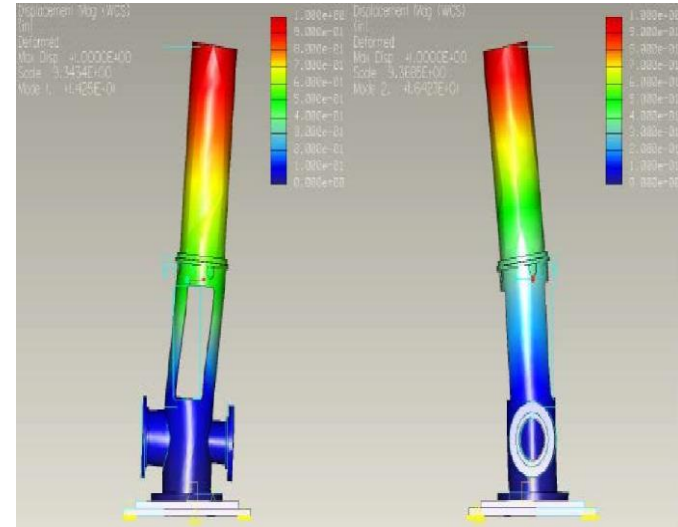
Operating Deflected Shapes at Resonance Speed

- Narrow operating speed range (885 – 985 RPM)
- Pump critical speed is highly reliant upon bushing clearances.
- Large clearance bushings were originally installed
 - Typical bushing clearance (per OEM):
6 - 13 mils diametral (1.7" journal, $Cd/D= 3.5\sim 7.6$)
 - Actual bushing clearance:
11 - 21 mils diametral (1.7" journal, $Cd/D= 6.5\sim 12.4$)

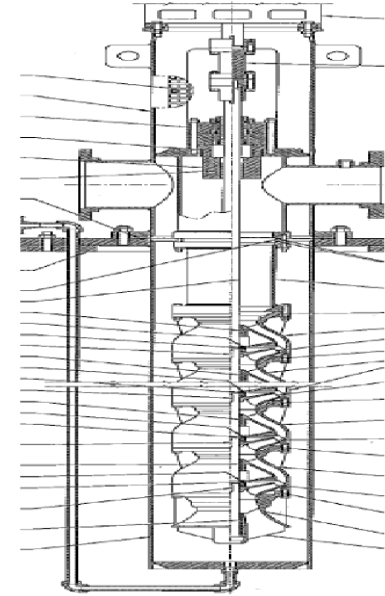
Wear Pattern – Shaft and Bushings

Flow recirculation on the top stage caused more damage to the top two bushings. Bottom 1st stage bushing was edge loaded.

Pump has 10 stages. Catalog picture used to show configuration:

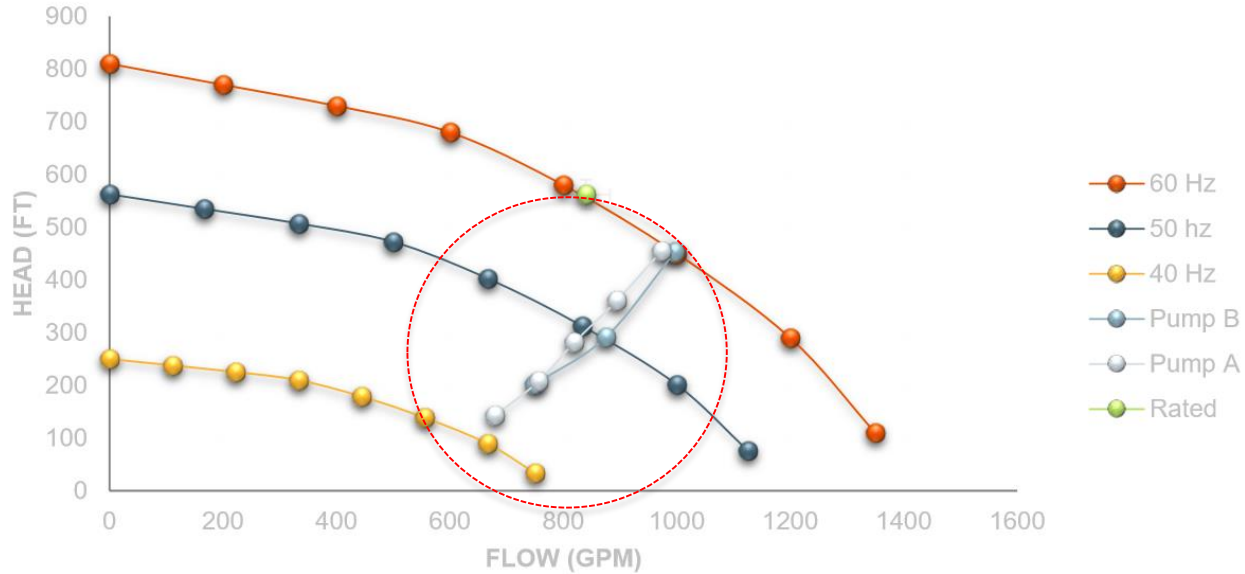
Pump Curve and Operating Points

- Reviewed pump curve and compared with other transport pumps for similar service. The review indicated pump re-staging would bring pump to operate closer to its rated condition and enable an extended operating range. This recommendation was not implemented.
- Vibration signatures at various speed and back pressure taken to generate Performance & Reliability Map (PRM) to set a “**safe to operate range**”.
- Transitional seal flushing orifice installed to reduce a turbulence flow effect on the rotor but results were marginal.
- In addition, a review of thrust loading showed absence of balance orifices in the impellers for VFD drive pump. Motor bearing selection needs to be reviewed to consider thrust load to prevent frequent bearing failure.

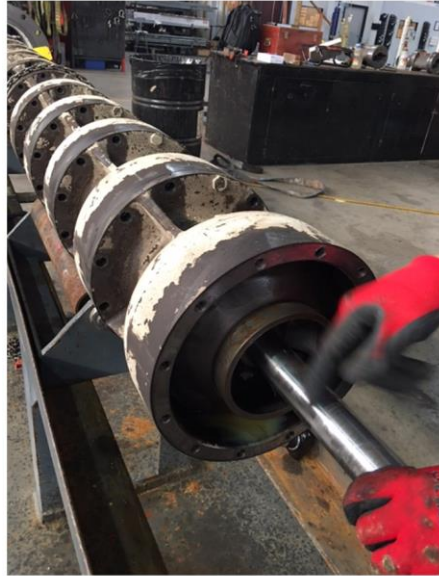
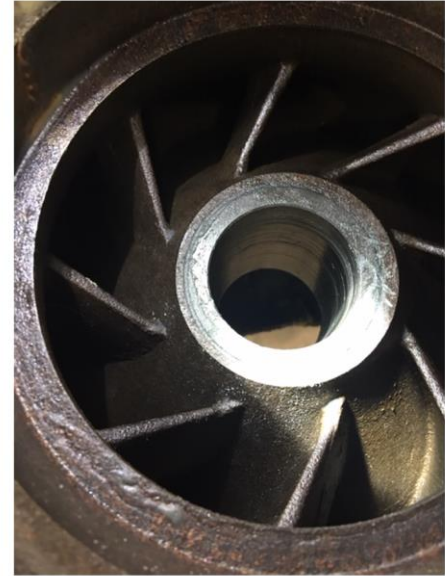
Turbine/Pump Impellers – No Balance Orifice

- Variable Speed Drive.
- Unbalanced impeller Thrust.
- Rigid Drive Shaft
- **Motor Bearing takes Thrust Load!!!**

- Proper seal design is key to reliability of the vertical pump.
- VFD driven pumps need to be performance and reliability tested for their intended service → to establish “good/safe to operate range.”
- Thrust loading need careful review and results utilized for a proper motor bearing selection. Current system has a rigid drive coupling and lacks a thrust load control.
