47TH TURBOMACHINERY & 34TH PUMP SYMPOSIA
HOUSTON, TEXAS | SEPTEMBER 17-20, 2018
GEORGE R. BROWN CONVENTION CENTER

MULTIDISCIPLINARY APPROACH TO FAILURE ANALYSIS OF TURBOMACHINERY COMPONENTS

Kirill Grebinnyk, P.E.

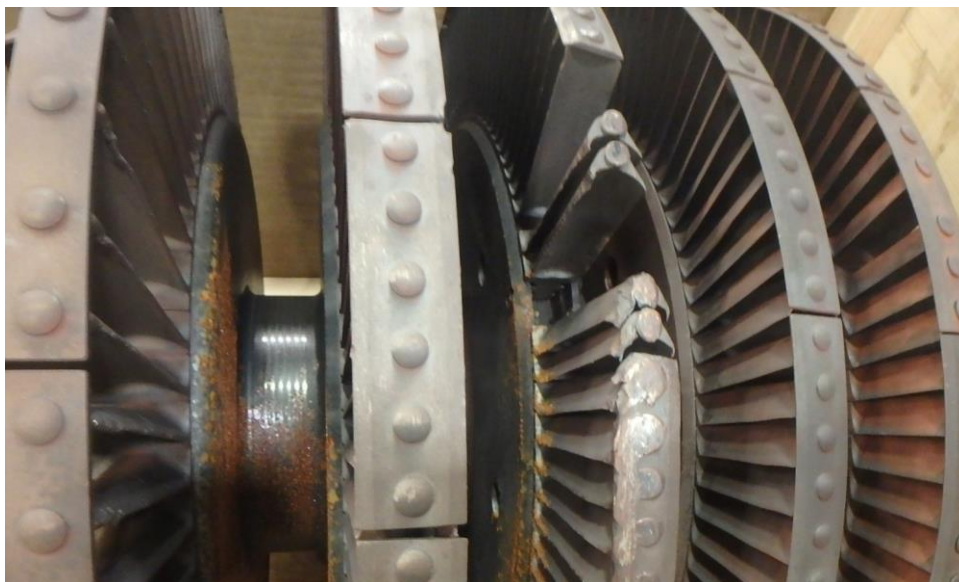
Figure 16: Hot Gas Expander in As Received Condition

An axial-flow hot gas expander rotor failed its 3rd stage (R-3) locking blade. General view of the rotor in as found condition is shown in Figure 16.

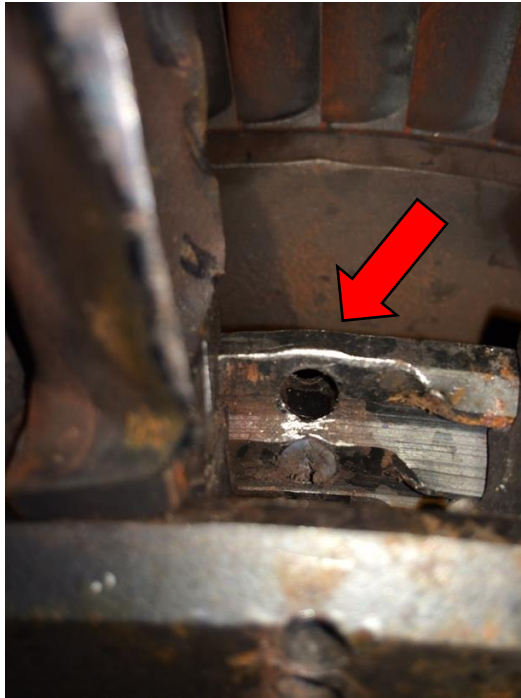
Figure 17: R-3 Locking Pin Hole Material Deformation

The subject stage had tangentially loaded double-hook T-root blades and employed a double pin locking mechanism. Upon detailed visual inspection, it was found that the locking pin hole and the material above it had deformed quite significantly into an oblong shape, as shown in Figure 17.

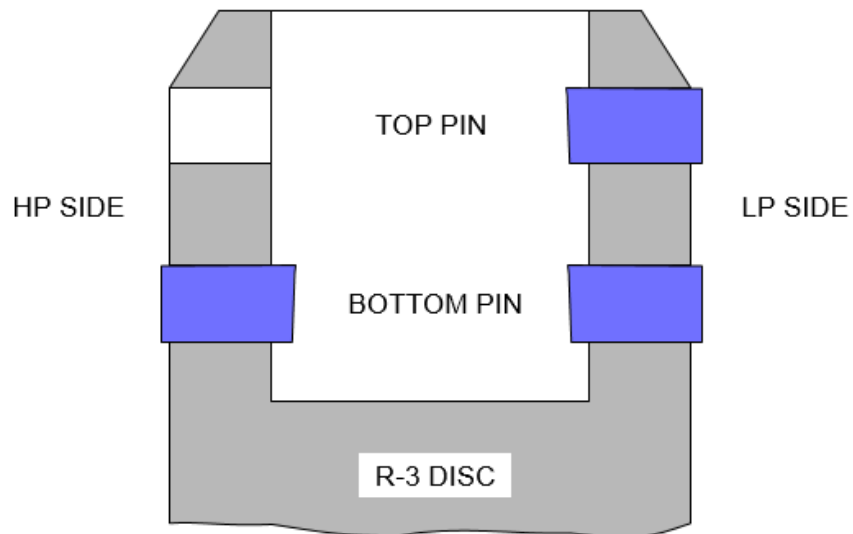
Figure 18: Sketch Showing the Locking Pin Pieces Found in the R-3 Disc

The initial findings pointed towards ductile failure of the locking pin, therefore, additional steps were taken to determine the underlying reasons for such failure. Metallurgical evaluation of the remaining portions of the locking pin as well as steady state structural FEA were performed. Only three pieces of the two locking pins were found in place. Figure 18 illustrates the findings.

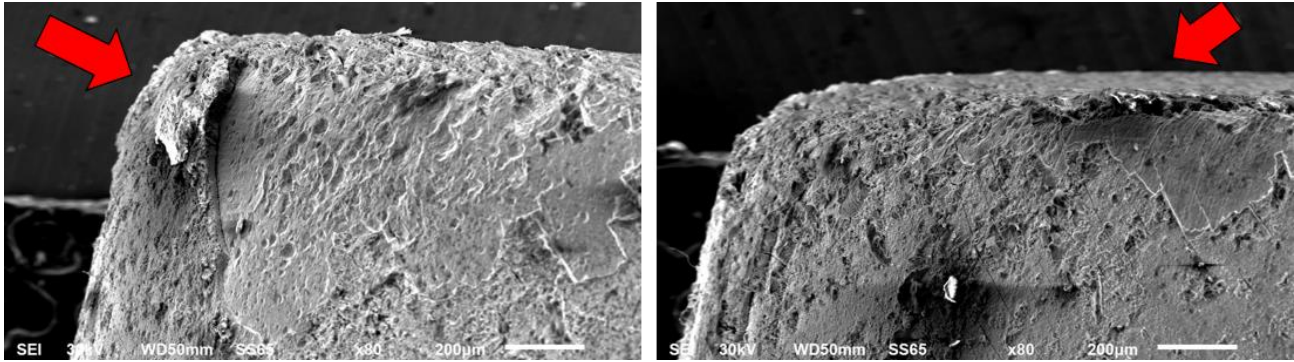
Figure 19: Suspected Fracture Initiation Location Found at the Bottom Pin Parts Under SEM

During examination of the fracture surface under SEM, significant deformation was found at the suspected crack initiation locations for both HP and LP sides of the bottom pin. Initiation locations are indicated by red arrows in Figure 19.

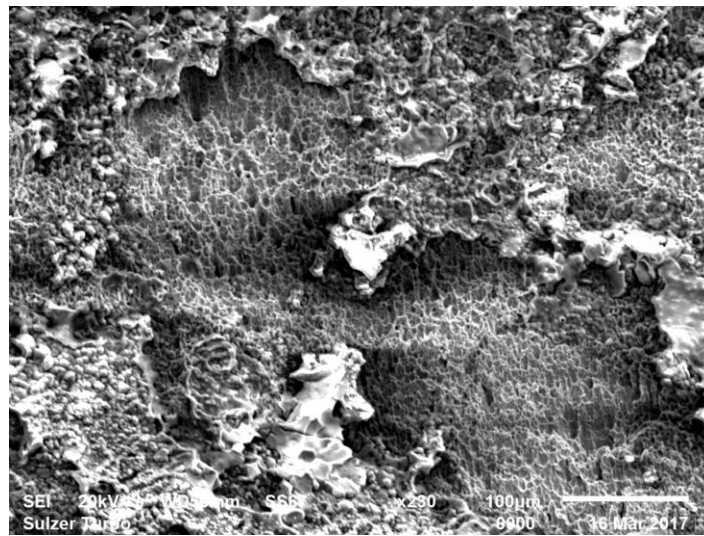
Figure 20. Top Pin Fracture Surface Showing Signs of Ductile Failure

Additionally, the fracture surface did not display any mechanical defects, pitting or other evidences, which would be typical for fatigue or stress corrosion cracking. Almost the entire fracture surface of the parts showed what appeared to be a classic example of ductile failure with multiple dimples, as presented in Figure 20.

Positive Material Identification (PMI) performed on all pieces of both pins confirmed that the material is H13 (tool steel). It was impossible to perform complete mechanical properties test due to the small size of the pieces. Hardness readings were collected using the polished and mounted samples of the pin. Measured hardness values ranged from 26 HRC to 30 HRC, and based on these findings, the yield strength of the pin was concluded to be approximately 110 ksi. A temperature of 800 °F was inferred for the 3rd stage blades based on the known inlet and outlet conditions for the hot gas expander. Therefore, the material's yield strength is expected to reduce to approximately 95 ksi during service. This results in shear strength equal to 54 ksi during operating. As a rule of thumb, the shear strength can be estimated as approximately 57% of the material yield strength.

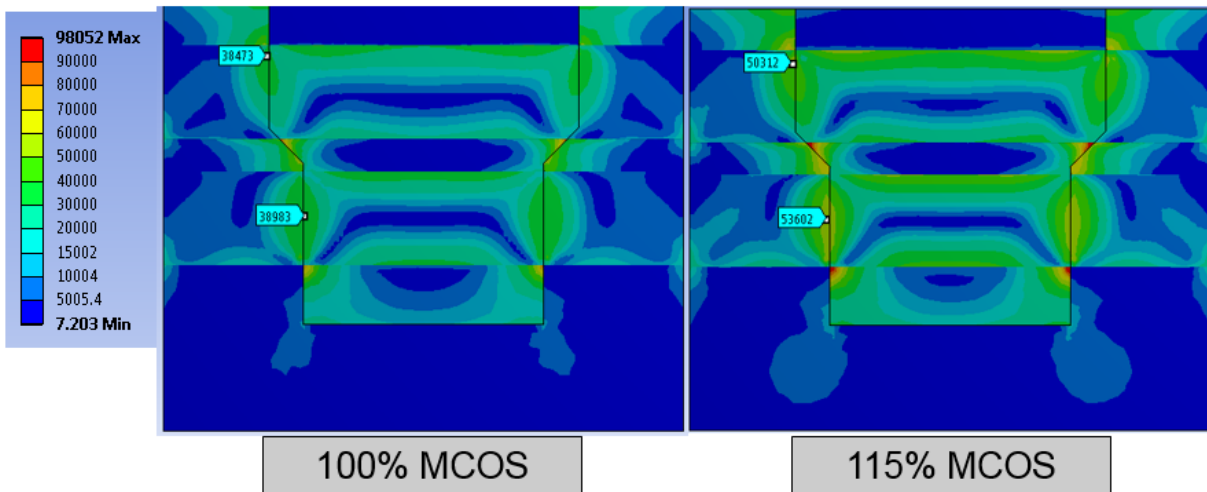
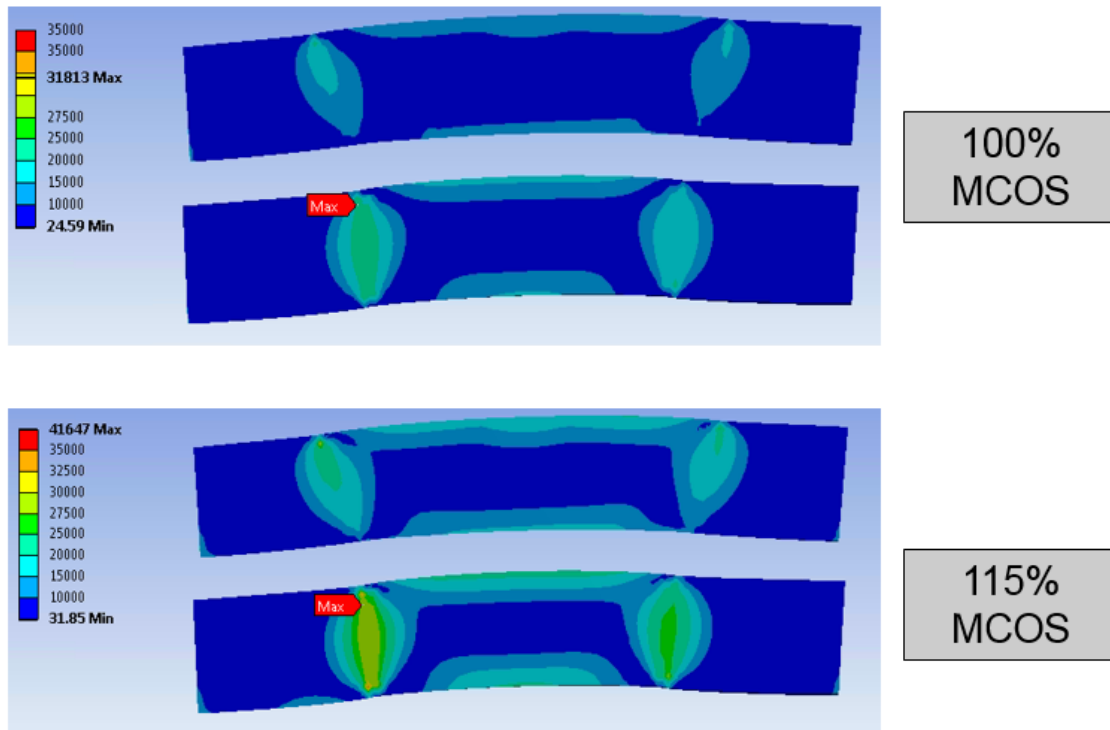
Stresses were calculated at 100 percent and 115 percent of MCOS. These operating speeds correspond to normal operation and overspeed trip events, respectively. Equivalent (von Mises) stress at these conditions for the blade and pins is shown in Figure 22. To improve clarity, Figure 23 shows stresses in the pins at the same operating conditions.

Figure 22: Equivalent Stress (psi) in the R-3 Locking Blade and Pins

Figure 23: Equivalent Stress (psi) in the R-3 Locking Pins (Deformations Exaggerated)

By means of FEA the safety factor for the pins is equal to 1.3 at 115 percent of MCOS. In general, for the authors, it appeared to be marginally sufficient. However, based on conversations with the plant personnel it was found that this unit may have experienced some temperature excursions and possible overspeeding beyond 115 percent of MCOS during its service. Therefore, in order to improve the design, the following modifications were recommended. Firstly, upgrade the pin material to 422SS with hardness from 42 HRC to 48 HRC. This will provide an increase in yield strength to approximately 130 ksi during service, and, correspondingly, increase the shear strength of the material. The yield strength in shear can be estimated as approximately 57% of material's yield strength. Secondly, it was proposed to further increase the safety factor by employing a locking block design in lieu of the locking blade. Reduction of the mass carried by the locking pins will positively affect its safety factor and provide an additional assurance that the repetitive failures would be avoided.

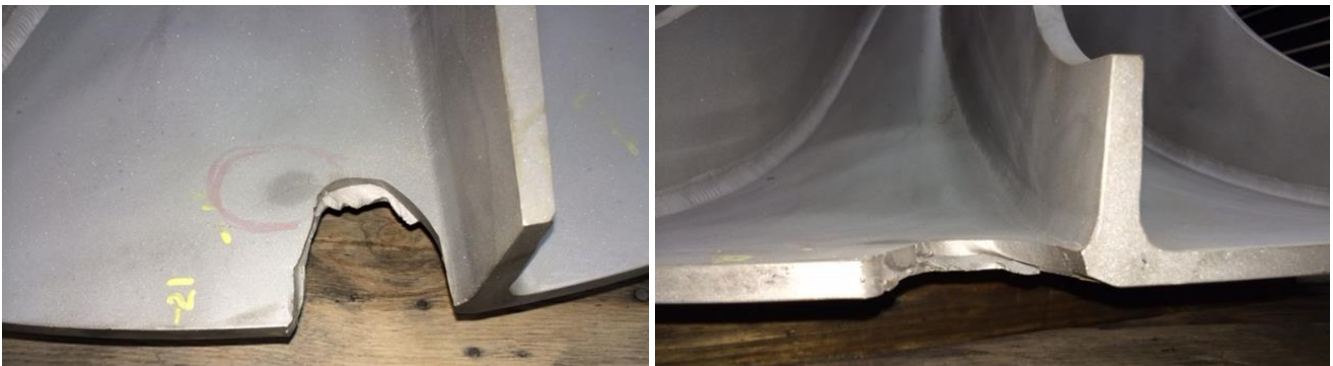
A centrifugal blower supplying process air at a plant has been removed from service for repairs after it tripped due to excessive vibration. The blower is a single stage, overhung, open-face impeller driven by a steam turbine, operating in a wide range of speeds (4,722 RPM – 7,083 RPM). Upon inspection, it was found that a piece from the backplate of the impeller was liberated causing excessive unbalance and high vibrations. The extent of the damage is shown in Figure 24. This was not an isolated incident as three other similar units reportedly failed in similar ways in the past. A failure analysis was performed to determine the inherent design flaw for the blower.

Figure 24: Backplate of the Impeller with Liberated Material Piece

The material of the impeller was identified as 17-4 PH stainless steel with a measured hardness of 28-35 HRC, which suggests that an approximate yield strength of the base material is 105 ksi. The analysis started with a metallurgical study of the fracture surface which identified high cycle fatigue (HCF) as the failure mechanism. In-situ replicas of the fracture surface were not clear enough to determine the location of crack initiation. Destructive metallurgical testing could not be performed because the plant wanted to repair the existing impeller. A mechanical structural analysis followed after sufficient data was gathered from the plant, namely service history and conditions at the time of the failure. The steady state finite element analysis showed that the operating stresses were well within the elastic range of the material with a safety factor of over 2.0 at the equipment overspeed trip speed of 110% MCOS (Figure 25). The findings from the FEA agreed with the study of the fracture surface and dismissed any possibility of static overload as the cause of the failure.

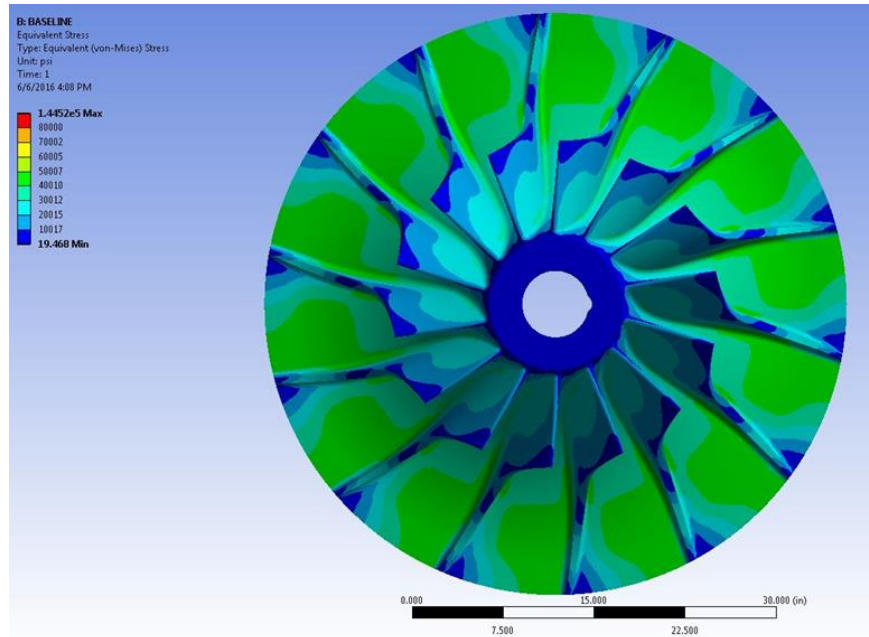
Figure 25: Equivalent Stresses (psi) at 110% MCOS

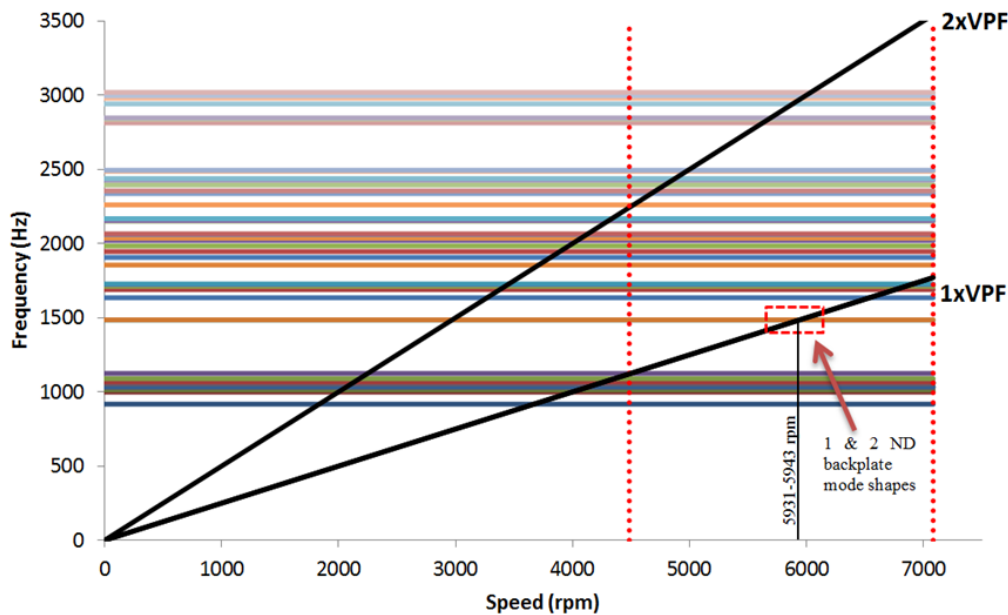
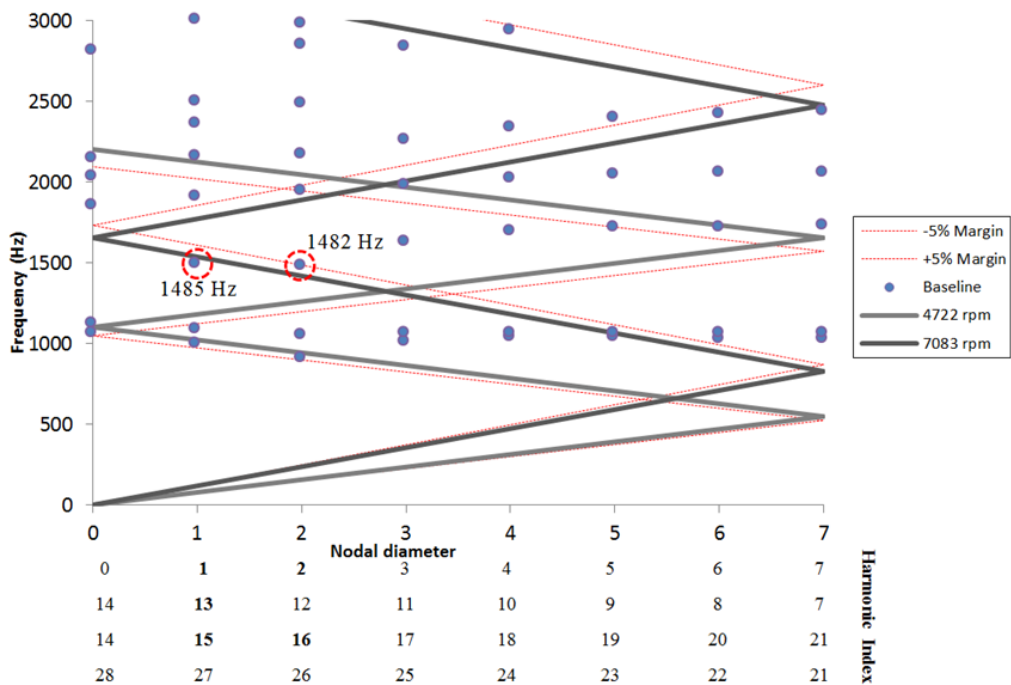
Figure 27: Campbell Diagram for the Impeller (Baseline Design)

Figure 28: Interference (SAFE) Diagram for the Impeller (Baseline Design)

Major design changes must be made to the structure to completely avoid resonance issues in the impeller. This could include changing the impeller’s material and construction or modifying the number of vanes in the stationary components, all of which are not

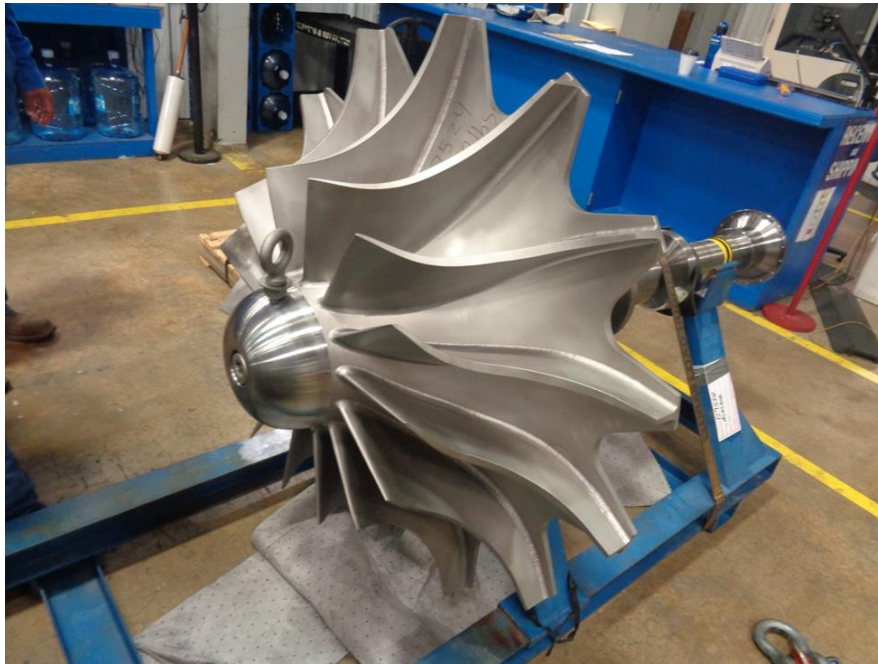
Figure 29: Impeller Geometry after Modification with “Scallops”

Impact testing performed on the final design confirmed that the natural frequencies no longer interfere with the vane passing frequency within the defined operating speed ranges. The redesigned impeller has been put in service and no further issues have been reported since then.

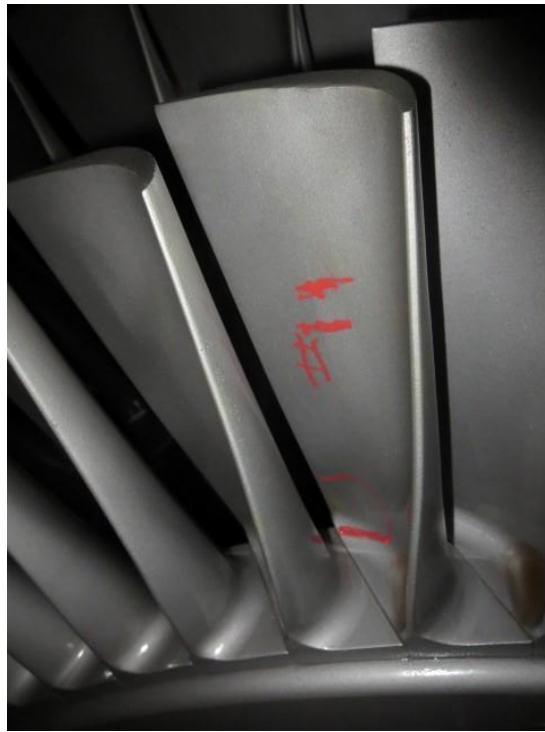
A crack developed in a blade (11th stage) of a steam turbine. The crack was located near the bottom of the trailing edge side of the blade as outlined in Figure 32.

Figure 32: Stage 11 Blade with Crack to the Trailing Edge

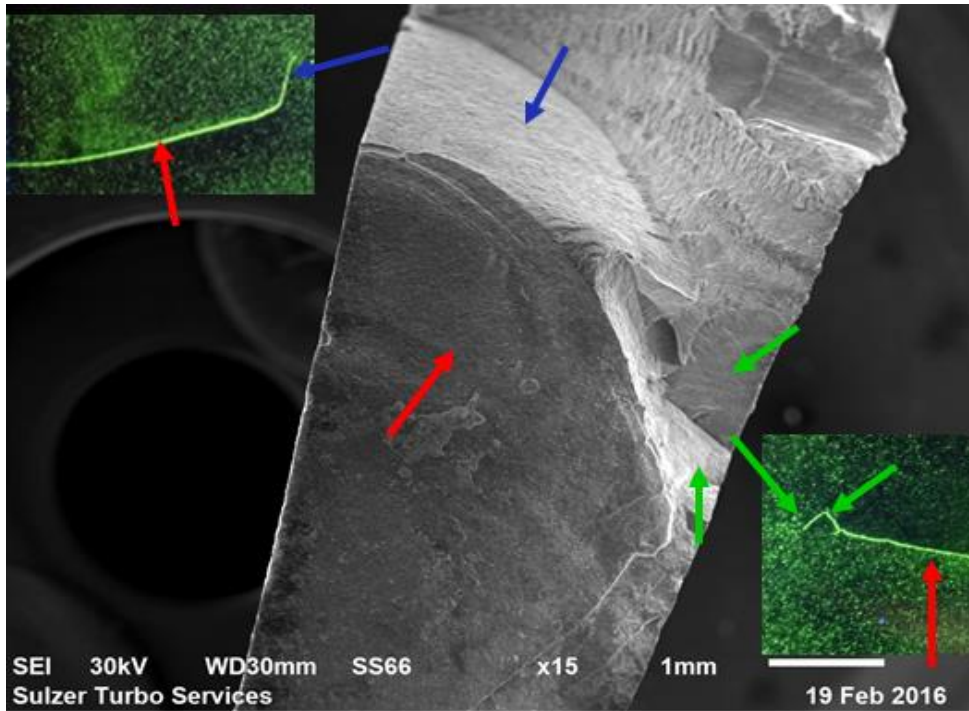
The cracked blade was mechanically opened to evaluate the fracture surface. Visual and stereo microscope evaluation showed that the fracture surfaces on both sides were flat until the crack changed direction. Faint evidence of beach markings, which is a telltale sign of fatigue, can be seen in some areas of the fracture surfaces as shown in Figure 33. The red arrows point to the primary fracture plane. The green arrows point to the secondary cracks on the convex side of the vane as shown by the inset at the lower right corner of the Figure. The blue arrows point to a secondary fracture plane on the concave side of the vane and these two cracks correspond to the magnetic particle indications (cracks) shown in the inset at the top left corner of the Figure.

Figure 33: SEM image of the fracture with different fracture plane.

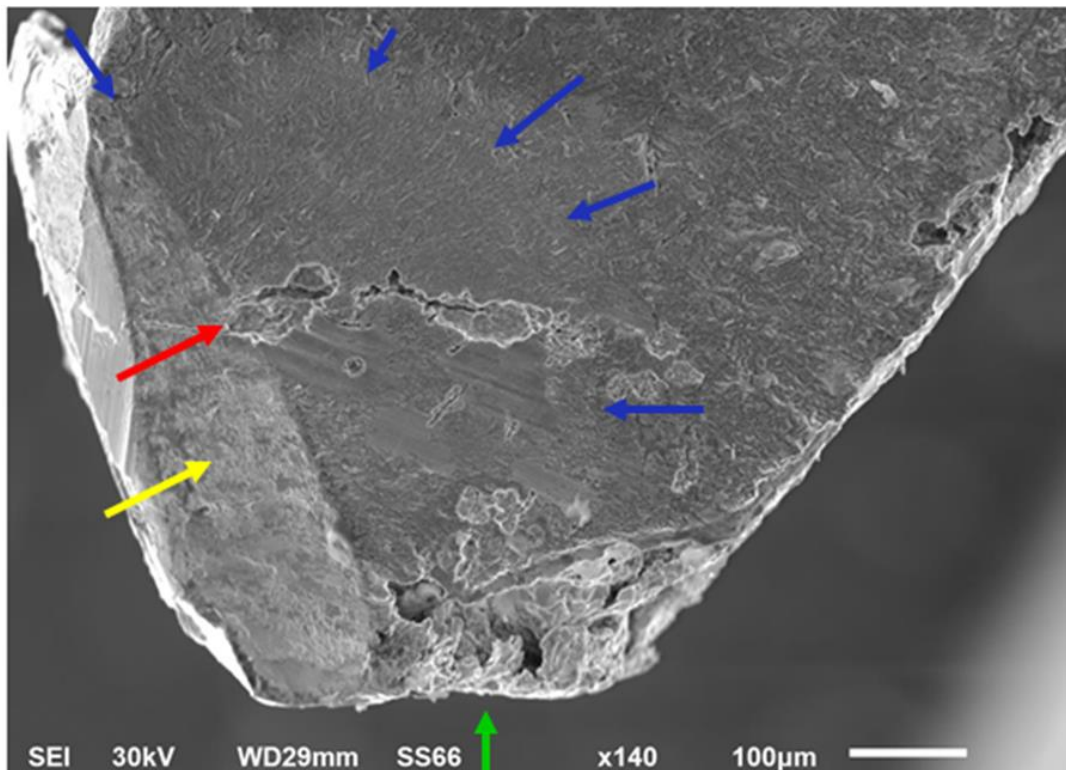
Figure 34 shows an SEM image of the fracture surface closer to the trailing edge of the blade. The blue arrows point to the pattern indicating the initial crack propagation region. The general surface area appears to be flat which itself is typical if crack propagation is due to fatigue. The fatigue propagation pattern appeared to indicate that the crack initiated at the corrosion damage pointed by the red arrow. This is deduced from the tiny light colored lines that seem to initiate from the area pointed by the red arrow. Corrosion pitting can be seen in the adjacent areas. The green arrow points to additional corrosion damage at the leading edge. The region of an impact damage in the fracture plane is indicated by the yellow arrow.

Figure 34: SEM Image of Fracture Surface at the Trailing Edge of the Blade

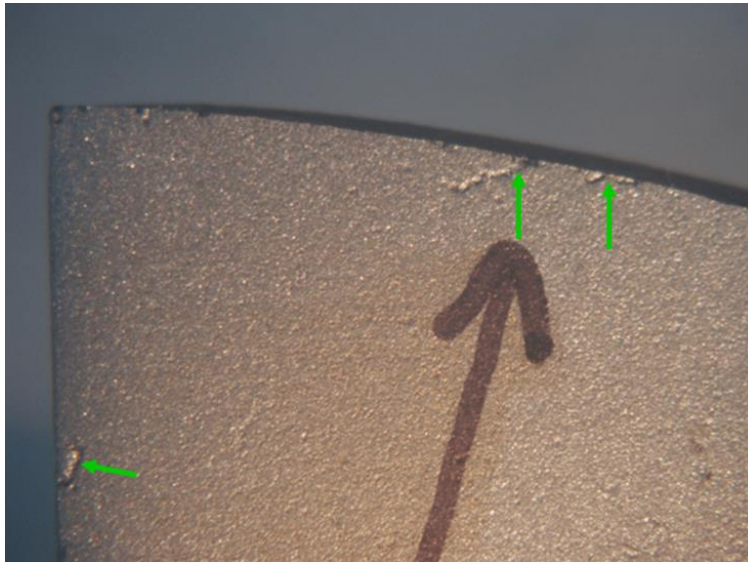
from the trailing edge. This means that the fracture surface closer to the trailing edge was exposed for a longer duration than the fracture surface towards the leading edge. It is most likely that this crack initiated due to local crevice corrosion cracking and its orientation was determined by location of the crevices. Further evidence of independent crevice corrosion can be found on the blade surface as shown in Figure 35, where green arrows point towards the corrosion pits on the surface.

Figure 35: Side View of the Cracked Blade with Corrosion Pits
