47TH TURBOMACHINERY & 34TH PUMP SYMPOSIA
HOUSTON, TEXAS | SEPTEMBER 17-20, 2018
GEORGE R. BROWN CONVENTION CENTER

Steam Turbine Reoccurring Rubs, Troubleshooting and Corrective Action

Patrick J. Smith
Brent M. Ziegler

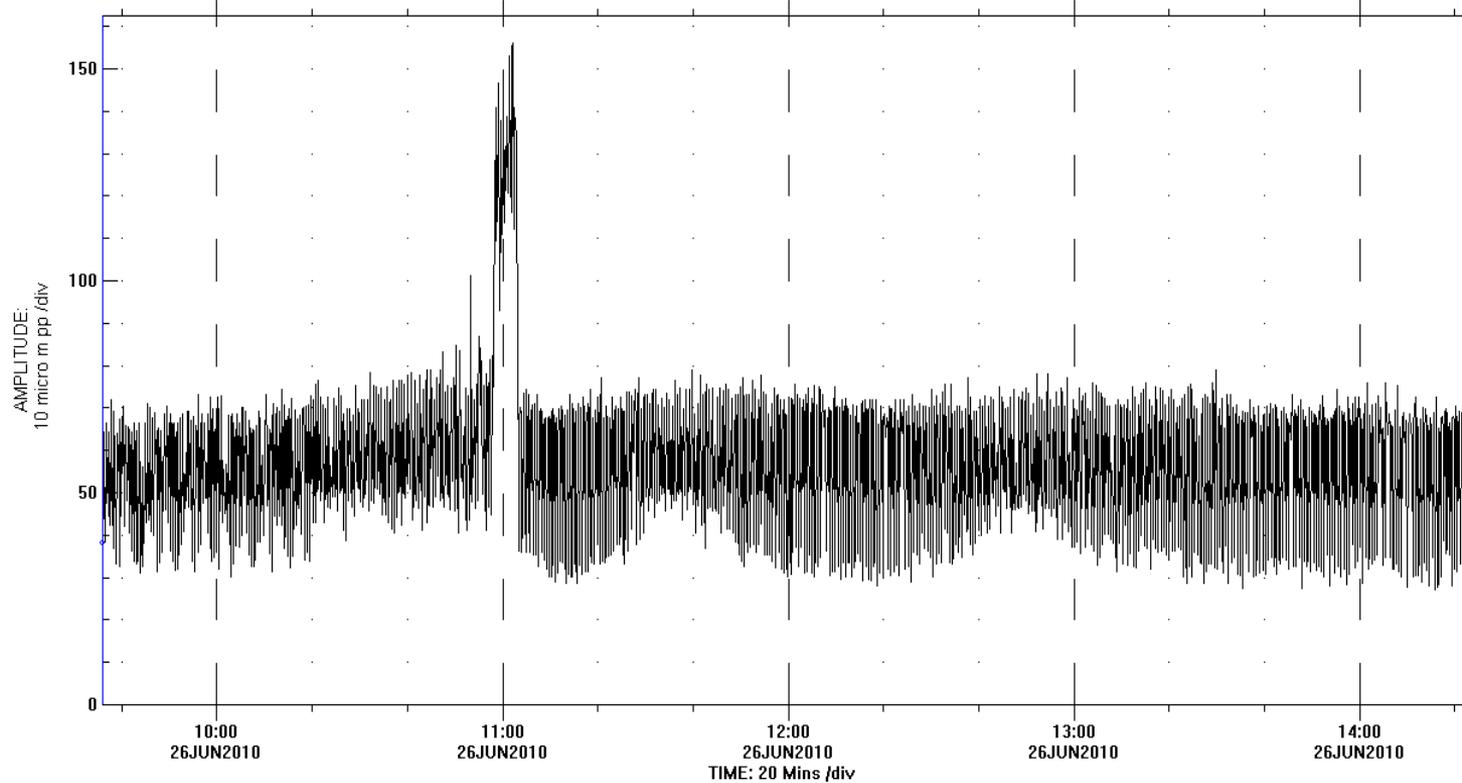
Trend from Water Mitigated Event

- How was the water spray mitigating the vibration?
- Focused evaporative cooling of only exhaust end casing support pedestals was proven effective to virtually eliminate the subsynchronous vibrations.
- Heat deflectors were added to shield the supports from the heat of the exhaust duct to the condenser.
- The exact excitation causing the subsynchronous vibrations remained elusive.

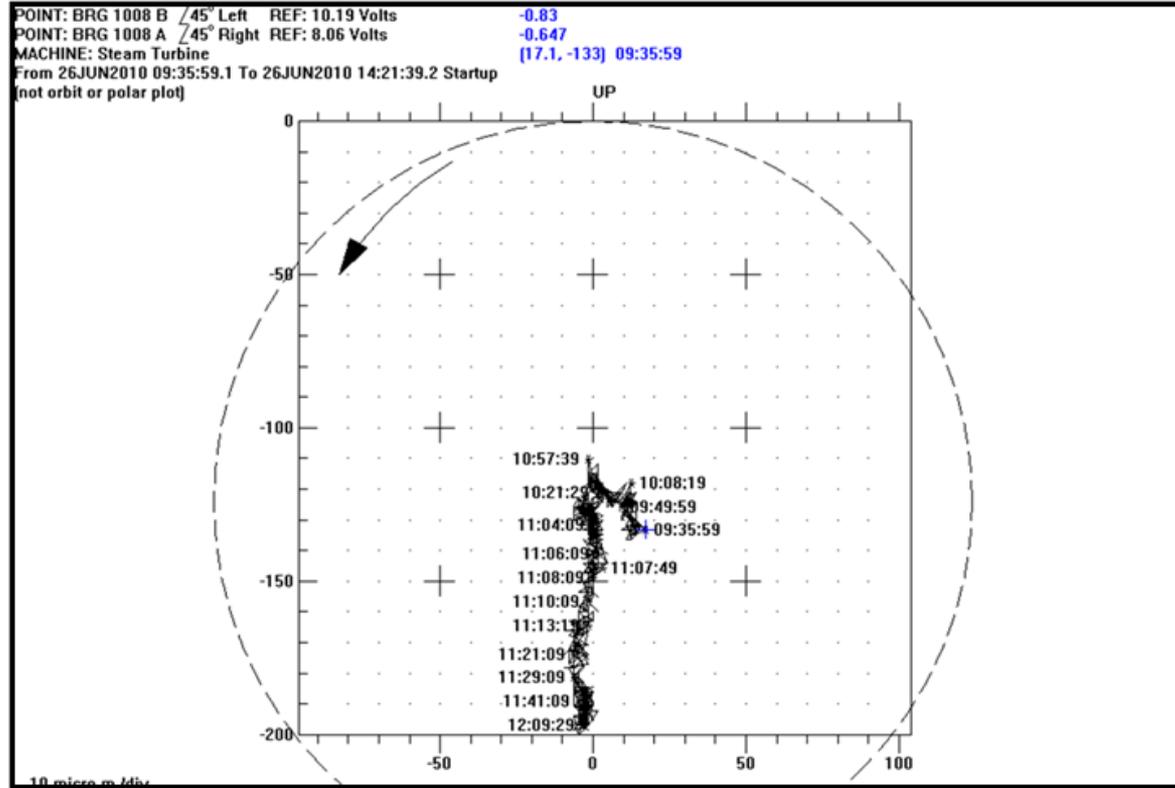
Shaft Centerline Plot for Mitigated Event

- Quick onset and disappearance of the subsynchronous vibration indicative of instability.
- Shaft centerline changes and Orbit flattens.
- .38x run speed, near rotor critical.
- Customer hired consultants deem the vibration behavior atypical of a rub, point to fluid instabilities in the seals or bearings.
- ***If it were a rub, how could the components not 'wear in' with so many hours in operation at elevated vibration levels?***

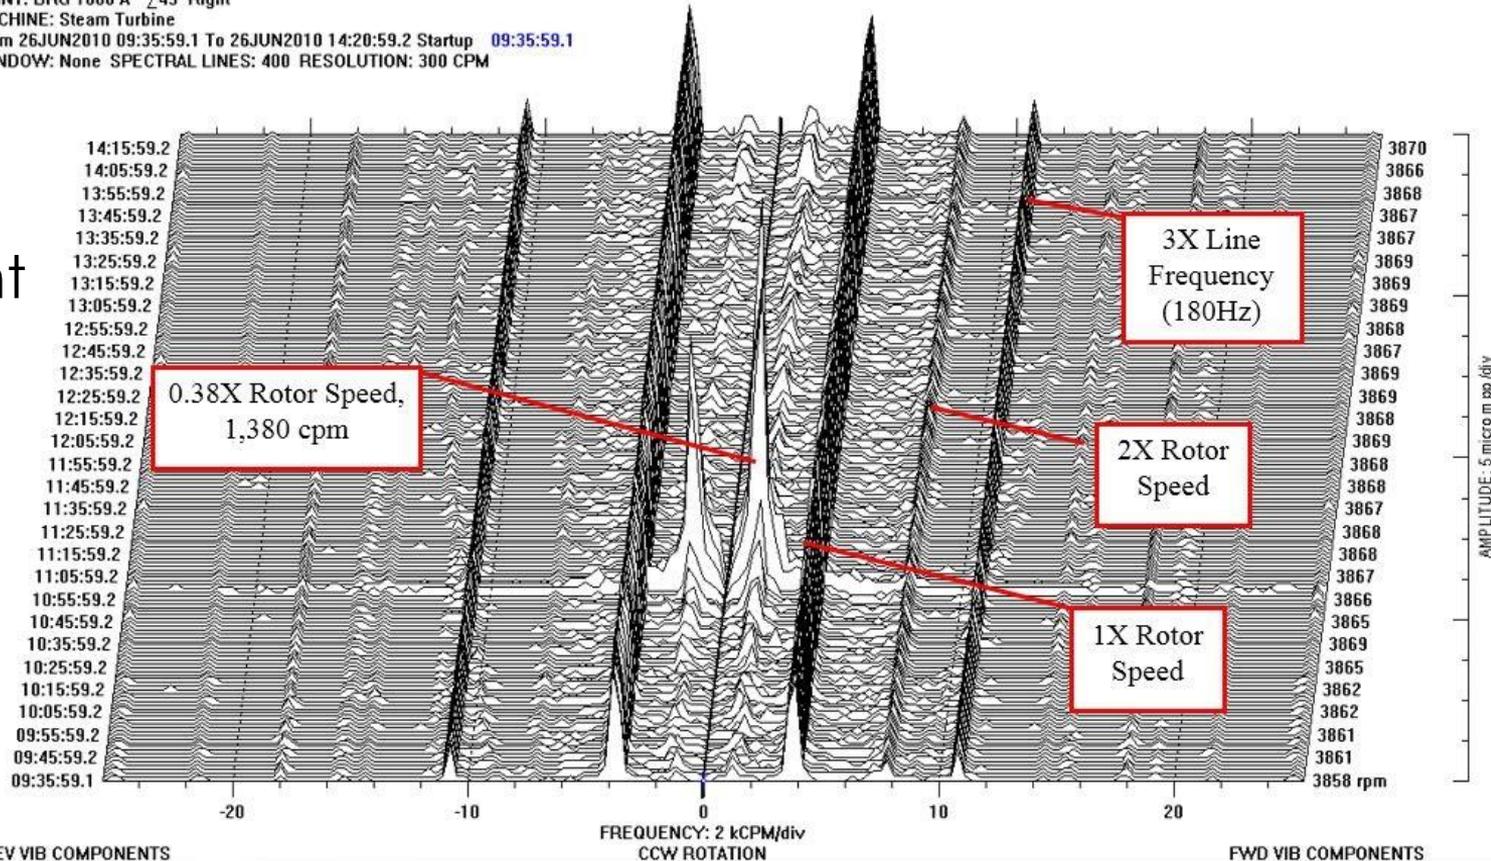
Full Spectrum Waterfall - Exhaust End

- Steady 1x Magnitude and Phase
- >2 mil displacement on bearing housing
- Mitigated with water cooling

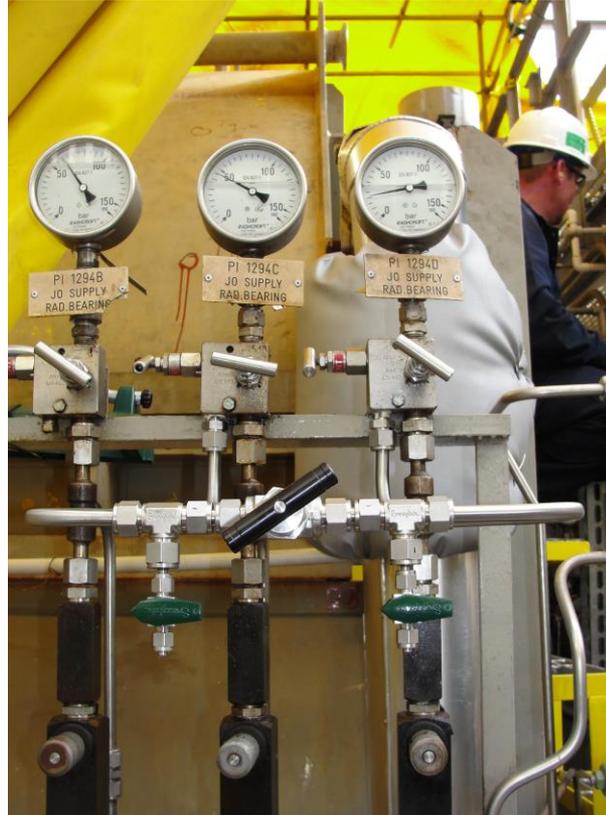
Jacking Oil Static Pocket Cross Tie

- OEM Rotordynamic analysis showed a very stable rotor bearing system.
- Ambient induced phenomenon with no correlation to load or steam conditions also puzzled vendor.
- OEM had experience cross tying the static bearing pockets of the jacking oil system on compressors with lemon bore bearings.
- Also tested running Jacking oil with Train at speed.
 - *Cross-tie enhanced stability but still required active cooling of pedestals and heat deflectors*

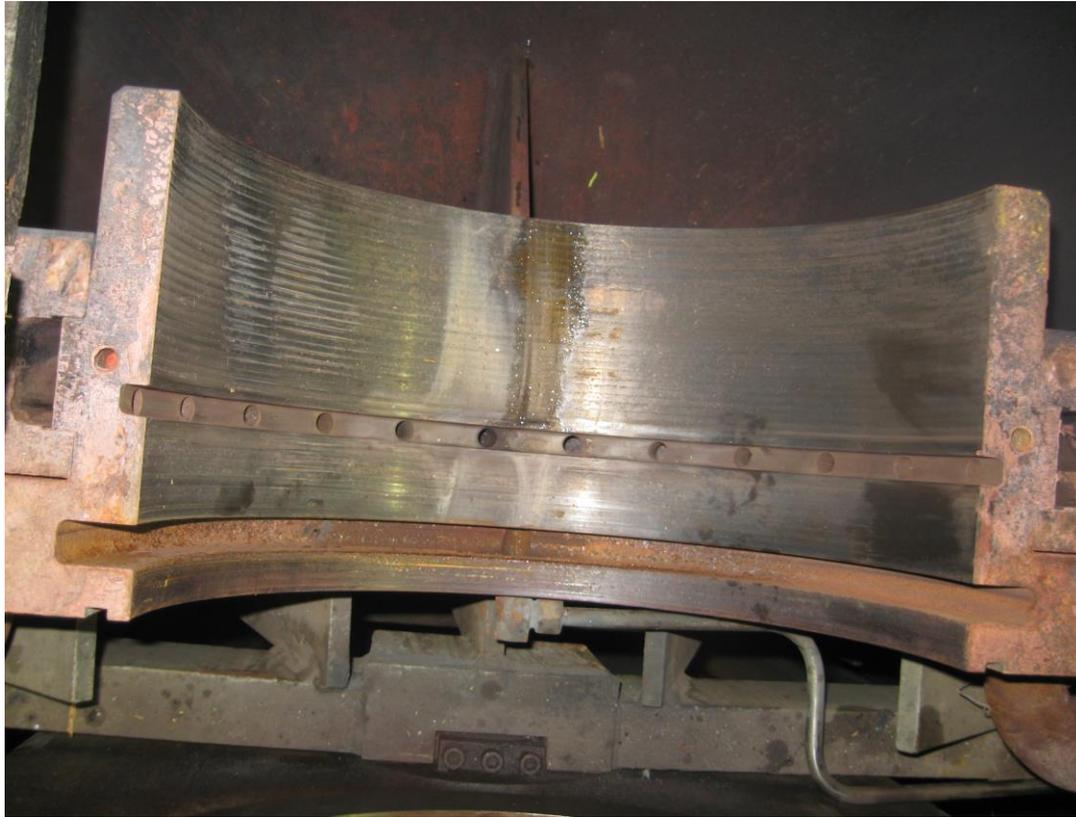
Exhaust End Gland Rub

- Exhaust end gland rub caused subsynchronous vibrations
- Multiple support surfaces and keys stuck.
 - No means to re-lubricate plain bearing areas. (history says this is not necessary indoors)
 - Turbine should not have been installed on standard support frame outside/uncovered.
- Casing was found distorted, there was not even weight distribution on supports. Difficult to assign cause between shop build, field install, and or some distortion in operation.
- Casing still moves slightly unevenly to one side during warmup. All external forces or support binding has not been fully resolved, but has had a 'clean run' since 2012.

- Re-shimmed casing improving on factory internal alignment and weight distribution on supports.
- Repositioned inner casing and blade carriers within casing to improve concentricity.
- Opened up Exhaust end gland clearance, custom machined offset geometry.
- Lubricated and moved without removal some inaccessible keys.
