47TH TURBOMACHINERY & 34TH PUMP SYMPOSIA
HOUSTON, TEXAS | SEPTEMBER 17-20, 2018
GEORGE R. BROWN CONVENTION CENTER

*Preventing a Major Wreck on a New Reciprocating
Compressor: The importance of commissioning testing*

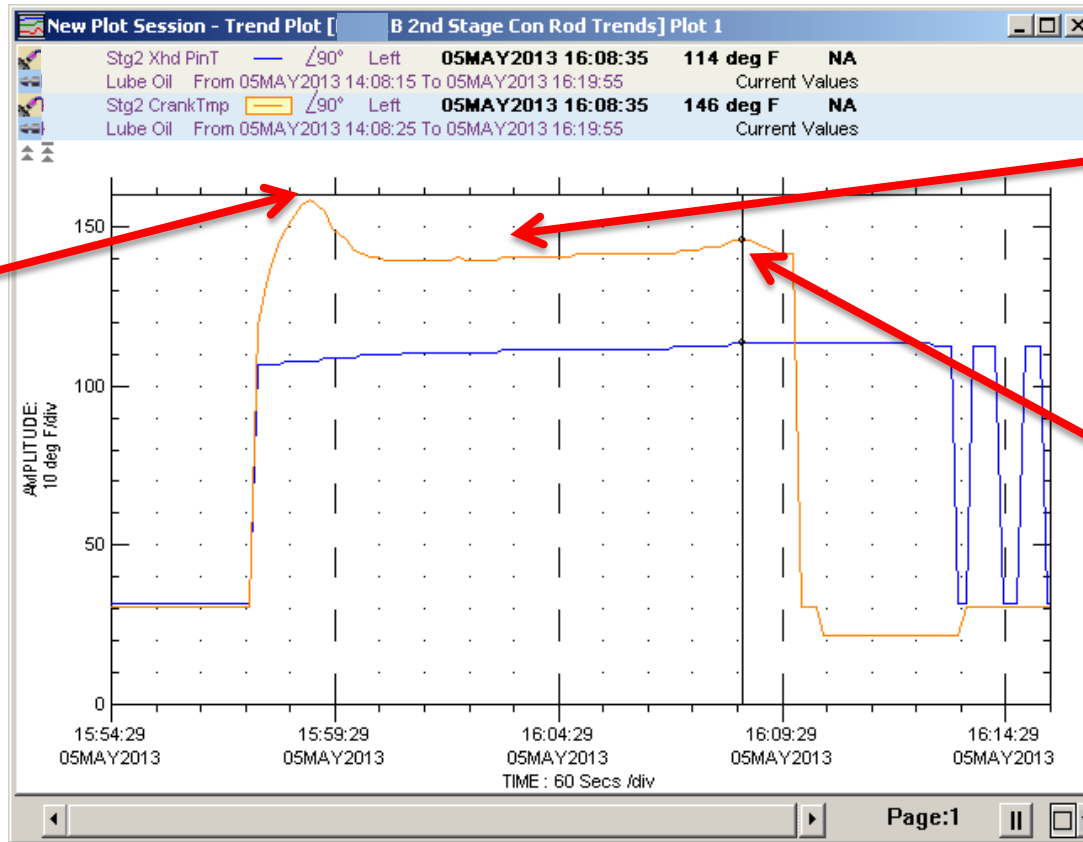
2nd Stage Connecting Rod Bearing Temperature

~ 1 ½ Minute peak was noted.

Temperature Dropped and leveled off

Slight increase near the end of the run

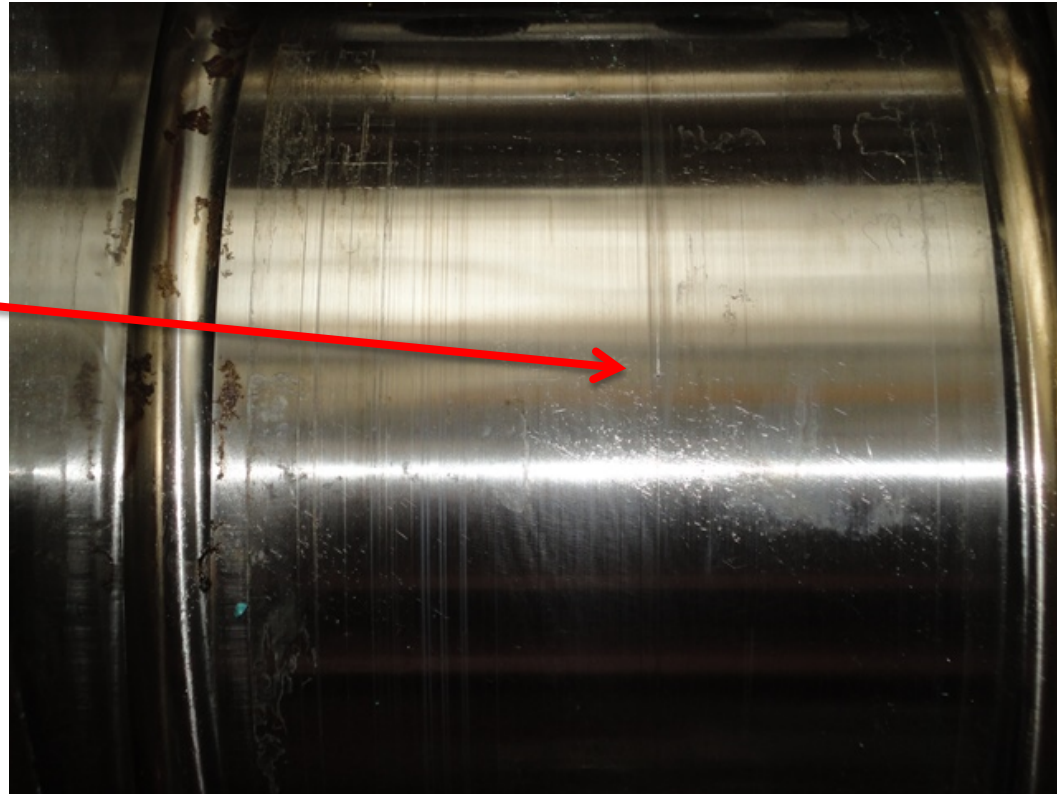
Debris in Crank Pin Journal

Embedded
Particle

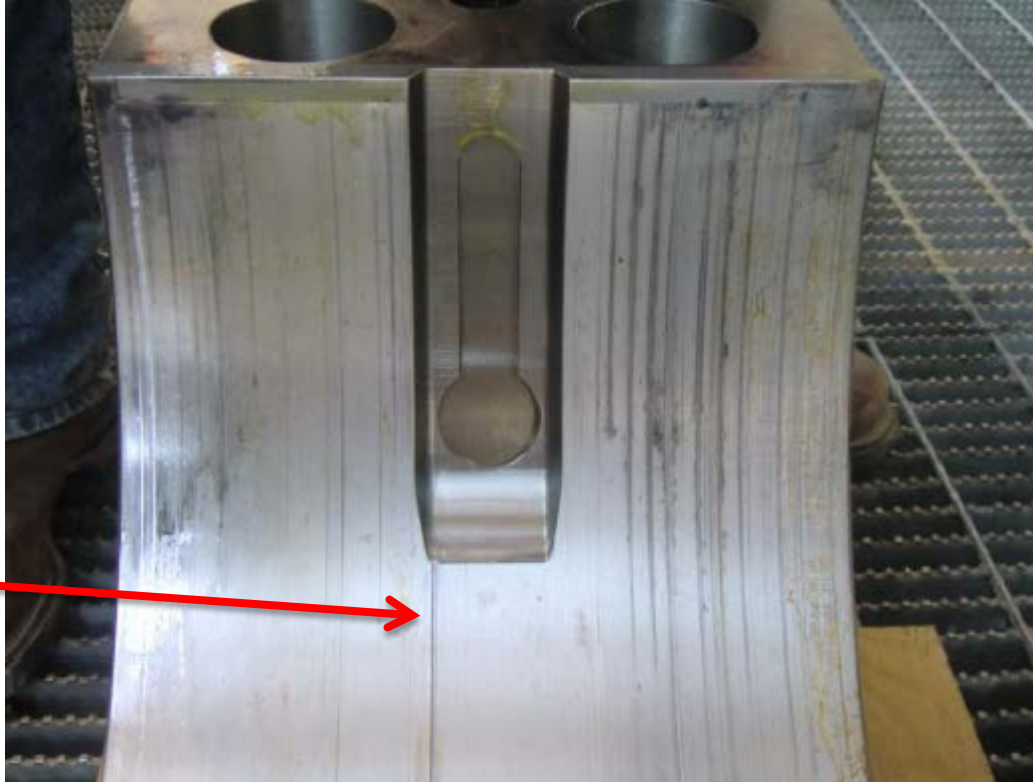
Debris in Crank Pin Journal Bearing

Damage
due to
embedded
particle in
shaft

- Protection/Monitoring system was active and alarmed during the test
- Debris Entered the bearing and embedded into crankshaft
- Location of temperature sensor was sufficient to measure the temperature rise
- Debris was removed and bearings replaced with out a major failure
