The Buncefield Accident

12/5/2010

Texas A&M University at Qatar

ABSTRACT

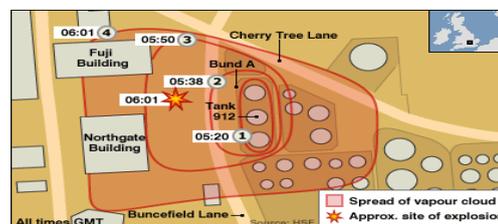
On Saturday 10 December 2005, petrol was being delivered through Buncefield's T/K pipeline to a tank, Tank 912 in bund A (Figure 2)⁴, in the northwest corner of the site.⁴ Usually, the gauges shown in Figure 3 take fuel level readings in the tank as it is being filled from a pipeline. In case the tank reaches its maximum volume limit, an automatic high level safety switch would activate an alarm, which then results in a system shutdown. Unfortunately, the safety system was not working at the time, and none of the workers realized that the filling has exceeded the tank's capacity. This resulted in fuel overflow through the roof vents. Investigators believe that the overflow occurred at around 5:20 am.³

Figure 2: How the vapor spread at Buncefield³

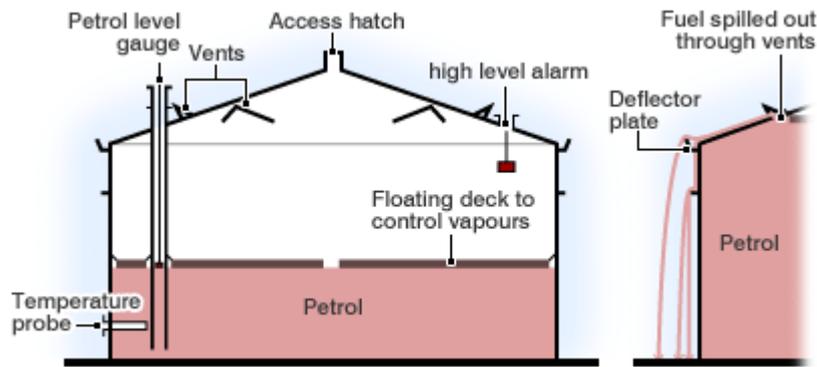
Figure 3: Tank 912³

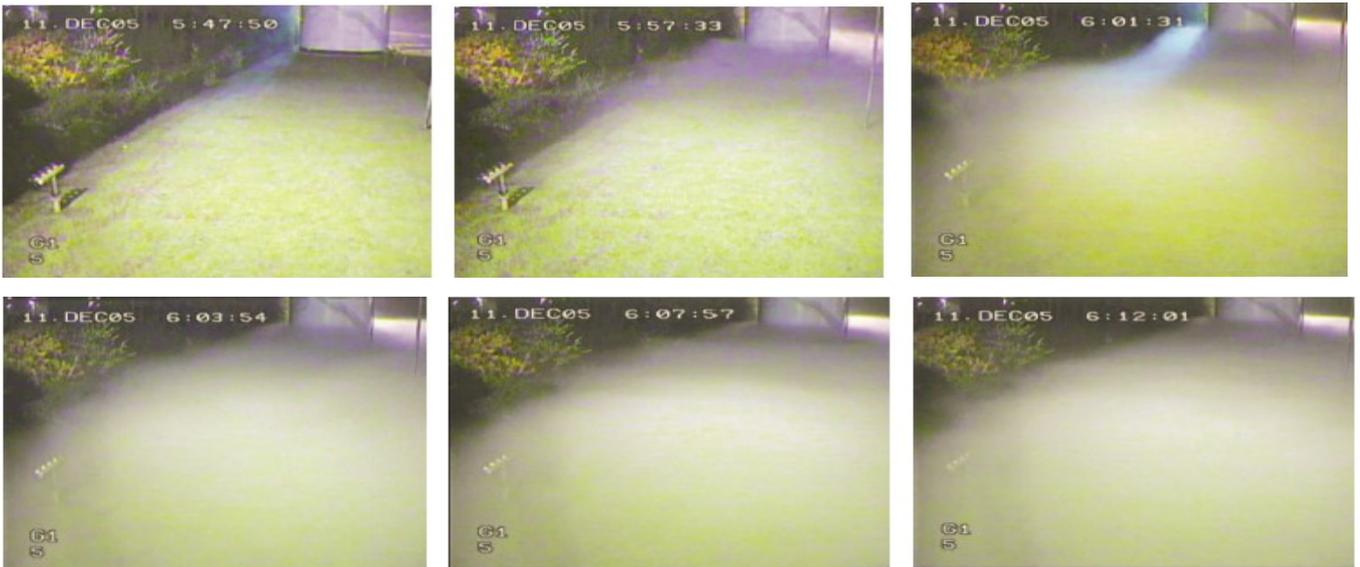
The overflow resulted in a formation of a vapor cloud rich in fuel and air at around 5:38 am. CCTV (Closed-circuit television) footages show the formation of a white misty cloud formation. (Figure 4)⁴. Although the exact composition and nature of the cloud is not known with full accuracy, investigators assumed that it might have been a volatile fraction of the original fuel, or ice formations that resulted from the chilled air as a result of the escaping fuel's evaporation.⁴

This cloud was initially approximately one meter deep; however it thickened until it reached around two meters, and started dispersing in different directions. Twelve minutes later, the vapor started drifting off near the site, close to the intersection of Cherry Tree Lane and Buncefield Lane. At 5:50 am, the rate of the fuel pumping into tank 912 was around 550 cubic meters per hour. In the next ten minutes, the rate increased to approximately 890 cubic meters per hour.³ Normally, petrol does not explode easily, however over three hundred tonnes of petrol were released from the tank, out of which approximately ten percent turned to vapor that mixed with air. This resulted in the formation of a flammable mixture, or a vapor cloud with concentrations that are high enough to combust.⁵ At 6:01 am, the vapor cloud blanketed a large area and reached the buildings next to the site where the first explosion occurred.³

Figure 4: Images from a CCTV footage⁴

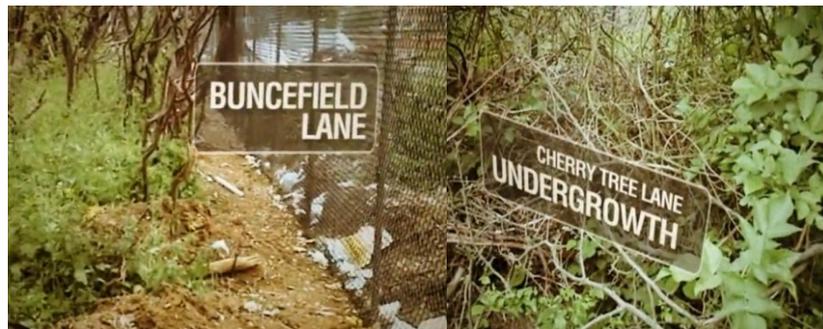
was found that the congestion that was present in the tank fire was not adequate enough to cause the high overpressure that had occurred. However, when the area of the Buncefield accident was examined, it led to the theory that the trees and the undergrowth along two roads enclosing the site formed the significant congestion that was responsible for the flame's acceleration and therefore the high overpressures in the flammable cloud ⁷.

Figure 5: Undergrowth and Trees Surrounding the Site⁷

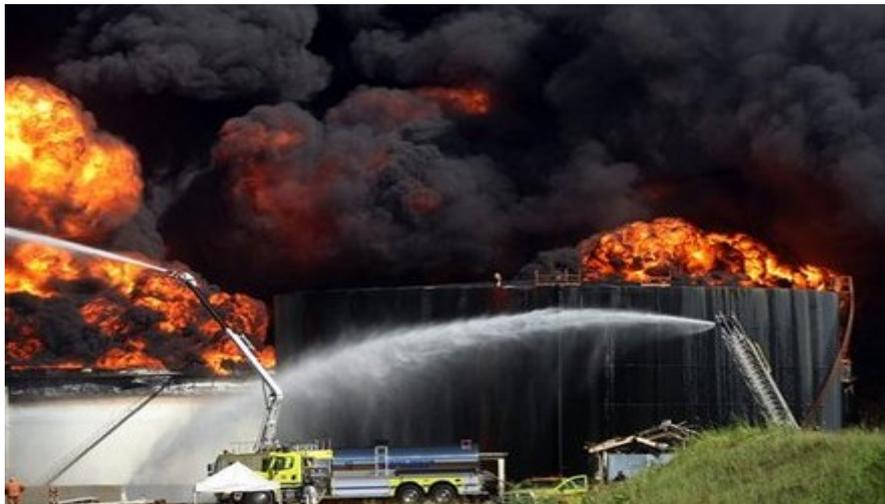
In October 23, 2009 a massive explosion and fire occurred in Puerto Rico near San Juan. More than half of the fuel depot's tanks (forty tanks) were burned. The fire lasted three days and many businesses and houses were burned. The incident was also a result of overfilling of a tank, which did not even have a monitoring system. As the gasoline started to spill from the tank, it vaporized and formed a vapor cloud approximately 2000 feet (610 meter) above the ground. The flammable vapor cloud ignited as soon as it got in contact with an unknown ignition source.¹³ Luckily enough, no one died as a result of this incident (only one person was taken to the hospital and 350 people were evacuated). The incident cost \$6.4 million.¹⁴ From the information presented, this accident was caused by the same reasons that led to the UK incident, and it can be clearly seen that the industry people did not apply the recommendations presented from the Buncefield fire.

Figure 6: Buncefield fire in Puerto Rico.¹⁴

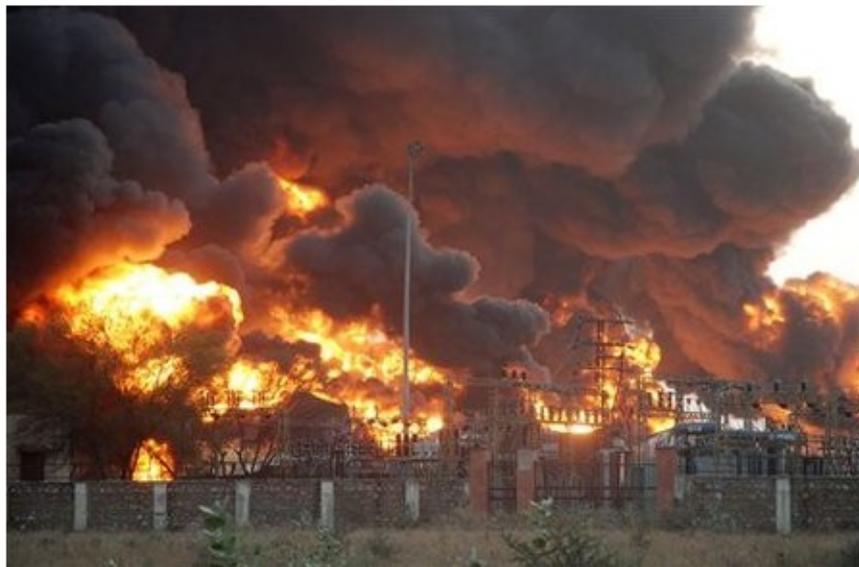
The other similar incident occurred in Jaipur, India, where the fire lasted for eleven days. Although the accident was also a result of tank overfilling, it was more careless than the previous ones as the workers bluntly overlooked all the signs of a hazard occurring. Reports reveal that alarms started and the smell of oil was detected, but the workers chose to withhold this information from the officials until it became out of anyone's control. ¹¹ Eleven tanks were burned out, and five workers died at the work site and many other were transferred to the hospital. ¹²

Figure 7: Buncefield in Jaipur, India.

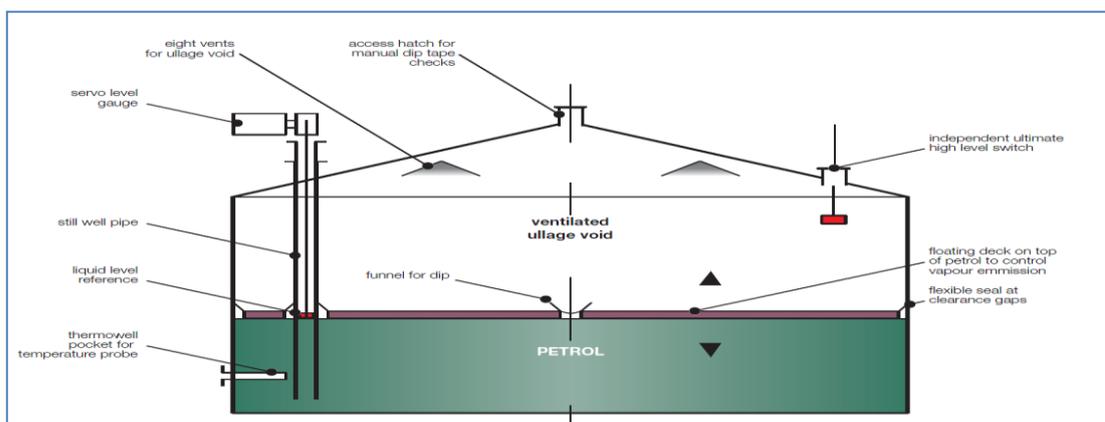
Figure 8: Diagram depicting the internal floating roof tank

The other aspect on the protection against primary containment includes fitting of automatic operating overfill prevention that is physically and electrically separate and independent from the tank gauging system. Moreover, an arrangement must be made to ensure the receiving site has control of tank filling i.e. the receiving site should be able to safely terminate or divert a transfer (to prevent loss of containment or other dangerous conditions) without depending on the availability of communications with the remote location. Hence in case of emergencies, the time delay could be prevented by not relying on communications from the transferring sites²⁰. The following Figure 8 shows the schematic diagram of a typical internal floating roof tank¹⁹.

According to the recommendation, the roof tank could be employed with an independent ultimate high level switch (upper right on figure 1). In the situation of power cutoff, the high level switch keeps functioning to monitor the safe level of the tank. The tank capacities fill levels and safety margins must also be clearly determined for all fuel storage tanks. To prevent an overflow, tanks should have headspace devices that enable the filling line to be closed off in time. The set points of high level trips and alarms should allow sufficient time for the action to be taken to deal with the developing situation¹⁷.
