TURBOMACHINERY
& PUMP SYMPOSIA

Shop Run Test Failure of an API 610 Vertical Sump Pump: what it exposed, and why it was critical to solve.

Mohamed Hazem Sadek

Enppi

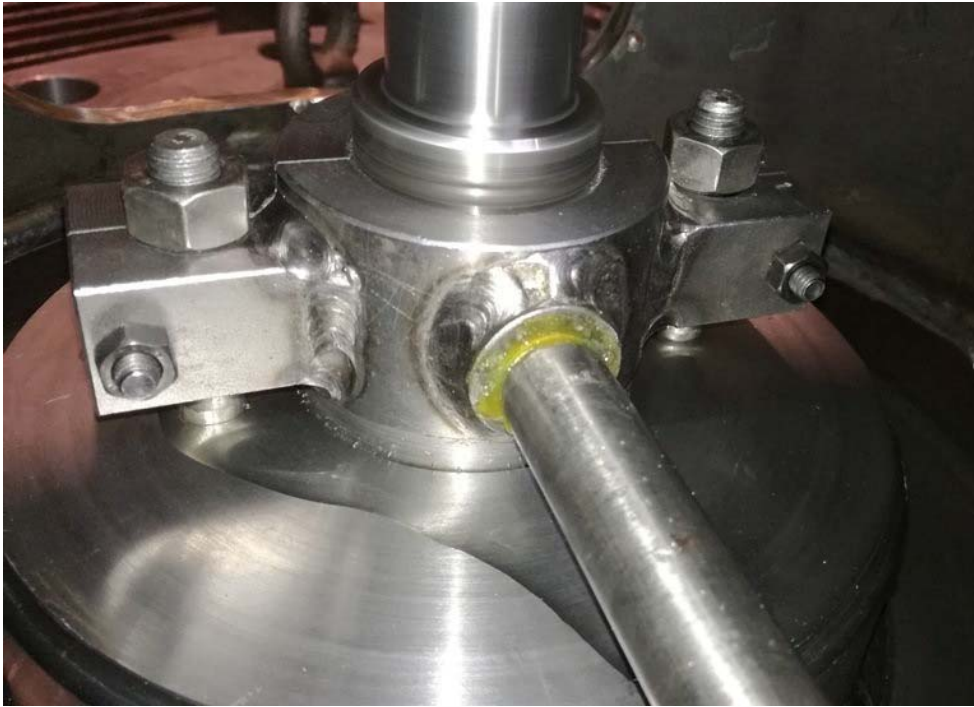
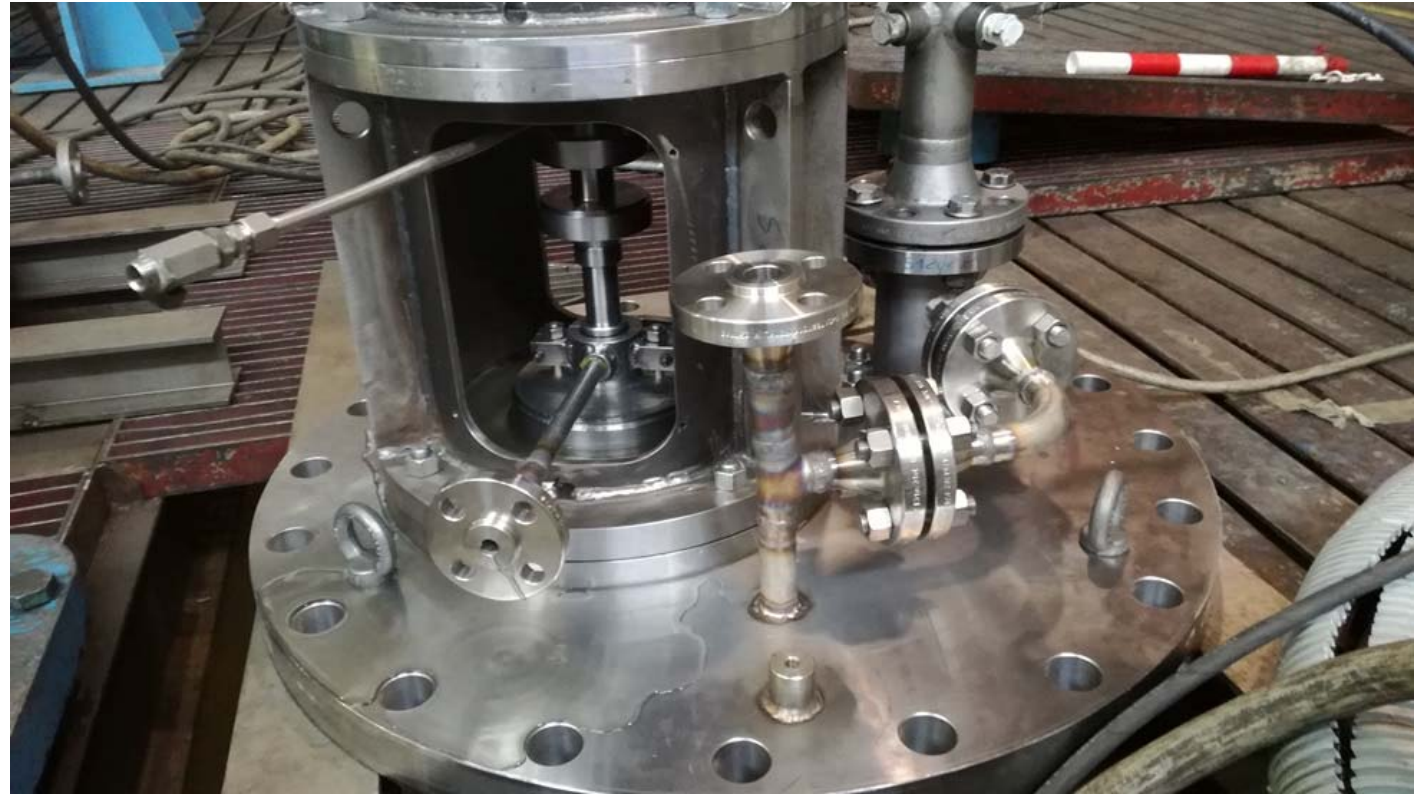
- Shop Run Testing was performed to a VS4 pump in Sulphur service for an SRU in a gas project.
- One acceptance criterion for run test is to have no leakage from pump sealing location.
- This specific service contained dry running packing due pump construction.
- The pump was found heavily leaking test liquid (Water) from the packing location which is considered a Non-Conformity.

Photos showing the test water leakage from the packing location

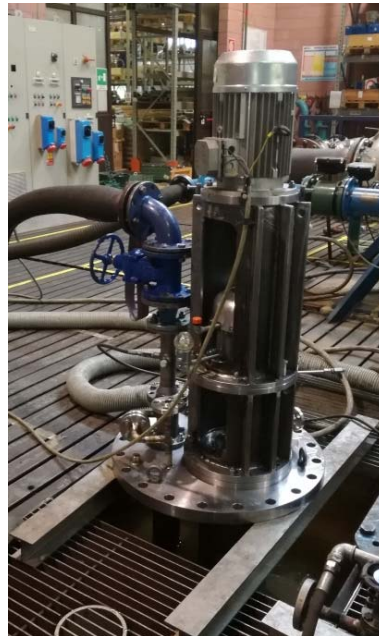
Pump at grade
Level

- The supplier suggested that the liquid level in the test bed was higher than the actual operating liquid level the pump shall operate at.
- Doubtfully, it was agreed to re-conduct the test with the pump elevated to simulate the correct liquid level at the workshop sump
- **Again the pump suffered leakage from the packing location!!!**

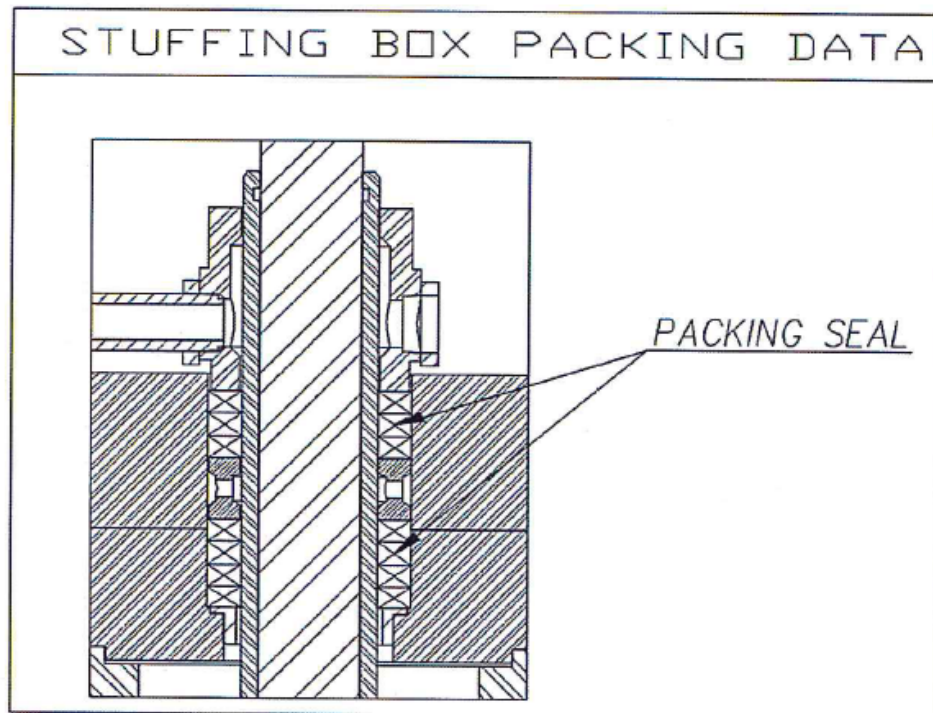
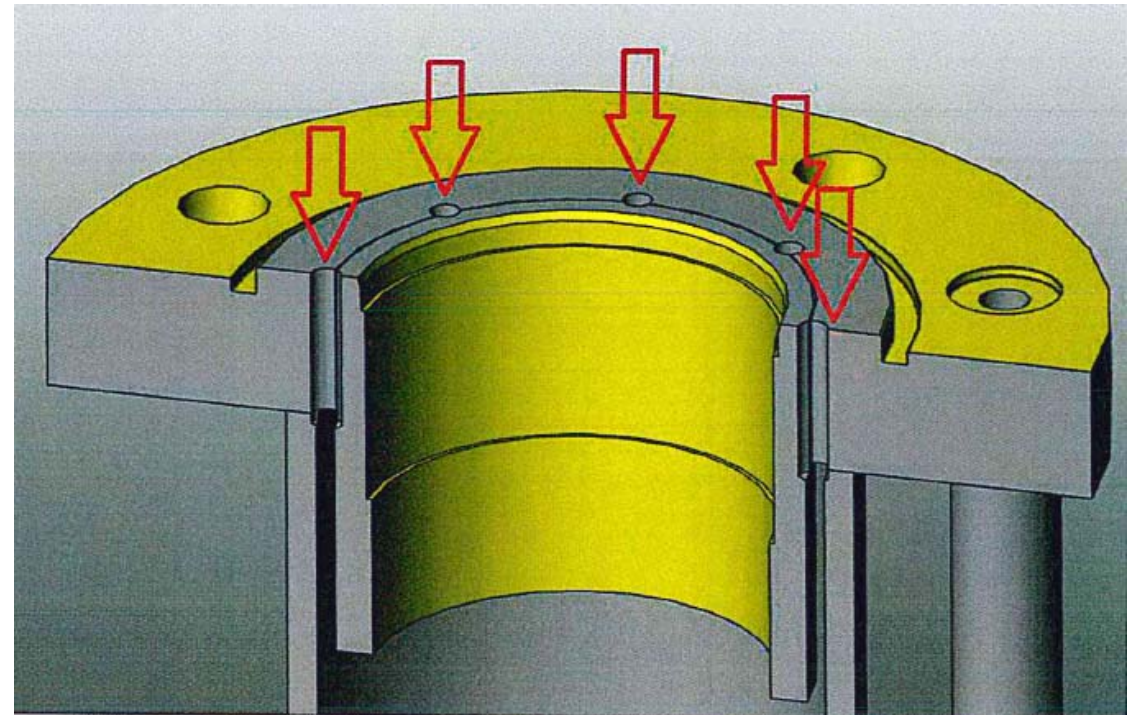
- One of the consequent suggestions raised to the supplier was to examine proper internal drainage of the pumped fluid to be sufficient.
- After conveying the concerns about drainage from the engineering team, Supplier performed a root cause analysis (RCA) to the issue.
- The RCA suggested also inadequacy of the drainage system inside the column (support pipes) that caused accumulation of the pumped liquid up to the packing location.
- Pump was disassembled and examined, which revealed that the **drainage holes were totally missing from both casing and intermediate support pipes!!!**

- The RCA and disassembly uncovered the missing drainage holes, immediately the supplier started with the remedy action needed: drilling 10 drainage holes in each location

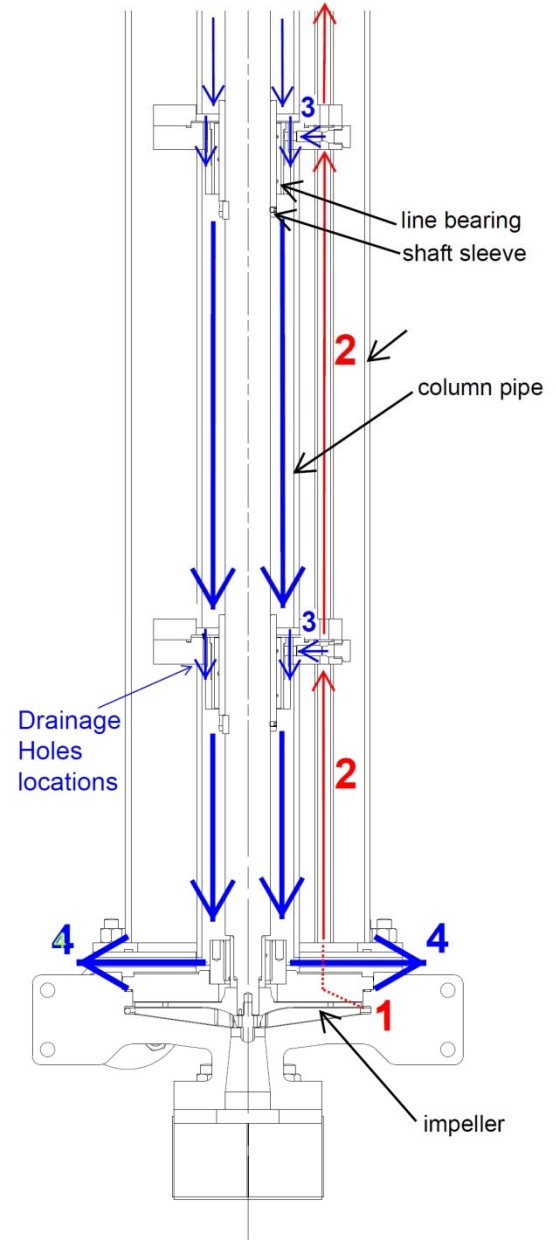
Legend and Explanation for Lubrication path inside the pump that caused leakage:

- 1) Source of liquid: Flow from impeller to guide bearings
- 2) Pipe route with flow from impeller to the bearings
- 3) Chamber where flow should take to fall back by gravity through the column
- 4) The path back to the vessel after passing through the drainage holes (That were missing)

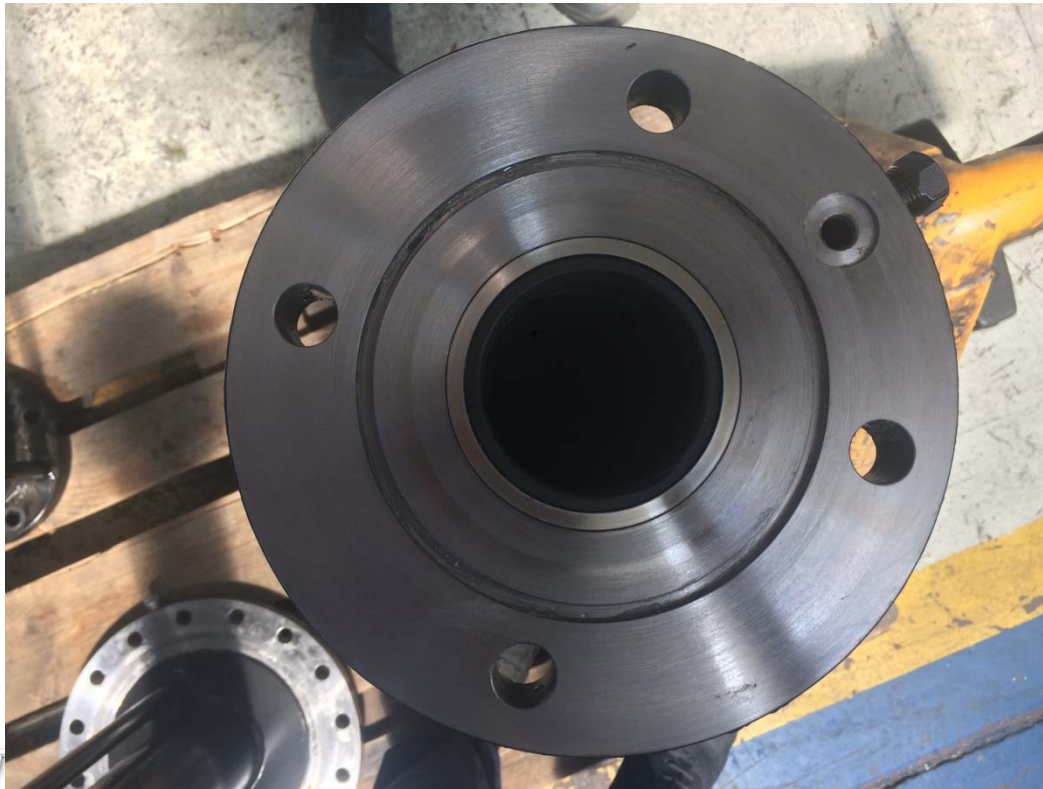
BEFORE

- The below Photos show the drilling location for drainage holes that were actually executed on the pump
