TURBOMACHINERY  
& PUMP SYMPOSIA

# Extending MTBF of Seals in Boiler Feed Water Service

Case Study – Christopher “Topher” Ropp  
Principal Engineer - Flowserve AMSS, Kalamazoo MI

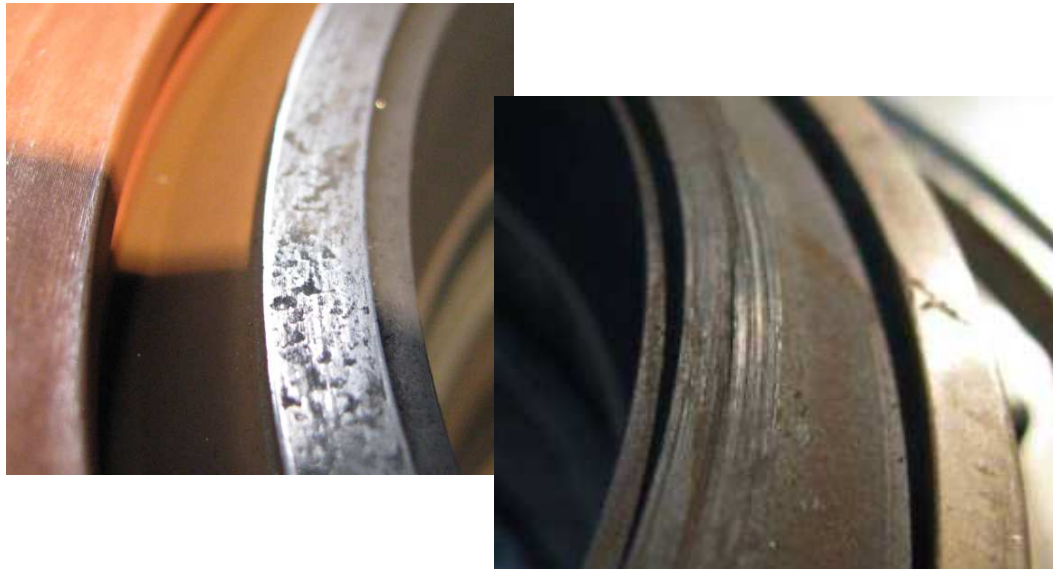
Carbon - Stator

# 1. Inadequate Cooling

Lead to Excessive Face Damage

- Added an internal pumping device to OD of Sleeve to increase the seal circulating device flow (3 – 5 gpm)
- Installed larger capacity Plan 23 seal coolers
- Needed more CW flow to remove heat - ran new CW piping to each end of the pump (10 - 15 gpm)

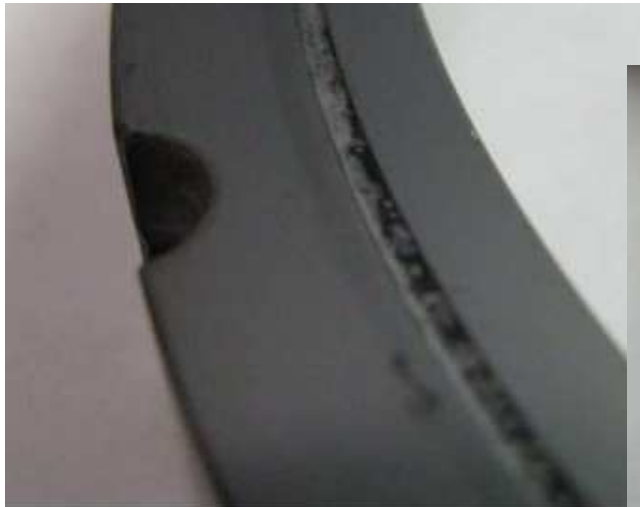
Heavy Fretting was noticed in three (3) distinct areas

Figure 38: Back of rotating face

- Seal cavity temperatures above 160°F can cause flashing and instability within the seal
- Reduced sleeve to shaft clearance to API 682 fits of **F7/h6** will reduce seal wobble
- Added 2<sup>nd</sup> key slot to the sleeve ID for higher speed mechanical stability at 5500 rpm

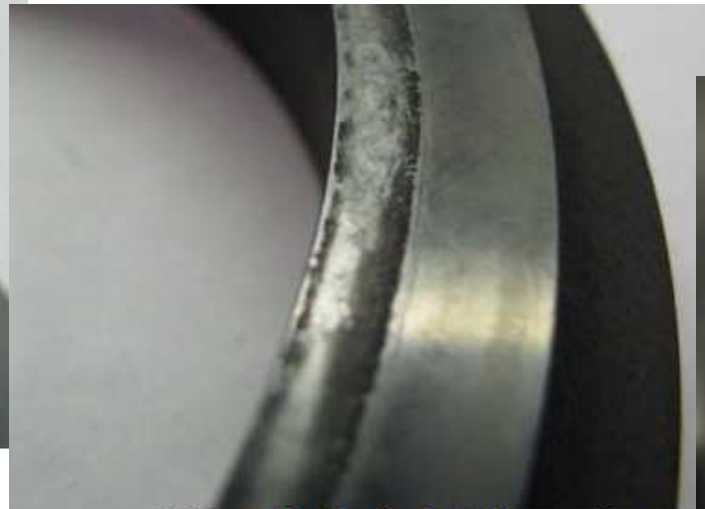
Figure 32: Back of stationary face

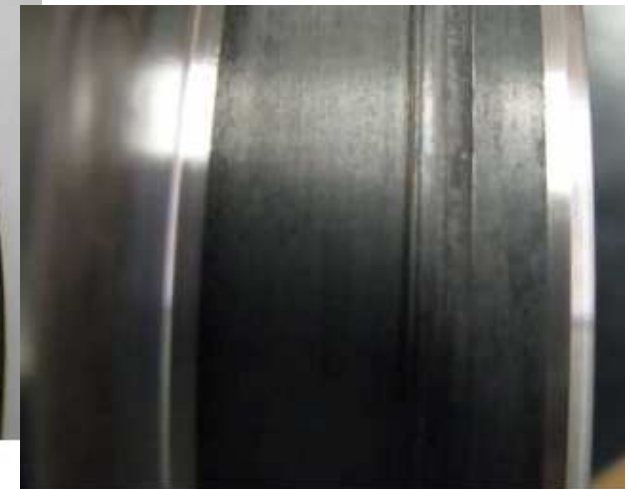
Figure 52: Fretting marks on dynamic

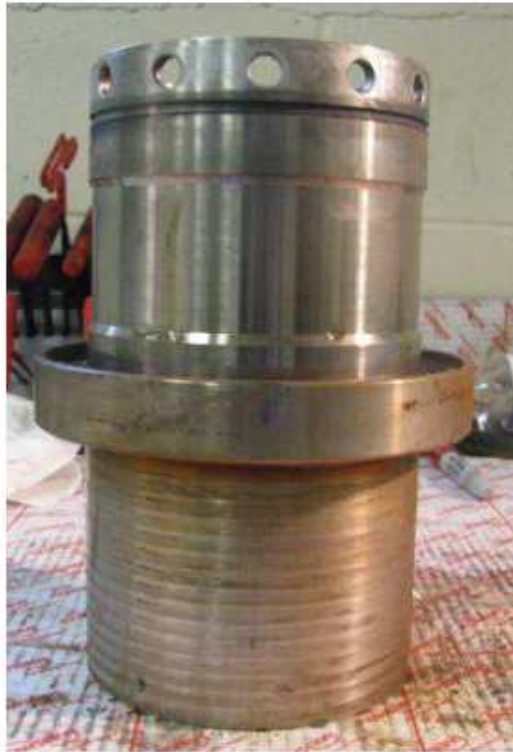
Figure 3 - Entire Sleeve as Returned

#### Heavy contact between the Sleeve OD and Bushing ID

- The Long Metal Bushing was designed for Pressure Breakdown
- Tight 0.015" radial clearance
- Loose sleeve ID to shaft OD clearance
- One key slot was in the bottom of the sleeve

- Redesign bushing to a shorter Carbon thermal break design vs. Metal pressure breakdown design
- Increased Bushing clearances to ensure no contact between the Bushing and Sleeve
- Changed sleeve to 17-4 material that is stronger and lower thermal expansion rate
