The Effects of a Water Plant Structural Foundation on Non-Clog Pump Vibration

Maki M. Onari

Sept. 12, 2019

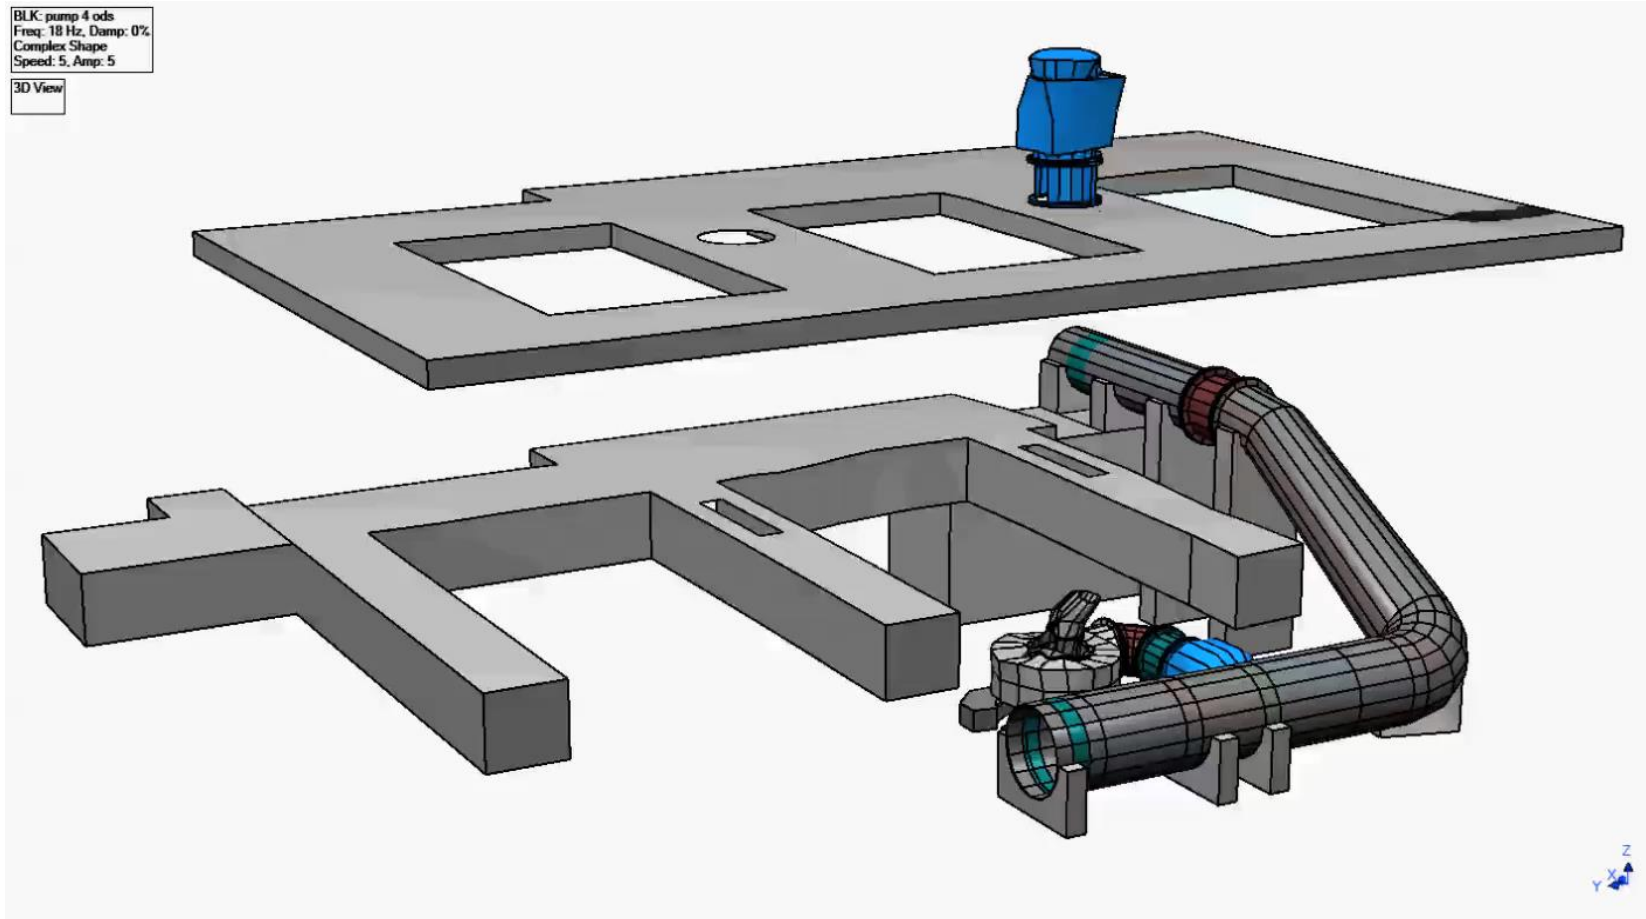
HLMSP#4 ODS Animation at 3x rpm of Step 4 (VPF or 18 Hz) with High WWL

4. The stiffness of the HLMSP#4 bridge has been compromised due to looseness detected between the bridge and the south side wall of the station, which is part of the wet well. This looseness at the wall connection caused non-linear changes in the structural natural frequency of the bridge. When the WWL was high, the water contained in the well compressed the bridge increasing the vertical bending mode of the bridge to 19.1 Hz, which fell into resonance with vane pass frequency (VPF) of the pump at Step 5 (19.0 Hz). Once the water level was reduced, the structural natural frequency of the bridge was also reduced down to 18 Hz. This increased the separation margin from the main excitation source (VPF).

4. The pump station should consider supporting the bridge of HLMSP#4 from the pump level using vertical I-beams anchored at the top and bottom or by using an additional concrete pier. Additional supports should also be considered near the north side of the station.

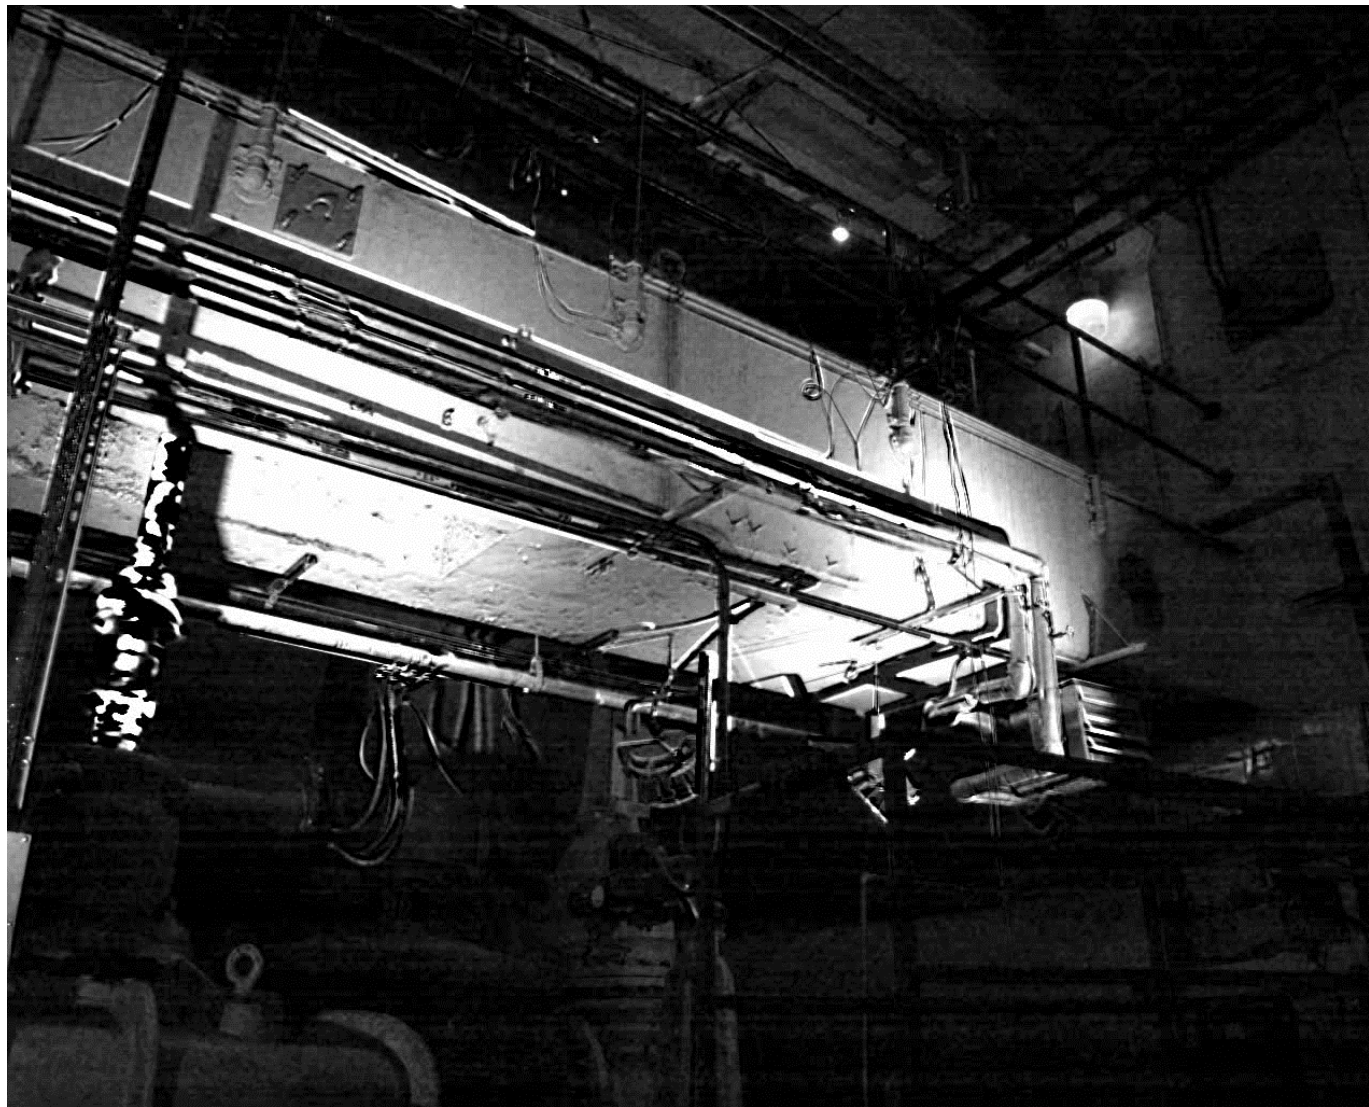
HLMSP#4 Intermediate Bearing MAV at 19 Hz (VPF at Step 5)

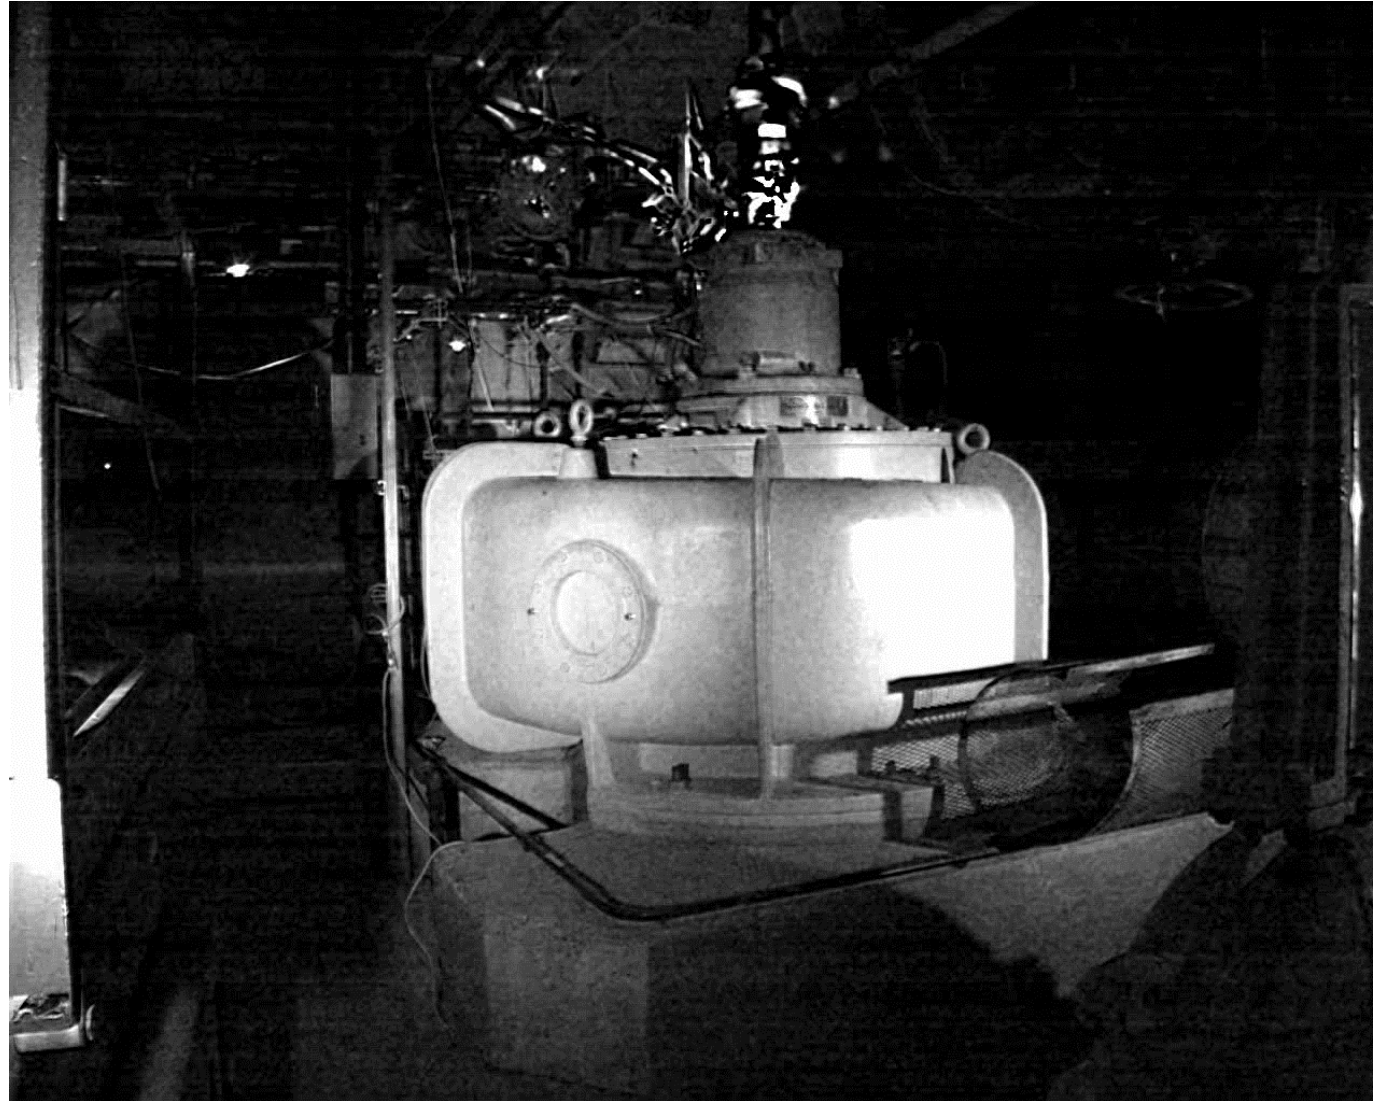
HLMSP#4 MAV at 19 Hz (1xVPF at Step 5)

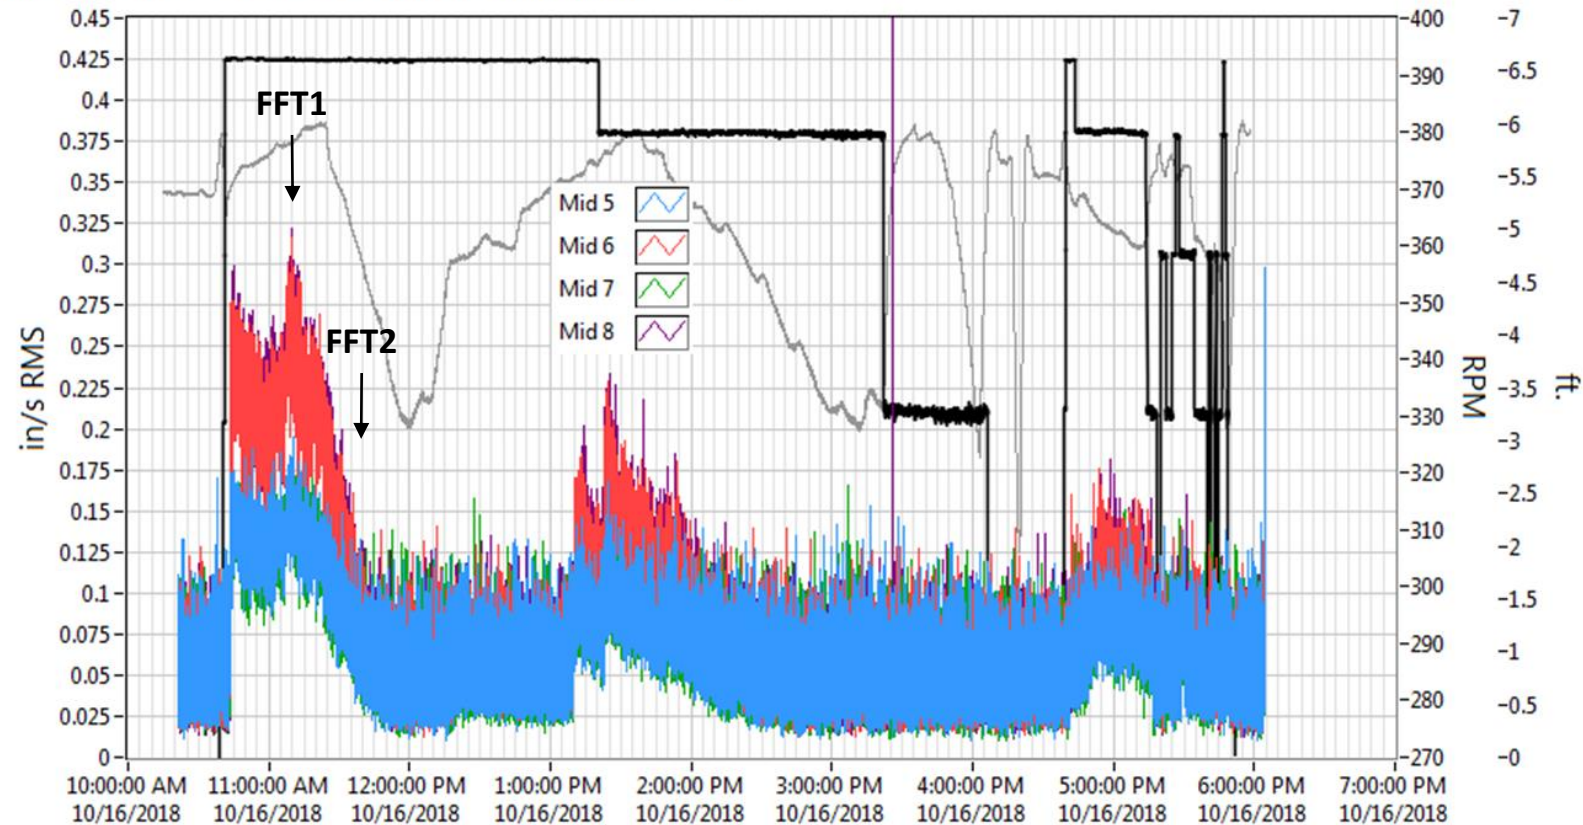
Overall Vibration at the HLMSP#4 Bridge (intermediate level) at Different WWL and Operating Speeds

Intermediate Floor Overall Vibration (Mid 5-8)

1. Upper and intermediate floor vibrations exceeded the recommended limit of 0.032 in/s RMS for *Workshop and non-sensitive areas* by a factor of 10, where the vibration can be distinctly felt.
2. HLMSP#4 bearing tower vibration was higher than the HI spec of 0.34 in/s RMS for operation within the POR, but was within the HI spec of 0.44 in/s RMS for operation within the AOR. The pump operates outside the AOR at Steps 5 and 6 at high WWL. This vibration caused lateral and vertical motion of the pump.
3. Pump vibration was transmitted to the intermediate bearing through the drive shaft (original drive shaft with four couplings). It was suspected that the teeth of the gear couplings were worn out due to prolonged use and potential lack of lubricant. These gear couplings are supposed to permit and tolerate axial motion (axial slip).

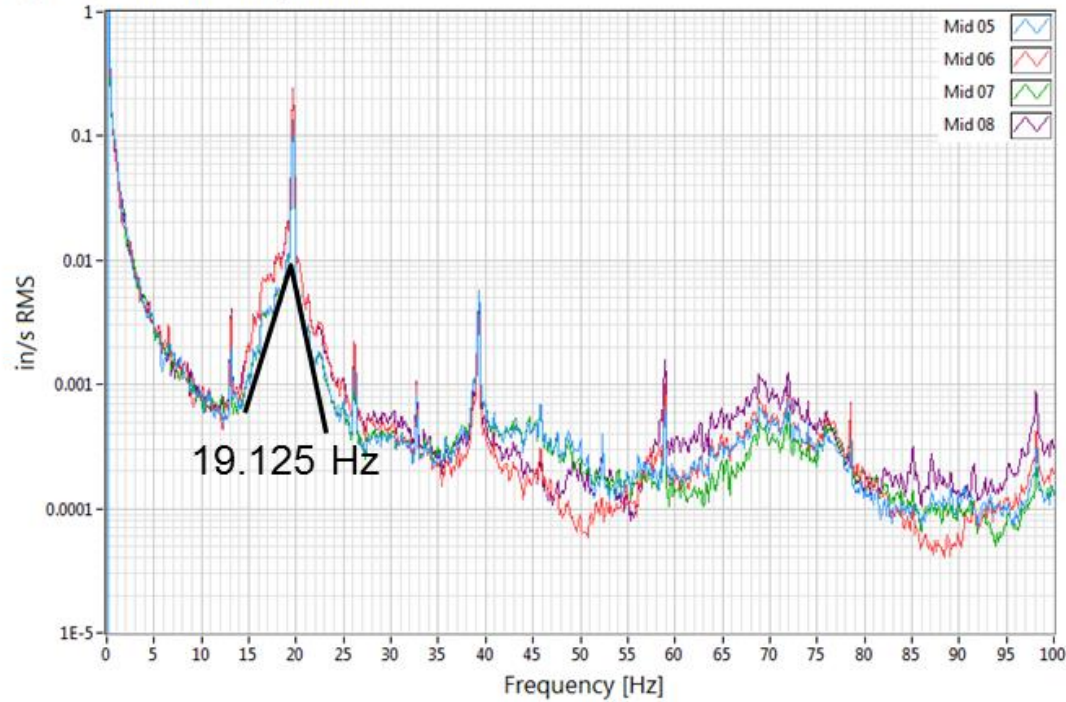
FFT1

Step 6 (390 rpm) and 6 ft WWL

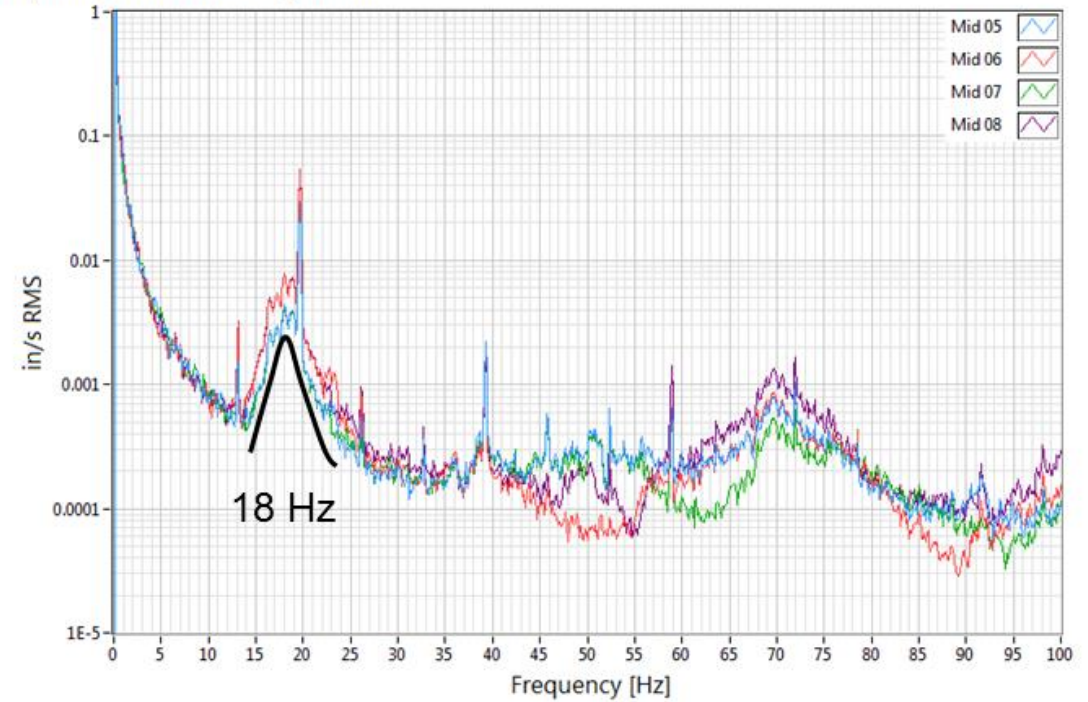
FFT2

Step 6 (390 rpm) and 4 ft WWL
