TURBOMACHINERY
& PUMP SYMPOSIA

Identifying the cause of a plunger pump shutdown

Data logging to the rescue

Kelly Eberle, Michal Gaca

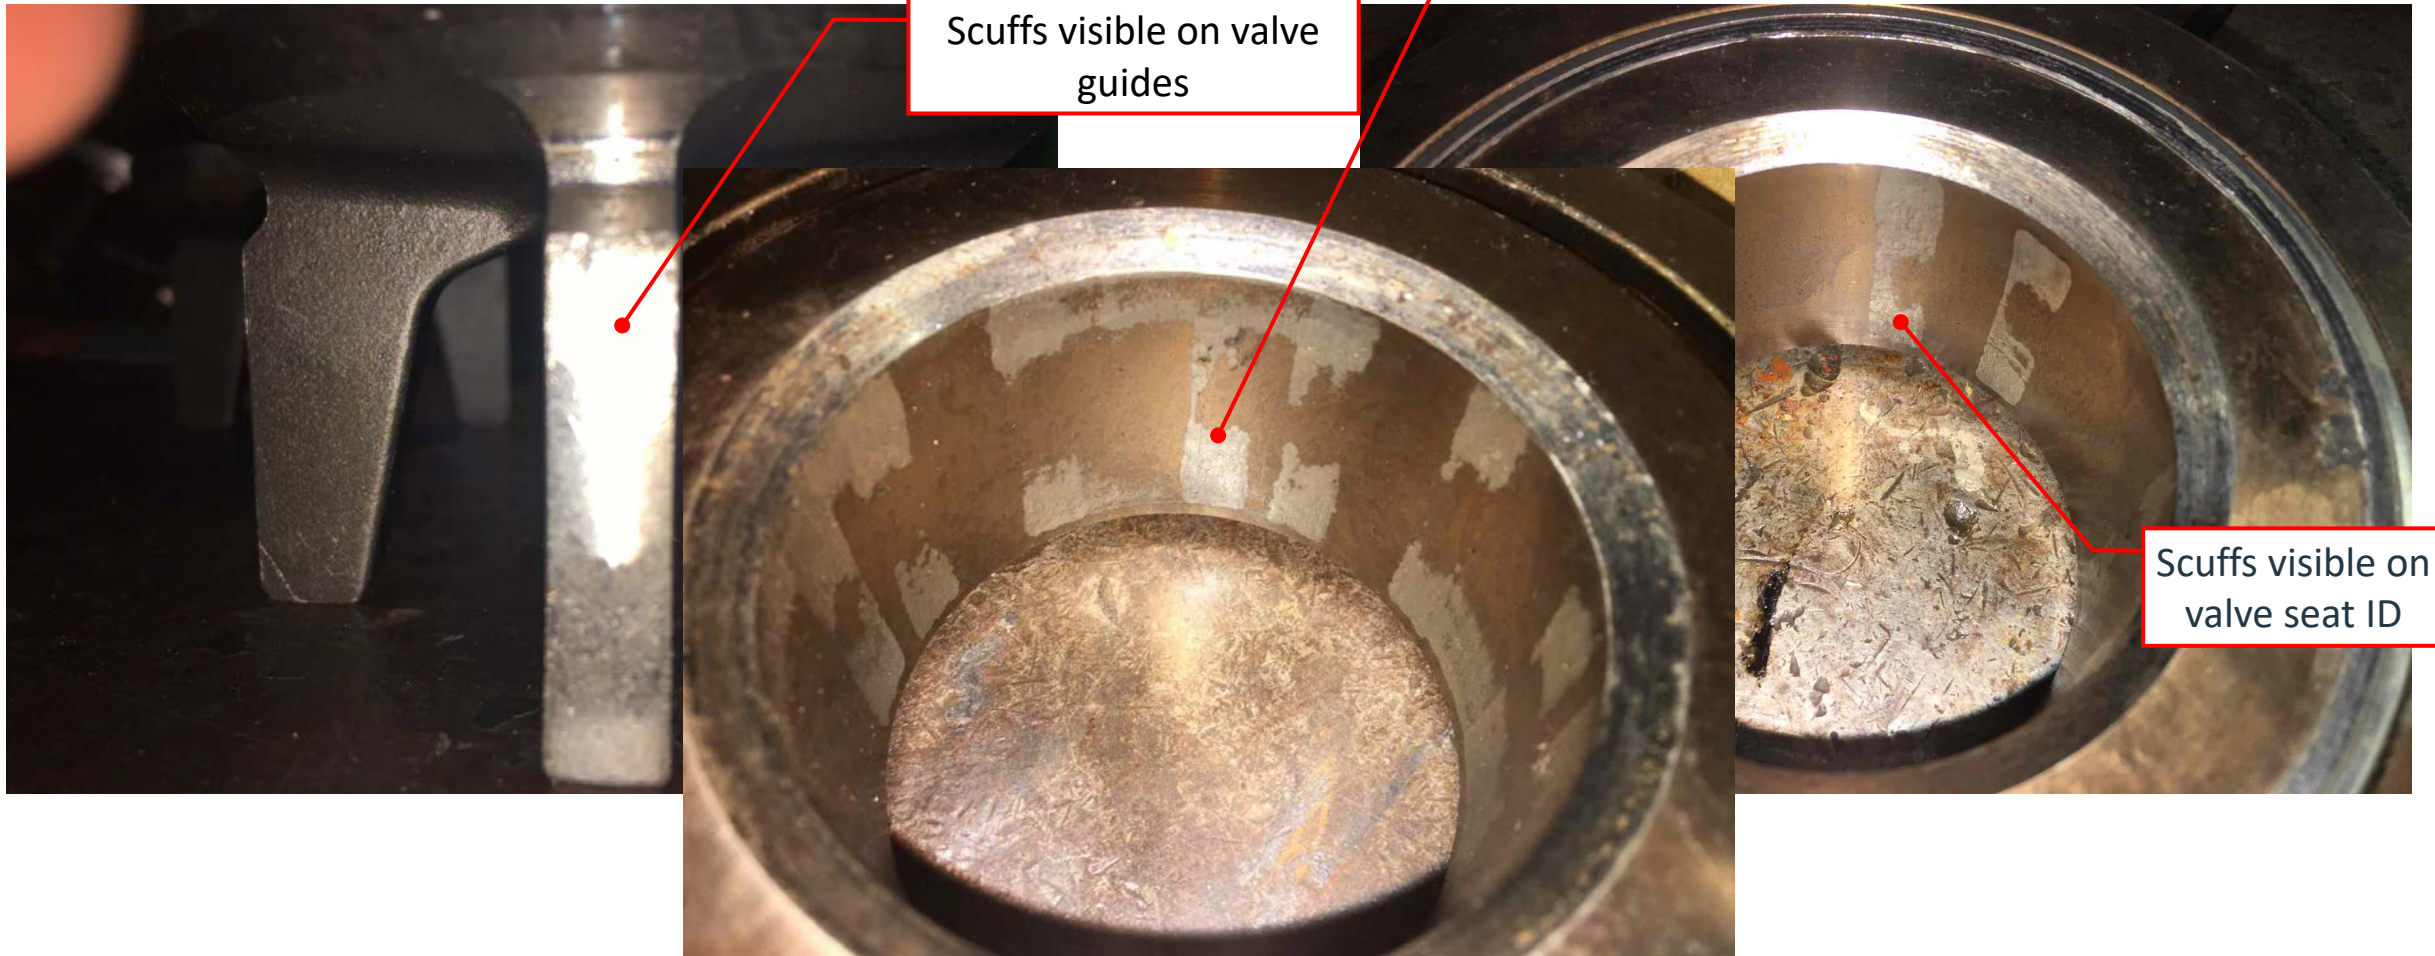
Damaged valves

- Inspection of pump valves: wear on valves was unusual, as they had recently been replaced
- Valve closing angles: ~ 15 degrees ADC when operating at high speed (233 rpm) with original valves/springs
- Old valves and springs (40# rating) were removed
- New valves installed with higher spring stiffness (80# rating) to improve valve operation
- Valve closing angles were reduced to 8 degrees with the new (2x stiffer) springs

Scuffs visible on valve seat ID

Scuffs visible on valve guides

- Change stiffer springs to more flexible springs
- Pumps have operated for several months without tripping with the more flexible springs
- Unsolved mystery: Why did the throw #2 discharge valve stick?
 - Only one of two pumps had problems
 - Problems appeared only on throw #2
 - Stiffer valve springs should have improved the performance
- Additional site testing and simulations proposed to determine root cause
- Pumps running OK with more flexible springs. No further work done.

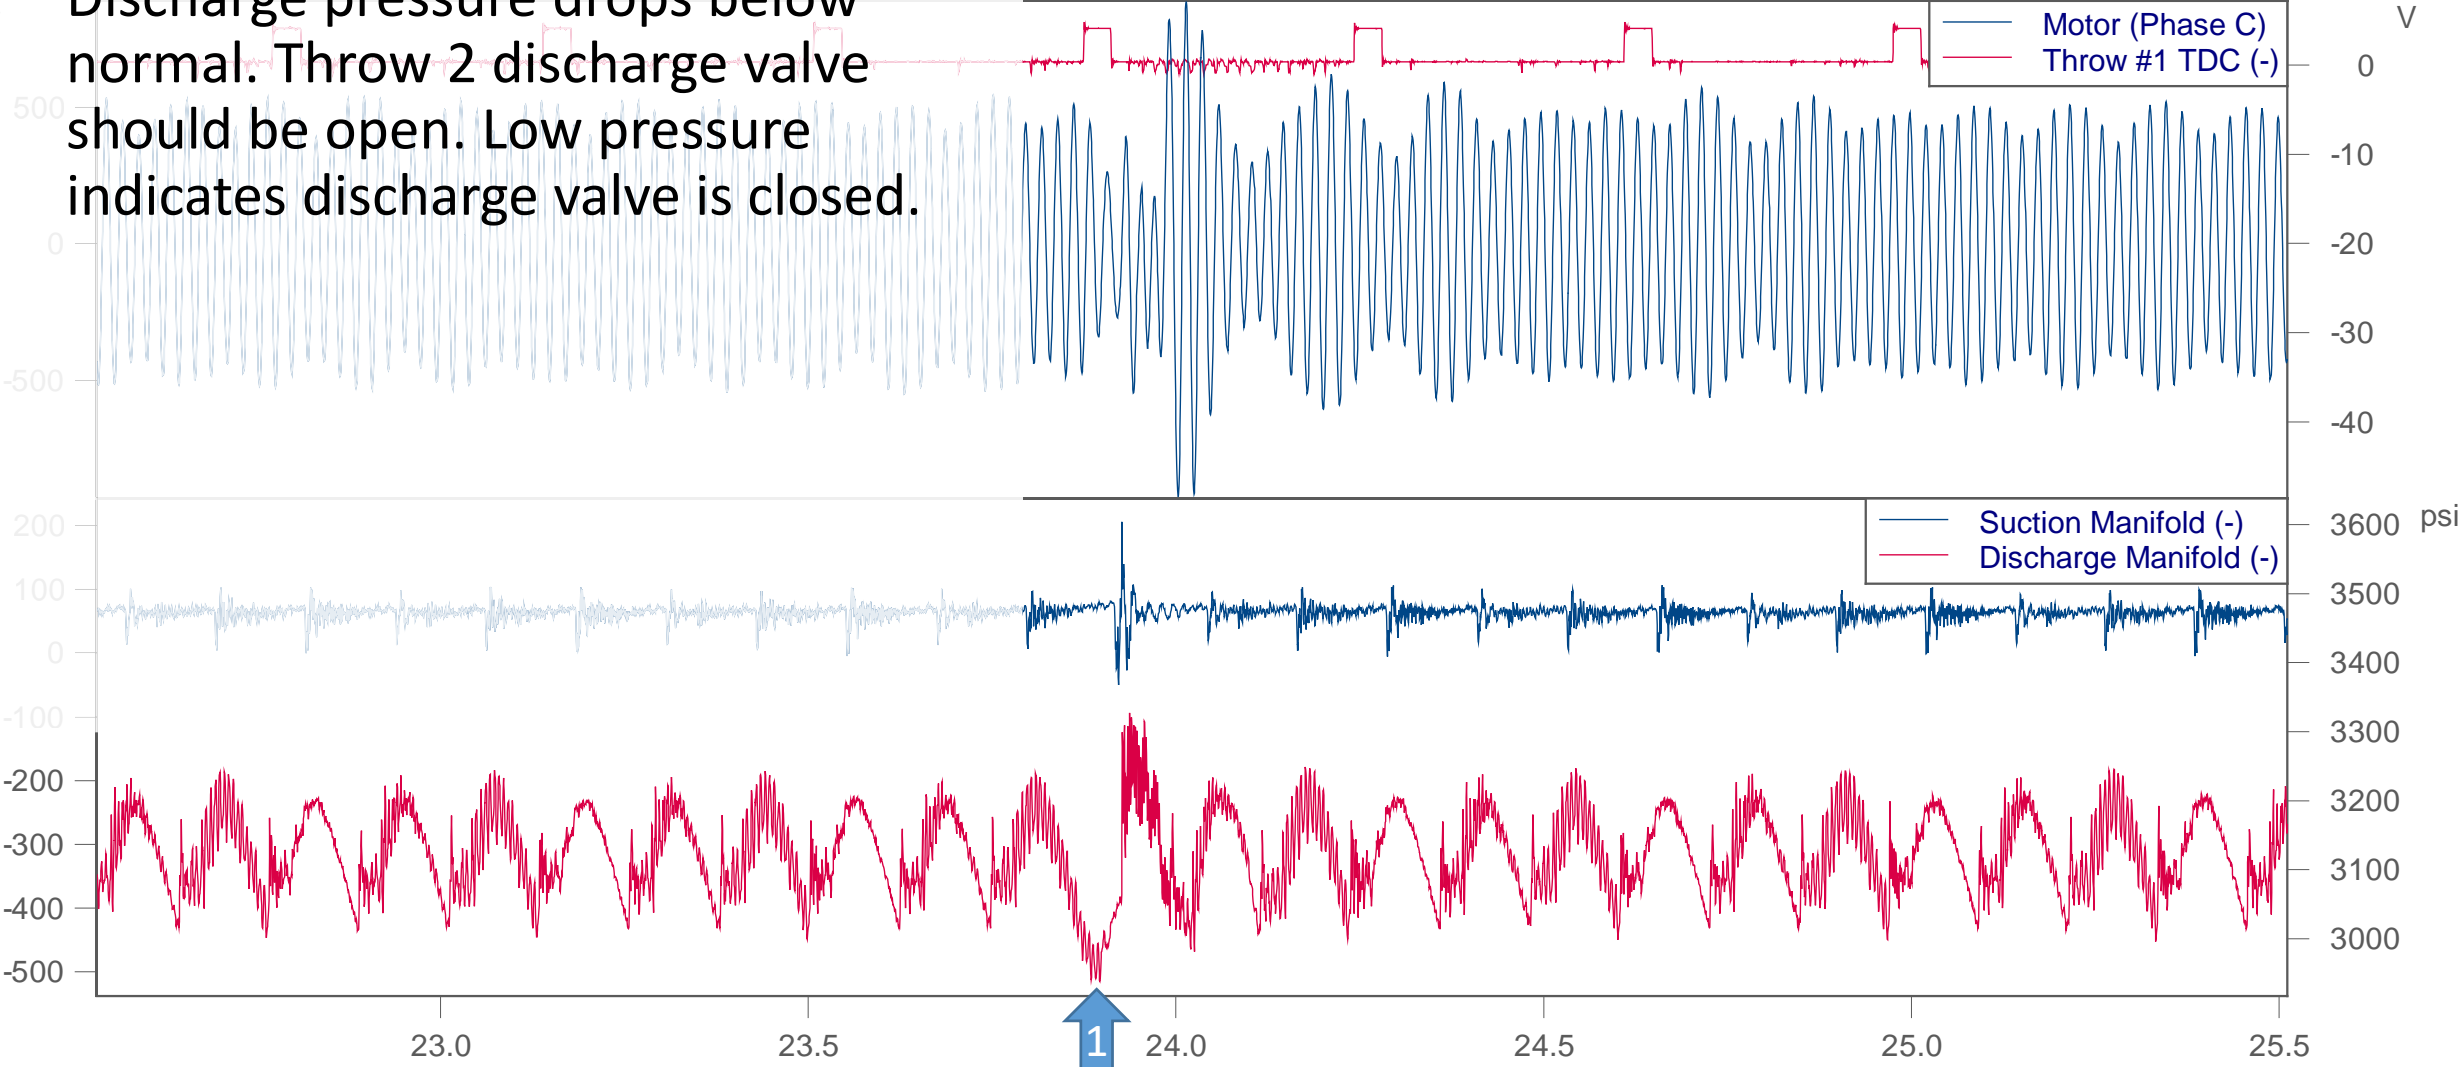
1. Discharge pressure drops below normal. Throw 2 discharge valve should be open. Low pressure indicates discharge valve is closed.

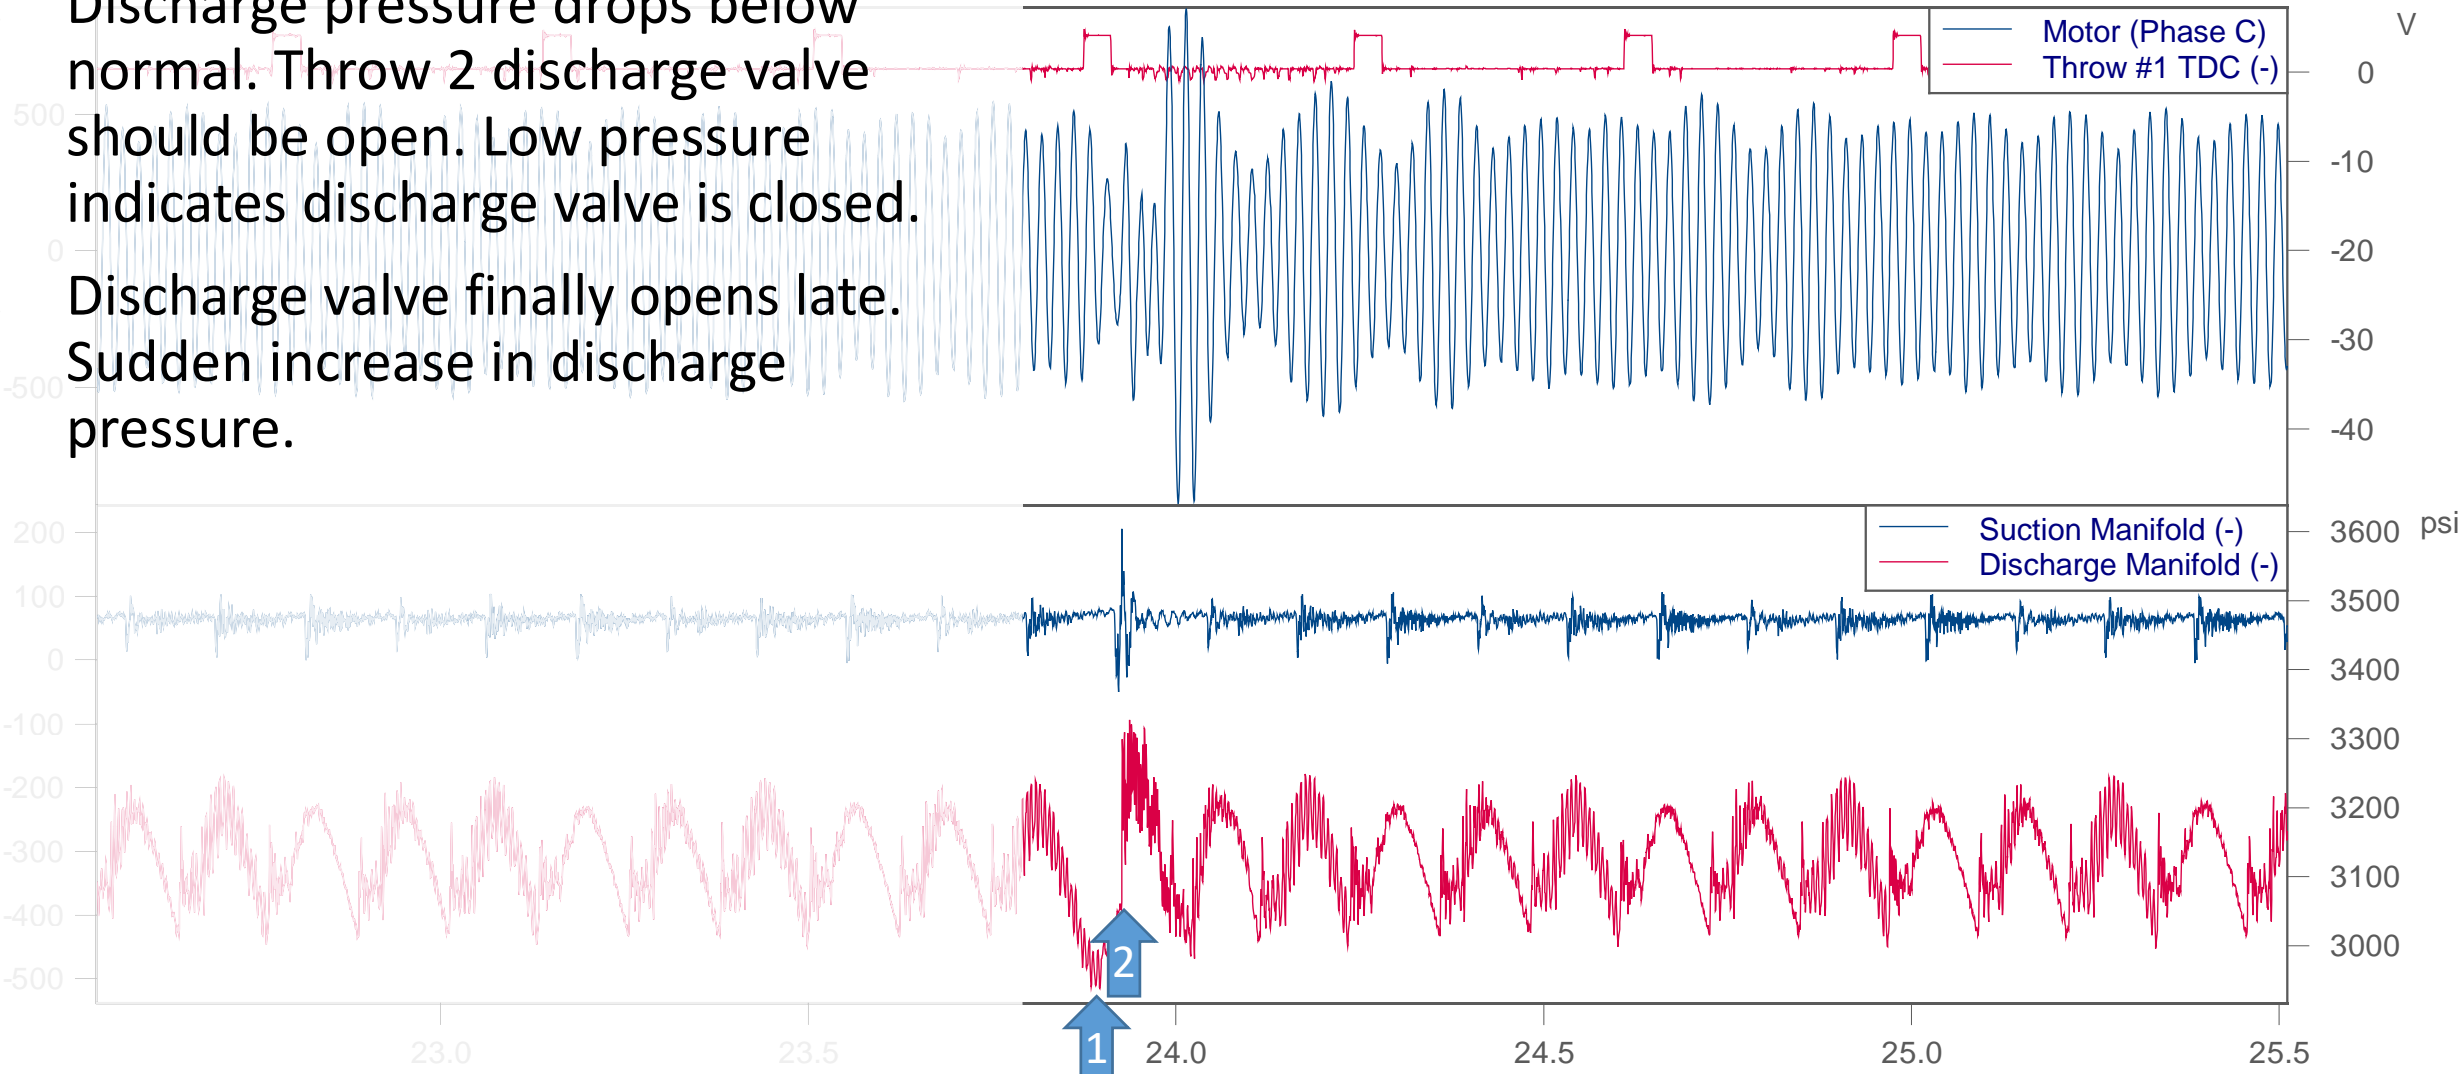
1. Discharge pressure drops below normal. Throw 2 discharge valve should be open. Low pressure indicates discharge valve is closed.
2. Discharge valve finally opens late. Sudden increase in discharge pressure.

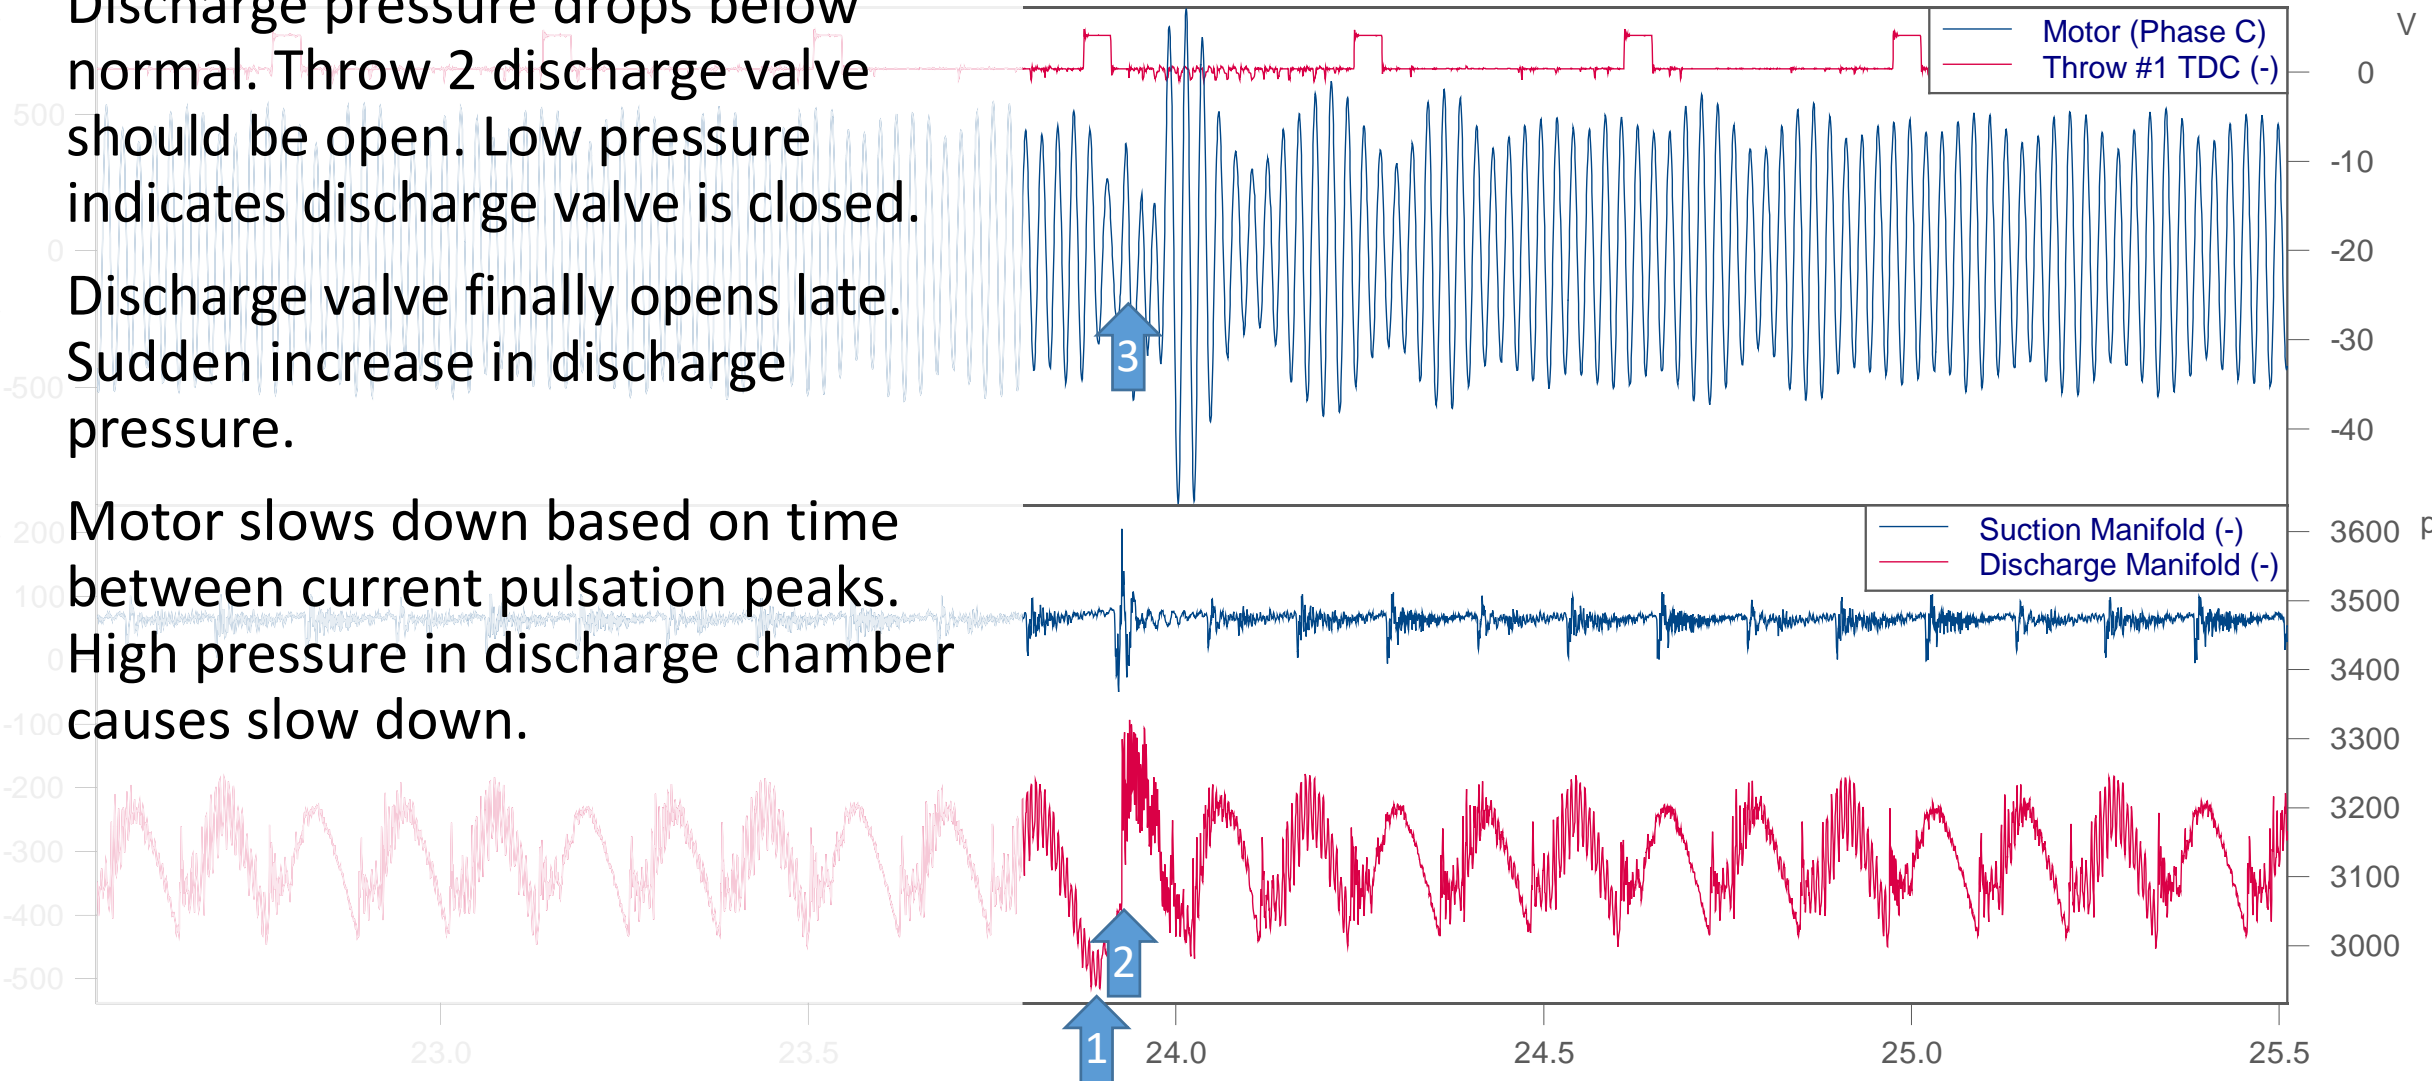
1. Discharge pressure drops below normal. Throw 2 discharge valve should be open. Low pressure indicates discharge valve is closed.

2. Discharge valve finally opens late. Sudden increase in discharge pressure.

3. Motor slows down based on time between current pulsation peaks. High pressure in discharge chamber causes slow down.

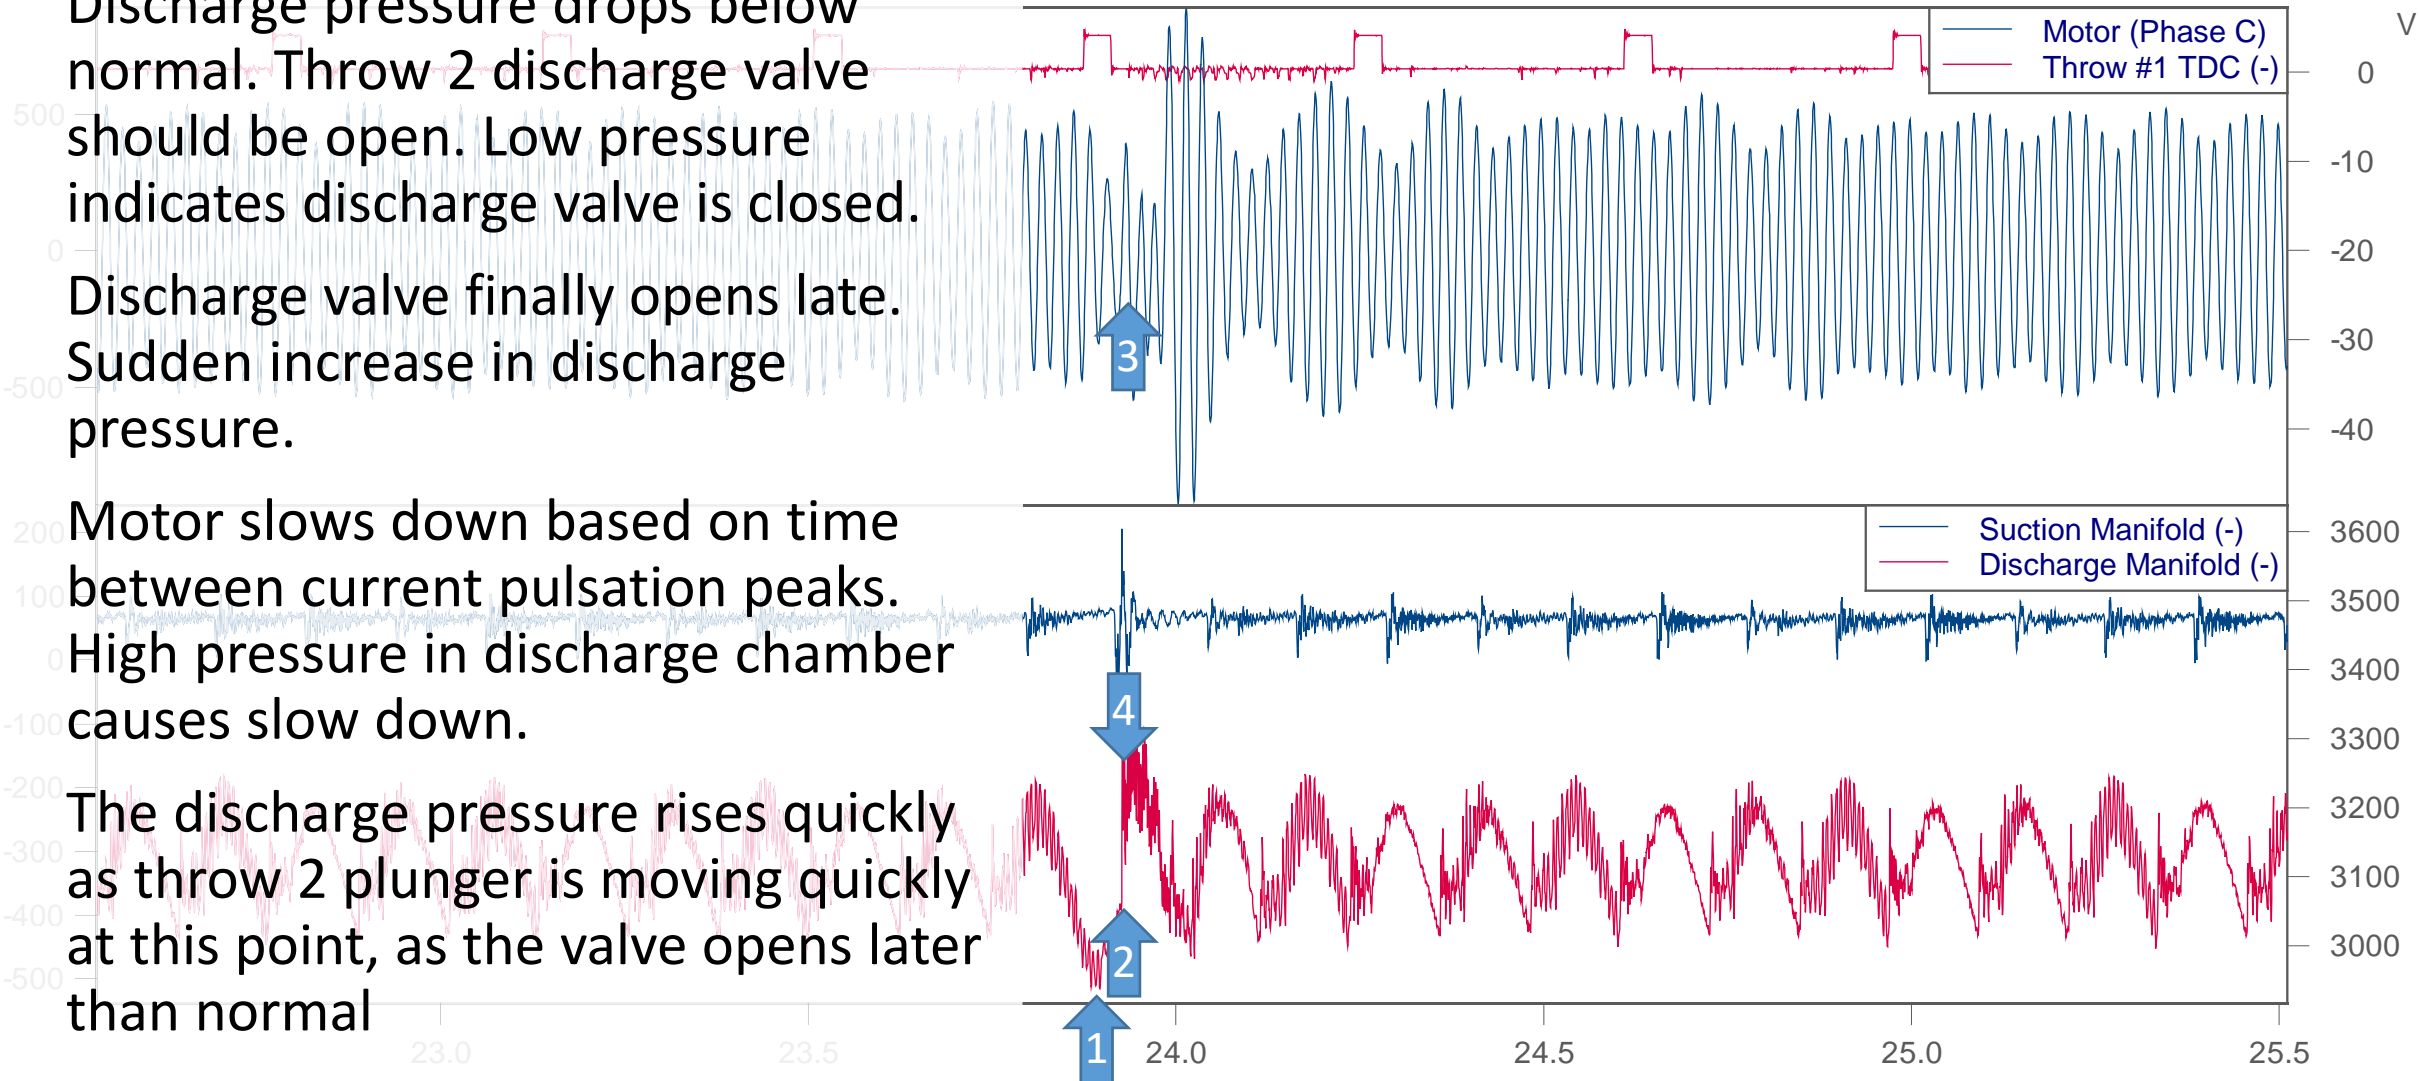
1. Discharge pressure drops below normal. Throw 2 discharge valve should be open. Low pressure indicates discharge valve is closed.
2. Discharge valve finally opens late. Sudden increase in discharge pressure.
3. Motor slows down based on time between current pulsation peaks. High pressure in discharge chamber causes slow down.
4. The discharge pressure rises quickly as throw 2 plunger is moving quickly at this point, as the valve opens later than normal

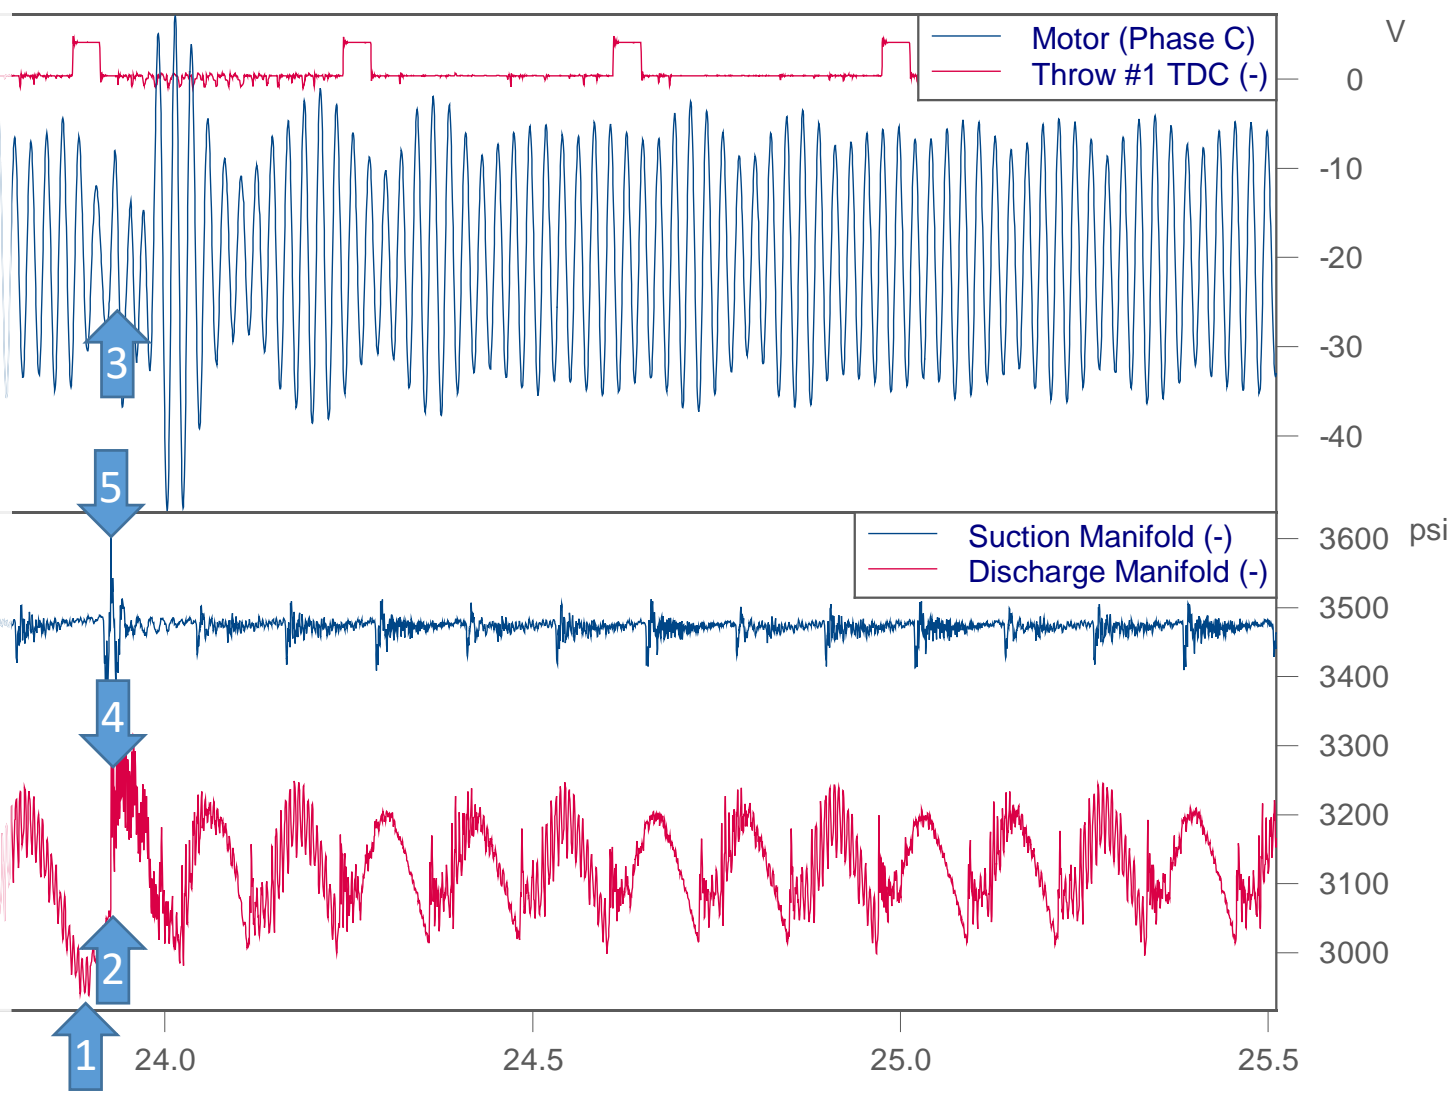
1. Discharge pressure drops below normal. Throw 2 discharge valve should be open. Low pressure indicates discharge valve is closed.

2. Discharge valve finally opens late. Sudden increase in discharge pressure.

3. Motor slows down based on time between current pulsation peaks. High pressure in discharge chamber causes slow down.

4. The discharge pressure rises quickly as throw 2 plunger is moving quickly at this point, as the valve opens later than normal

5. Suction pulsation shows an unusual shape, around the time throw 1 suction opening event happens

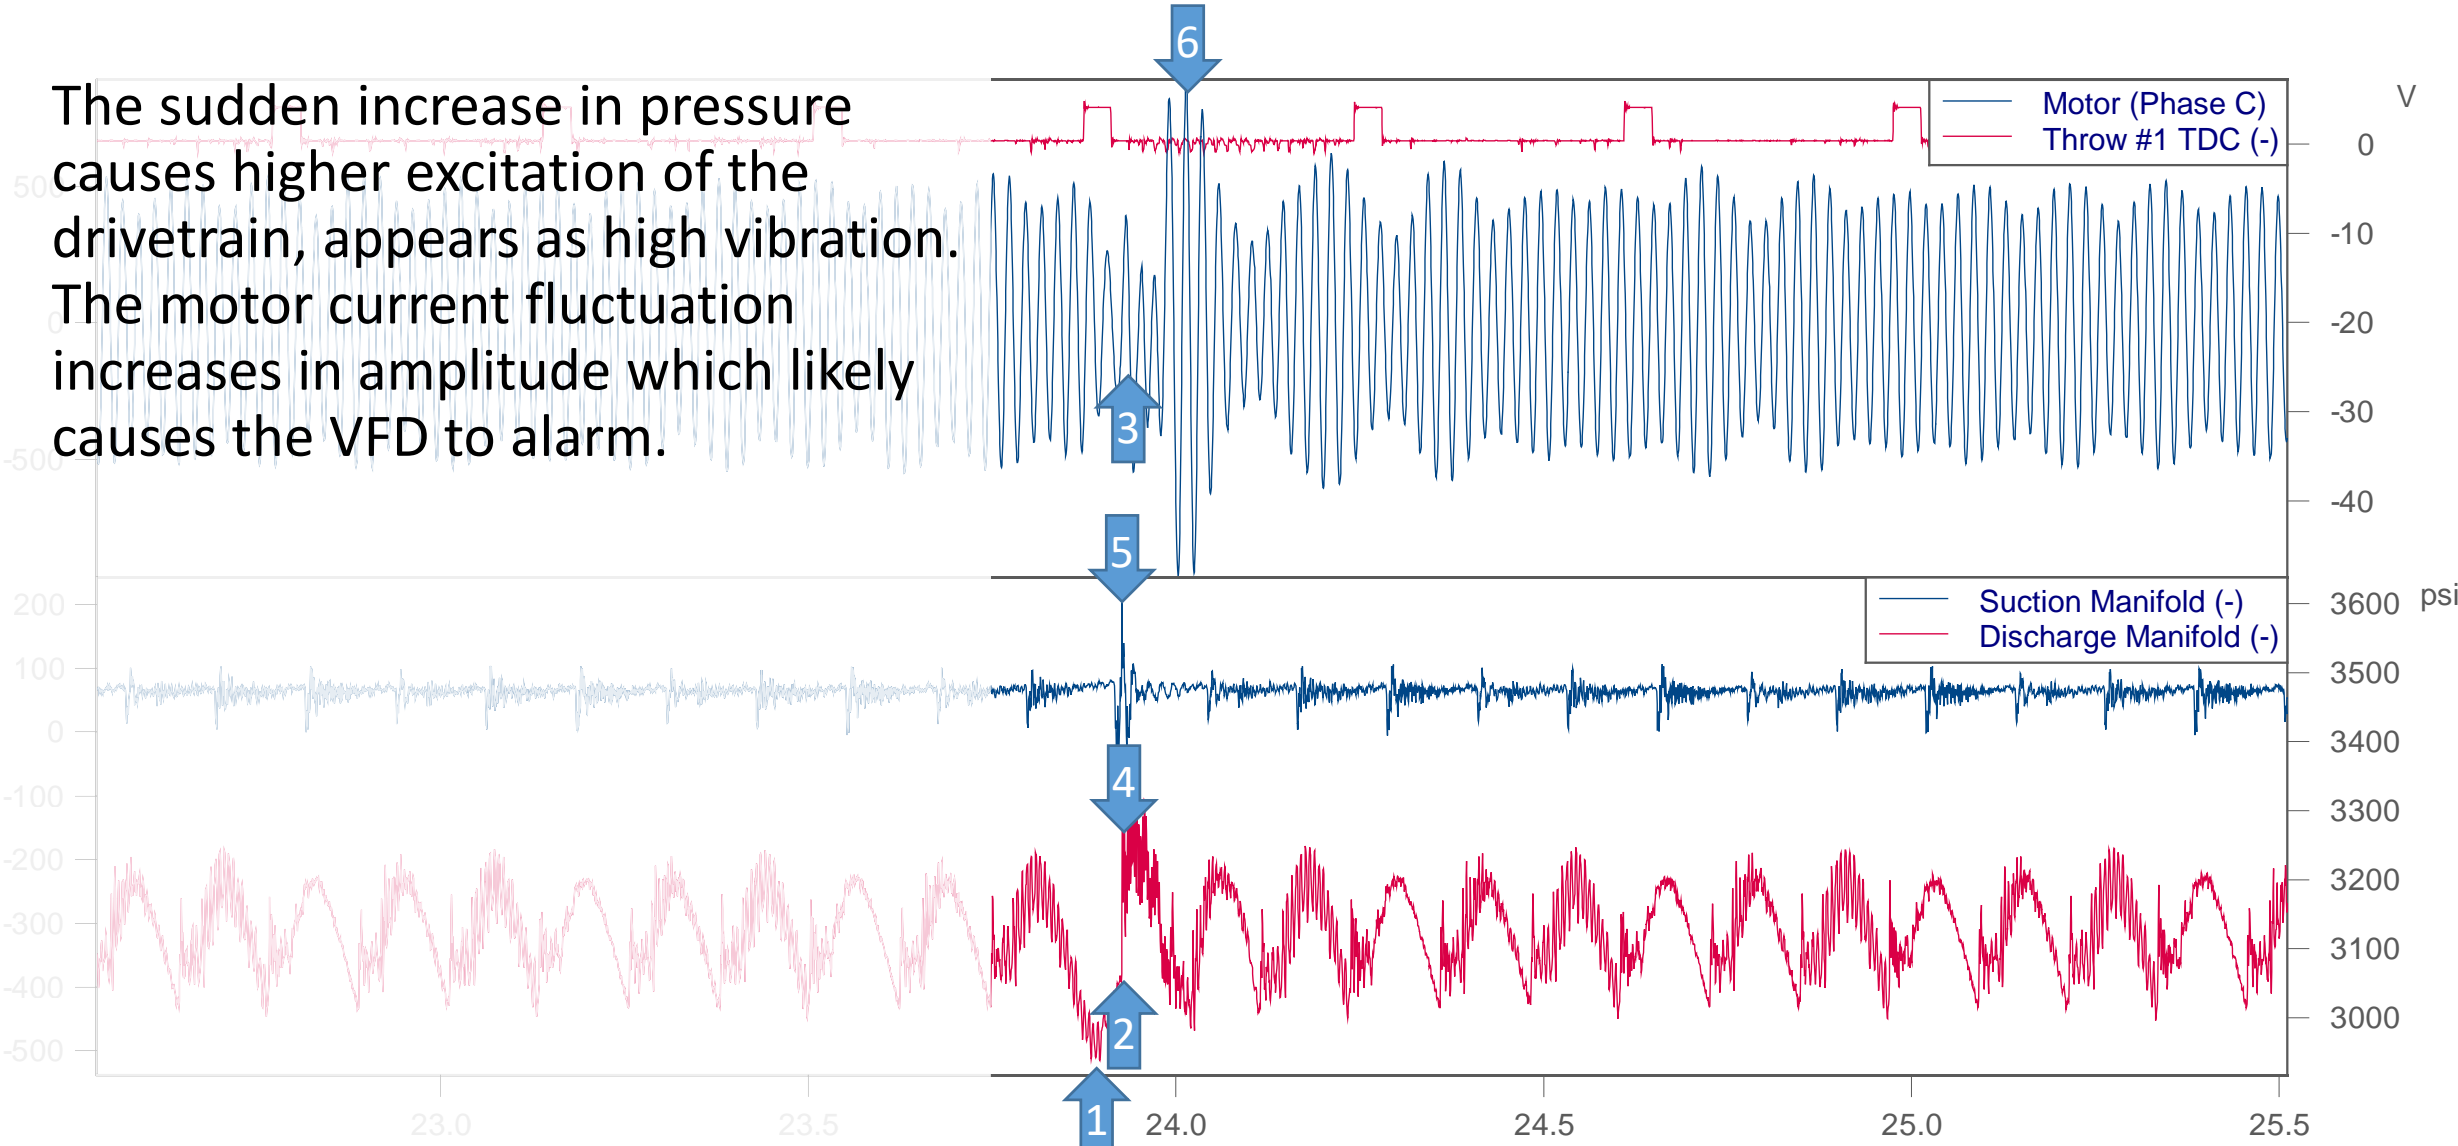
6. The sudden increase in pressure causes higher excitation of the drivetrain, appears as high vibration. The motor current fluctuation increases in amplitude which likely causes the VFD to alarm.

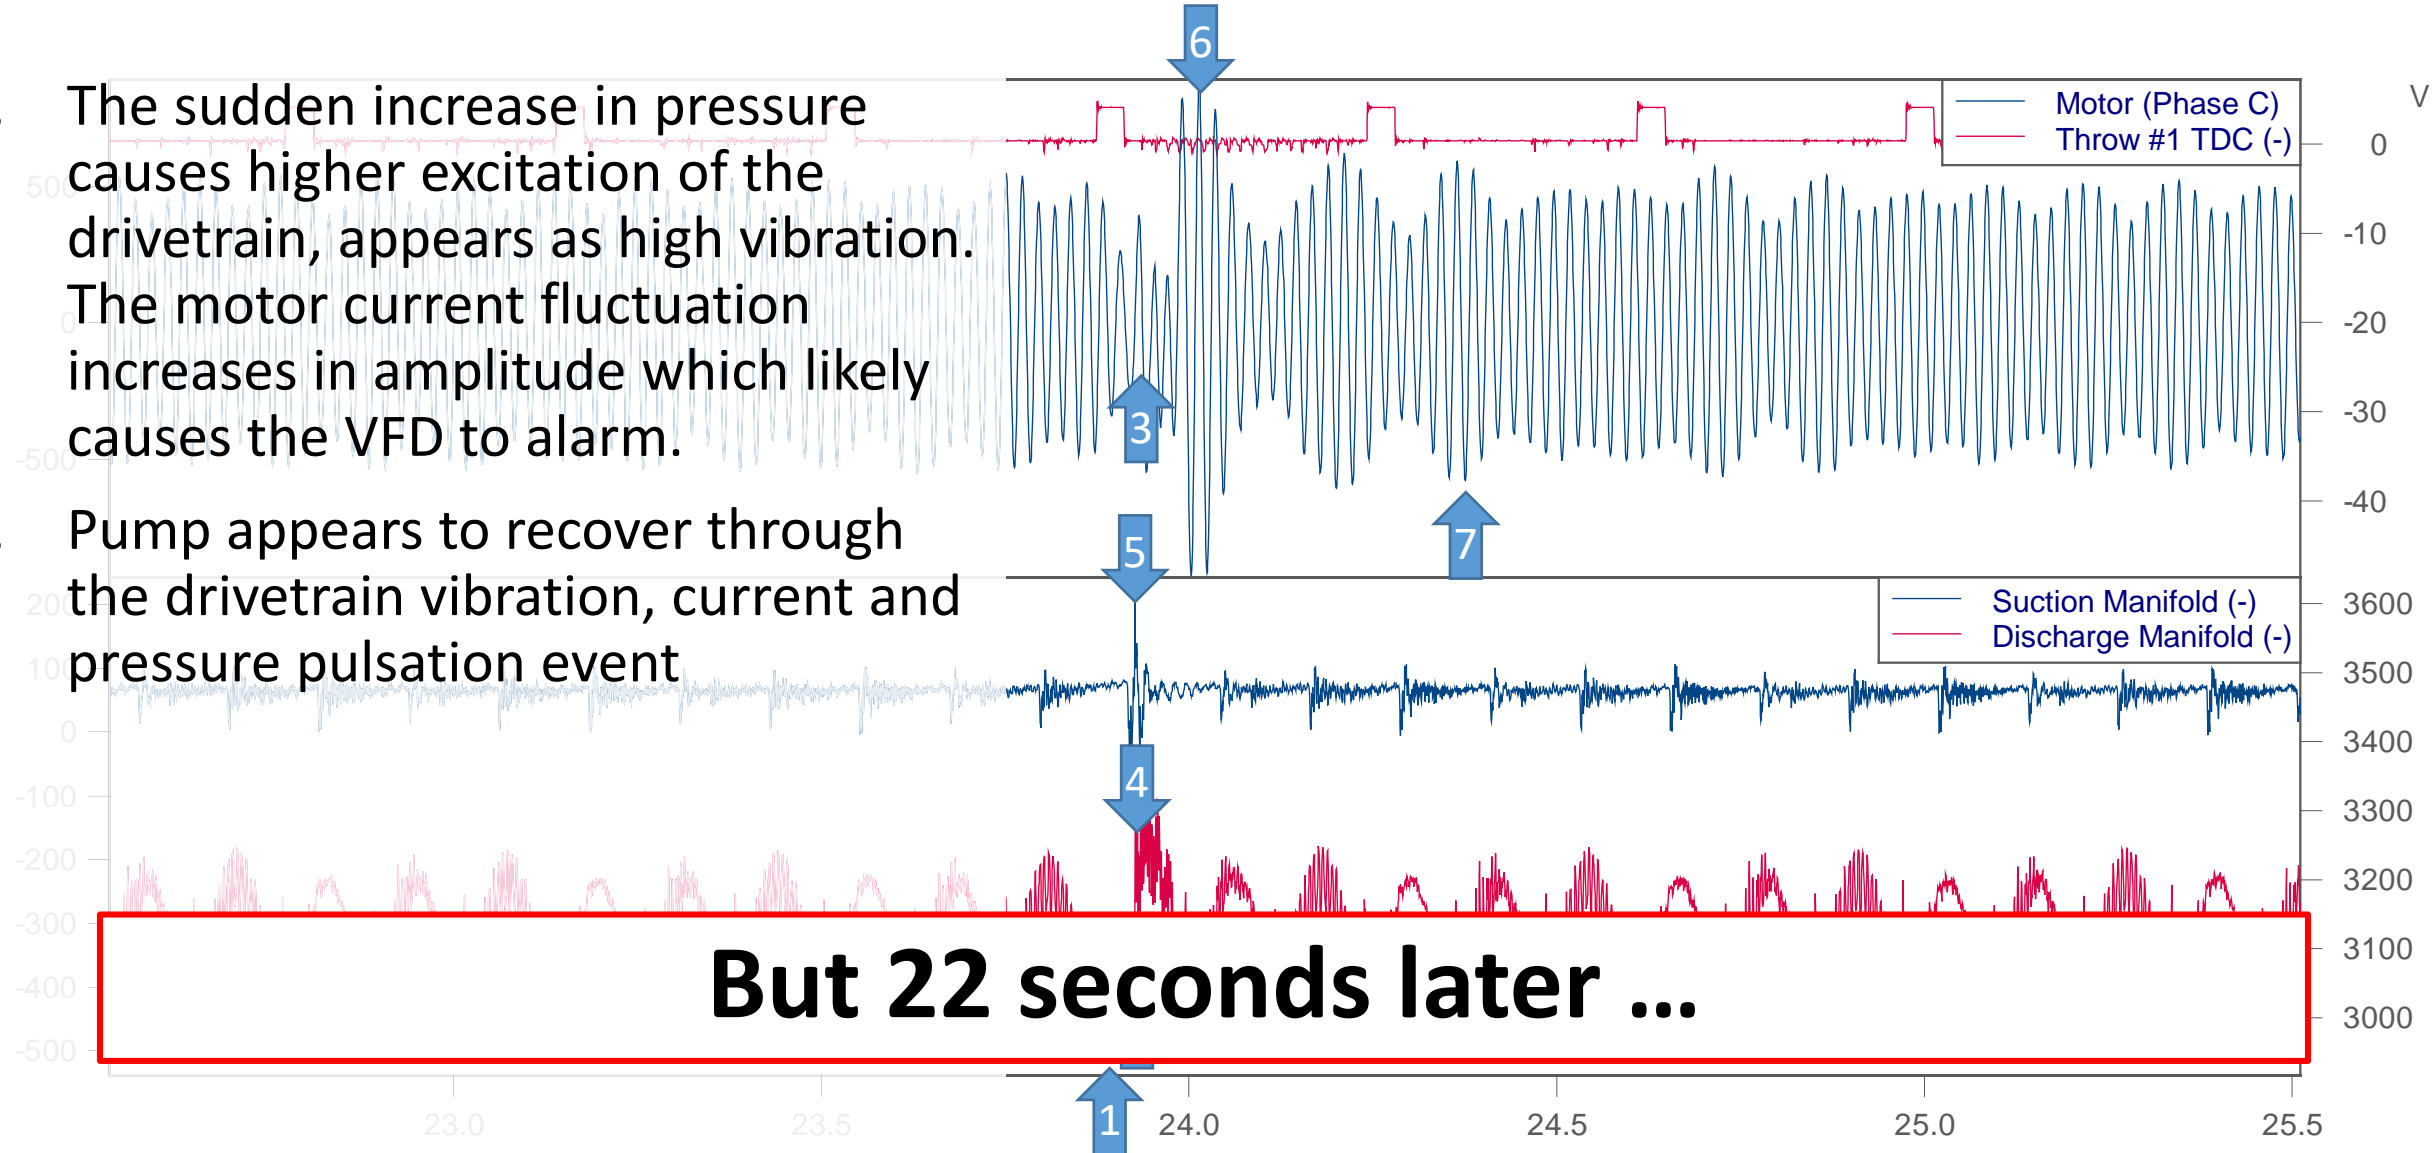
6. The sudden increase in pressure causes higher excitation of the drivetrain, appears as high vibration. The motor current fluctuation increases in amplitude which likely causes the VFD to alarm.

7. Pump appears to recover through the drivetrain vibration, current and pressure pulsation event
