TURBOMACHINERY
& PUMP SYMPOSIA

Identifying the cause of a plunger pump shutdown

Data logging to the rescue

Kelly Eberle, Michal Gaca

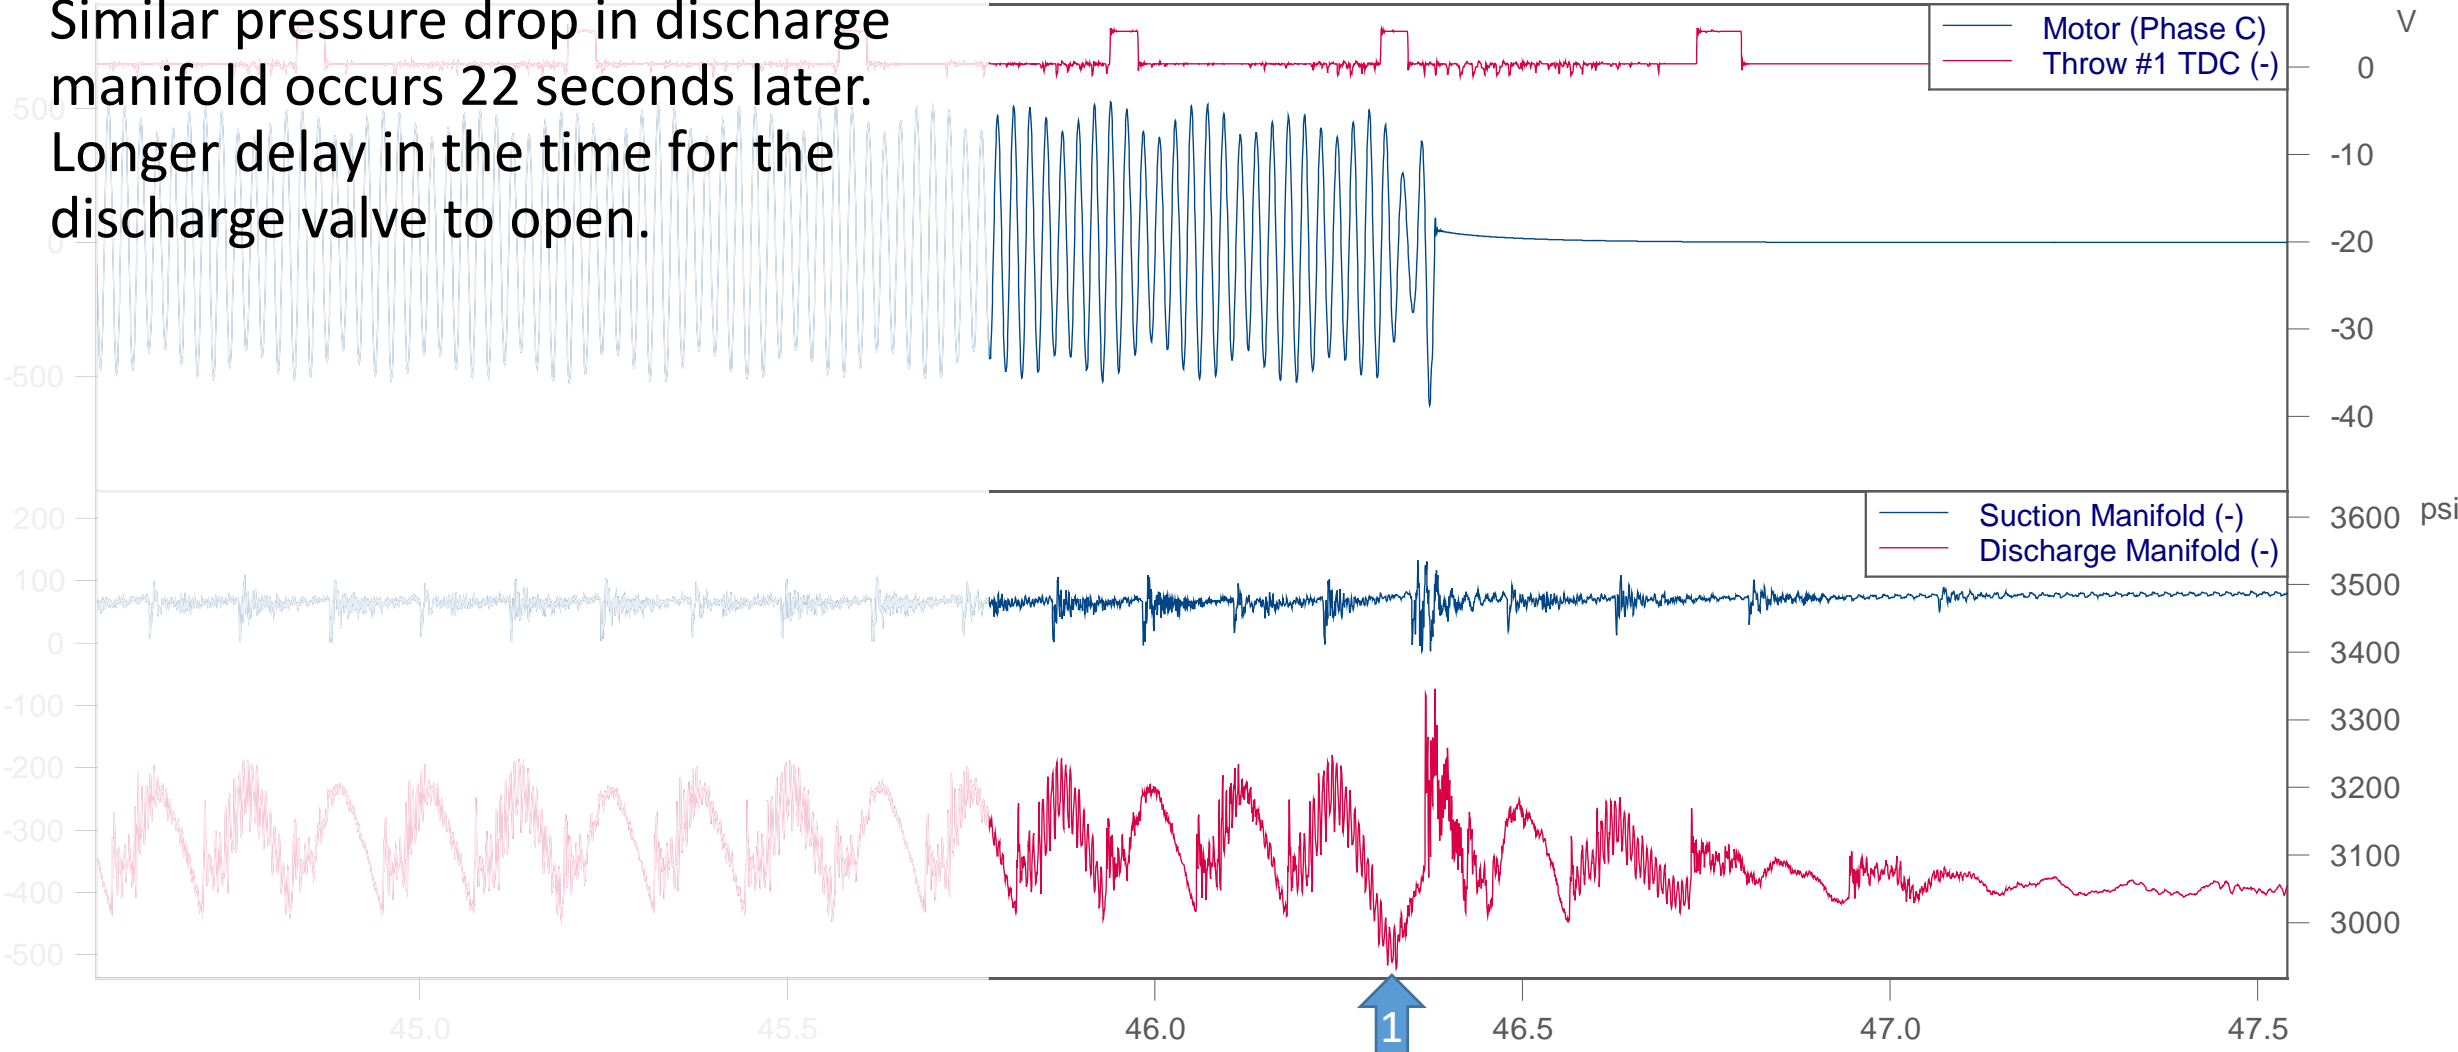
1. Similar pressure drop in discharge manifold occurs 22 seconds later. Longer delay in the time for the discharge valve to open.

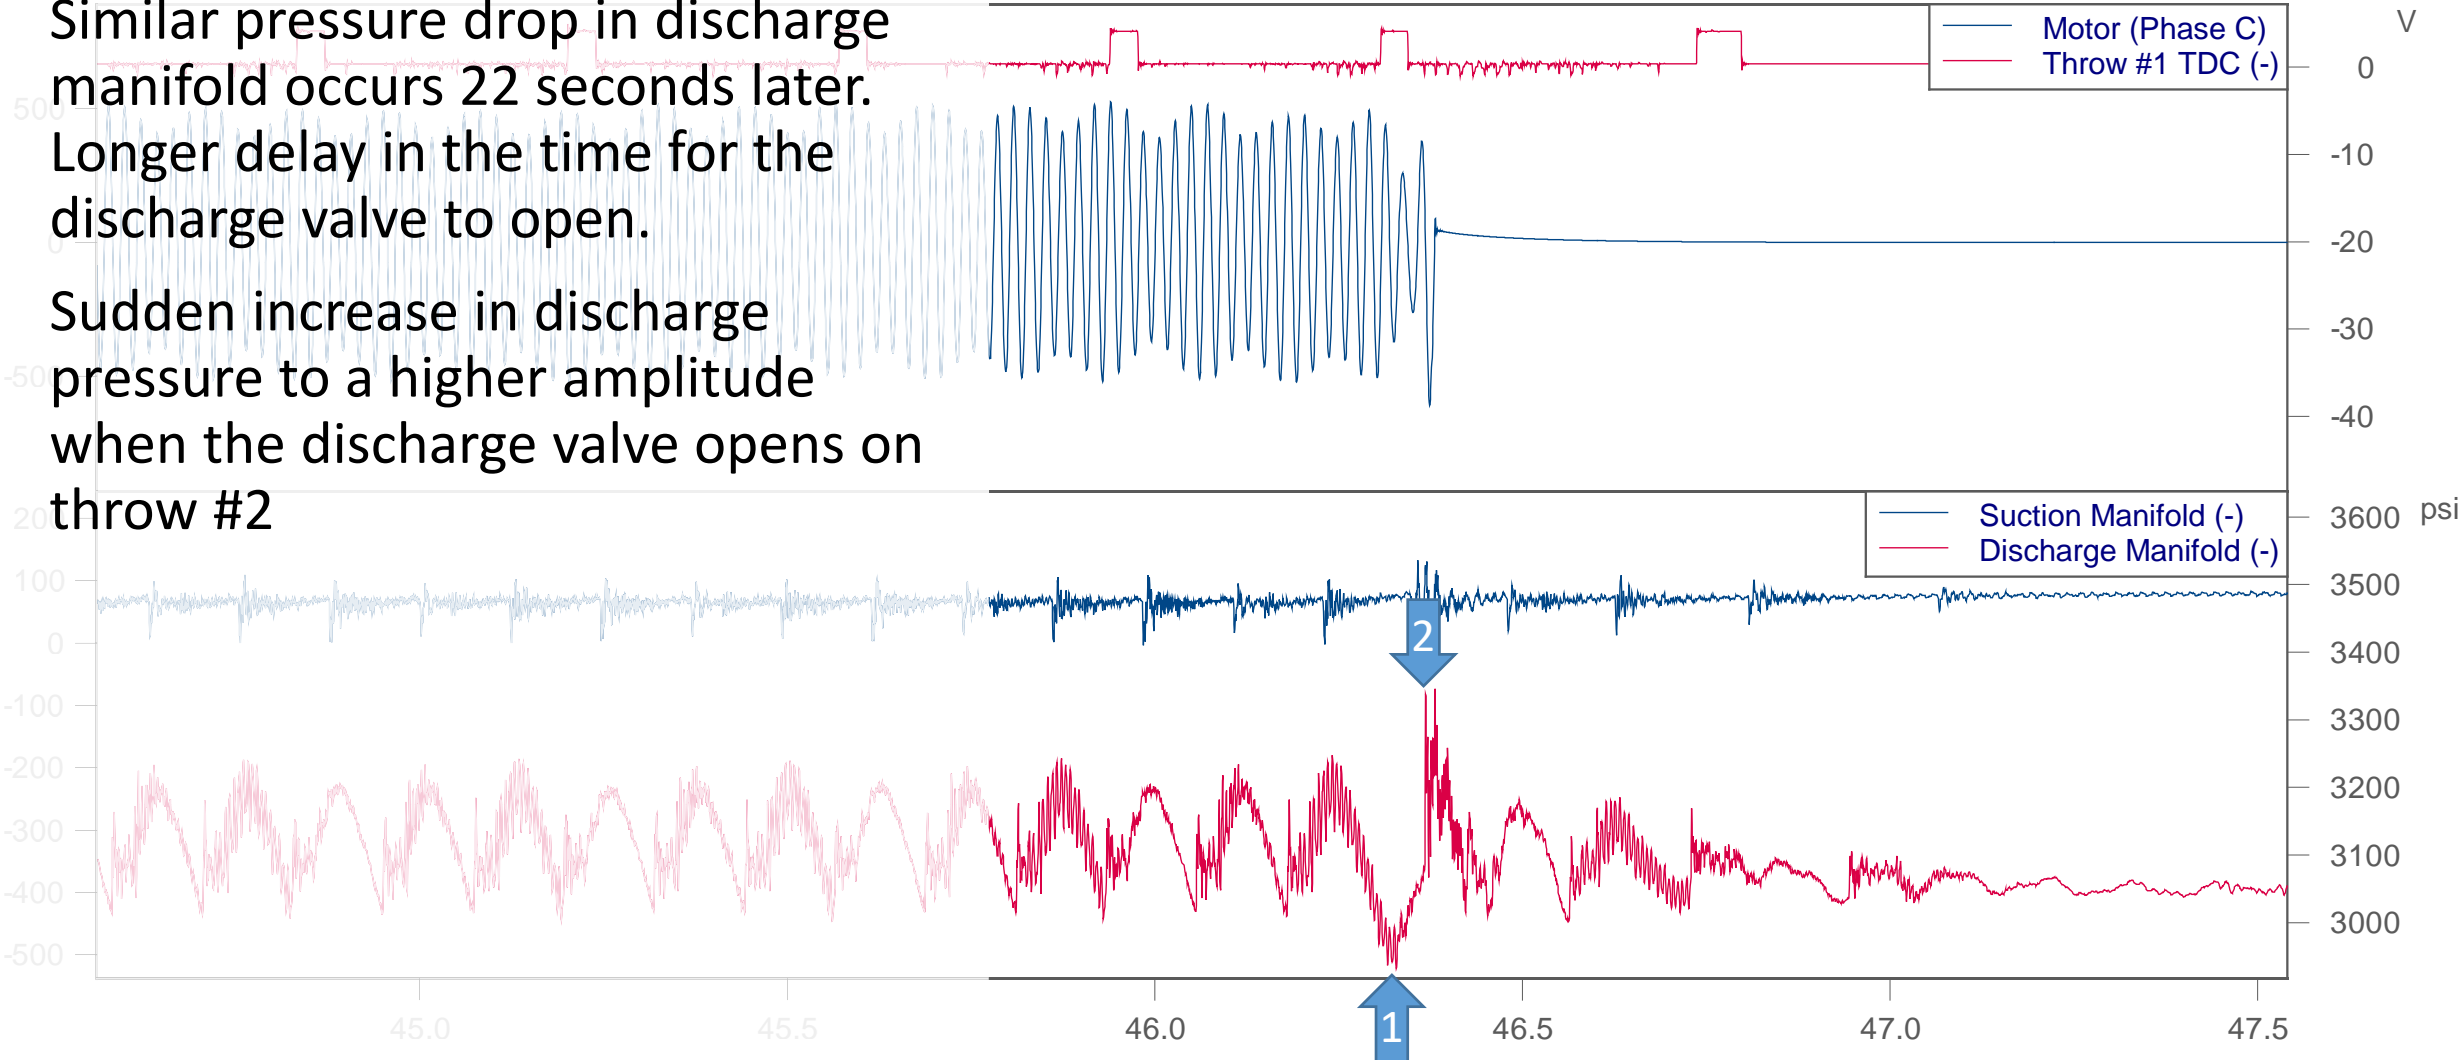
1. Similar pressure drop in discharge manifold occurs 22 seconds later. Longer delay in the time for the discharge valve to open.

2. Sudden increase in discharge pressure to a higher amplitude when the discharge valve opens on throw #2

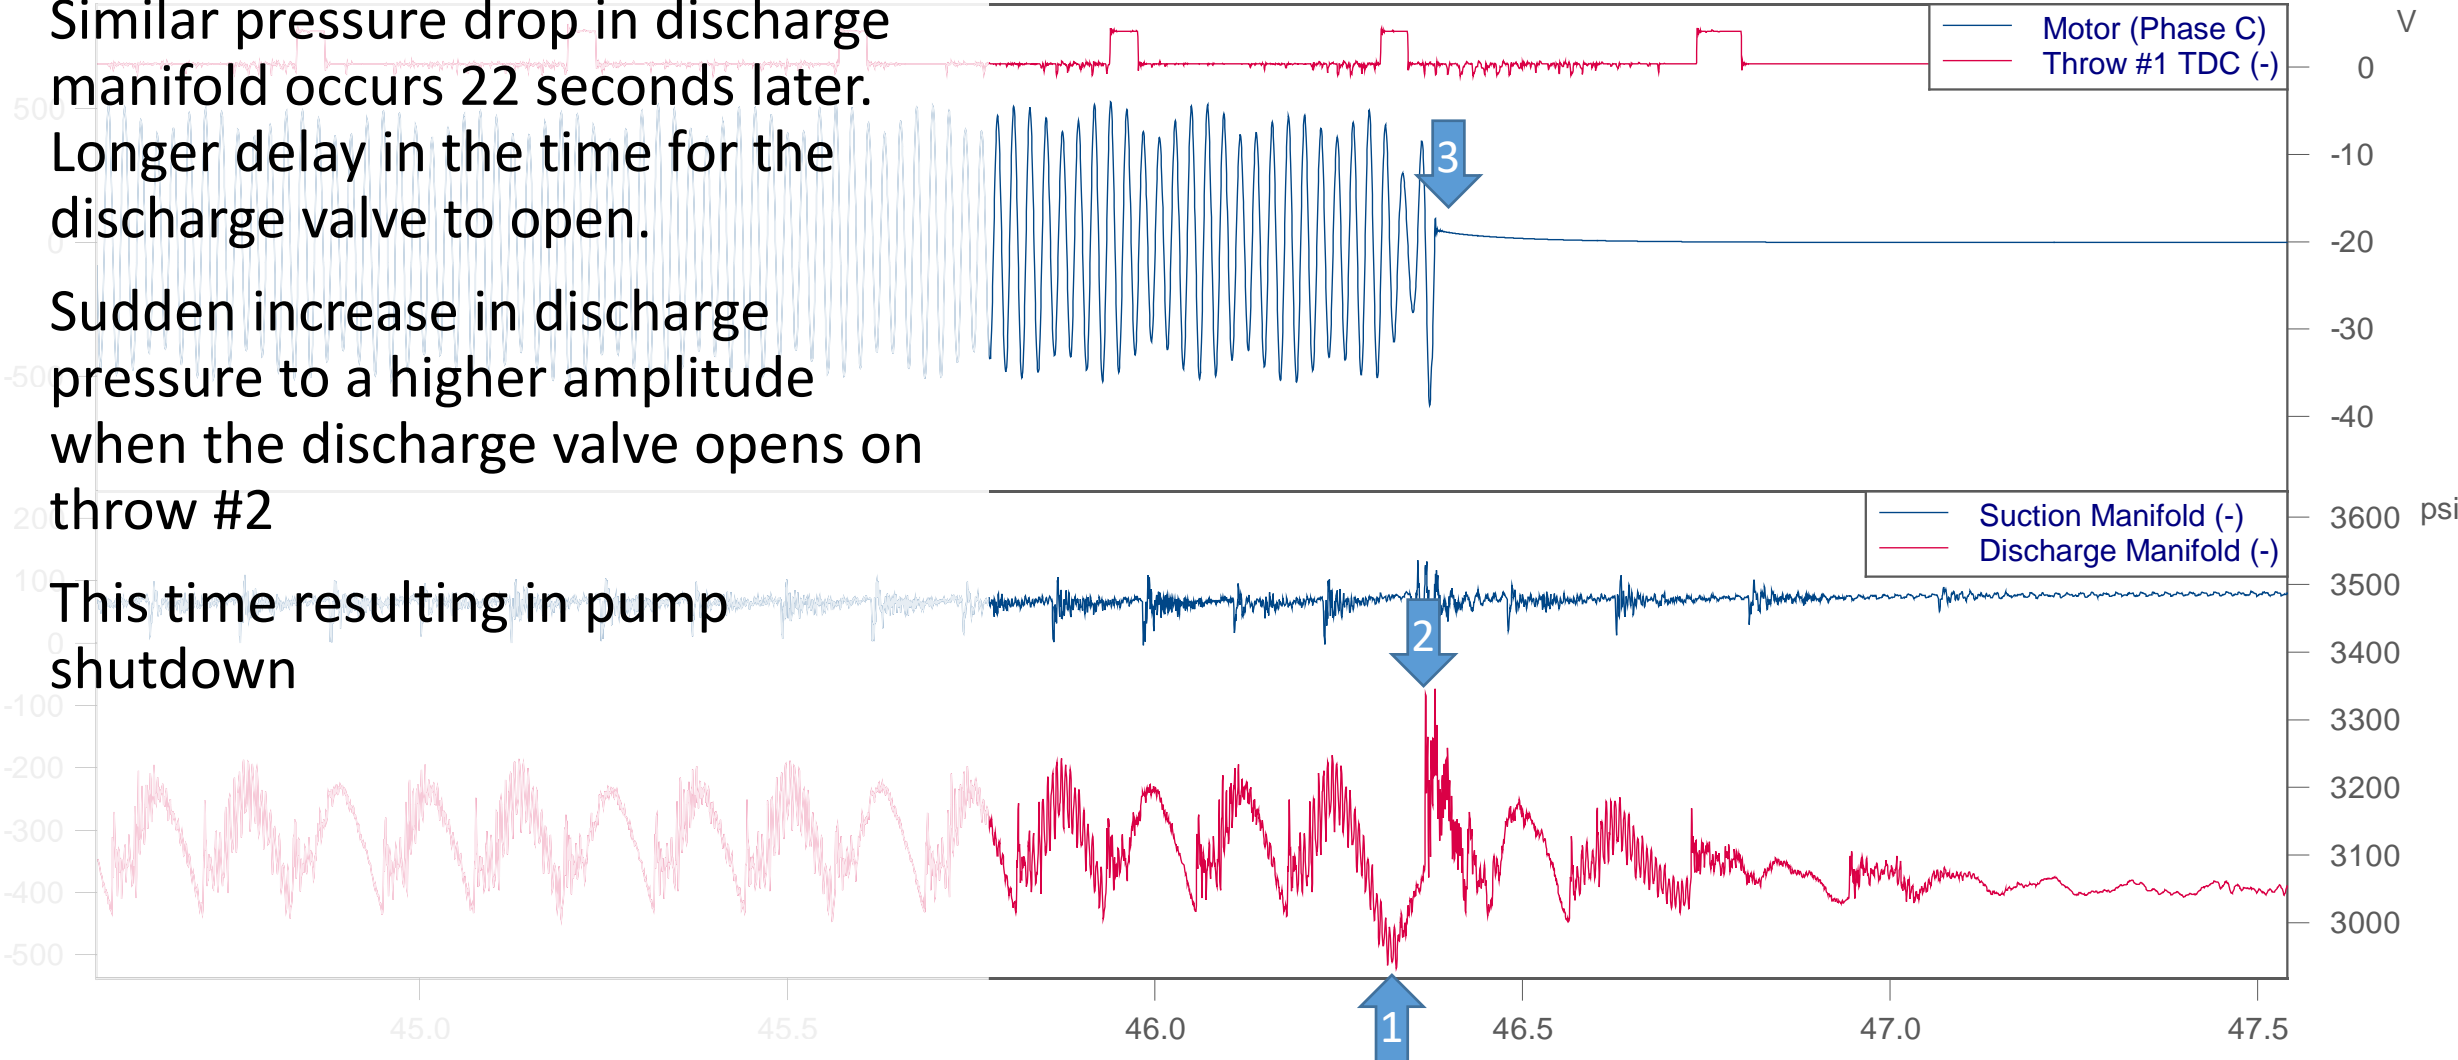
1. Similar pressure drop in discharge manifold occurs 22 seconds later. Longer delay in the time for the discharge valve to open.

2. Sudden increase in discharge pressure to a higher amplitude when the discharge valve opens on throw #2

3. This time resulting in pump shutdown

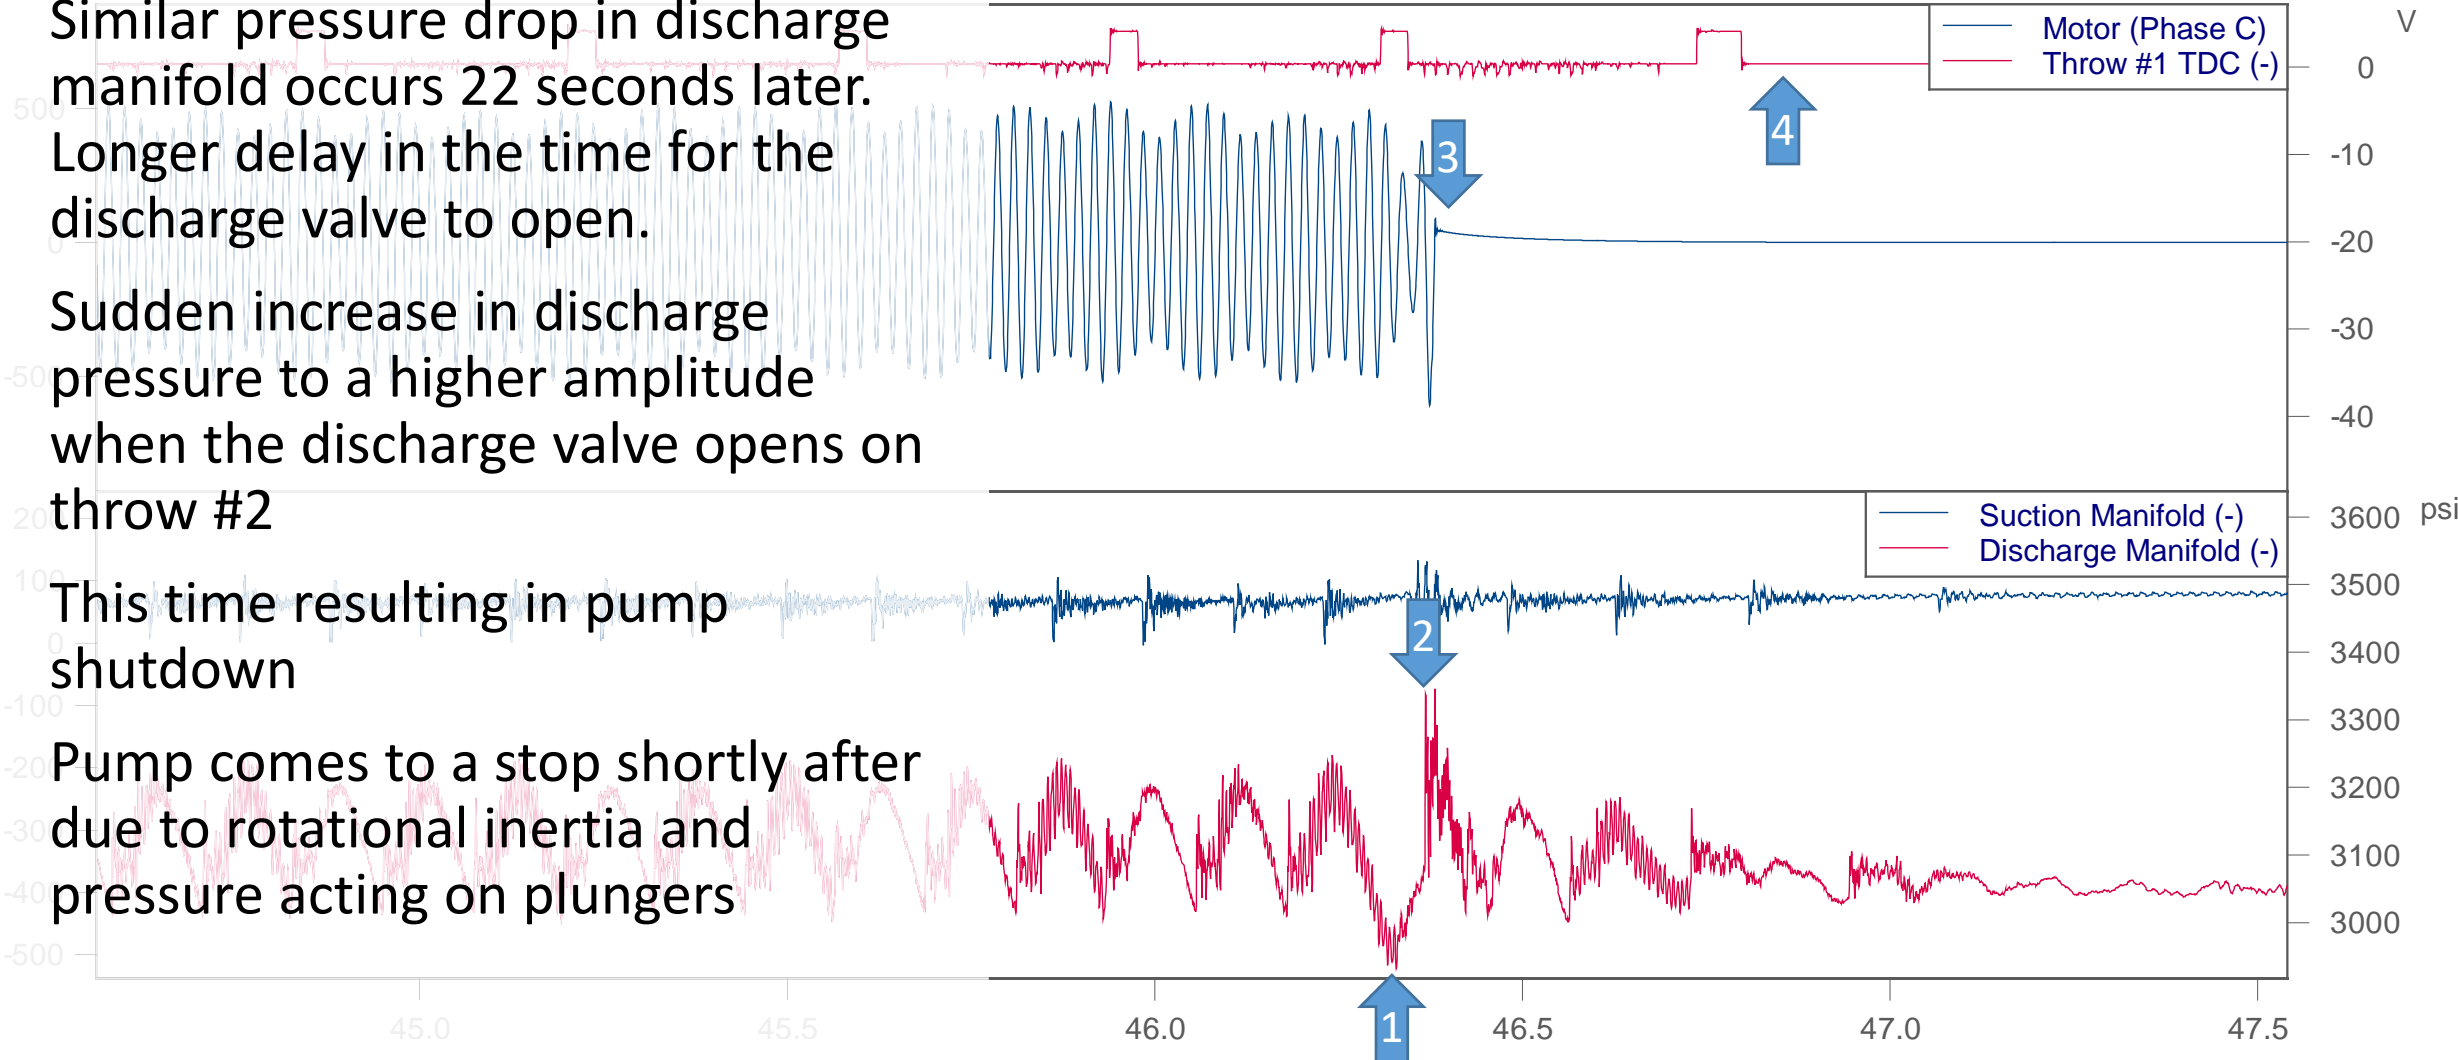
1. Similar pressure drop in discharge manifold occurs 22 seconds later. Longer delay in the time for the discharge valve to open.

2. Sudden increase in discharge pressure to a higher amplitude when the discharge valve opens on throw #2

3. This time resulting in pump shutdown

4. Pump comes to a stop shortly after due to rotational inertia and pressure acting on plungers

- Delayed opening of the Throw #2 discharge valve triggers the trip. “Stuck” valve causes pump to momentarily slow down.
- Late and sudden opening of the discharge valve results in a sudden drop in load
- Motor momentarily speeds up which turns the motor into a generator resulting in an over-voltage in the VFD and pump shuts down
- Problems appeared after the stiffer springs were installed. Damage to valves observed.

- Change stiffer springs to more flexible springs
- Pumps have operated for several months without tripping with the more flexible springs
- Unsolved mystery: Why did the throw #2 discharge valve stick?
 - Only one of two pumps had problems
 - Problems appeared only on throw #2
 - Stiffer valve springs should have improved the performance
- Additional site testing and simulations proposed to determine root cause
- Pumps running OK with more flexible springs. No further work done.
