RCA report on governing valve seat failure for ERC Turbine

48th Turbomachinery & 35th Pump
Symposia | Sept. 9-12, 2019

1. Site observation of valve seat failure in Governing valve

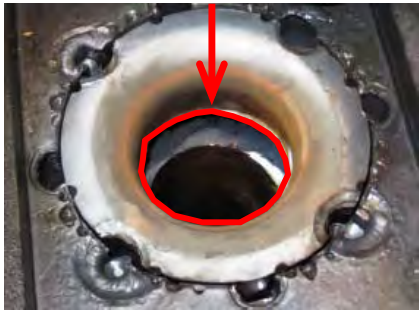
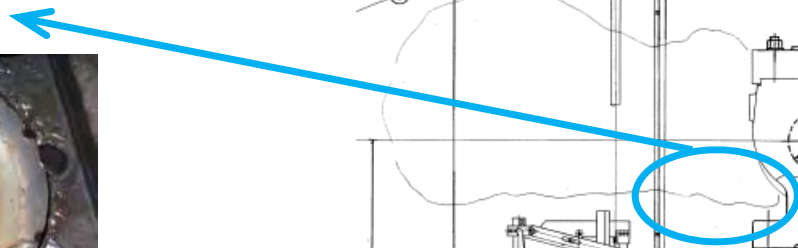
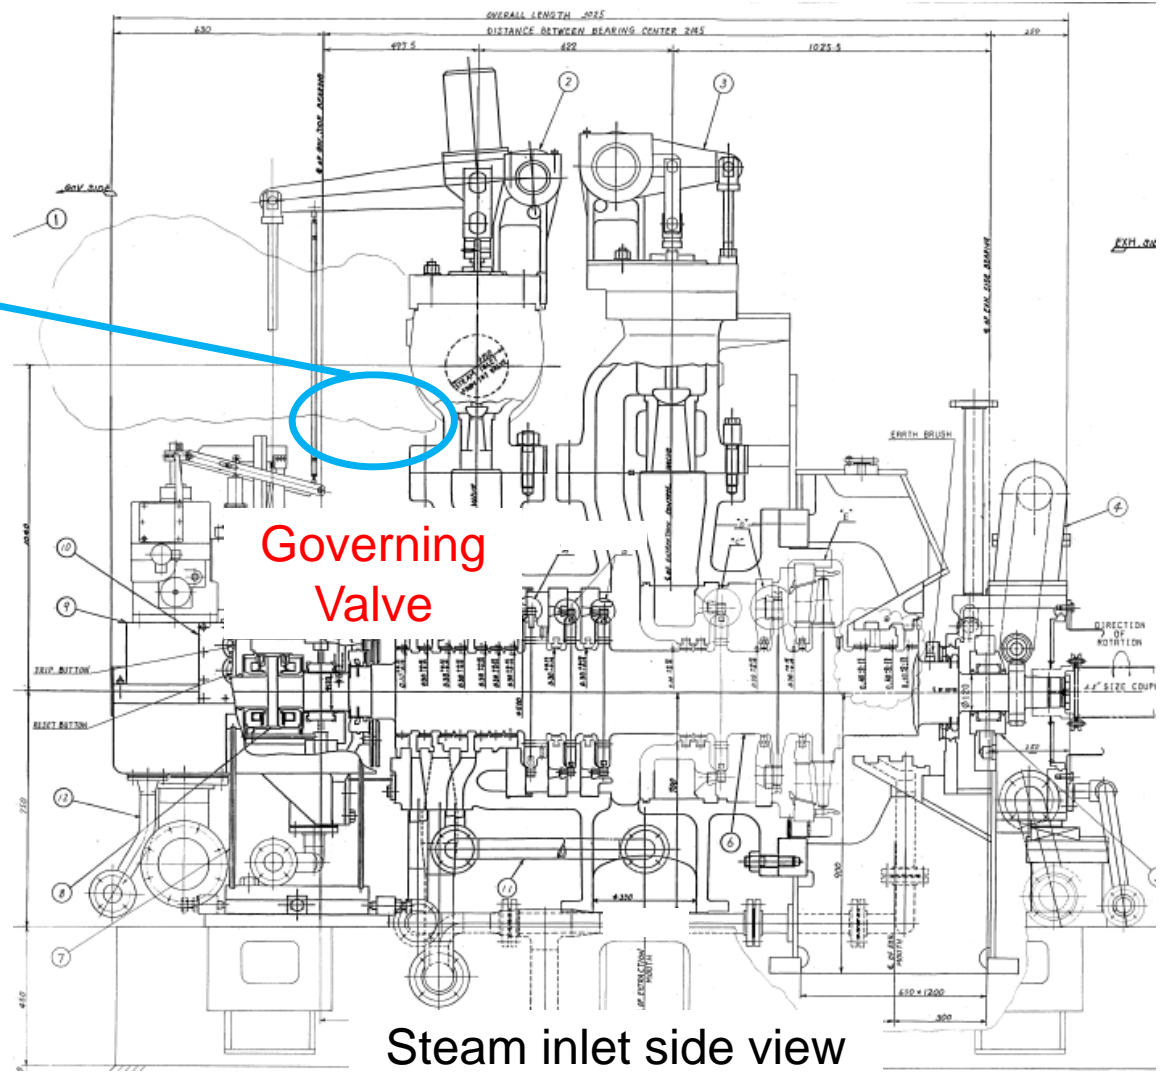
2nd valve seat (out of 3 valve seats) broke in the valve box of Governing valve.

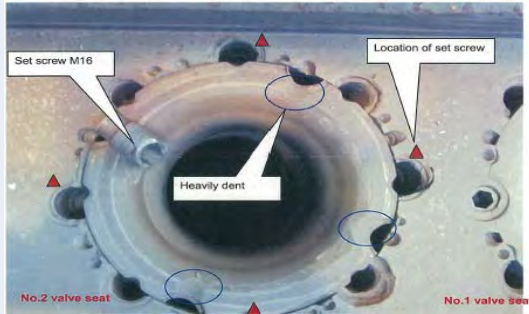
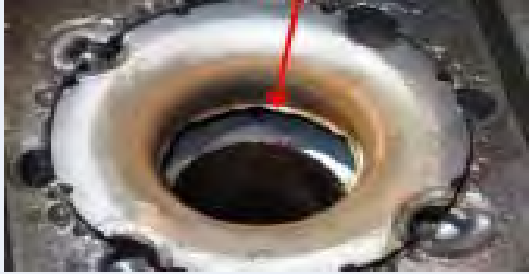
Lower part of valve seat broke away from the main body.

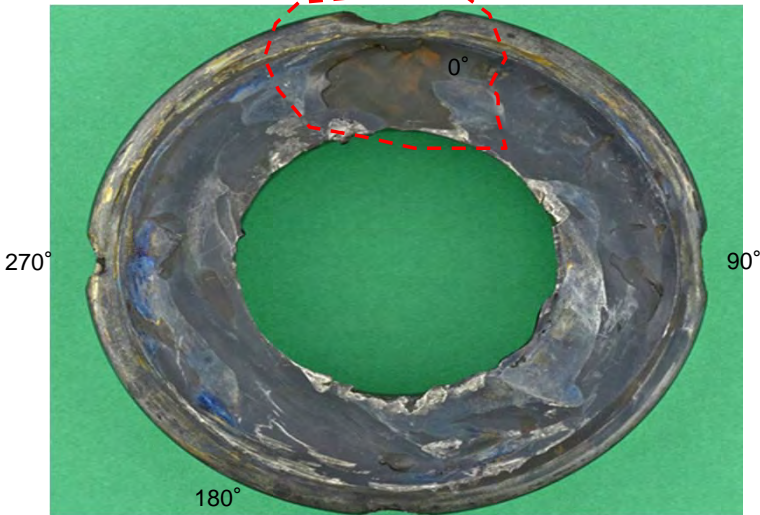
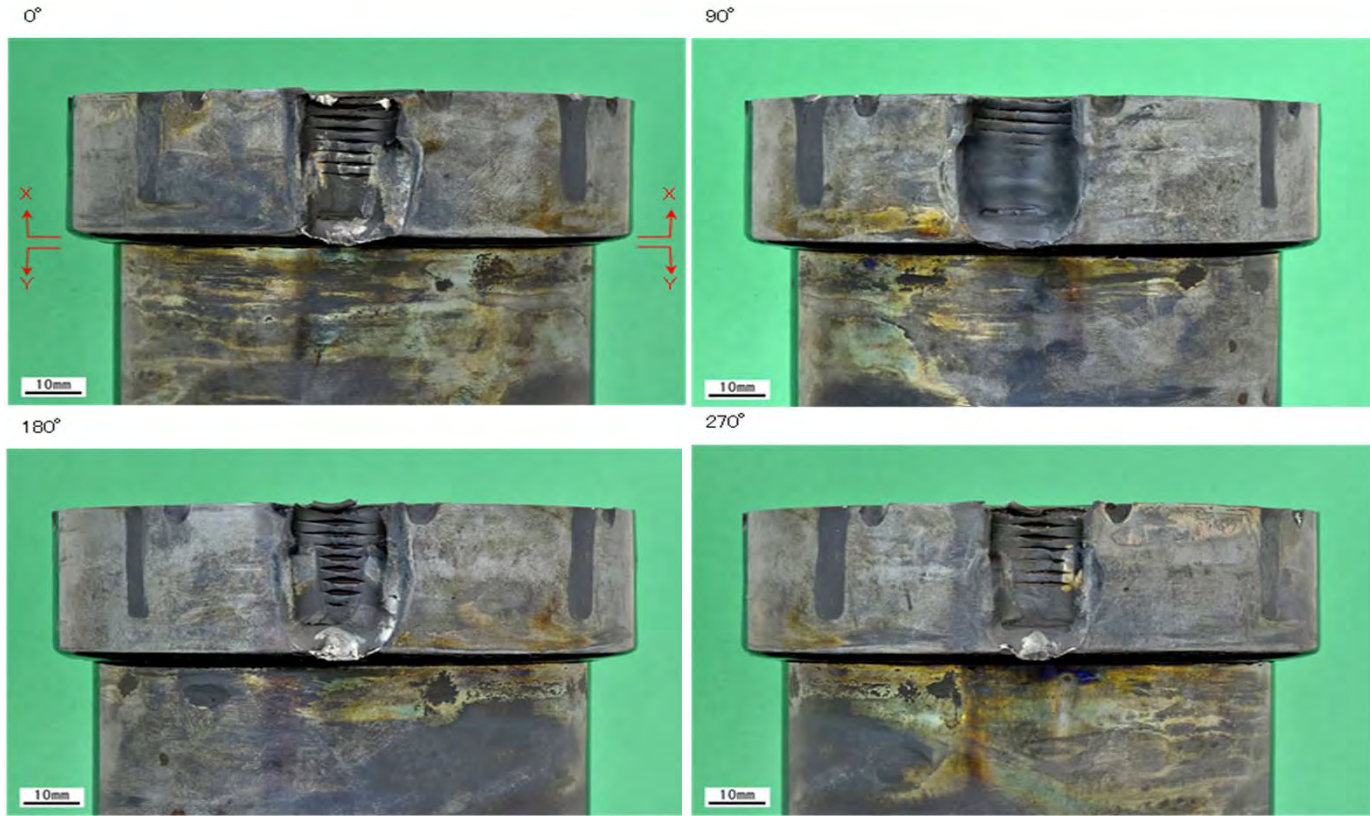
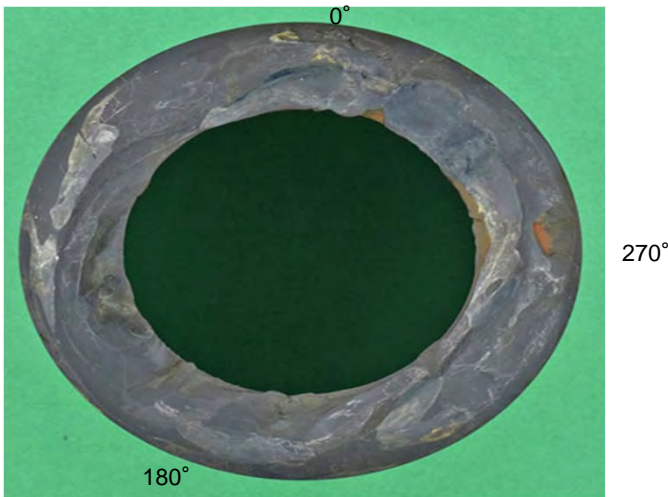
3. Fracture analysis for Valve seat (1)

- 1) All thread screws were severely worn out.
- 2) Except for red boxed area, the surface was eroded and not confirmed as a typical fracture surface.

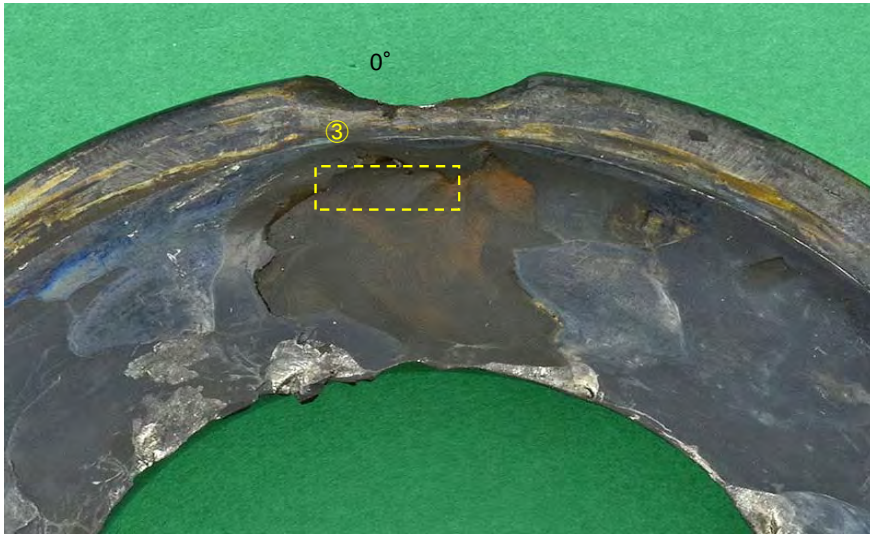
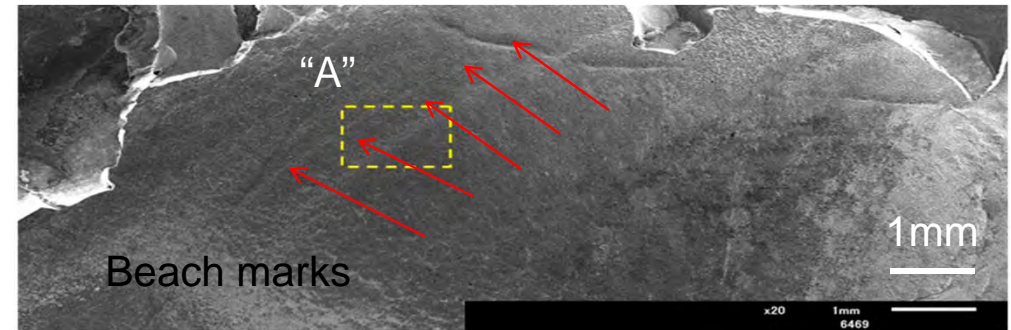
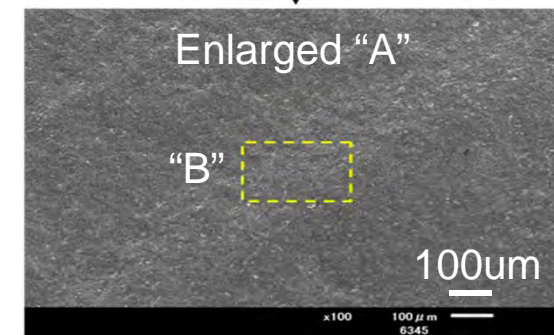
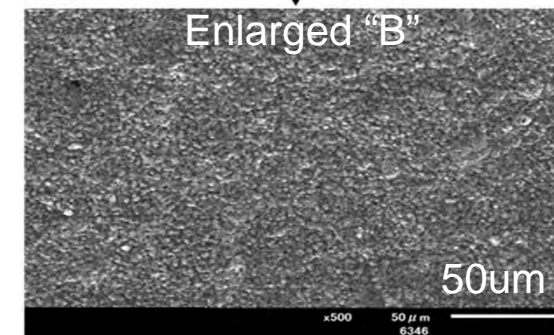
3. Fracture analysis for Valve seat (2)

Fatigue fracture pattern like beach mark can be seen on the surface without erosion.

(In micro analysis for more detail, no striation pattern was observed due to oxide scale under high temperature.)

-> This shows a possibility of fatigue fracture.

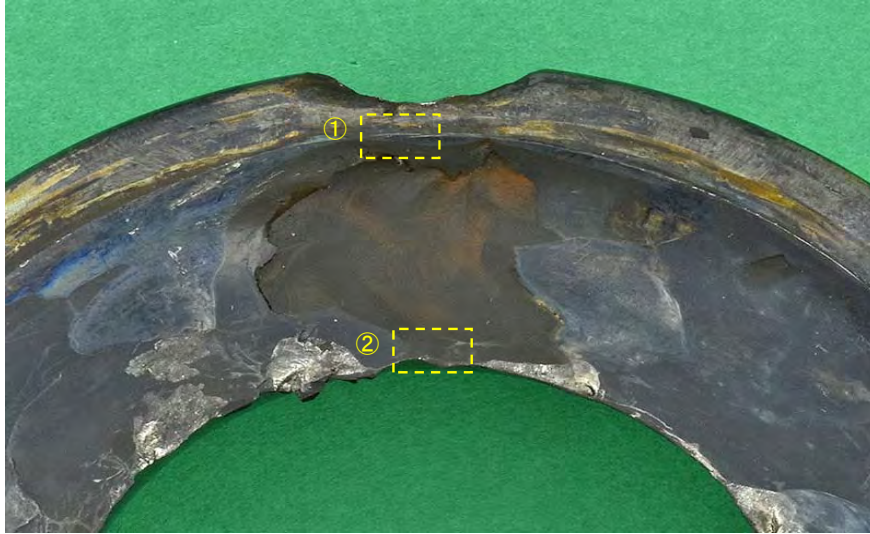
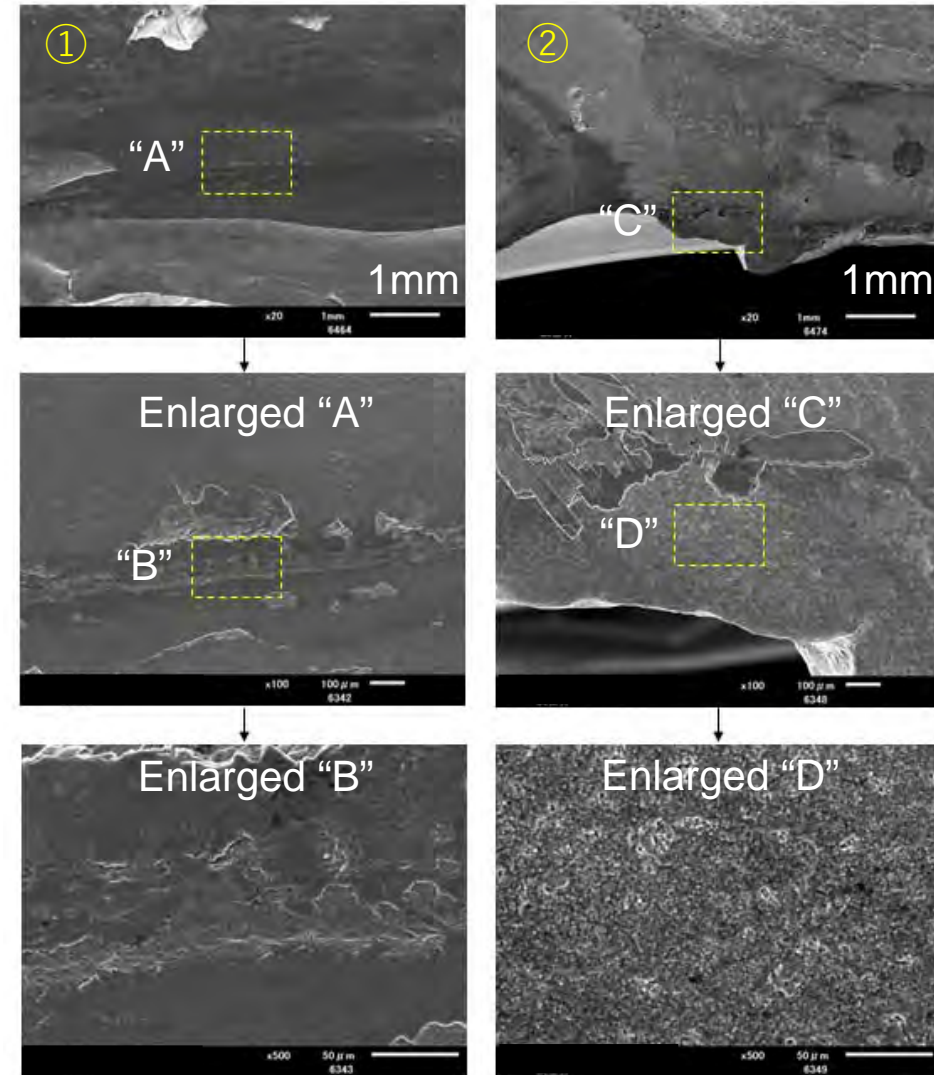
3. Fracture analysis for Valve seat (3)

To check the validity of fatigue fracture, fracture marks are needed on the valve seat surface.

However, since most the valve seat surface was destroyed either by erosion or by oxidation of steam, it is very difficult to find the fracture marks on the broken surface of valve seat.

->No typical fracture marks were observed.

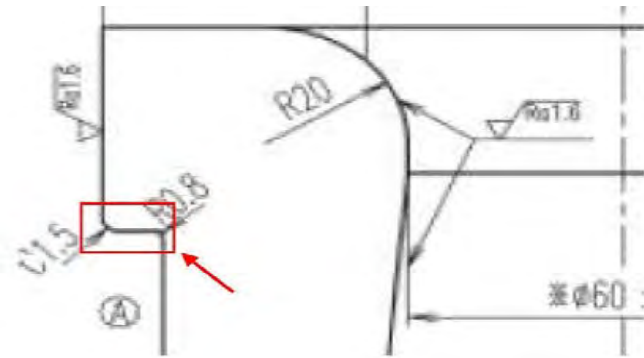
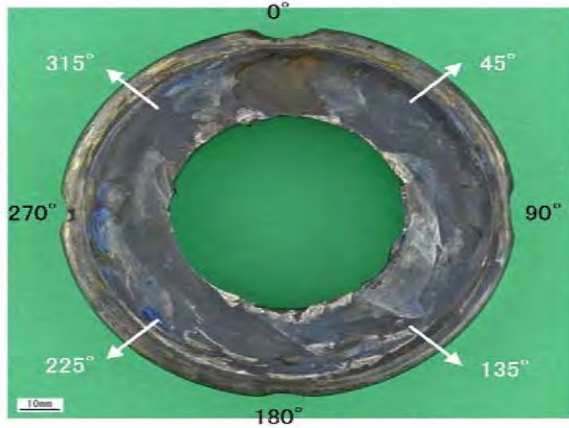
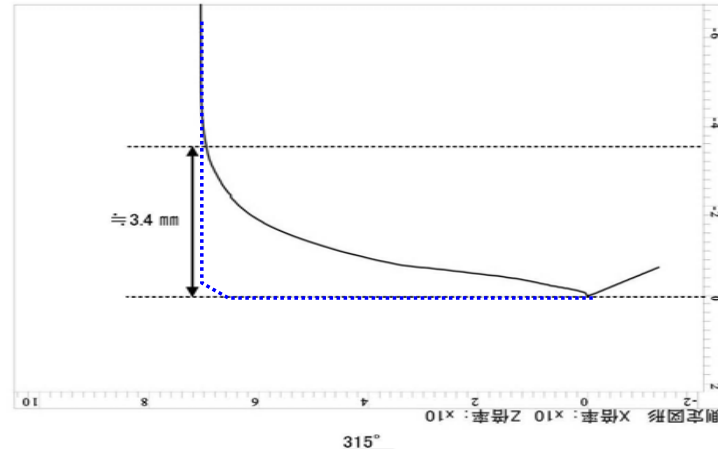
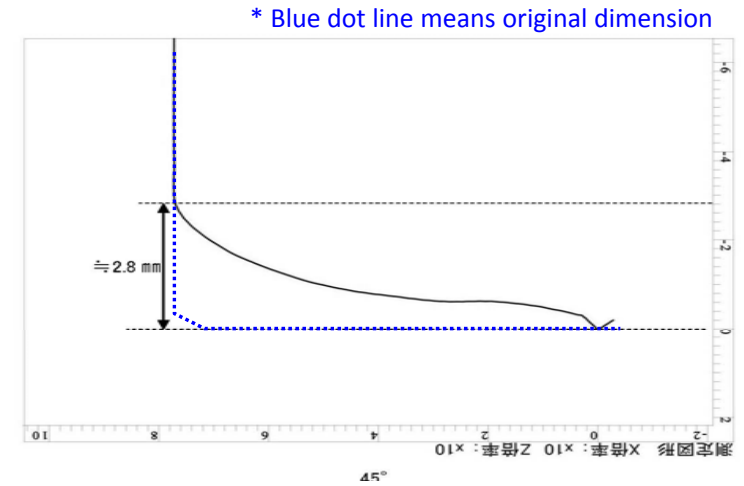
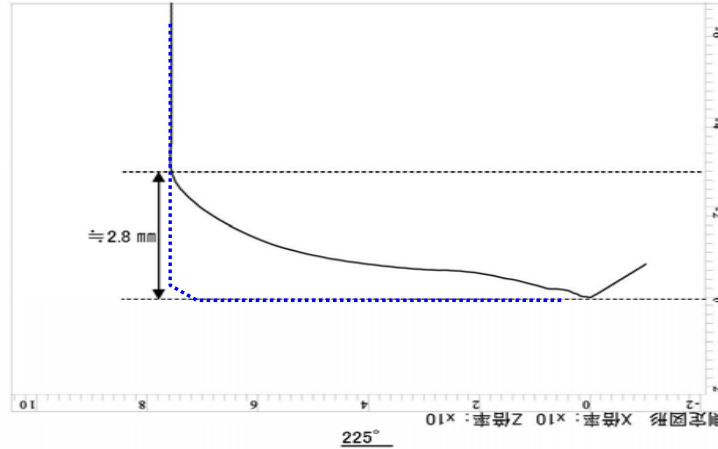
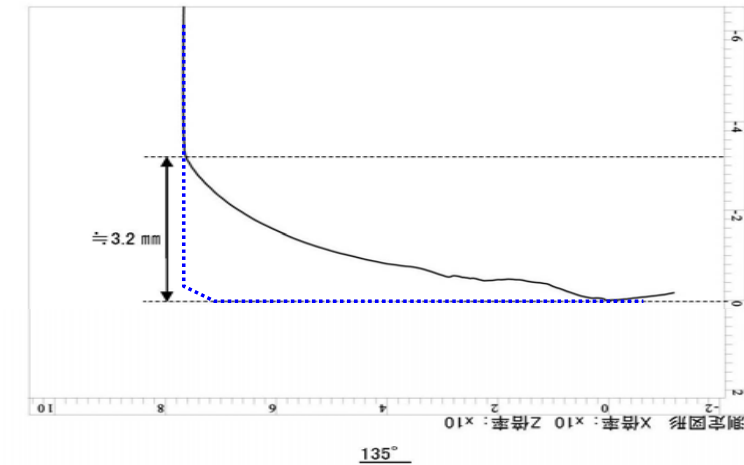
3. Fracture analysis for Valve seat (4)

-> Contact surface of valve seat was worn out.

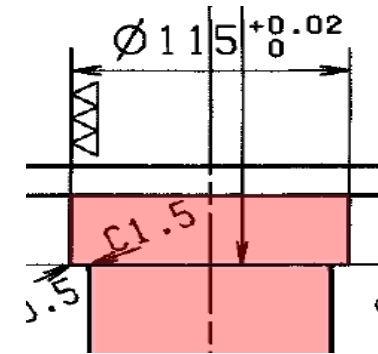
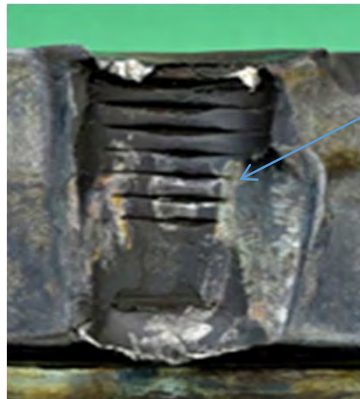
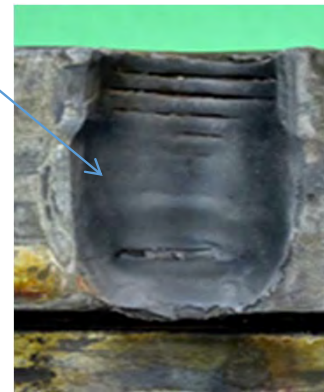
In 2011, the clearance between valve seat and valve box was increased according to the service report. (No record was remained in 2011.) In 2018, this got even bigger as per table.

Due to too large clearance, the setting bolts were not installed properly, which leads to an incomplete fixing. Then, excessive wear occurred on screw portion after long term operation by vibration or steam flow etc.

Wear

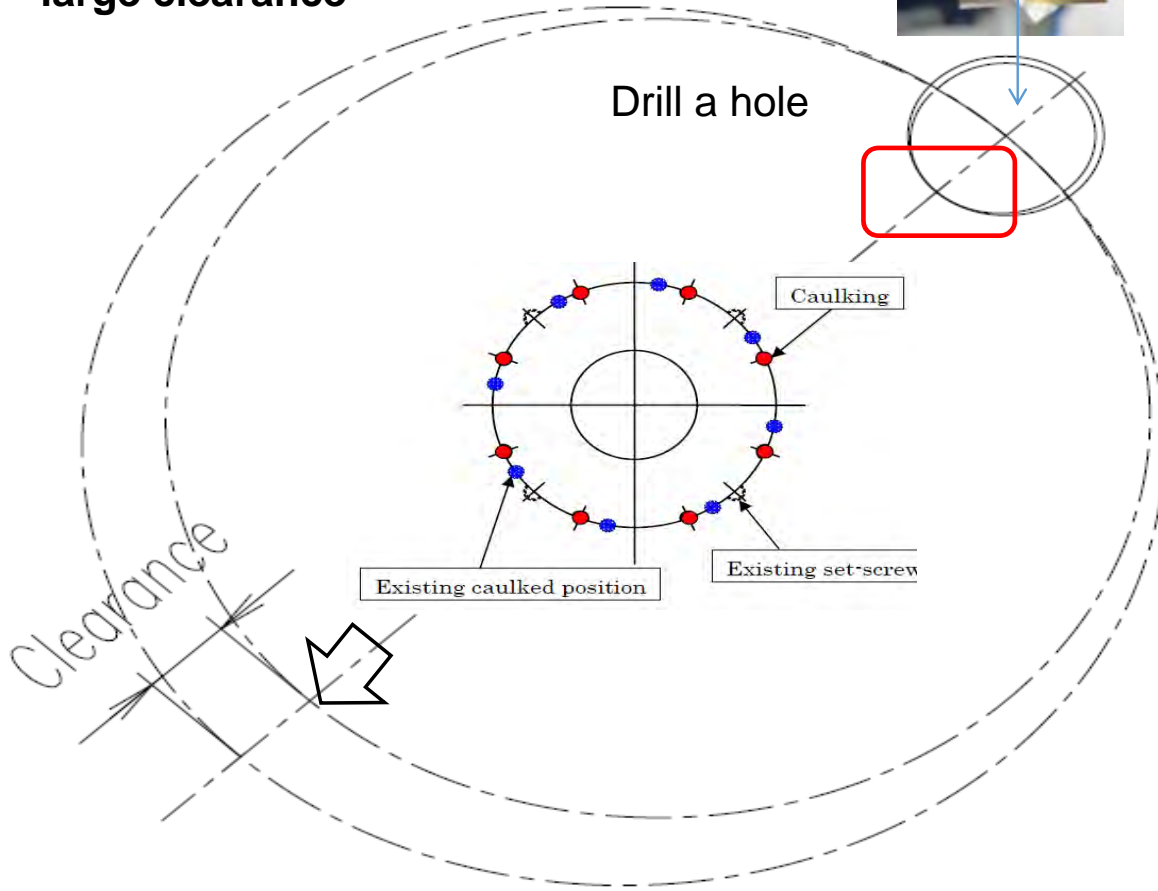
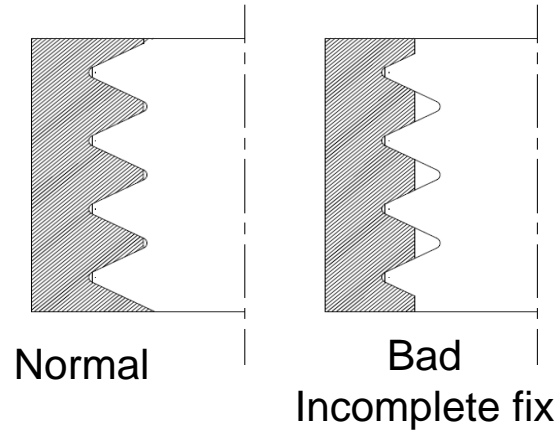
If clearance is large, it is a high risk to process the pilot hole improperly to be shape of an ellipse .

Then, screw engaged area decreases to be incomplete fixing like below Figure.

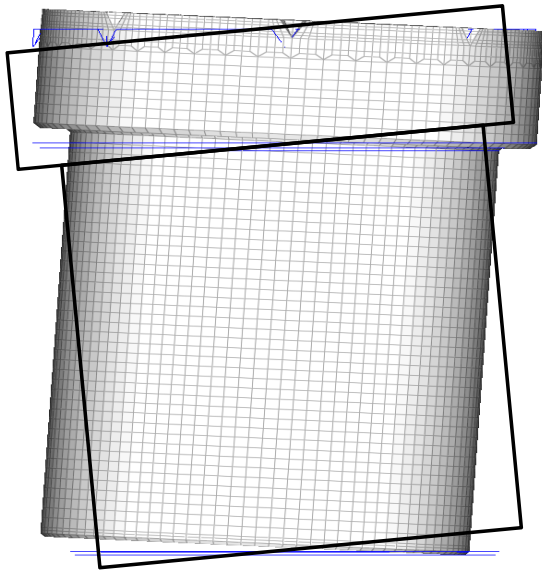
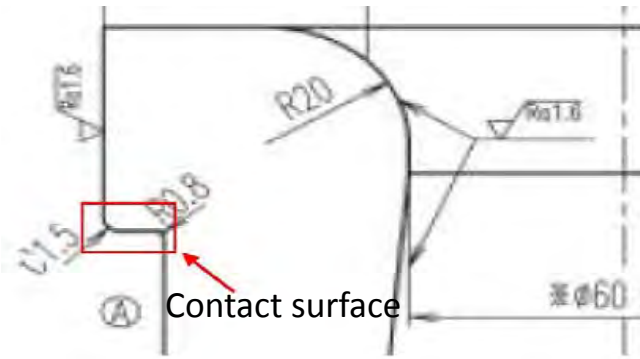
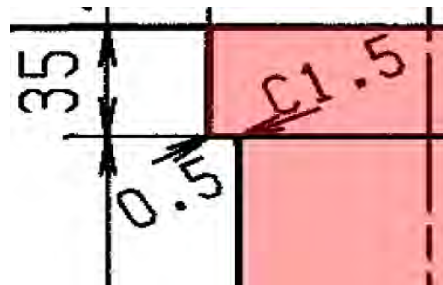
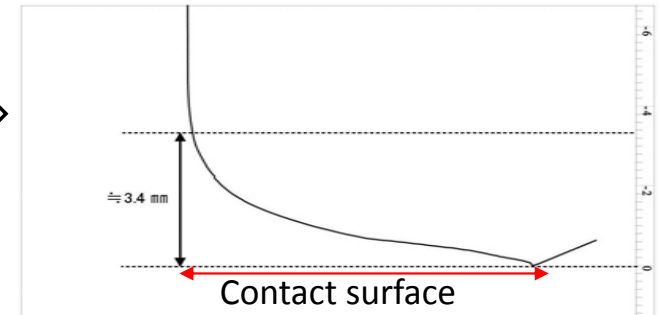
After loosening or wearing screw, valve seat was excited by steam flow or vibration, then unusual wear occurred on contact surface between valve seat and valve box.

Valve seat excited by vibration Or steam flow.

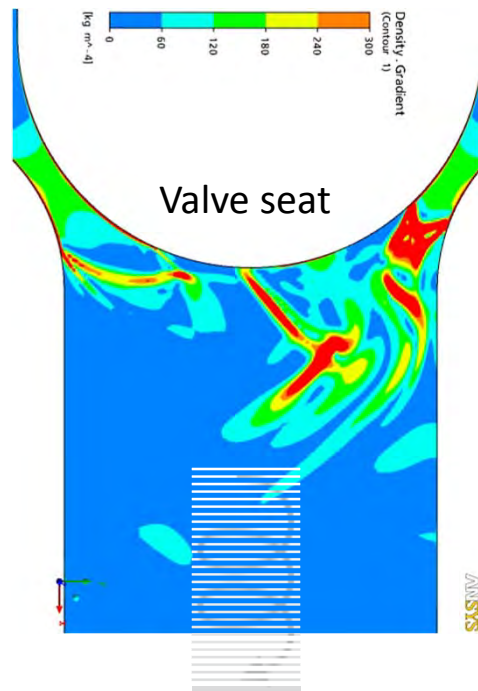
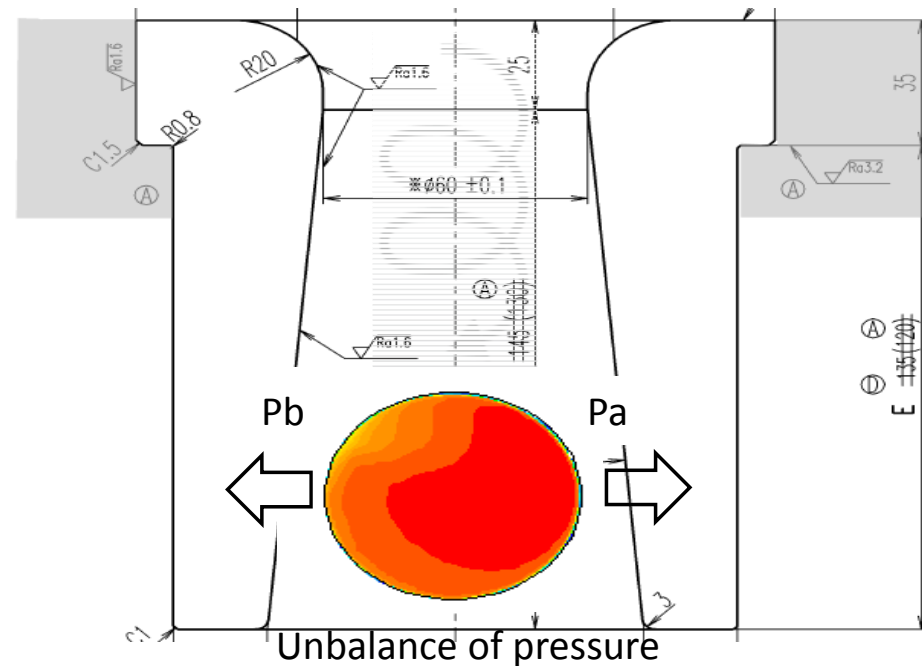
If there is a unstable pressure distribution circumferentially, it's possible to slip valve seat without fixing by screw

Unstable pressure distribution (about 0.2% of static pressure) causes a valve slip if there is not set screw. This unstable pressure is a realistic level due to its small value. Then, unusual wear is high possible in long time operation.

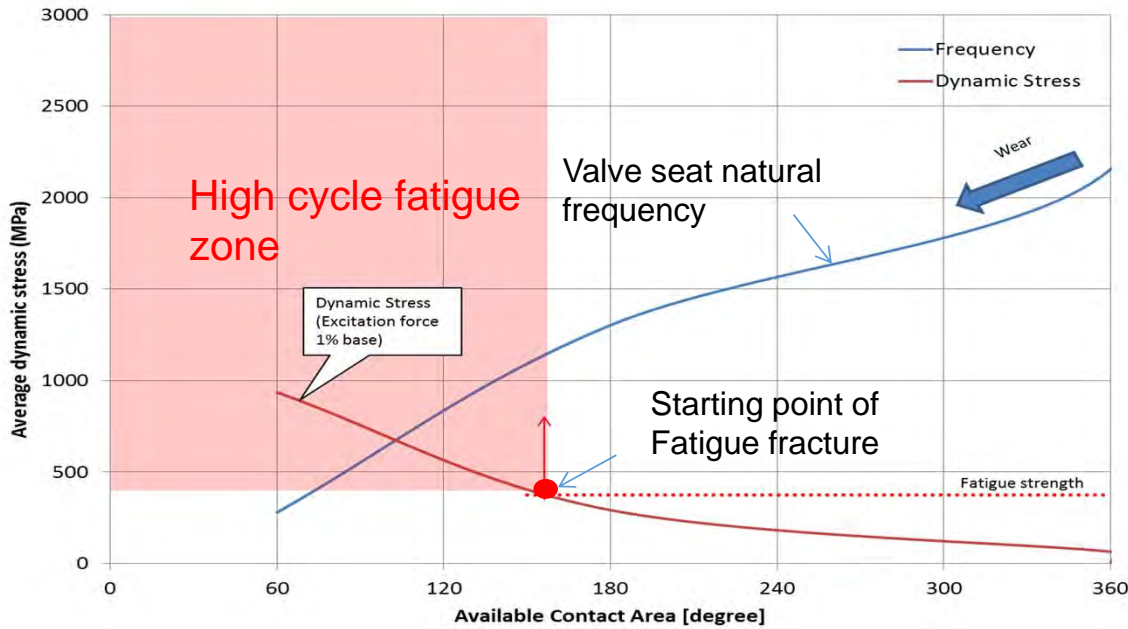
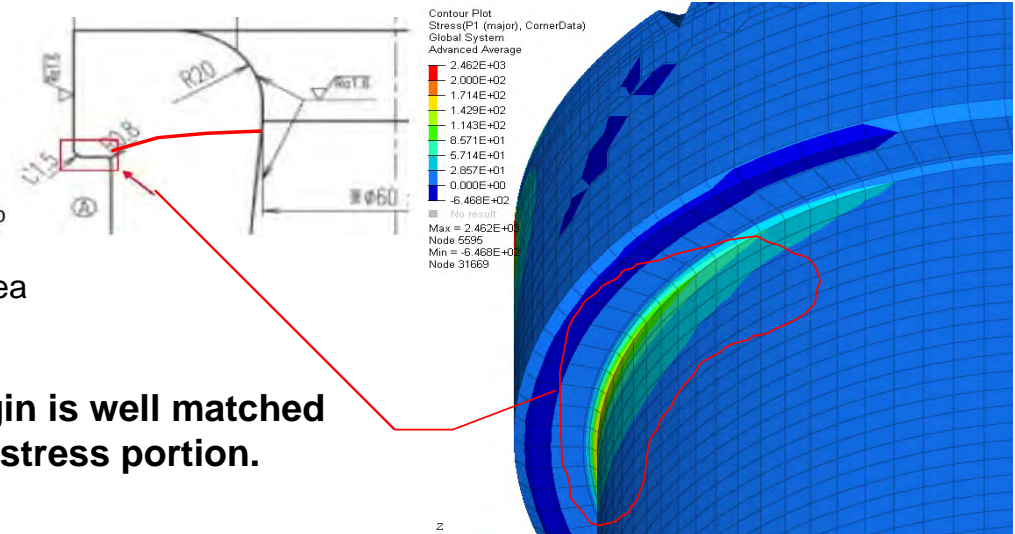
Fig. Relation of Valve seat natural frequency, dynamic stress VS Contact area
(Assumed excitation force = 1% fluctuation of static pressure)

1. Valve seat was not fixed by set screw looseness
2. Usual pressure fluctuation caused valve seat slip which leads to wear damage on contact surface.
3. Valve seat natural frequency is decreased by contact area reduction. Also, dynamic stress is increased.
4. Valve seat was failed by high cycle fatigue.

Valve seat natural frequency is 3700Hz in proper fixing, which is far from this abnormal condition.

Crack origin is well matched with peak stress portion.

In abnormal situation of valve seat slip and wear on contact surface, dynamic stress rapidly increases and exceeds to material fatigue limit as contact area is reduced.
