**TURBOMACHINERY  
& PUMP SYMPOSIA**

# **RESOLUTION of HIGH VIBRATION on a GENERATOR**

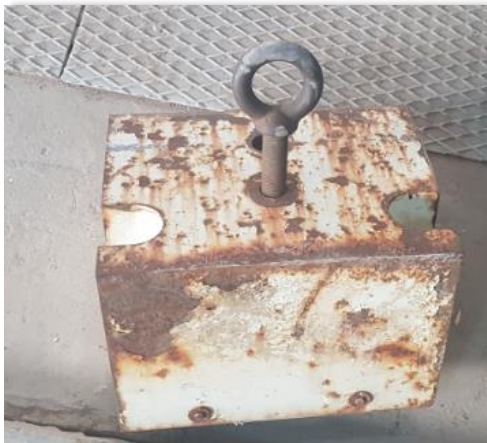
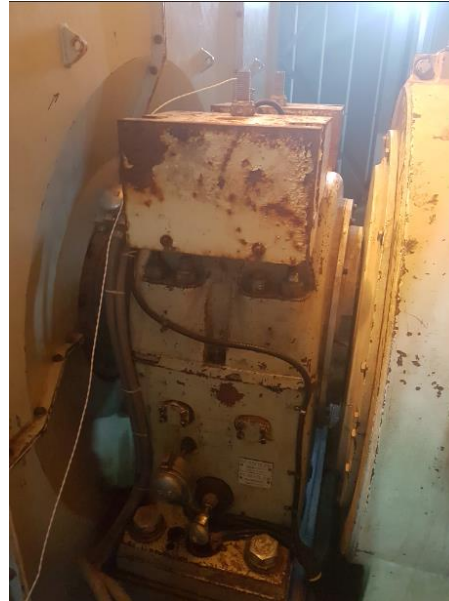
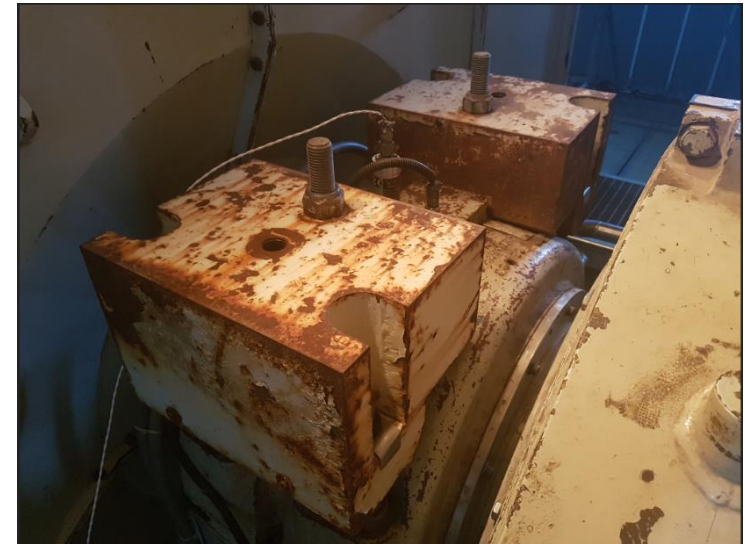
Vibration absorber blocks installed by OEM on top of the bearing housing did not show any improvement in the Generator vibration level. (2 Blocks of 400 Kg each)

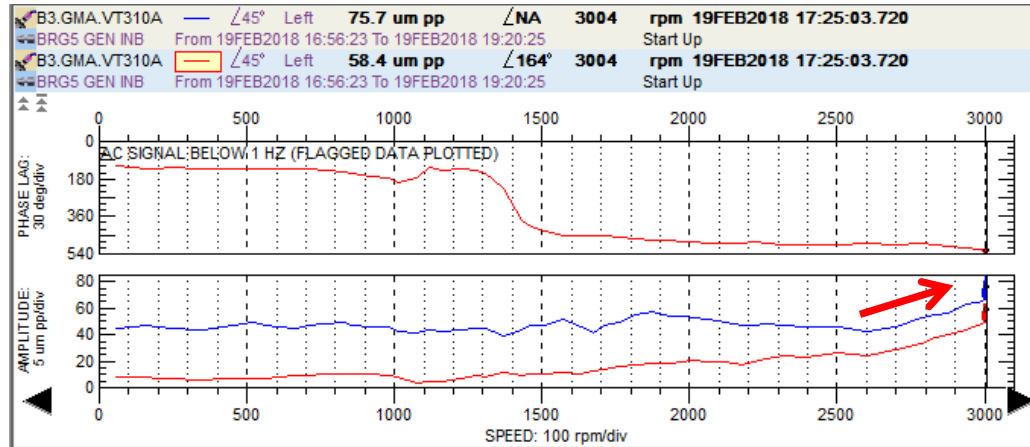
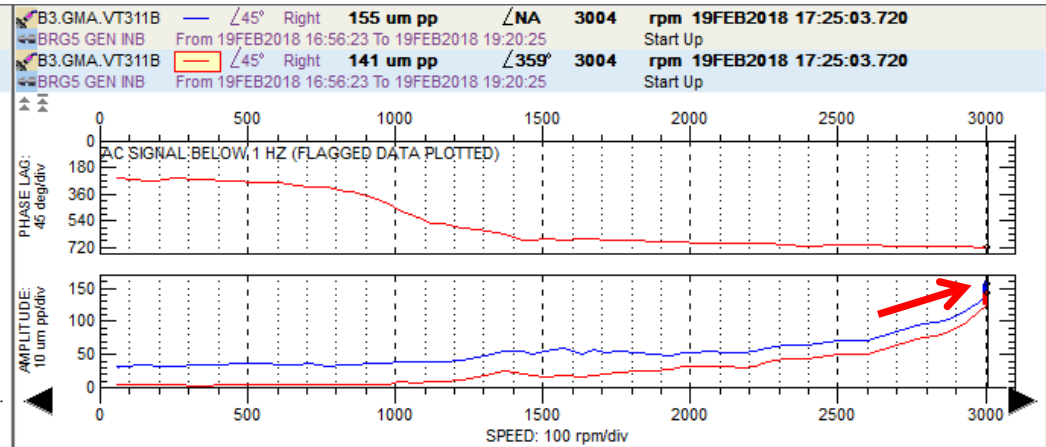
In-board Bearing

- The shaft vibration on Generator IB & OB bearings were high, close to 155  $\mu\text{m pk-pk}$  (6.1 mils PP).
- Bode plot of Gen IB & OB shows machine running close to second critical.

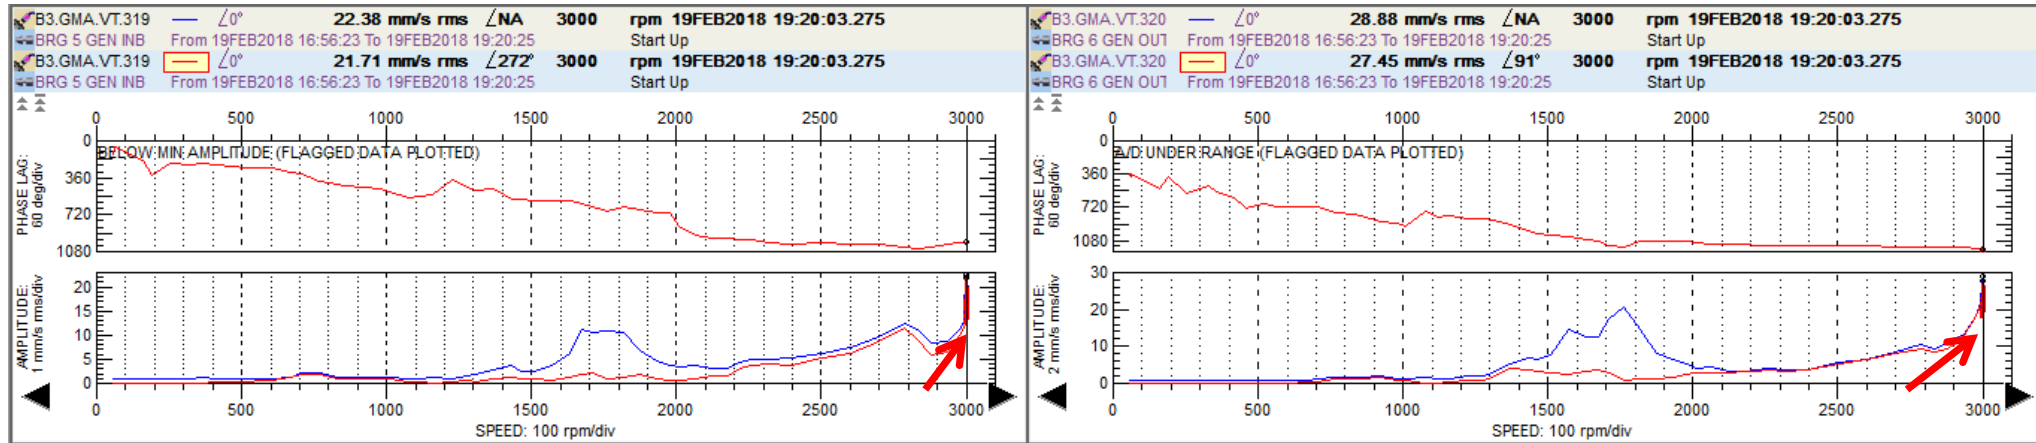
- Vibration readings on the IB and OB generator bearings were close to 29 mm/sec or 1.1 in/s (RMS). High vibration when the unit close to running speed.

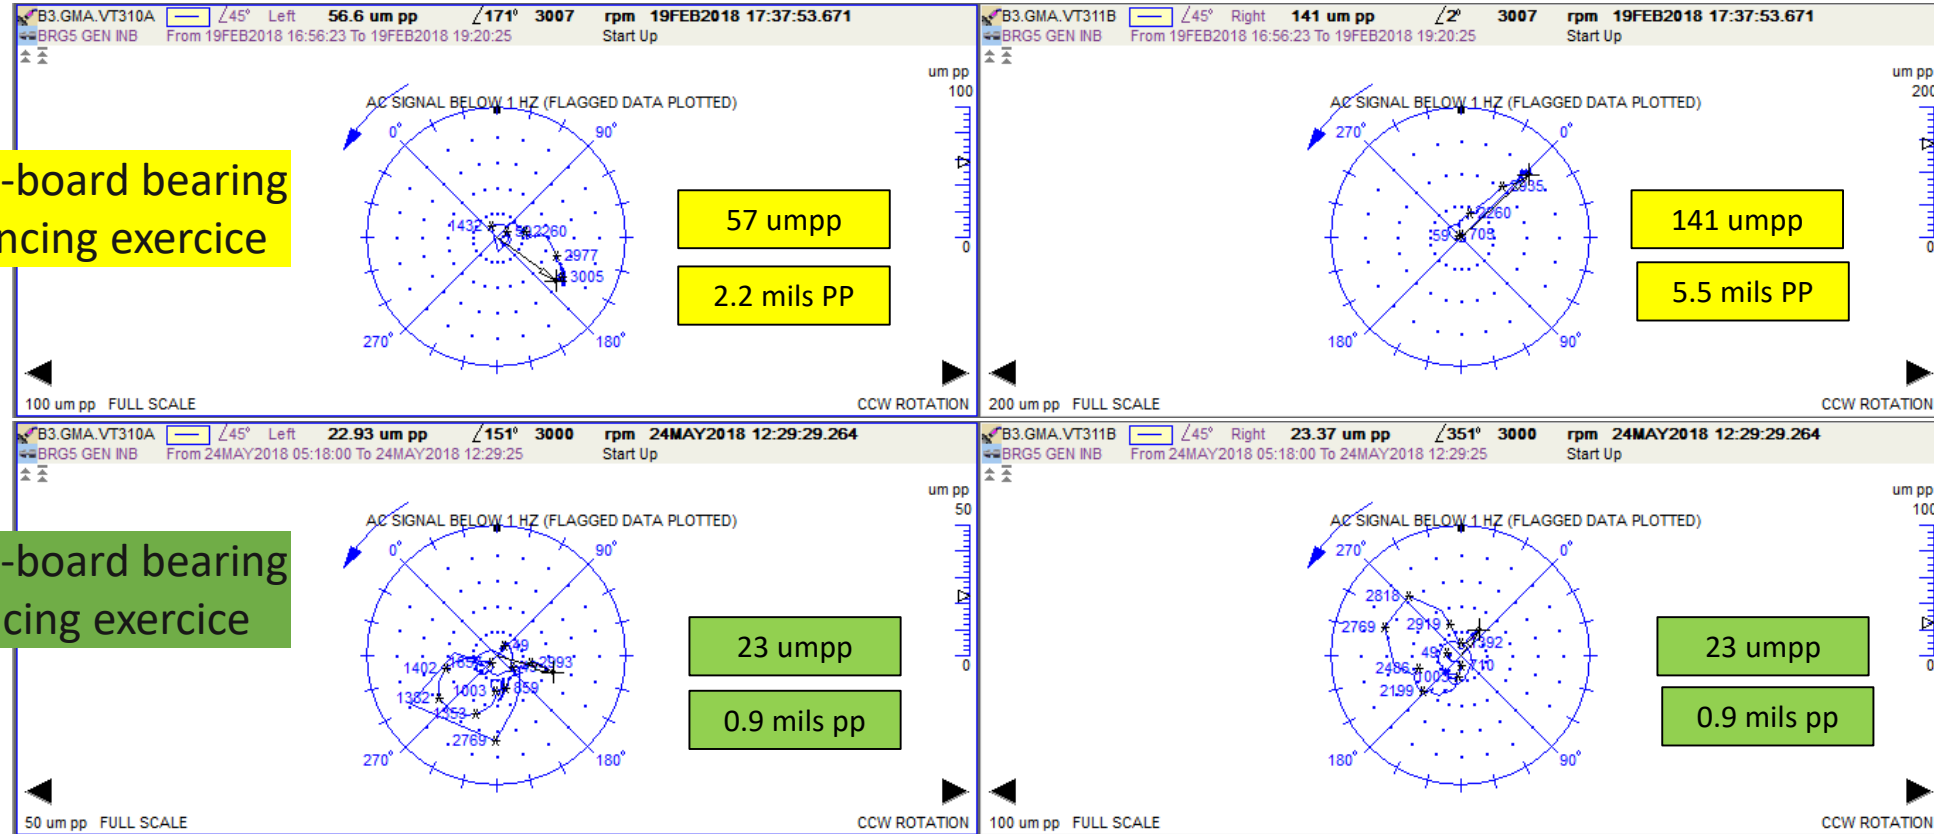
- Significant improvement noticed at Generator In-board bearing after balancing

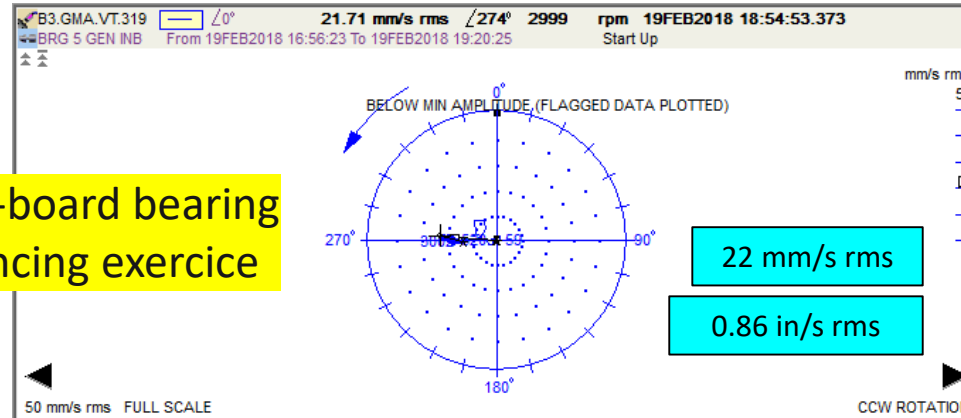
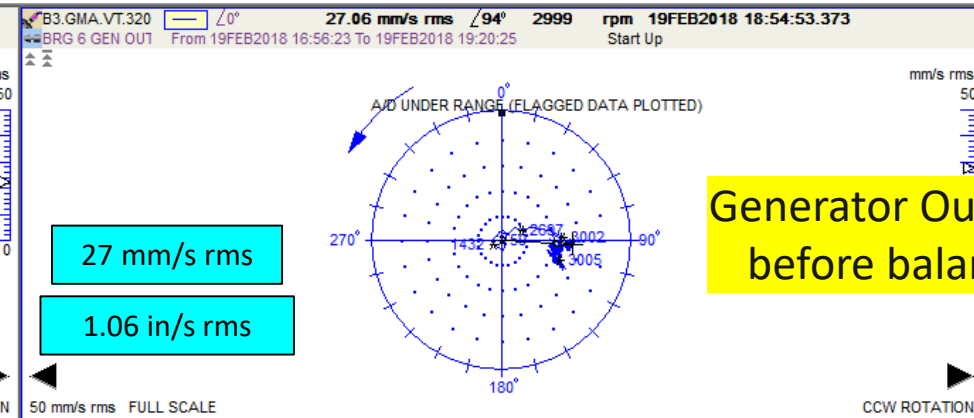
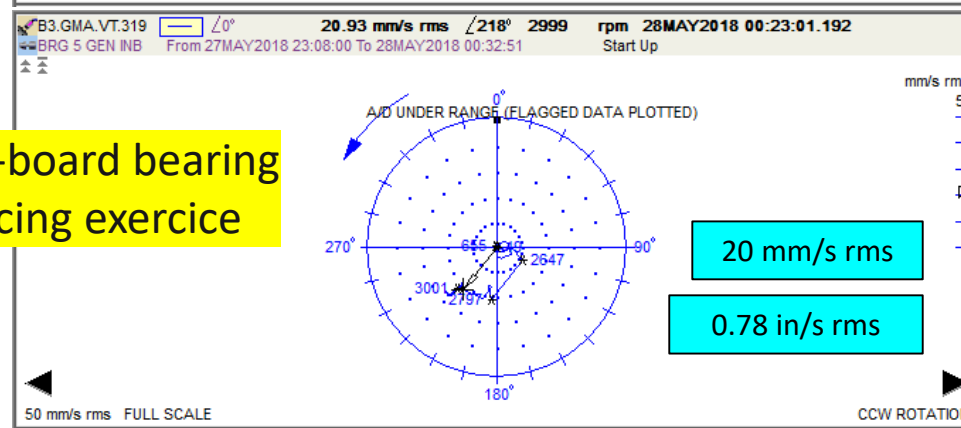
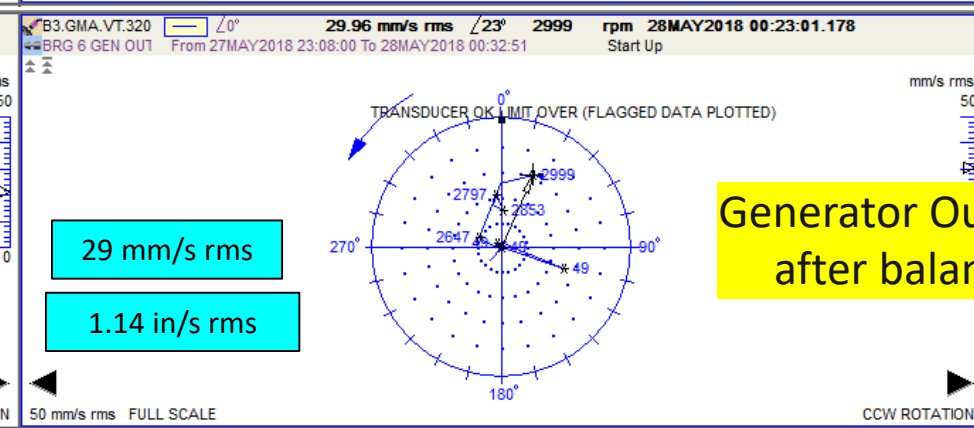
- *Not much changes noticed on the casing vibration even after balancing*

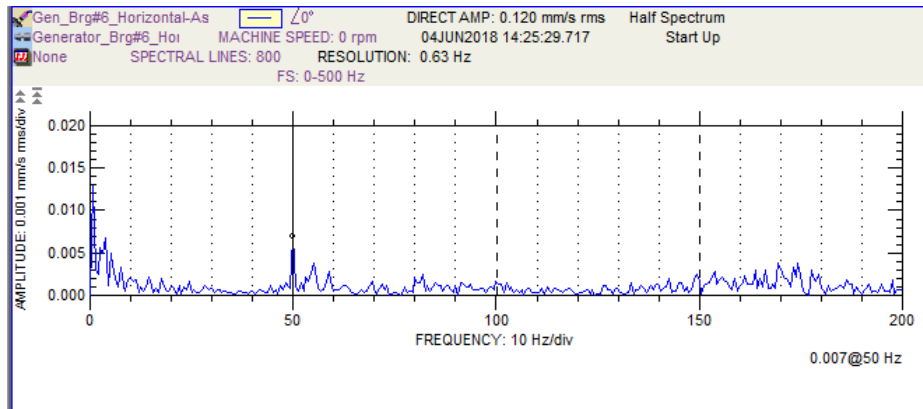
Generator Out-board bearing Horizontal direction

**Test result:** The impact test showed that the natural frequency of the outboard bearing aligns with the running speed.

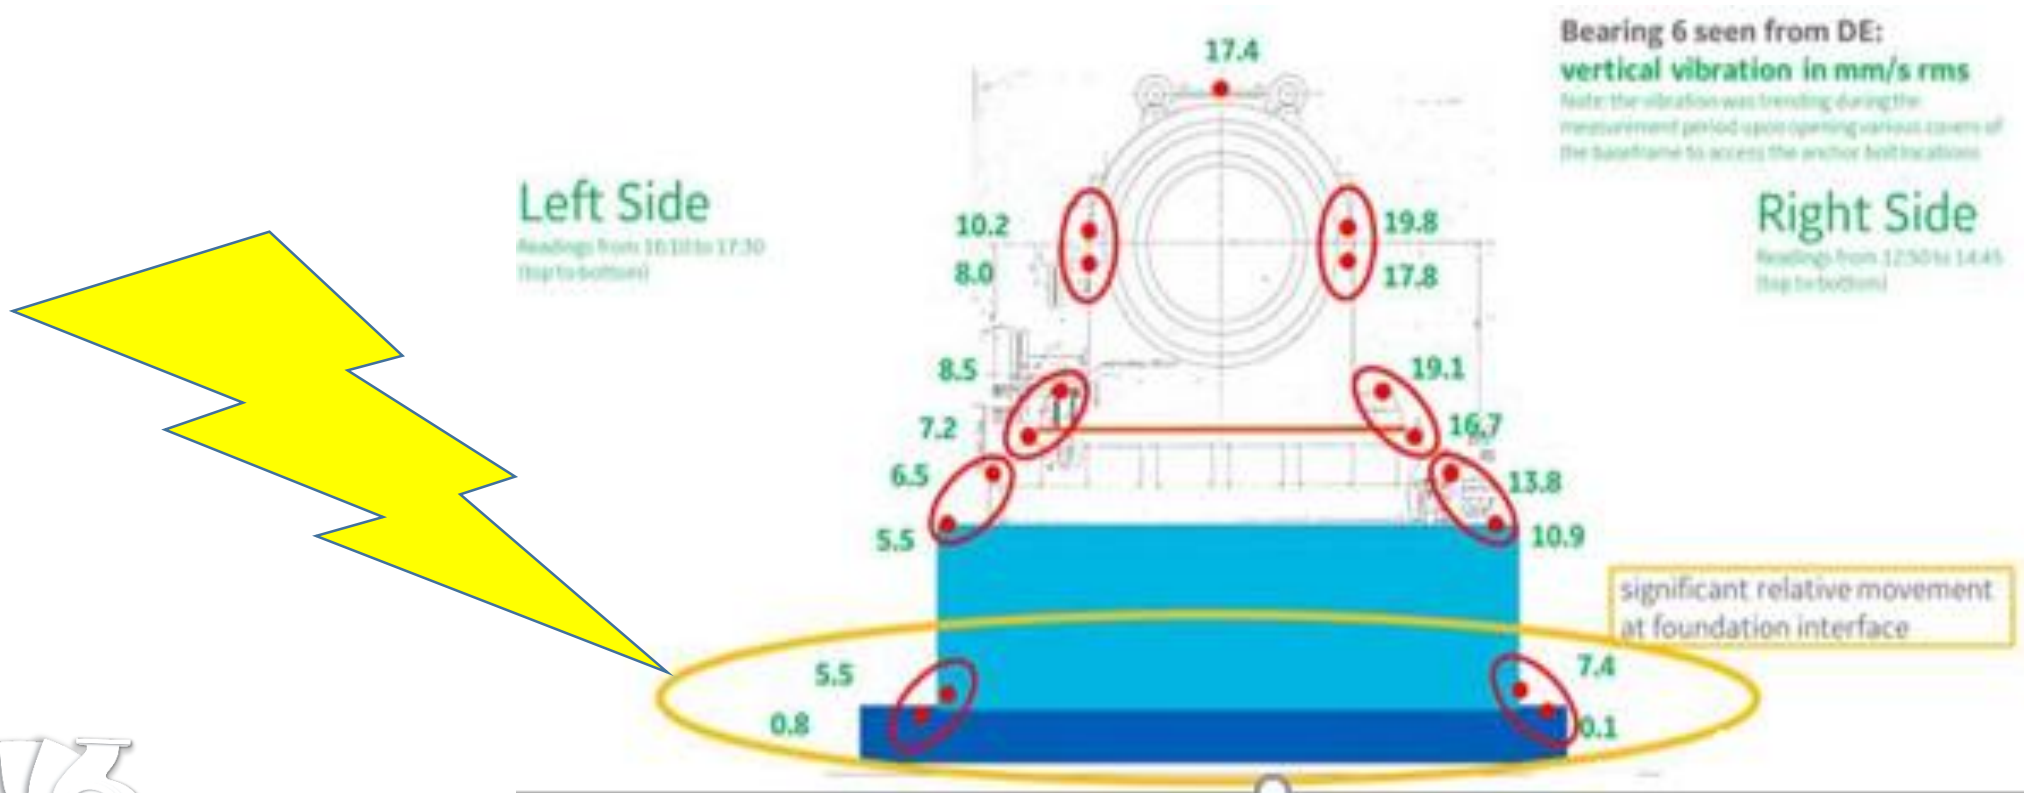
- Significant relative movement at interface foundation on outboard bearing (location 8) was located

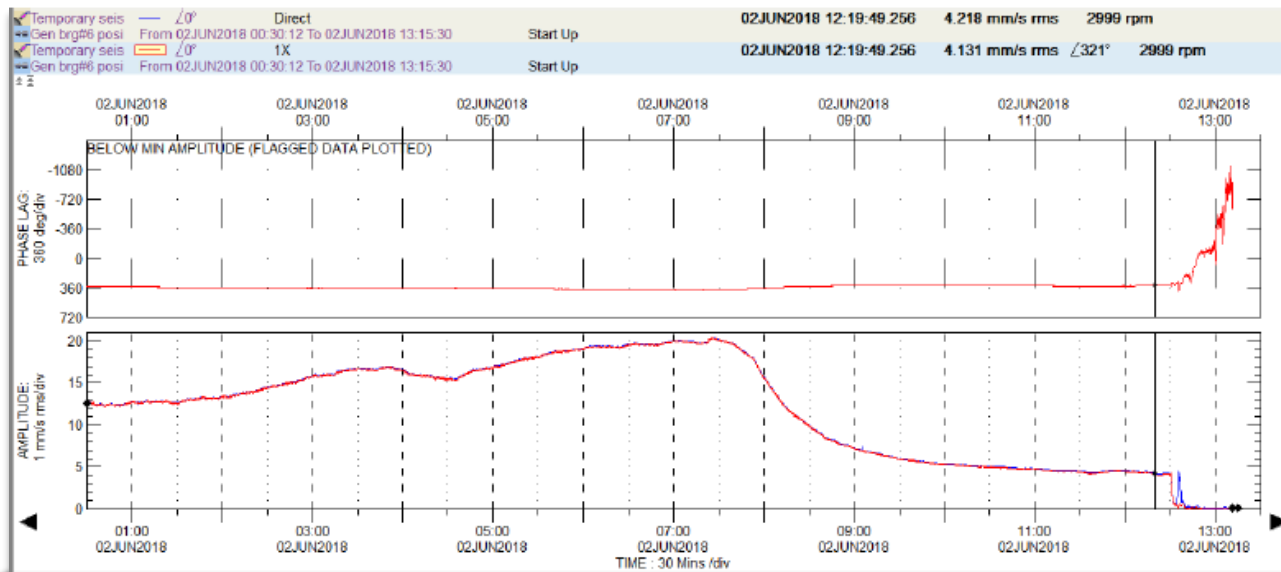
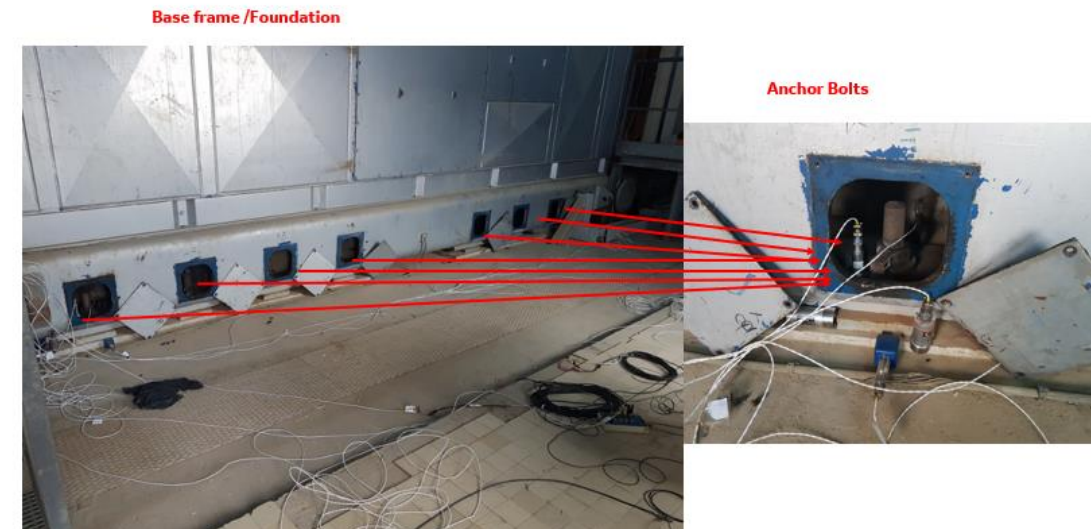
- An interesting event occurred during the soft foot check: The vibration readings started to decrease gradually on both Generator bearings and stabilized at low levels after opening the anchor bolts trapdoors.
- The above test was repeated with closing/opening of the anchor bolts trapdoors and the test confirmed that the trapdoors of anchor bolts location of base frame/foundation affected both shaft and casing vibration of generator.

- The phenomenon of vibration reduction during opening of anchor bolt trap doors is suspected to be a resemblance of thermal transient where generator bearing housing and frame trying to attain thermal equilibrium whereas it is causing high vibration due to frame distortion when trap doors are closed.
- The above behavior suggested an issue on anchor bolts tightness or soft foot issue.
- Following was recommended:
  - ✓ **Check tightness at the 4 foundation anchors below the outboard bearing pedestal (area S and S1, area R and R1) and ensure proper tightness of shims.**

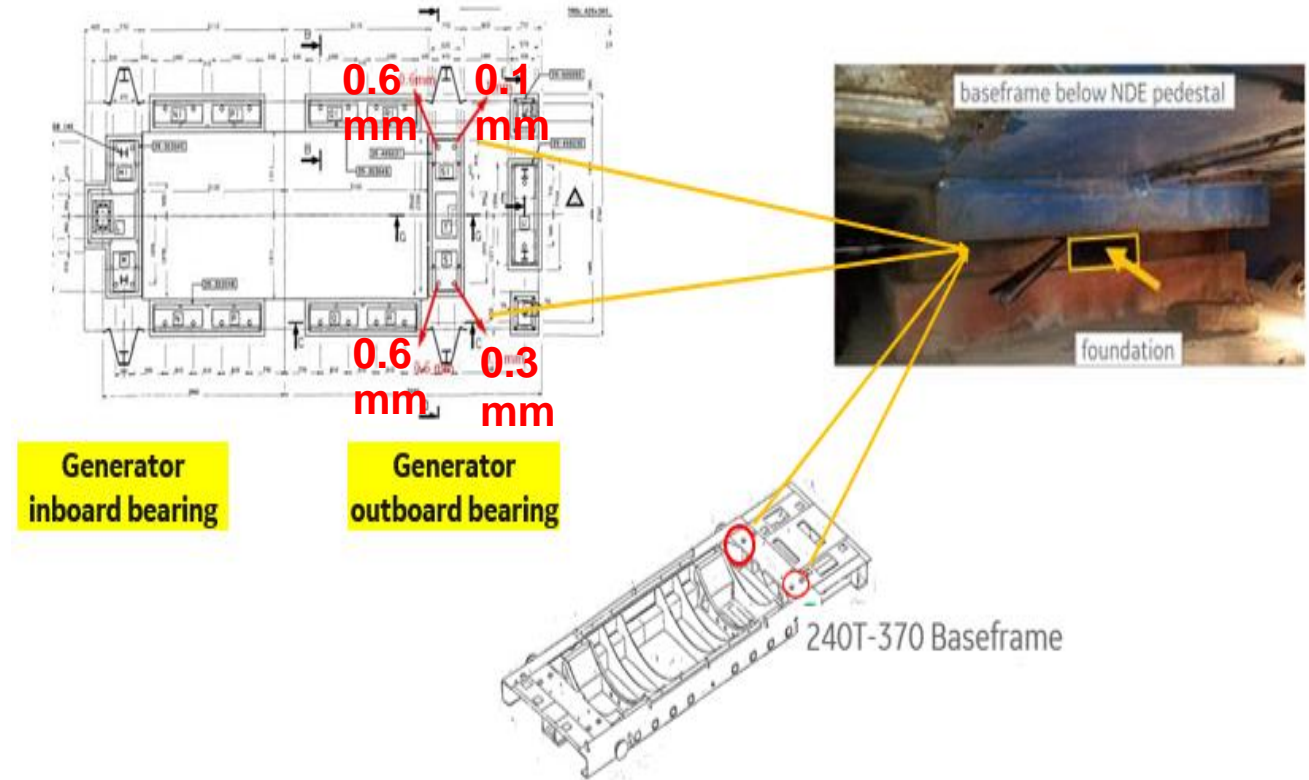
- No loose shimming found at the 4 foundation anchors below the generator bearing pedestals.
- Anchor bolts were already properly tightened with a torque of 800 N.m but there was an abnormal gap of 0.1 mm and 0.61 mm were measured on the Generator NDE bearing pedestal.
- The above observation concluded that this is the root cause of high vibration on the Generator bearing casing.

- Encircled are the locations of NDE pedestal area where gaps found.

- Shimming was added below the 4 foundation anchors of the generator outboard bearing pedestal.
- Correction was completed by jacking the generator frame up off of the baseplate. Shims at the interface point were removed and the interface points on the baseplate and pedestal were cleaned and new shims were then installed. The generator frame was then lowered and proper level and contact was confirmed.

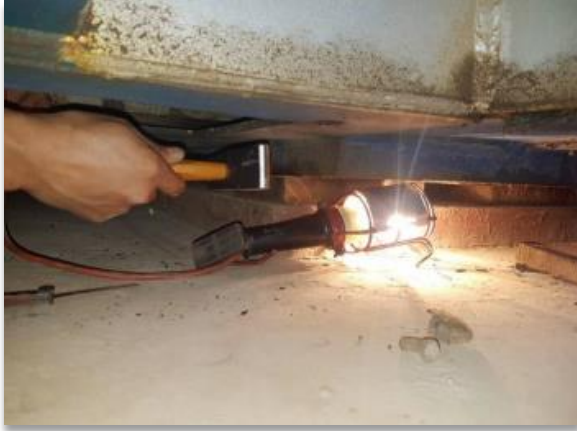
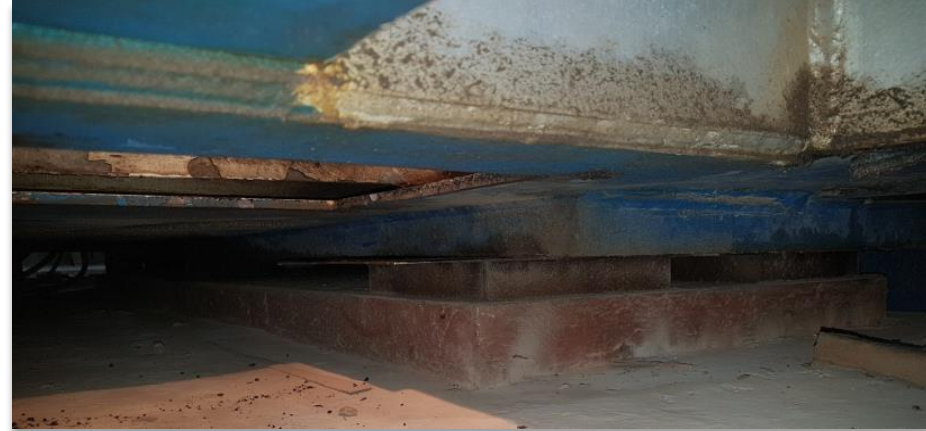
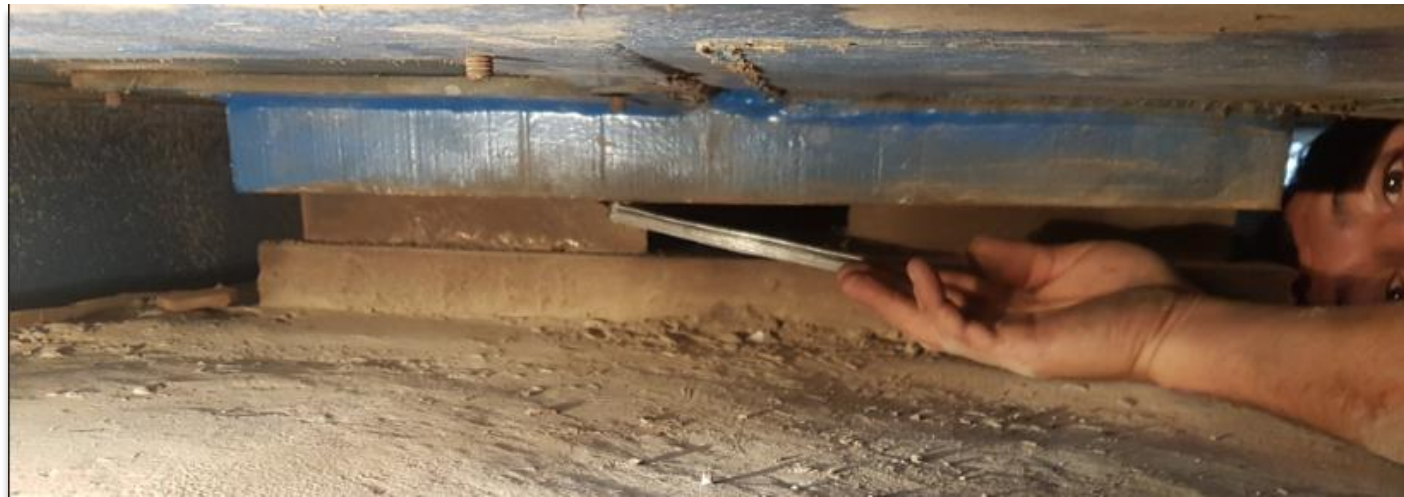
- Gaps were measured below Generator NDE pedestal

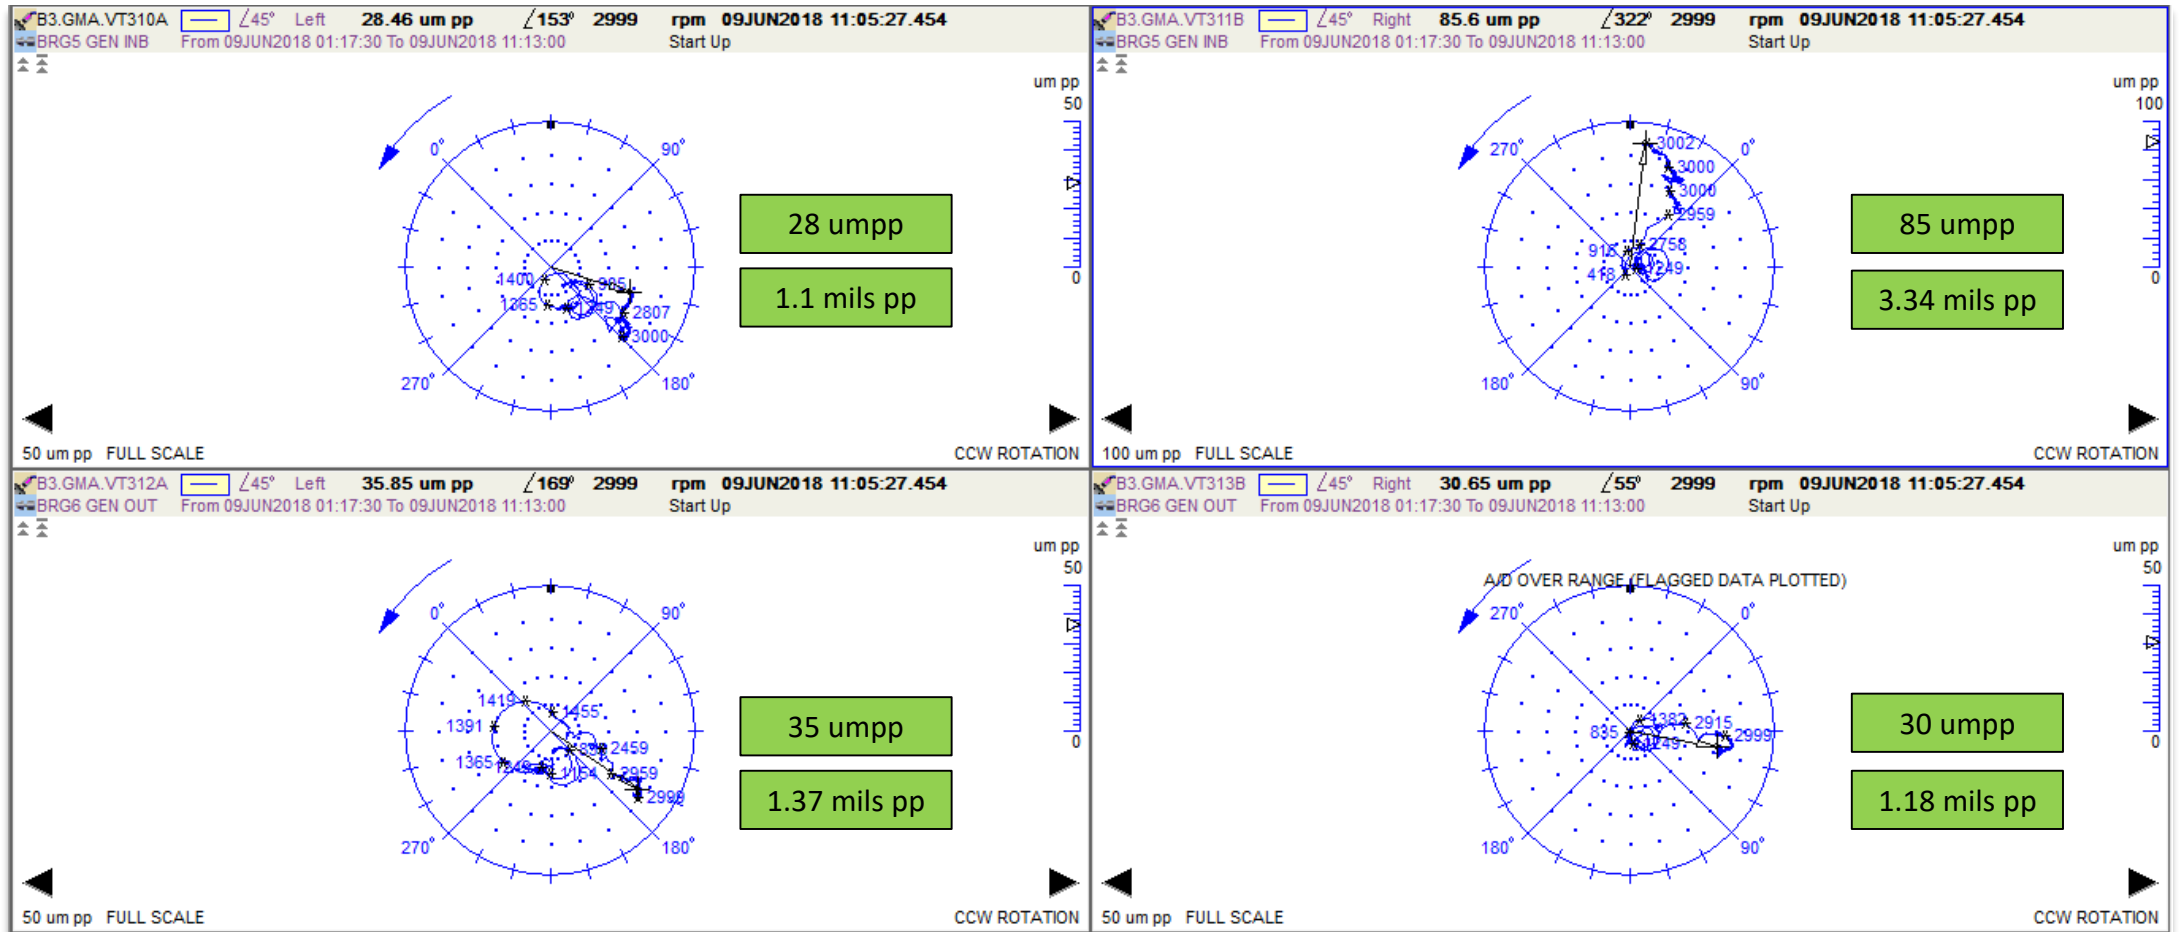
- Shaft Vibration / 1X polar plot after actions indicate acceptable vibration level

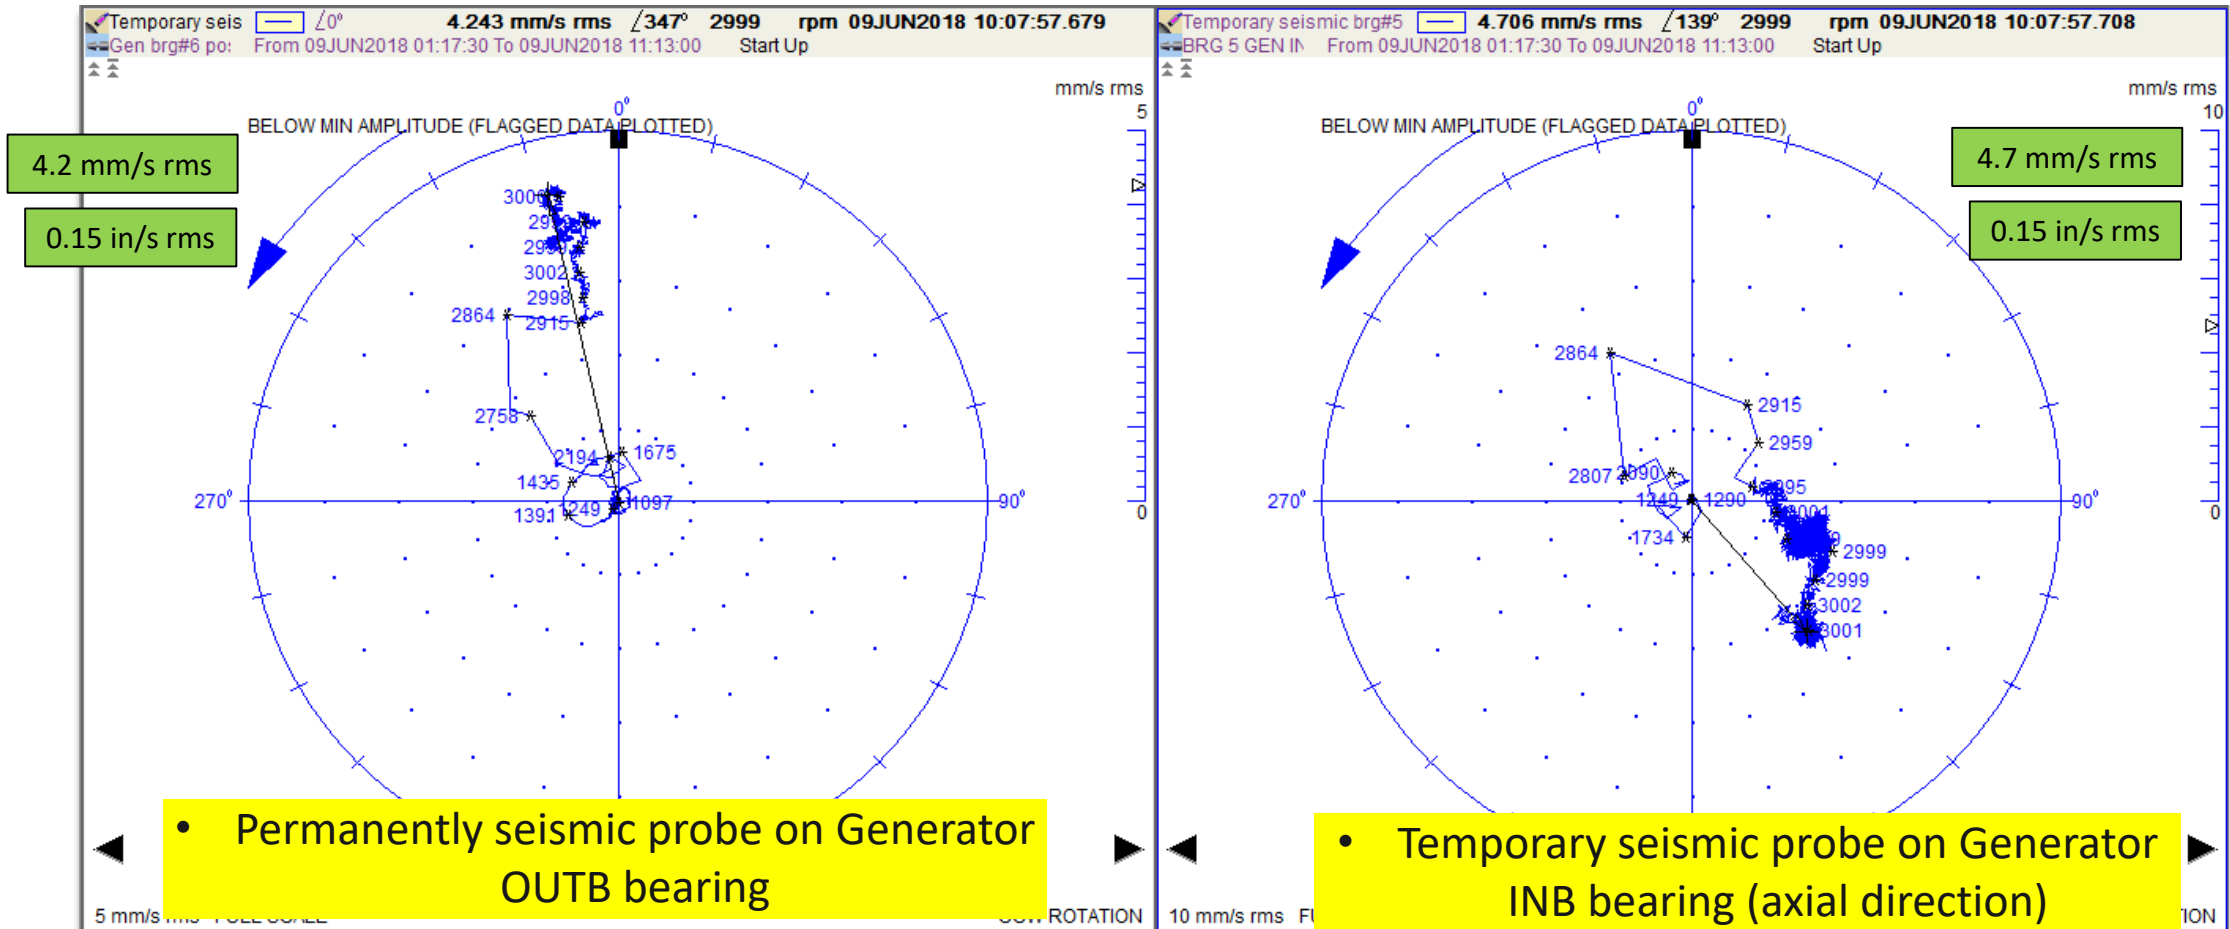
- Casing Vibration / 1X polar plot after actions indicate acceptable vibration level
