TURBOMACHINERY
& PUMP SYMPOSIA

High Vibration at Low Speed on a 25 MW Turbogenerator System

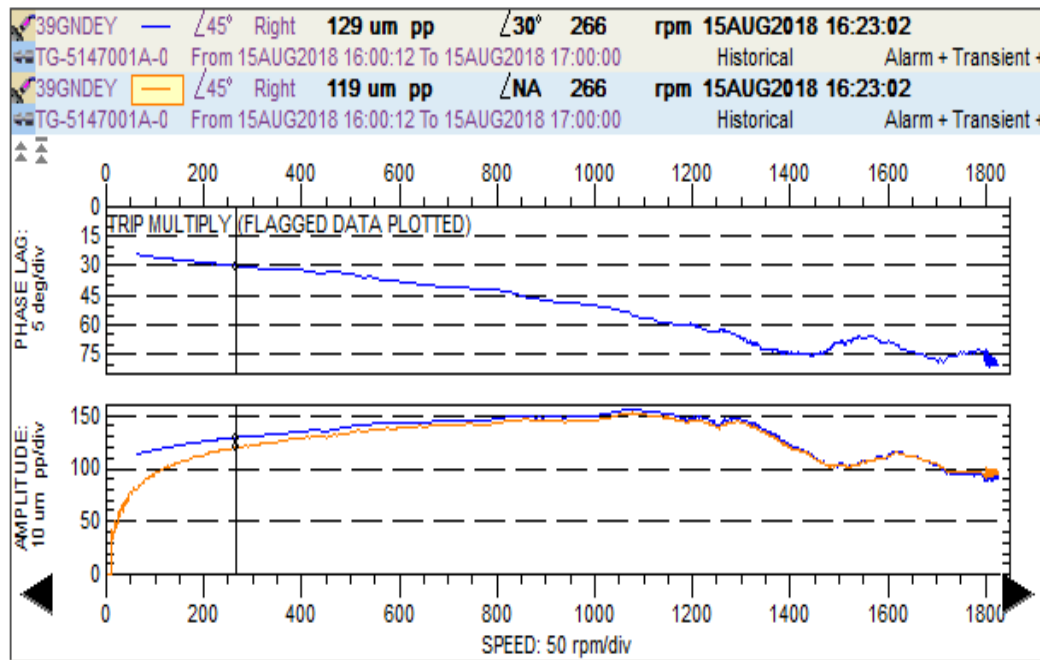
AC Generator Drive End:
130 μm pk-pk at slow roll

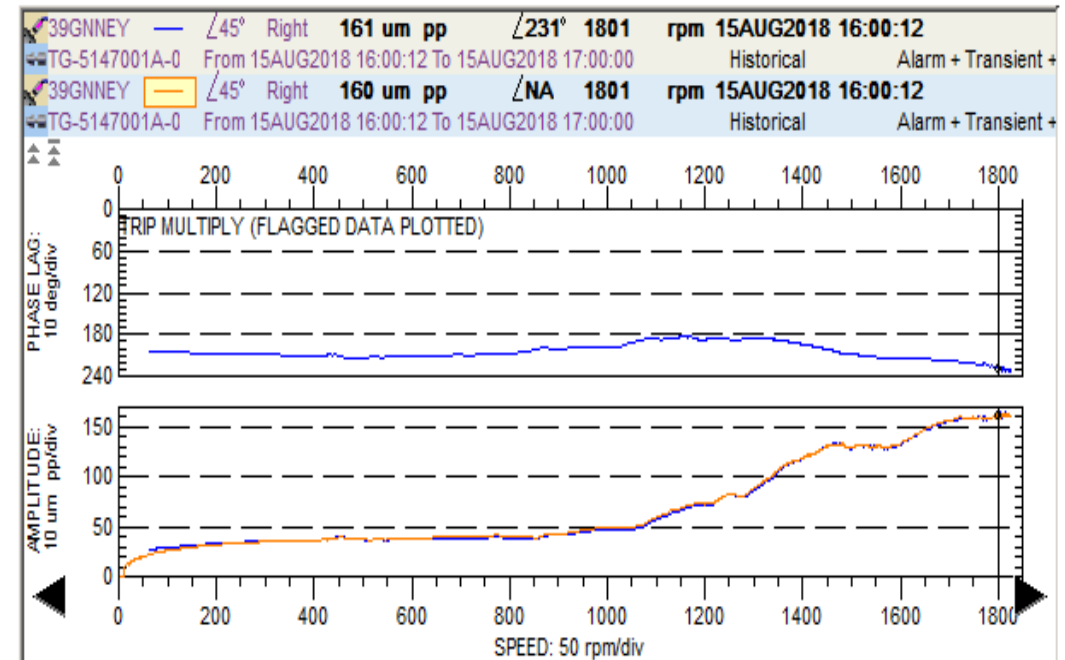
AC Generator Non-Drive End
160 μm pk-pk at full speed

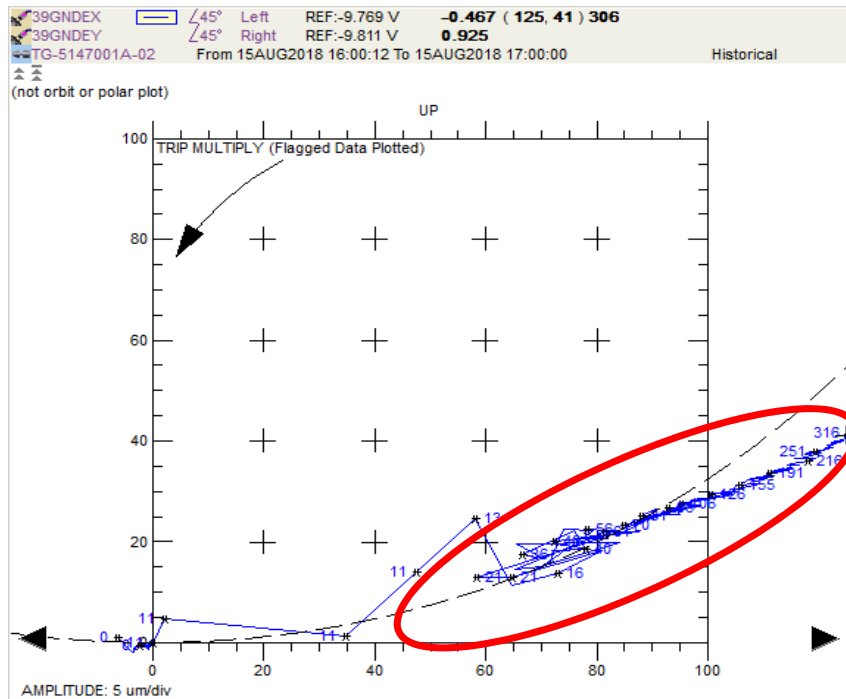
AC Generator Drive End:
 Inconsistent shaft centerline position
 during machine stop

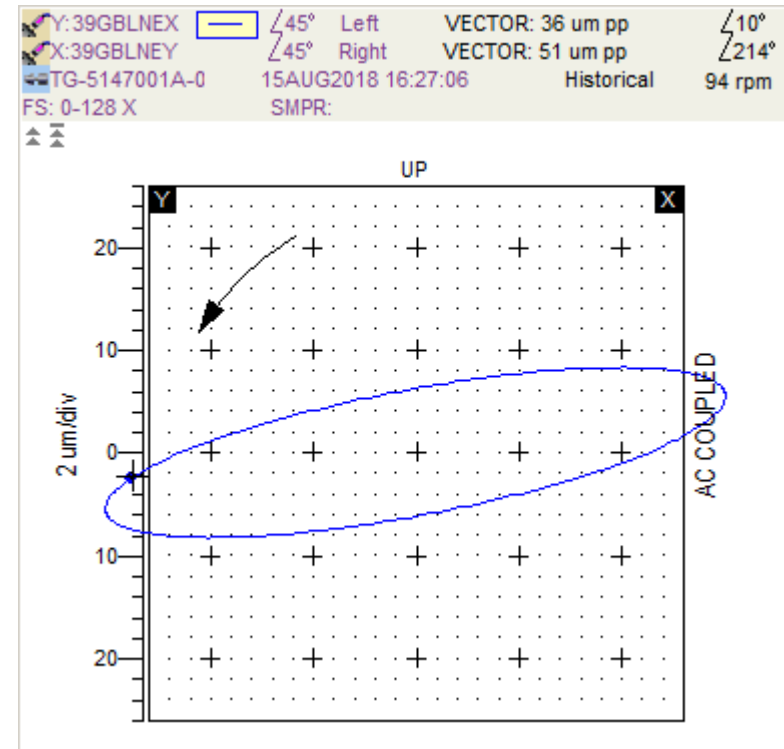
Gearbox LS Shaft Non-Drive End:
 High synchronous vibration at slow roll

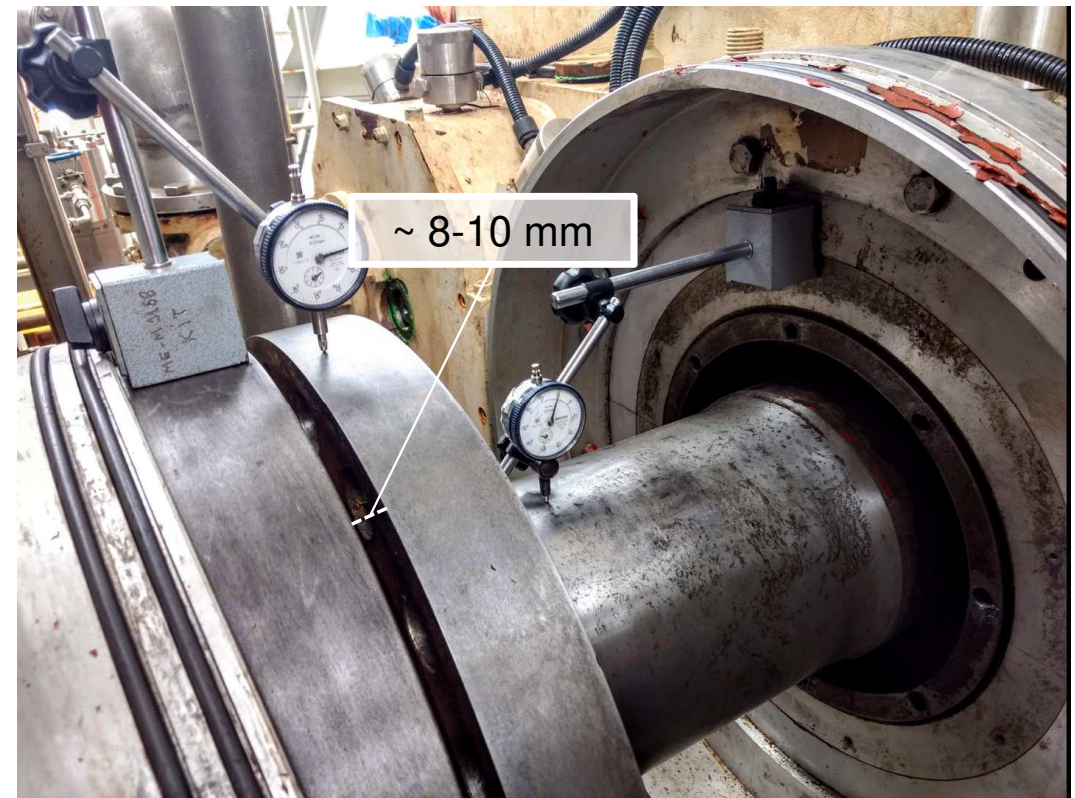
- 8 – 10 mm max. gap between uncoupled flanges
- Quill shaft runout was acceptable
- No rotor bow
- Low *glitch* (electrical and mechanical runout) measured at probe areas

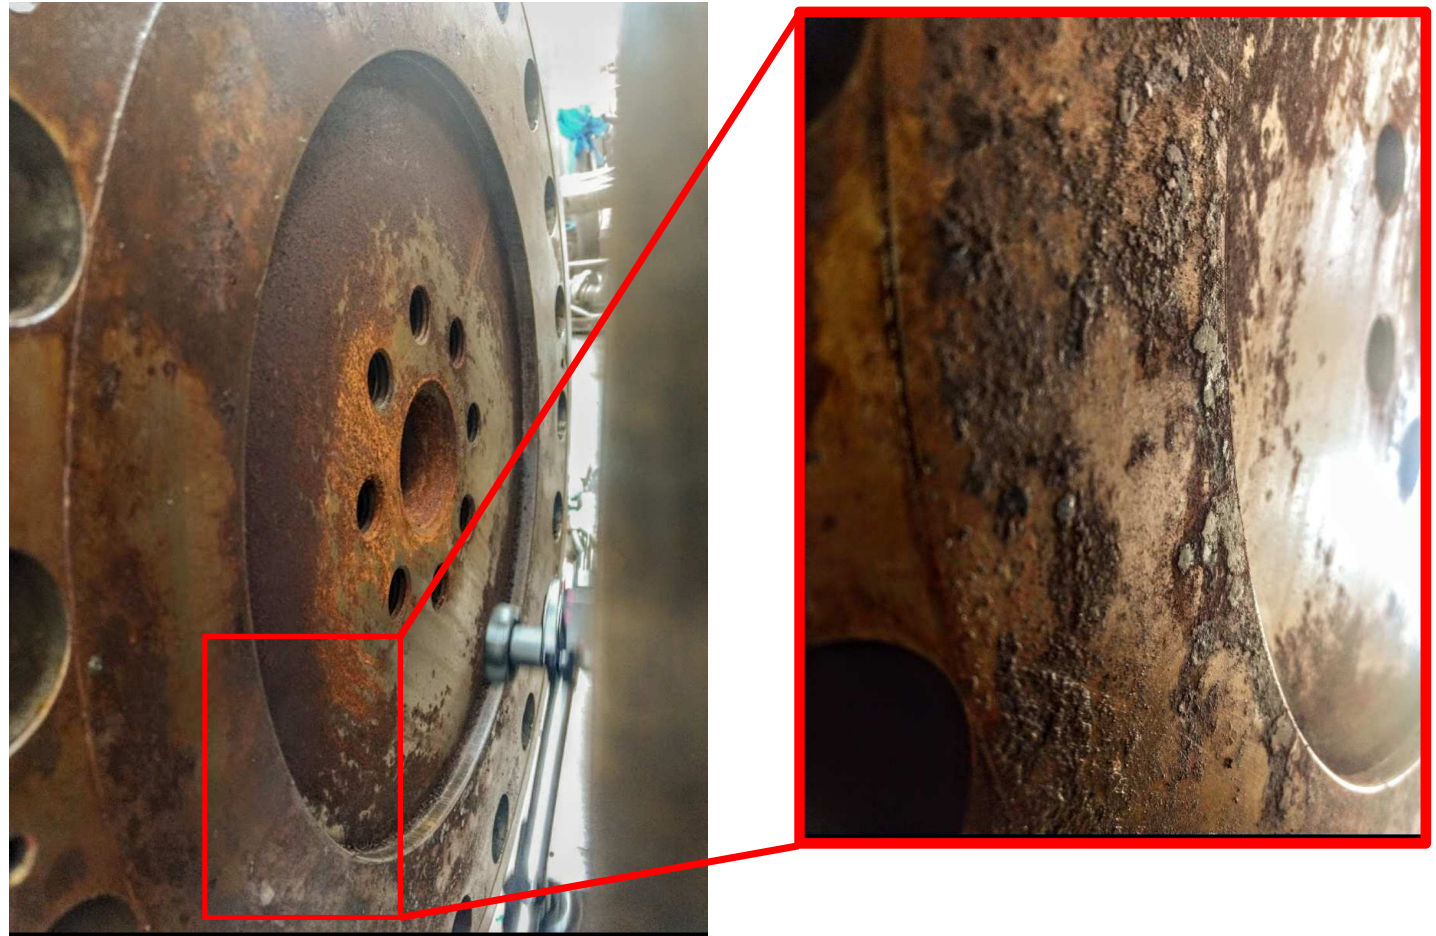
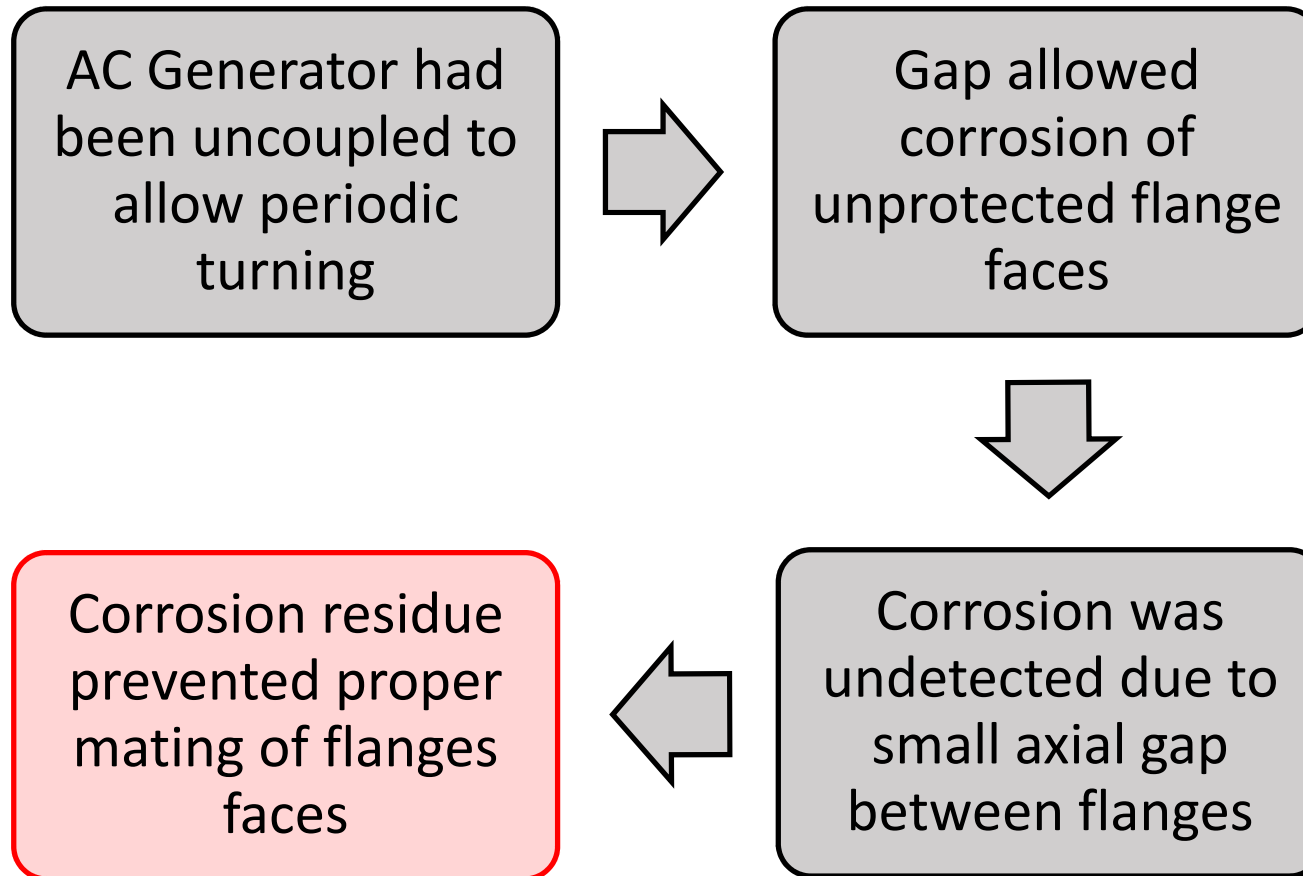
Corrosion residue layer
unevenly distributed
on the flange face

- > Avoid long storage periods for machine trains mounted on skid
- > When long storage is unavoidable, proper preservation should be applied
 - Volatile Corrosion Inhibitors (VCI) can be an alternative
- > Flange faces must be inspected and, if needed, thoroughly cleaned before final assembly
 - This requires sufficient axial separation between flanges

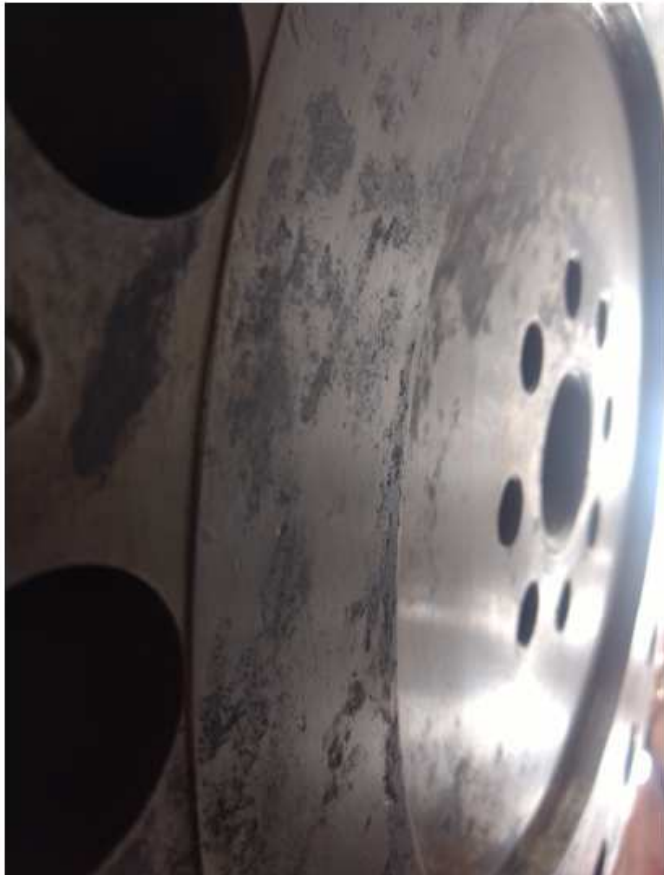
Flanges after cleaning

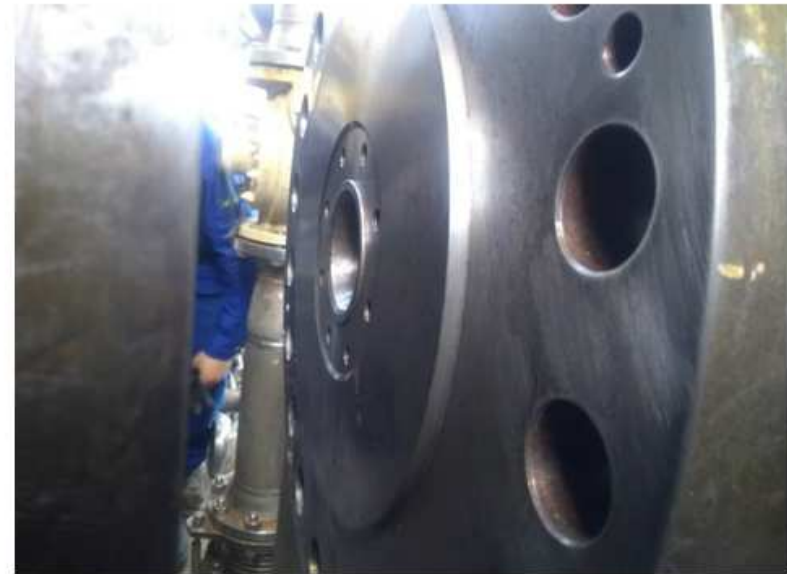
Low speed vibration after cleaning

Before cleaning	After cleaning
DE	130 μm	35 μm
NDE	35 μm	20 μm
