TURBOMACHINERY
& PUMP SYMPOSIA

Hydrogen recycle gas compressor fouling mitigation using higher suction temperature.

Martyn J Williams AMiEAust C Eng A NER (Snr Machinery Engineer @ BP Refinery Kwinana Western Australia)

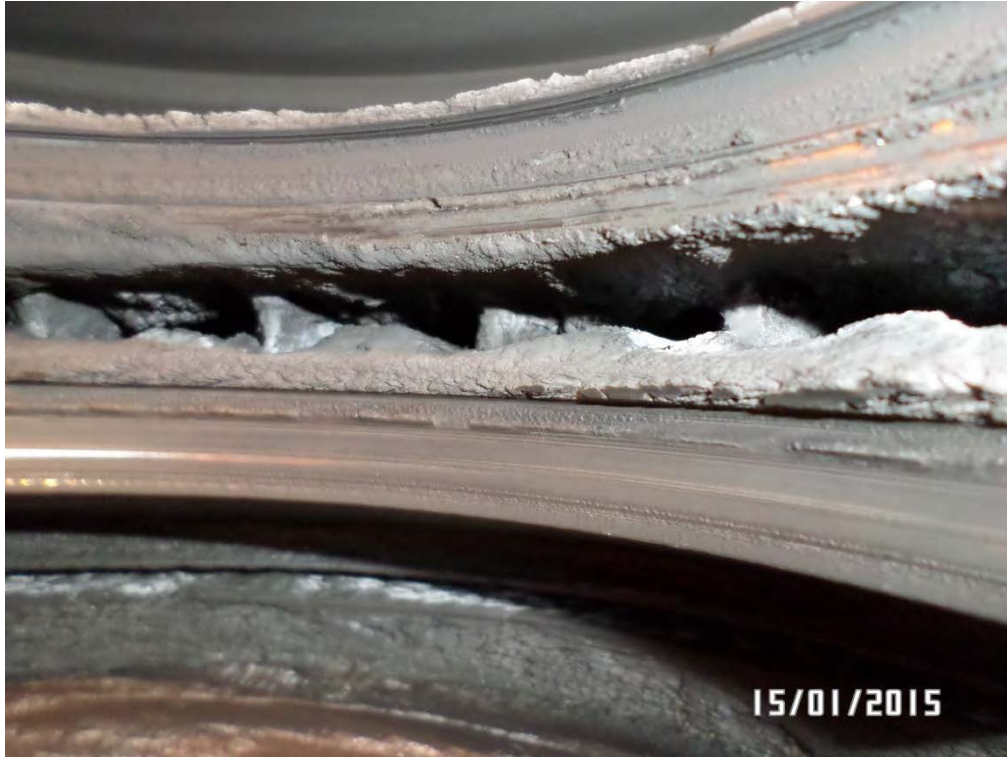
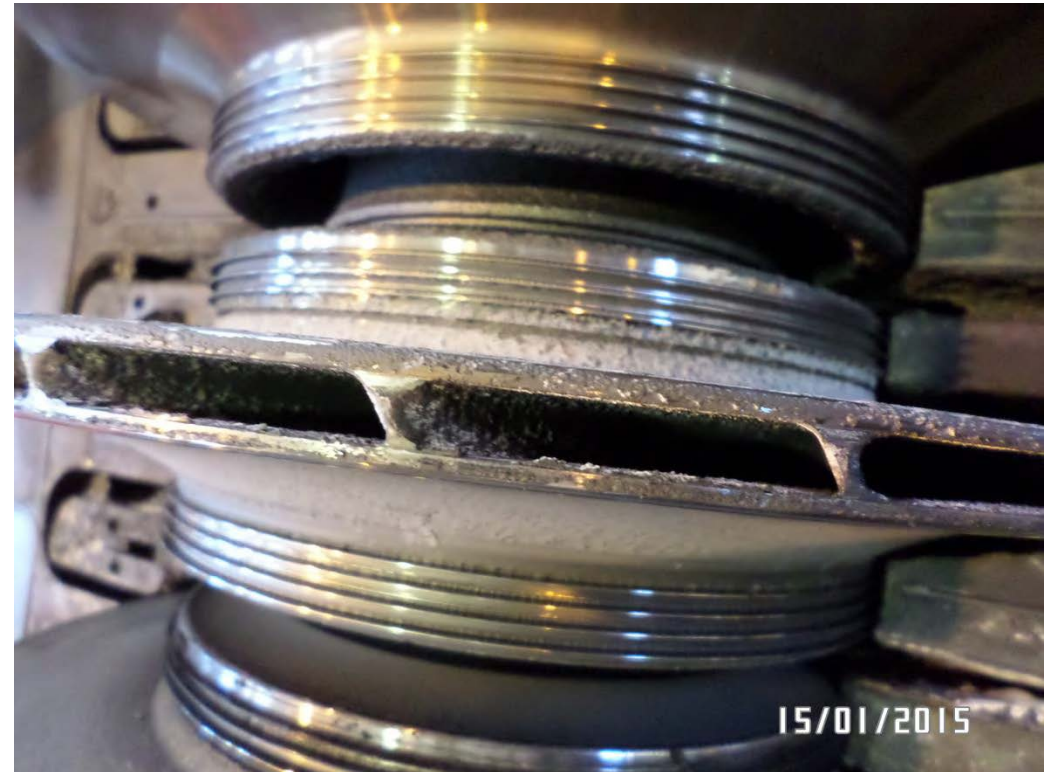
Casing diffusers and rotor heavily contaminated with chlorides reducing compressor efficiency. Typically took between 9 to 12 months to go from clean to as shown.

- The first solution opted for was to shut the compressor down in a controlled manner and carry out a rotor and diffuser clean based on compressor efficiency, expected to be done roughly every 9 to 12 months depending on process conditions. This was the initial approach. ***Less than ideal stripping complex machinery on an annual basis.***

- Install a coalescer to remove entrained water within the process stream. A large project. ***Installed in 2017 TAR, helped but not the solution***
- Change the wash water injection position to minimise entrained water in the gas stream going to the compressor. ***Again helped however not the solution.***

- ***Running higher suction inlet temps to sublimate the chloride solids back into the gas stream. Has proven very successful now at two BP sites, however this comes with process related concerns @ BPRK, gas seal overall reliability an ongoing issue.***

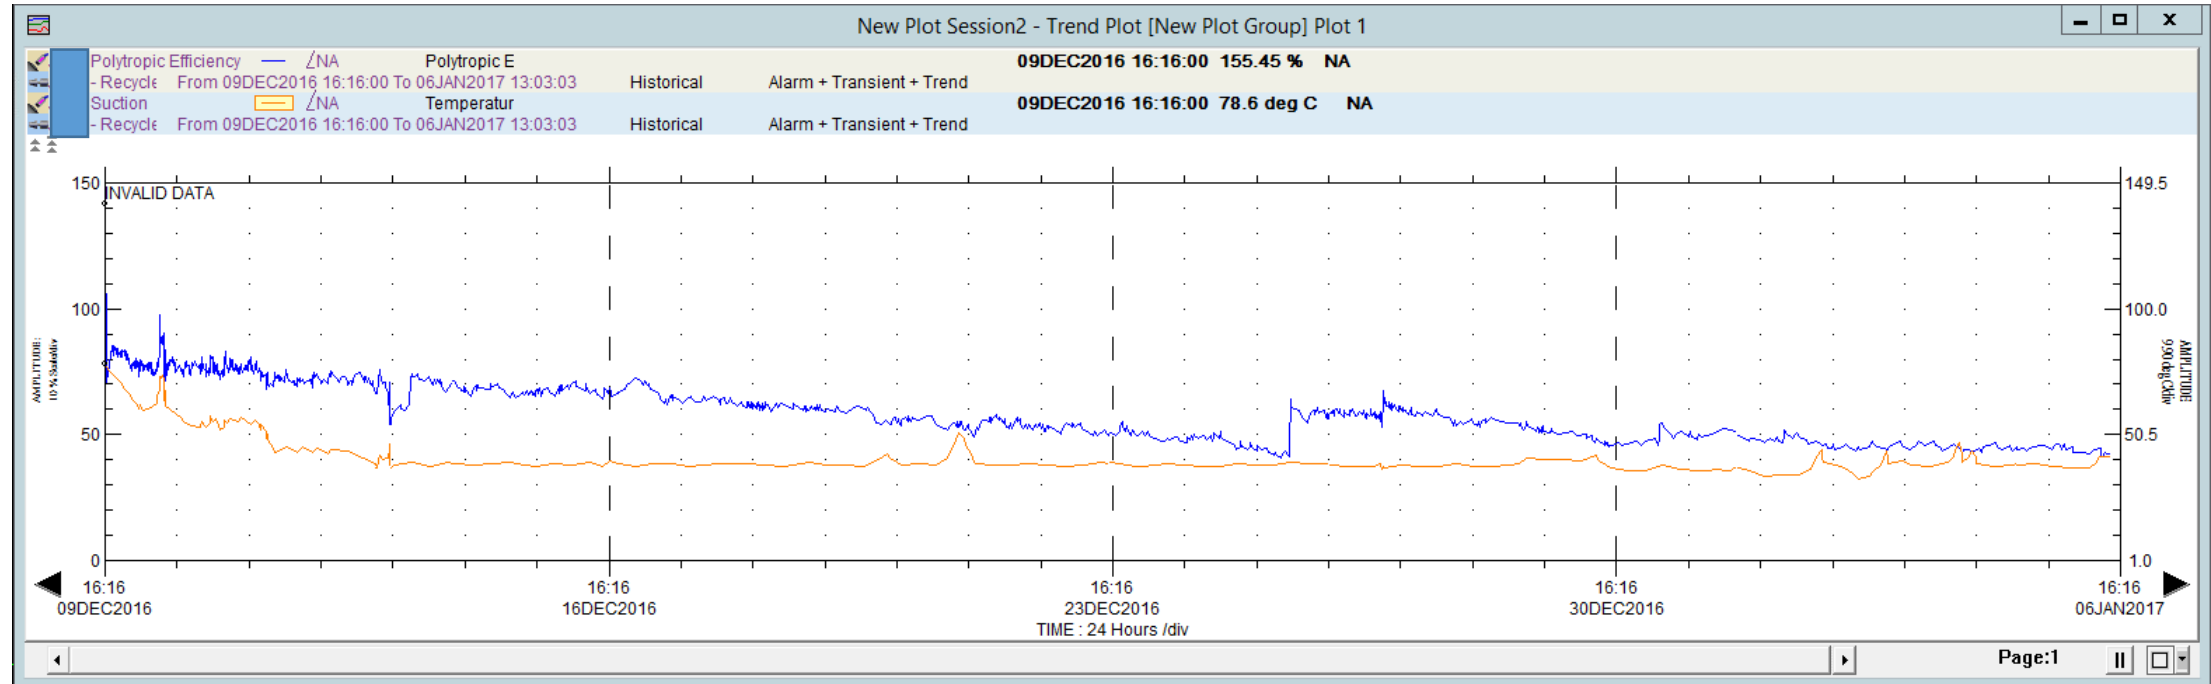
Compressor efficiency from Dec 16 to Jan 17

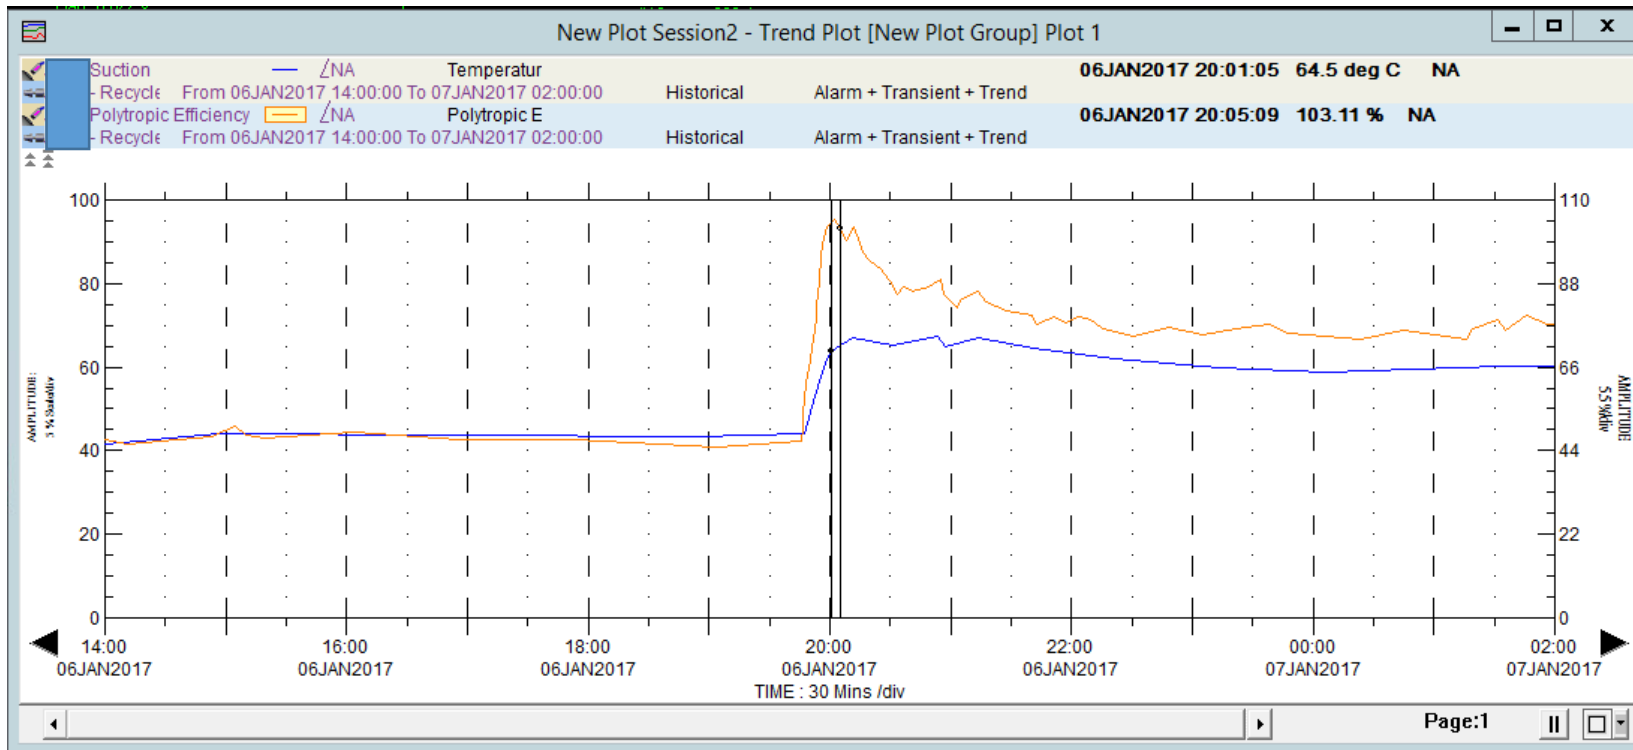
Hot strip of the compressor initial impact

- The initial impact of the suction temp increase can be seen on the trend. Together with this vibes levels were a bit “ordinary” during the transition from 40 degrees to 68 degrees over a 30 minute period.

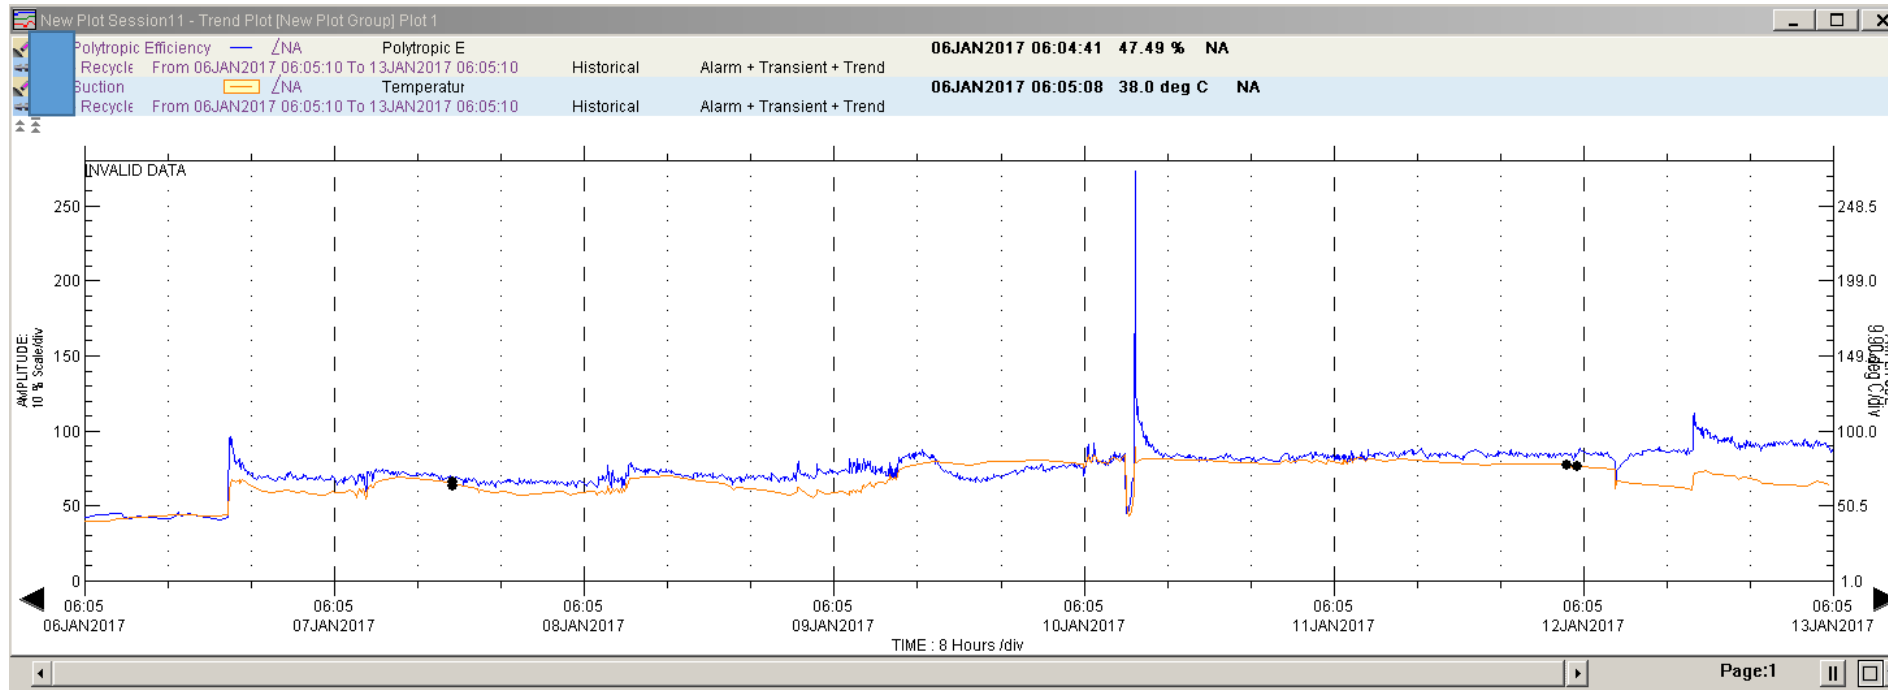
Hot strip of the compressor on line.

- Above can be seen the long term effect of the raised suction temp and polytrophic efficiency.

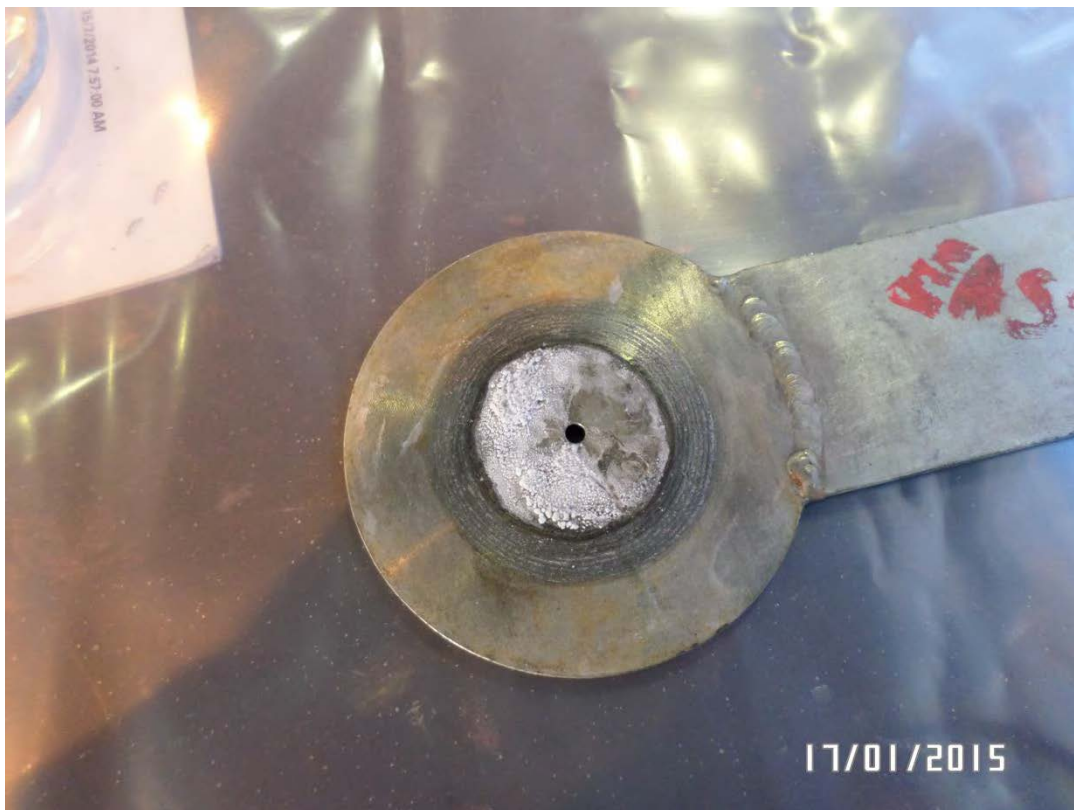
Chloride build up on the seal gas orifice plate

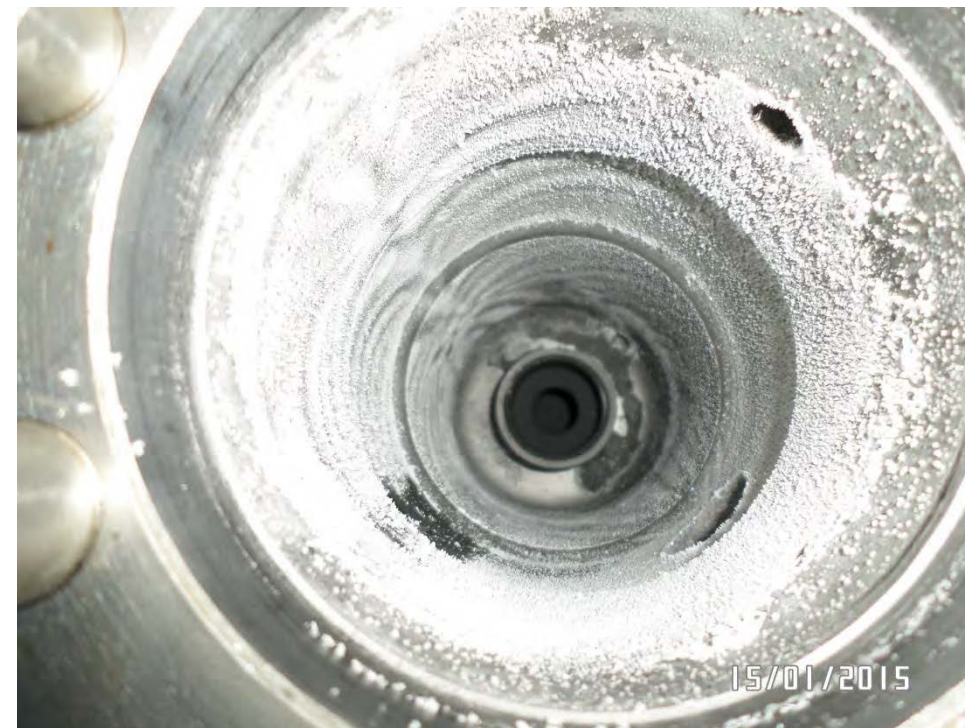
Seal gas filter housing, the clean side

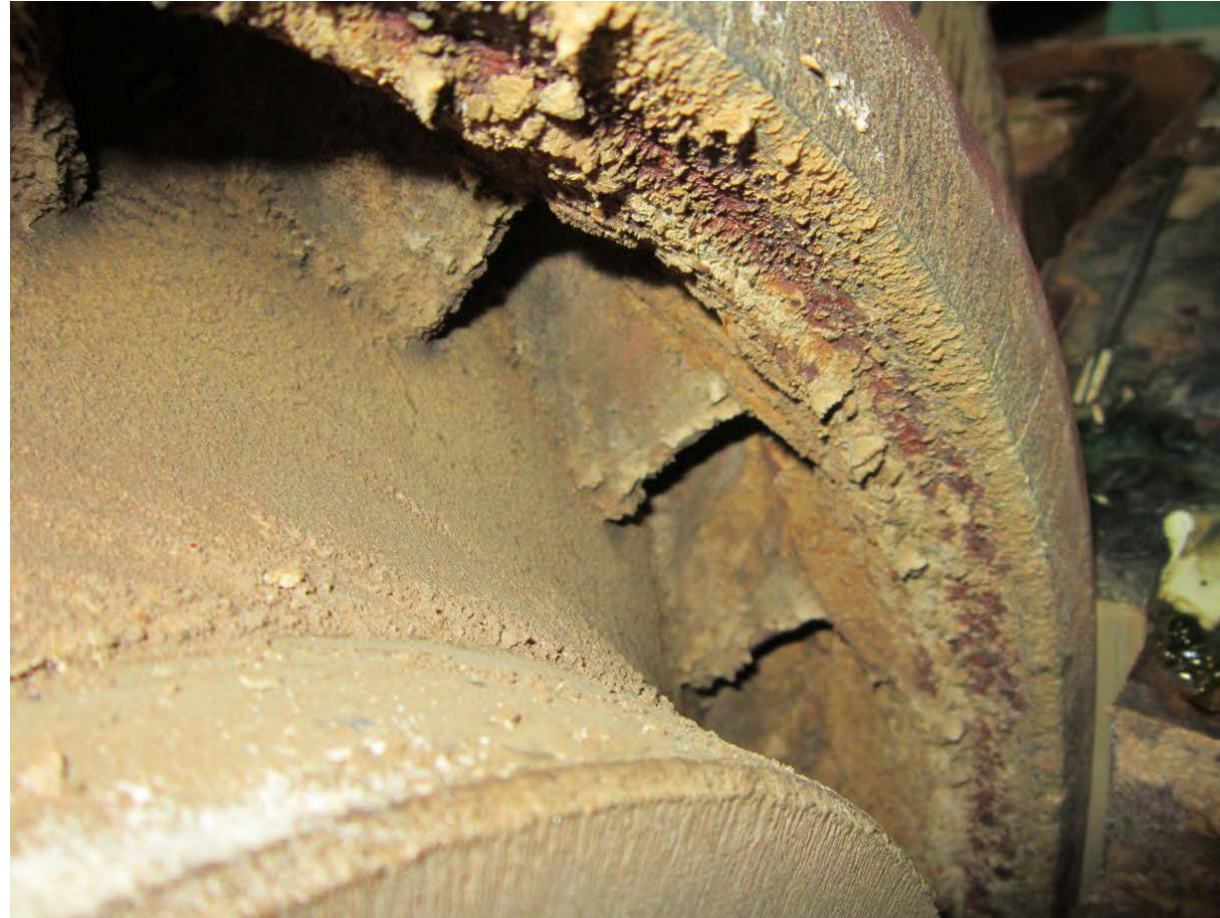
Another example of significant chloride contamination on a centrifugal compressor

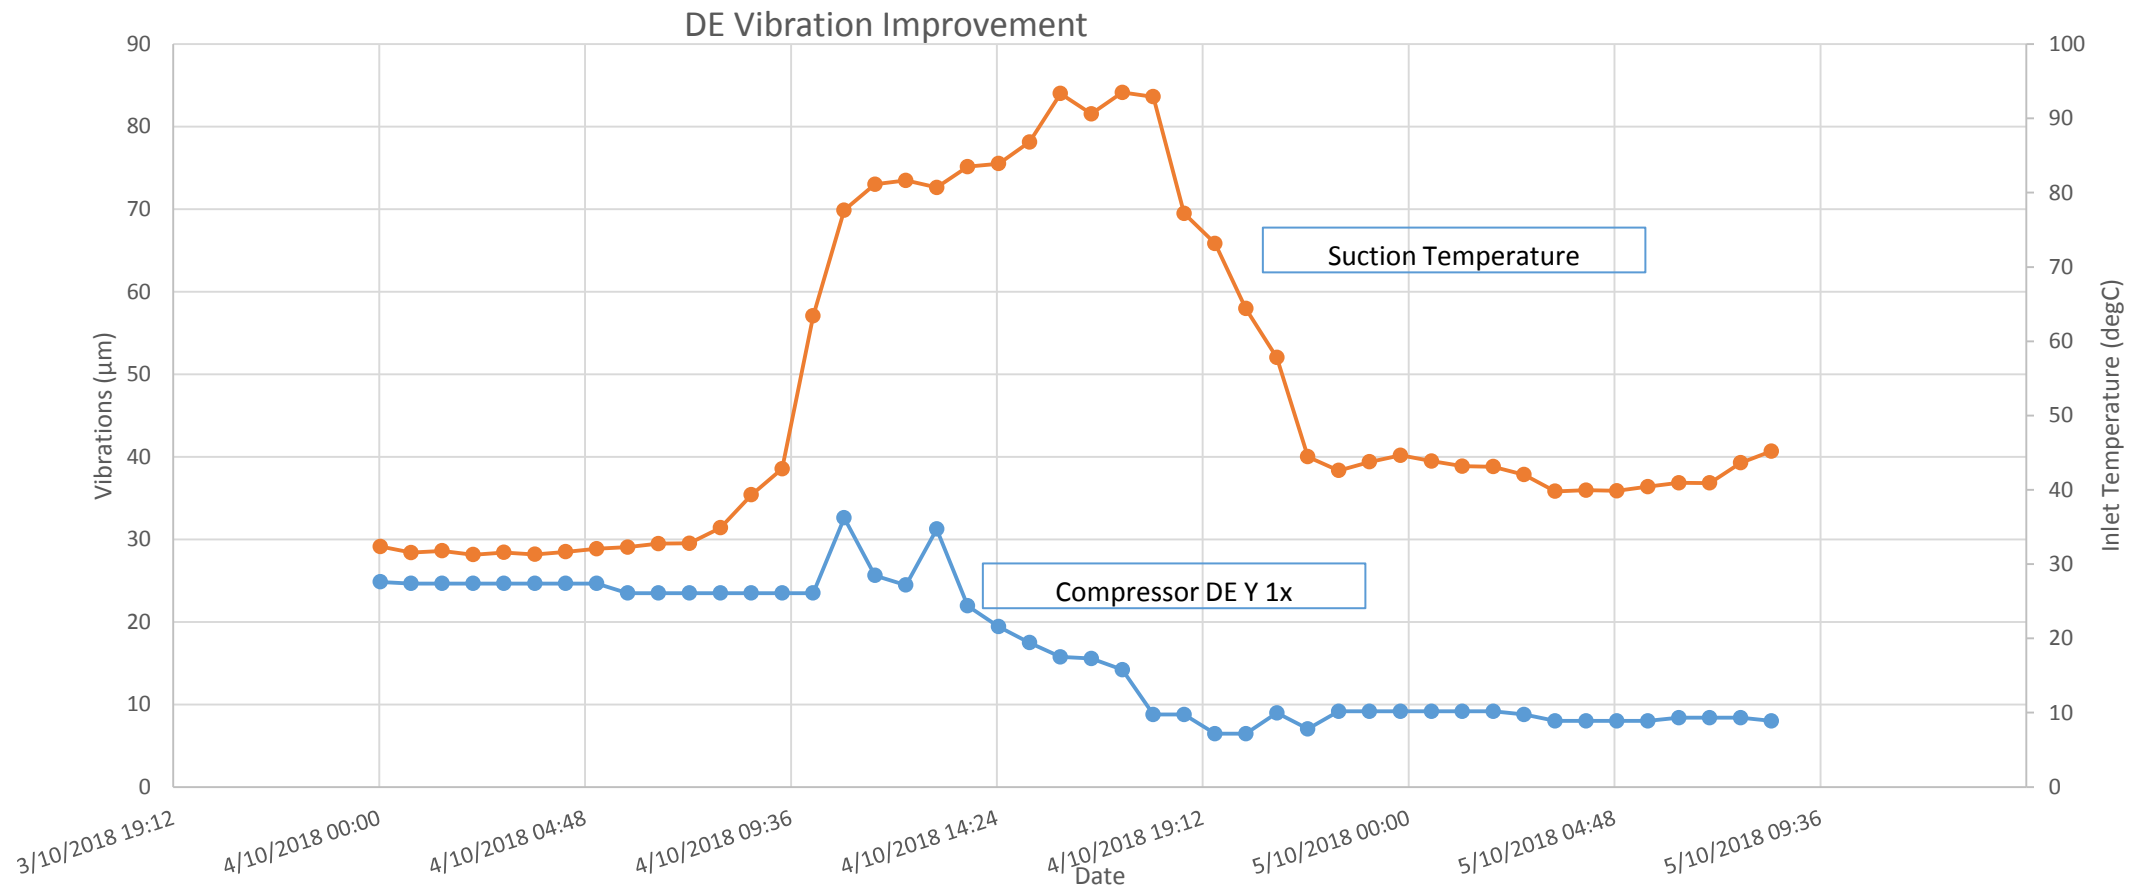
Compressor performance during the “hot strip” over 24 hours
