TURBOMACHINERY
& PUMP SYMPOSIA

Blade failure analysis for steam turbines used for driving centrifugal compressors

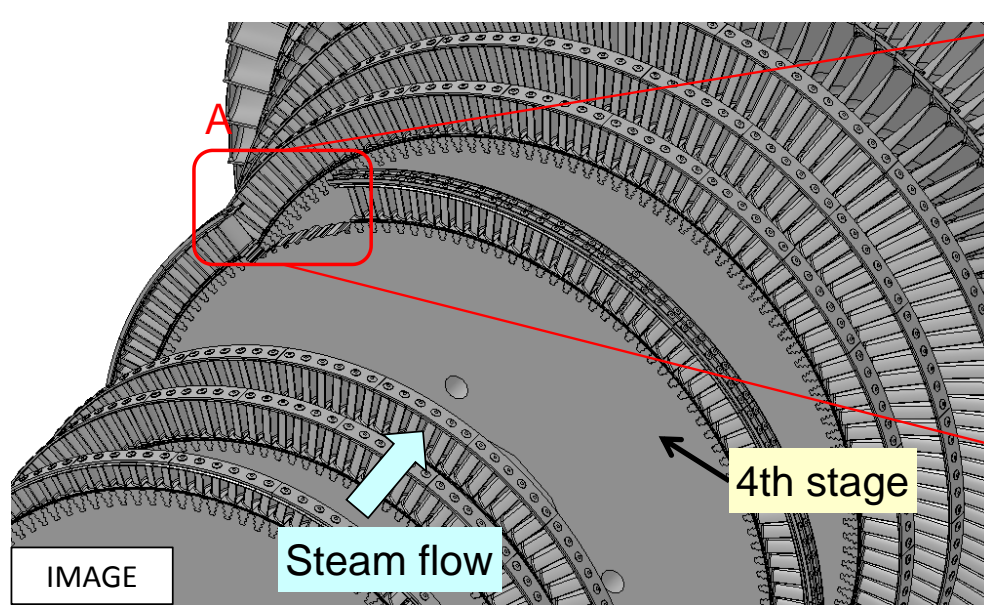
Rotor condition

In 2016, the compressor drive steam turbine was tripped by high radial vibration. After that, turbine casing was opened for internal parts check.

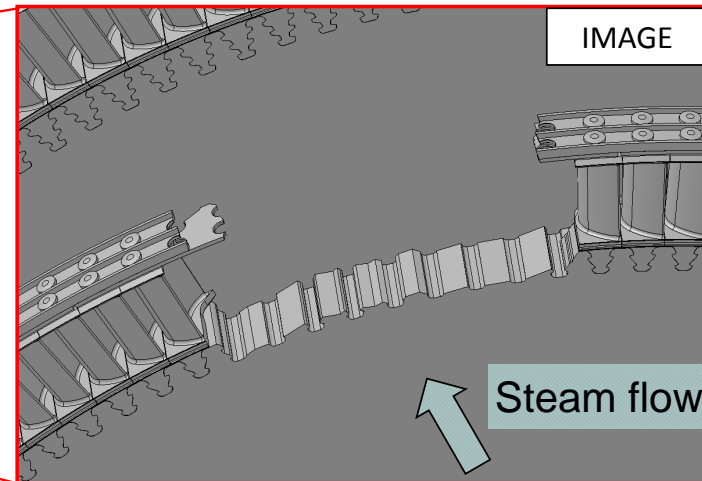
4th stage disk condition (Magnification A)

- 4th stage disk failure was found
 - 9 blades broke away and disc failure occurred at serration part of the groove.
 - 8 blade roots of disk side situated next to failed blades were cracked

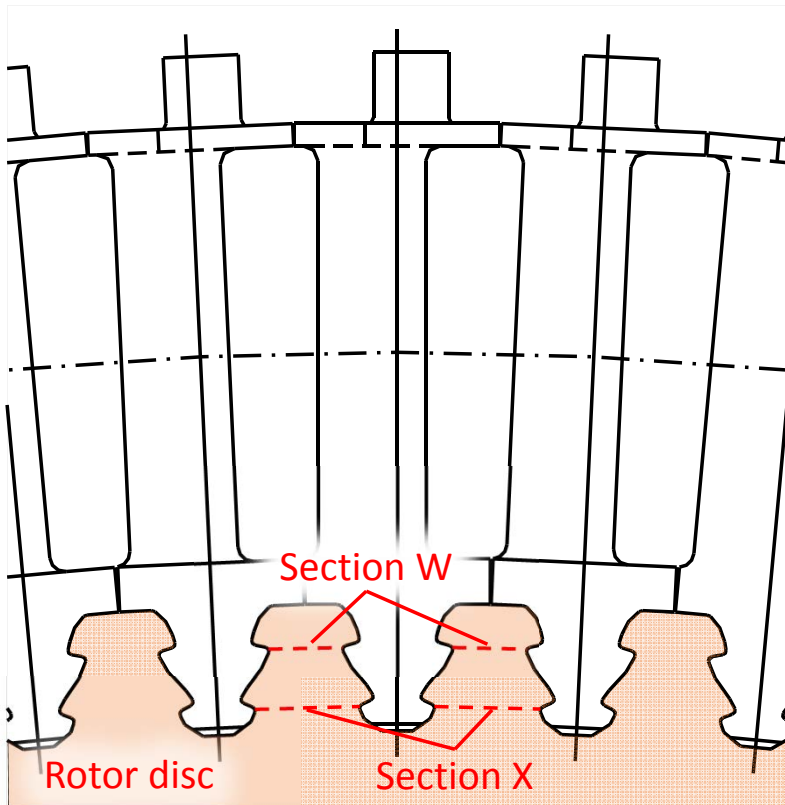
Table. Result of groove wall stress of 4th stage disc.

Stage No.	Part of groove	Calculated Stress [kgf/mm ²]	Allowable Stress [kgf/mm ²]	Safety Factor
4 th stage	Section W	4.9	28.2	5.8
	Section X	7.0	28.2	4.0

- Groove wall stress for 4th stage has enough safety margin as compared to the allowable stress.

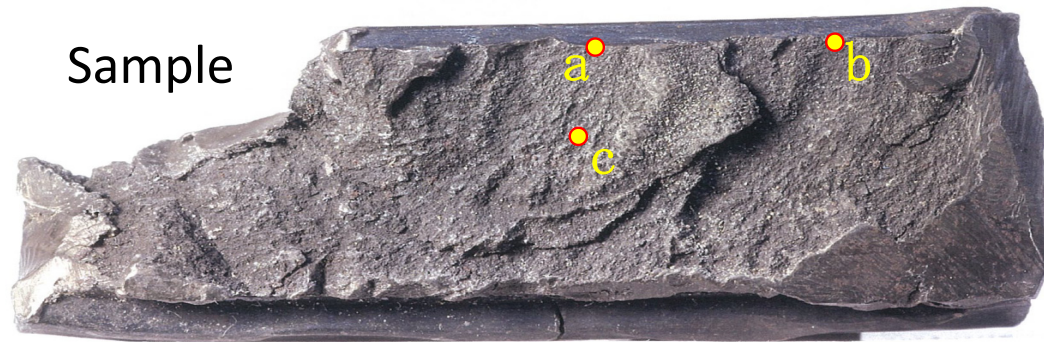
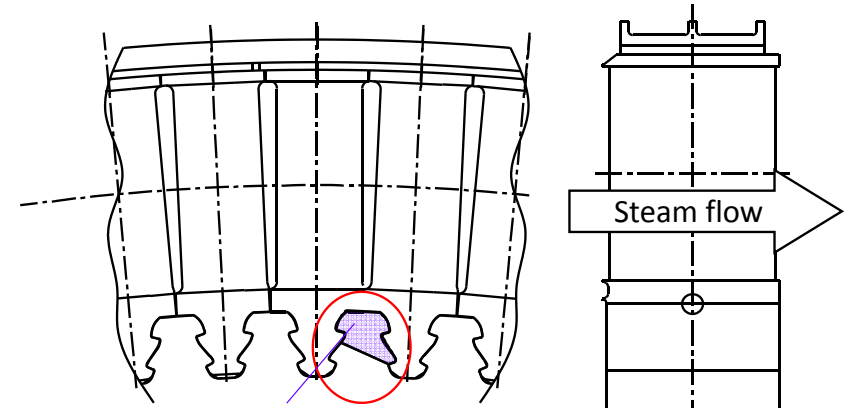
Inspection sample of rotor disk

- Na, Cl, K were detected from fractured surface except from base material.
- Corrosive material such as Na, Cl were detected on fractured surface.

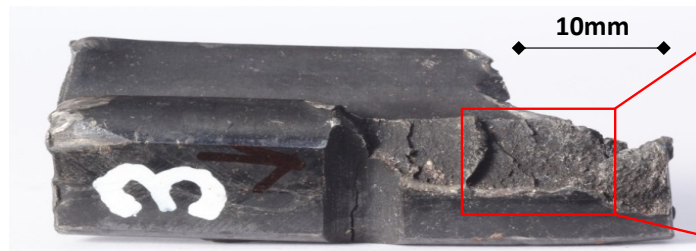
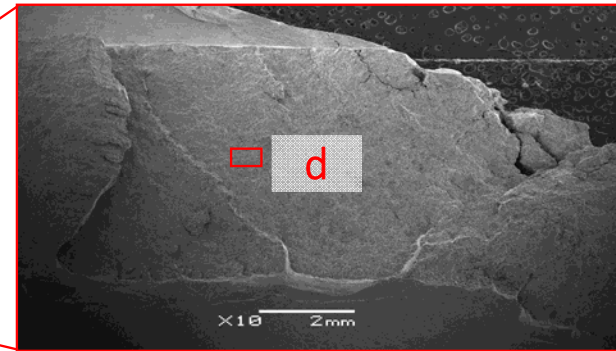
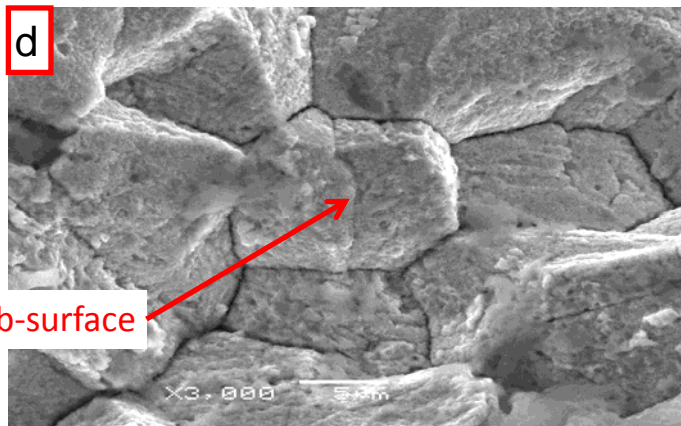
Intergranular sub-surface

- The intergranular sub-surfaces were observed on fractured surface, which is a typical characteristic of SCC.

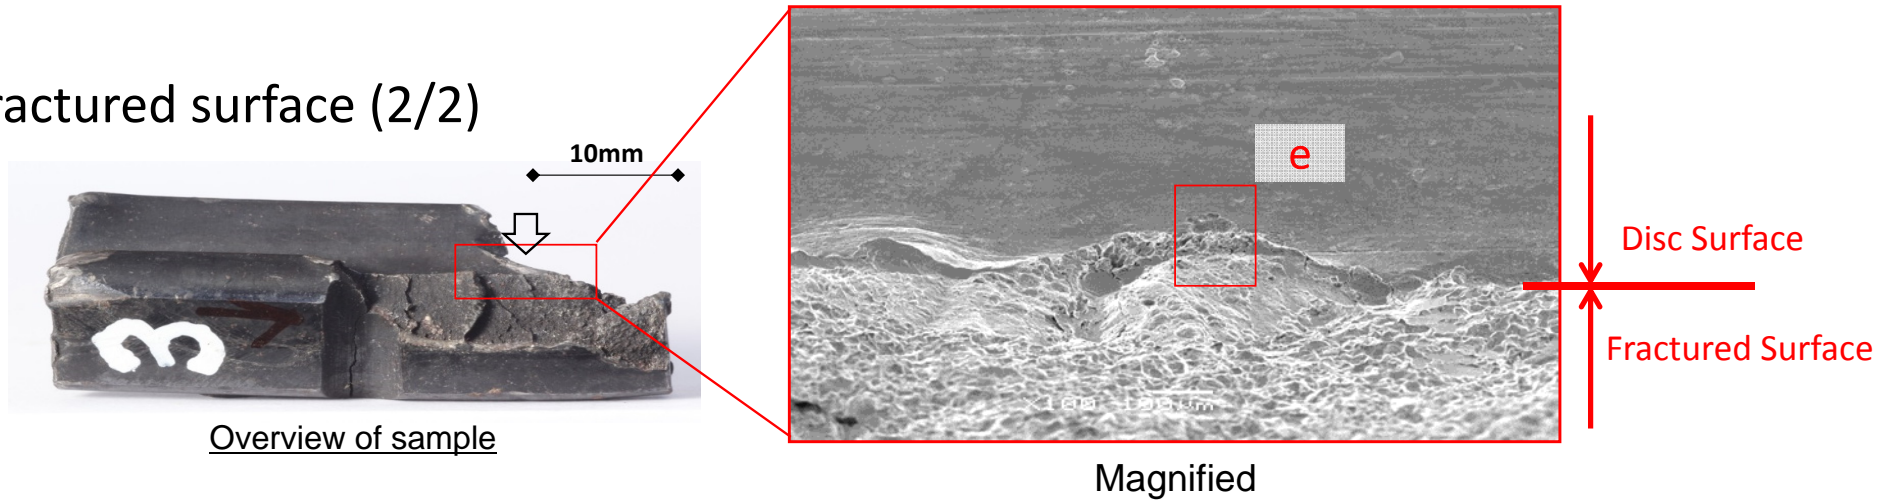
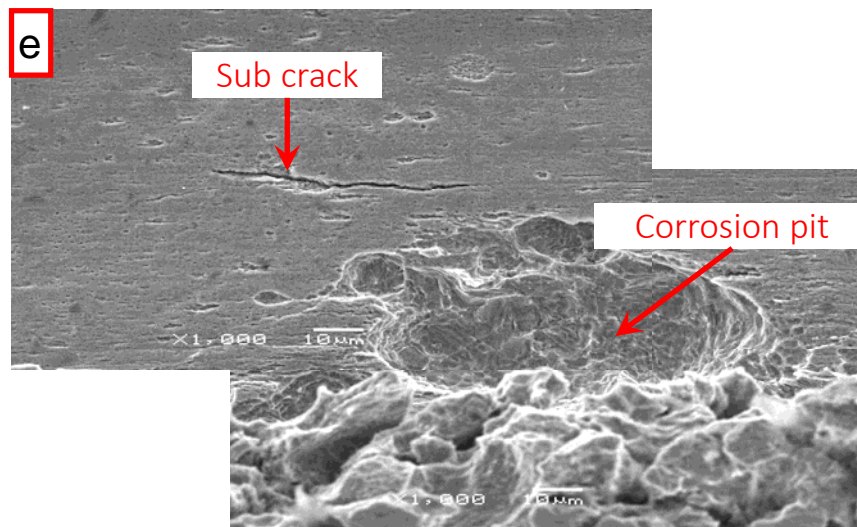
Fractured surface (2/2)

- Some corrosion pits and sub-cracks were found on disc surface near the crack.

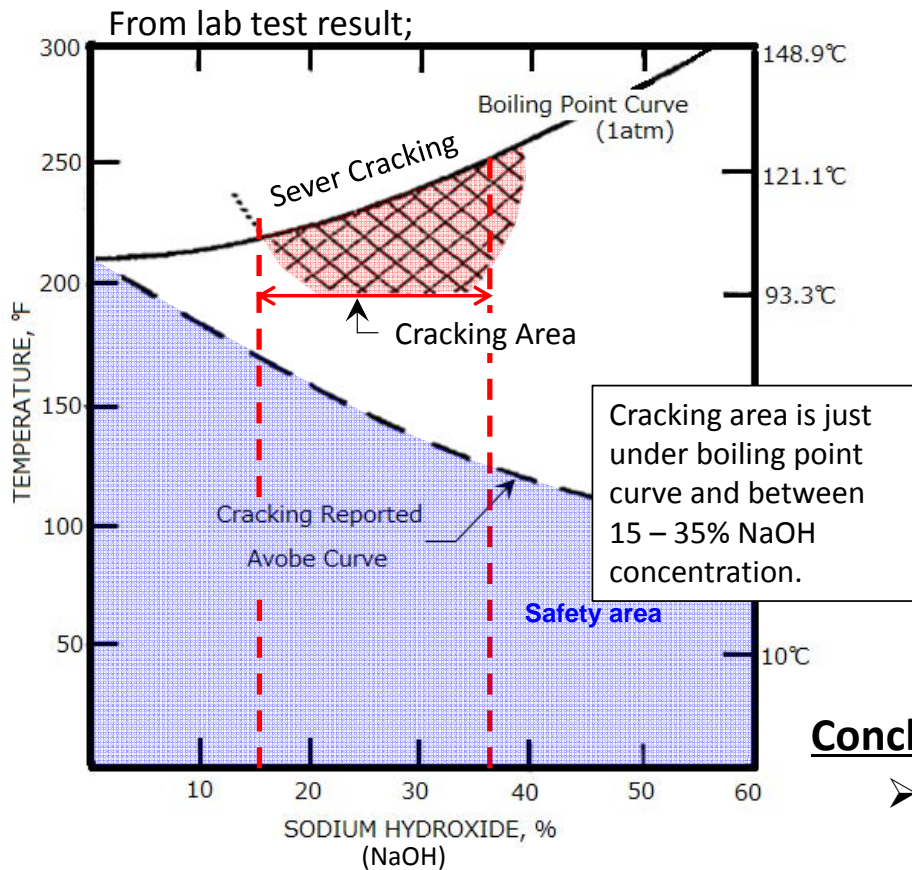
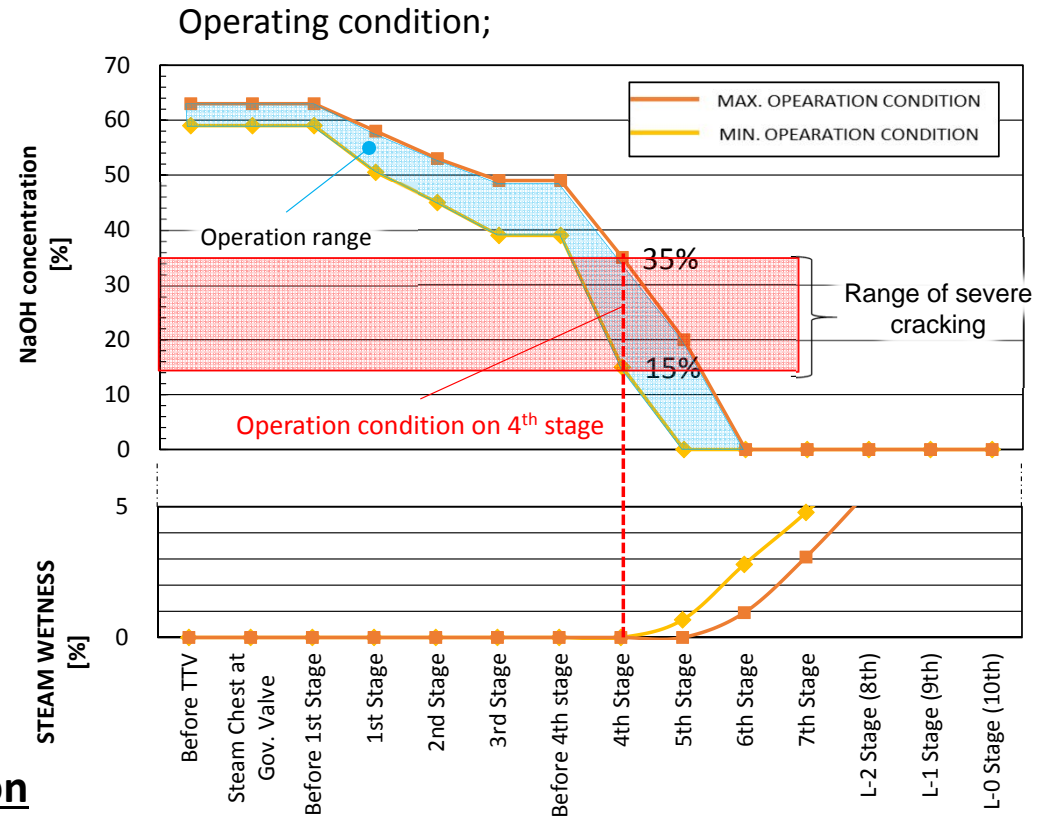
- This analysis shows that the concentration of NaOH solution in 4th stage blade was 15-35%. This concentration falls in severe cracking area and this result corresponds with actual failure location in turbine.
