48<sup>TH</sup> TURBOMACHINERY & 35<sup>TH</sup> PUMP SYMPOSIA  
HOUSTON, TEXAS | SEPTEMBER 9-12, 2019  
GEORGE R. BROWN CONVENTION CENTER

## INTRODUCTION TO SCC FAILURES IN STEAM TURBINES AND SOLUTIONS

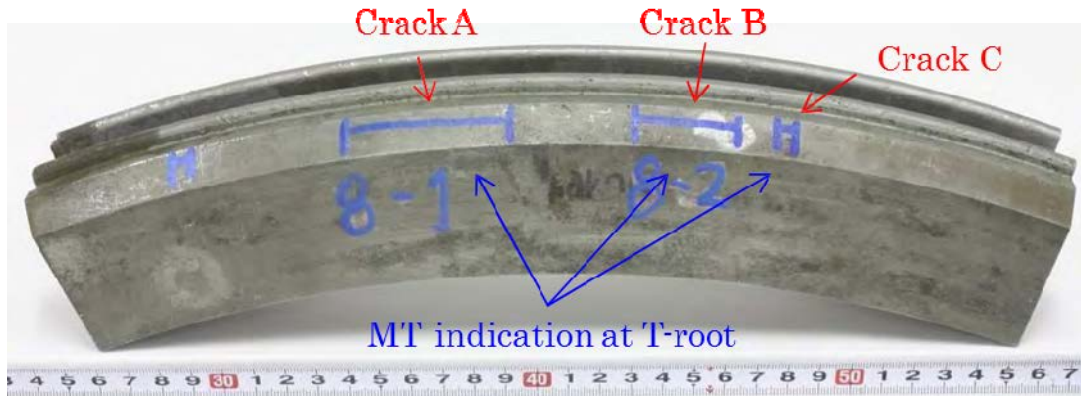
Fig.3 Overview of the cut disc (from exhaust side)

The damaged blade disc was cut into 8 test coupons and magnetic particle inspection (MT) was performed to verify the PAUT result. Fig.3 shows a representative coupon and Fig.4 shows the coupons after being split to expose the cracked areas on exhaust side of the root.. MT indications, shown in Fig. 5 & Fig. 6 matched the discontinuities found by PAUT in two locations on the 9<sup>th</sup> stage disc. This result verified the reliability of PAUT inspection.

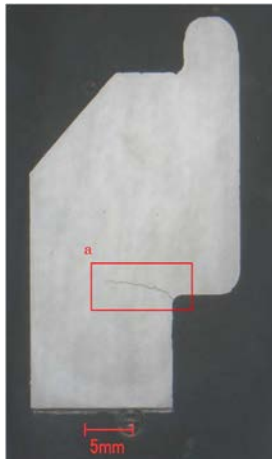
Fig.7 Section A-A on part B

- The crack was found on the corner R of the disc groove where it is likely to be highest stress point. (See Fig.7)
- The crack had a jagged appearance, and exhibited crack branching, and scale within the crack. (See Fig 8.)
- Microhardness examination revealed no significant deviation in hardness (267 ~ 287HV) on adjacent to the crack compared to other areas (>248HV).
- The micro structure of this material was normal, tempered martensite.

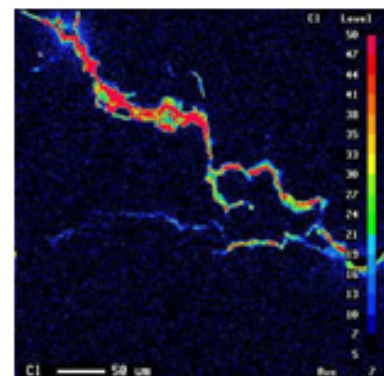
Next, chemical analysis by Electron probe Micro-Analyzer (EPMA) was performed on the scale within the crack in order to confirm the existence of corrosive materials in the environment during crack growth.. As the result of this test, chlorine was detected throughout the crack. Analysis results are given in Table II.

Fig.10 EPMA result of scale on crack

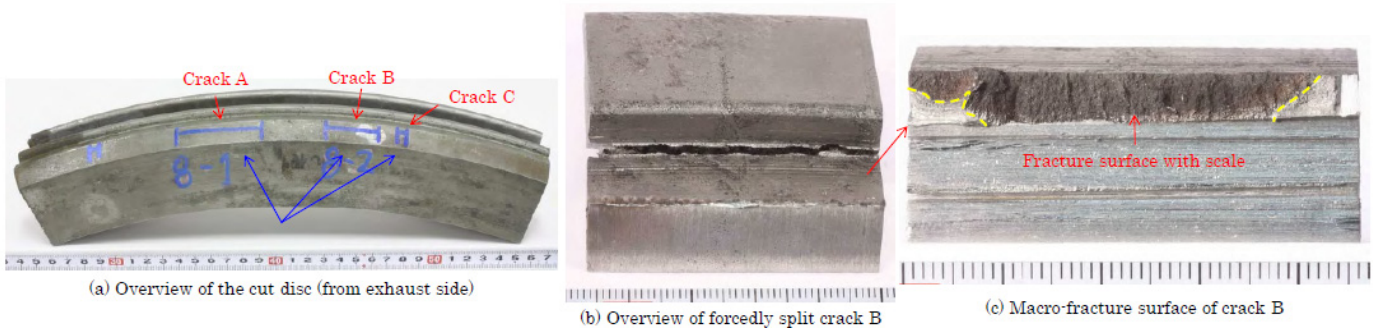
Fig.11 Overview of the split disc (Crack “B”) of the exhaust side

Additionally, the fracture surface was examined fractography study was carried out to identify Scanning Electron Microscope (SEM) on crack "B". Fig. 11 shows the overview of this test sample and Fig.12 shows the SEM image of this result. As a result of this study, following results were found.

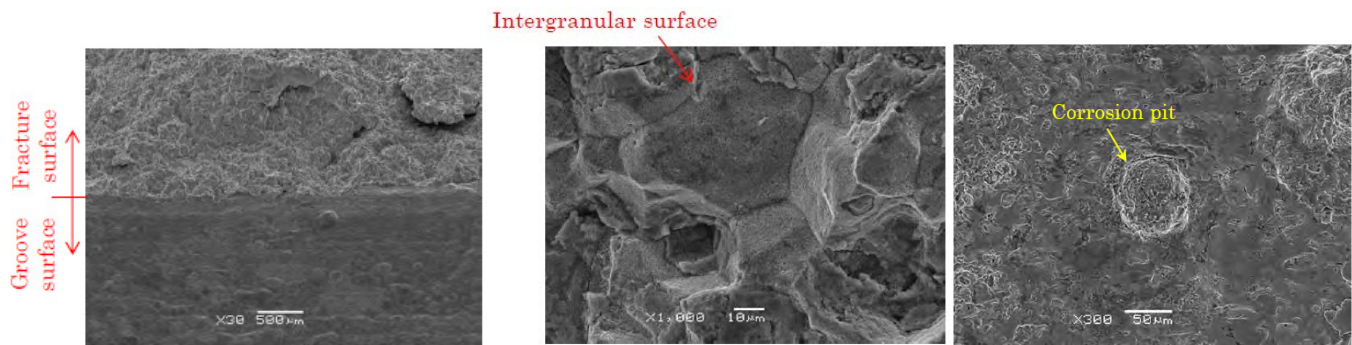
Fig.12 SEM image of fracture surface

- The whole surface on crack is covered by scale and this surface was relatively rough. It was found that the scale also contains about 6wt % chlorides by EMPA.
  - Corrosion pits, ranging from 0.2 – 20μm were observed through the fracture surface.
  - Intergranular fracture was the primary crack propagation mechanism.
- The crack initiated at a corrosion pit approximately 50μm in depth.

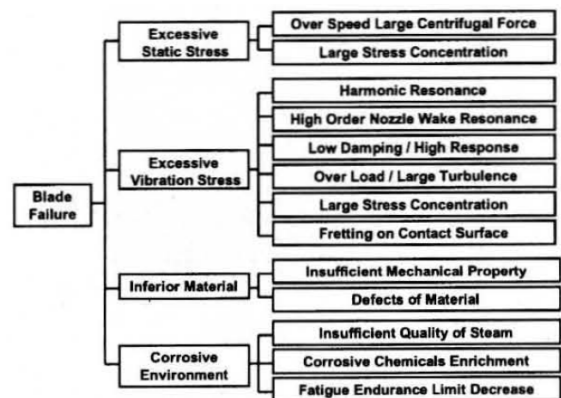
- 1) A Crack was observed on the corner R of groove where highest stress occurs and corrosive material(Chloride) was detected within the crack. Additionally, intergranular fracture, typical of SCC, was observed in fracture surface. Based on this information, the root cause was determined to be Stress Corrosion Fracture.
- 2) No striation pattern was observed. Low possibility of corrosion fatigue fracture.
- 3) Typical Root cause analysis is shown on Fig.13.

Fig. 13 Root cause analysis for rotor damage

- 1) The customer’s decision to improve the rotor was based on the desire to have a reliable and and safely operating turbine. So, the root design was changed from circumferentially loaded T-slot root to an axial entry christmas tree roots, to reduce stress and prevent accumulation of corrosive materials.
- 2) In order to change the root, the existing disc with crack was rebuilt by overlay welding.

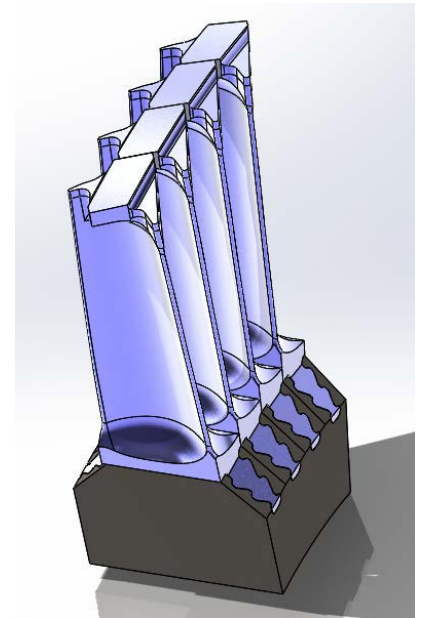
Fig 19 Upgrade blade design for replacement

Risk of SCC can be reduced significantly by reducing the stress in the blade root. In this approach, axial entry roots offer several advantages to their radial entry counterparts. Radial entry blades do not present a surface to react tangential loads, so a twist-lock style blade cannot be used. They also rely on pack compression in order lock the blades in position. The design also is not open to steam flow which allows for localized accumulation of corrosive contaminants. Finally, the “closed” nature of the design makes inspection difficult, if not impossible. Axial entry roots provide an answer to each of these design difficulties. Additionally, axial entry root designs with christmas type reduce radial stresses 30-50% over the conventional design.

In order to change the root, the existing discs have to be rebuilt weld repair. To qualify the welding procedure, welding parameters are chosen based on the chemical composition of the rotor, and a post-weld heat treat (PWHT) is developed that can achieve desired properties through the base metal, heat-affected zone (HAZ) and weld material.

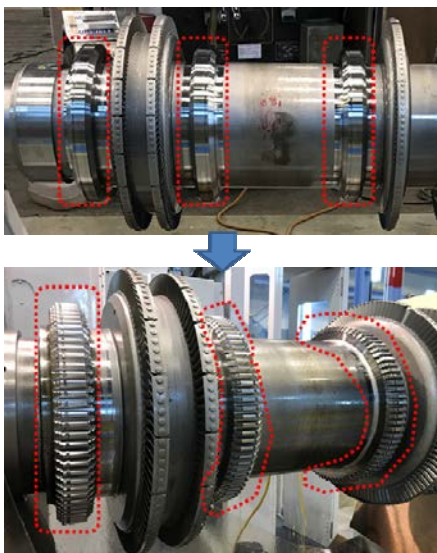
Figure 21  
Before and After for welded rotor

After successful qualification, the rotor is prepared for welding by machining off the existing discs. Care is taken to establish reference radial bands to ensure that no significant distortion or bowing occurred during welding or stress relief heat treatments. After welding, the discs are rough-machined and thoroughly inspected for cracks or other flaws by ultrasonic inspection (UT) and magnetic particle inspection (MT). The rotor is then post-weld heat treated to relieve welding stresses and temper the material in the same manner as the test piece. Finally, the new discs are machined into their new shape as shown in Figure 20, and axial-entry roots are cut. New blades are installed and the rotor is at-speed balanced.
