TR-374
2011

Measured Water Losses of Lateral A in Hidalgo County Irrigation District No. 2

April 2011

Measured Water Losses in Lateral A of Hidalgo County Irrigation District No. 2

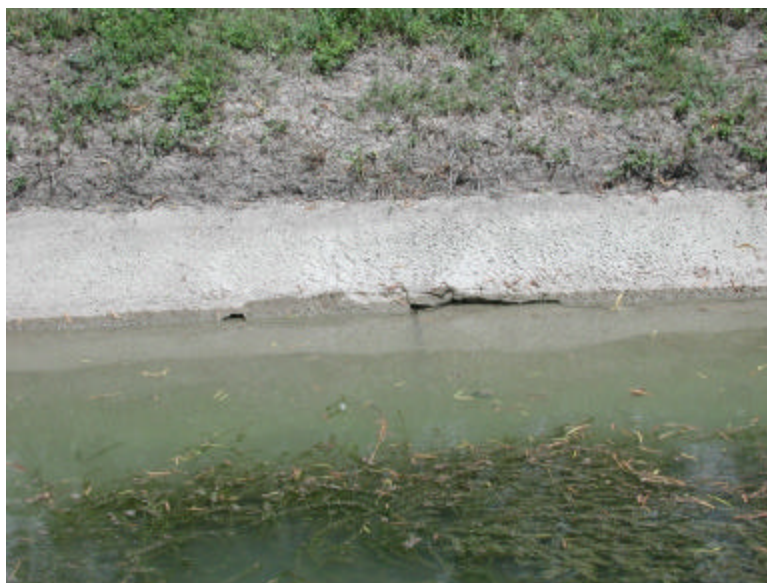
Figure 4: Large crack in the canal lining and aquatic vegetation growing from the bottom of the canal (lateral A - Stewart Rd)

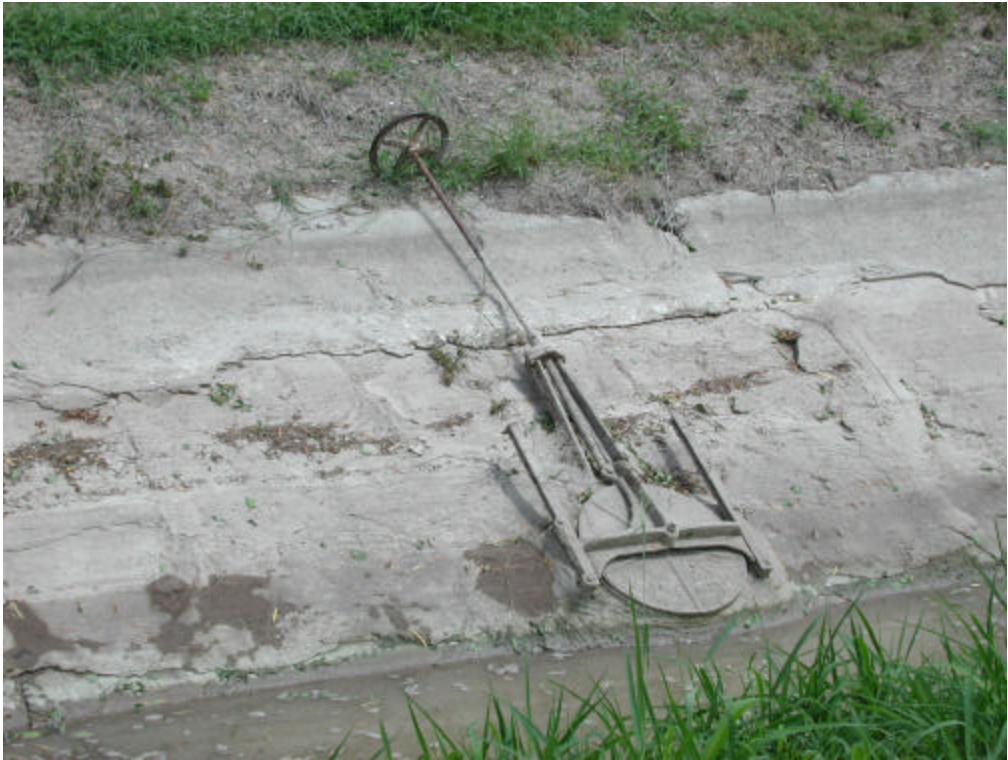
Figure 8: Cracking of lateral A - Stewart just down stream of the test section.

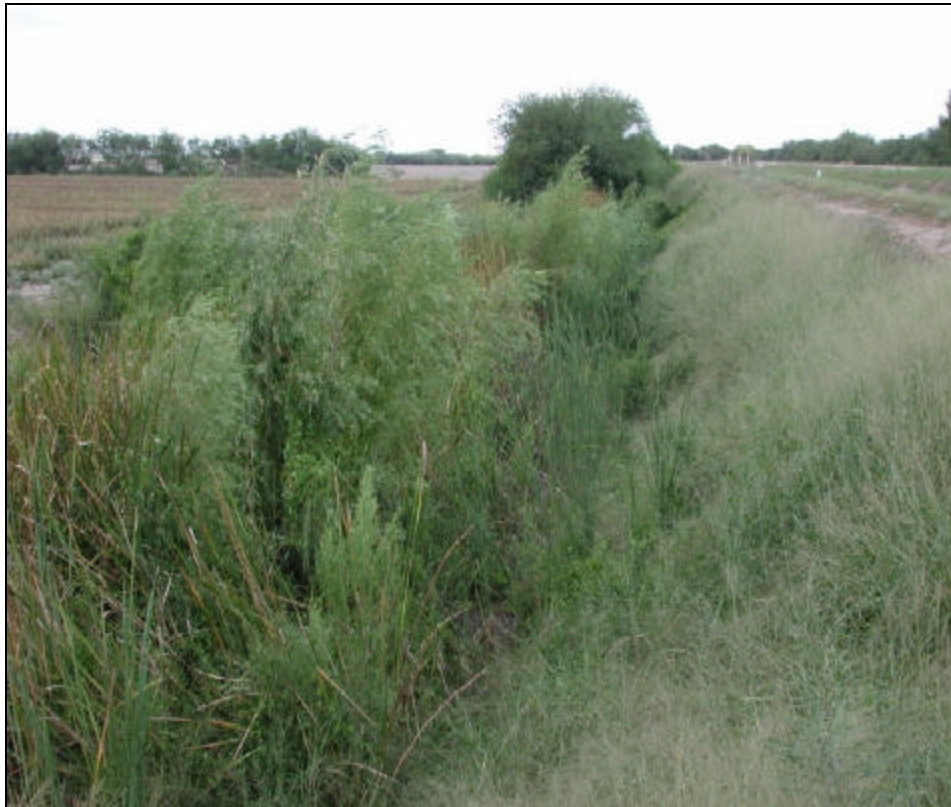
Figure 11: Large amounts aquatic vegetation growing next to lateral A - I Rd.
