Documentation and Conditions Assessment of Jacob's Ladder, St. Helena (CHC 2020-01-04)

Report prepared for the British Napoleonic Bicentenary
Trust and St. Helena Government

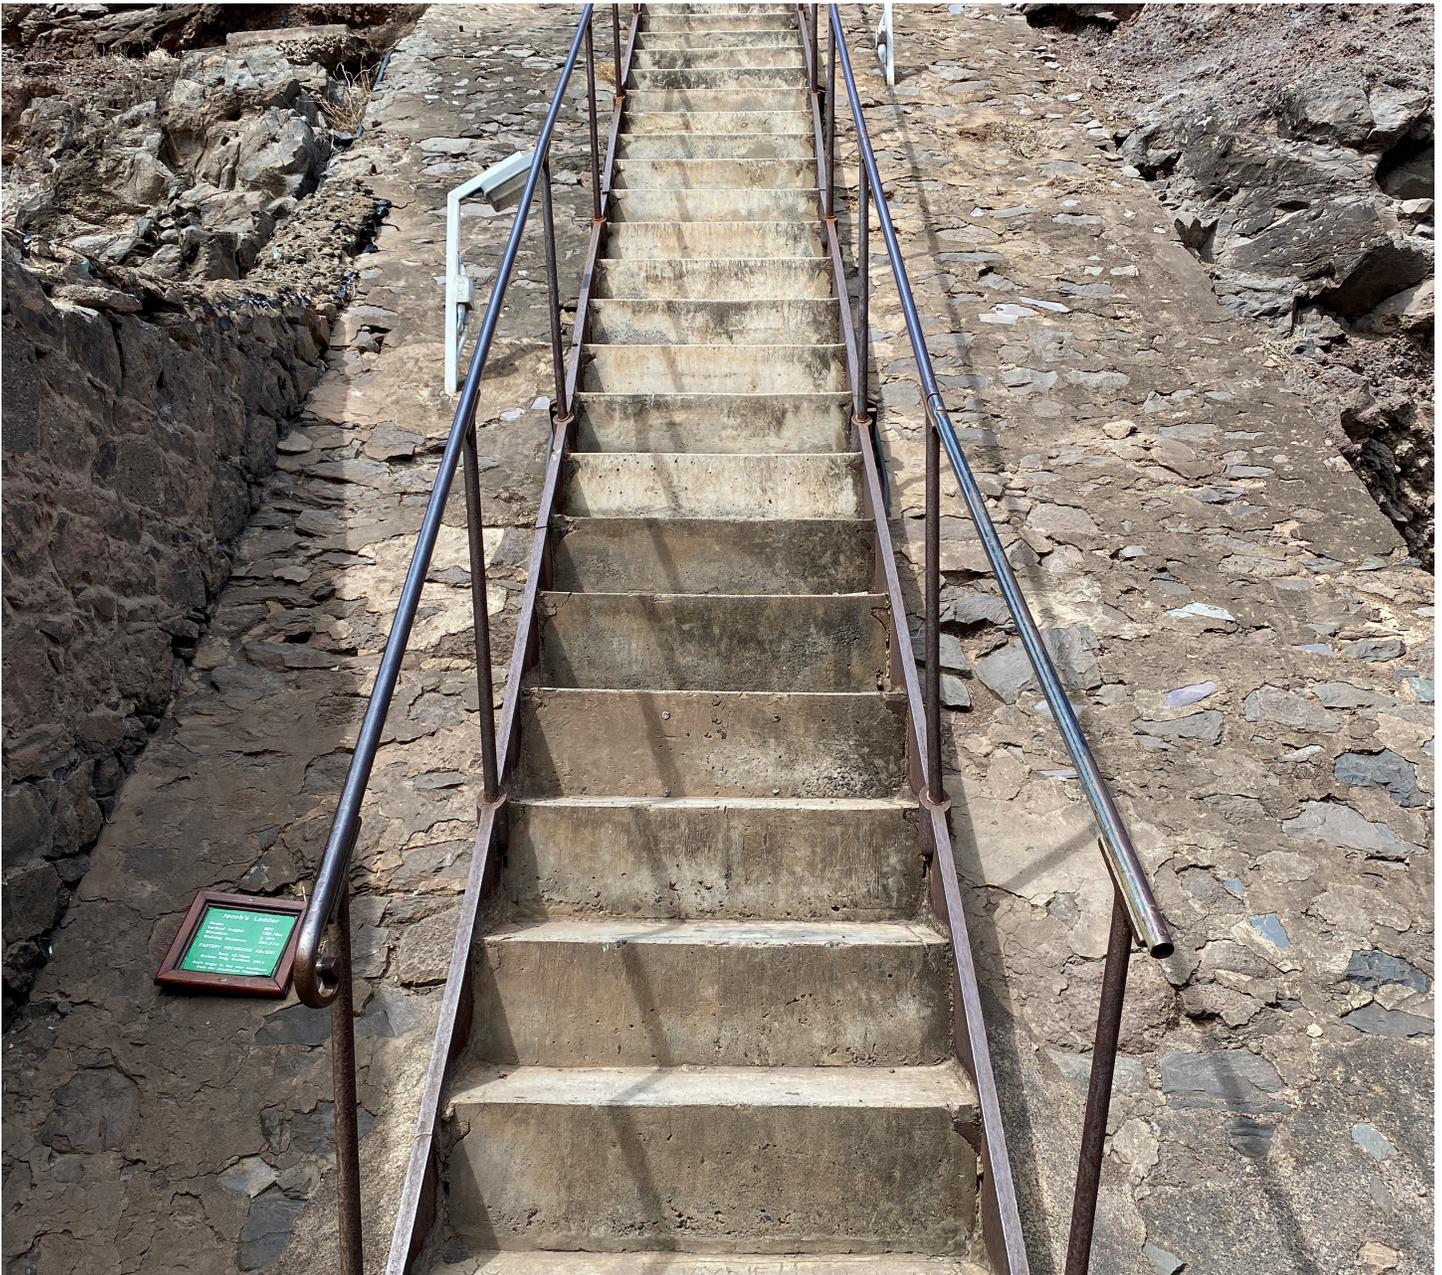
The steps run the entire length of the site. The steps are in various states of condition with varying amounts of cracking and wear present. Generally the steps are in good shape and appear to be structurally sound with normal use-wear present. The steps are skim-coated with a cementitious coating. Some of the steps have metal straps on the riser. A large majority of the cracks take place on the skim coating and do not appear to be structural. Additionally there is significant cracking occurring at the interface between the step and the side rails. The steps feature various bio-growths and soiling and as such vary greatly in color. Some of the original steps have been removed and replaced by a modern cementitious block, left uncoated (with visual similarities to those repairs done at High Knoll Fort in 2001).

Figure 11: Base of Jacob's Ladder (Image: B. Fortenberry).

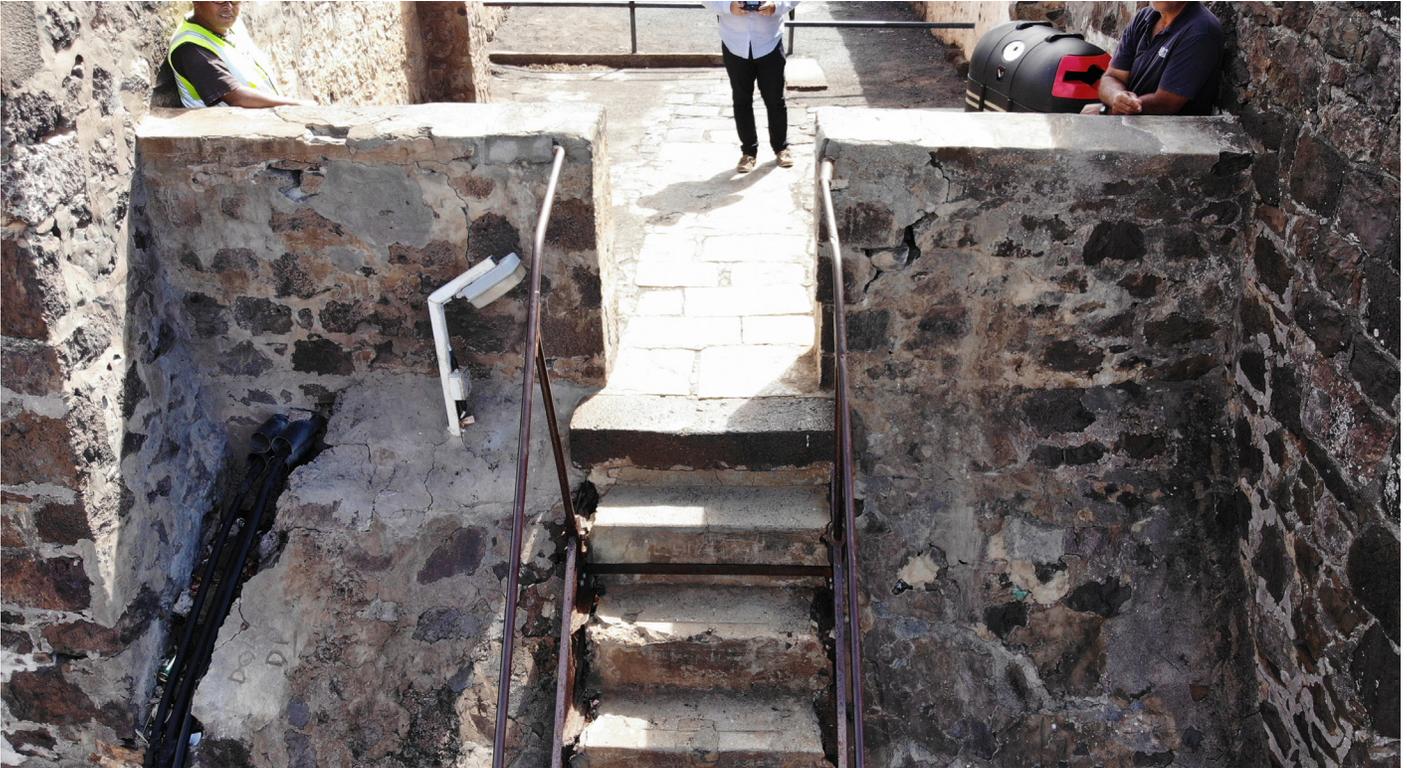
Figure 12: Summit of the ladder showing step failure and metal strapping (Model: B. Fortenberry).

1. Remove the metal straps from the risers that are present bracing some of the steps. These straps hold water to the surface of the steps, allowing bio-growth and causing cracking and further deterioration of the surface. If the step is found to be structurally unsound once the strap is removed, steps need to be taken to rebuild the step under the supervision of an architectural conservator and conservation contractor. If rebuilt, care should be taken to preserve the physical appearance of the historic steps.

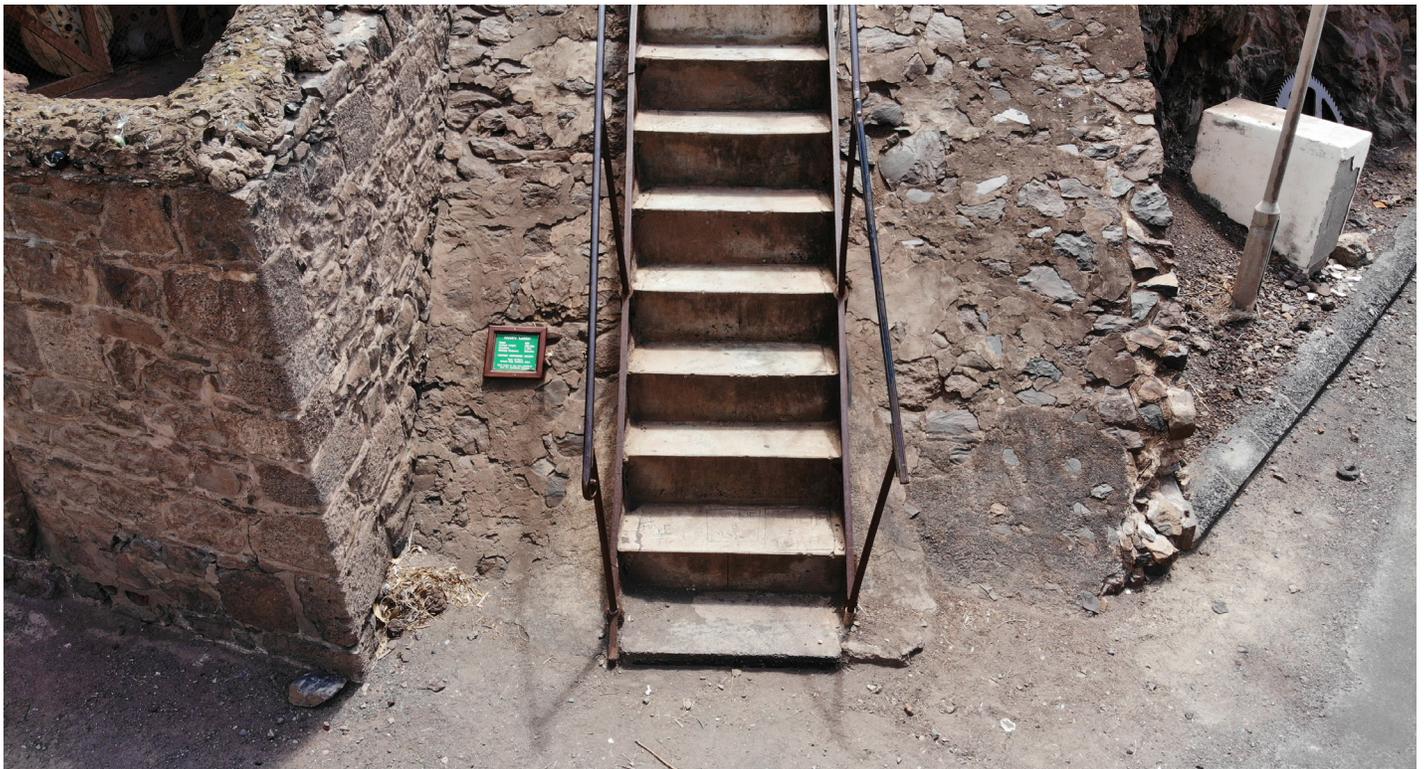
Figure 13: Base of the ladder showing steps in better condition than the summit (Image: B. Fortenberry).

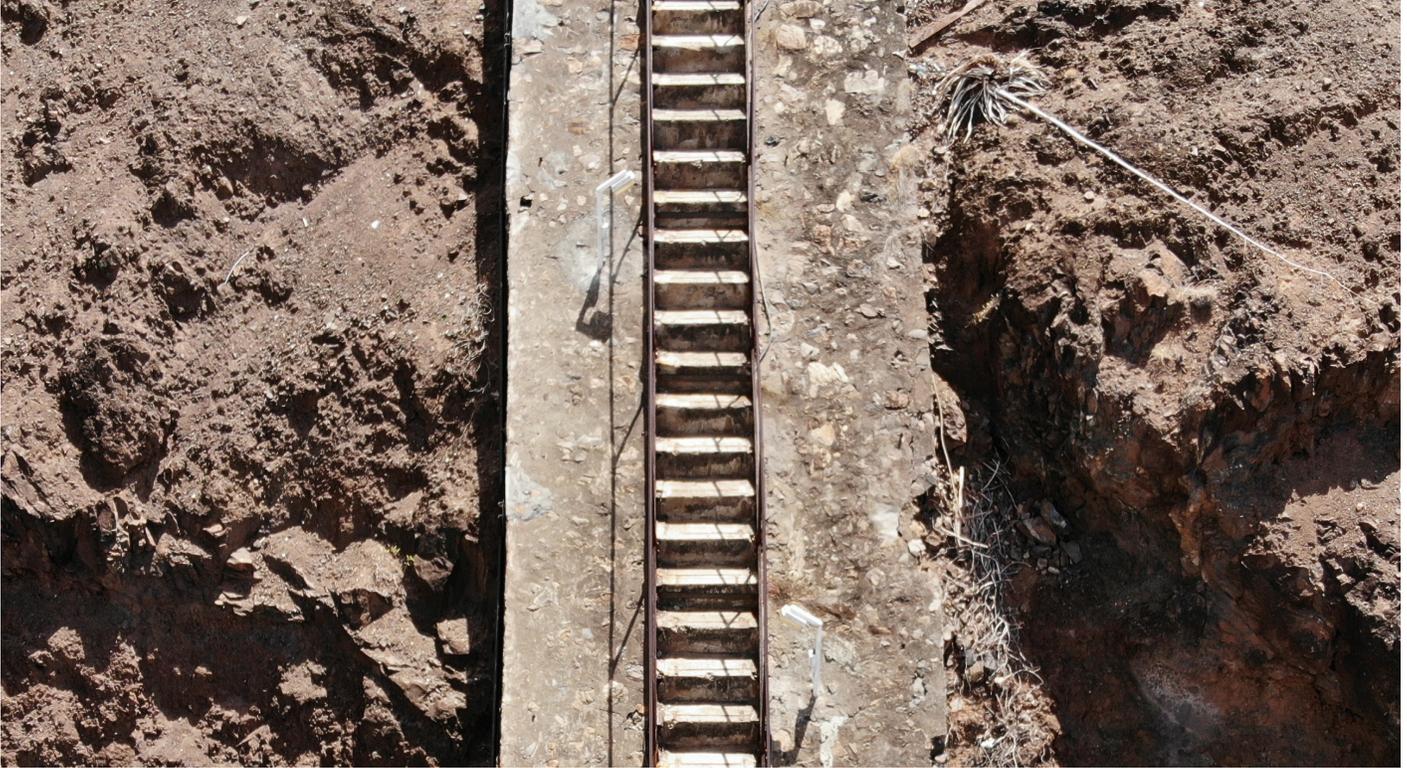
Figure 14: Soiled steps mid-way up the ladder (Model: B. Fortenberry).

2. Clean and treat steps with a conservator approved bio-cide solution such as D2 to remove bio-growth and soiling.

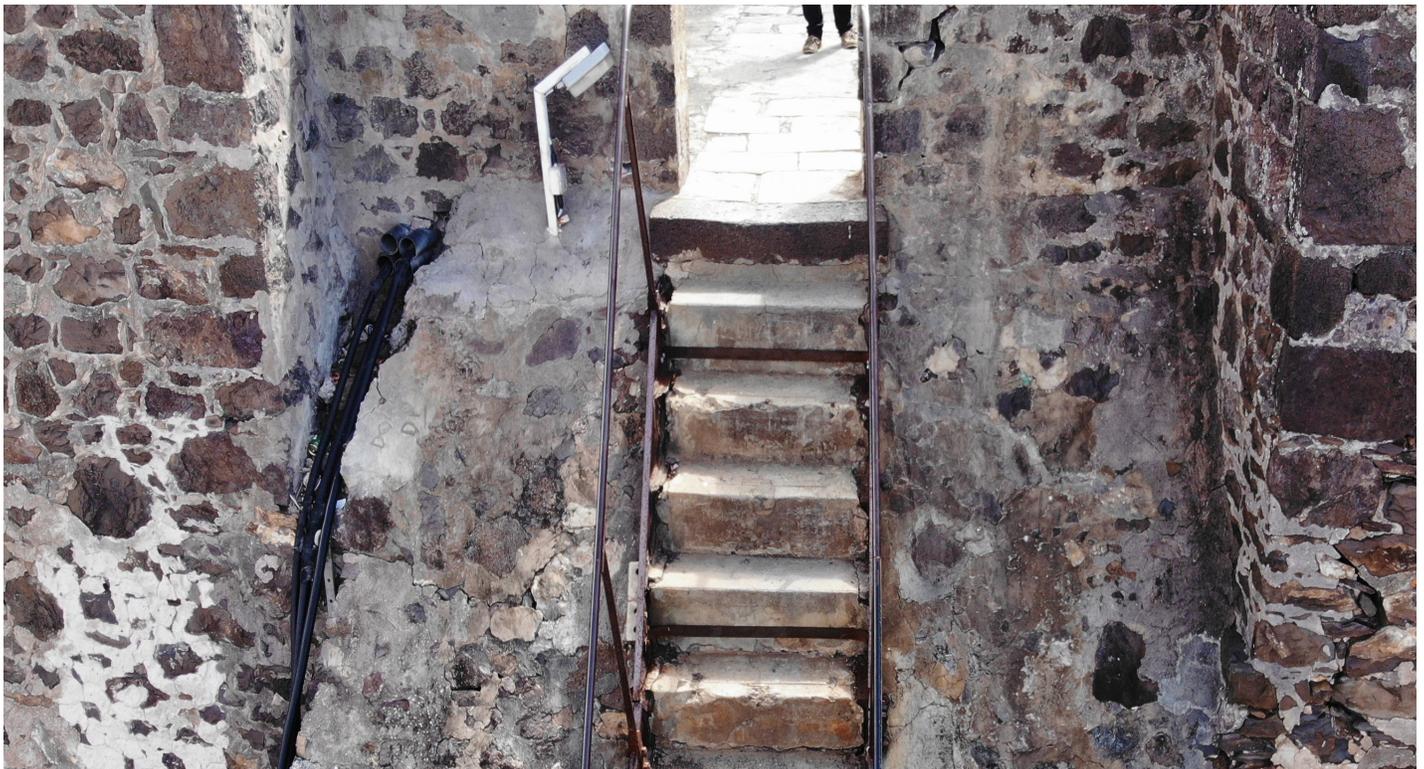
Figure 15: Detailed view of strapping and failing steps at summit (Image: B. Fortenberry).

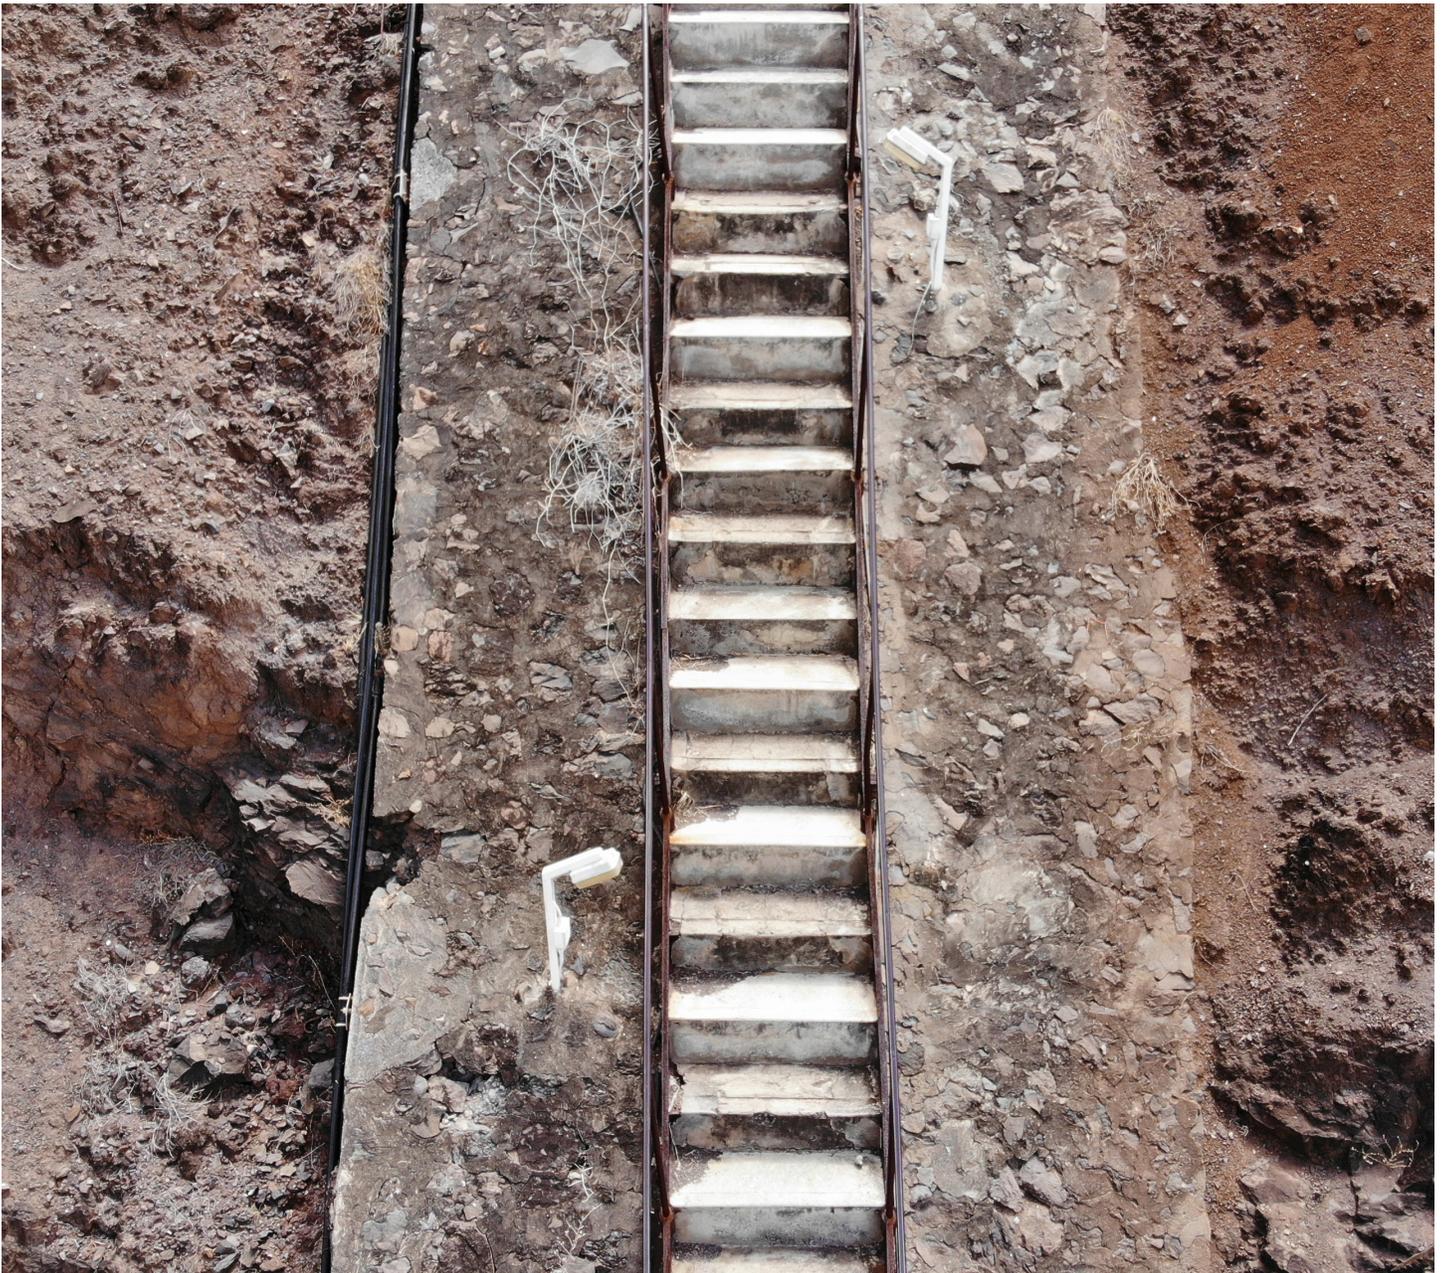
There are handrails on either side of the steps, the entire length of the site. The handrails are connected by stringers. Both the handrails and stringers appear to be in fair condition. They appear to be structurally sound. There is significant corrosion present on these metal elements and some rust jacking (i.e. the expansion of corroded metal breaking surrounding surfaces) is occurring.

Figure 16: Handrails that are out of plumb, braces recommended (Image: B. Fortenberry).

2. The handrails and stringers should be treated with an anti-corrosion solution. They should then be coated to prevent further corrosion.
3. If found to be lacking in structural integrity, braces should be crafted and placed at regular intervals along the length of the railing. A structural engineer should be consulted for details and plans for bracing. All bracing should have the appearance of the historic metalwork.

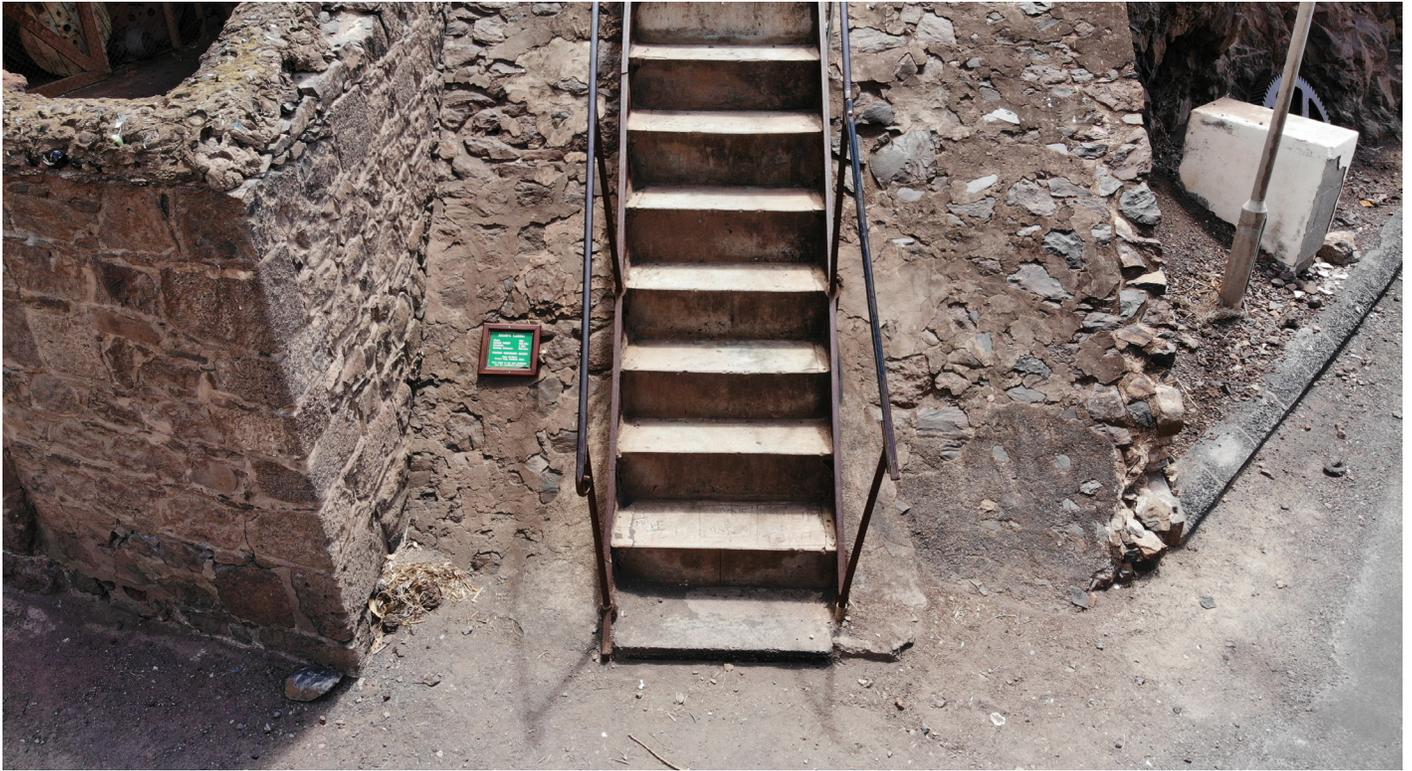
Figure 17: Handrail out of plumb at base of the ladder (Model: B. Fortenberry).

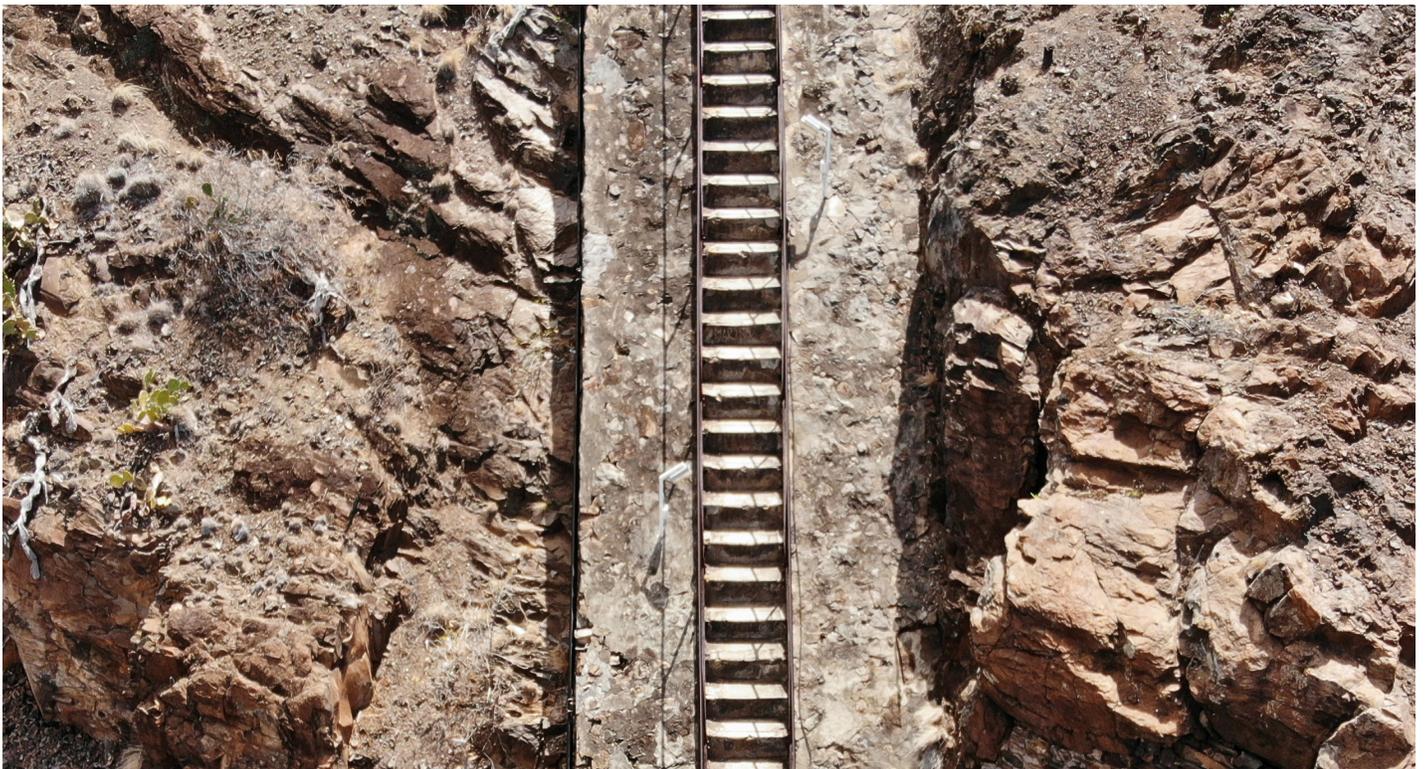
Figure 18: Separation from handrails at base from steps, mid-way up the ladder (Image: B. Fortenberry).

4. The rust jacking (i.e., the expansion of corroded metal breaking surrounding surfaces) has caused significant cracking to occur at the ends of the steps. If, during the repair of the surrounding surfaces, the metal is found to be no longer viable, the metal elements should be replaced. Replacement metal elements should appear visually similar to the historic elements, however, it is recommended to use a marine grade stainless steel where possible. This will slow future corrosion damage. A structural engineer can recommend specific grades of steel that are appropriate for use in the site's climate.

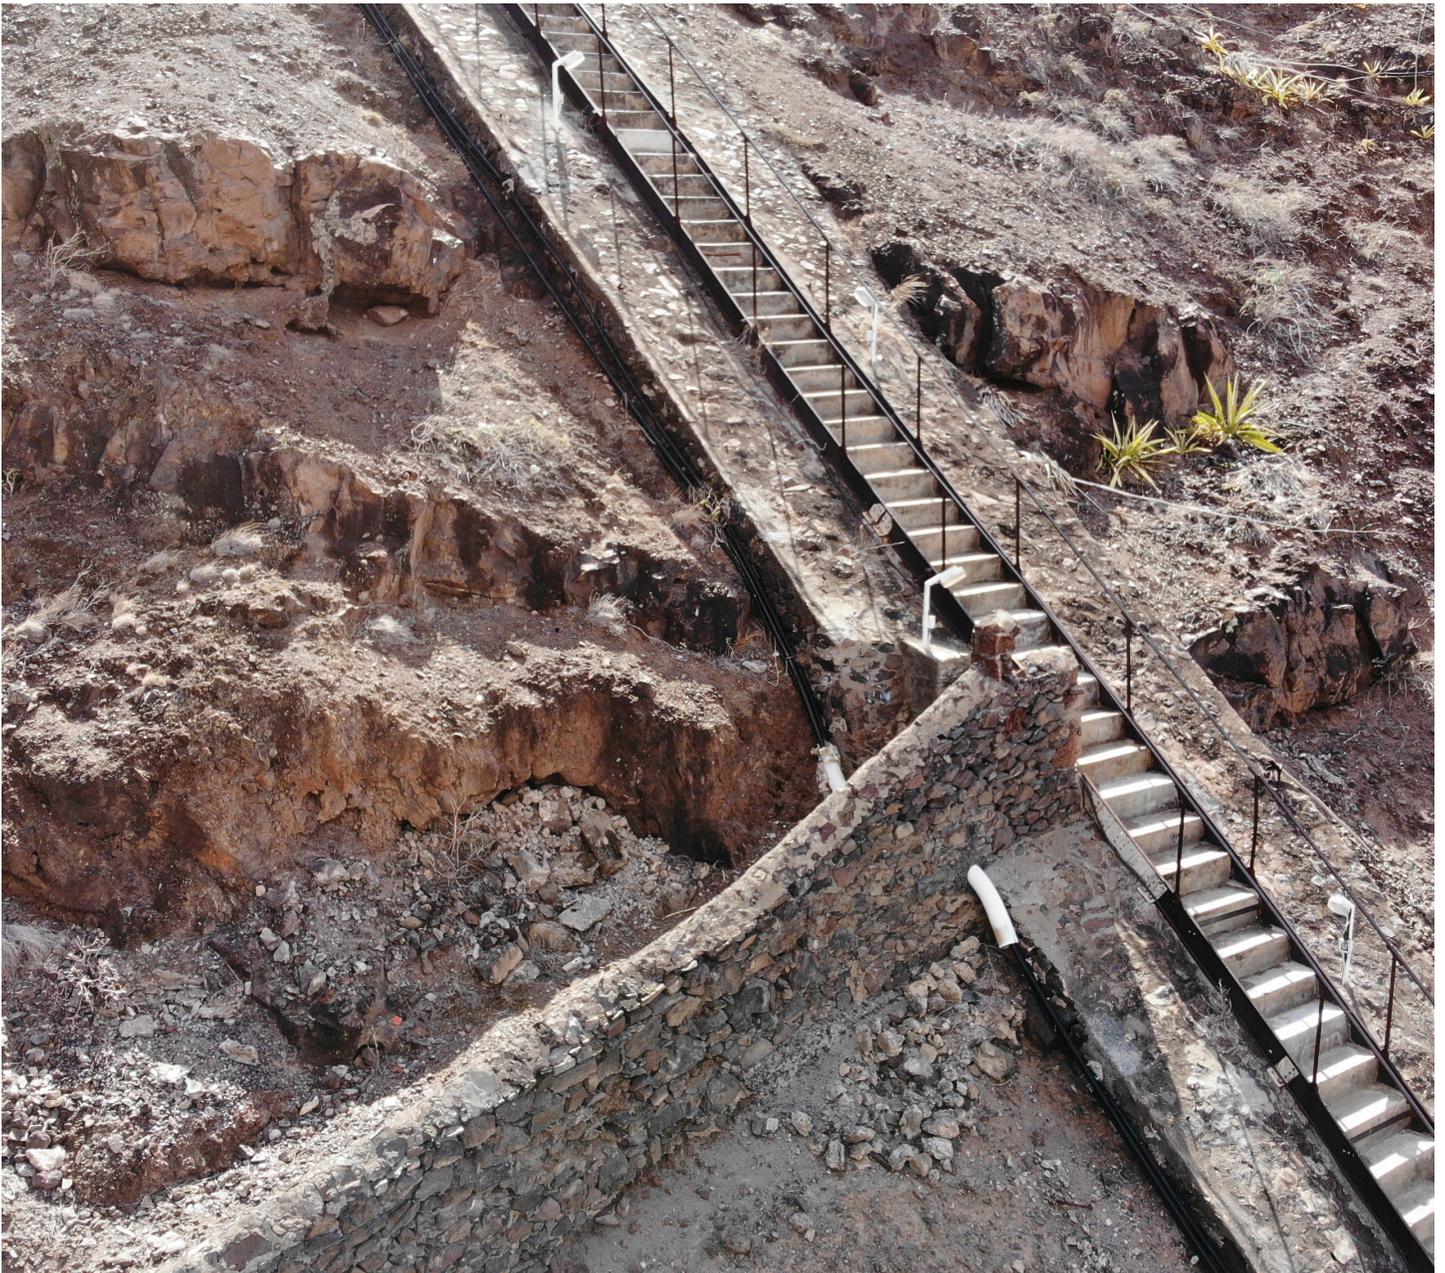
Figure 19: Stone abutment connection with historic path, note exposed utilities (Image: B. Fortenberry).

1. A structural engineer should be consulted to inspect the connections between the abutments and the hill surface. This area has been identified as an area of concern, as failure in the abutments will cause complete failure of the steps.
2. Clean and treat stone abutments with a conservator approved bio-cide solution such as D2 to remove bio-growth and soiling.
3. Tubes, electrical lines, and other wiring should be placed to the side of the abutments, rather than on the top. This will prevent water from pooling in these areas, leading to bio-growth and cracking. It is also in line with preserving the historic character of the abutments.

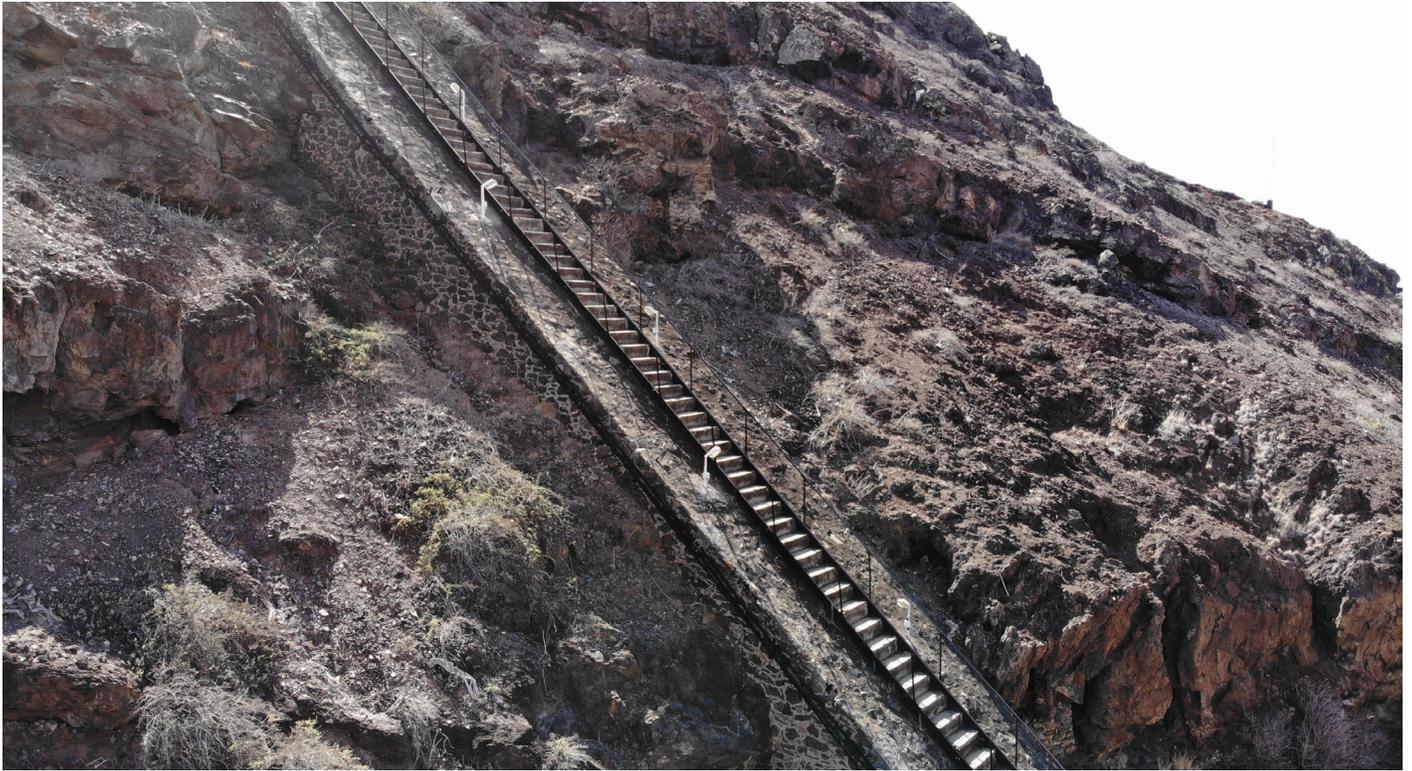
Figure 20: Recently re-pointed stone abutment section (Model: B. Fortenberry).

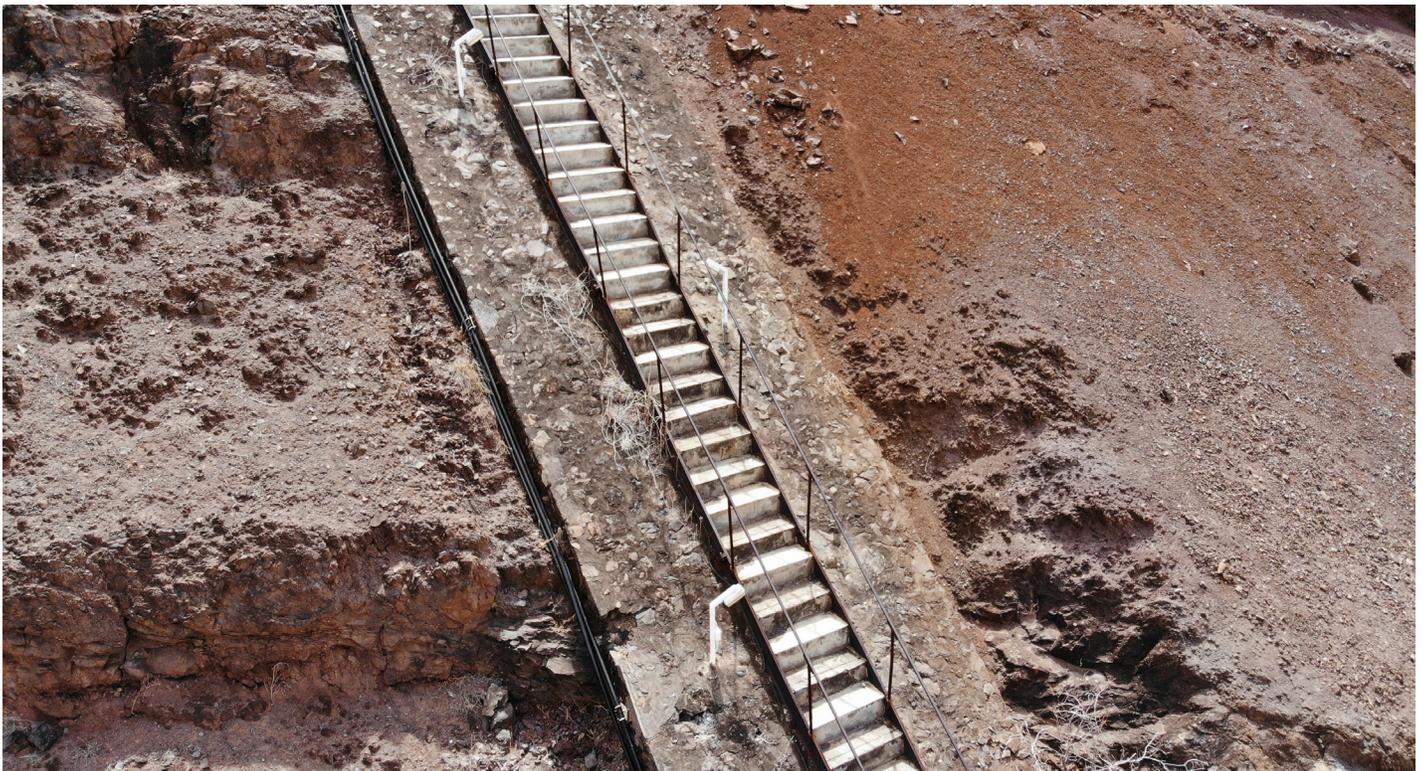
Figure 21: Stone abutments with bio-growth present (Image: B. Fortenberry).

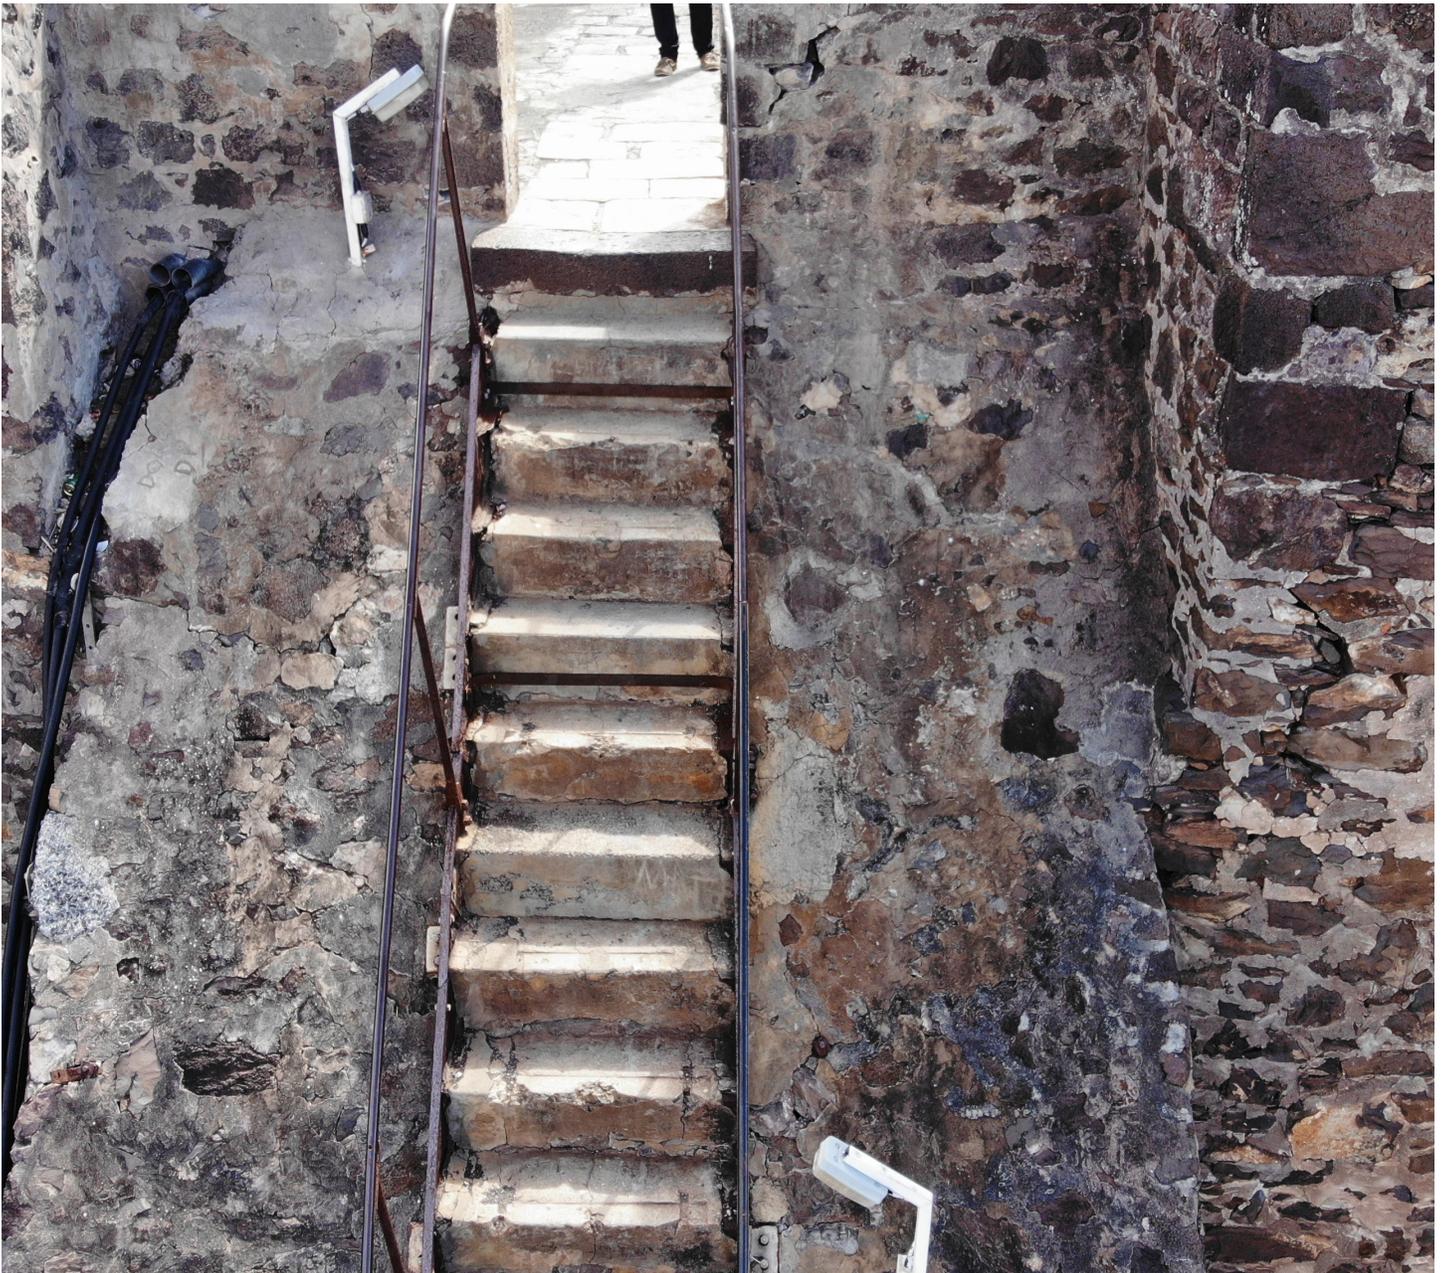
There are various metal elements present, mainly the straps on the steps. These straps are corroded. They appear to be in fair condition.

Figure 22: Support strapping on steps at ladder summit (Image: B. Fortenberry).

1. If chosen to leave in place, the straps on the steps should be treated with an anti-corrosion solution. They should then be coated to prevent further corrosion. .

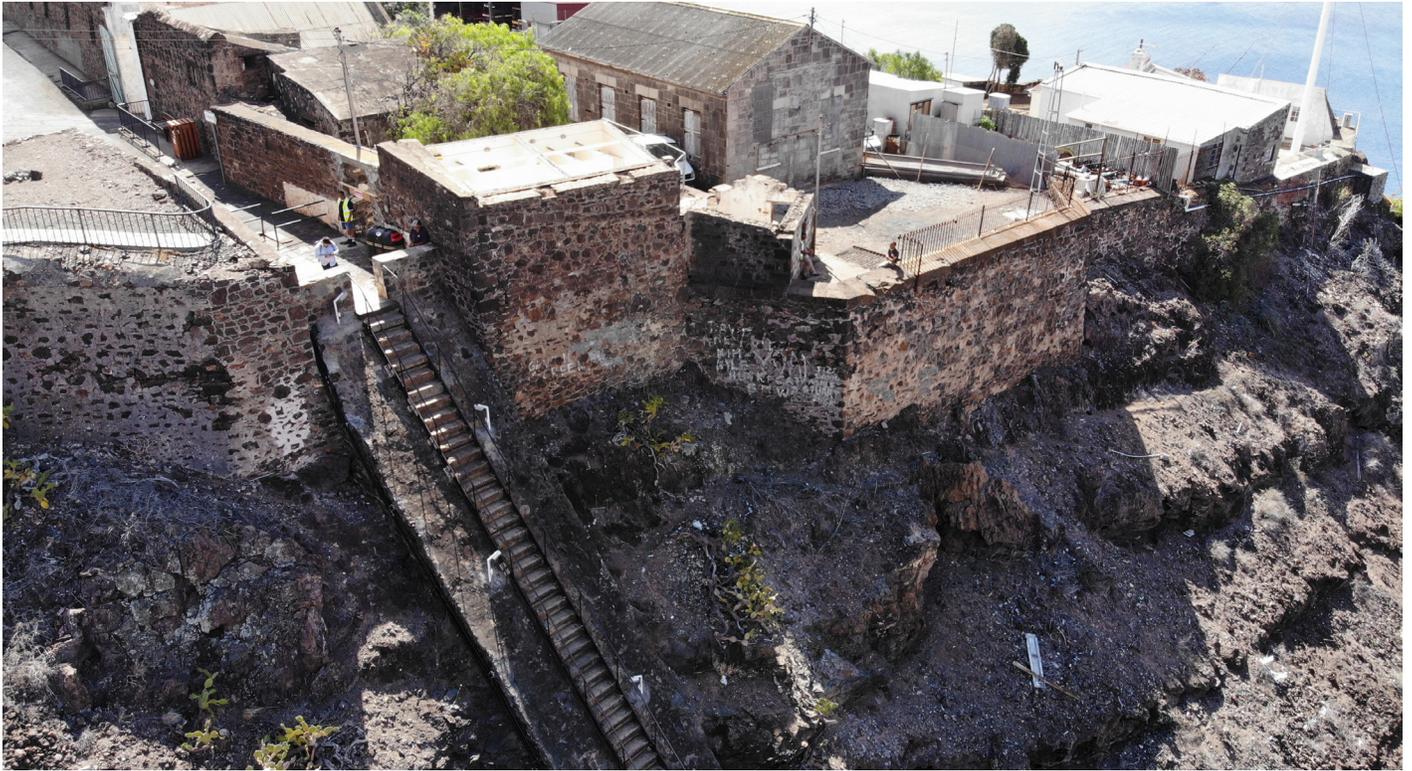
Figure 23: Upper section of ladder near summit showing step strapping (Model: B. Fortenberry).

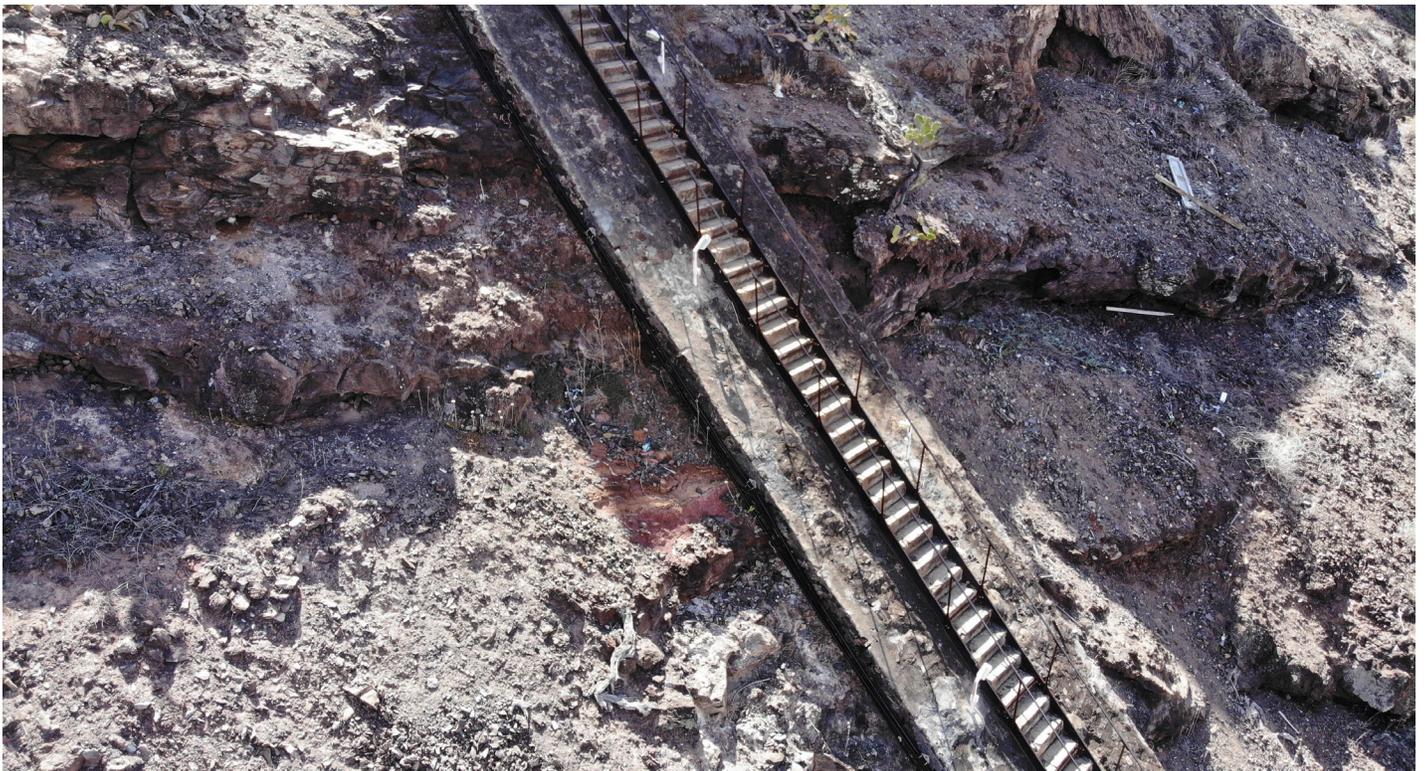
Figure 24: Metal strapping present on stair, mid-way up the ladder (Image: B. Fortenberry).
