Documentation and Conditions Assessment of Banks' Battery, St. Helena (CHC-2020-01-03)

**Report prepared for the British Napoleonic Bicentenary
Trust and St. Helena Government**

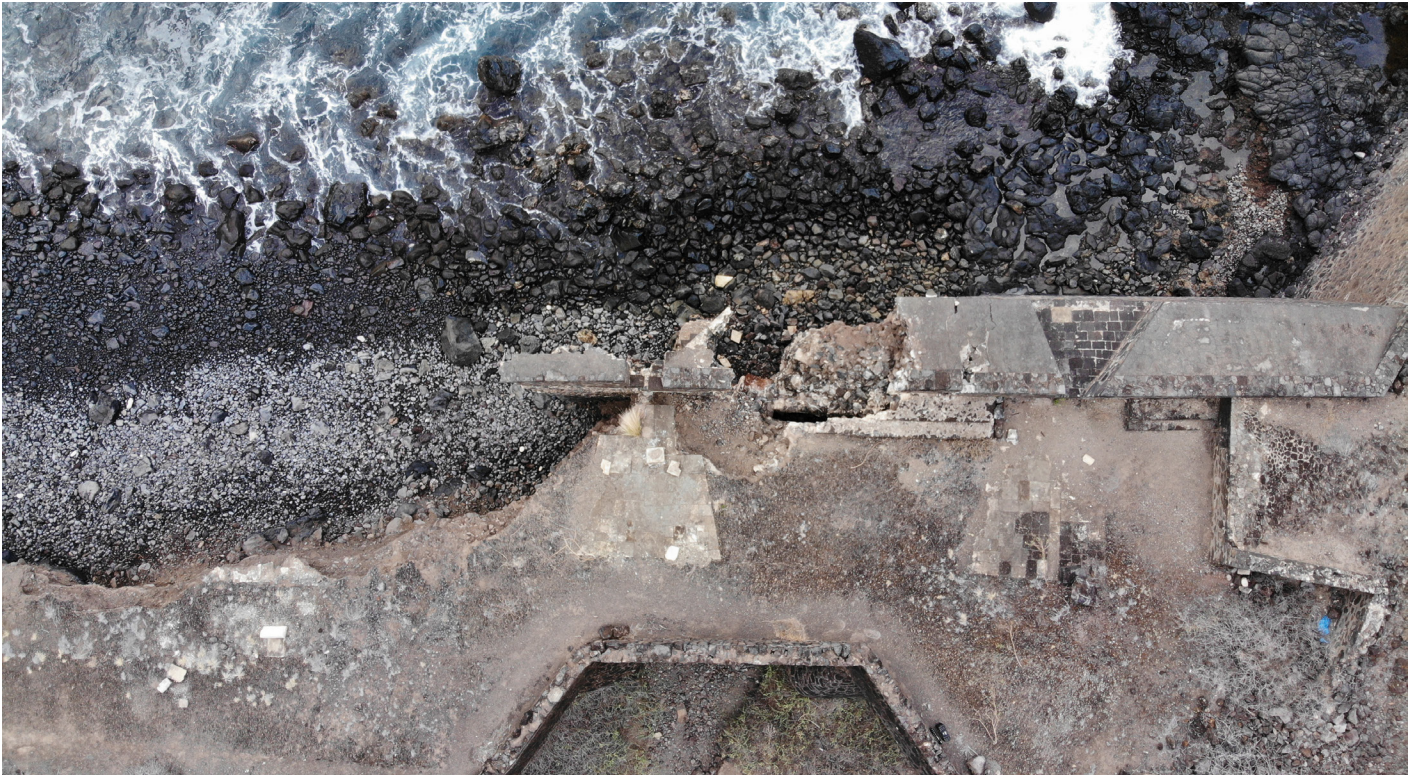
There are several areas of failure along the curtain wall at Lower Banks', all a product of the natural erosion process and deferred maintenance. On the curtain wall the failures occur primarily along the southern half of the line where the stone wall is pulling out (west) from the face. It is likely that erosional processes are pushing sediment outward and down the hill to cause this failure. A second failure to the north of this primary failure, due to the same impacts. In the storm water tunnel the arched opening is also failing as wall movement is pulling the bonding apart. The top, west side (seaward) top of the archway is failing as well.

Figure 17: Aerial nadir image of failing curtain wall at Lower Banks' Battery (Image: B. Fortenberry).

1. The multiple wall curtain wall and arch failures at Lower Banks' Battery are the most pressing condition that needs to be addressed, and a structural engineer specializing in historic buildings should be consulted prior to any conservation work taking place. The engineer should examine the photographs, drone images, 3D models, and drawings to make preliminary determinations of the scope of rehabilitation and repair. An on-site visit is preferable for detailed inspection (The ruined buildings could best be conserved as ruins. As such, no roof structures would need to be constructed).

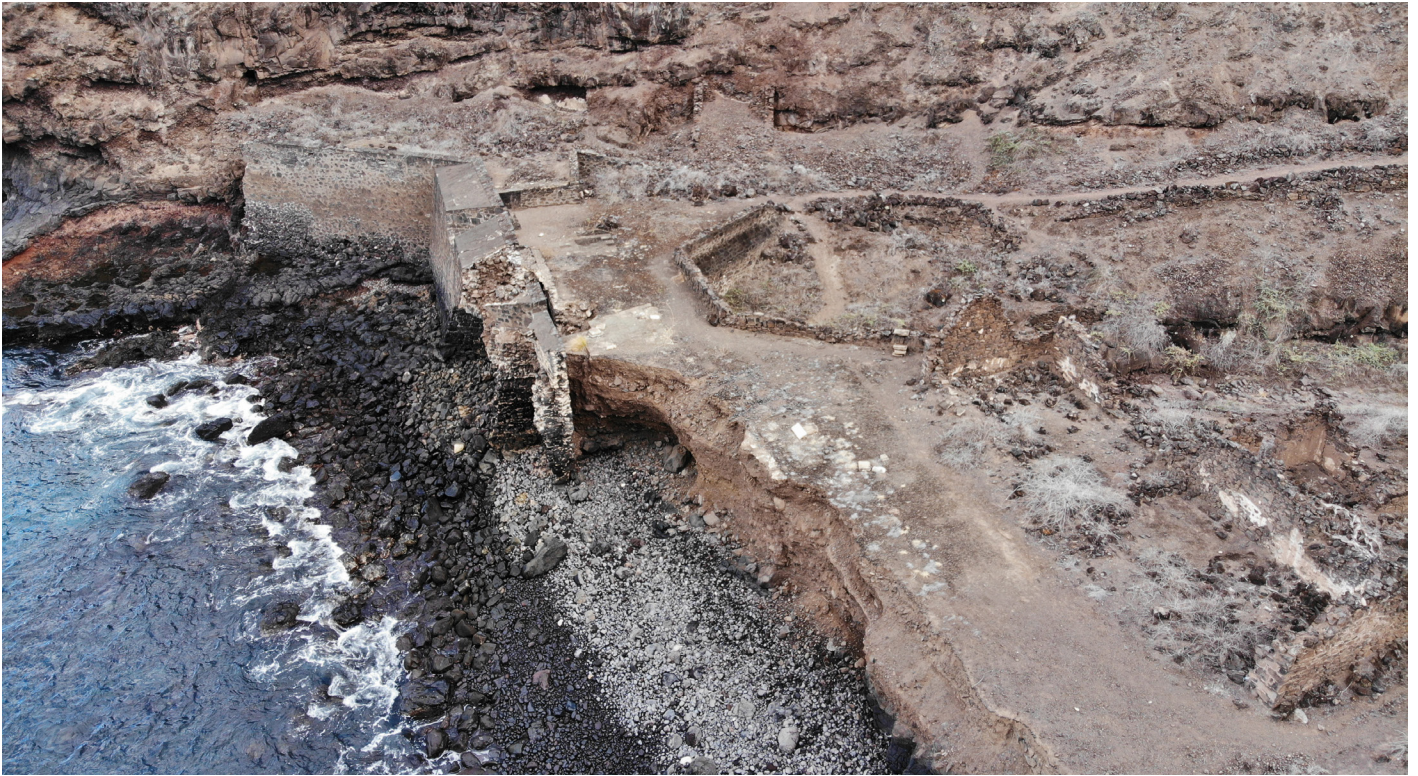
Figure 19: Aerial image of failing curtain wall looking north Lower Banks' Battery (Image: B. Fortenberry).

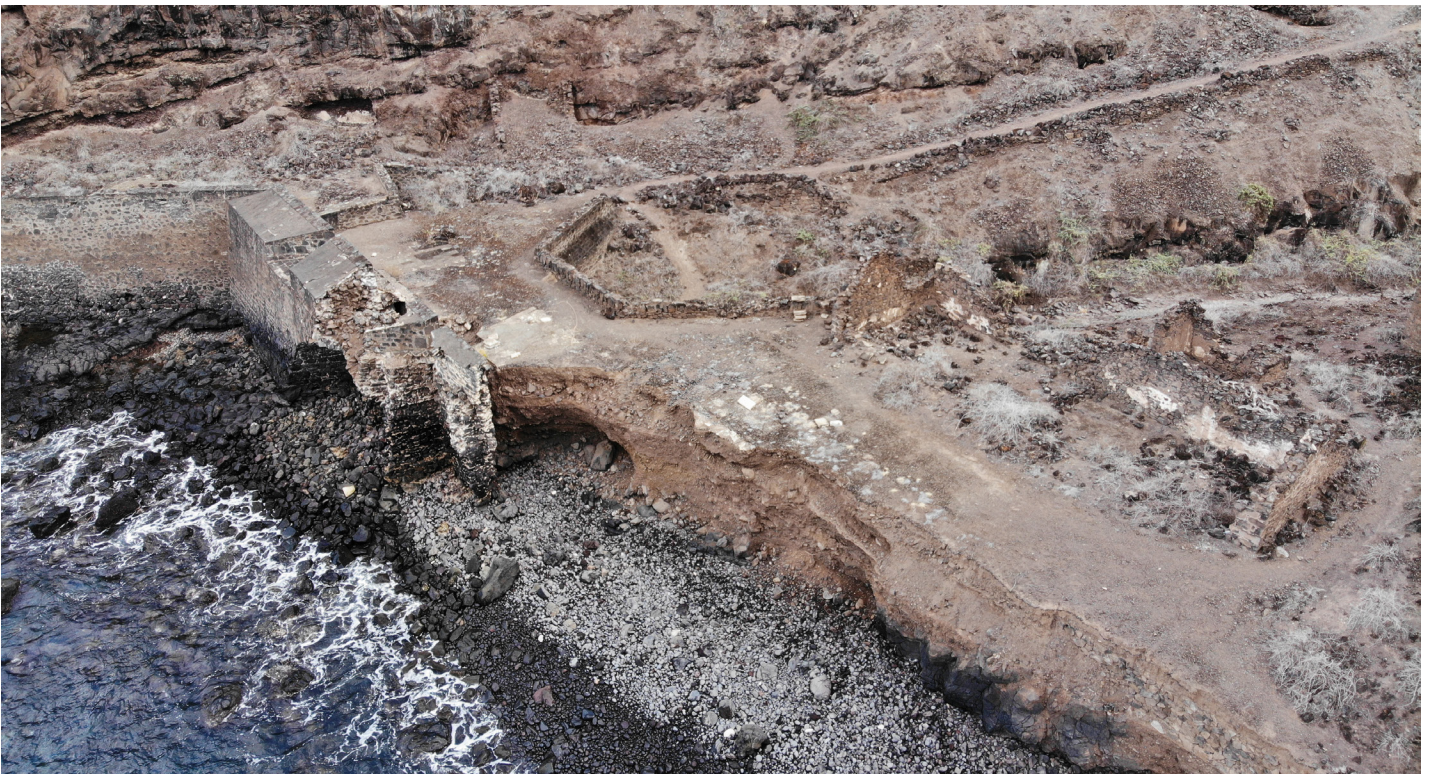
Figure 20: Aerial image of failing curtain wall and lost rampart Lower Banks' Battery (Image: B. Fortenberry).

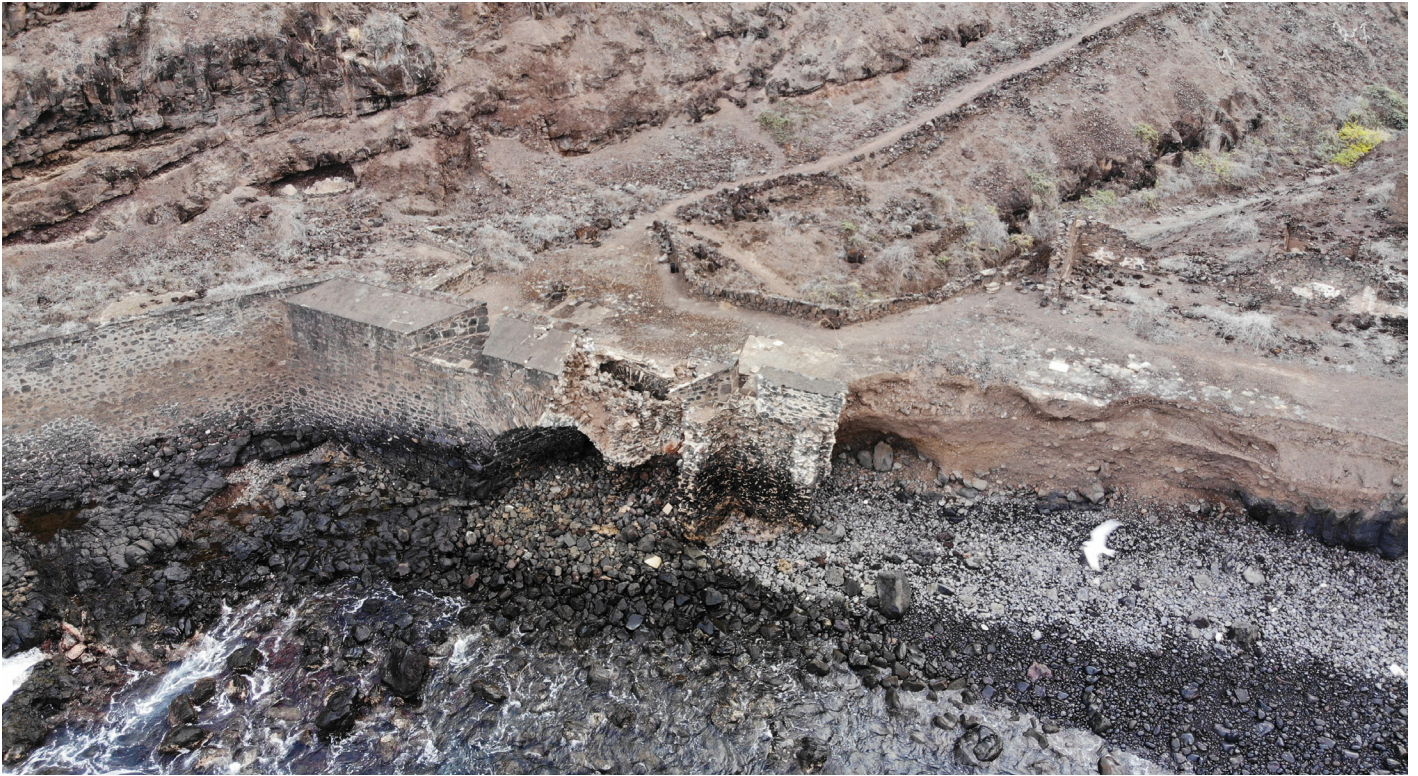
Figure 21: Aerial image of failing curtain wall looking east at Lower Banks' Battery (Image: B. Fortenberry).

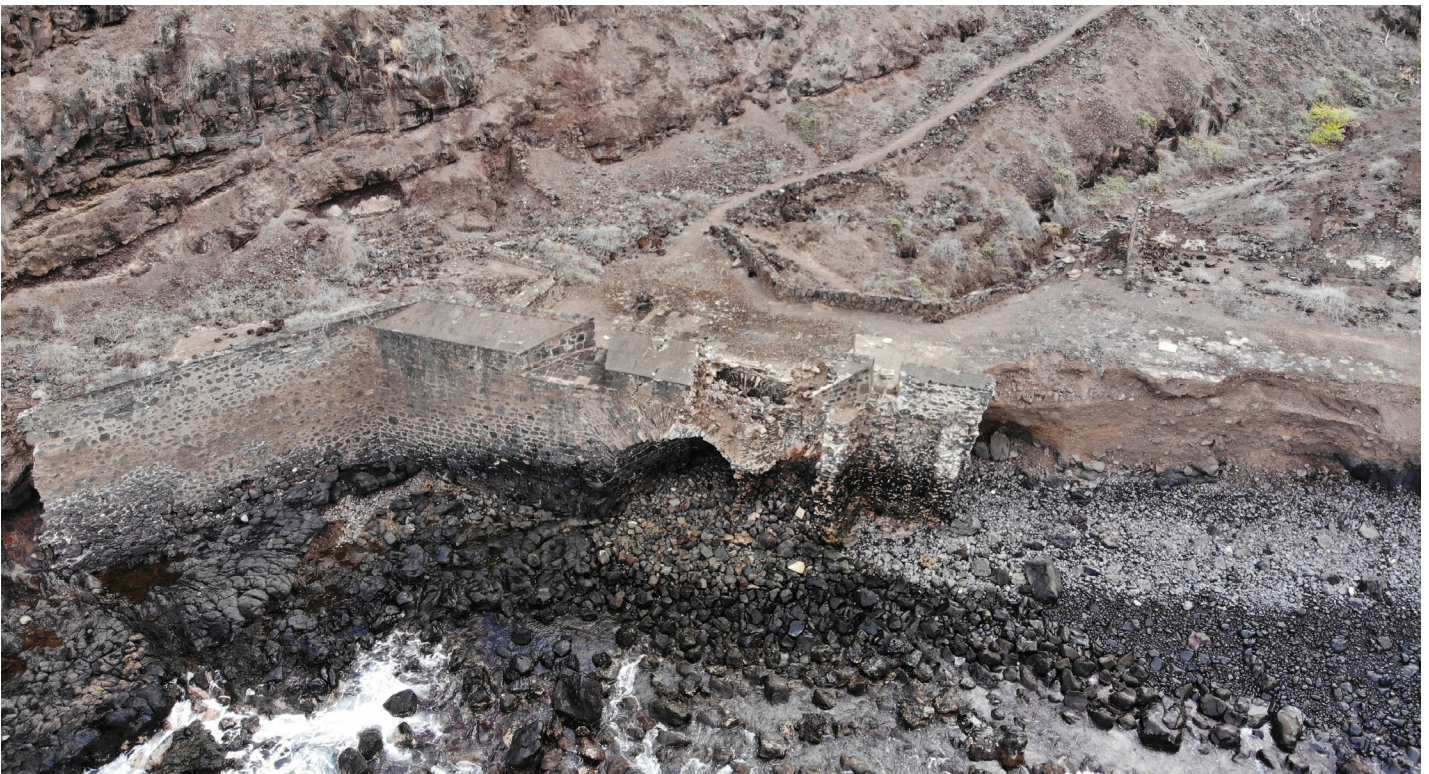
Figure 22: Aerial image of failing north wall and curtain wall at Lower Banks' Battery (Image: B. Fortenberry).

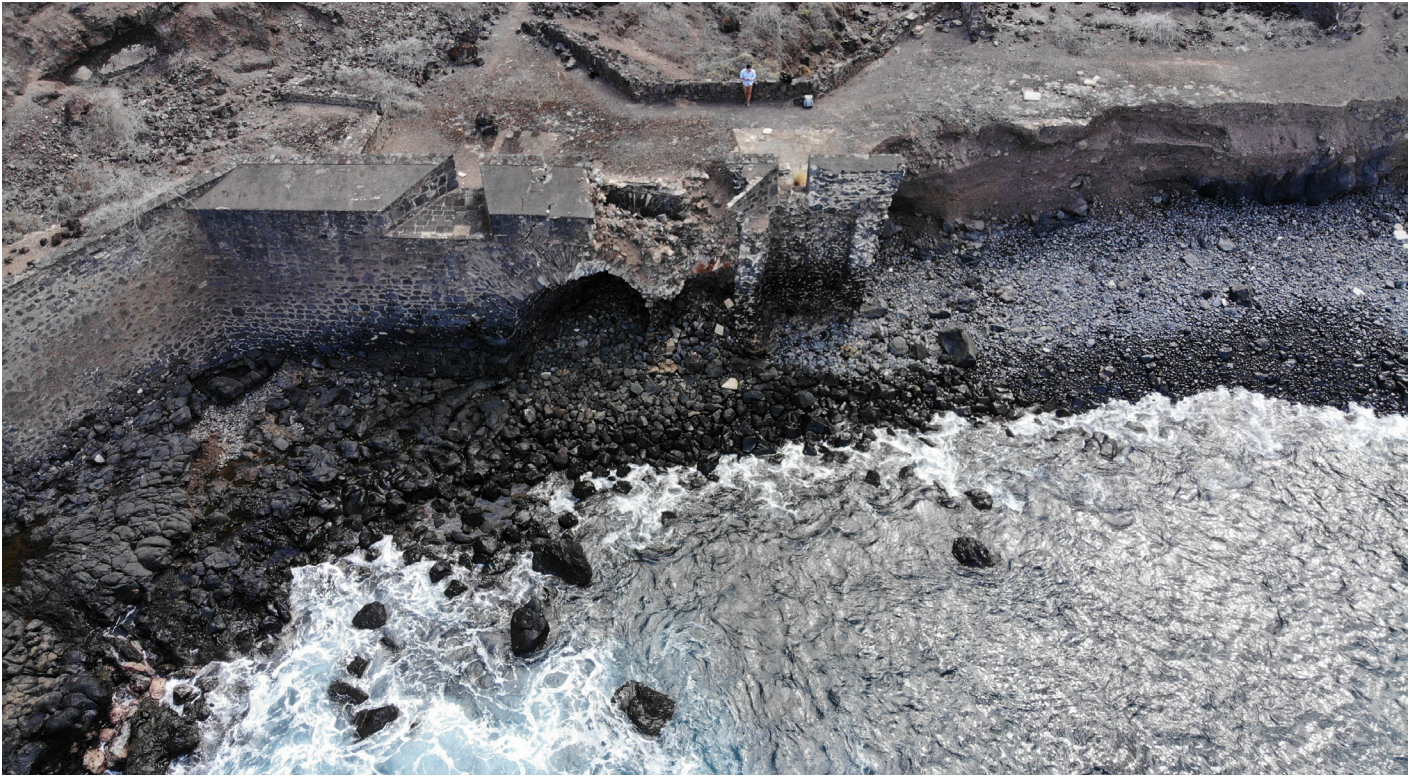
Figure 23: Aerial image of failing curtain wall, Lower Banks' Battery (Image: B. Fortenberry).

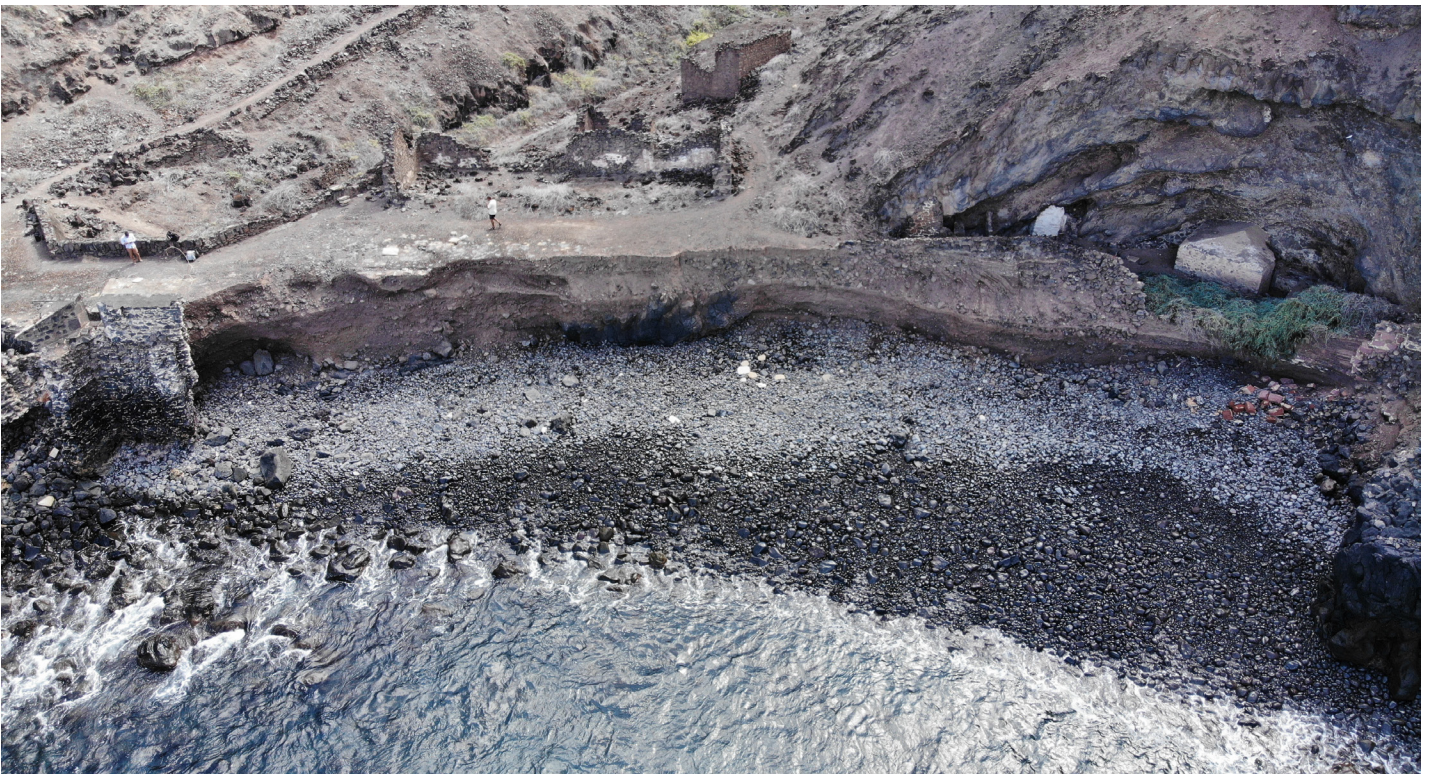
Figure 24: Aerial image of lost curtain wall due to erosion at Lower Banks' Battery (Image: B. Fortenberry).

3. While the structural engineer will address the historic fabric, a geologist or environmental engineer should also be consulted to discuss how current erosion conditions contributed to the collapses and how they might be mitigated as a part of site rehabilitation.

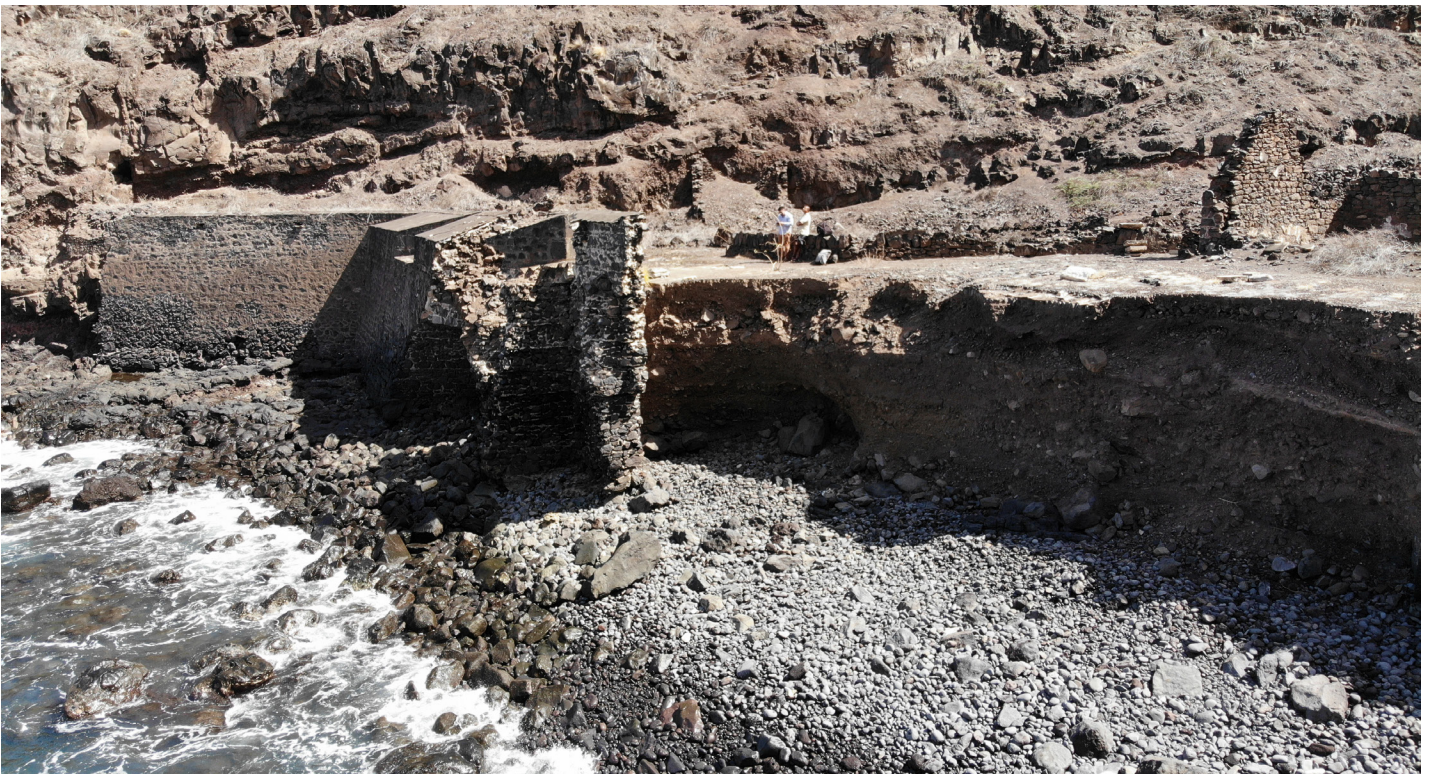
Figure 28: Aerial section image of failing curtain wall at Lower Banks' Battery (Image: B. Fortenberry).

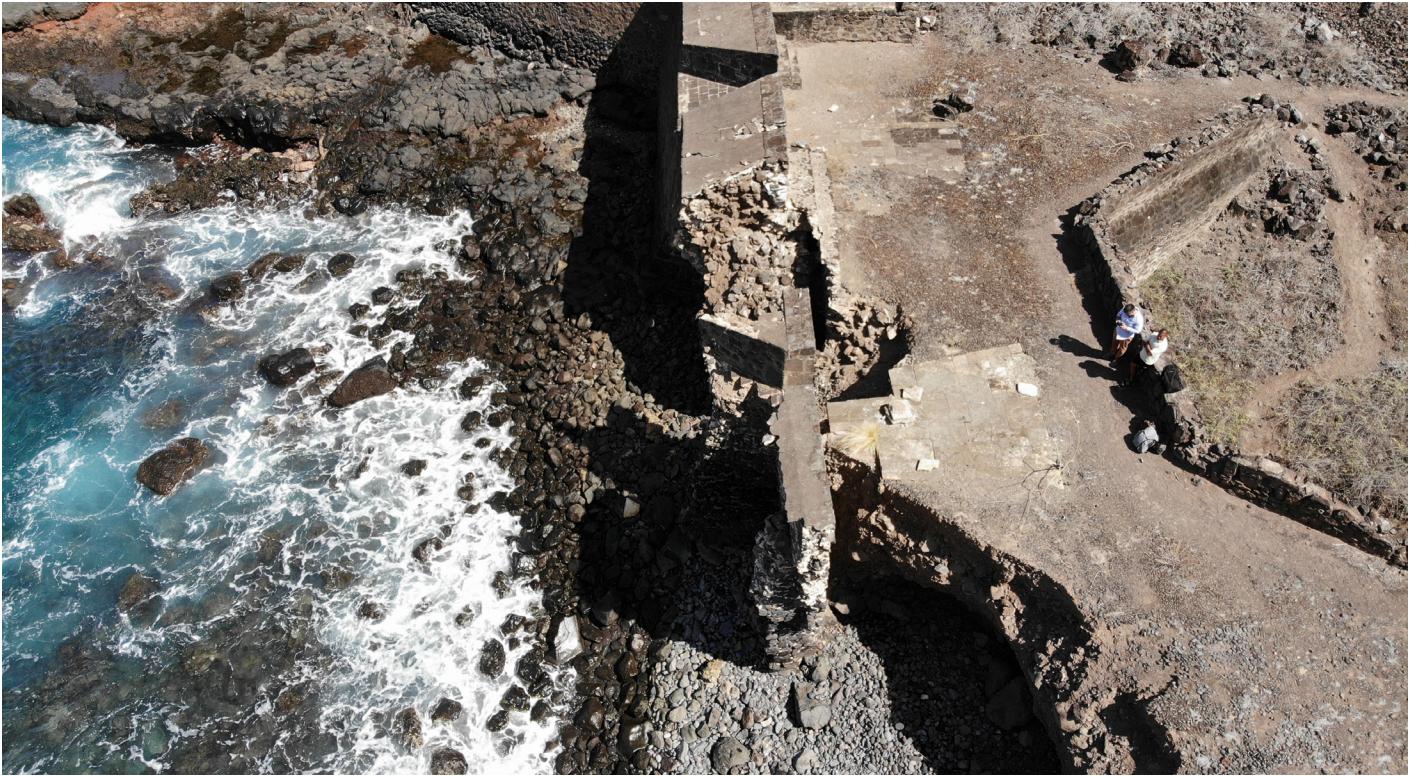
Figure 29: Aerial oblique image of failing curtain wall at Lower Banks' Battery (Image: B. Fortenberry).

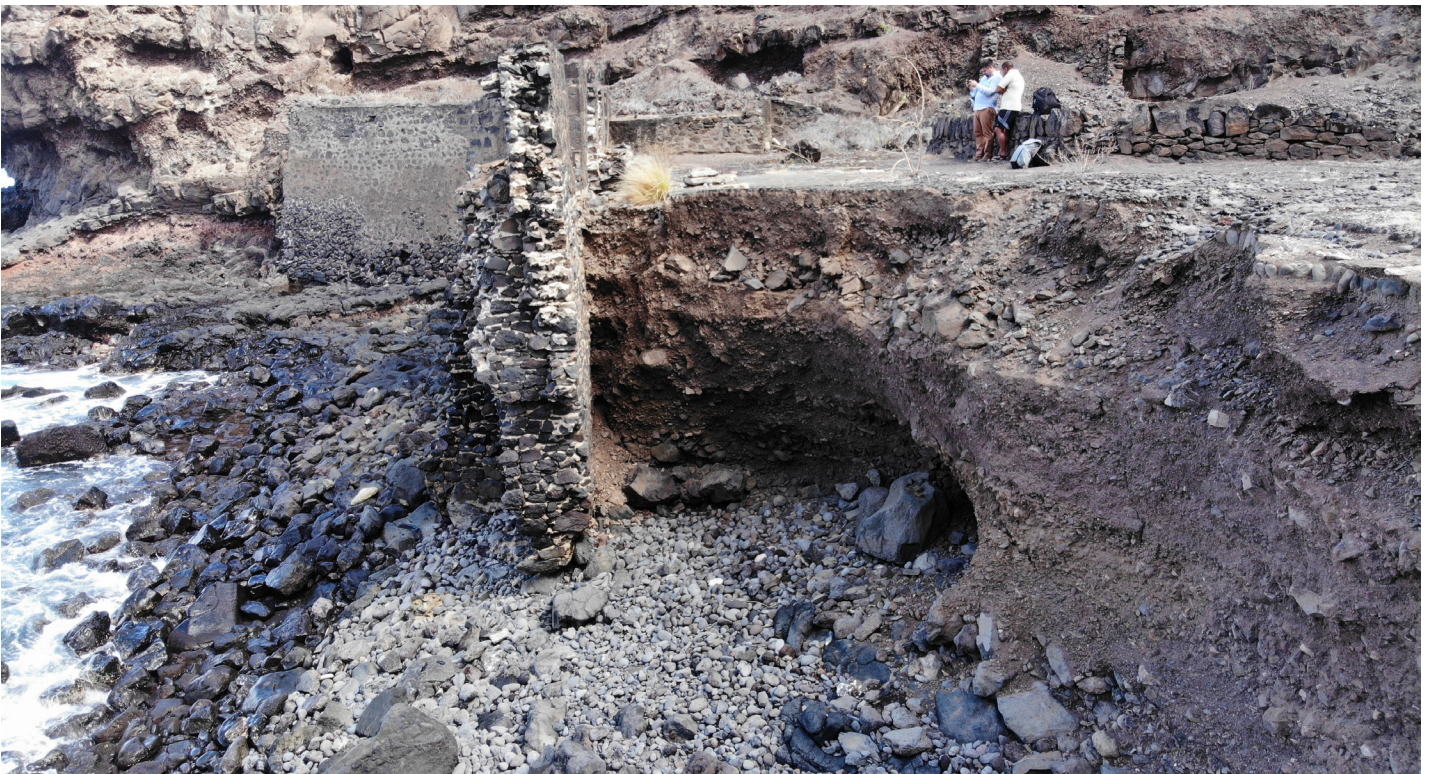
Figure 30: Detail section view of failing curtain wall at Lower Banks' Battery (Image: B. Fortenberry).

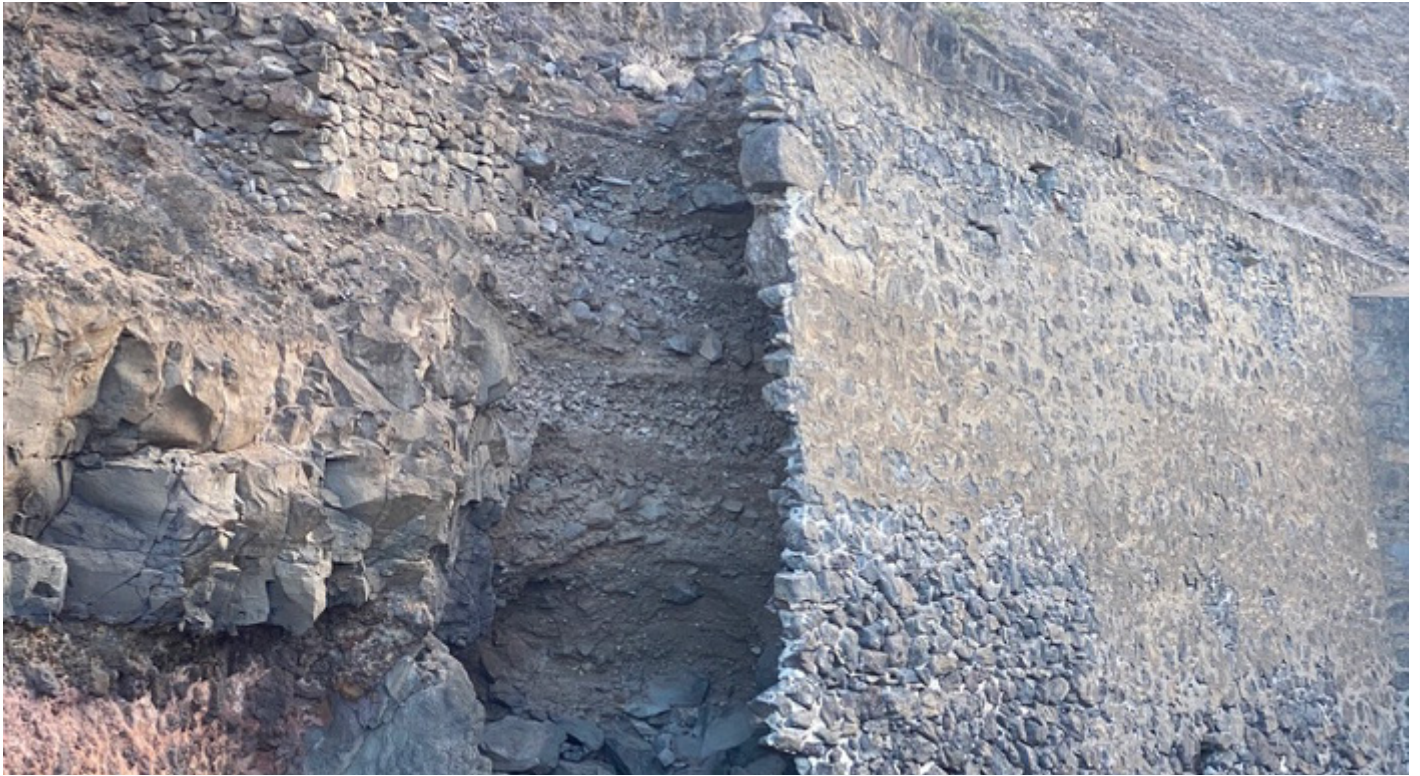
Figure 31: Detail image of northern failure of north curtain wall at Lower Banks' Battery (Image: B. Fortenberry).

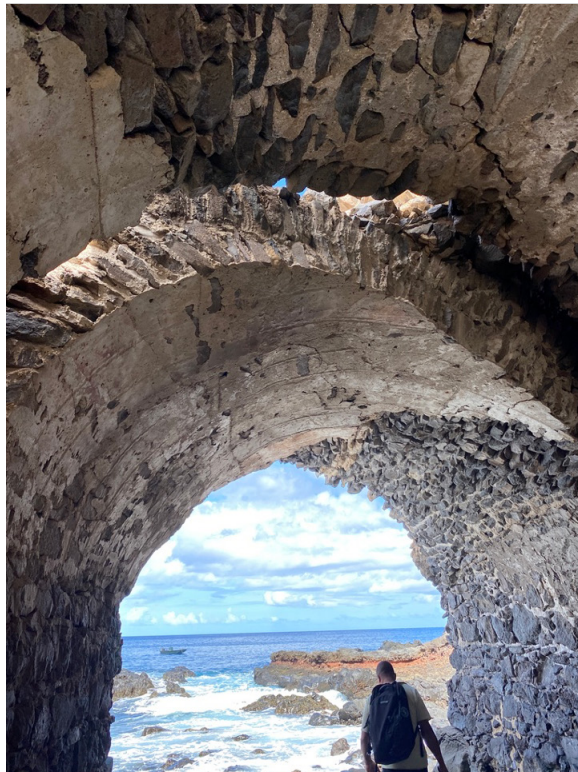
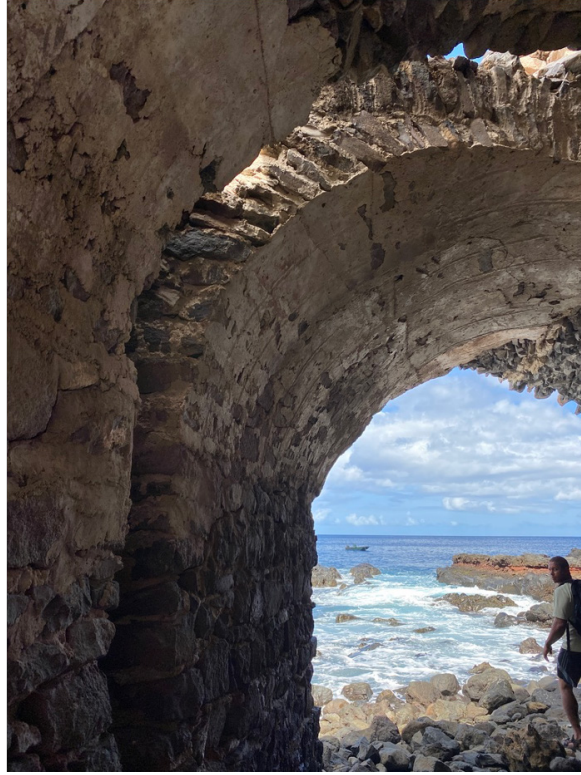
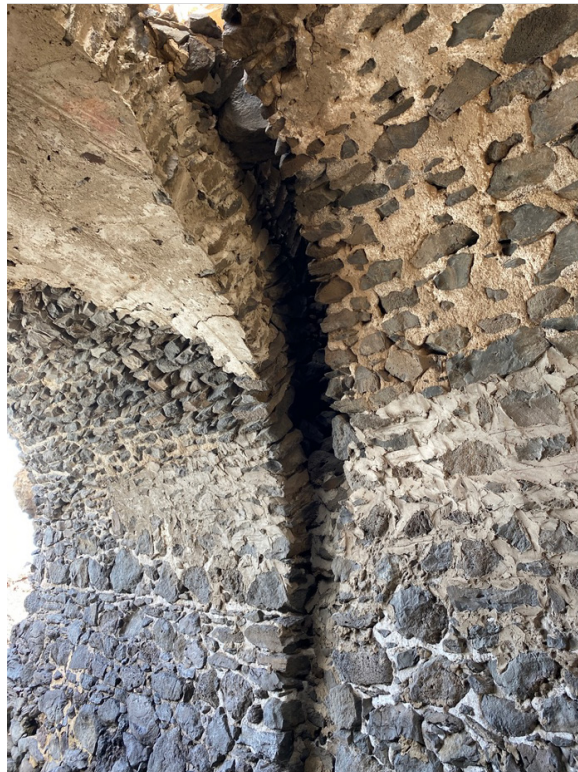
Figure 32: Detail of failing arch at Lower Banks' Battery (Image: B. Fortenberry).

Figure 33: Detail of failing arch at Lower Banks' Battery (Image: B. Fortenberry).

Figure 34: Detail of failing arch at Lower Banks' Battery (Image: B. Fortenberry).

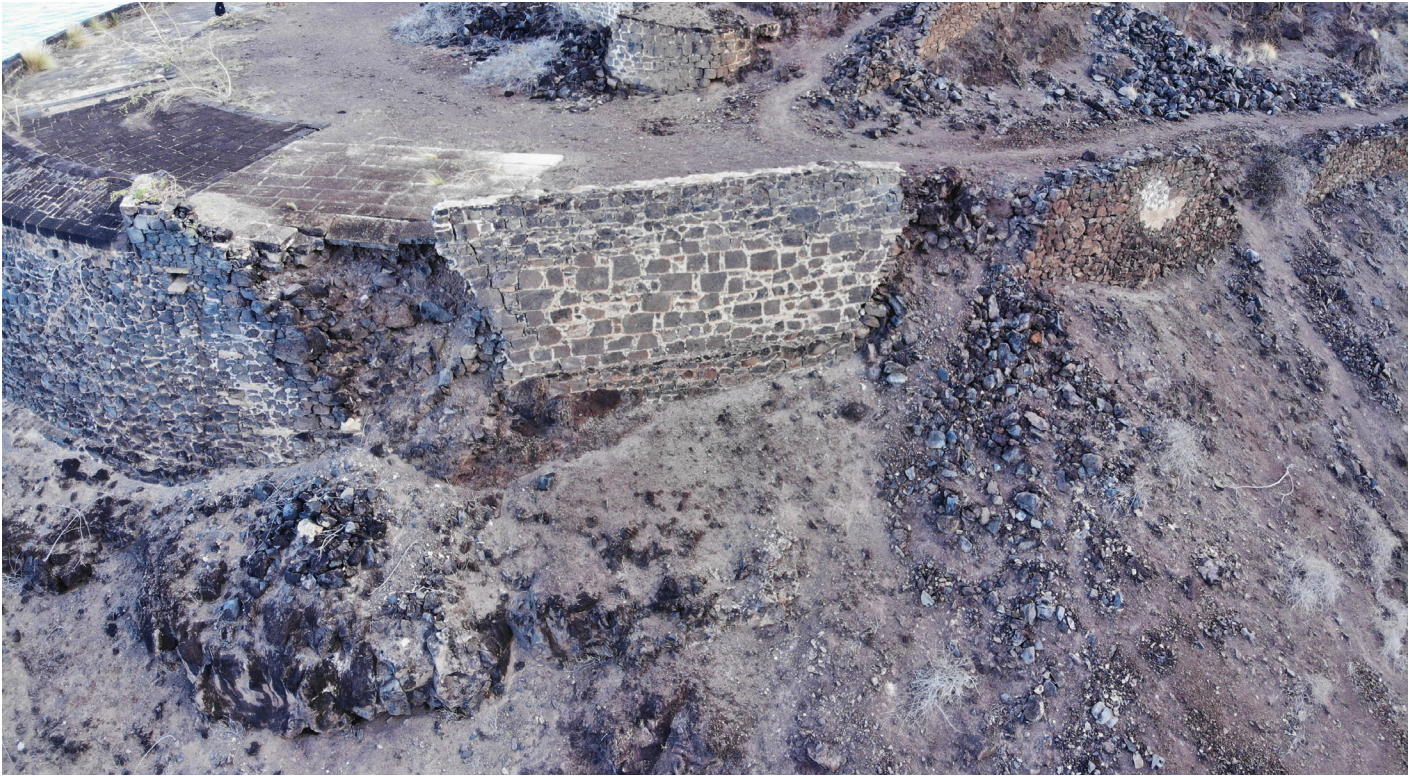
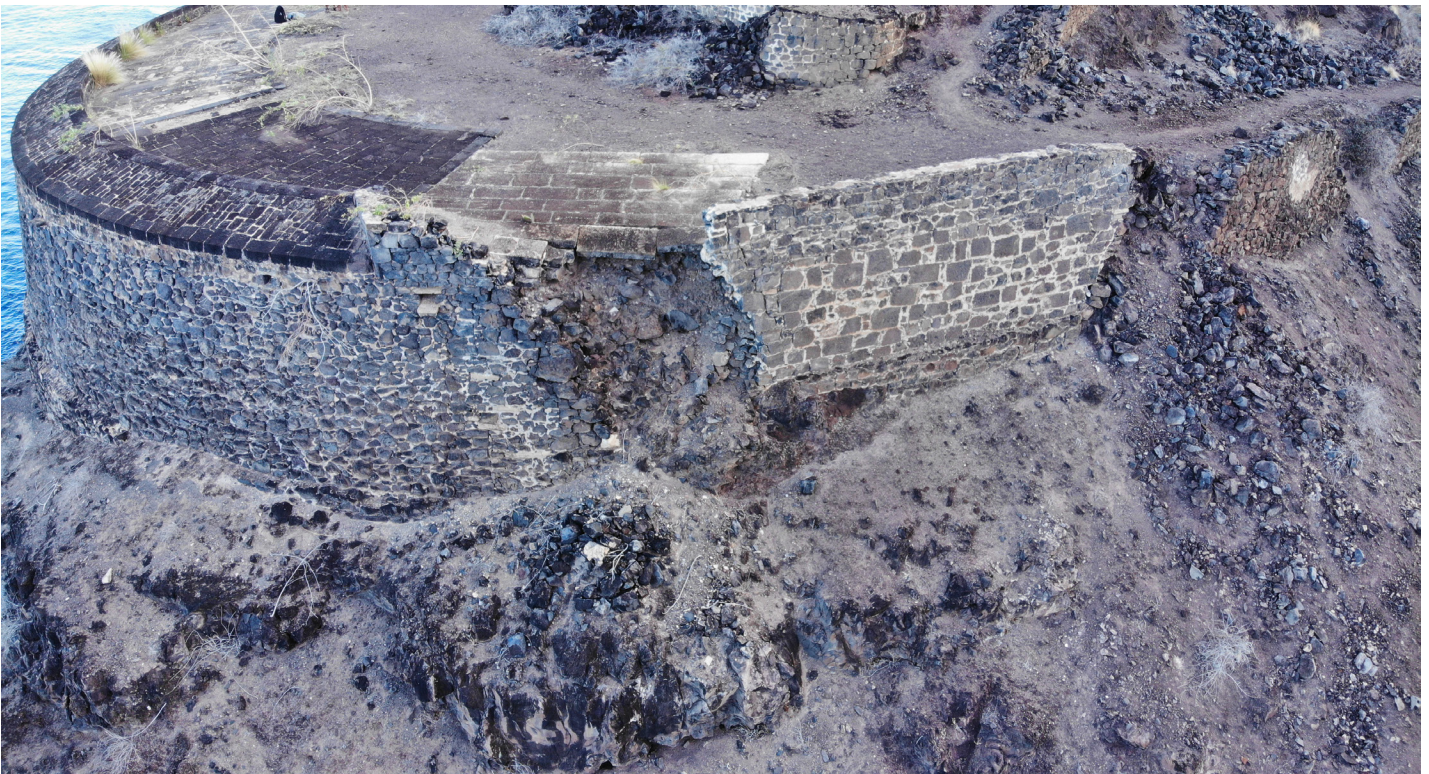
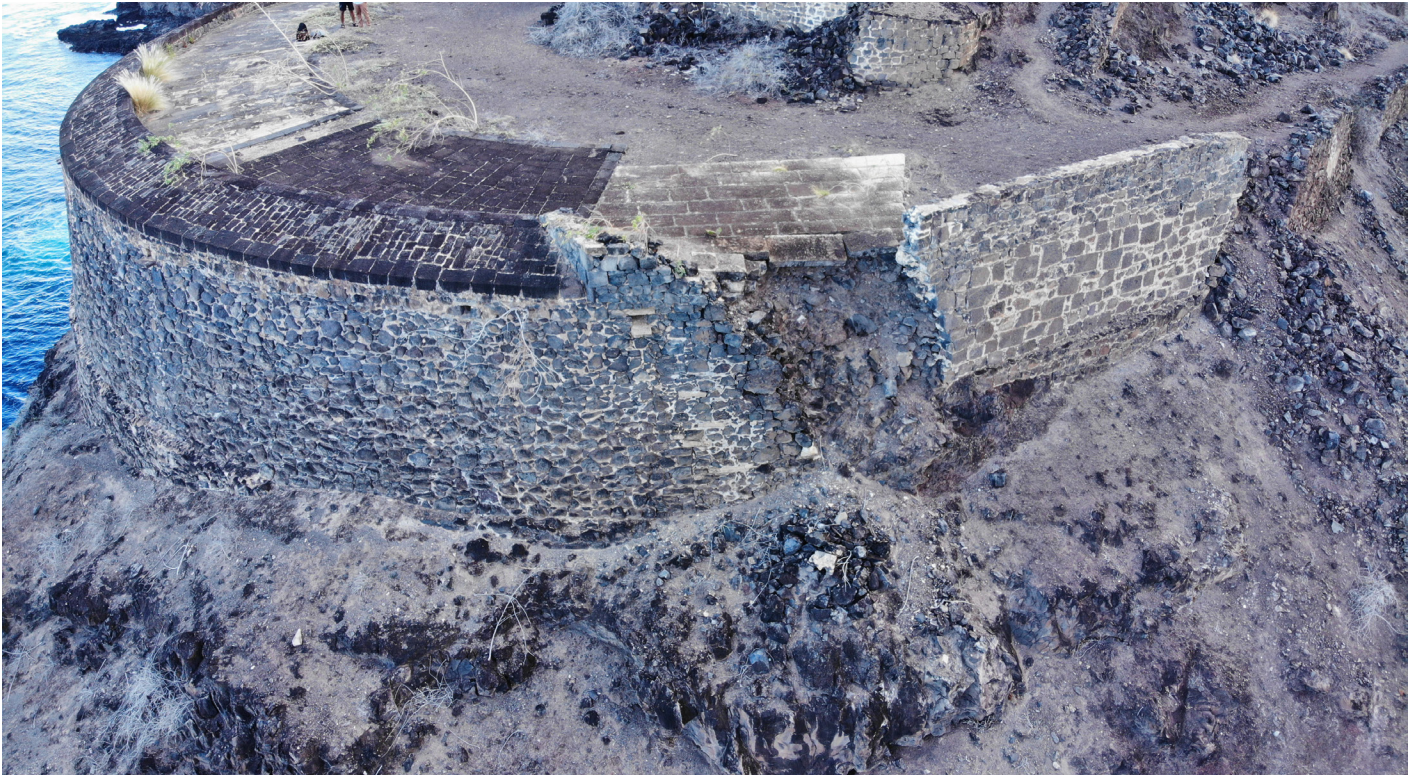
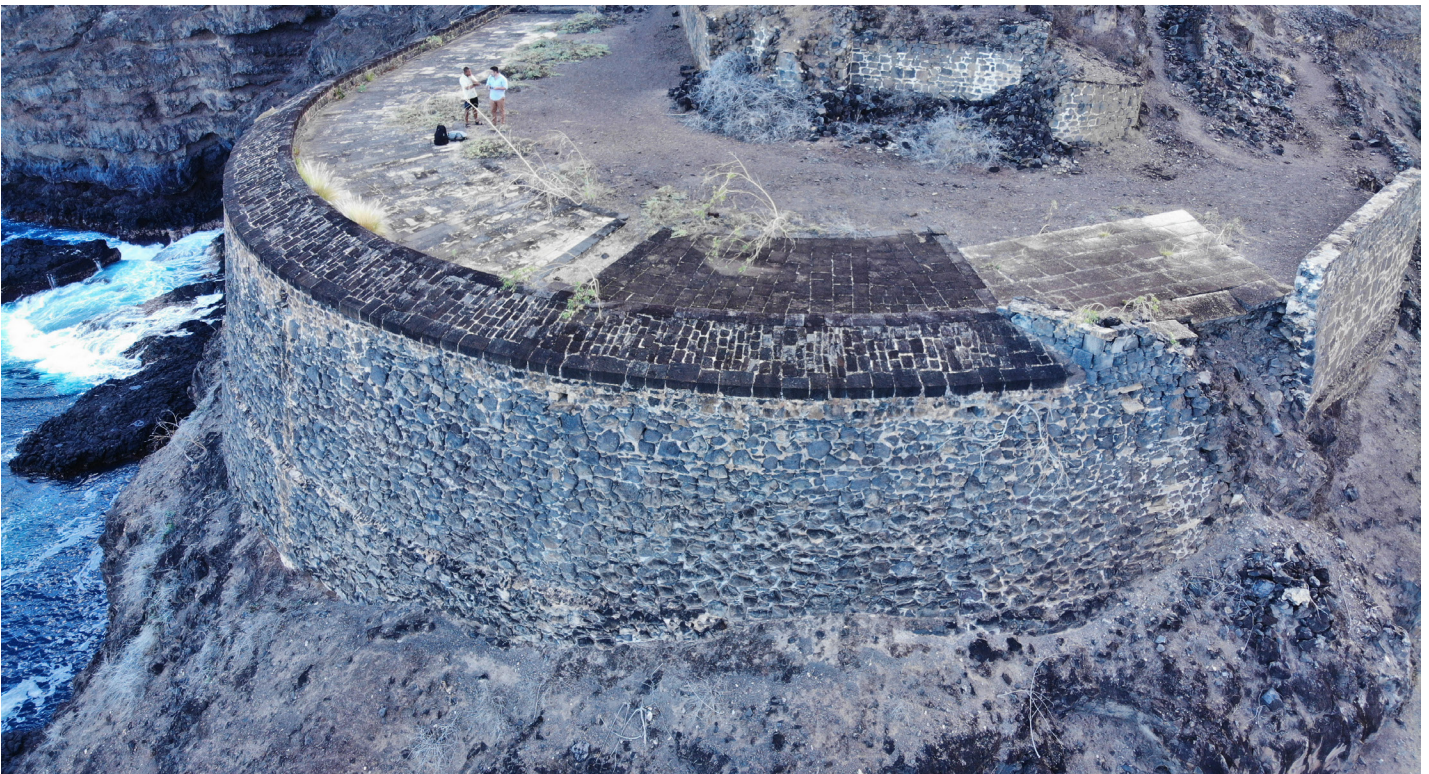
A large section of the southern battery wall has collapsed due to deferred maintenance and erosion. The section is eleven feet wide. It shows the cross section of the wall in the area to be five feet deep set directly into the hill side. The irregularly laid stones are local and are bonded together using a historic lime mortar. There does not appear to be later cementitious mortar repairs here.

Figure 40: Oblique aerial view of wall collapse at Upper Banks' Half Moon Battery (Image: B. Fortenberry).

Figure 41: Oblique aerial view of wall collapse at Upper Banks' Half Moon Battery (Image: B. Fortenberry).

Figure 42: Oblique aerial view of wall collapse at Upper Banks' Half Moon Battery (Image: B. Fortenberry).

Figure 43: Oblique aerial view of wall collapse at Upper Banks' Half Moon Battery (Image: B. Fortenberry).

1. The multiple wall curtain wall and arch failures at Upper Banks' Battery are the most pressing condition that needs to be addressed, and a structural engineer specializing in historic buildings should be consulted prior to any conservation work taking place. The engineer should examine the photographs, drone images, 3D models, and drawings to make preliminary determinations of the scope of rehabilitation and repair. An on-site visit is preferable for detailed inspection (The ruined buildings could best be conserved as ruins. As such, no roof structures would need to be constructed).

4. Immediate action should be taken to segregate this area from the public areas of the site. There are no barriers, permitting individuals potential access to hazardous areas in and around the collapse of the Half Moon Battery wall. The area needs to be marked using health and safety guidelines.

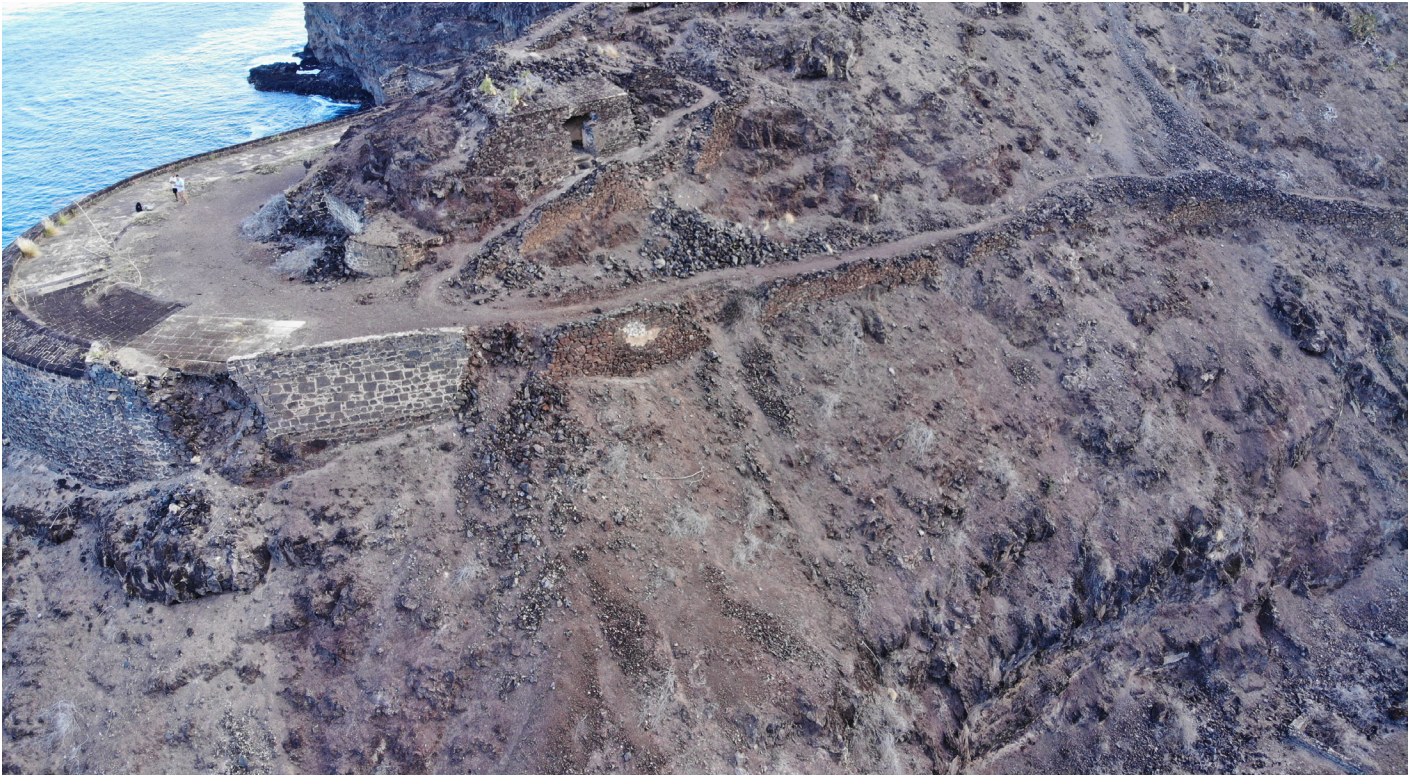
Figure 48: Oblique aerial view of wall collapses on the south side of Upper Banks' Battery (Image: B. Fortenberry).

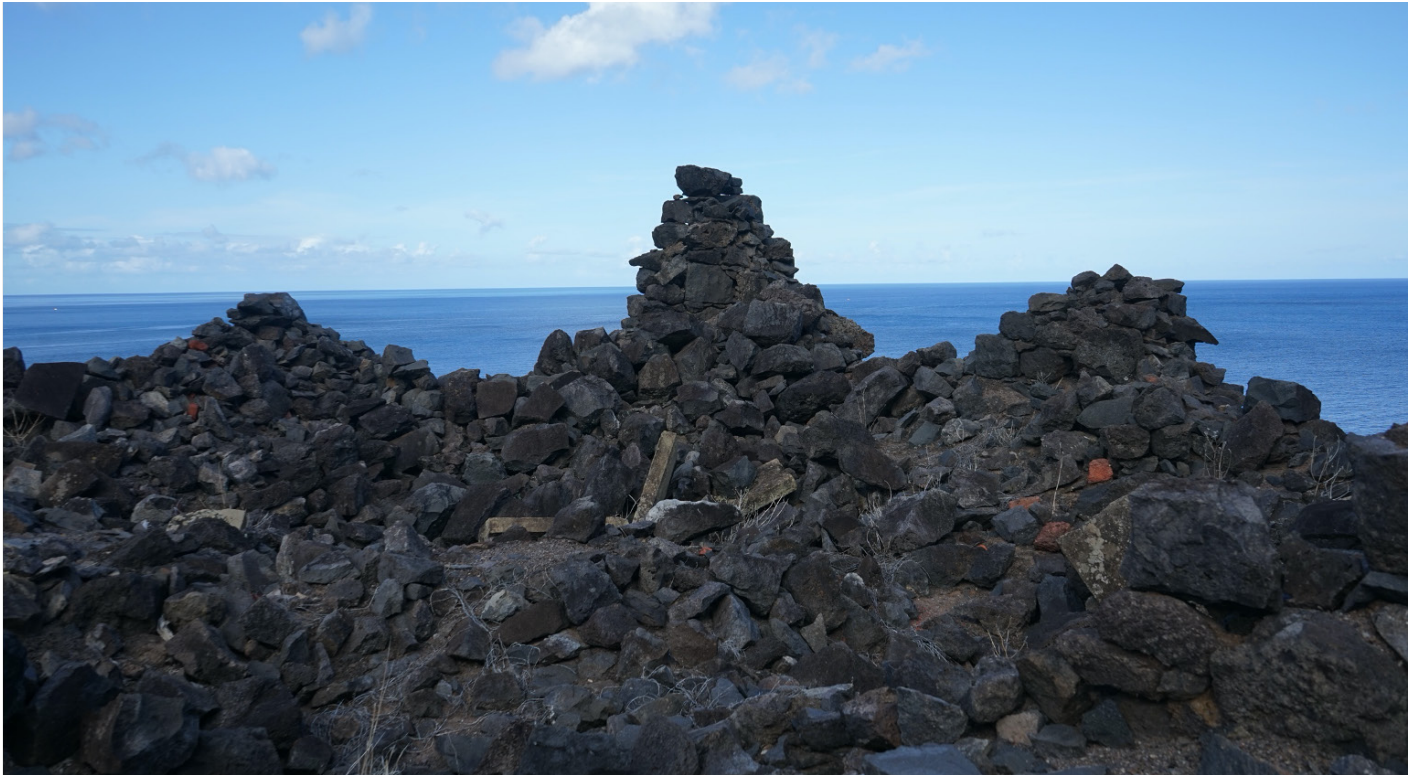
The ruined buildings are in various states of decay, however they all are constructed of worked local stone bonded by lime-based mortars. In some cases, repairs have been made with cementitious mortars. Of note is that some interior plaster survives at the officers' barracks.

Figure 52: Detail view of ruined Officer's Barrack's at Upper Banks' Battery (Image: B. Fortenberry).

2. Concurrent with the engineer's inspection, all surviving wall fragments of the ruined structures should be recorded and documented in situ, and recovered from being used a part of the reconstruction of the walls.

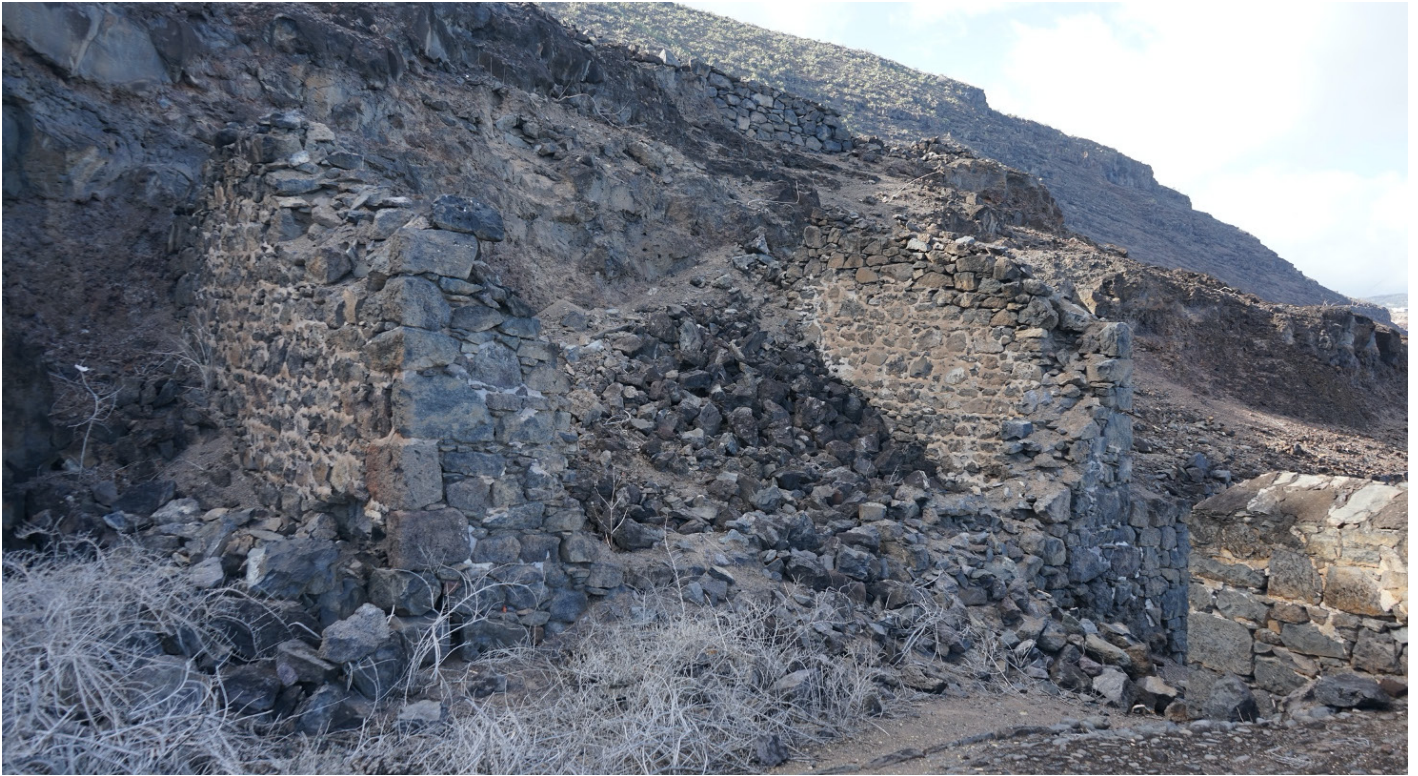
Figure 54: Collapsed support structure on the north edge of Half Moon Battery at Upper Banks' (Image: B. Fortenberry).
