Documentation and Conditions Assessment of Banks' Battery, St. Helena (CHC-2020-01-03)

**Report prepared for the British Napoleonic Bicentenary
Trust and St. Helena Government**

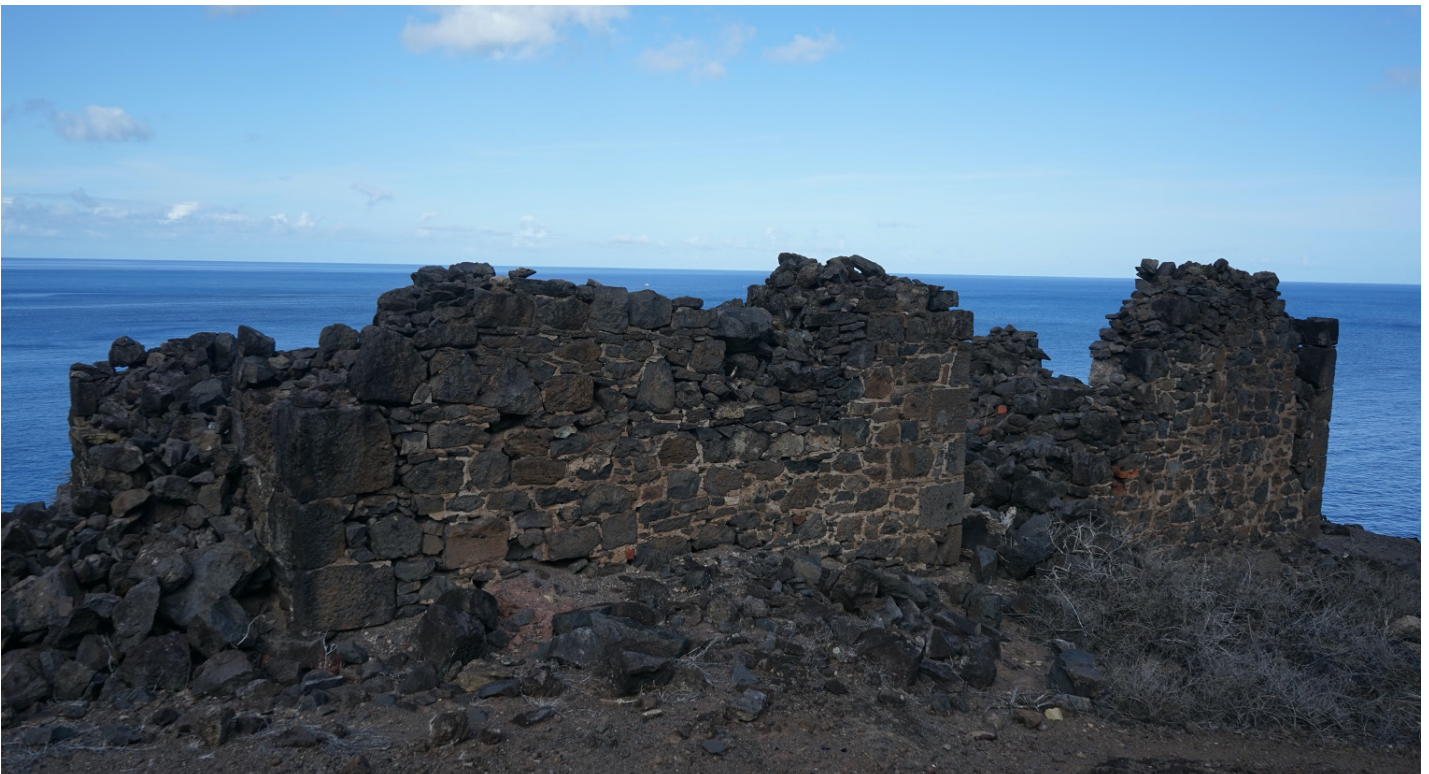
The ruined buildings are in various states of decay, however they all are constructed of worked local stone bonded by lime-based mortars. In some cases, repairs have been made with cementitious mortars. Of note is that some interior plaster survives at the officers' barracks.

Figure 55: Detail view of ruined Officer's Barrack's at Upper Banks' Battery (Image: B. Fortenberry).

2. Concurrent with the engineer's inspection, all surviving wall fragments of the ruined structures should be recorded and documented in situ, and recovered from being used a part of the reconstruction of the walls.

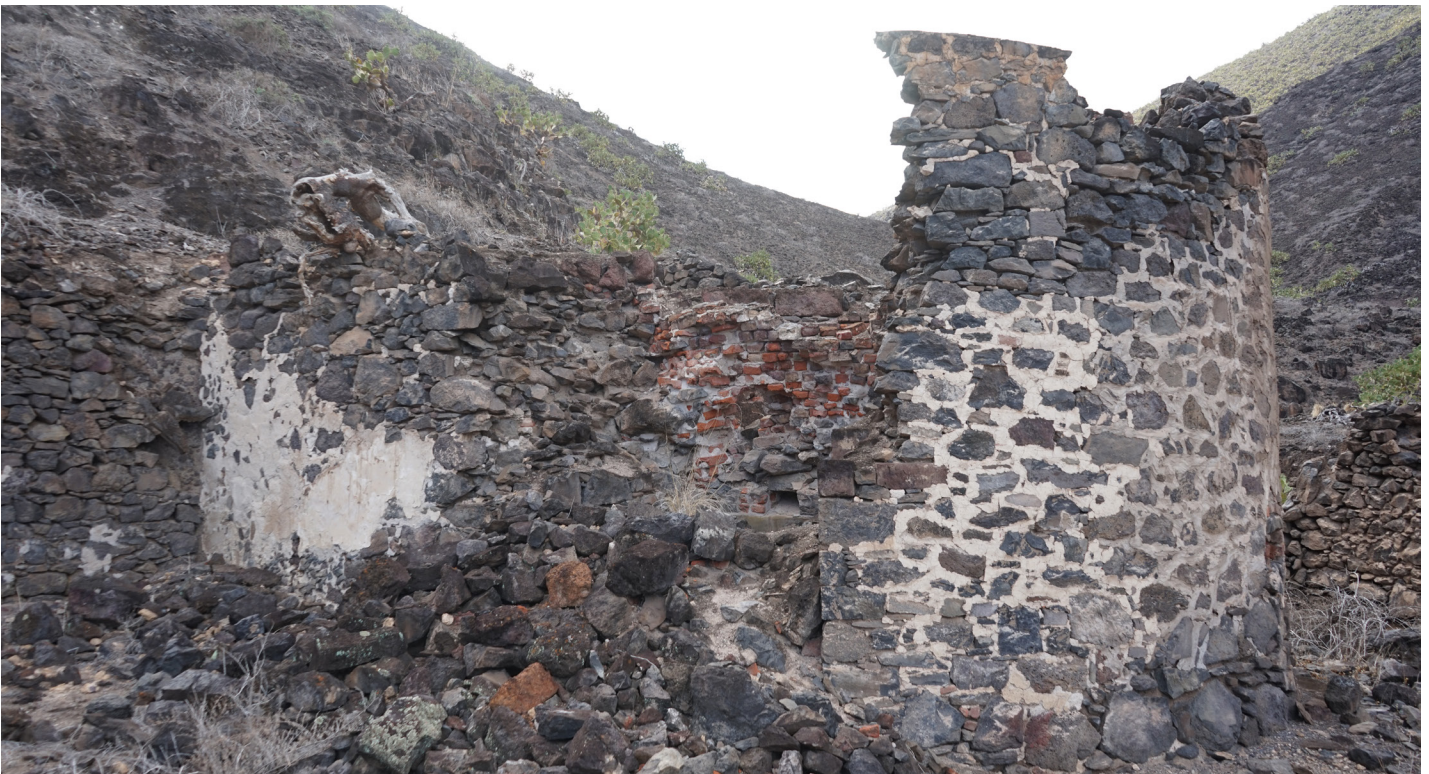
Figure 62: Ruined west wall of Lower Banks' Lime Kiln. (Image: B. Fortenberry).

1. The collapse of the lime kiln outer walls should be addressed as a part of the site's conservation, and a structural engineer specializing in historic buildings should be consulted prior to any conservation work taking place. The engineer should examine the photographs, drone images, 3D models, and drawings to make preliminary determinations of the scope of rehabilitation and repair. An on-site visit is preferable for detailed inspection.
