# Documentation and Conditions Assessment of Munden's Battery Hill, St. Helena (CHC-2020-01-02)

Report prepared for the British Napoleonic Bicentenary  
Trust and St. Helena Government

Brent R. Fortenberry, Associate Director, Center for Heritage Conservation  
Jane Ashburn, Architectural Conservator

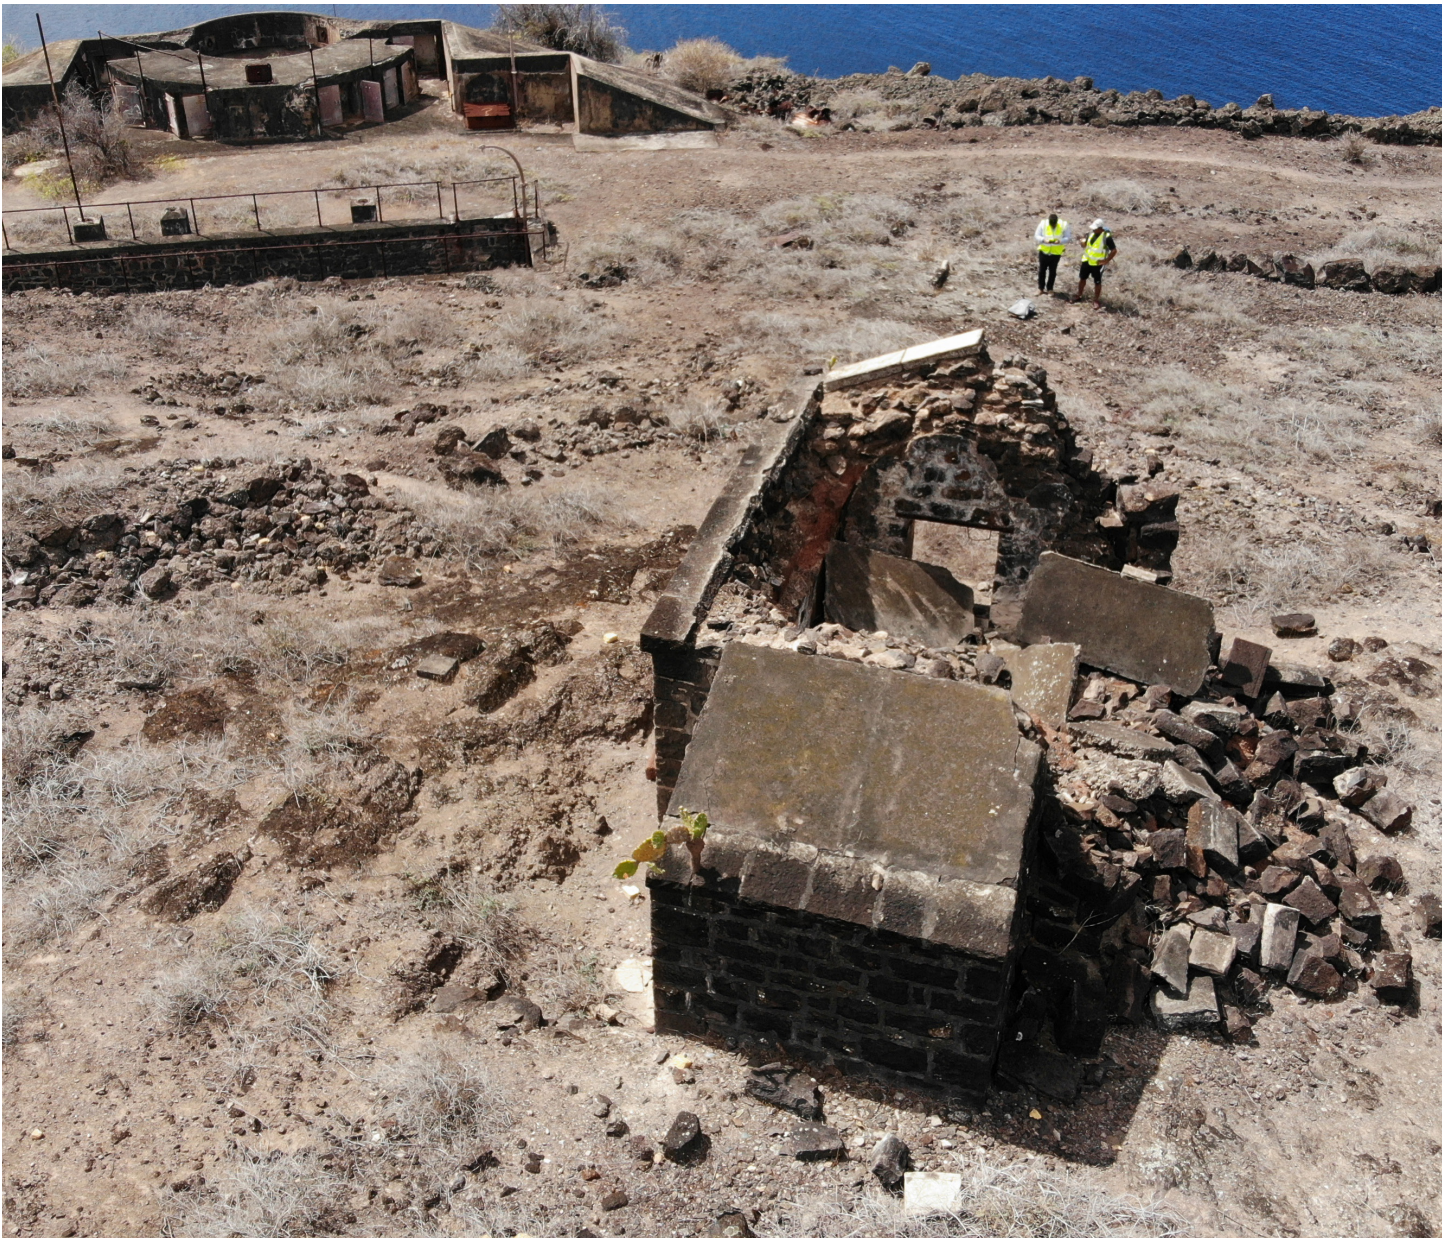
Figure 11: Oblique aerial view of ruined structure at West Munden's Hill (Image: B. Fortenberry).

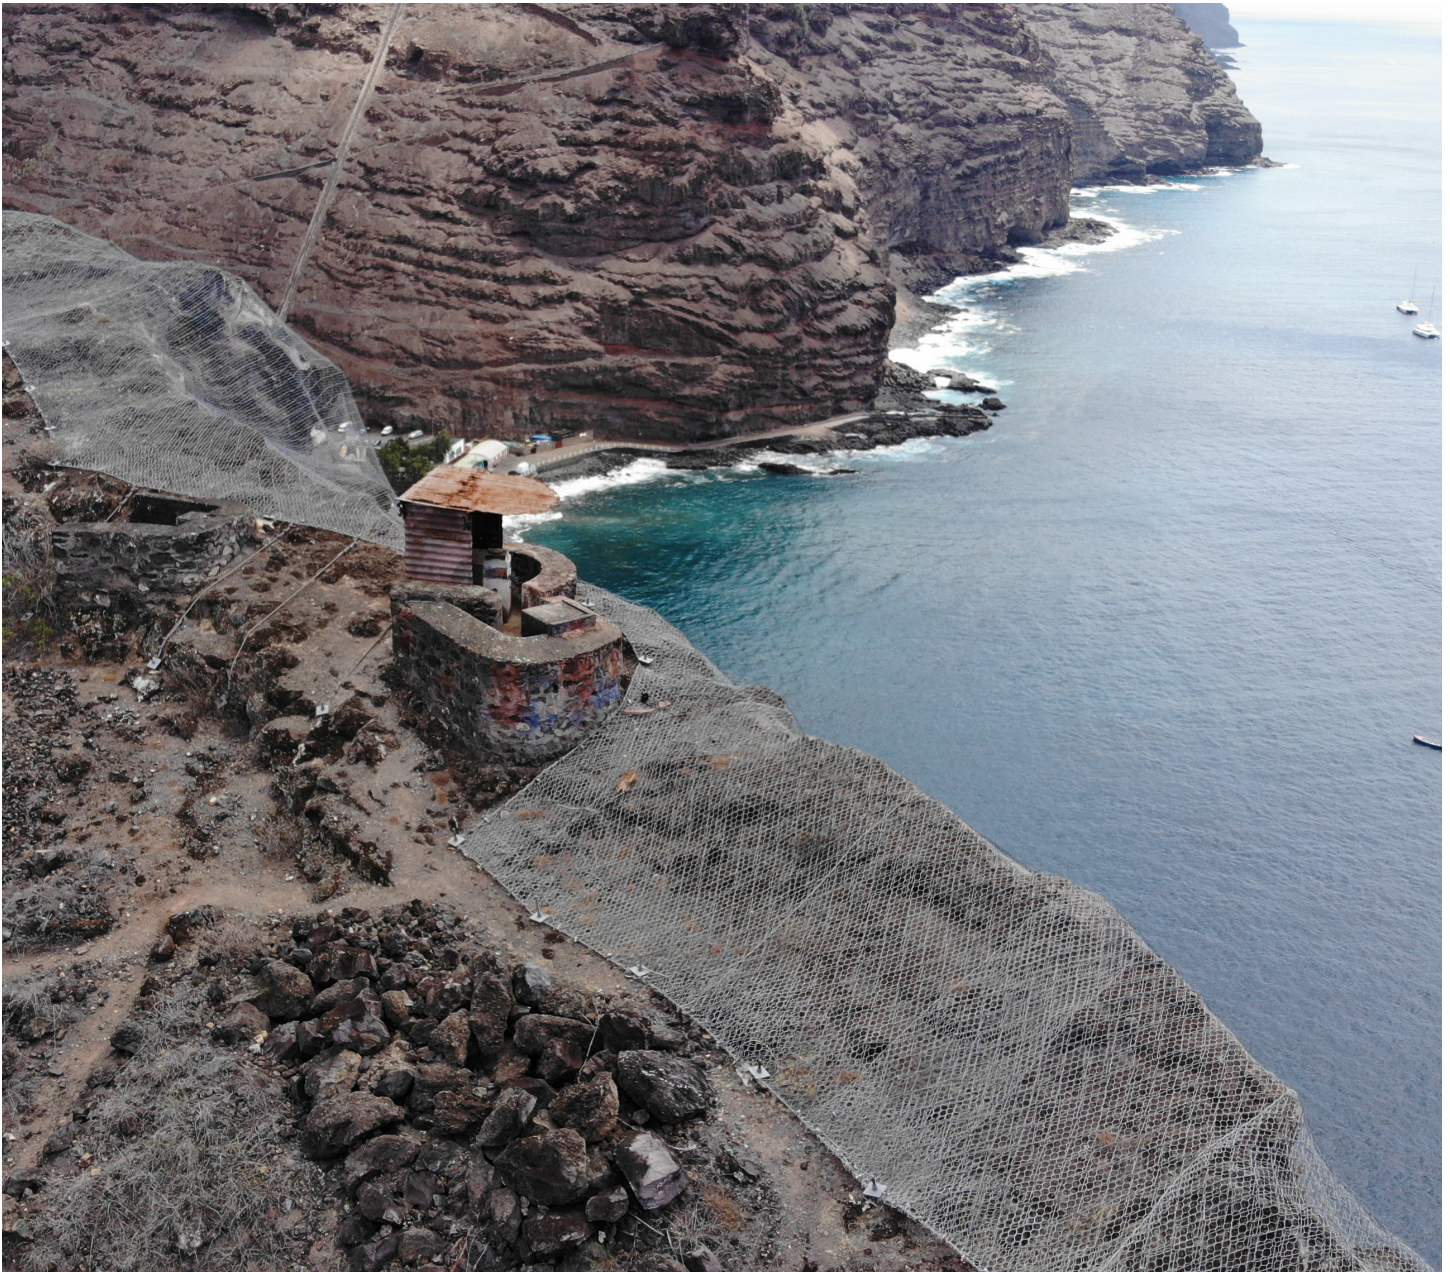
The primary condition observed was graffiti present on the firing position. A slight failure of stone the stone wall was also present on the west side.

Figure 12: Oblique aerial view of surviving fabric at East Munden's Hill (Image: B. Fortenberry).

1. Monitor the state of the surviving walls and consult an architectural conservator and preservation engineer to stabilize and rehabilitate any failures.
2. Removing the graffiti might be too invasive given the slight nature of the surviving Napoleonic remains. Unless further vandalism takes place it is best to not attempt to remove the existing paint.

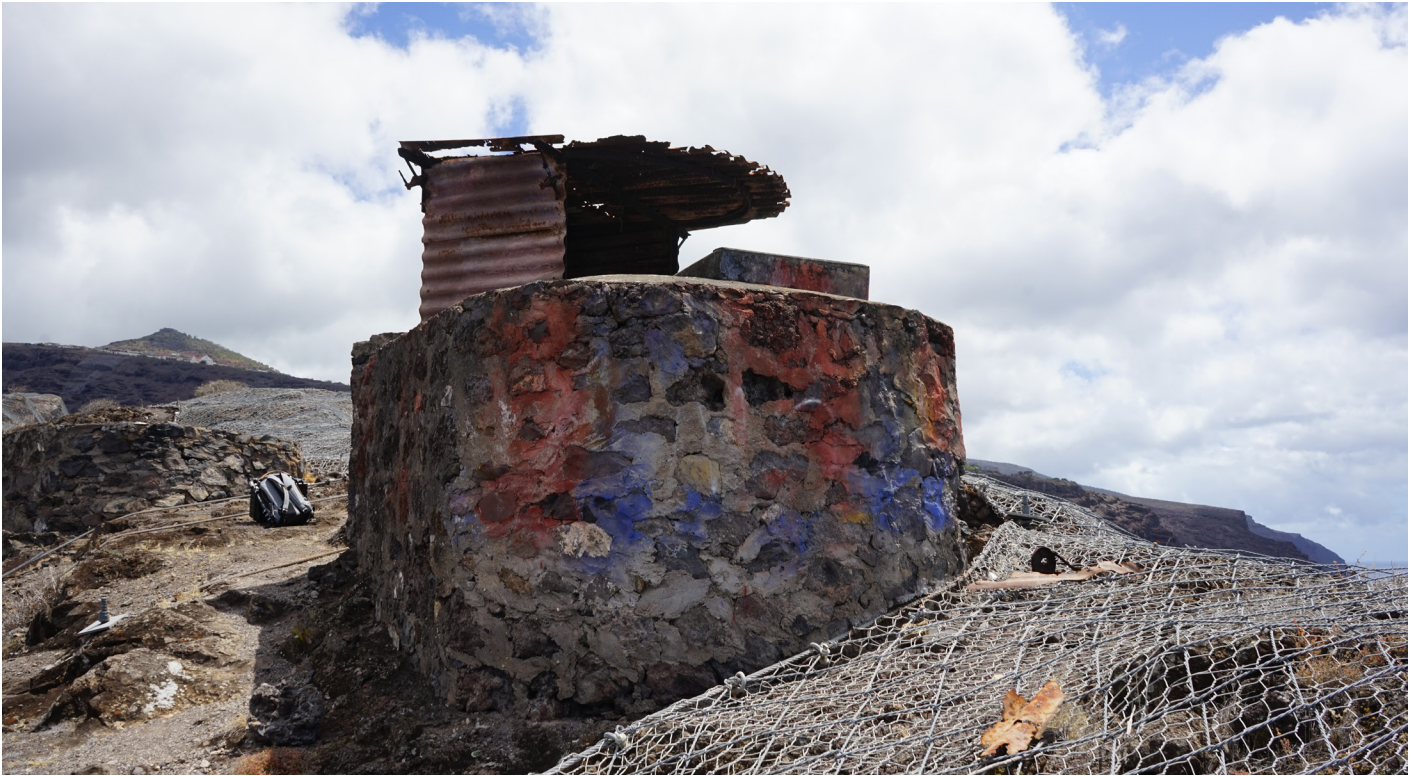
Figure 13: Detail of surviving fabric at East Munden's Hill (Image: B. Fortenberry).

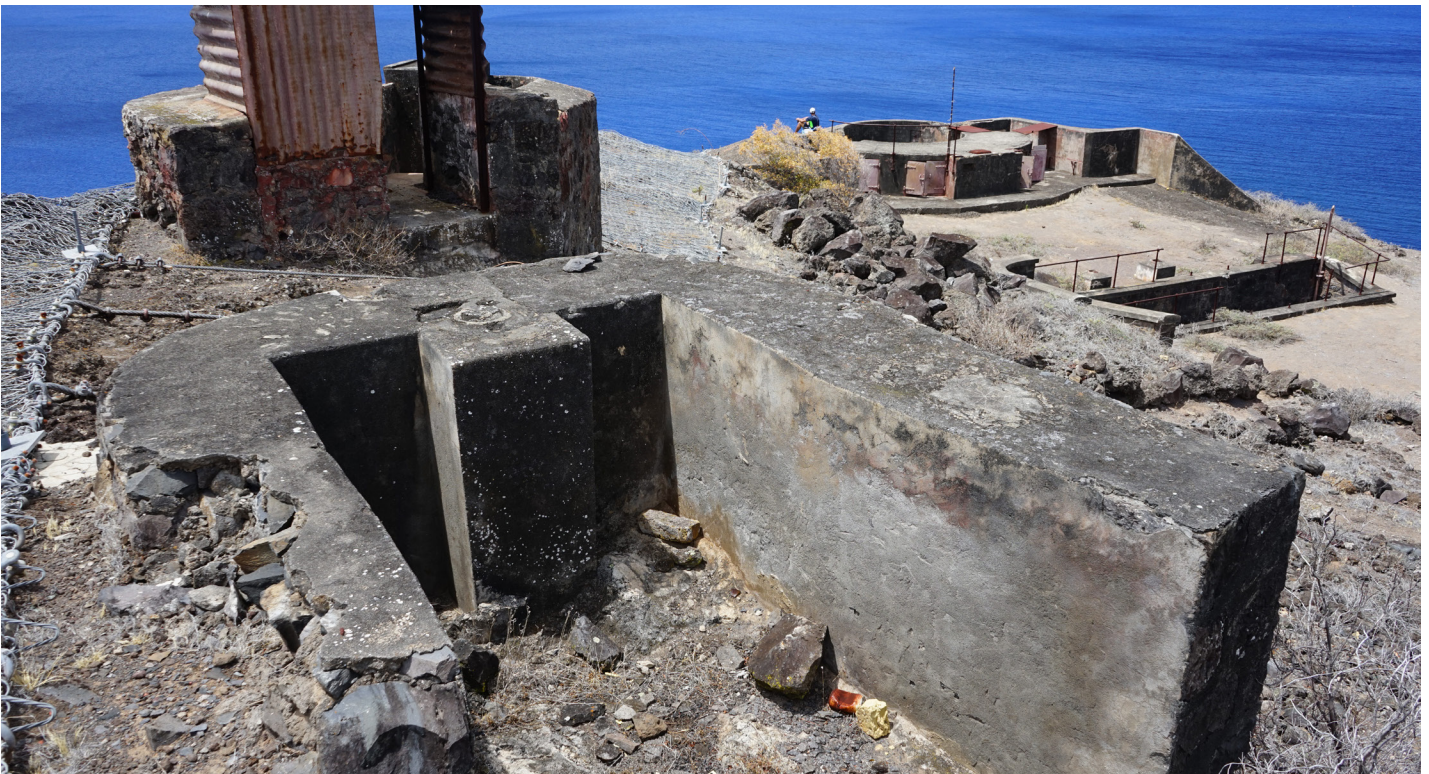
Figure 14: Detail view of surviving fabric at East Munden's Hill (Image: B. Fortenberry).

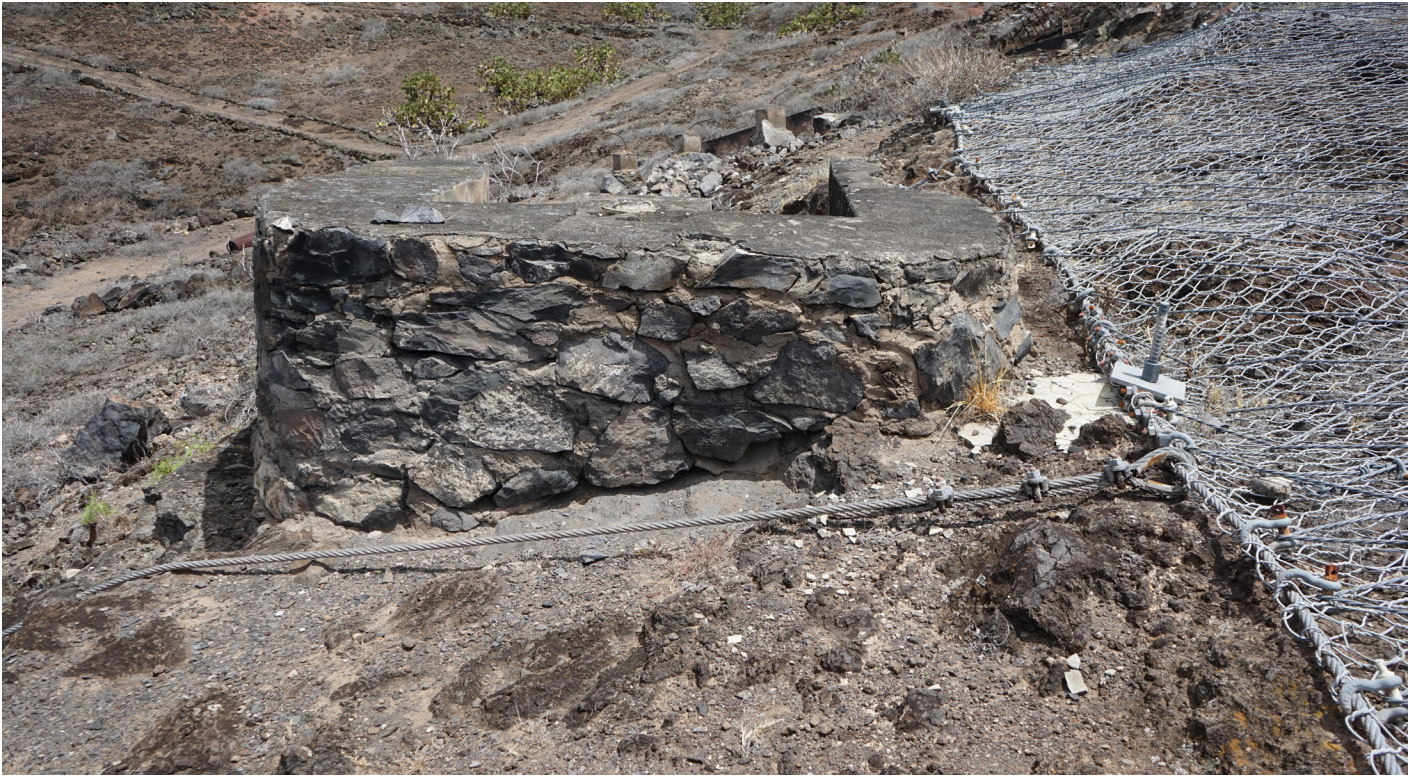
Figure 15: Surviving firing position at East Munden's Hill (Model: B. Fortenberry).

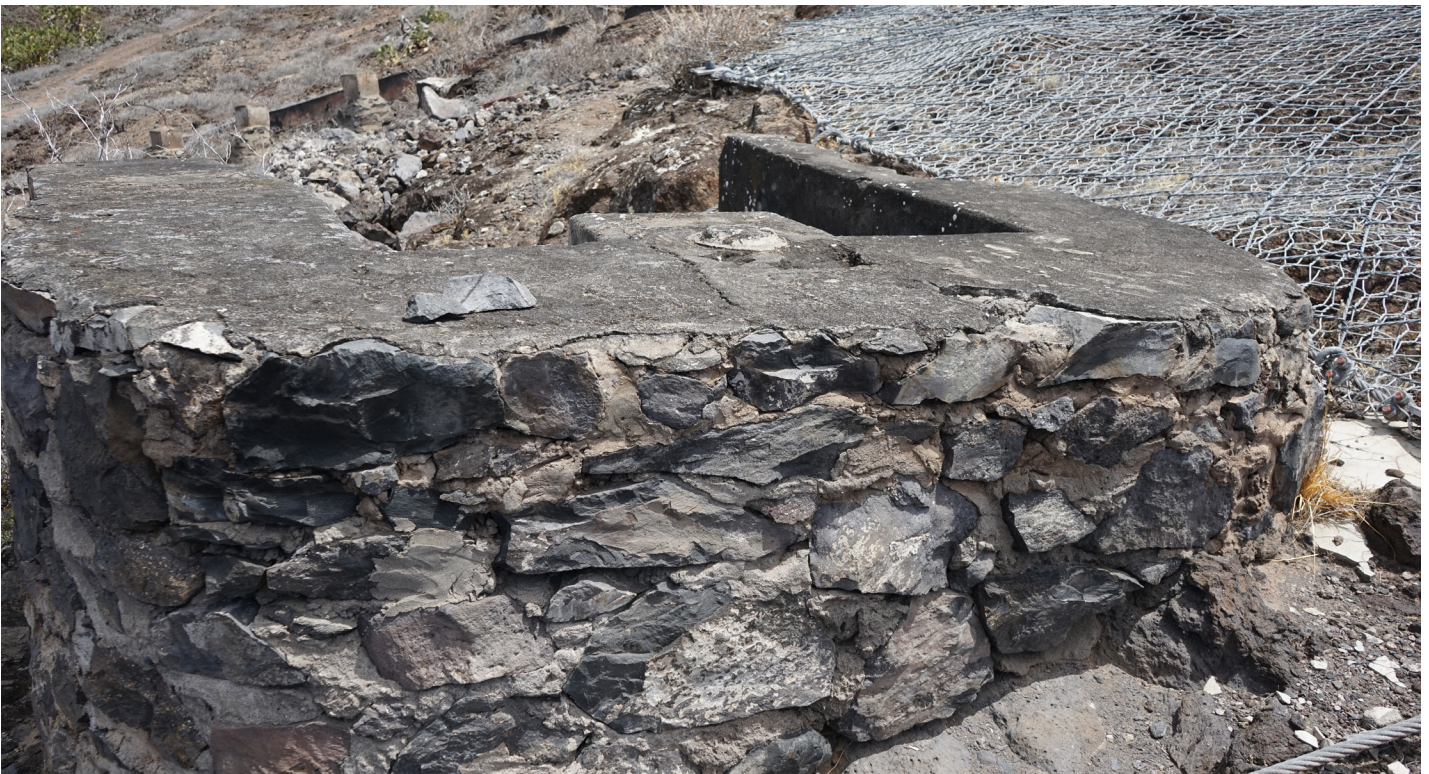
Figure 16: Detail view of surviving firing position at East Munden's Hill (Image: B. Fortenberry).

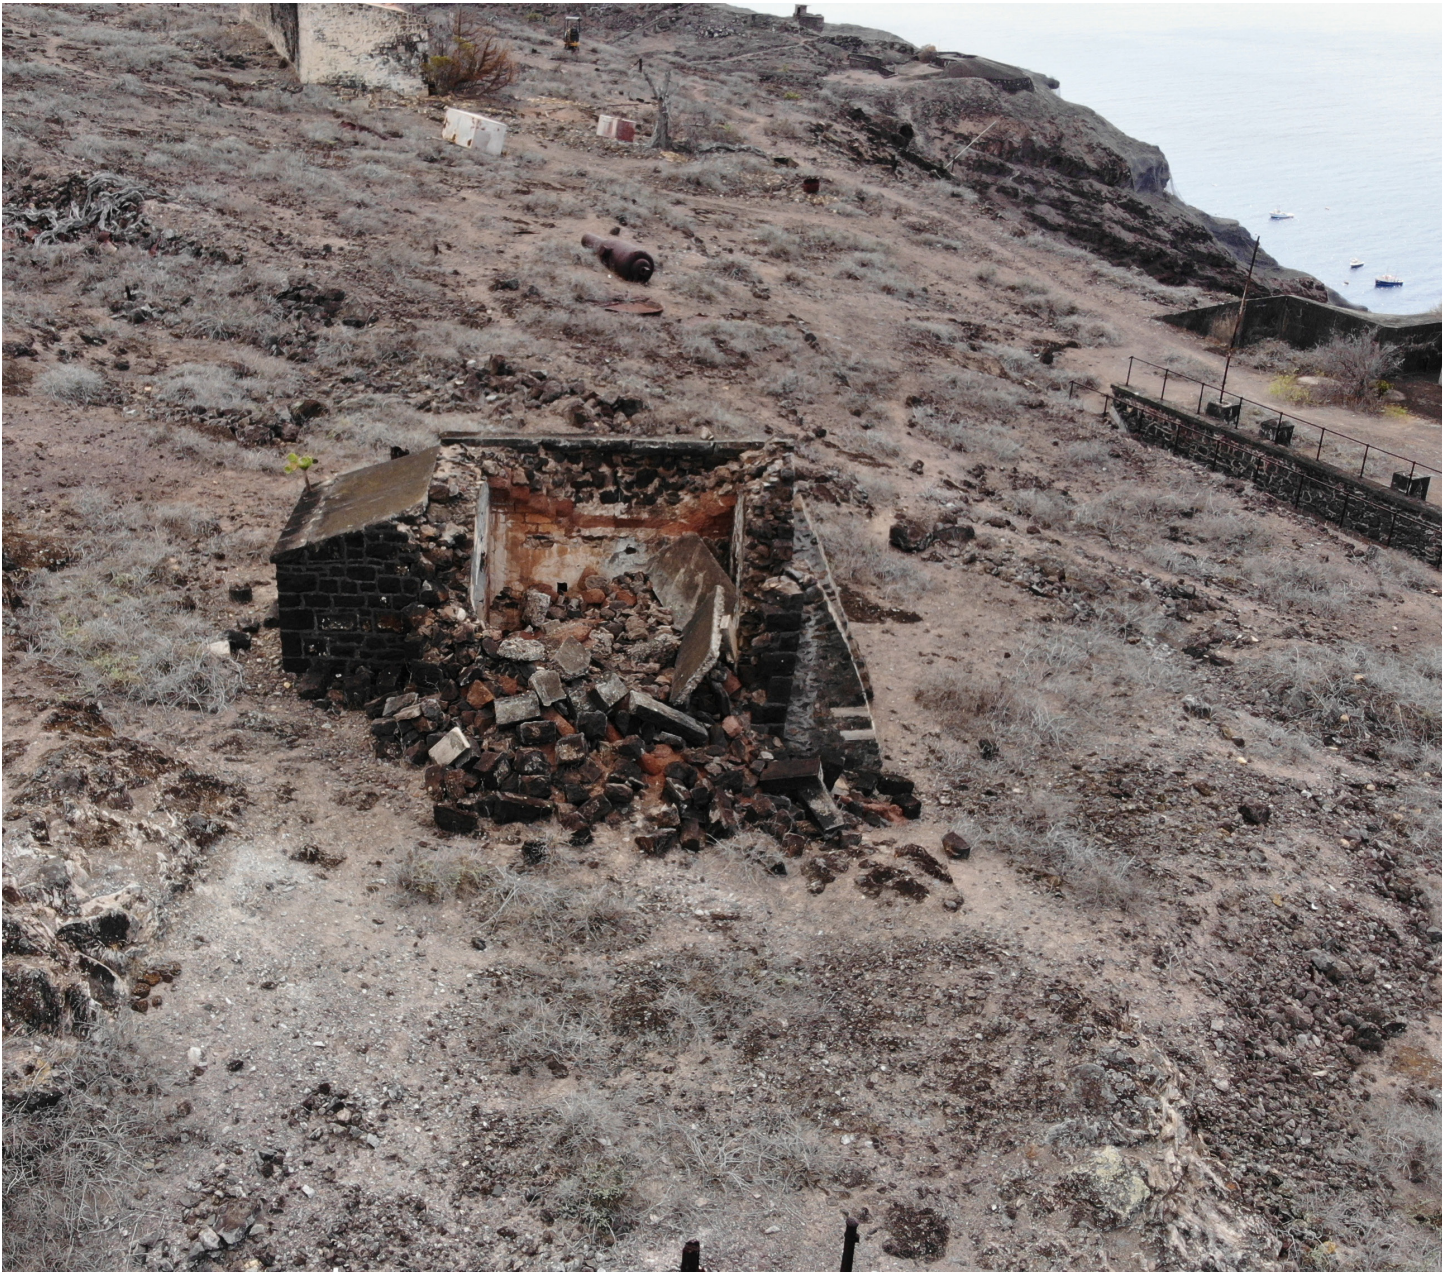
On the north side of Munden's Hill a small mid-19th-century building stands partially collapsed. The structure is rectangular in form and a single story. It has character-defining buttresses on the east and west walls with a slight shed addition on the east. The building is roughly fifteen feet east to west and ten feet north to south. The walls comprise stones of various colors with a lime mortar present. The structure is earlier than the barracks building to the south which in construction appears to be late 19th and potentially early 20th century.

While much of the surviving lime mortar is still in place, however there are section of standing walls with inappropriate cementitious mortars.

Figure 19: Oblique aerial view of ruined structure at West Munden's Hill looking southwest (Image: B. Fortenberry).

1. The wall collapse is the most pressing condition that needs to be addressed at North Munden's Hill and a structural engineer specializing in historic buildings should be consulted prior to any conservation work taking place. The engineer should examine the photographs, drone images, 3D models, and drawings to make preliminary determinations of the scope of rehabilitation and repair. An on-site visit is preferable for detailed inspection.

2. Concurrent with the engineer's inspection, all surviving wall fragments from the collapse should be recorded and documented in situ, and recovered from being used a part of the reconstruction of the wall.

3. Identify and test in-context, identified historic mortars. Samples should be taken from the south and north exterior walls and tested through aggregate analysis and acid digestion to identify appropriate historic composition. This should be done by an architectural conservator.

4. Do not remove inappropriate mortars without oversight from an architectural conservator. Monitor these areas for mortar failure and repair with historically appropriate mortar composition derived from mortar analysis (Recommendation 1). Mortar replacement should be completed in consultation with an architectural conservator.

5. Immediate action should be taken to segregate this area from the public areas of the site. At present, there is no barrier, permitting individuals potential access to hazardous areas in and around the collapse. The area needs to be marked using health and safety guidelines.

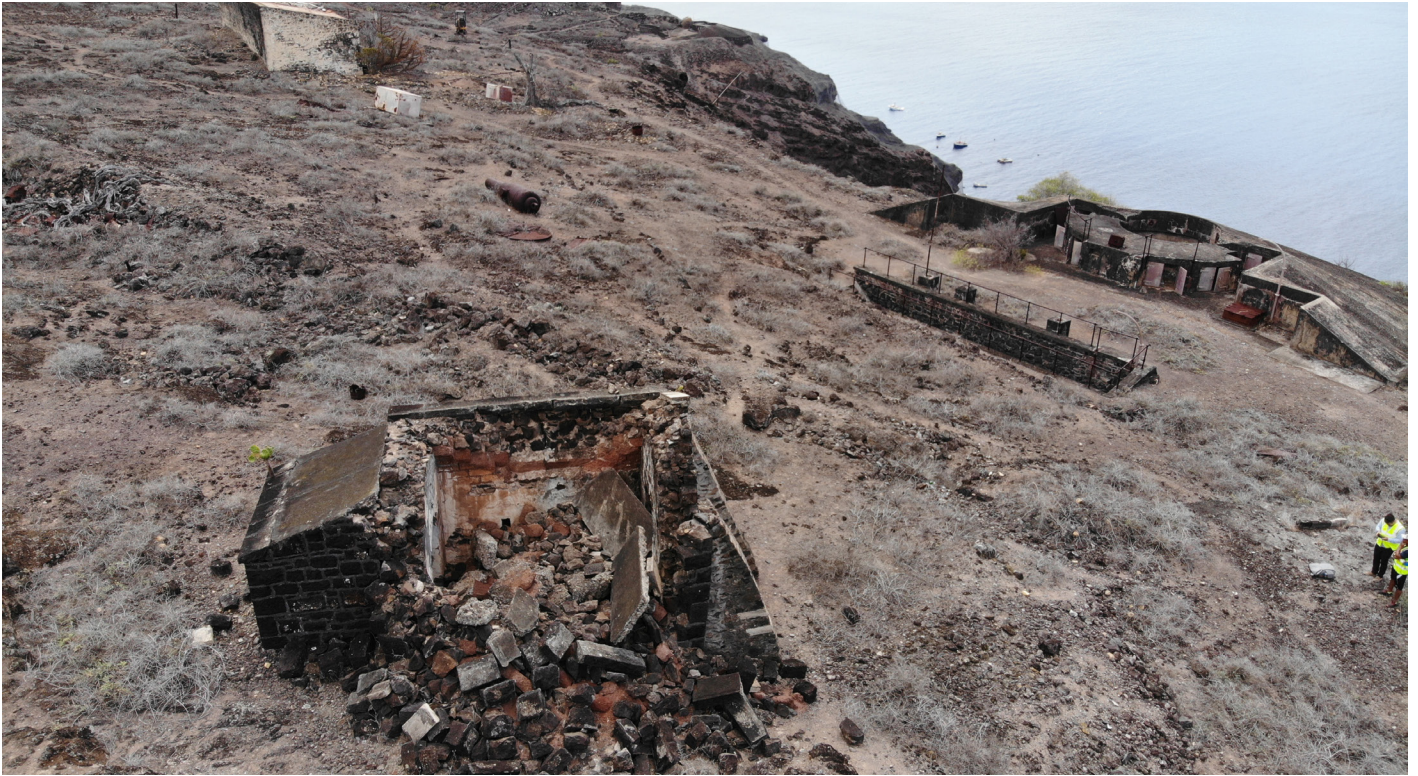
Figure 20: Oblique aerial view of ruined structure at West Munden's Hill looking south (Model: B. Fortenberry).

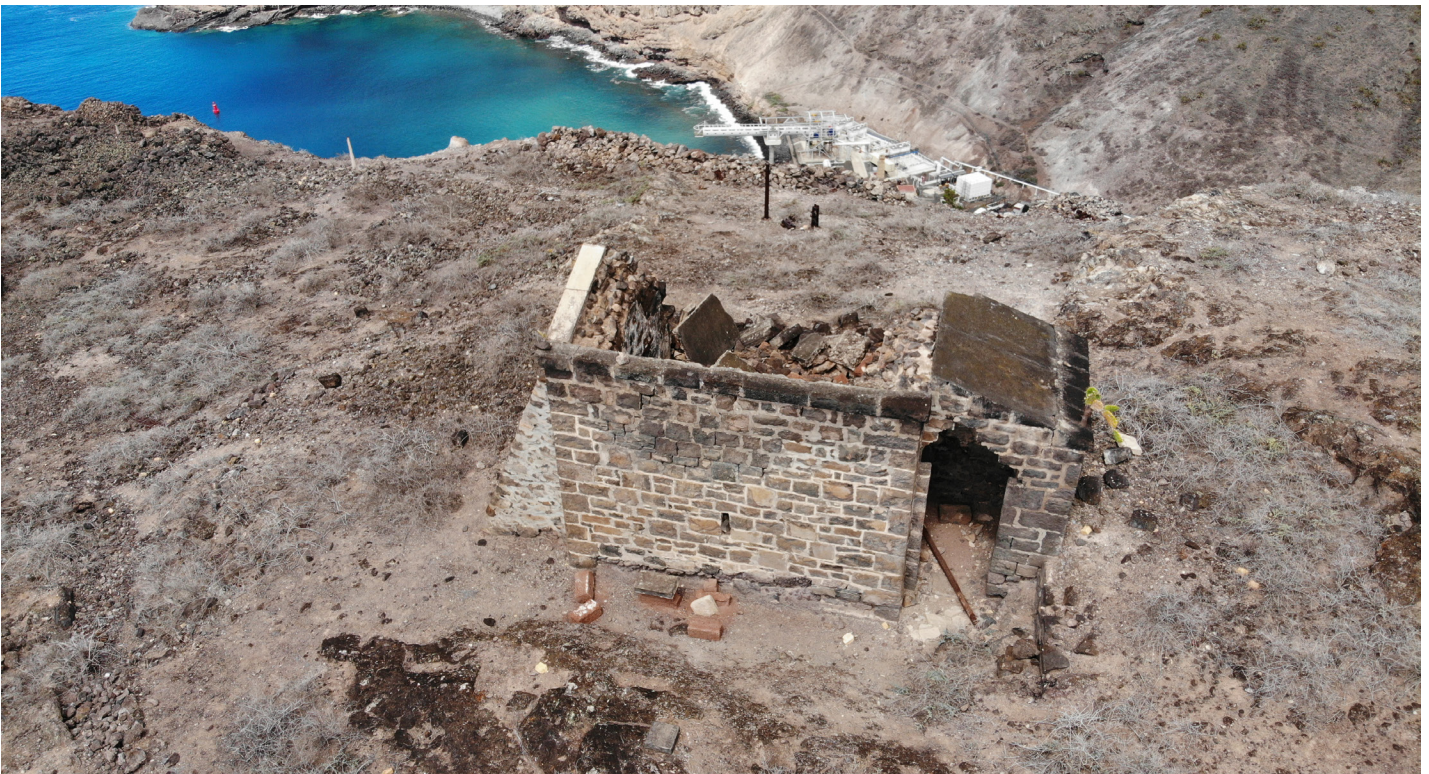
Figure 21: Oblique aerial view of ruined structure at West Munden's Hill looking north (Image: B. Fortenberry).

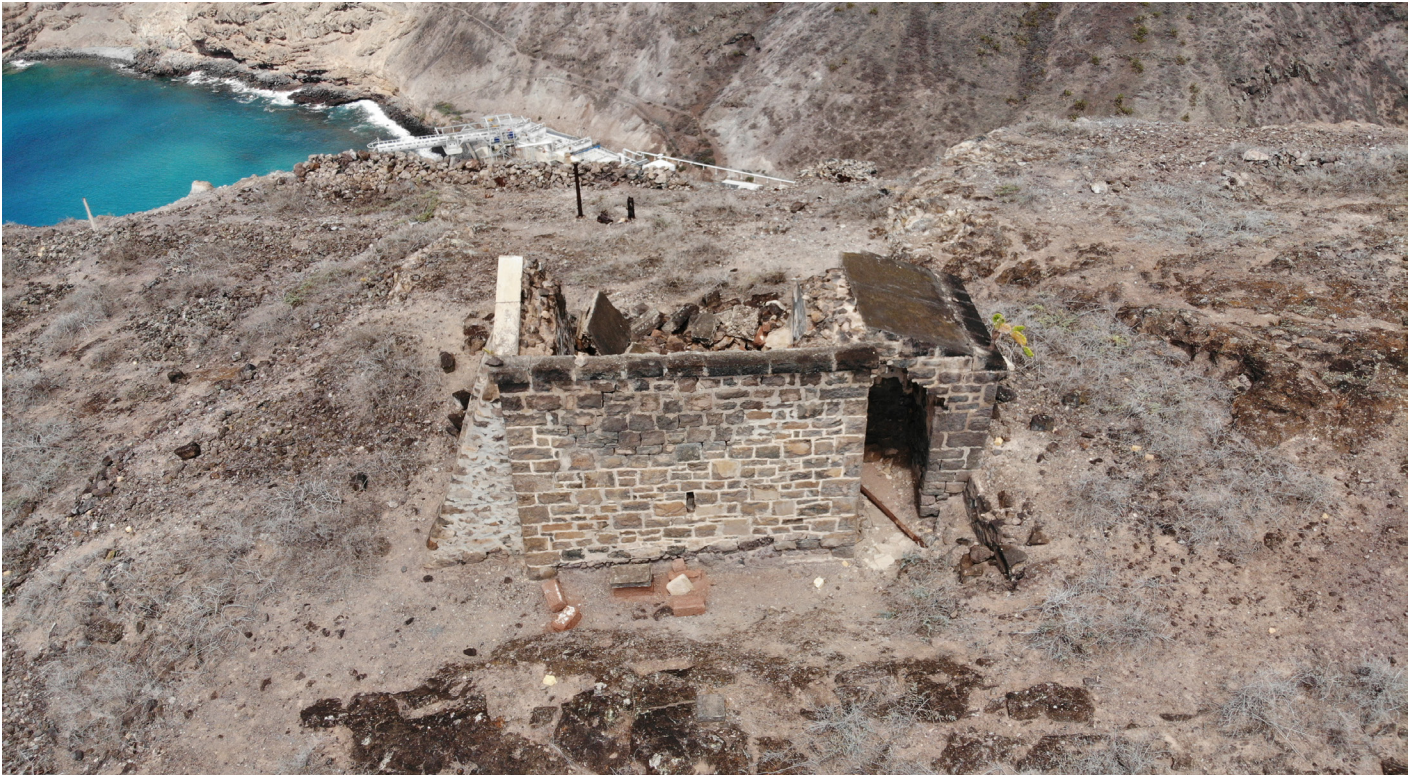
Figure 22: Oblique aerial view of ruined structure at West Munden's Hill looking northwest (Image: B. Fortenberry).

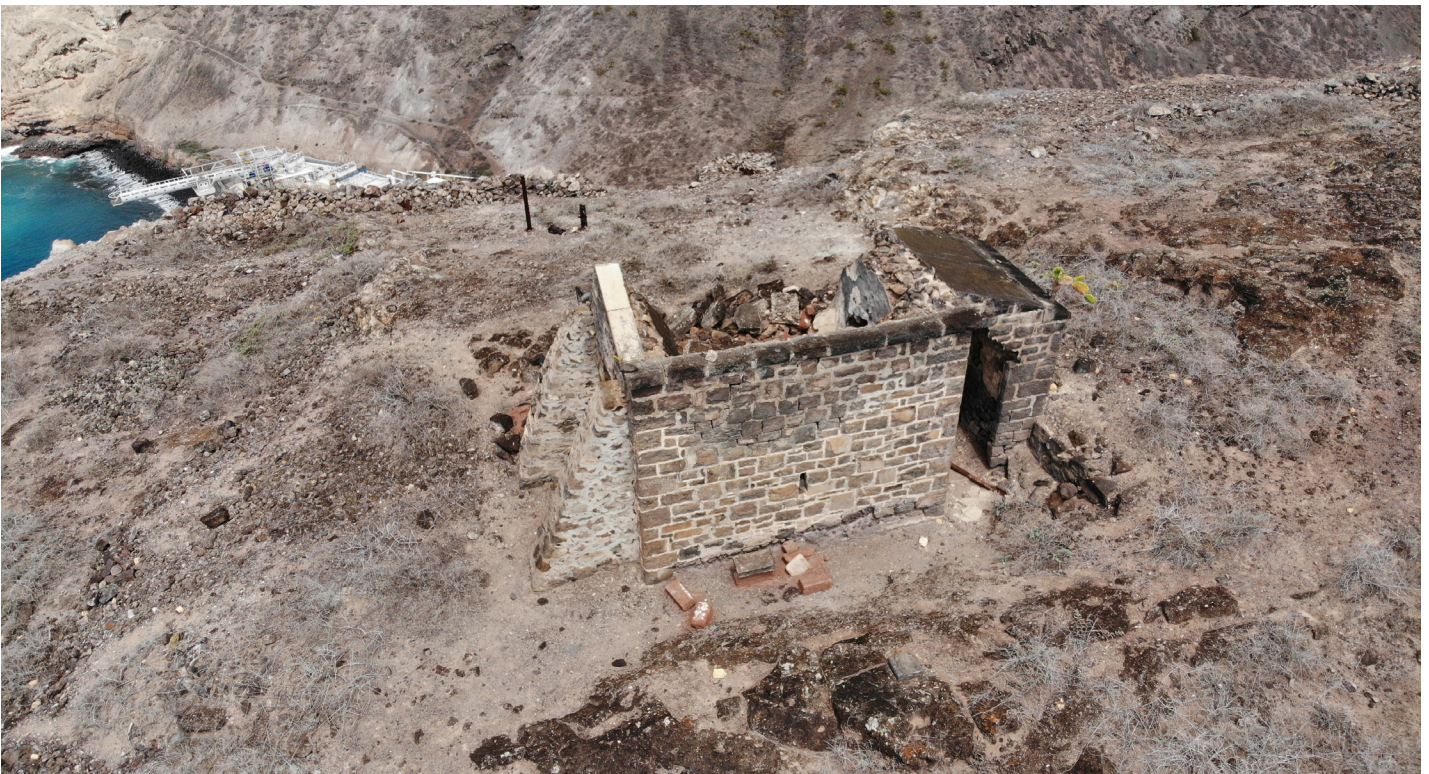
Figure 23: Oblique aerial view of ruined structure at West Munden's Hill looking northwest (Image: B. Fortenberry).

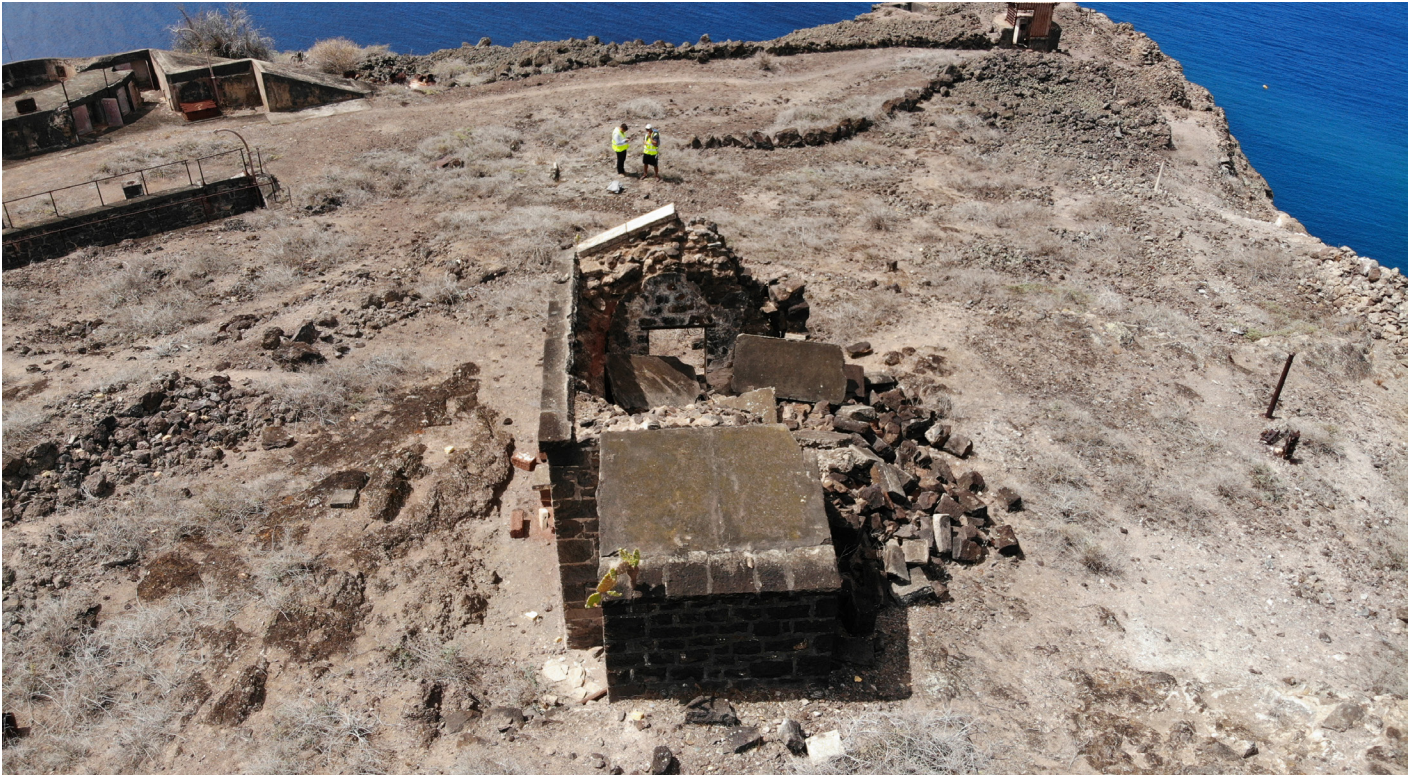
Figure 24: Oblique aerial view of ruined structure at West Munden's Hill looking west (Model: B. Fortenberry).

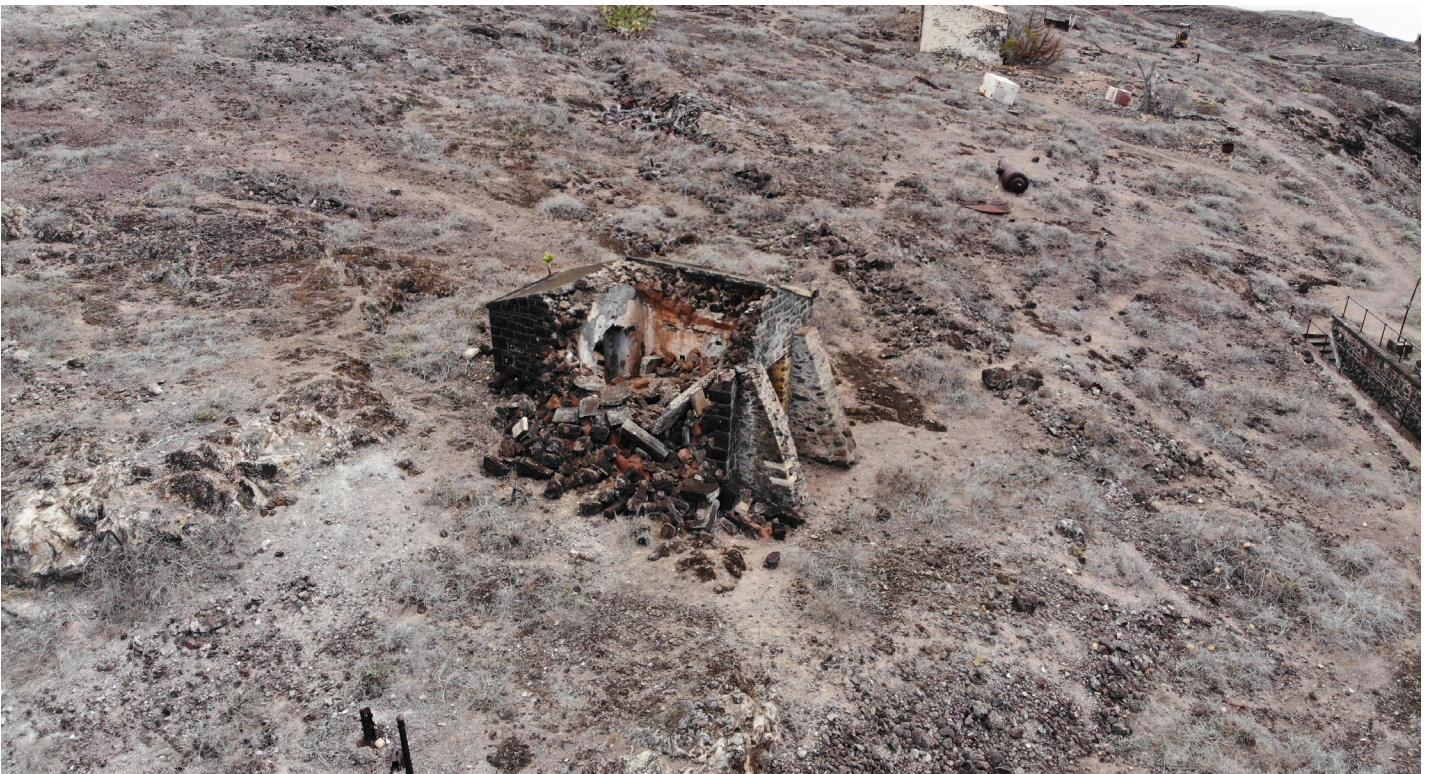
Figure 25: Oblique aerial view of ruined structure at West Munden's Hill looking south (Image: B. Fortenberry).

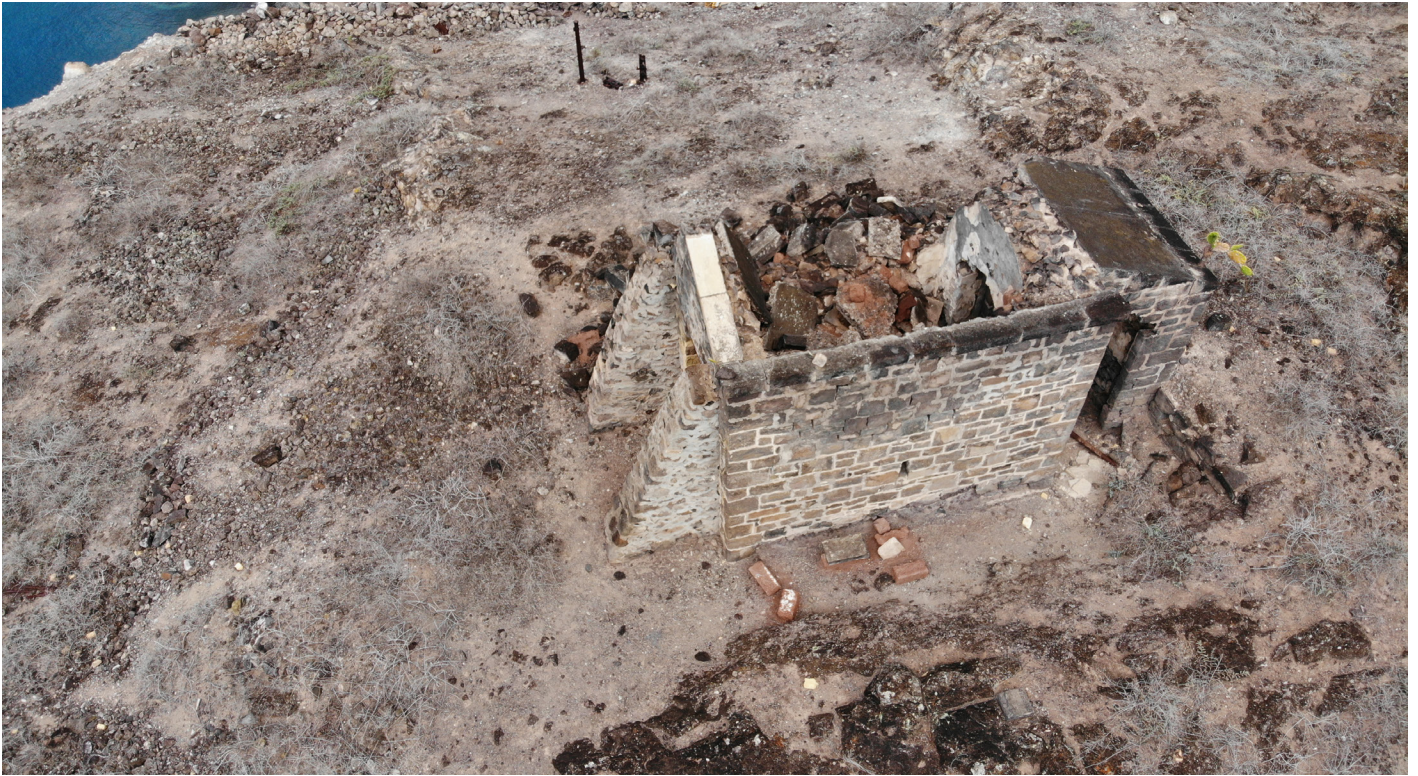
Figure 26: Oblique aerial view of ruined structure at West Munden's Hill looking west (Model: B. Fortenberry).

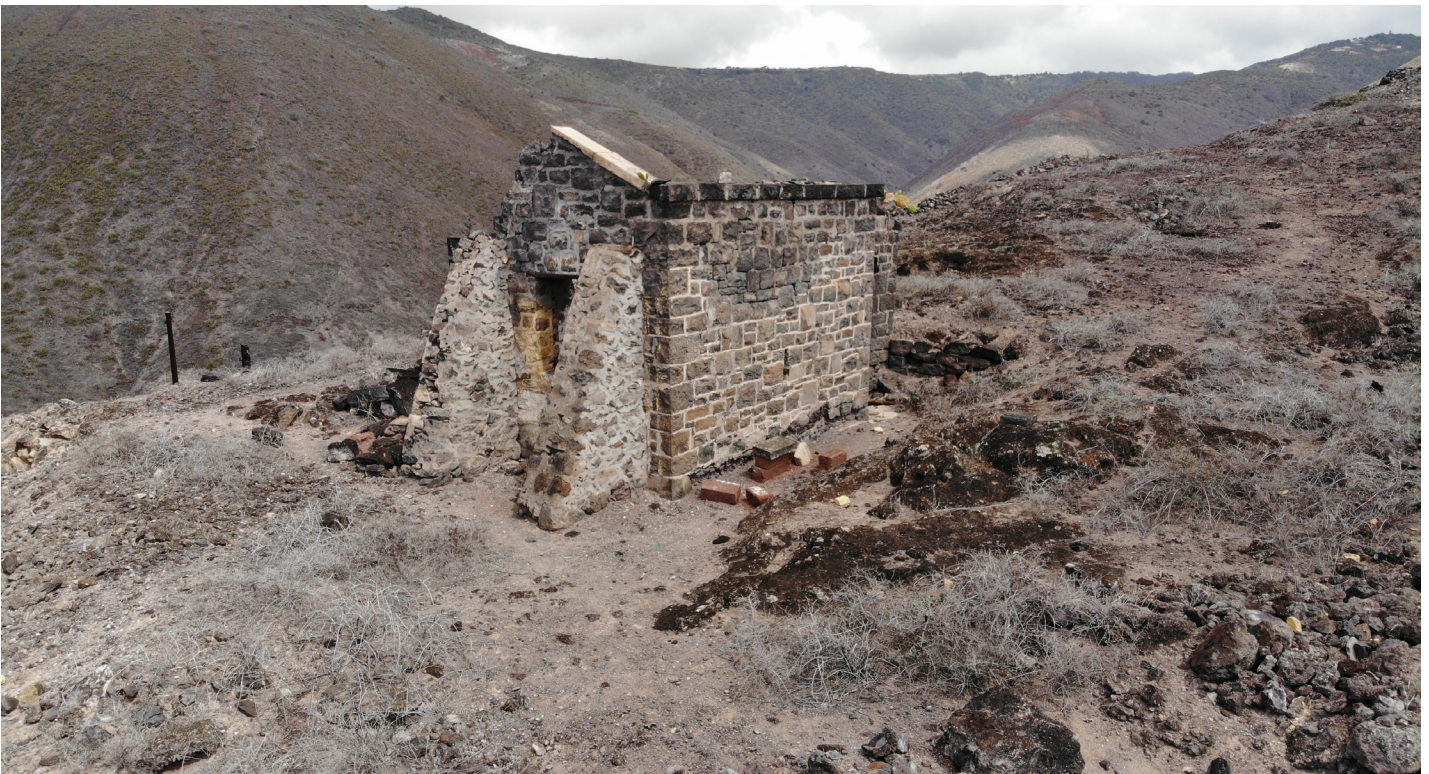
Figure 27: Oblique aerial view of ruined structure at West Munden's Hill looking east (Image: B. Fortenberry).

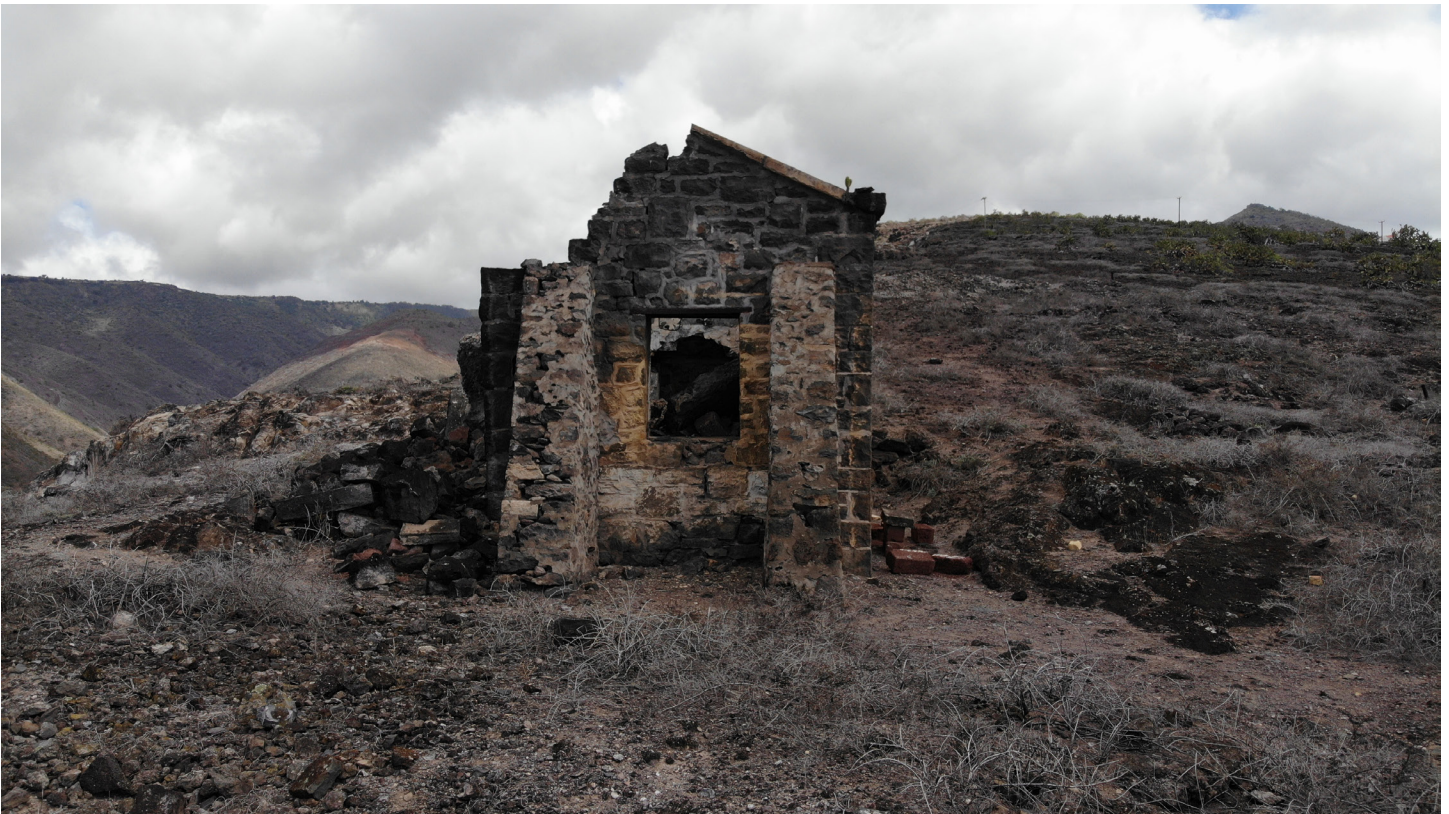
Figure 28: Ground image looking east towards ruined structure at Munden's Hill West looking east (Image: B. Fortenberry).

1. **IMMEDIATE:** Isolate the collapsed building on North Munden's Hill from the general public and erect health and safety signage.
2. **SHORT TERM:** Consult an architectural engineer for wall rehabilitation of the structural collapse on the North side of the Munden's Hill.
3. **MEDIUM TERM:** The lower areas of the Munden's complex (including Chubb's Hill) should be documented and assessed as a part of the heritage trail and general heritage conservation. These areas are accessible and would be relatively easily reached by heritage tourists.
