21st Annual International Symposium
October 23-25, 2018 | College Station, Texas

Fire Incidents at Ethylene Oxide Reactors in Ethylene Glycol Plant

Kevin S. H. Hsueh

Assistant Vice President, Nan Ya Plastics Corporation

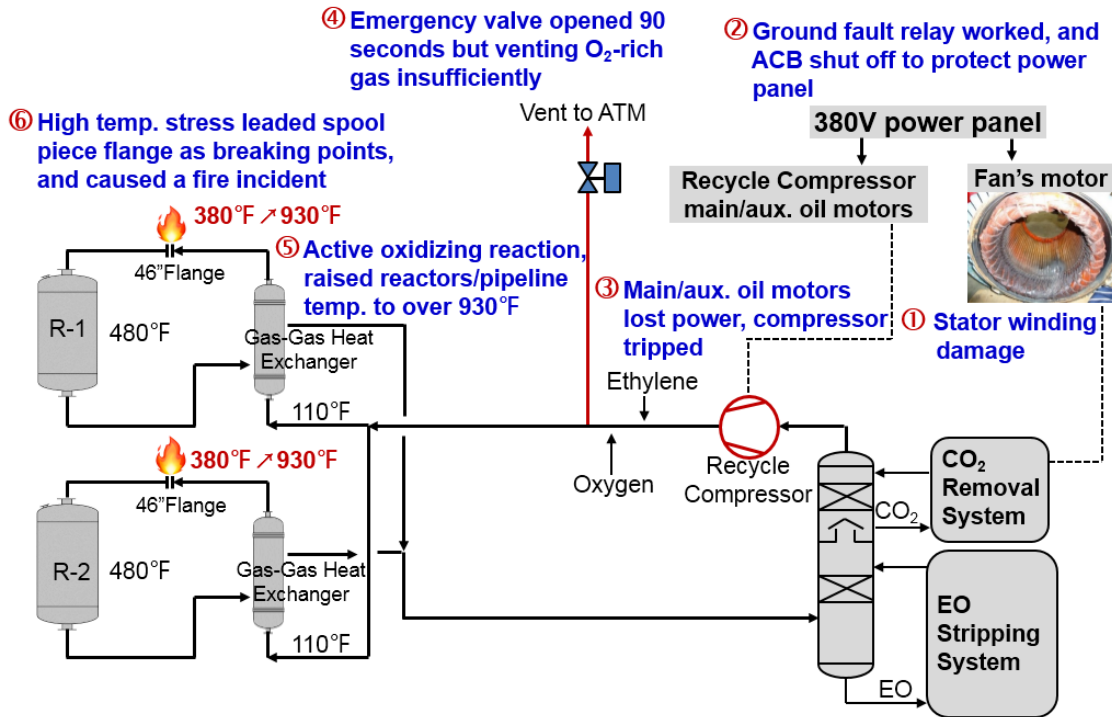
Figure 4. Line-Up during Pipeline Flange Fire

In September 26, 2012 NYPC Mailiao Ethylene Glycol (EG-4) plant reported fire incidents on the spool piece flanges of inlet pipeline of both two Ethylene Oxide (EO) reactors, R-1/R-2, which were founded 43 minutes later after Recycle Compressor tripped. Events sequence shown as figure 3 and line-up during pipeline flange fire shown as figure 4.

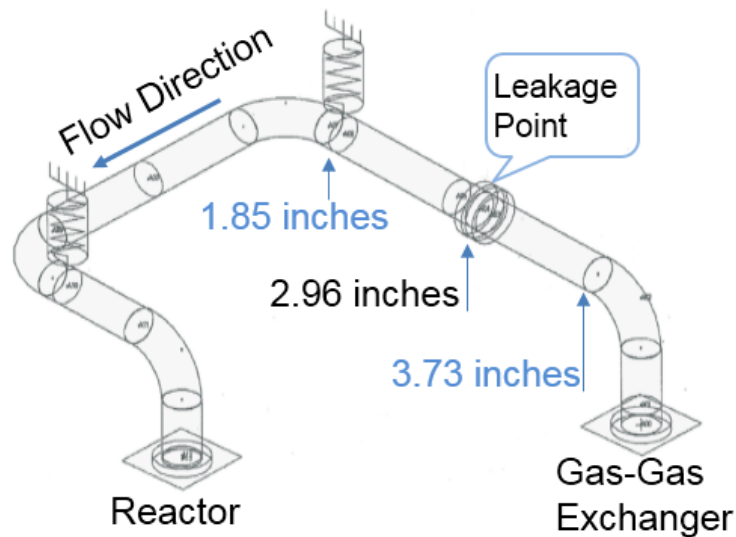
Figure 5. Simulation of heat expansion of pipeline at 930°F

The bolt deformation on the Inlet pipeline spool piece flanges of both R-1 and R-2 reactors, caused by unexpected extra high temperature (>930°F), led to the leakage of ethylene mixed gas and spontaneous combustion.

- (1) According to Table 1, the strength of bolting materials will reduce to 34% at 950°F.
- (2) Unequal thermal expansion across the pipeline at 930°F causes higher stress on spool piece flange, which simulation result is shown in figure 5.

- (1) Eliminate the spool piece design of the reactor inlet pipeline to strengthen its high temperature endurance, shown as figure 6. Use the bigger crane to lift up the whole pipeline to perform the internal inspection during overhaul

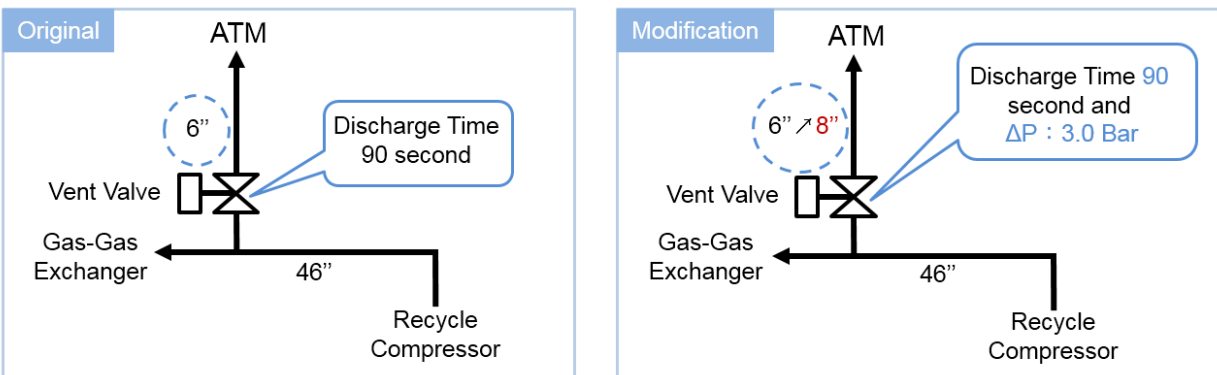
Figure 8. Emergency Vent and Interlock Modification

The insufficient emergency vent, following the Recycle Compressor trip, triggered the abnormal oxidation reaction of ethylene/oxygen mixed gas at the front ends of both two reactors, 180 seconds after compressor trip, and led the temperature to above 930°F in the reactor inlet pipeline and reactor dome.

The six inches valve of emergency vent kept open 90 seconds following the compressor trip, but the pressure reduce was only 1.5 Bar, less than the safety criterion 3.0 Bar, that indicated an insufficient vent quantity and created a possible pocket of gas of explosive concentration. On the other hand, PHA failed to confirm whether or not the amount of emergency discharge reached safety limitation.

- (1) Emergency vent valve and line size is replaced from 6 to 8 inches, and interlock logic is modified to take into account not only venting time (90 seconds) but also process pressure drop (>3.0 Bar), the modification shown as figure 8.
- (2) All the safeguards, included emergency vents and pressure relief valves, must be reviewed not only the mechanical function but also its discharge quantification.

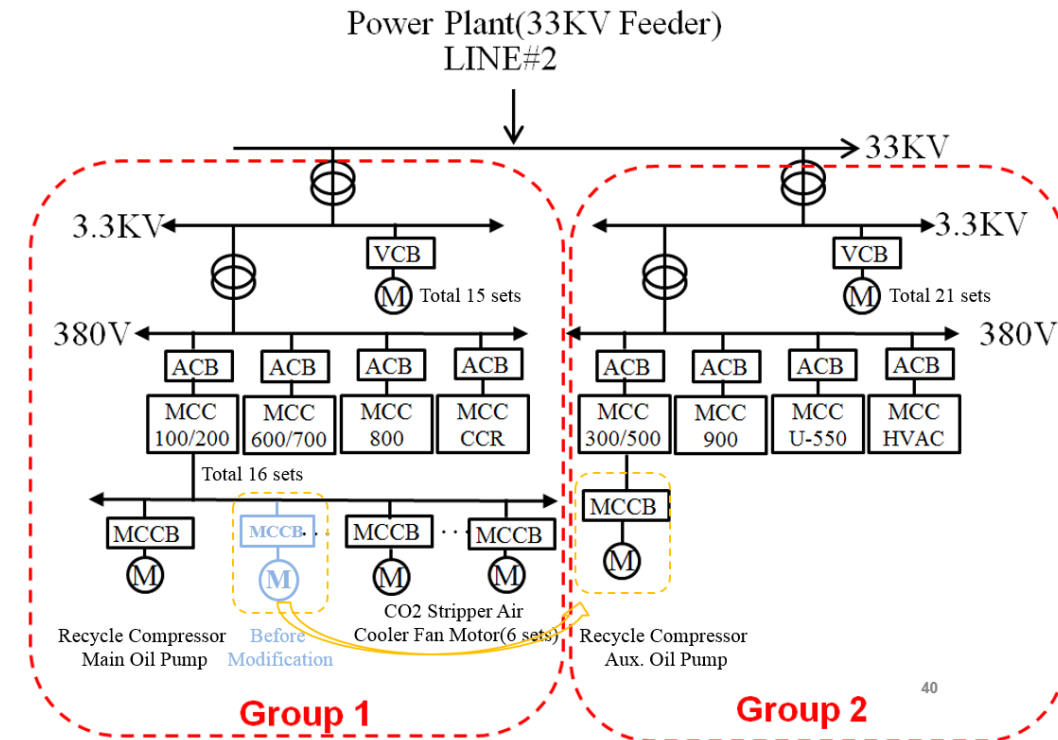
Figure 8. Power Supply Scheme Modification

Recycle Compressor was tripped by low oil pressure while its affiliate main and auxiliary oil pumps losing 380V power supply at the same time.

- (1) The main oil pump and auxiliary oil pump of Recycle Compressor came from the MCC-100/200 panel which was belonging to middle/low voltage GROUP #1 originally. In order to reduce the risk that the auxiliary oil pump is modified to relocate to another MCC-300/500 panel, belonging to middle/low voltage GROUP #2, to reduce the risk of losing both oil pumps at the same time. The modification is shown in figure 8.
- (2) Other affiliated oil pumps and blowers of major equipment, such as incinerator...etc., are also modified to be supplied from different power supply panels.

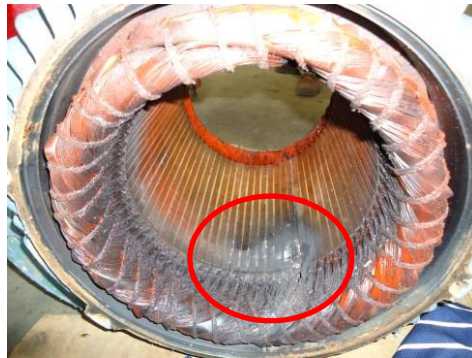
Figure 9. Insulation failure between layers of stator

The stator winding damage of air cooler fan motor was expected to be protected by its own MCCB. However, it tripped the upstream 380V power supply panel for the improper protection setting of ground fault relay of ACB.

- (1)The insulation and ground resistance tests of fan motor were performed three months before the incident. Its insulation resistance $>100M\Omega@500V$ and ground resistance 0.12Ω showed that the motor was at good condition.
- (2)The failed motor is analysis by TUV that the root cause is insulation failure between layers of stator which could be the manufacture defect or maintenance non-conformity. The insulation failure result is shown in figure 9.

Because of the motor can be protected by its own MCCB with rated current protection and short circuit delay, that Protection Trip Design of ACB is modified to delete the ground fault relay.
