20<sup>th</sup> Annual International Symposium  
October 24-26, 2017 • College Station, Texas

## **Analysis of Leak and Explosion from an Underground Pipeline in Kaohsiung, Taiwan**

Hui-Ning Yang, Jen-How Chen, Home-Jo Chiu, Ting-Jia Kao, Hsiao-Yun Tsai, and  
Jenq-Renn Chen\*

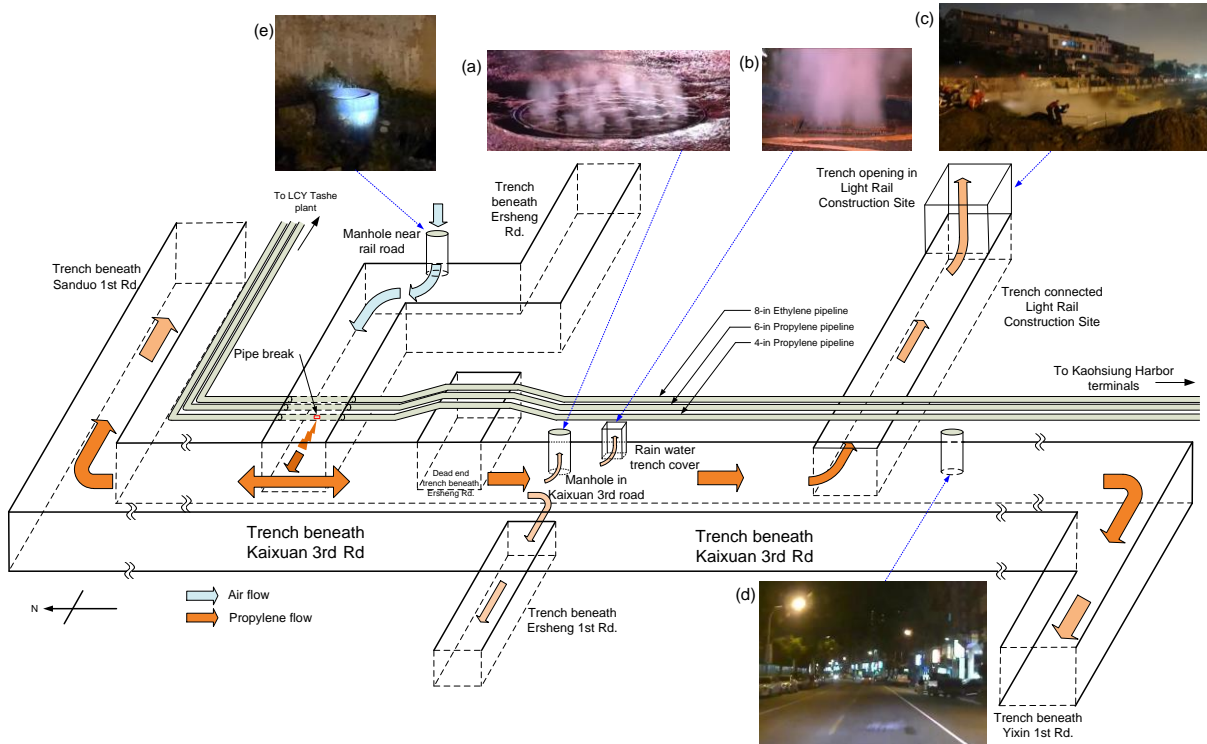
The incident was first reported from an unknown fog to come out intermittently from roadside rainwater trench covers and manholes of the storm trench beneath the junction of Ersheng 1st Road and Kaixuan 3rd Roads in downtown Kaohsiung City on 20:46 July 31st 2014, as shown in the inserted photos (a), (b) and (d) in Figure 1. Fire fighters from Kaohsiung City Fire Bureau reached the site on 20:50, secured the area and began spraying water on the fog. An incident command post was also setup in the foot path of the road junction. Efforts were made to identify the leak materials and leak source but were unsuccessful. While the fog erupting from manholes of the storm trench beneath the junction of Ersheng 1st Road and Kaixuan 3rd Roads diminished gradually, a small explosion in the manhole of storm water trench occurred about 1 km away from the initial leak scene on 22:20. The explosion however did not escalate. Around 22:50, a major white smoke was found coming out from a nearby light rail construction site underground trench opening as shown in the inserted photo (c) in Figure 1. This opening was then considered as the source of the leak and the site was considered as the hot zone with restricted entry. Air samples were also taken back for analysis. Unfortunately, explosion occurred before the air sample was analyzed. Another peculiar and unresolved finding at 23:45, right before the explosion, was an intermittent suction or flowing sound from a manhole near the railroad as shown in the inserted photo (e) in Figure 1. There was however no vapor eruption from this manhole. Thus, there was no clear conclusion regarding the leak gas, the leak source and the source owner before the explosion. Formal confirmation of the leak gas to be propylene was delayed to 6:30 am the following day by residual gas on the intact storm water trench in Ersheng 1st Road. Figure 1 shows the schematic diagram of the pipeline, underground trench, the spread of the leak vapor and corresponding photos for the vapor eruption at different locations.

Figure 1: Schematic diagram of the pipeline, underground trench, the spread of the leak vapor and corresponding photos for the vapor eruption at different locations.

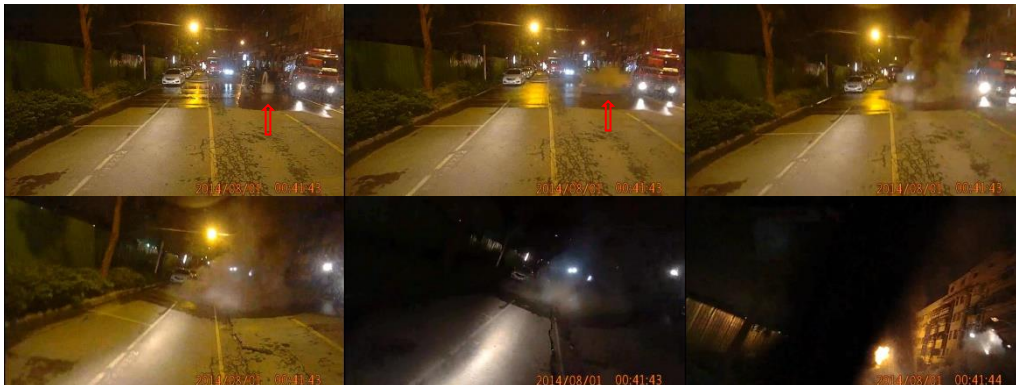
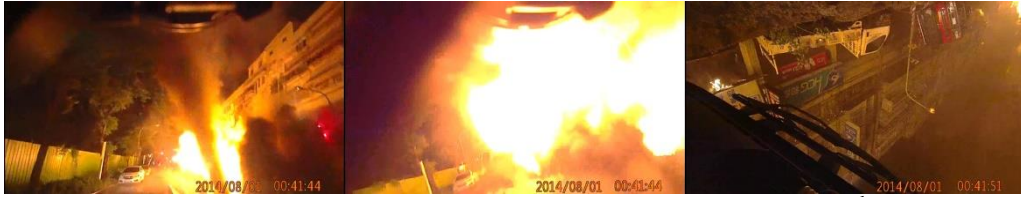
Without any warning, an explosion occurred near the command post on 23:57 July 31st. The explosion was occurring beneath the road surface with a smoke erupting out from the storm water trench manhole, followed by road surface crack, and a large fire erupted out. Figure 2 shows a sequence of frame from a recorder on a fire truck. The arrow in the first frame indicates the first smoke eruption from the manhole. The road surface was blown out and pushed upwards all vehicles and personnel on the road and then collapsed to the trench. The fire truck in Figure 2 was eventually turned upside down.

Figure 2: Sequence of explosion recorded on a fire truck in Kaixuan 3<sup>rd</sup> road facing south bound.

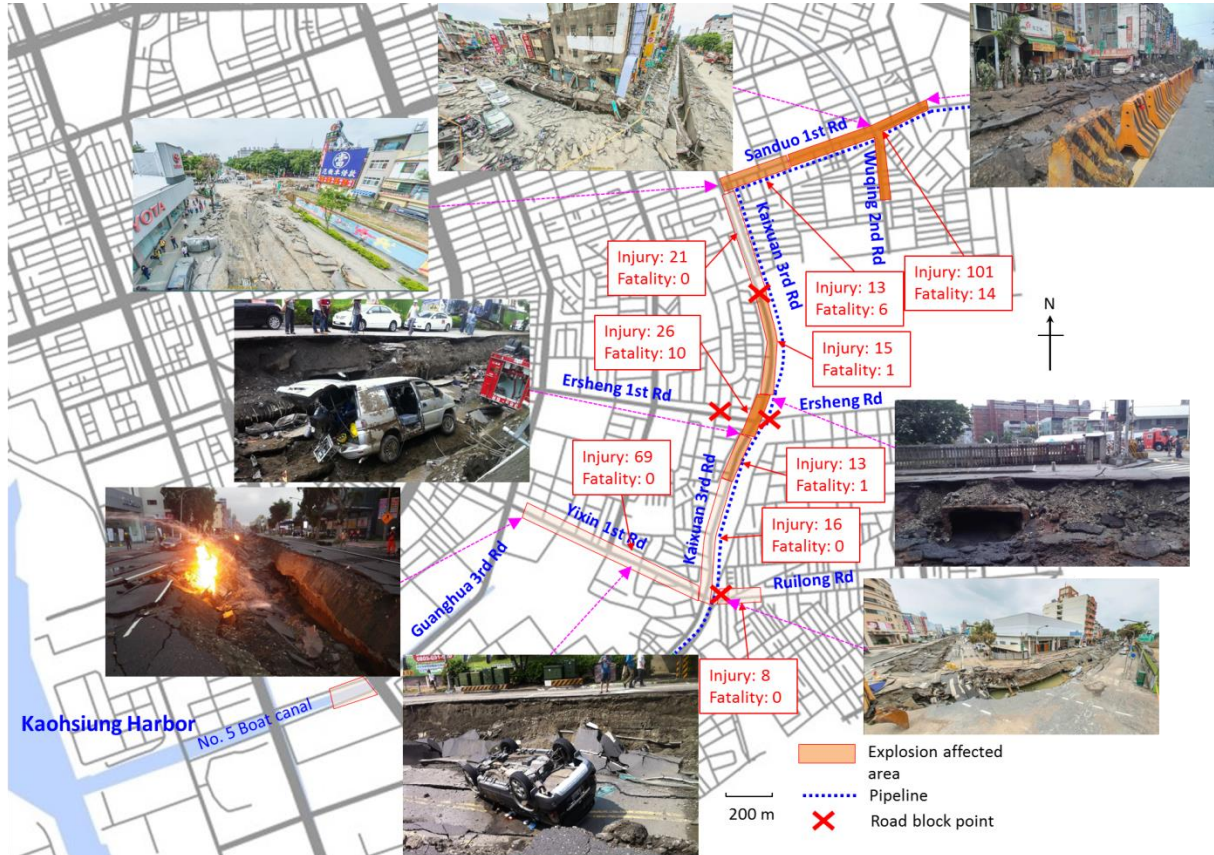
Figure 3 shows the pipeline route, the explosion affected area, the distribution of causalities, and corresponding photos for damages. The explosion propagated along the Kaixuan 3<sup>rd</sup> road to the north and south along the storm water trench. At the north end of Kaixuan 3<sup>rd</sup> road, the explosion propagated towards Sanduo 1<sup>st</sup> road and its junction to Wuqing 2<sup>nd</sup> road. A total of 4.5 km road were blown out.

The junction of Sanduo 1<sup>st</sup> road and Wuqing 2<sup>nd</sup> road suffered the largest fatalities and injuries as indicated in Figure 3. Wuqing 2<sup>nd</sup> road is famous for many midnight snack shops. A surveillance video showed that there was a red light stopping several cars and scooters right before the explosion. Another factor contributed to the significant fatalities in this area is that the road surface covering the storm water trench was only about 0.5 m which is very thin comparing with the 1 ~ 2 m in other roads. The explosion not only blew out the road surface but also shattered the road into small fragment and debris. Some of the debris was even blown up to the roof of four-floor houses as seen in Figure 3. Causalities were mostly caused by the debris impact and the explosion flame. The explosion on the Sanduo 1<sup>st</sup> road eventually diminished about 400 m east from the junction of Wuqing 2<sup>nd</sup> road.

The second largest fatalities were occurred in the junction of Kaixuan 3<sup>rd</sup> road, Ersheng road and Ersheng 1<sup>st</sup> Road which centered on the incident command post. Fire trucks that parked on the Kaixuan 3<sup>rd</sup> road were overturned by blown out road as shown in Figure 3. More than twenty fire trucks were damaged. Most fire fighters stayed near the fire trucks were injured or buried by the debris or the overturn fire trucks. Seven of the ten fatalities on this road junction were fire fighters. The explosion damage on the south side of Kaixuan 3<sup>rd</sup> road and Yixin 1<sup>st</sup> Road was less severe compared with other area as shown in Figure 3. It is likely that most explosion energy was dissipated by the thick road surface on top of the storm water trench. Vehicles remained intact even

Figure 3: The pipeline route, the explosion affected area, the distribution of casualties, and the corresponding photos for damages.

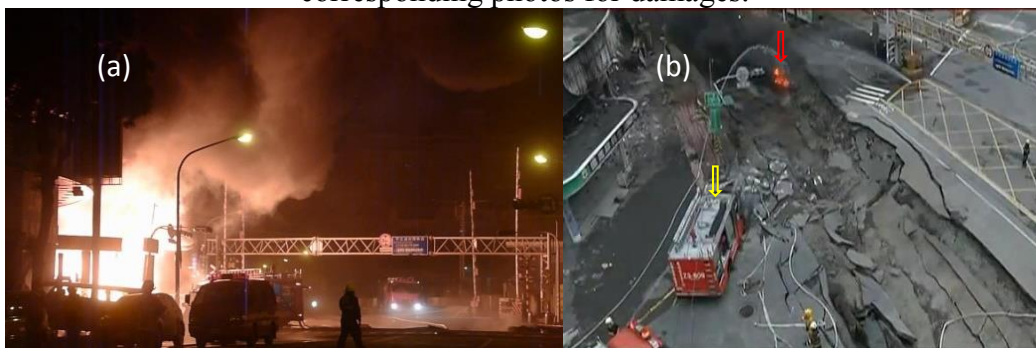
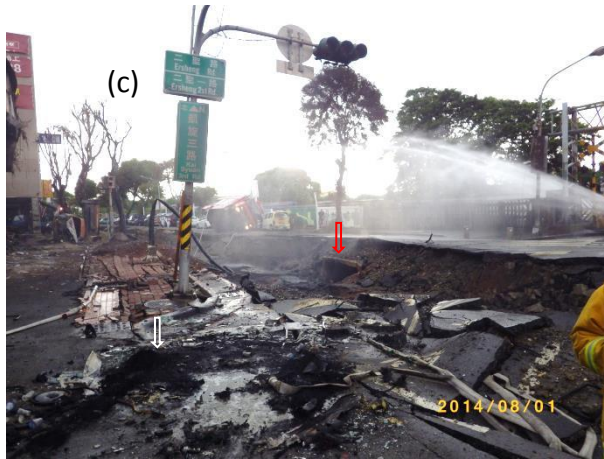
Despite the complicated leaks and silence of the pipeline operators, the identification of the leak source after the explosion was straightforward without ambiguity. After the explosion, a large jet fire developed near the junction of Ersheng 1<sup>st</sup> Road and Kaixuan 3<sup>rd</sup> Road as shown in Figure 4(a). This was the largest fire after the explosion and it lasted till 6 am the following day. As the fire diminished gradually, it can be seen clearly that the fire was coming out from a branch of storm water trench as indicated in Figure 4 (b) and (c). Clearly, this would be the source of leak.

As the area were blocked for traffic, the only available ignition sources were the fire trucks which remained running to provide firewater. In fact, there was a fire truck near the junction of Ersheng 1<sup>st</sup> road and Kaixuan Road as shown in Figure 4(b). The engine of the fire truck after the explosion

was completed burnt down, yet Figure 4(c) showed that the road sign in front of the engine remained intact. Thus the fire on the fire truck engine was unlikely to be caused by the jet fire from the leak pipeline. Figure 4(c) also showed the char from burnt fire truck tire after the removal of fire truck. The white arrow in Figure 4(c) was the location of a telephone cable junction box cover. The telephone cable junction box is not sealed but usually drained to nearby storm water trench. It is very likely that the vapor in the storm water trench spread out into the junction box, and eventually escaped the cover to meet the truck engine and ignited. The ignition resulted in flame propagation and explosion along the storm water trench with smoke eruption from the trench manhole. With flame accelerated along the trench, the explosion intensity also increased. Eventually the road surface blew out with erupted flame. The explosion propagated through the entire trench that filled with flammable vapor.

Figure 4: Photos of the fire after the explosion on the north side of junction of Kaixuan 3<sup>rd</sup> road and Ersheng 1<sup>st</sup> road. Time of the photos: (a) 12:00 am (b) 06:00 am (c) 07:05 am. Red arrow indicates the location of storm water trench branch with the leaked pipeline. Yellow arrow indicates the fire truck engine suspected to be the ignition source. White arrow indicates the char from burnt fire truck tire. Note for the road sign in front of the engine remained intact.

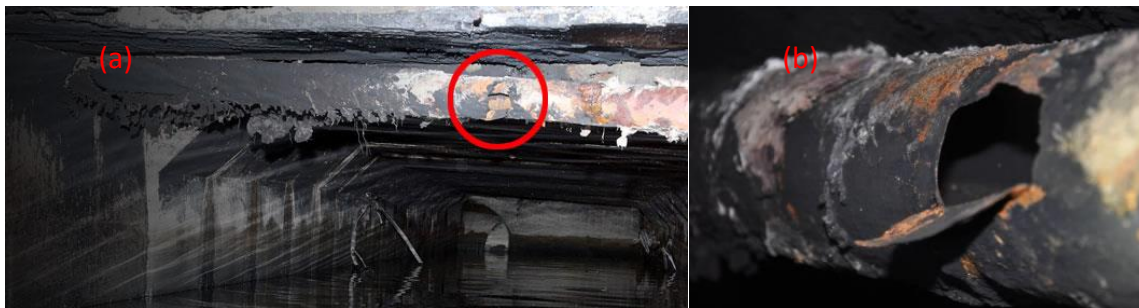
Subsequent inspection of the trench branch with jet fire revealed that there were three pipelines passing through the trench. The 4-in line was completely exposed in air and had a break opening of 4 cm by 7 cm as shown in Figure 5. The 6-in and 8-in lines were located next to the 4-in line, partially exposed in air, and remained intact. These two pipelines did not suffer the jet flame impingement from the 4-in line as they were located on the back side of the 4-in line opening. Inspection of the leaked pipeline also showed pipeline wall thickness greatly reduced from its original 6 mm to less than 1 mm by corrosion from the humid ambient environment in the trench. Thus, it is concluded that it was the LCY 4-in propylene pipeline leaked and caused the explosion.

Figure 5: Photos of (a) the storm water trench, the 4-in propylene pipeline and the break, (b) close view of the break opening.

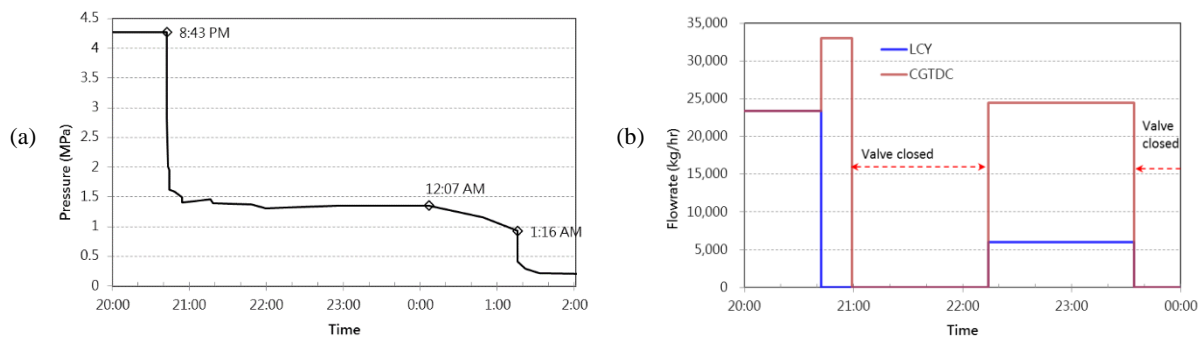
It is important to estimate the leak rate and amount of leaked in order to assess the potential damage and evacuation zone. The leak rate was dominated by leak opening and the pipeline pressure. Figure 5(a) shows the pipeline pressure recorded at Taiwan CPC Cianjhen terminal which is a branch line to the CGTDC and LCY pipeline. As the Taiwan CPC Cianjhen terminal was close to CGTDC pumping station, the recorded pressure can be a good approximation of the upstream pressure of the leak. As the boiling point of propylene is far below the ambient pressure, the leak from the pipeline may or may not flash depending on the upstream pressure. If the upstream pressure is higher than the saturation vapor pressure, the propylene may leak out as a liquid before flashing. If however the upstream pressure is close to the saturation pressure, flashing is expected and the typical two-phase flashing flow across an orifice may be used (Crowl and Louvar, 2012). As Figure 6(a) indicates that the pipeline upstream pressure after the break was very close to propylene saturation pressure, flashing two-phase flow will be the dominant mode of leak. Although more detailed modeling can be done for the two-phase pipe flow, Chen et al. (1995) showed that the liquid dried out is expected to occur in about 10 s for a 100 m pipeline containing liquid propane and butane. In the present case with very long pipeline and long leak time of more than 1 hr, liquid dry out was also expected near the break and the vapor choked flow equation (Crowl and Louvar, 2012) can be a good estimation of leak rate.

Figure 6(b) showed the recorded flowrate on CGTDC and LCY side. The area difference between the two records will be the amount lost during pumping and mostly in liquid form. Direct integration gives 34,000 kg. For the valve closed period, a total of 97 min, the loss is calculated to

be 56,800 kg from the vapor choked flow equation and 160,000 kg from the flashing flow equation. The latter is far larger than the possible pipeline inventory of 100,000 kg based on the 27 km of pipeline volume and propylene density. As expected, the value from vapor choked flow calculation is considered a more realistic value compared with that from flashing flow equation. Thus, a total of 90,800 kg propylene was estimated to leak before the ignition. The estimated amount of leak is far too large to be safely dispersed in air without ignition and explosion. There is also no way to safely dispose or mitigate the flammable cloud from the trench.

Figure 6: (a) Pipeline pressure recorded at Taiwan CPC Cianjhen terminal, a branch line to the CGTDC and LCY pipeline. (b) Recorded flowrate on CGTDC and LCY side

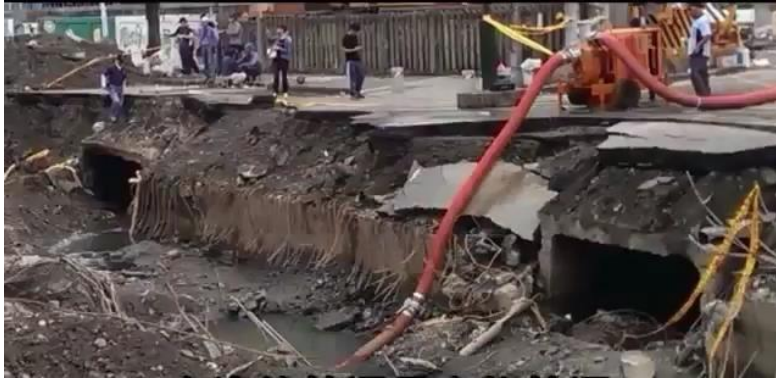
It is important to know how the leak in the trench was spread such that responders may take proper action in future incidents. Investigation revealed that there were two storm water trench branches as shown in Figure 7, one being directly beneath the Ersheng Road but is only 7 m in length and sealed in the other end, the other being about 10 m north of the dead ended branch and housed the pipelines. The later was then connected to the trench beneath Ersheng Road. We put up a schematic diagram in Figure 1 showing all the trenches and trench openings. The trench branch that housed the pipeline had a manhole upstream which was the manhole with the suction sound. As the pipe break was facing towards the main trench, the leak from the break would form a jet and entrained significant air from the upstream trench. The direction of the leak is thus in consistent with the finding of suction sound in the upstream manhole. It is also consistent with the fact that there was virtually no damage in Ersheng road. The vapor jet impinged on the trench beneath Kaixuan Road and spread in both direction regardless of the trench sloping as shown in Figure 1. The vapor flow was completely different from a liquid leak which would flow by gravity. The spread of the leak vapor in the underground trench was governed by the flow resistance which is in turn affected by trench size, branched flow and trench opening to ground. Branch flow is in general much smaller than line flow in a tee junction. Flow into a larger branch is also favored over a small branch. Finally, the area with most vapor escaped do not necessarily corresponds to the leak source but rather depends on the size of opening to ground. These findings will be useful for all incident commanders dealing with underground pipeline leak incidents provided that all underground trenches are well documented and available during the incident.

Figure 7: Photo of the storm water trench branches, the left one housed the pipelines and the right one was sealed in the other end with a total length about 7 m.
