5th Annual Symposium, Mary Kay O'Connor Process Safety Center
"Beyond Regulatory Compliance: Making Safety Second Nature"
Reed Arena, Texas A&M University, College Station, Texas
October 29-30, 2002

**Designs that Lacked Inherent Safety:
Case Histories**

Roy E. Sanders
PPG
P O Box 1000
Lake Charles, LA 70602-1000 USA
Phone: (337) 708-4322
Email: rsanders@ppg.com

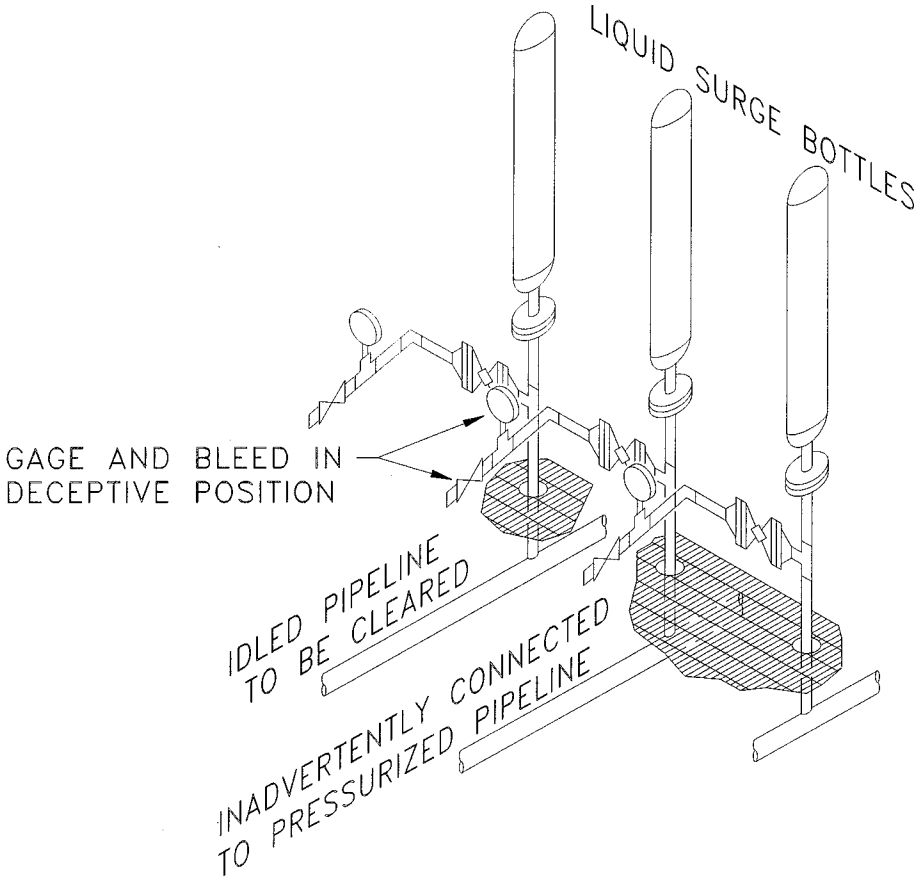
PIPELINE CLEARING INCIDENT
FIGURE 1

The piping arrangement under nighttime conditions was deceptive in geometry and camouflaged by the rust colored primer versus the bright yellow colored paint of the adjacent fittings. There were three parallel two-inch pipelines below the grating on the second level; each line had purge connections that confused the team. (See Figure 1 for details.)

The task of clearing pipelines for maintenance is almost second nature to well-experienced operators in this unit. Typically, pipeline clearing is routine and is uneventful. This time, however, the dry air system was also being utilized as a source for instrument air in the operating area. Hence this corrosive material could backflow and create expensive instrument damages.

Damage to analyzers and instrumentation from the intrusion of acid gases into the instrument air system was extensive. Repair costs were about \$300,000.

- The investigating team determined the accident was a result of human error by talented, well-trained, dependable operators. The operator took several steps to change fittings to make the hose connection. The piping arrangement was deceptive in both geometry and paint color. Under nighttime lighting conditions the piping connections are even more misleading.

- The use of the 100-psi dry-air system for instrument air must be reviewed.
- The release resulted from backflow of a corrosive into a utility air header as a result of human error, and the subsequent leaking from purges, bleeds and leaks on the instrument air system that was being supplied from the utility air system.

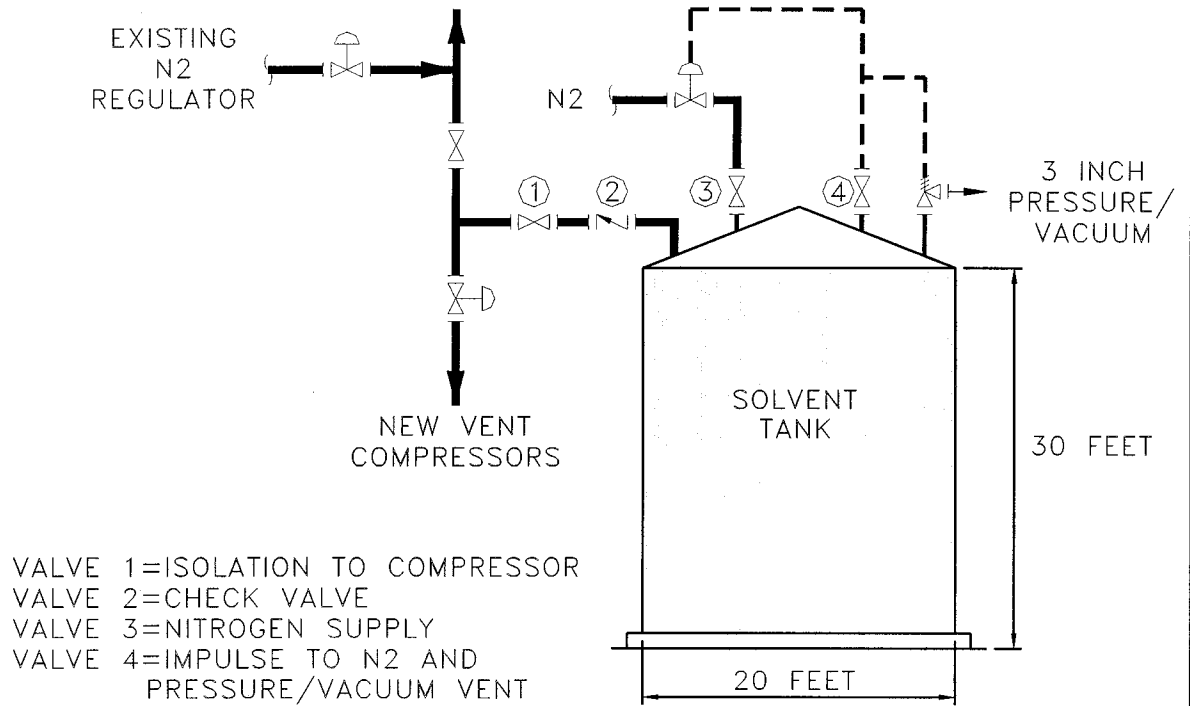
BLOCKED IMPULSE VALVE INCIDENT
FIGURE 2

A perfectly good low-pressure solvent tank ended up as useless scrap metal after the vent system had been "improved." This early 1990's mistake cost about \$100,000 to correct. Fortunately, there were no leaks and only egos were injured when the 20-foot in diameter and 30-foot tall vessel was destroyed. Prior to the incident, this unit was reducing volatile organic emissions step-wise within a tank farm by replacing simple hinged breather vents with a more sophisticated nearly zero leakage system. (References 11 &12)

The solvent tank was returned to service and was filled to the proper level. The roof and top two courses of 1/4-inch thick vertical walls were dramatically sucked in the first time the contents were pumped out after vent improvements. The product was analyzed and a transfer from the tank was started in the early evening. The collapsed sections of the tank were observed before sunrise the next morning.

With all due respect to the findings of the investigating team, the root cause appears to me to be an inherent unsafe design. The new piping system looked simple but in fact this unique system was confusing. A check valve was installed on the vent header to prevent cross contamination. A small block valve was installed on the vacuum relief impulse line to provide easy isolation. (See Figure 2 for more details.)

A small block valve is usually installed at the tank on any instrument impulse line just in case a leak develops on the small tubing. In this unit block valves are generally avoided on overpressure or vacuum relief devices. If a block valve which can defeat an overpressure device cannot be avoided, such a valve is locked open or car-sealed opened and a protocol is developed to administratively control accidental closing of such a prime safety feature.

The investigating team made several training and Management of Change recommendations and decided to eliminate the impulse valve (valve no. 4) connected to the pressure/vacuum vent. The elimination of the impulse valve removed the unintended trap for the operators.
