What You Ask For Isn't Always What You Get

K. Kas
Rohm and Haas Company
Spring House, PA, USA

Engineers designing equipment for a new process routinely specify the required material of construction. But how can we be sure that the specified material of construction was actually installed? These three incidents illustrate the consequence of installing the wrong material of construction and highlight the need for improved systems to ensure that the proper materials are used.

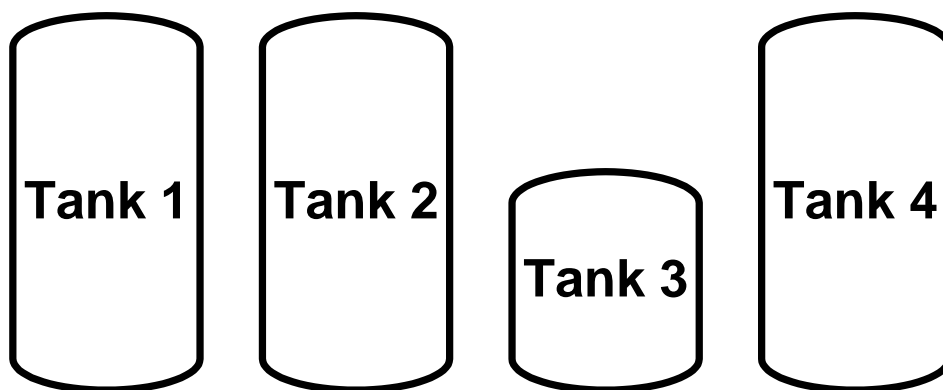
Figure 1: Four tanks in similar service. Why is Tank 3 half as high as the others?

were identical. A few months after startup, an operator observed a small leak in the upper part of the side of Tank 3. The tank was taken out of service immediately and inspected. To everybody's surprise, the entire wall of Tank 3 in the area of the leak was found to be "paper thin." This was quite a shock to the process design engineers because extensive corrosion testing had been done during the process development and 304 stainless steel was known to have good corrosion resistance. The severe corrosion of the tank after a few months of service was totally unexpected. Naturally, this discovery led to concern about the integrity of the other tanks in closely related service, so they were also inspected. None of the other tanks had any evidence of significant corrosion.

A more thorough inspection of the Tank 3 revealed that the corrosion was localized in a particular section of the top of the tank side wall. The rest of the tank, including the top and bottom heads and the rest of the side walls, had no significant corrosion. At this point, samples of the metal in the corroded area were taken and analyzed, and the metal was found to be 316 stainless steel, not 304 stainless steel! Apparently, one 316 stainless steel plate had been welded into the side wall of the 304 stainless steel tank. The tank fabrication records did not indicate any problem, and showed all materials used in construction to be correct. Apparently at least one plate of 316 stainless steel had been labeled and documented as 304 stainless steel by the steel manufacturer, and this plate had found its way into the failed tank.

So, how was the Tank 3 repaired? Fortunately, only a portion of the tank wall, less than half of the total tank height, was corroded. The lower half of the tank, built from 304 stainless steel as specified, had no corrosion, as expected based on the extensive testing which had been done. As a temporary repair which could be done quickly, it was decided to cut the top of Tank 3 off, put the top head back on the reduced height tank, and do the appropriate inspections and testing to meet the vessel code requirements. After this was done, the plant ran just fine, and it was determined that the smaller Tank 3 provided sufficient capacity for ongoing operation of the plant. There was no need to install a new tank of the same capacity as the original.
