TURBOMACHINERY & PUMP SYMPOSIA

DECEMBER 14-16, 2021

The Use of Online Condition Monitoring in The Identification of Gas Compressor Rotor Damage

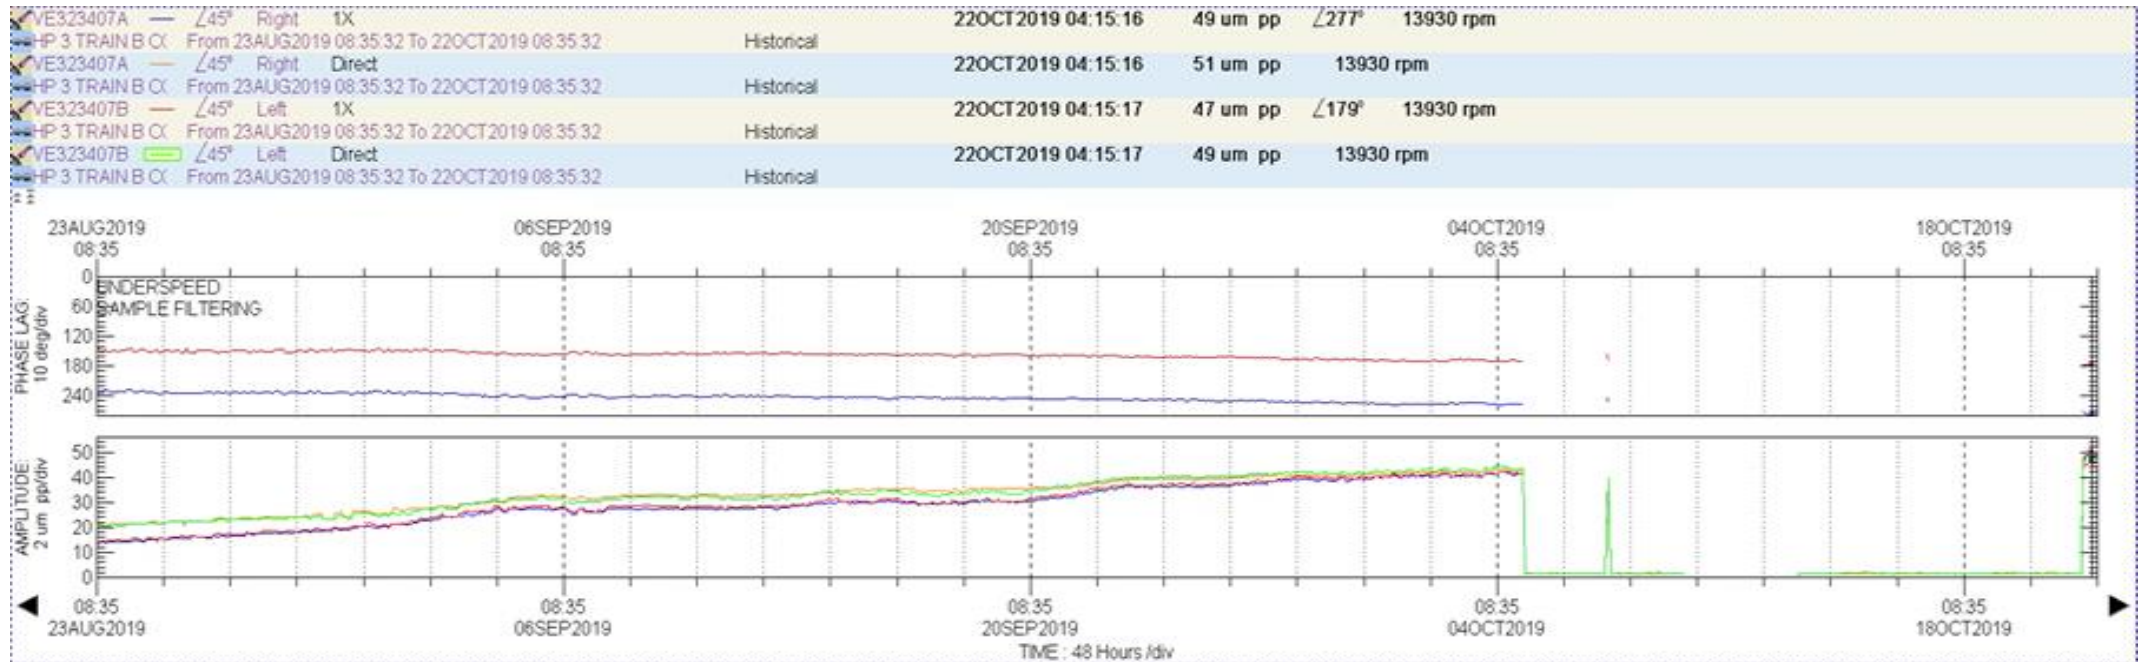
Figure 2 – Compressor DE/NDE Direct & 1x Trend (System 1)

- Increasing vibration compressor NDE and DE (to a lesser extent)
- Stable bearing temperatures, shaft centerline and axial position
- The orbit timebase was circular in shape but continuously increasing in amplitude on NDE

Outcome - recommended additional measurements and transient data analysis

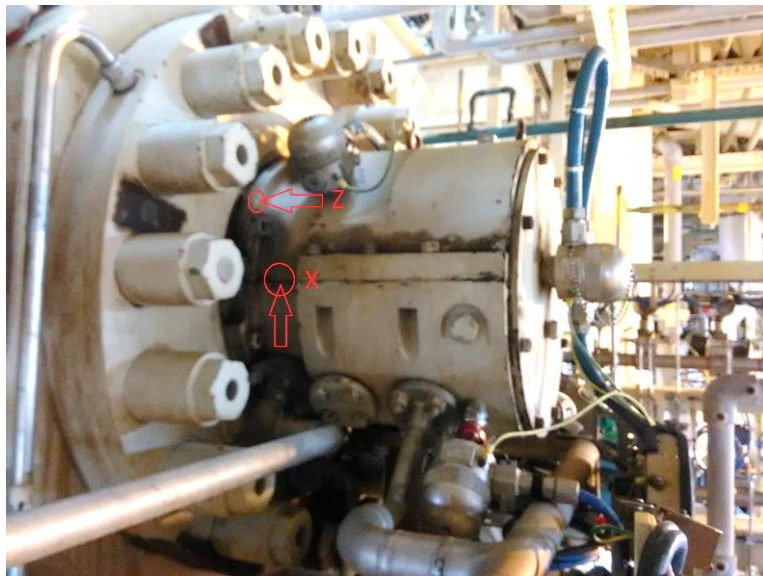
Figure 3 – Offline Bearing Housing Measurements

- Bearing housing vibration measurements
- Lube oil temperature checks
- Effect of changing compressor load
- **Outcome** – No apparent issues

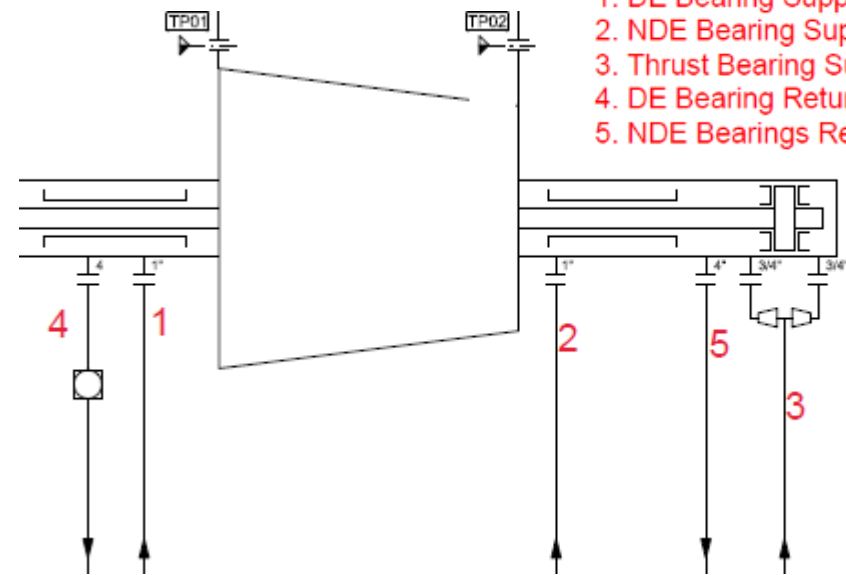
Figure 4 – Lube Oil Temperature Gun Checks

Temperature gun measurements to be taken from the locations as indicated on the P&ID

1. DE Bearing Supply
2. NDE Bearing Supply
3. Thrust Bearing Supply
4. DE Bearing Return
5. NDE Bearings Return

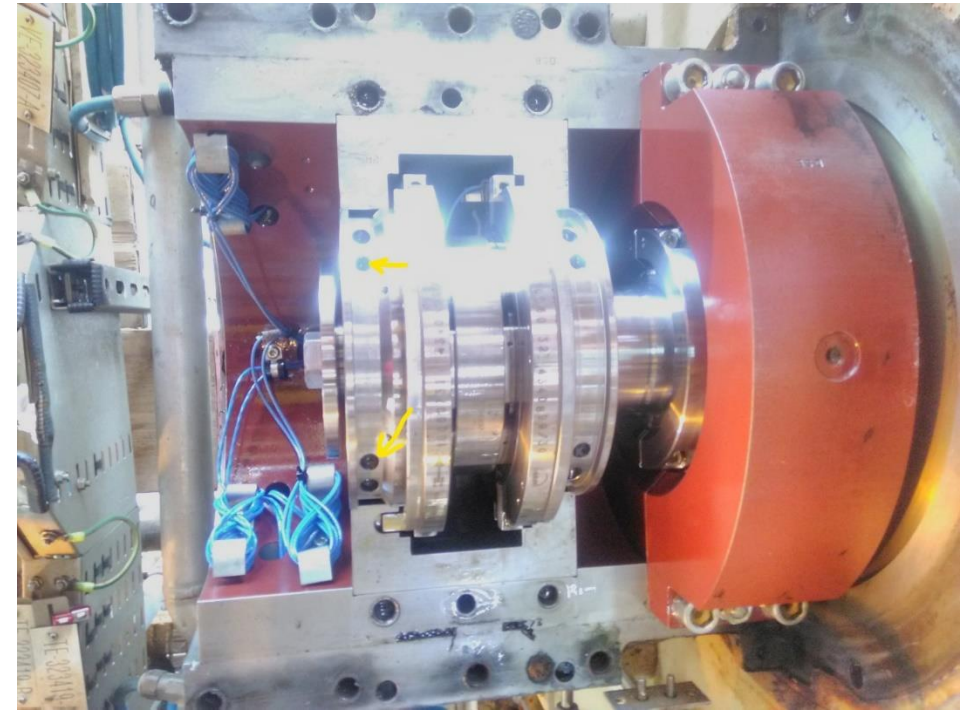
Figure 5 – NDE Bearing Inspection

- Radial and thrust bearing clearances within tolerance
- Bearing crush within tolerance (no evidence of looseness)
- Tilting pads in good condition
- **Outcome** – no issues found bearing recommended for continued operation

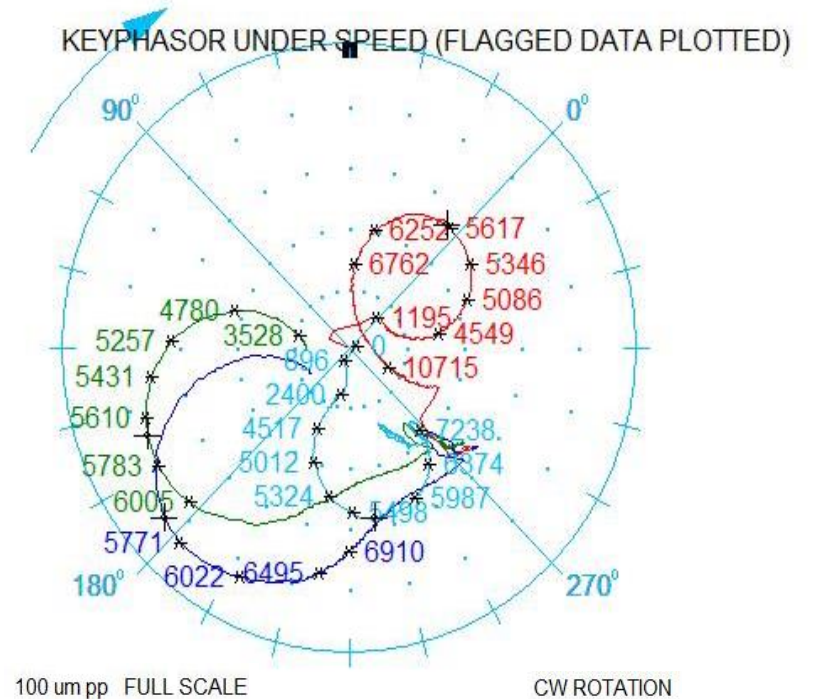
Figure 6 – Compressor NDE Start Up Comparison Polar Plot (System 1)

- No evidence of change in the **critical speed**
- Changes to the **heavy/high spot** location and rotor response passing the first **balance resonance**
- Evidence of an abnormal **unidirectional 1X change** in rotor response and it's **repeatable** for different start-ups.
- **Outcome** – Issues of concern, recommended rotor inspection

VE323407A	85.1 um pp	∠176°	5676 rpm	26NOV2019 16:48:52.844
Compressor	From 26NOV2019 16:48:50 To 27NOV2019 08:40:33			
VE323407A	52.3 um pp	∠5°	5665 rpm	09NOV2019 17:18:56.956
Compressor	From 09NOV2019 15:28:22 To 09NOV2019 22:58:20			
VE323407A	75.89 um pp	∠157°	5668 rpm	21OCT2019 21:38:35.995
Compressor	From 21OCT2019 21:38:33 To 22OCT2019 00:04:53			
VE323407A	56.54 um pp	∠234°	5666 rpm	07OCT2019 15:20:50.000
Compressor	From 07OCT2019 15:00:50 To 07OCT2019 16:30:00

- Raise the vibration trip limits from 67um to 82um
- Expand monitoring parameters - Bearing temperature/bearing lube/axial position/etc
- Inspect NDE bearing
- Remove from service at revised Trip Limits

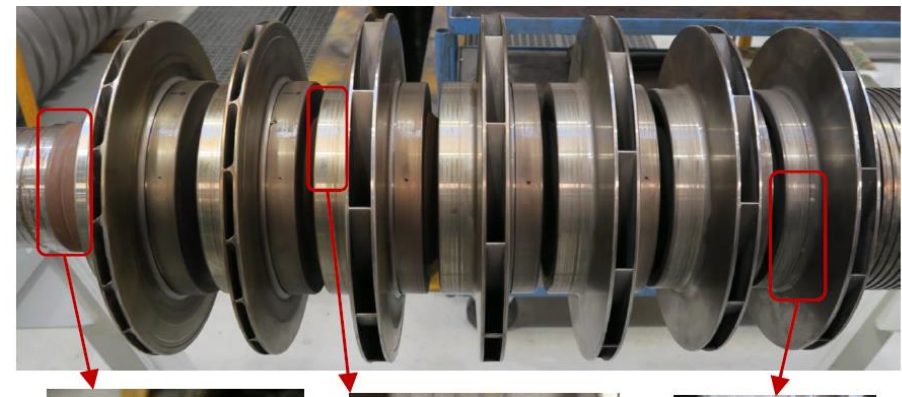
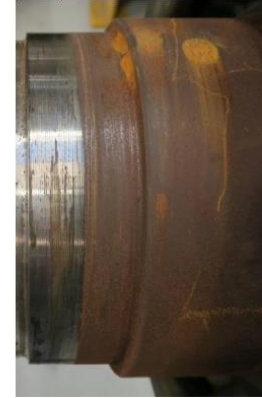
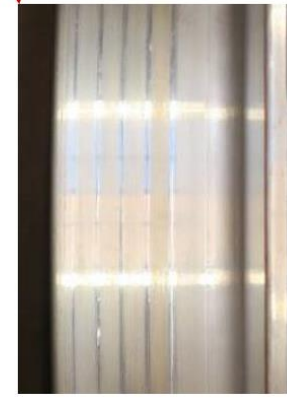
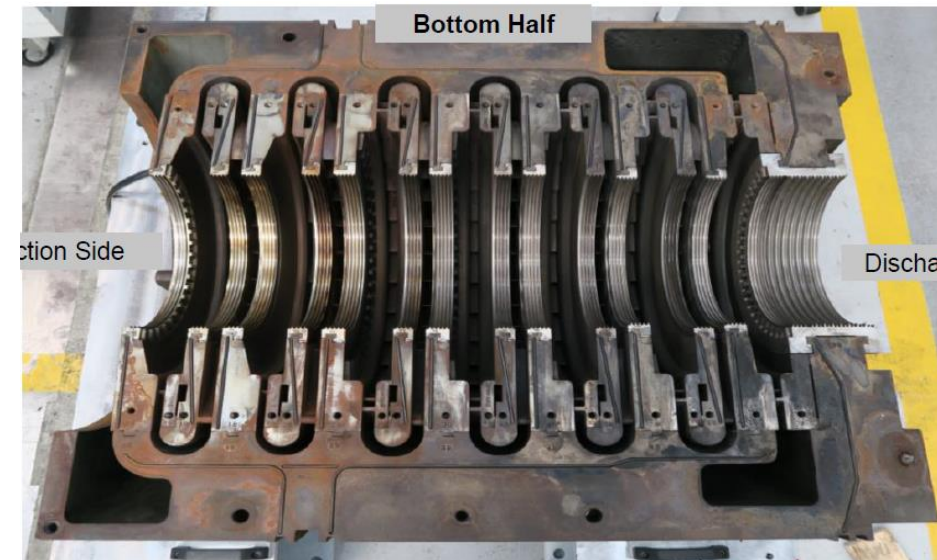
Figure 8 – Compressor Strip Down

- OEM accommodated a “virtual strip”
- Light corrosion on shaft – preservation?
- A fine film of dirt towards discharge side – not an issue
- Some minor scores on sealing surfaces – not cause of vibration
- Clean and in good condition

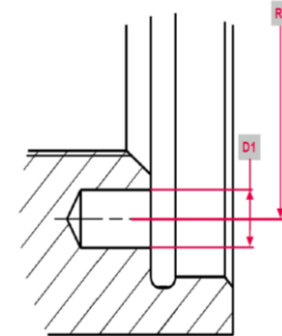
Figure 10 – Locating Hole Measurement Check

- Heavy split pin location hole is out of position and oversized
- The positioning pin is deformed/ bent
- Severe surge contributed to the pin deformation and subsequent parts wear
- The increase wear led to thrust collar eccentricity
- The unbalance caused by thrust collar eccentricity resulted in the increasing NDE vibration

All values in mm	All values in mm
	Bore diameter	Radial bore Position
Position	D1	R1
Value	5.7	20.45
Acceptable Y/N	N	N

- The drilling of the locating hole for the pin was done manually which compromise the collar assembly
- Post build quality checks did not include locating hole measurement and the issue was missed
- The end user will request the locating hole measurement check after future overhauls on the operated fleet
- The primary means of identifying this defect will be online vibration monitoring

- **Outcome** - The OEM acknowledged the problem and changed the drilling process from a manual to a machining activity

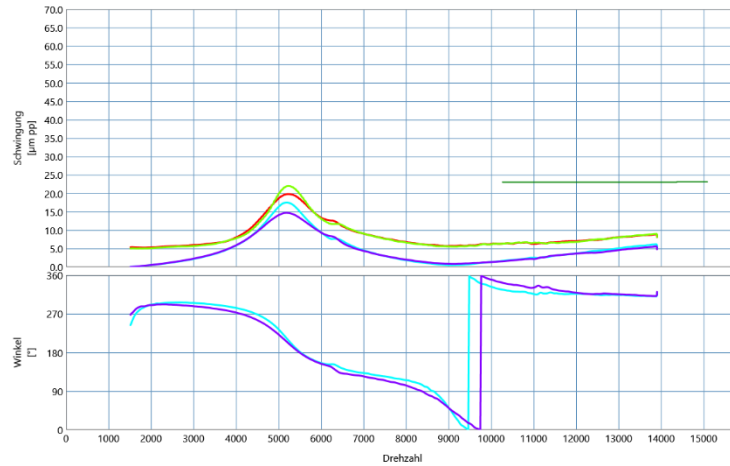
Run 1 – Thrust Collar assembled towards sound centring.

DE/NDE - 7/10µm-pp

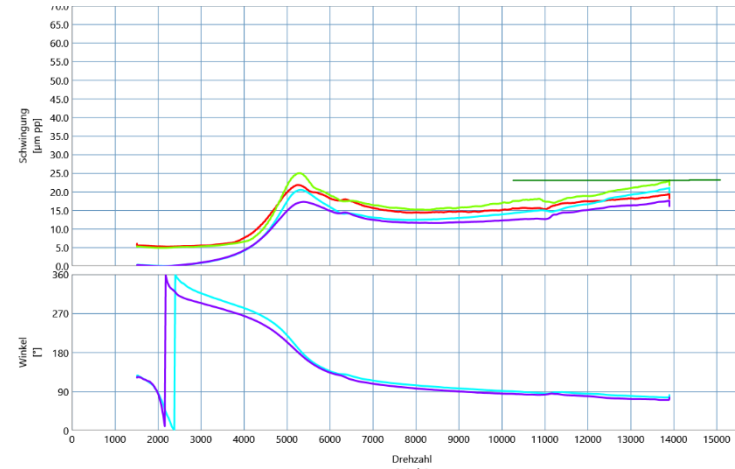
Run 2 – Thrust Collar assembled towards worn centring.

Runout - 0.12mm
DE/NDE - 8/22µm-pp
Unbalance - 378gmm

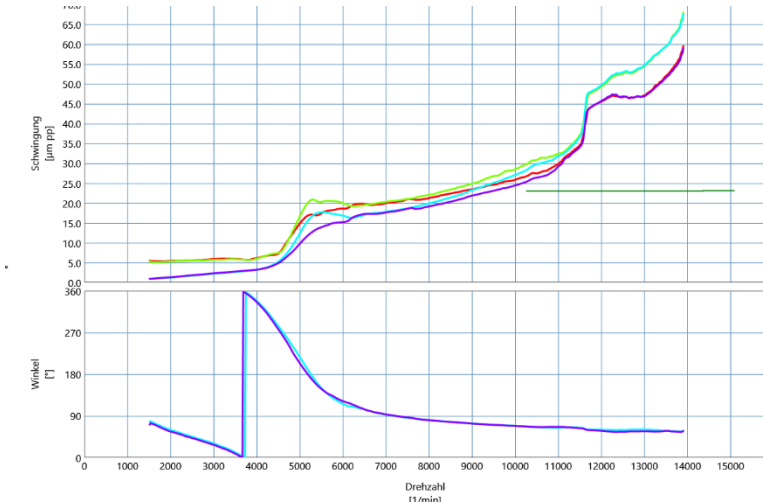
Run 3 – Thrust Collar assembled towards worn centring. (Pin Reversed)

Runout - 0.25mm
DE/NDE - 21/68µm-pp
Unbalance - 788gmm
