Vibration Spike During Start-up of an Integrally Geared Compressor

During workshop testing of a new 3-stage main air compressor, higher than expected vibration levels were detected at stage 1 and 2 at start up. They are high enough that the machine could not be brought to the full speed. This case study will cover the basic design of the compressor, the history of the problem, the root cause analysis, conclusions and corrective action.

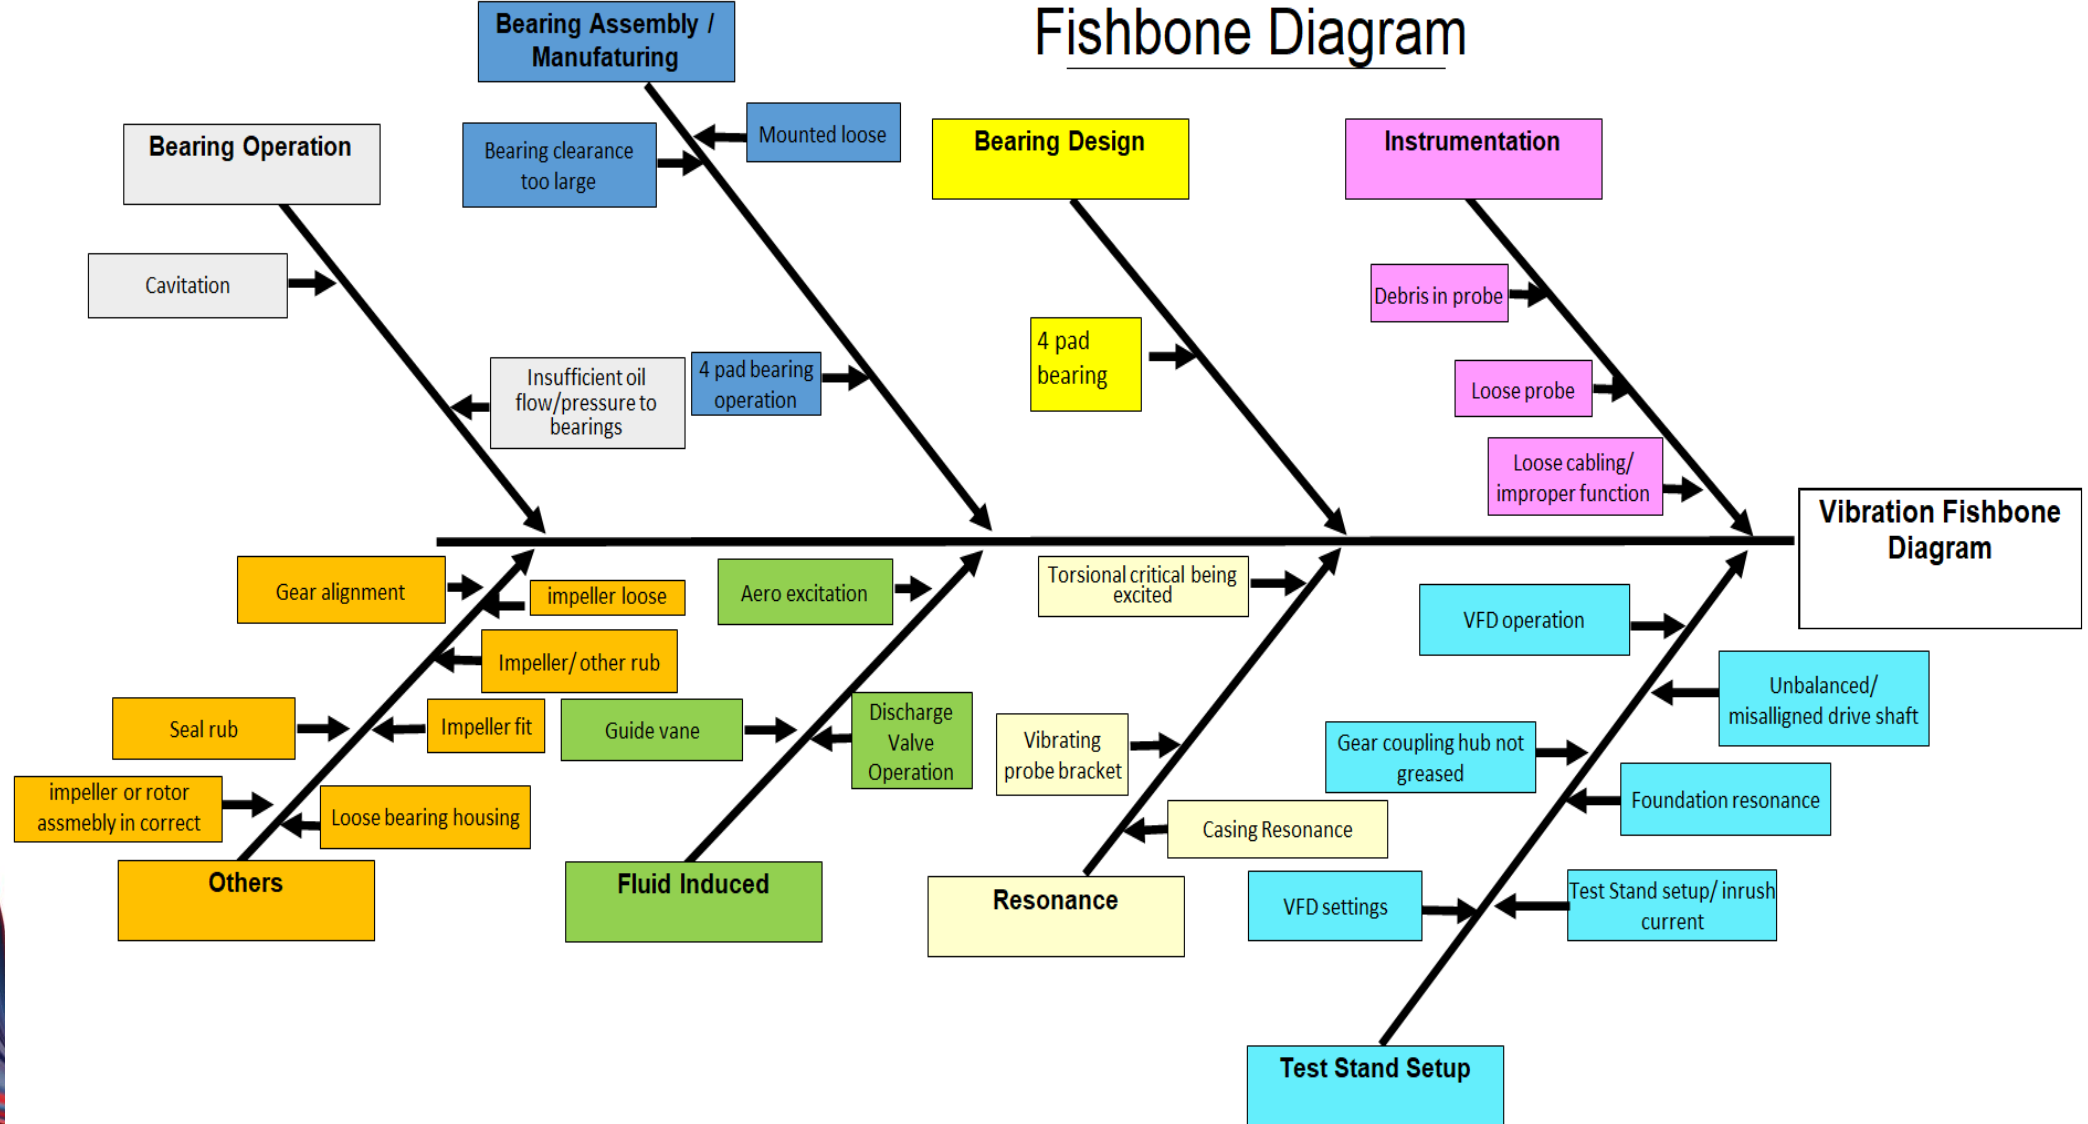
Fishbone Diagram

Potential Root Causes Considered:

Bearing was mounted loose or bearing clearance was not set properly

Instrumentation noise

Test Stand and its VFD were not set properly

Longer than usual flexible coupling was used on the new test bed

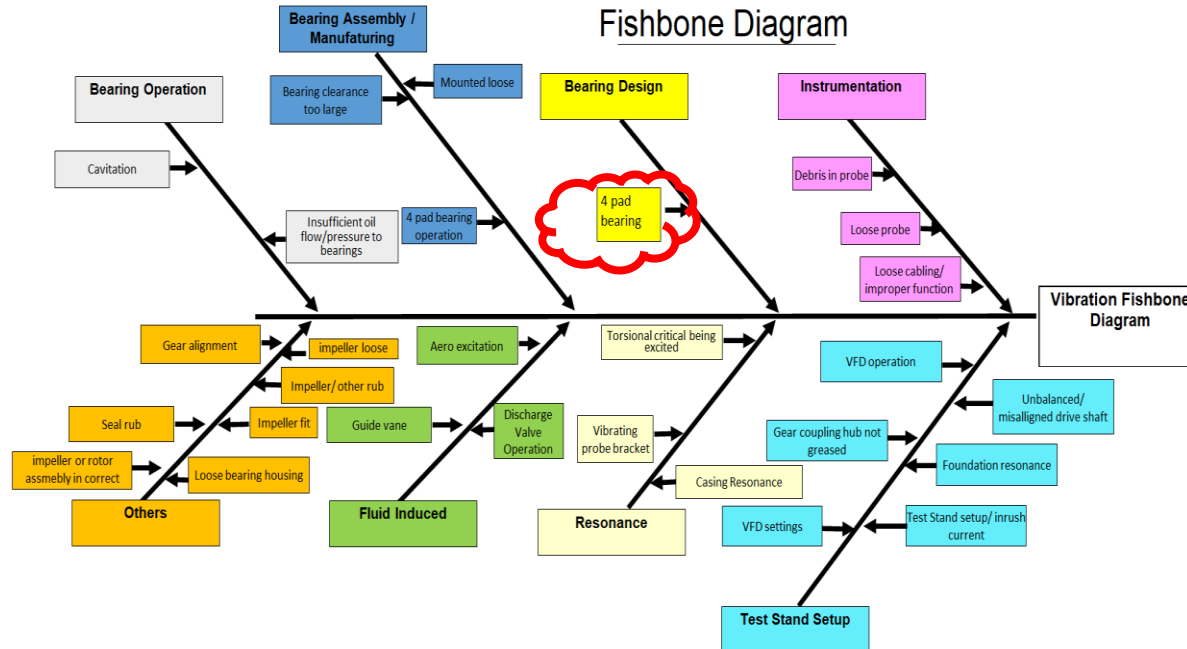
It was decided to send the machine to a different facility for more in depth testing. The initial test showed the same behavior as the previous shop tests.

The collected data and Fishbone Diagram were reviewed.

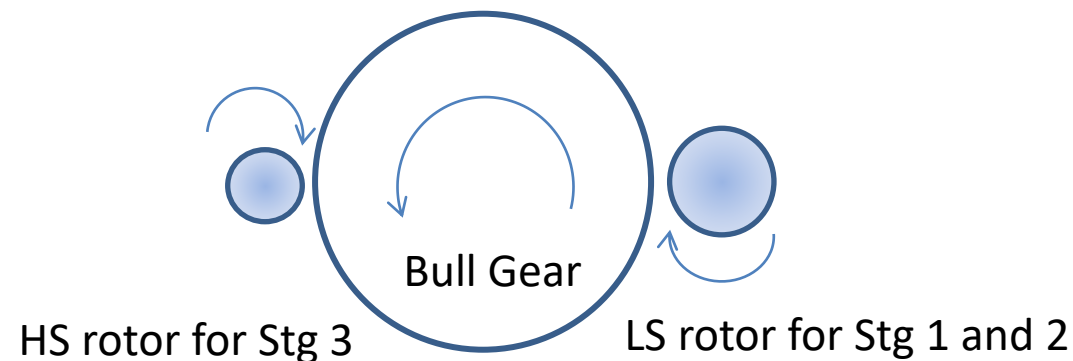
The LS rotor for the 1st and 2nd stages in the compressor is up driven. For up driven pinions during start-up, the initial torque can push the rotor upward. With the low aero load at start-up, the rotor can instantaneously move upward in the pinion bearings.

Besides, the LS rotor on this machine is installed with smaller impellers and it's the lightest weight LS pinion assembly being installed in this compressor frame size.

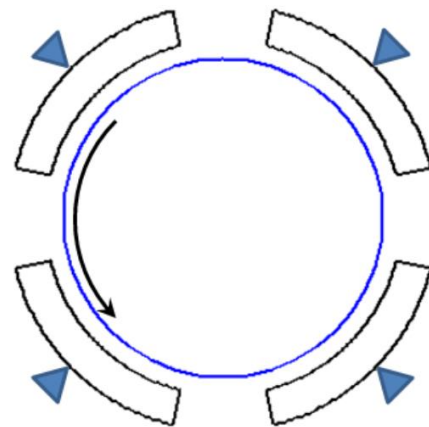
Before

With the same clearance (7 mils), the 4-pad design will lead to more displacement than the 5-pad one due to the geometric arrangement.

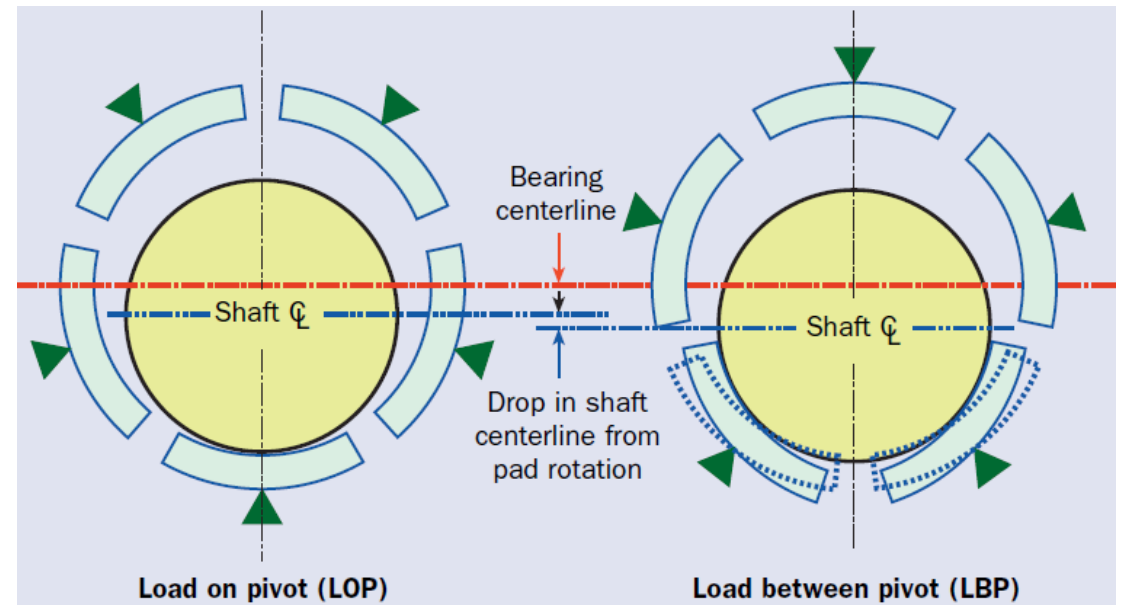
Bearing Clearance, Lift and Factor Table*

Brg Clearance = Factor x Lift → Lift = Brg Clearance ÷ Factor

Vibration Probe is detecting the Lift Displacement

LOP	LBP
3 pads	0.667 × lift	0.667 × lift
4 pads	lift	0.707 × lift
5 pads	0.894 × lift	0.894 × lift
6 pads	lift	0.866 × lift
