Aero-Derivative Gas Turbine Vibration Troubleshooting **Comparing Traditional ODS** and Motion **Magnification Video** Techniques

Maki M. Onari President Mechanical Solutions, Inc. (MSI) maki.onari@mechsol.com

Combined Cycle Plant near Darwin, Australia

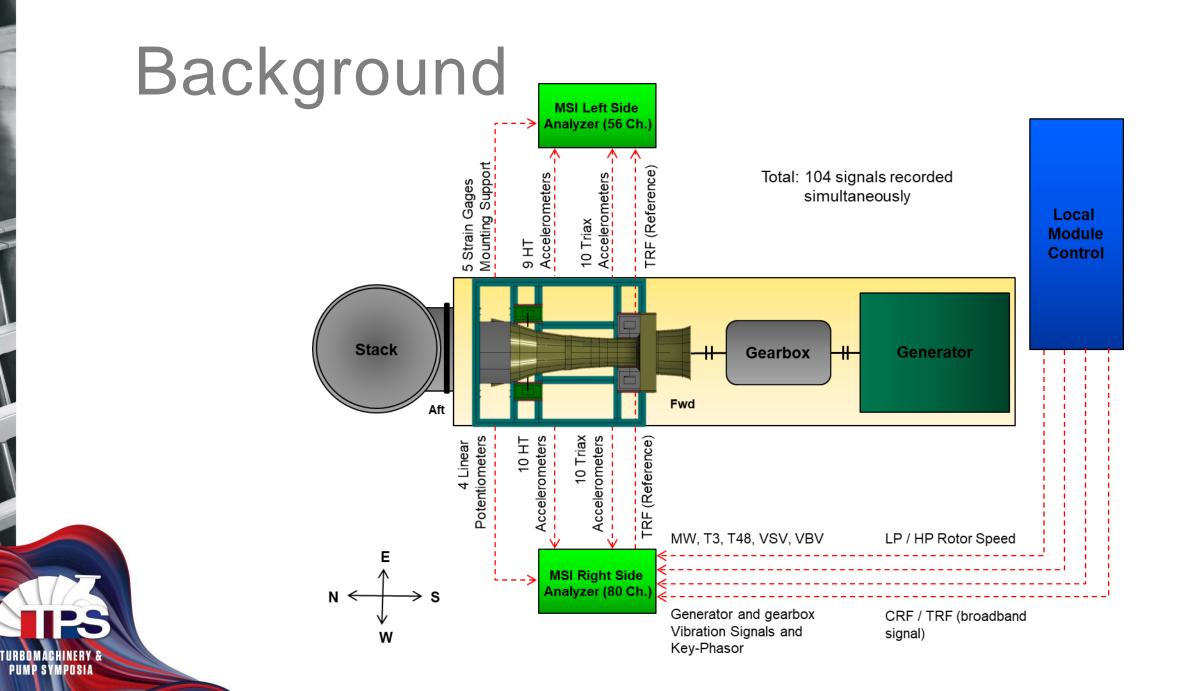
- Engine designed to operate for short durations at full power and long durations at low power
- Vibration at LP Rotor exceeded alarm and trip set points at 1.4 and 2.0 in/s peak filtered at 60 Hz
- Original package was modified at factory where engine mounts/ foot print were changed (longer than former units)
- Similar dynamic behavior (up to 1.5 in/s peak between 5 to 10 MW) with different leased engines
- Unsuccessful attempts to reduce vibration amplitude

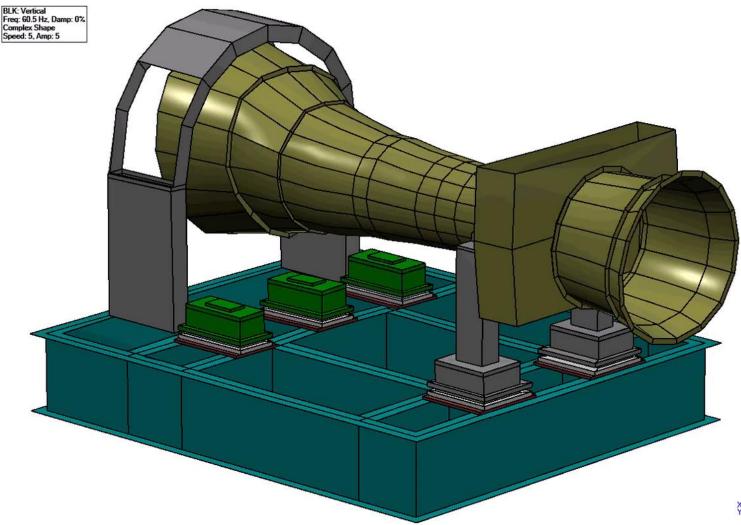
Experimental Modal Analysis (EMA) Test Results (64 Hz)

- Root cause of elevated vibration at low load operation (~8 MW) was due to a structural resonance of supporting system
- 2. Experimental modal analysis (EMA) test identified several structural natural frequencies near 1x rpm LP rotor speed mostly in vertical direction
- 3. Offending mode at 64 Hz (at rest) was tuning in and out depending on initial stiffness of support structure or mounts under load conditions
- Change in frequency is not related to thermal loading change in stiffness occurs suddenly as load applied through to Aft mounts changes

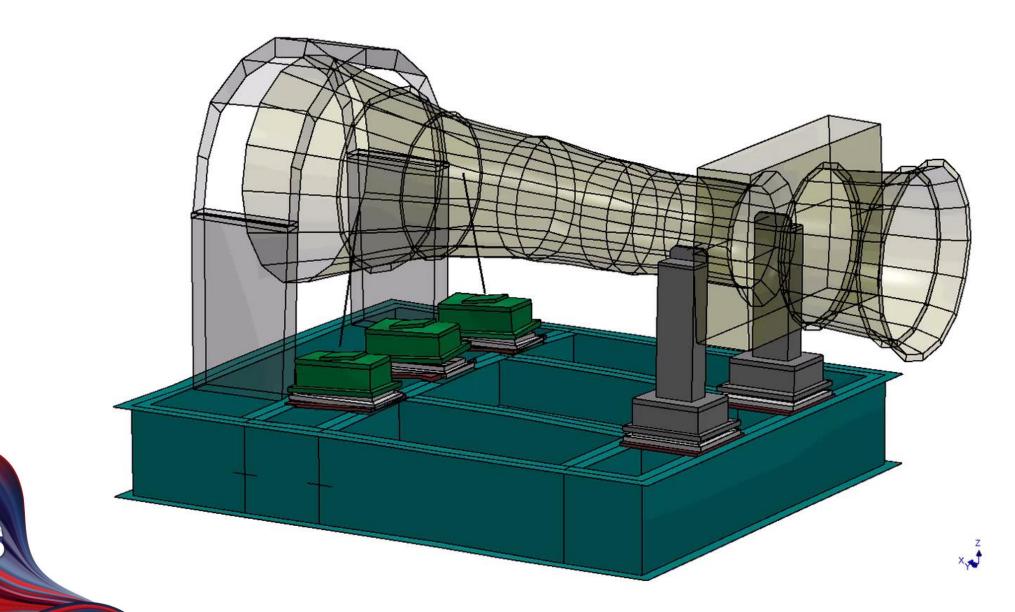
ODS at 60 Hz (5 MW Load)

- 5. As load was increased to 5 MW, this natural frequency shifted downwards to 61 Hz. At 7.8 MW, when maximum amplification was reached, this mode shifted to 60.5 Hz (LP rotor speed). After 14 MW, mode is slightly below LP rotor speed (~60 Hz), and at full load (33 MW) finally drifted down to ~55 Hz (9% separation margin from LP speed).
- Based on Operating Deflection Shape (ODS) testing, excessive flexibility was detected at baseplate underneath TRF Aft section, where Aft mounts are located – appears that cross I-beams, in cantilever attachment, are allowing excess vertical bending.

- 1. Shift offending structural natural frequency away from LP rotor speed.
- Eliminate looseness at bearing/ bushing of Aft mount supports by replacing bushing/ bearings and torque bar supports (restoring original tight clearances).
- 3. Additional gussets (1/2 inch thick) between two cross I-beams that support torque bar and Aft mounts. Ideally, cross I-beams should be same size as main I-beams (main baseplate frame) to avoid bending. Therefore, cross-I-beams can also be supported with concrete floor (to eliminate gap between lower flange of cross I-beams and concrete floor). New supports must be anchored to concrete floor.
