High Vibration of a Centrifugal Compressor Casing Caused by the Gas Leakage across a Damaged Gasket

TURBOMACHINERY & PUMP SYMPOSIA

DECEMBER 14-16, 2021

Baker Hughes

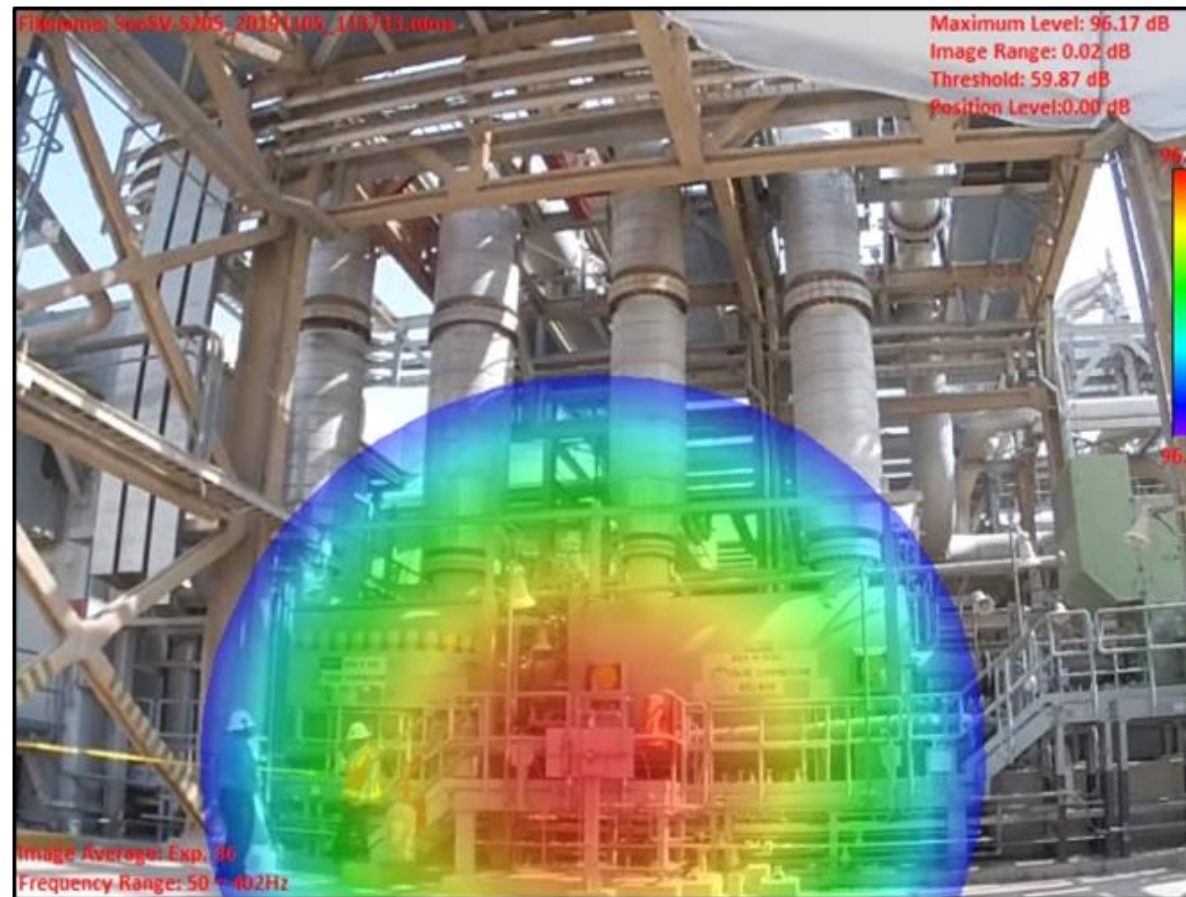
Sound camera confirmed the noise source to be from compressor discharge side

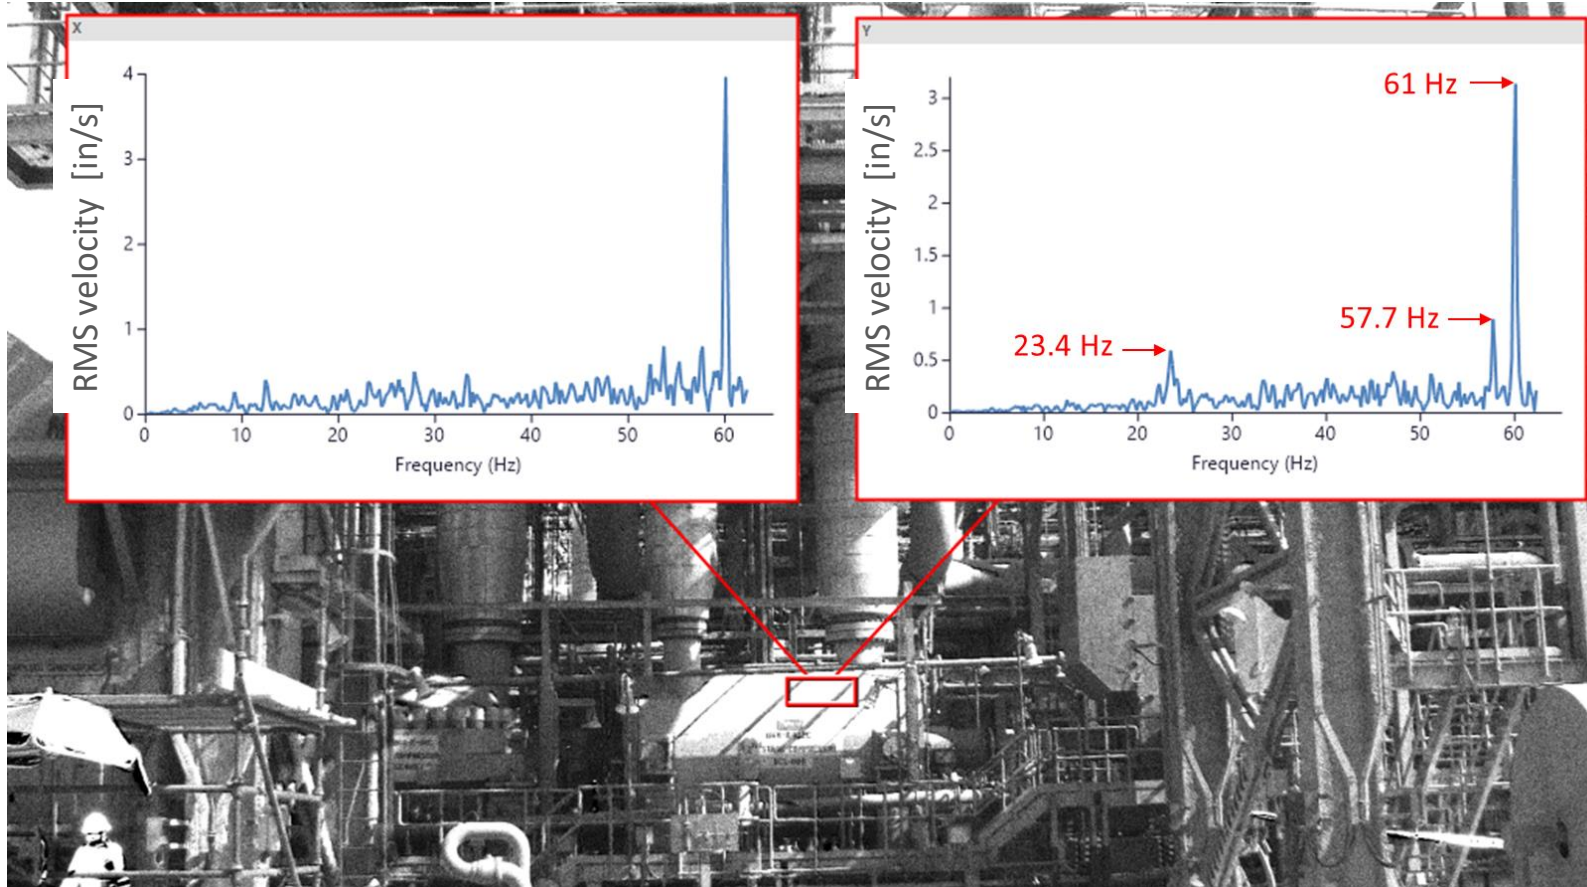
Motion amplification technology was utilized to confirm that the abnormal vibration stems from the casing itself and not from the surrounding structure.

- The dominant frequency of 1x (61 Hz) seen in the frequency spectrum originates from the machine running speed.
- The abnormal frequency component of 0.9x (57.7 Hz) observed on radial and casing vibration was also observed with the motion amplification camera.
- An abnormal frequency of 23.4 Hz was identified in the frequency spectrum which was sensitive to overall vibration levels. The source of this component was not clear.

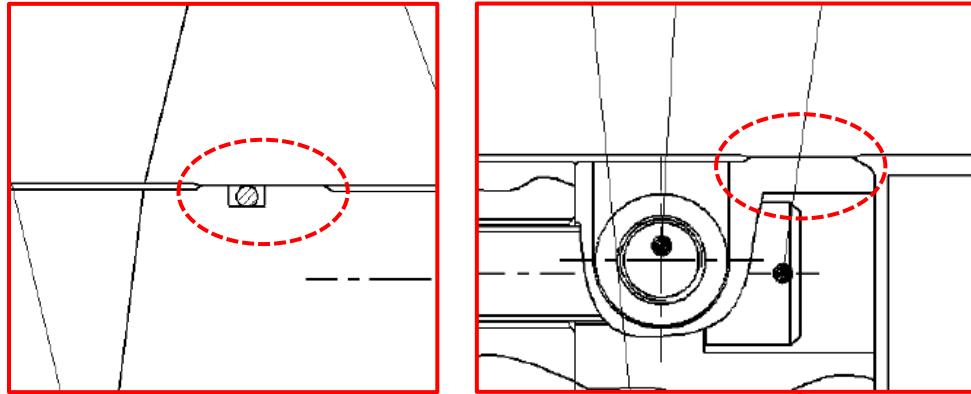
For fitting & sealing purpose there are two close-gap points between bundle and casing: A and C.

The clearance in zone B (large-gap) is much wider.

Diametral clearance @ location A & C: $a = 0.23 \text{ mm}$

Diametral clearance @ location B: $b = 6.25 \text{ mm}$

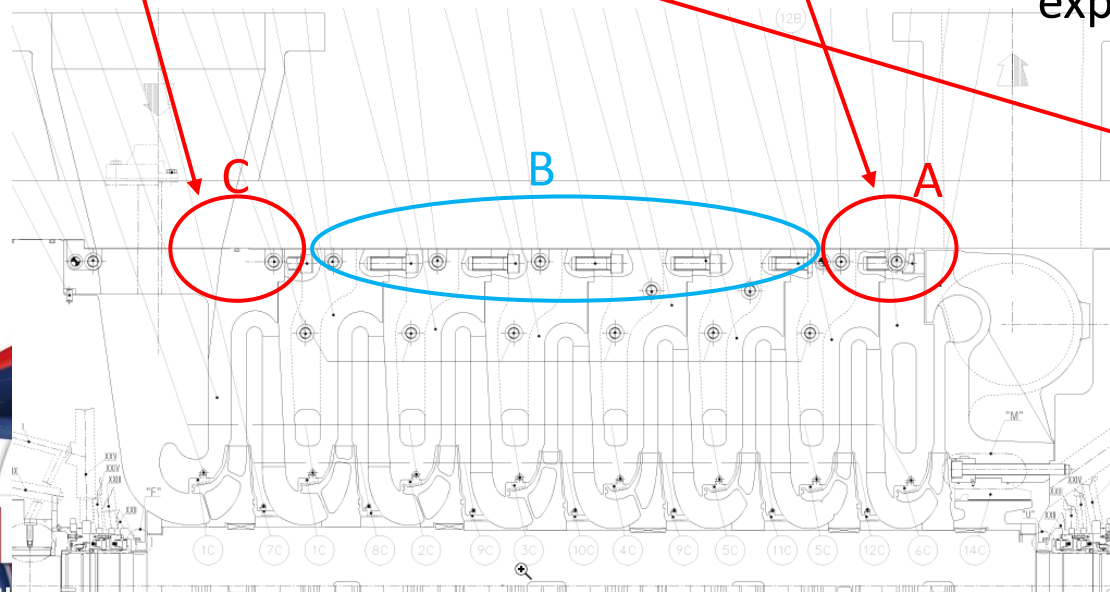
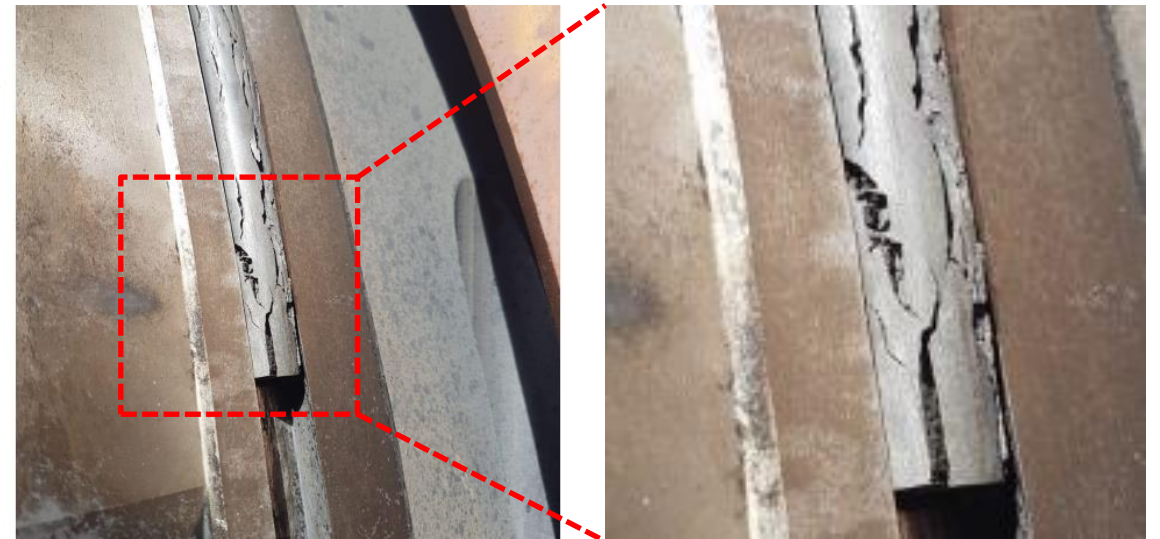
The O-ring at point C, separating gas @ $p_{\text{discharge}}$ from gas @ p_{suction} , was found severely damaged during inspection. The appearance of the failed O-ring is typical of explosive decompression.

The failed O-ring was replaced with a new one (resistant to explosive decompression) and the unit was reassembled and restarted in Feb. 2020.

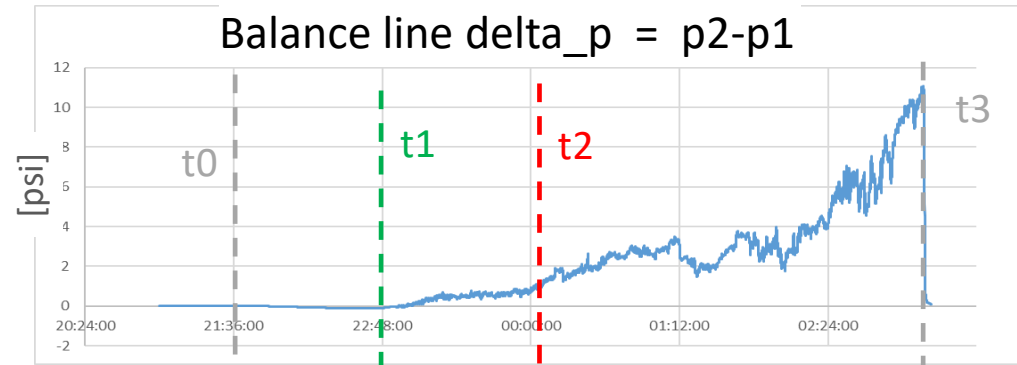
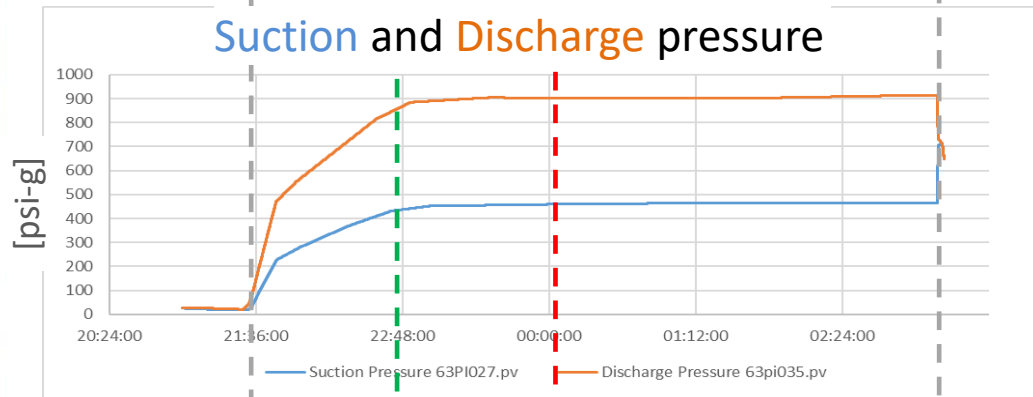
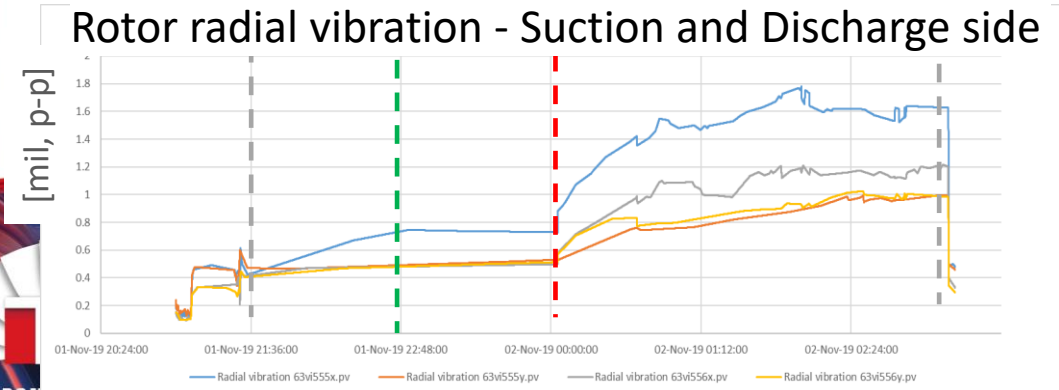
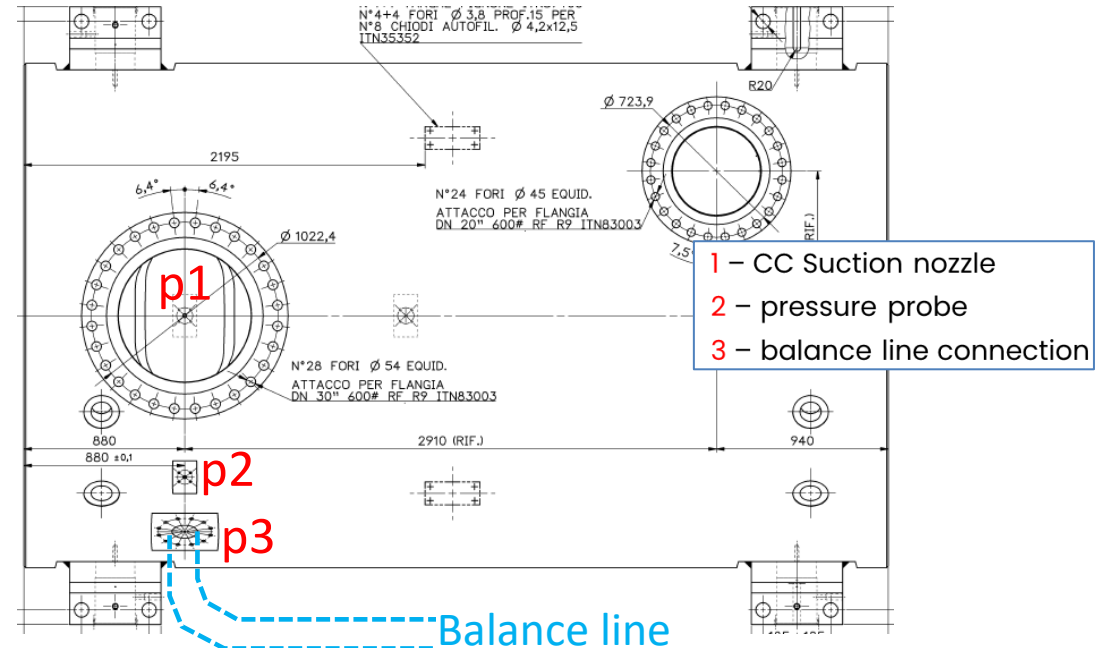
- Unit is started up at time t0. During normal operation, at time t1 (when pressures are stabilized) the balancing line delta_p starts increasing.
- At time t2 rotor and casing vibrations suddenly increase
- Unit is tripped at t3.
- Running speed is constant from t0 to t3.

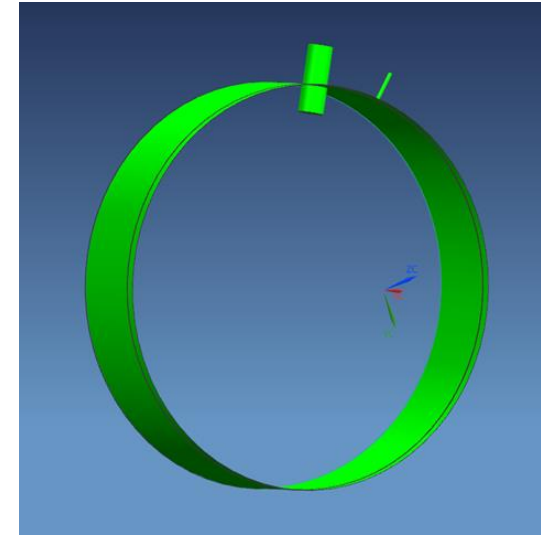
A CFD analysis was run to simulate the pressure differential between balancing line outlet **p3** and pressure tap **p2**, when the O-ring at location C is failed and therefore there is a calculated 7.1 kg/s leakage across the gap, limited by the sonic flow across location C gap (area $S_C=828 \text{ mm}^2$).

Results show a differential pressure up to 1.4 bar, fully compatible with the DP value measured at site.

3. P @ balance line outlet 34.8 bar

2. P @ pressure tap region 36.3 bar

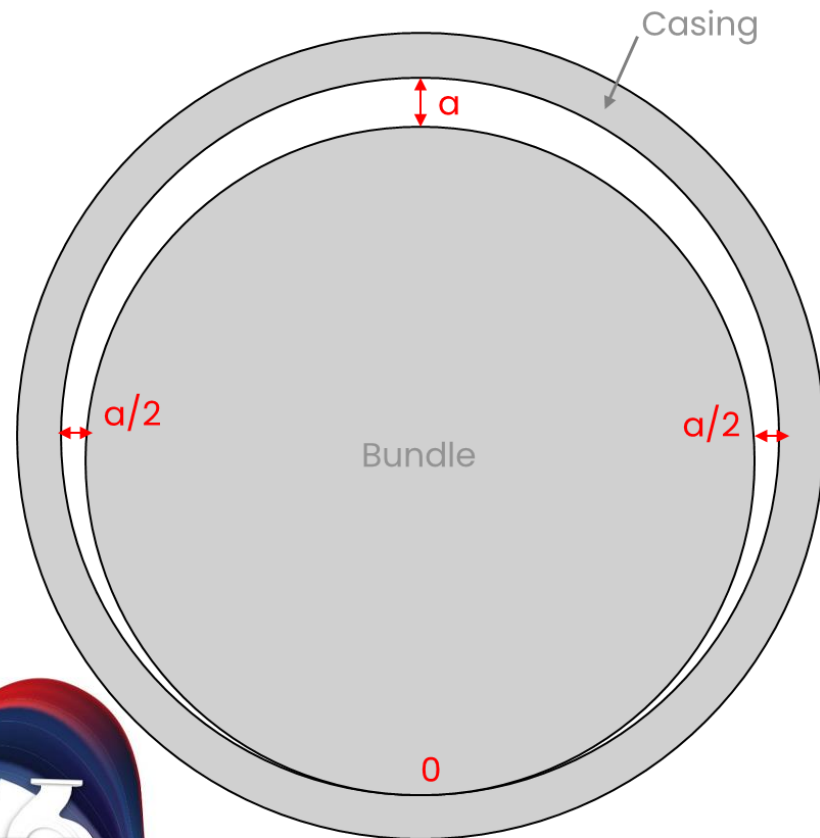
When the O-ring is working the bundle is resting on the bottom of the casing. The casing-bundle clearance at close-gap locations is $a=0.23$ mm at top, 0 mm at bottom and $a/2=0.115$ mm at sides.

Gas leakage velocity is $\cong 0$, due to the presence of the O-ring.

When the O-ring fails, the gas leakage is $G=7.1$ kg/s, limited by the sonic flow across close-gap location (area $S_c=828$ mm²).

The velocity of the gas leakage is not uniform around the bundle, since it is proportional to the local gap width:

- at bundle top, = **17.2** m/s
- at bundle bottom, = **0** m/s
- at bundle sides, = **8.6** m/s

Therefore the mean velocity along the bundle surface is $v_{TOP} =$ **12.9 m/s** for the top half, while it is $v_{BOTTOM} =$ **4.3 m/s** for the bottom half.

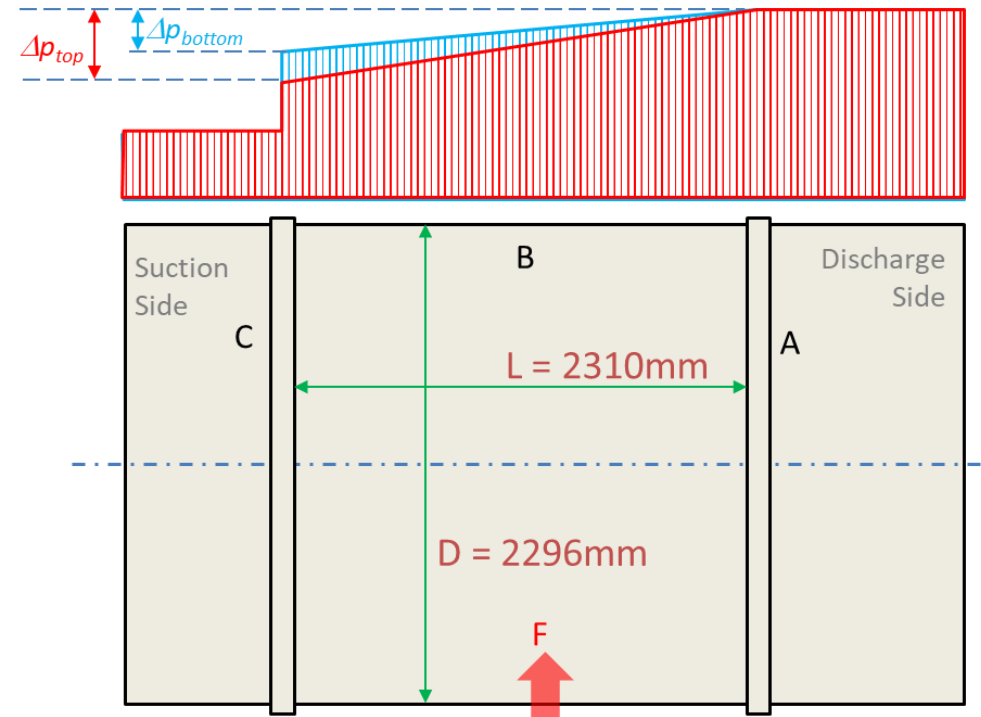
The resulting pressure distribution yields a net upward force $F = \frac{1}{2}(\Delta p_{\text{TOP}} - \Delta p_{\text{BOTTOM}})LD$.
Considering a $\pm 10\%$ uncertainty (mainly due to f):

$$F = 46,200 \text{ to } 56,400 \text{ kgf}$$

F in the same range of bundle weight (~54,000 kg): the O-ring failure may cause the lifting of the bundle.

The lifted bundle may then vibrate according to its natural frequency, when excited by the inlet process gas. Vibration may be further increased by matching of acoustic natural frequencies of the gas volumes.

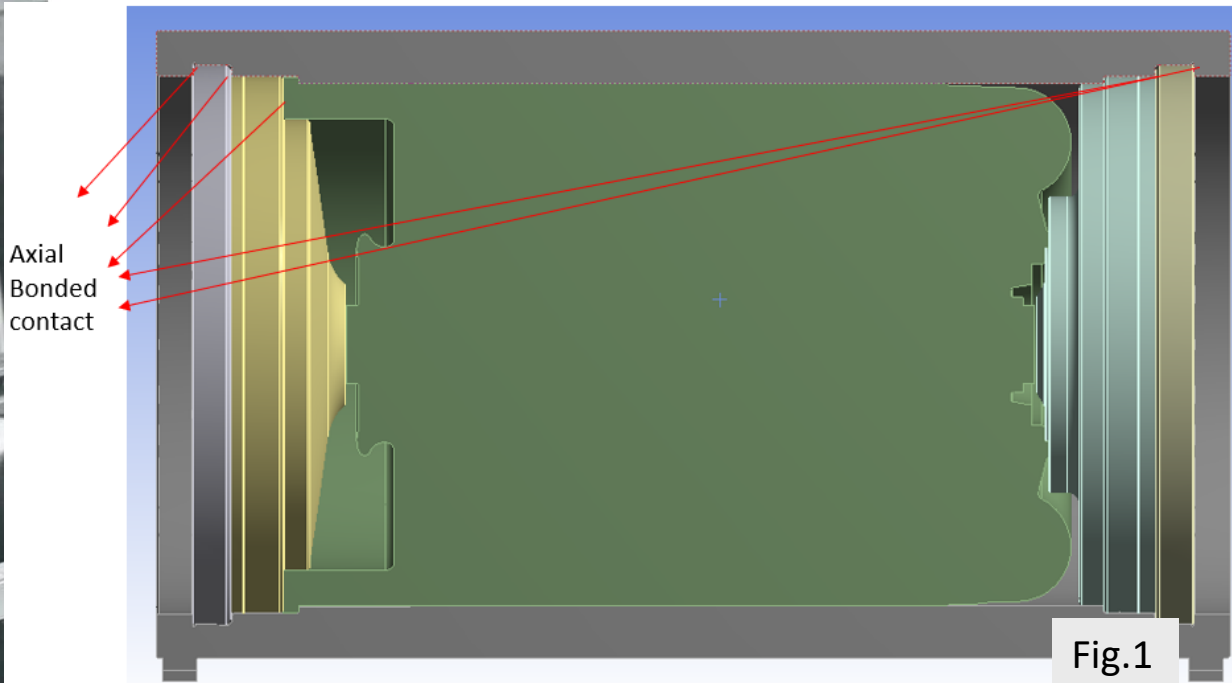
A FEA was run constraining the bundle, casing and head flange as in Fig.1. Constraints were also placed on casing feet, to simulate the locking on supports.

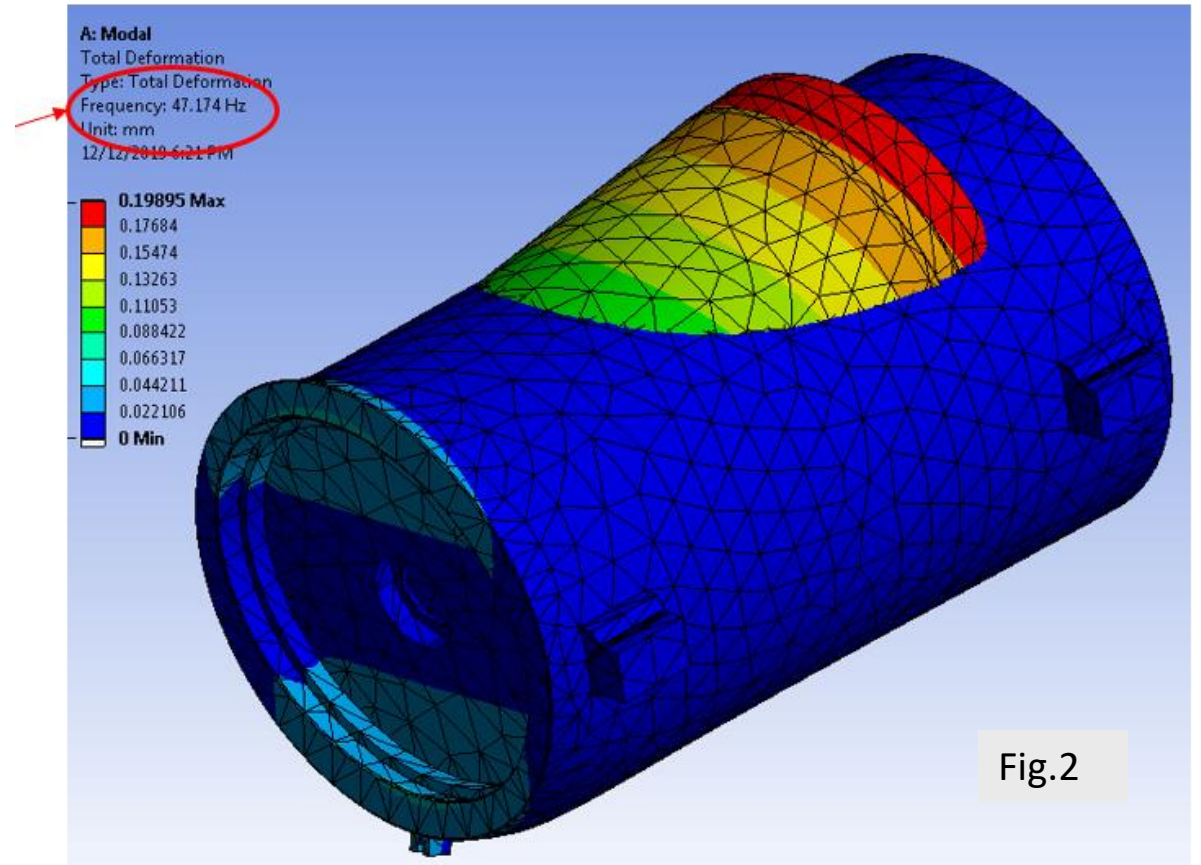
The first natural mode of the system (Fig.2) is ~ 50 Hz, corresponding to 0.9X of rotating speed and matching the observed frequency.

This mode is normally suppressed by the own weight of the bundle. But the uneven pressure distribution associated to the failed O-ring can lift the bundle, removing this constraint.

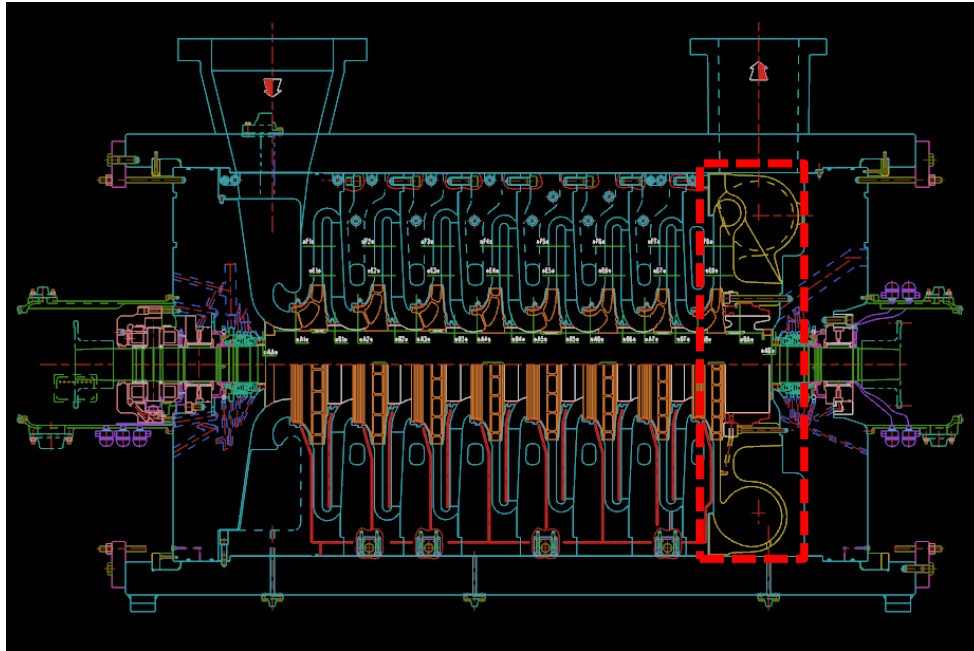
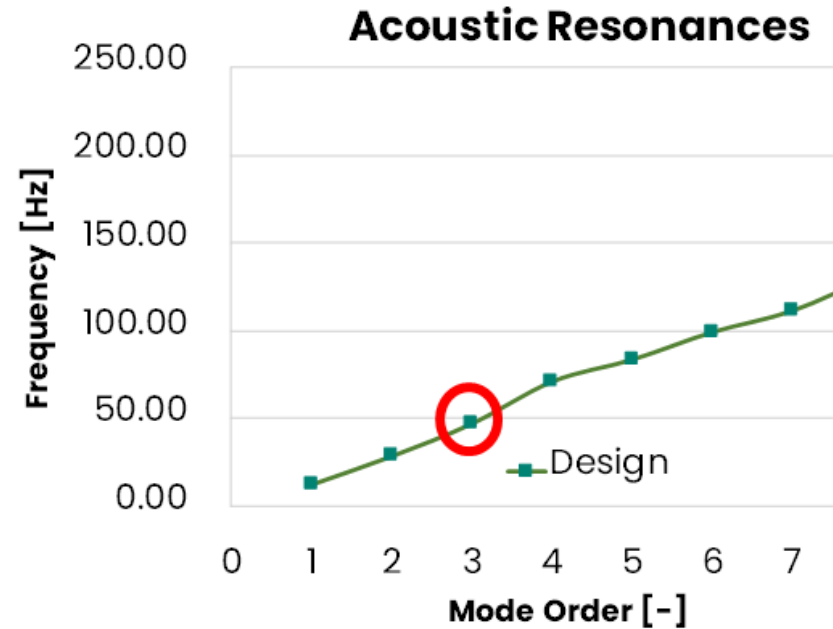
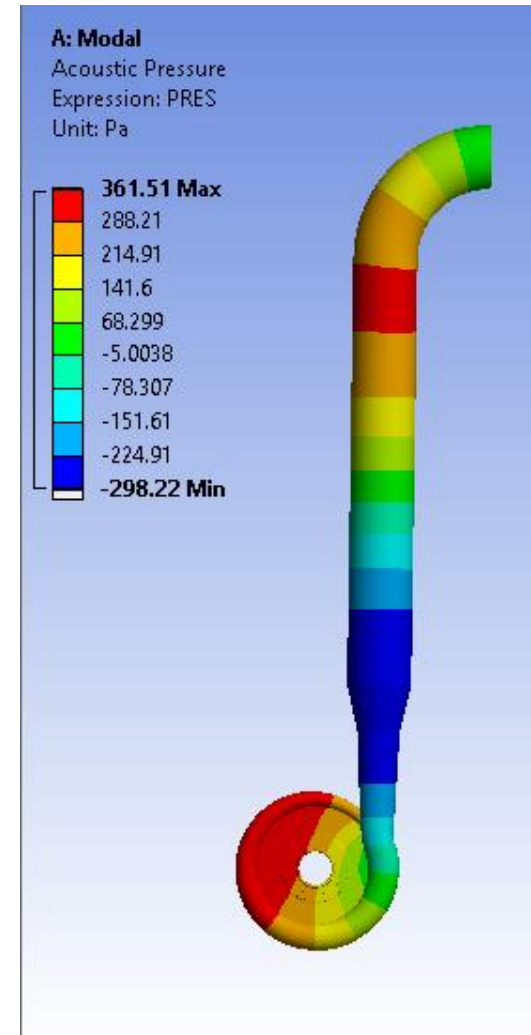
- Acoustic cavities at compressor discharge were modeled by CFD: 1) discharge scroll + piping, 2) cavity btw. last impeller and diaphragm, 3) cavity btw. discharge scroll and casing, 4) balancing line.
- Acoustic analysis results show that the 1st natural mode of cavity #3 is 47 Hz, matching the vibration frequency.
 - This coincidence btw. acoustic & vibration frequencies yields an amplification of the excitation, and is the most likely reason for the loud noise detected @ compressor discharge.
