# 49<sup>TH</sup> TURBOMACHINERY & 36<sup>TH</sup> PUMP SYMPOSIA

## Analyzing and Resolving an ID Fan Failure Due to Torsional Vibration

Gary Galloway, Carmeuse Lime  
Dan Phillips, Regal Beloit America, Inc.

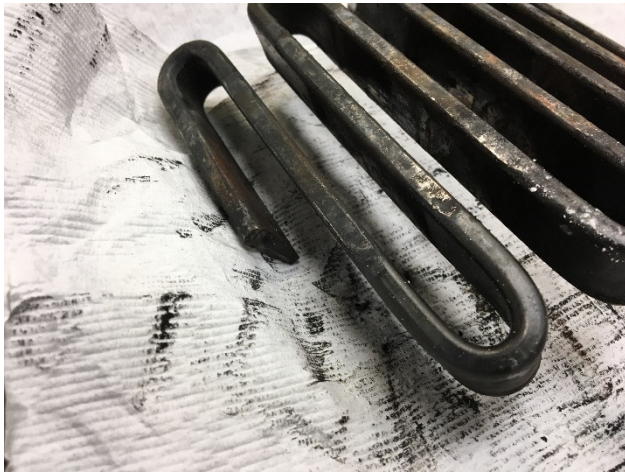
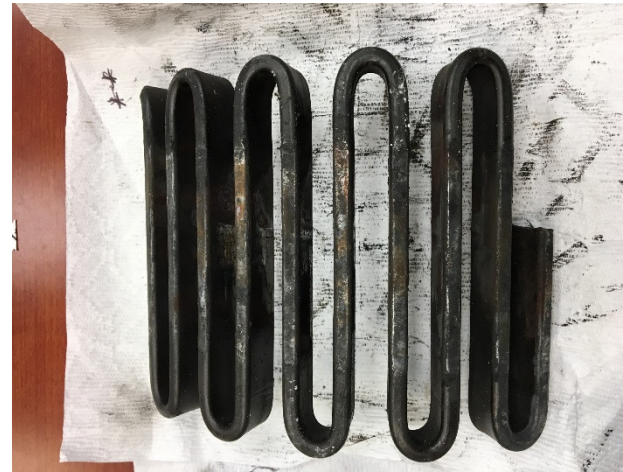
- Occurred approximately 3 days after start-up, following removal of the fluid drive and VFD installation
- Motor shaft cracked at 45 degree angle, originating at the keyway
- Grid coupling element showed signs of excessive heat

Broken Grid Coupling Element + Indications of Excessive Heat

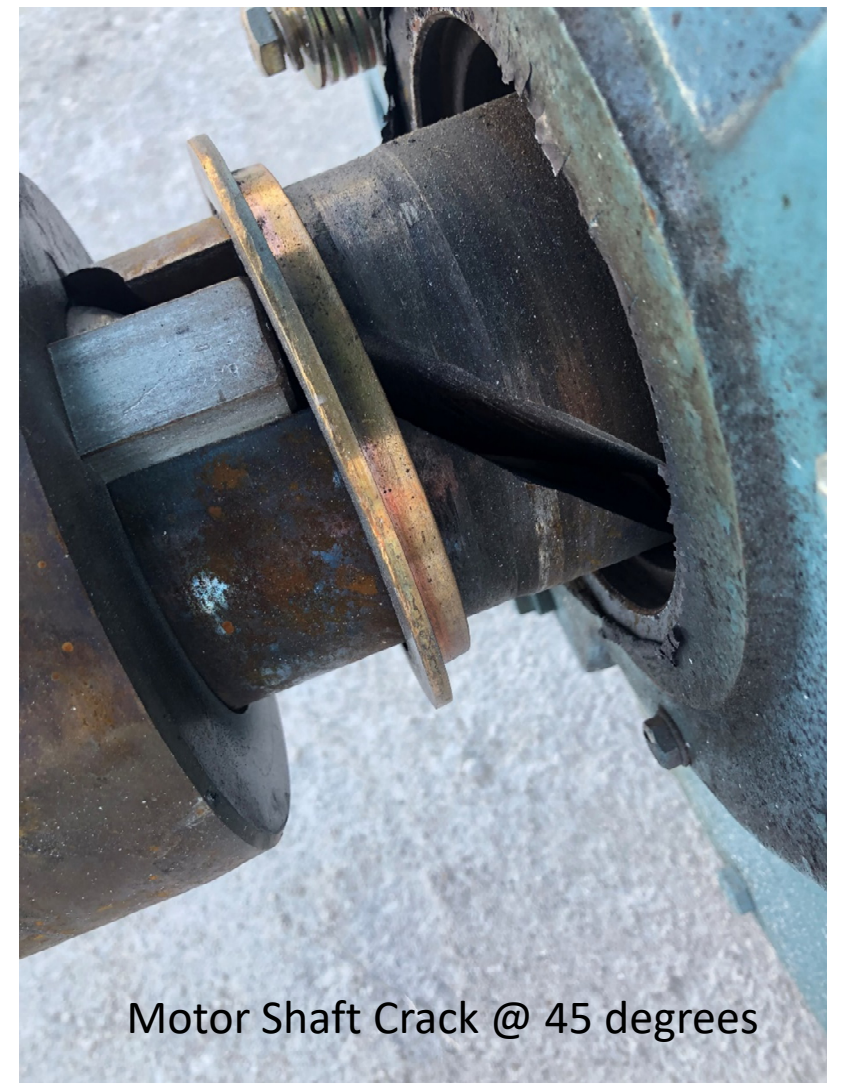
Motor Shaft Crack @ 45 degrees

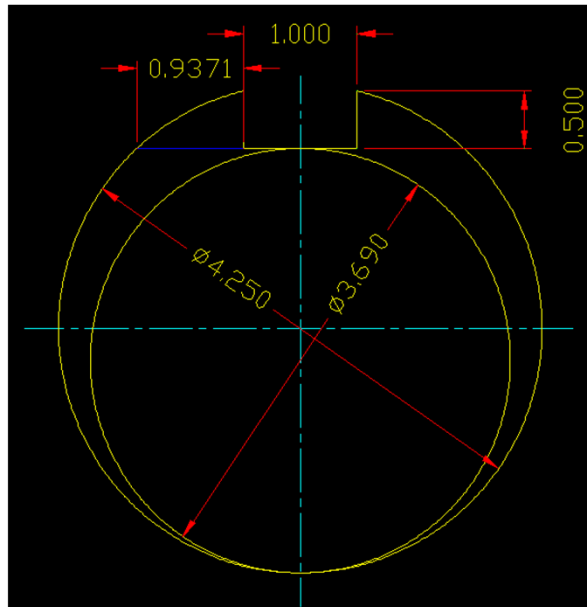
- Stress Analysis of Shaft and Fan shaft locations was performed to estimate the magnitude of loads required to damage shafts.
- Calculations also utilized to convert values of strain measured on shaft elements to torque
- Torque (and stress) used to determine allowable loading, both static and dynamic

Location	Safety Factor @ Normal Torque	Safety Factor @ Peak Torque (1.91 X Nominal)	Considered Shaft Material
Motor Shaft	6	3.15	AISI 4140
Fan Shaft	8.13	4.26	AISI 1045

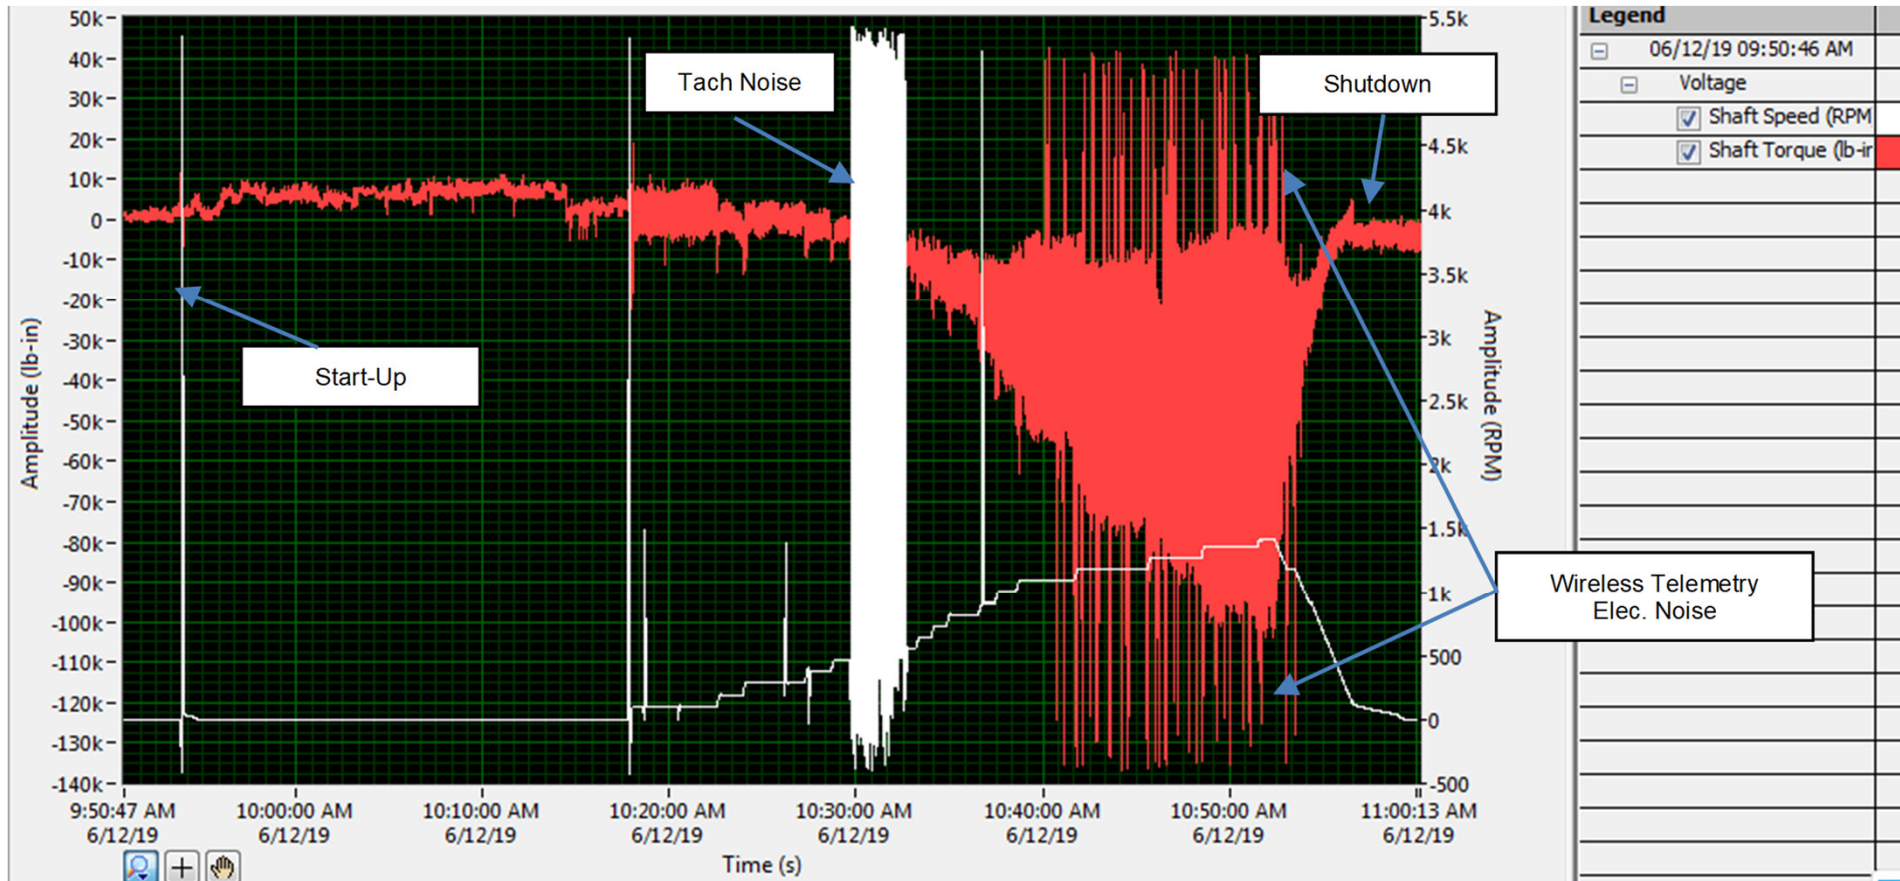
- During start-up there were minor reversing torques, typical in these applications due to the fan inertia.
- Frequency of oscillations occurred at 21 Hz, most likely the torsional natural frequency (TNF)
- Frequency of oscillations increased with load - Elastomeric blocks do not have a constant stiffness across the entire load range, stiffness increases with torque - and increases the TNF of the system.

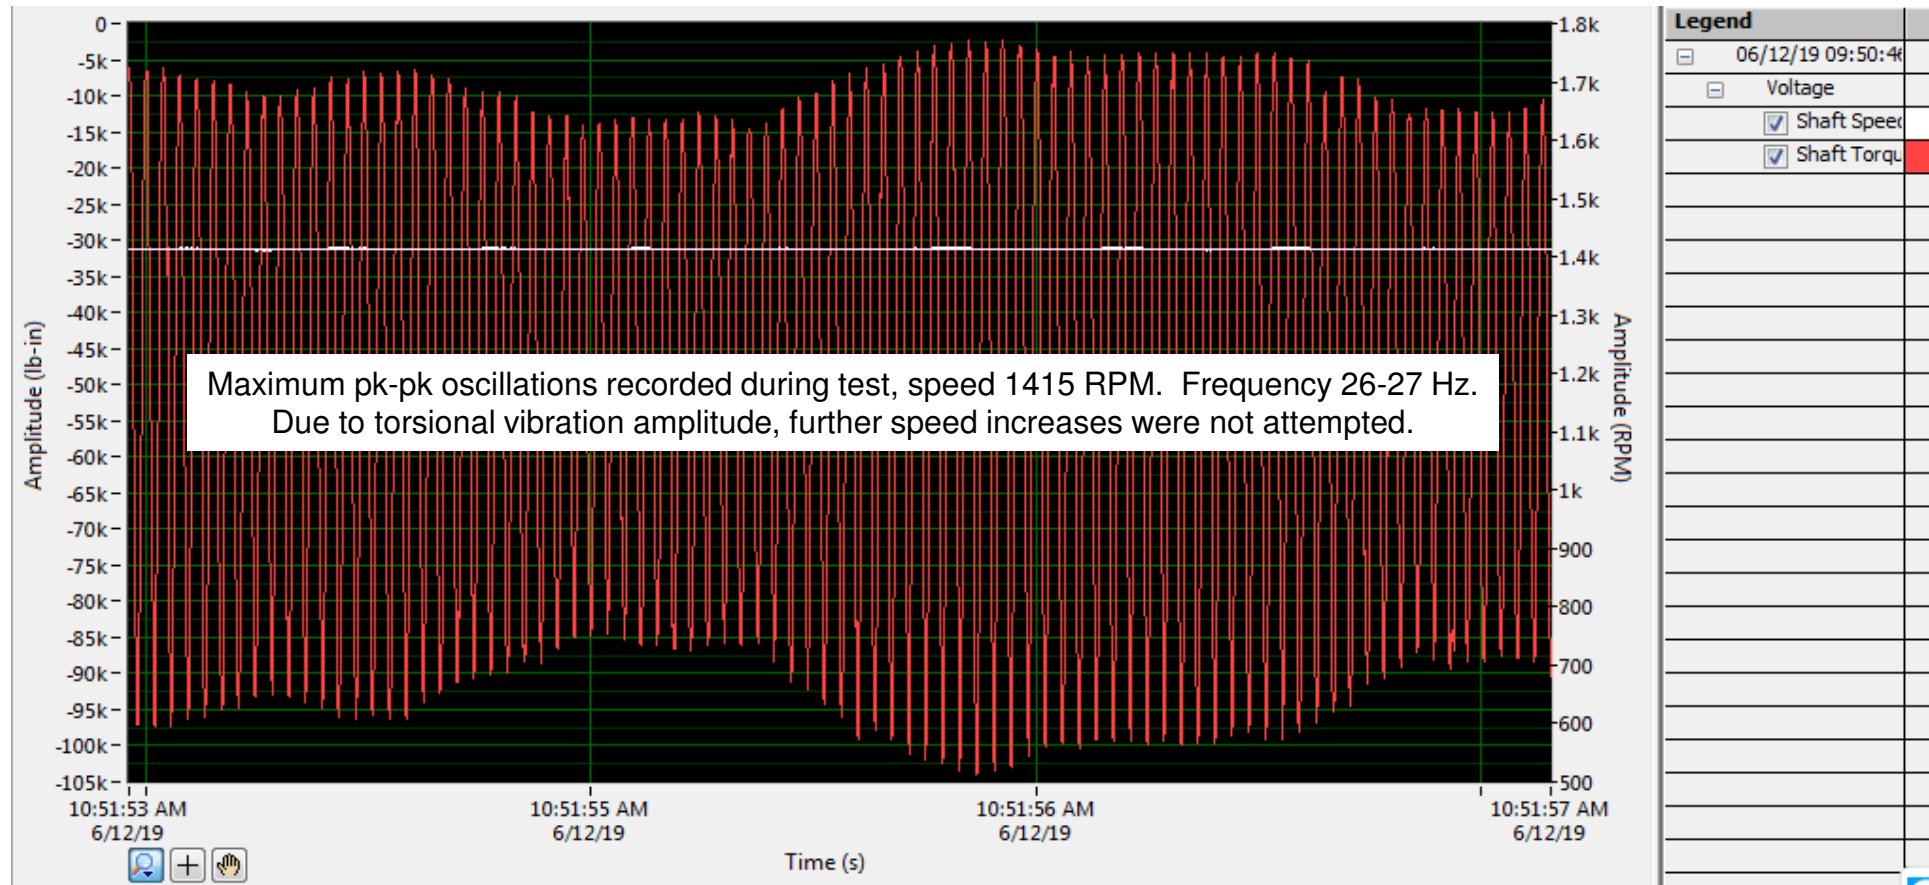
- As speed increased, the magnitude of the oscillations increased to over 2X nominal torque and frequency steadily increased to 26-27 Hz. There was some modulation which was noted in the torque waveform.
- Suspected that oscillations could be from gain settings in the PID controller integral to the drive. Testing of the drive in conjunction with torque measurements showed no effect.

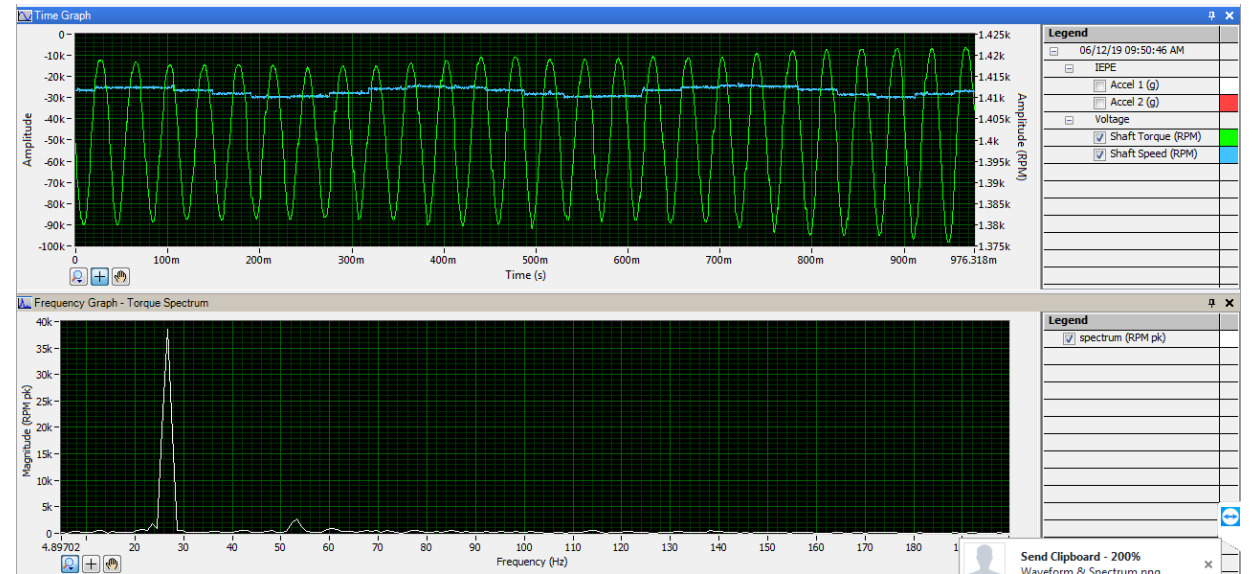
During testing with K2 coupling, oscillations started at 21 Hz, and increased to 27 Hz as speed and load increased.

The stiffness of the elastomeric coupling will increase with load, creating an increase in the natural frequency of the drivetrain. The TNF measured corresponds with the expected range of the coupling stiffness + load.

Dominant 27Hz frequency at 1410 RPM  
 Testing ceased before further speed increases due to torsional amplitude.

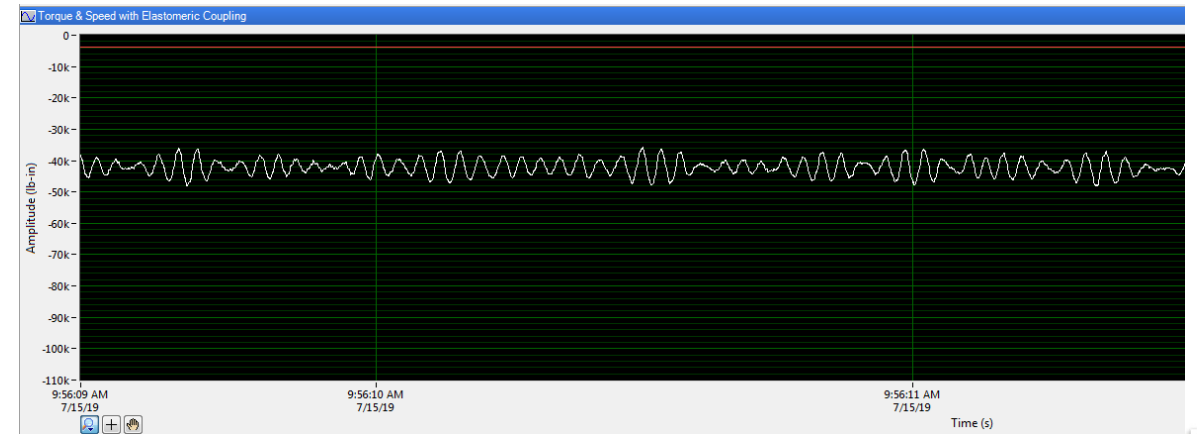
- Final testing showed a significant reduction (80%) in the torsional vibration, keeping the stress in the motor shaft below the endurance limit for the material.
- Testing was performed throughout the entire speed range with the kiln at  $\sim 600$  °F and showed no torsional oscillations of concern.

After Coupling Replacement  
Harmful oscillations reduced by 80%

Size 5.5 WB (Wedge Block) Selected based on increased system natural frequency and allowable dynamic torque ratings

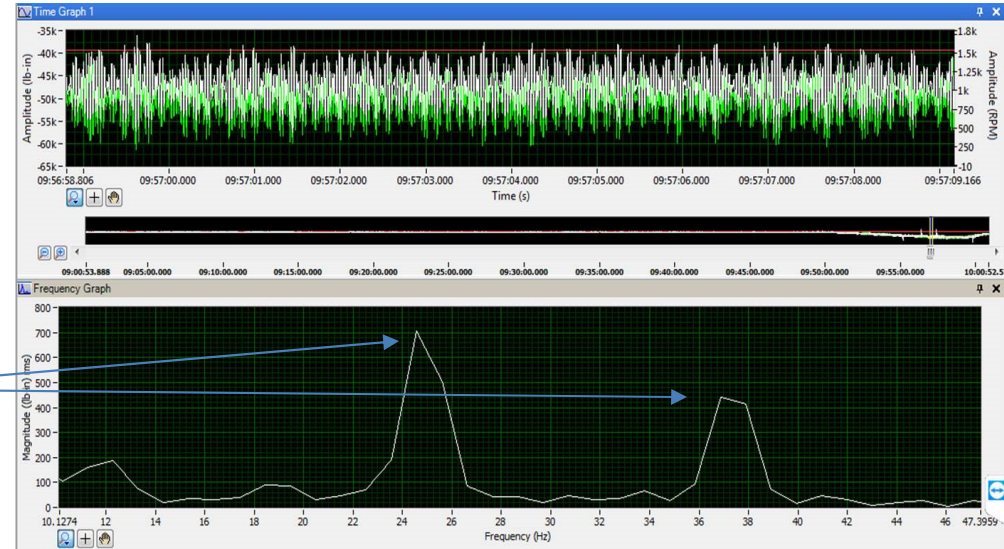
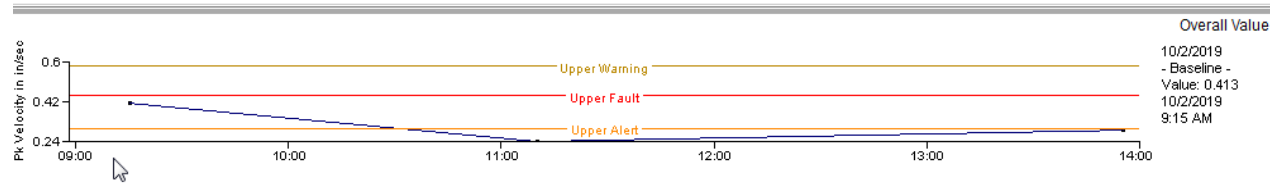
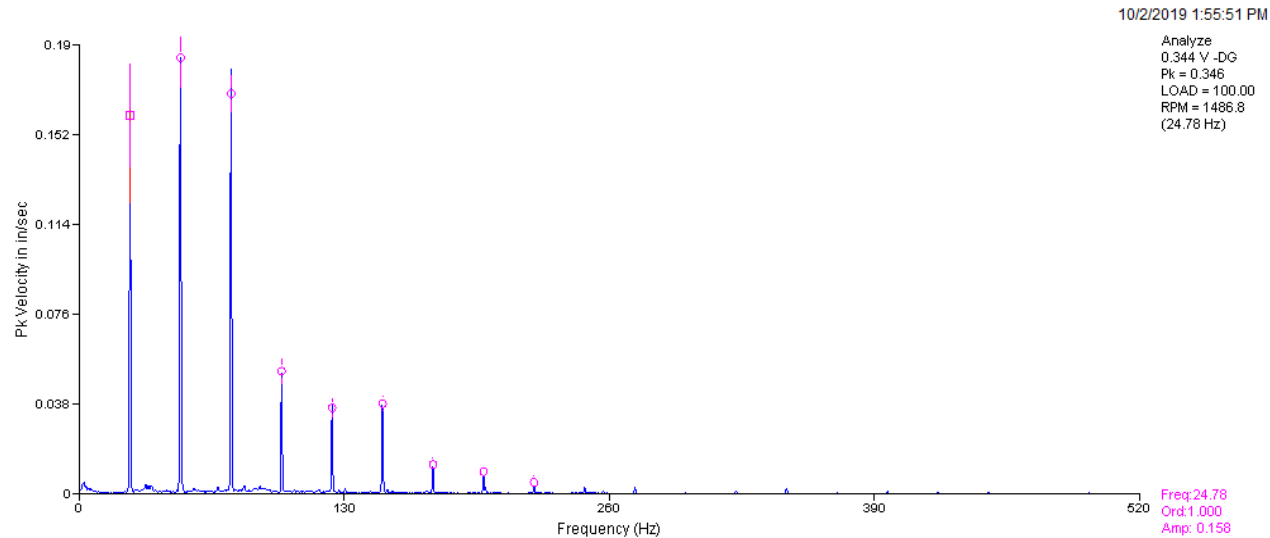
- From the torsional analysis, a TNF of ~40 Hz (dependent on torque applied) is expected. From the measurements, we see that there are oscillations occurring at 37 Hz (2220 CPM).
- Torsional Vibration Spectral data shows (2) distinct peaks now
- Additional Vibration testing on the bearings

Radial Vibration levels on the inboard fan bearing show high harmonics at 1-3x RPM which is a sign of looseness and misalignment.

Phase readings across the coupling show a phase shift of 110° in the horizontal plane, 180° in the vertical and axial planes.
