# 49<sup>TH</sup> TURBOMACHINERY & 36<sup>TH</sup> PUMP SYMPOSIA

## Carbon Ring Seal Failure in a High Pressure CO<sub>2</sub> Compressor

Patrick J. Smith and Matthew I. Barausky

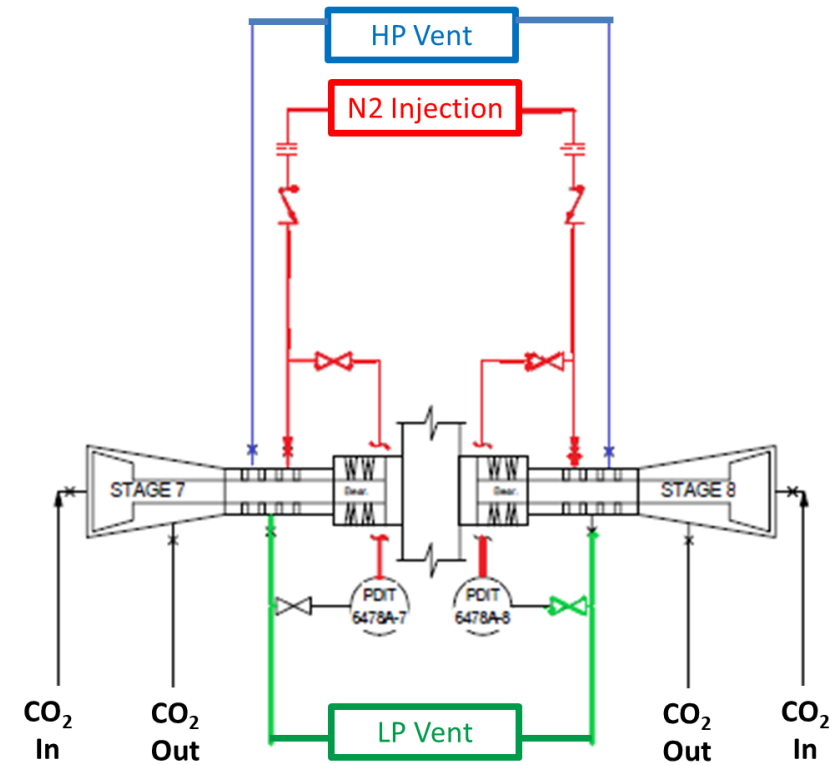
- During commissioning (first test runs), HP vent flow meters went off scale on the stages 6, 7 and 8 shaft seals. A design error was identified with the flow meter specification which resulted in an inadequate range. However, after retrofitting with higher range flow meters, the flow meters still read off scale.
- A manual valve added to the HP vent header to allow for throttling and increasing back pressure on the vent ports.
- Four new plants feed into this compressor and each was new so that there was a long list of open issues. A decision was made to continue operating while open issues were worked through.

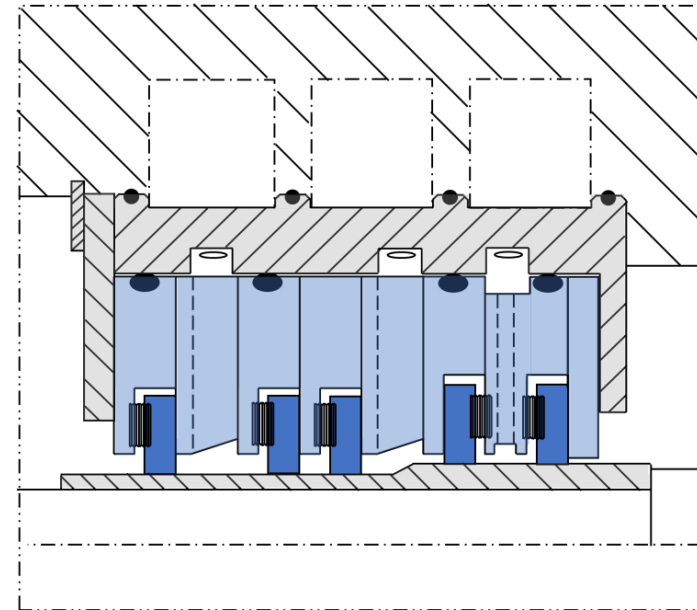
- The compressor continued to operate with the high vent flows while the cause was investigated. Plants were online at this time so the machine could not be shutdown for internal inspections without causing curtailments.
- After a few months in service, the machine tripped on high vibration. While repairing the cause of the vibration, the stage 7 and 8 seal cartridges were changed out with spares.
- After the outage, the stage 7 and 8 seals were inspected with the OEM and substantial deformation of the seal support plates (lantern rings) was discovered.

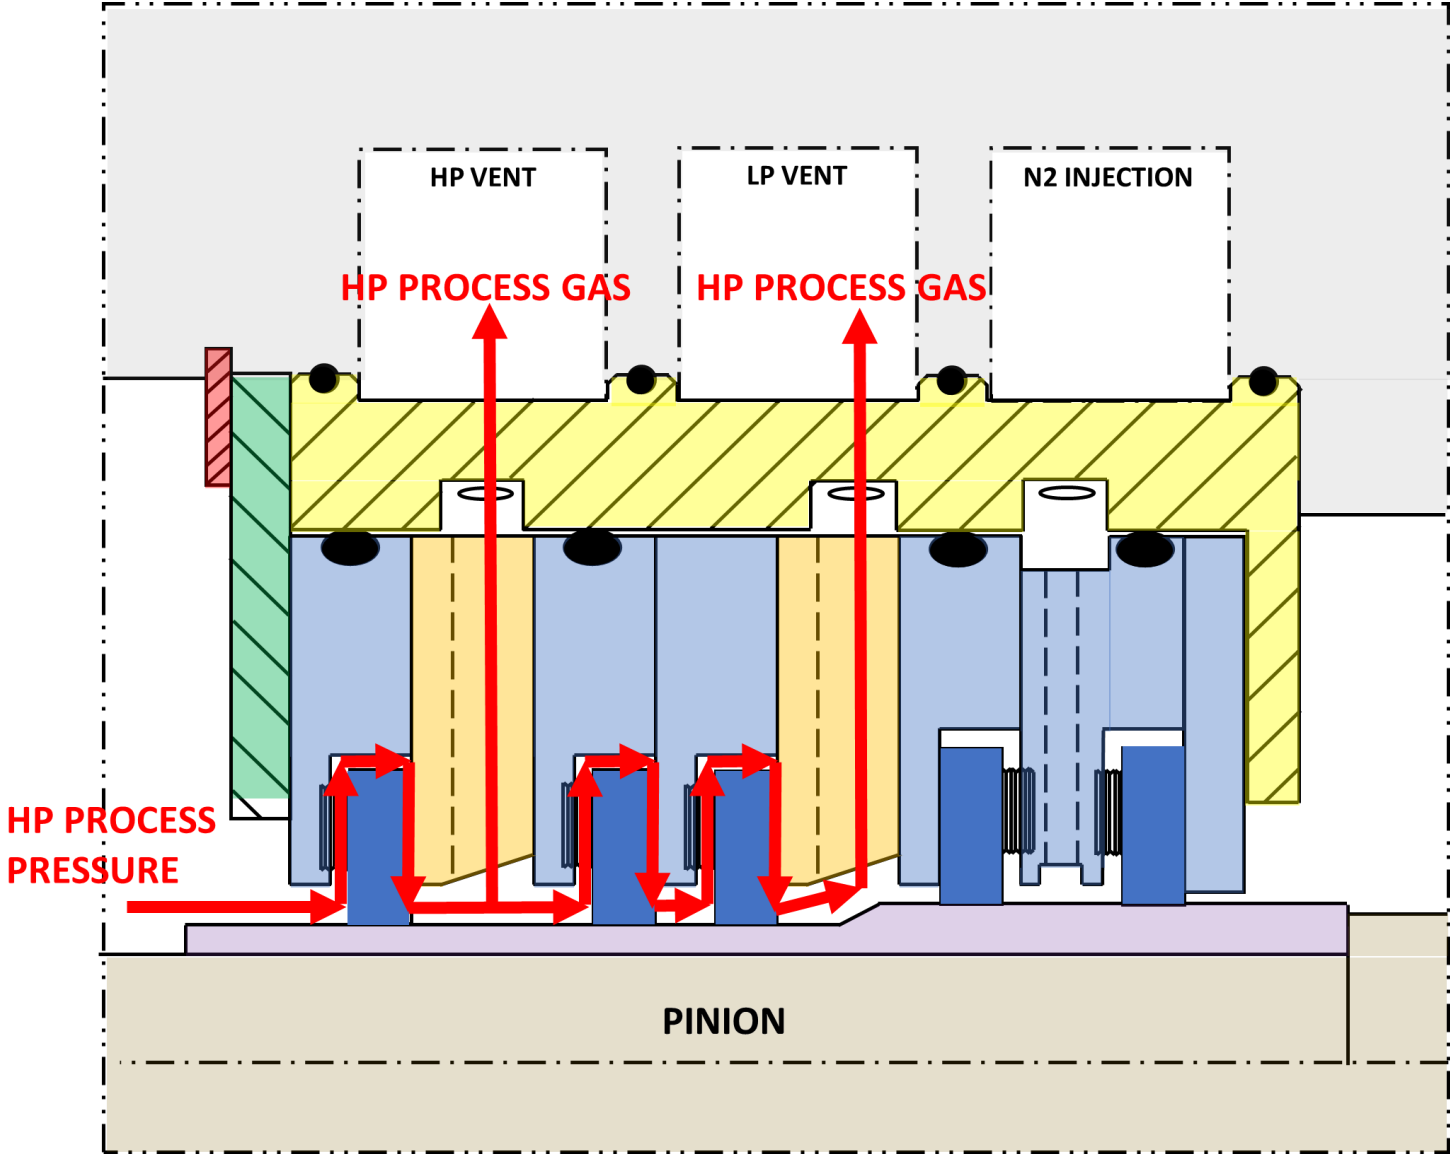
- **Root Cause**: The axial force from differential pressure across the seal rings transmitted to the lantern rings and their thin sections were permanently deformed. This allowed substantial high pressure gas to leak past the carbon ring seal faces.
  - ~8,000 lbf axial force from pressure differential on 7<sup>th</sup> stage.
  - Lantern rings deformed ~0.040 inch (1 mm) at midspan between supports. Plate thickness in this area is ~0.110 inch (2.8 mm).
- **Solution**: Strengthen the thin areas of the lantern rings by increasing the number of support ribs.
