49TH TURBOMACHINERY & 36TH PUMP SYMPOSIA

LUBE OIL CARBONISATION

Power station has a combined power generation capacity of around 230 MW. This unit (~40 MW) was brought back into service after being in cold storage for 4 years.

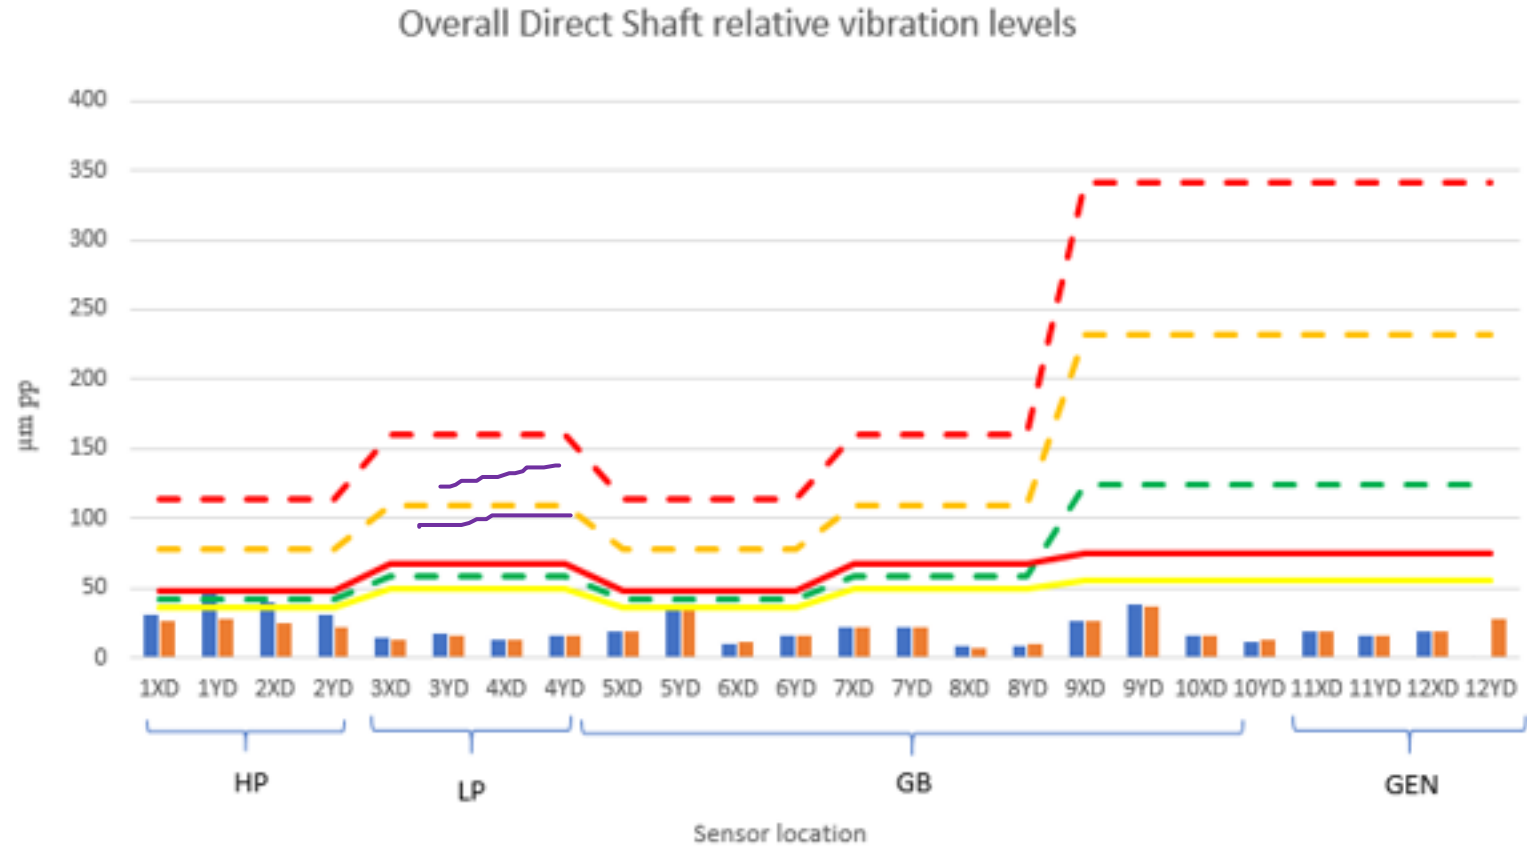
Overall levels were well below trip levels at normal operating condition however the levels exceeded alarm levels during one of the spiking event leading to a trip.

- Direct Vibration levels just before trip
- Direct vibration levels- Normal operating conditions
- ISO 7919-3 Zone A
- ISO 7919-3 Zone B
- ISO 7919-3 Zone C
- OEM Alarm
- OEM Danger

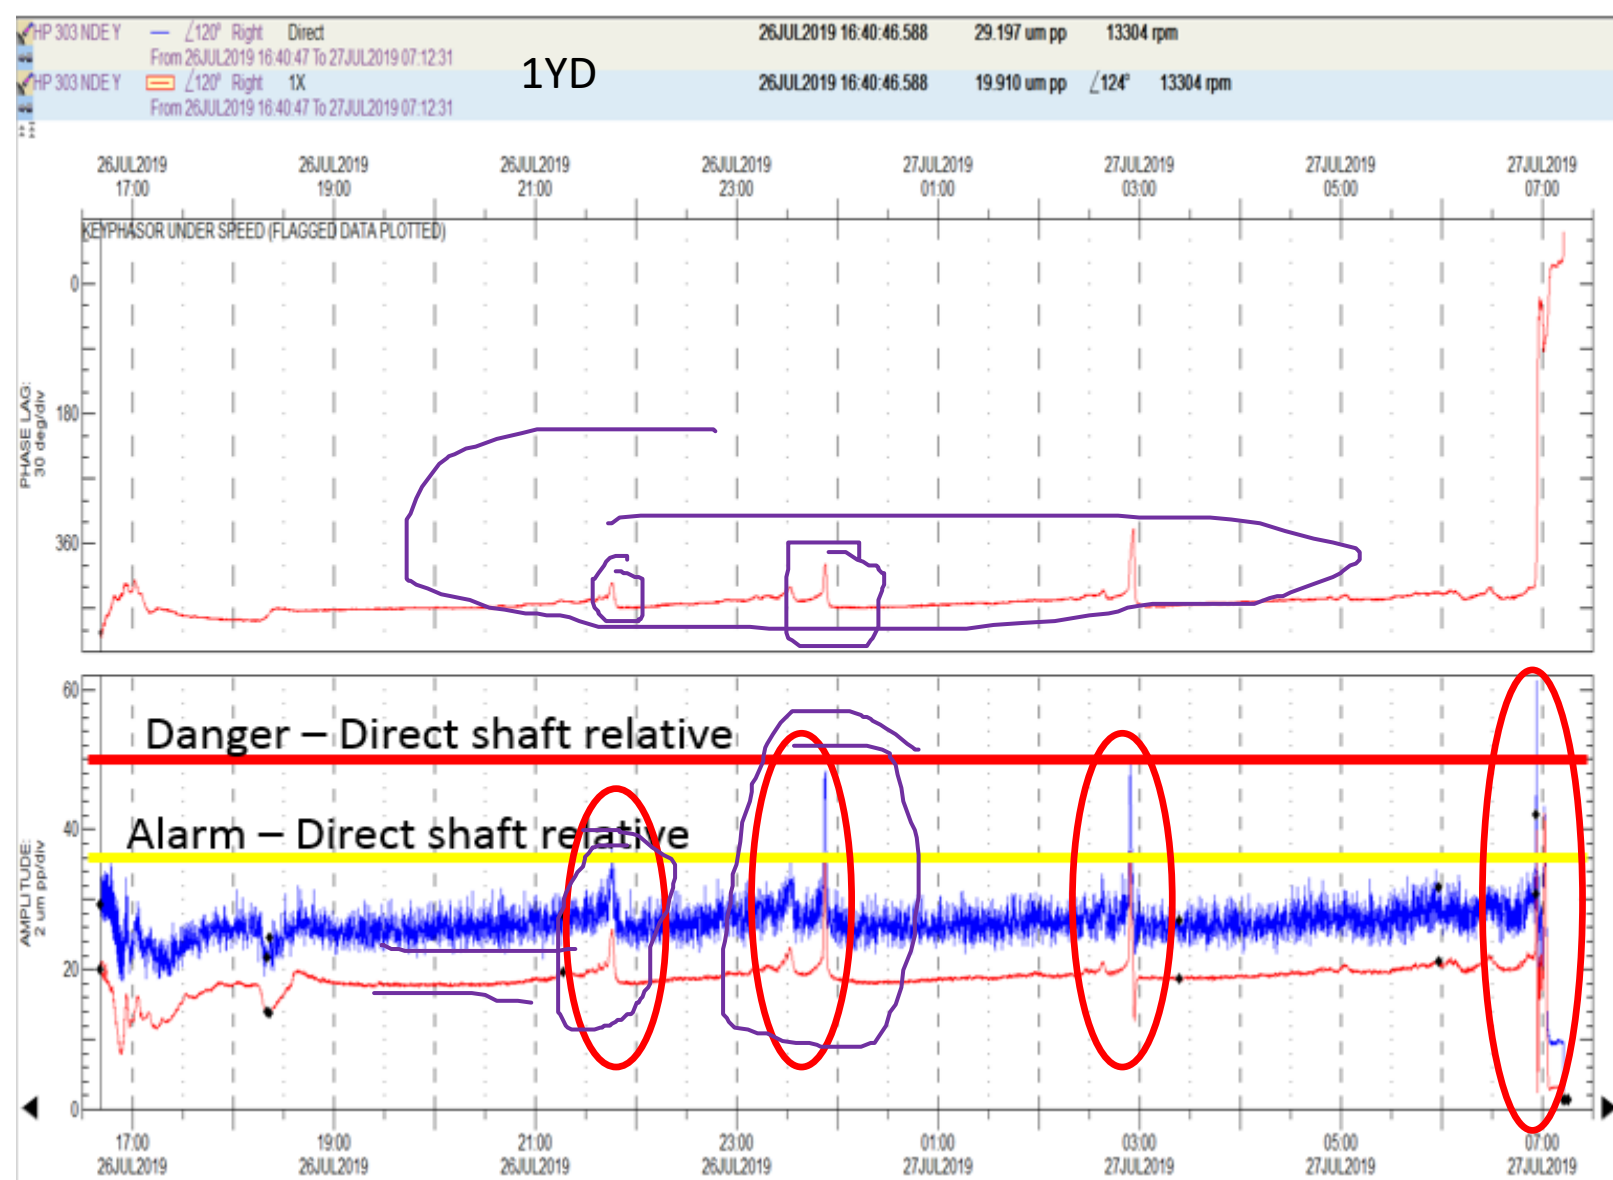
Vibration excursions occurred every few hour intervals.
Change in phase is also noticed at the same time as vibration excursion.
Observed increase in 1X vibration (HP NDE Y).

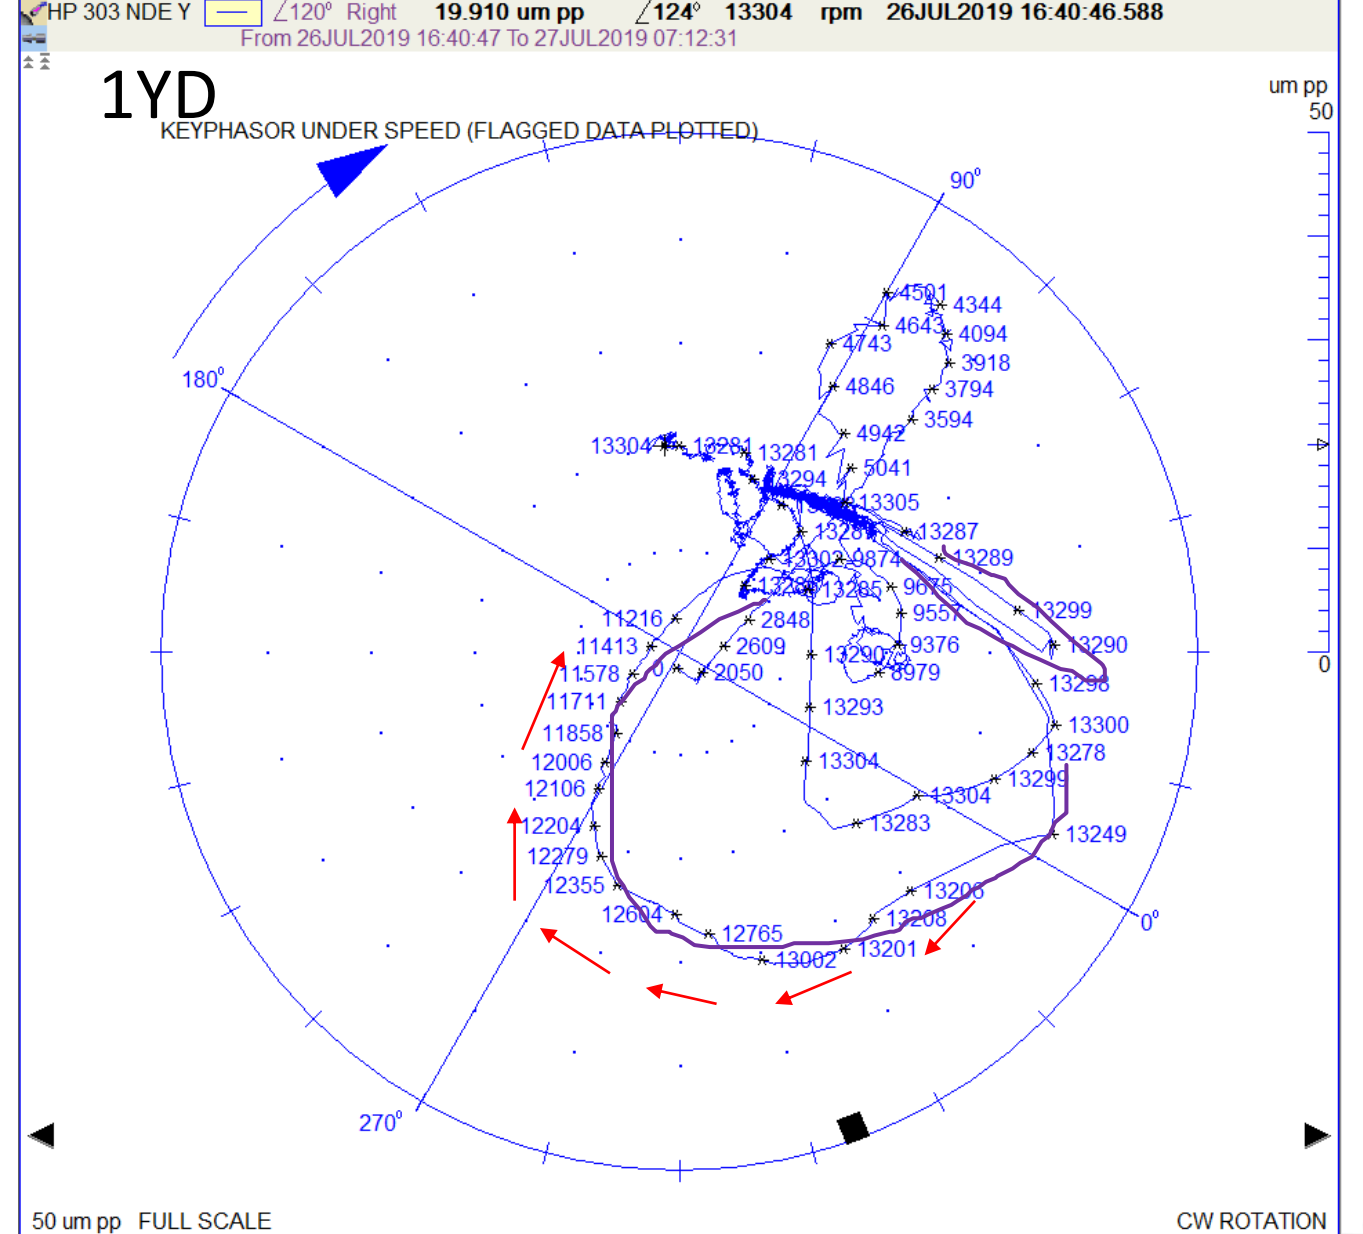
Polar plot showing rolling phase which happens at the same time as vibration excursions.

This is due to frictional forces when there is a partial rub phenomenon which induces a thermal bow and increase in 1X vibration.

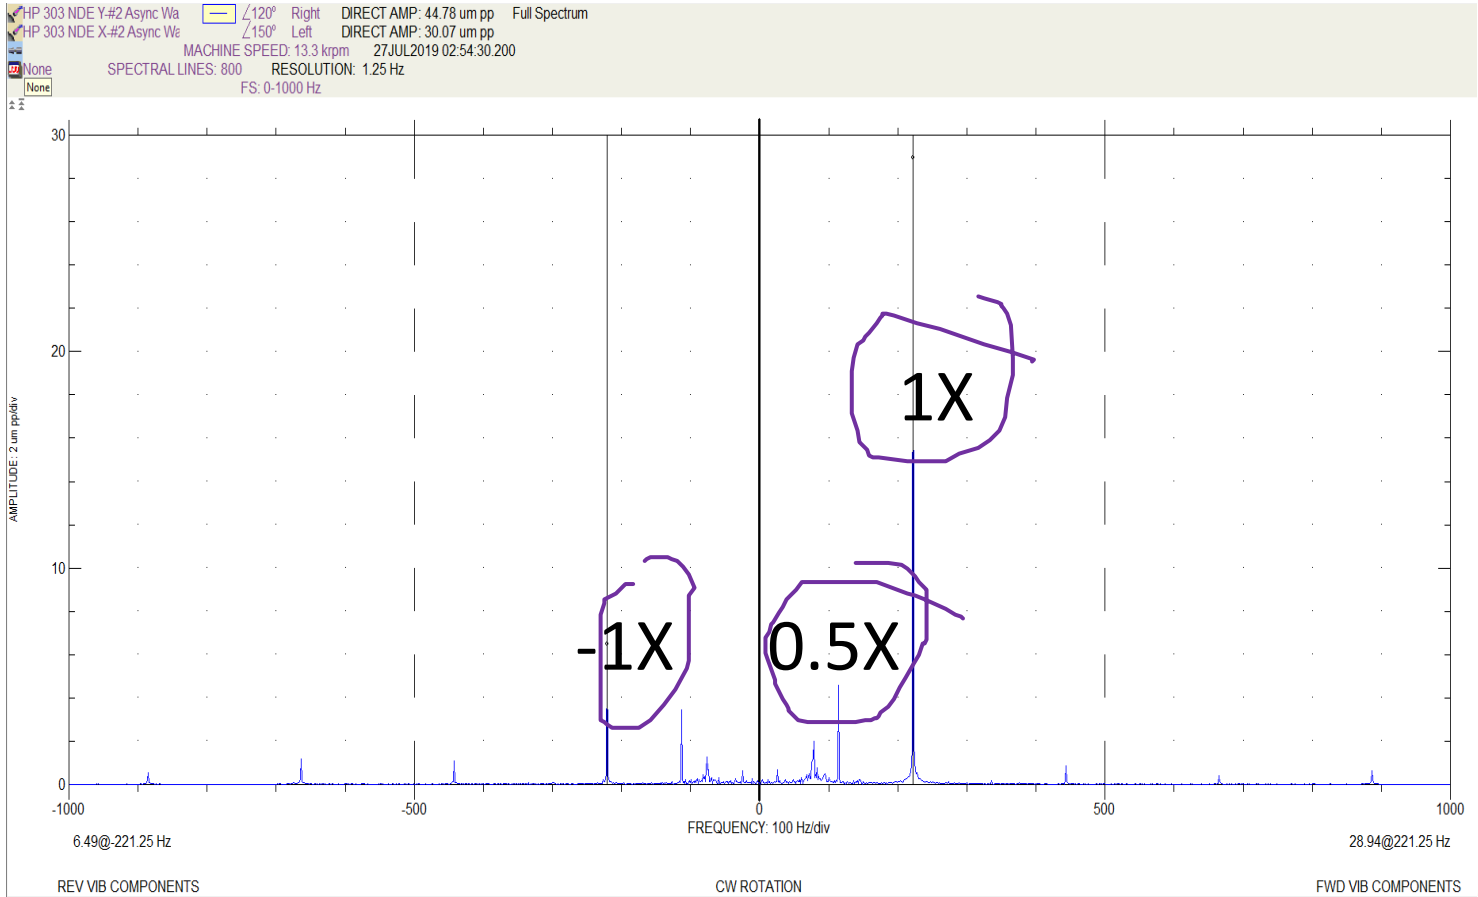
Sub synchronous vibration was evident with low levels of reverse precession amplitude. However in case of severe rub, reverse precession will be more prominent.

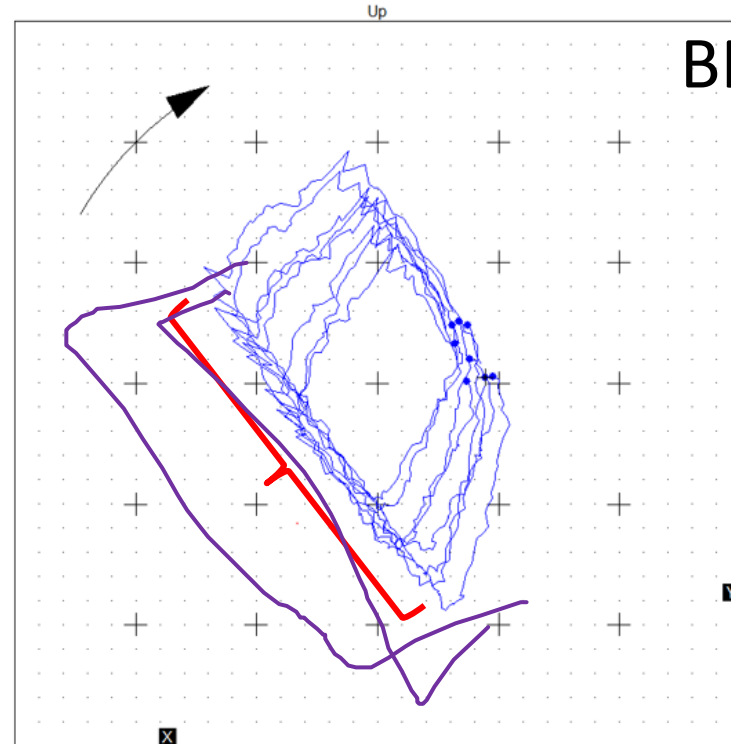
Orbit plot showing before and during vibration excursion. Flat side of the orbit is due to restricted movement.

Flat orbit showing partial rub

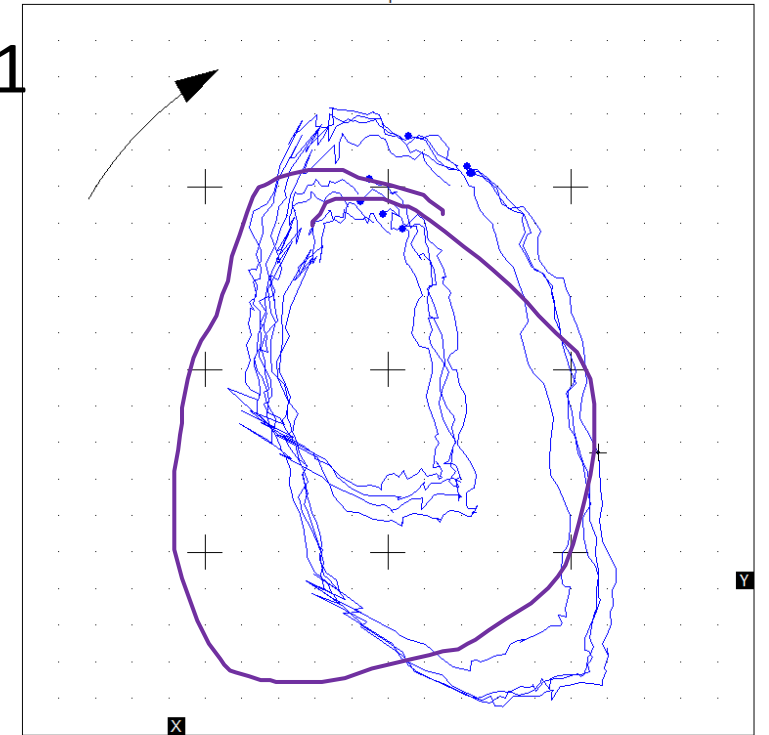
Before Rub – no flat side

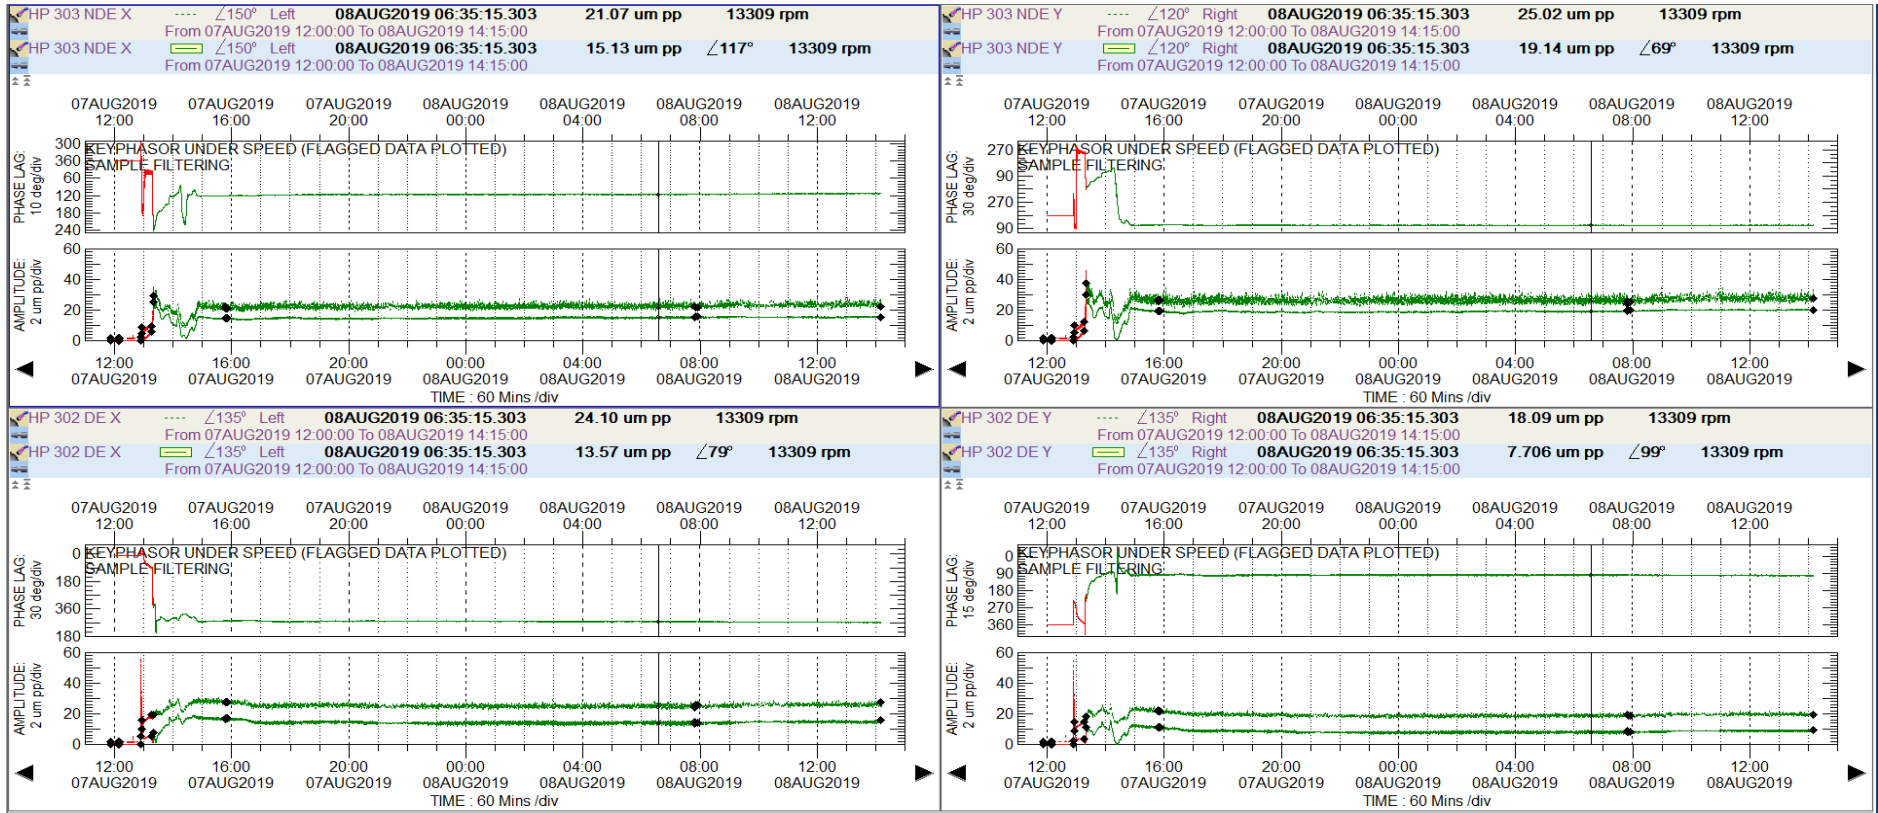
Vibration data post change in gland steam pressure

Recommended to set gland steam pressure per OEM guidelines.

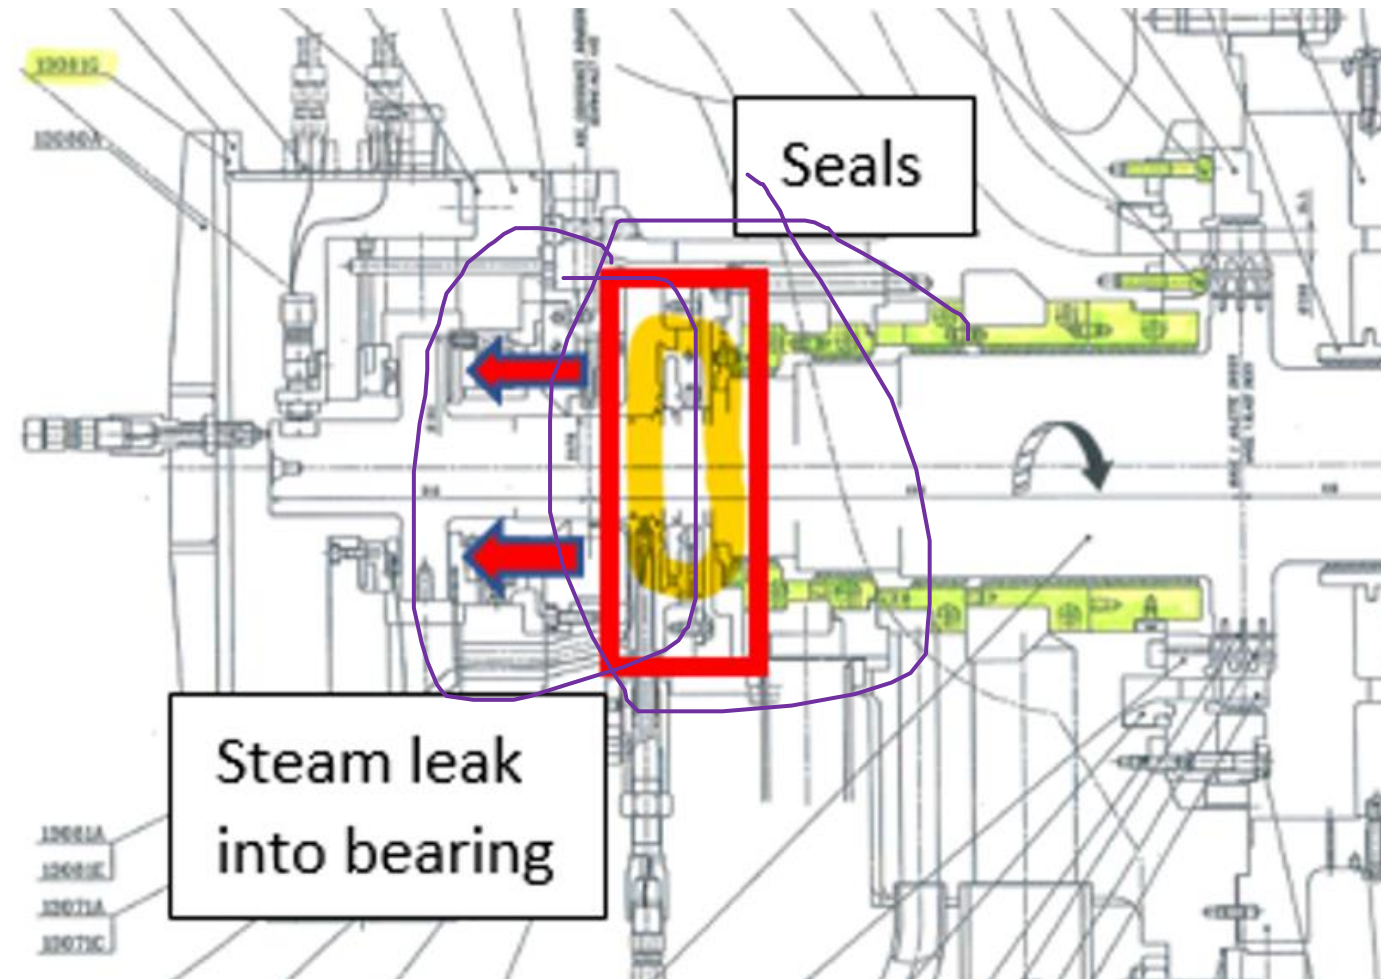
Gland steam pressure was very high at 60 Kpa way above normal operating range of 20 Kpa due to failure of pressure control valve. At low loads, the pressure inside the turbine will be low and gland steam is supplied to the seals to prevent ambient air from leaking into the system. If the pressure is too high the steam may leak past the seal system which could have happened in this case.

Schematic of turbine showing seal and steam path

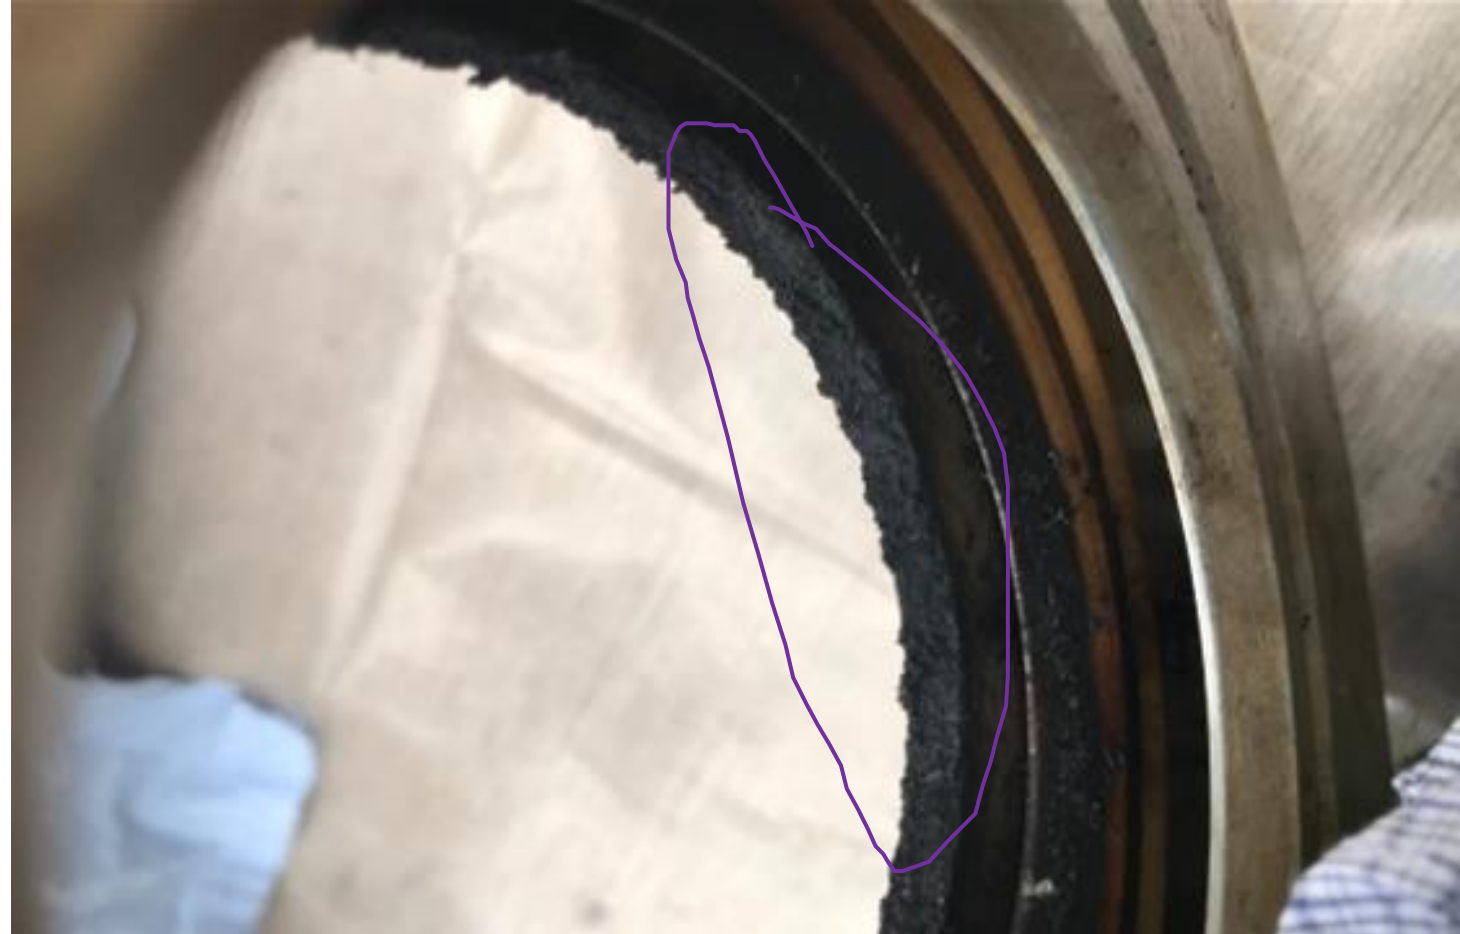
- Upon inspection lube oil carbonization was evident.
- Lube oil filter was in poor condition.
- No locking tab on carbon seal.
- Pressure control was found to have failed increasing the gland steam pressure.

High gland steam pressure was forcing the steam to leak past carbon seals causing carbonization.
