49TH TURBOMACHINERY & 36TH PUMP SYMPOSIA

Modernization of 75-year old Turbo Generator Emergency Trip System

Matthew D. Moll, Celanese

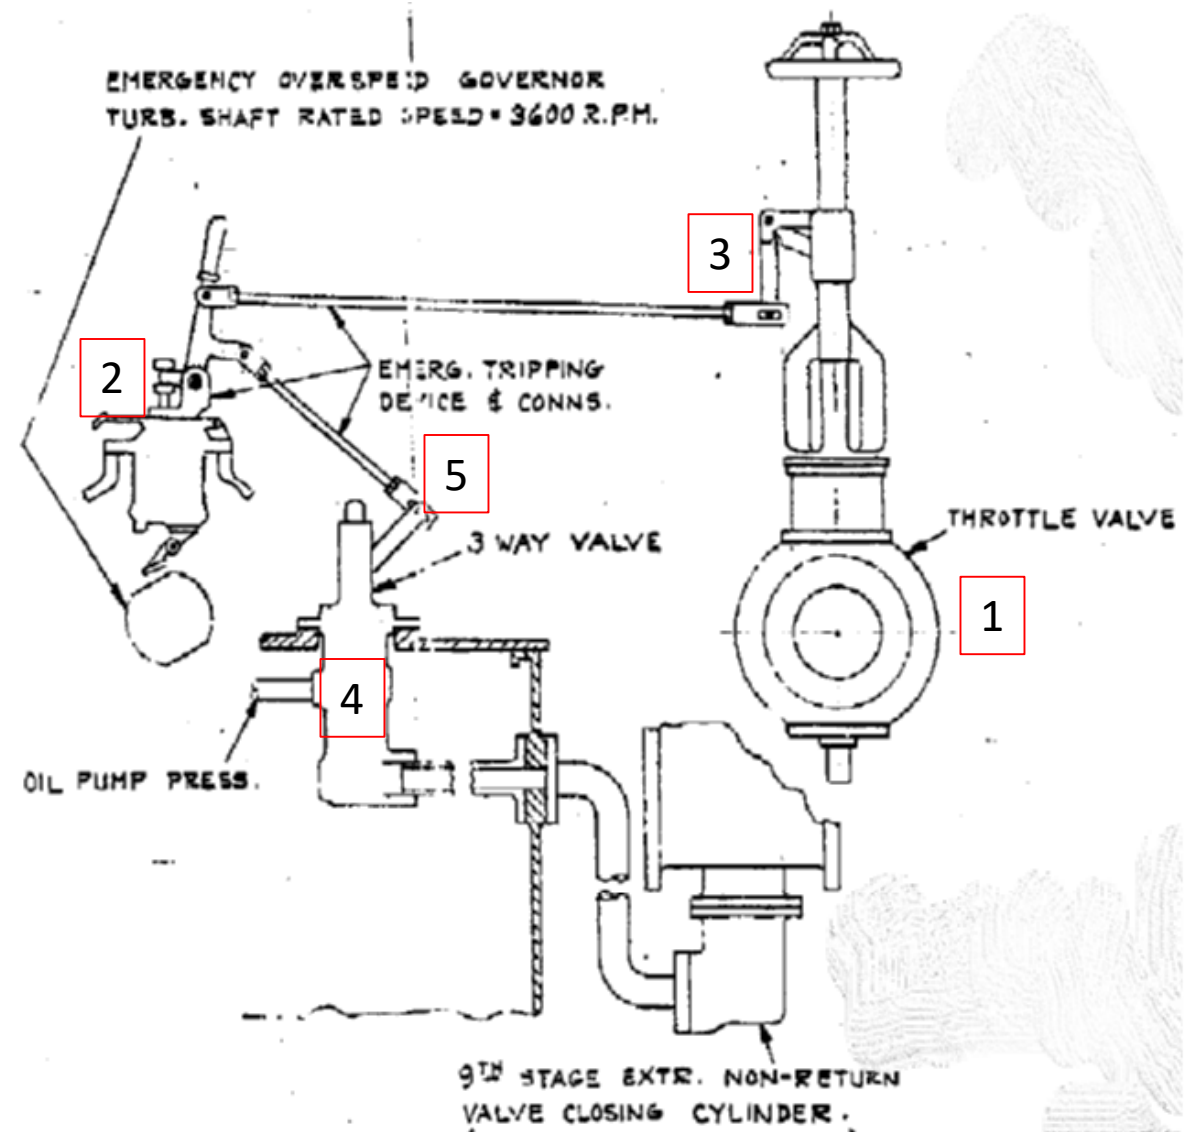
Existing Installation

1. Inverted mechanical latch T&TV
2. Mechanical bolt with spring loaded linkage actuator (with retrofit solenoid activation – not shown)
3. Hammer Blow Loop Linkage
4. 3-Way valve controlling (internal to oil sump) Non Return Valve (NRV)
5. Individual operator control of NRV during startup by linkage design

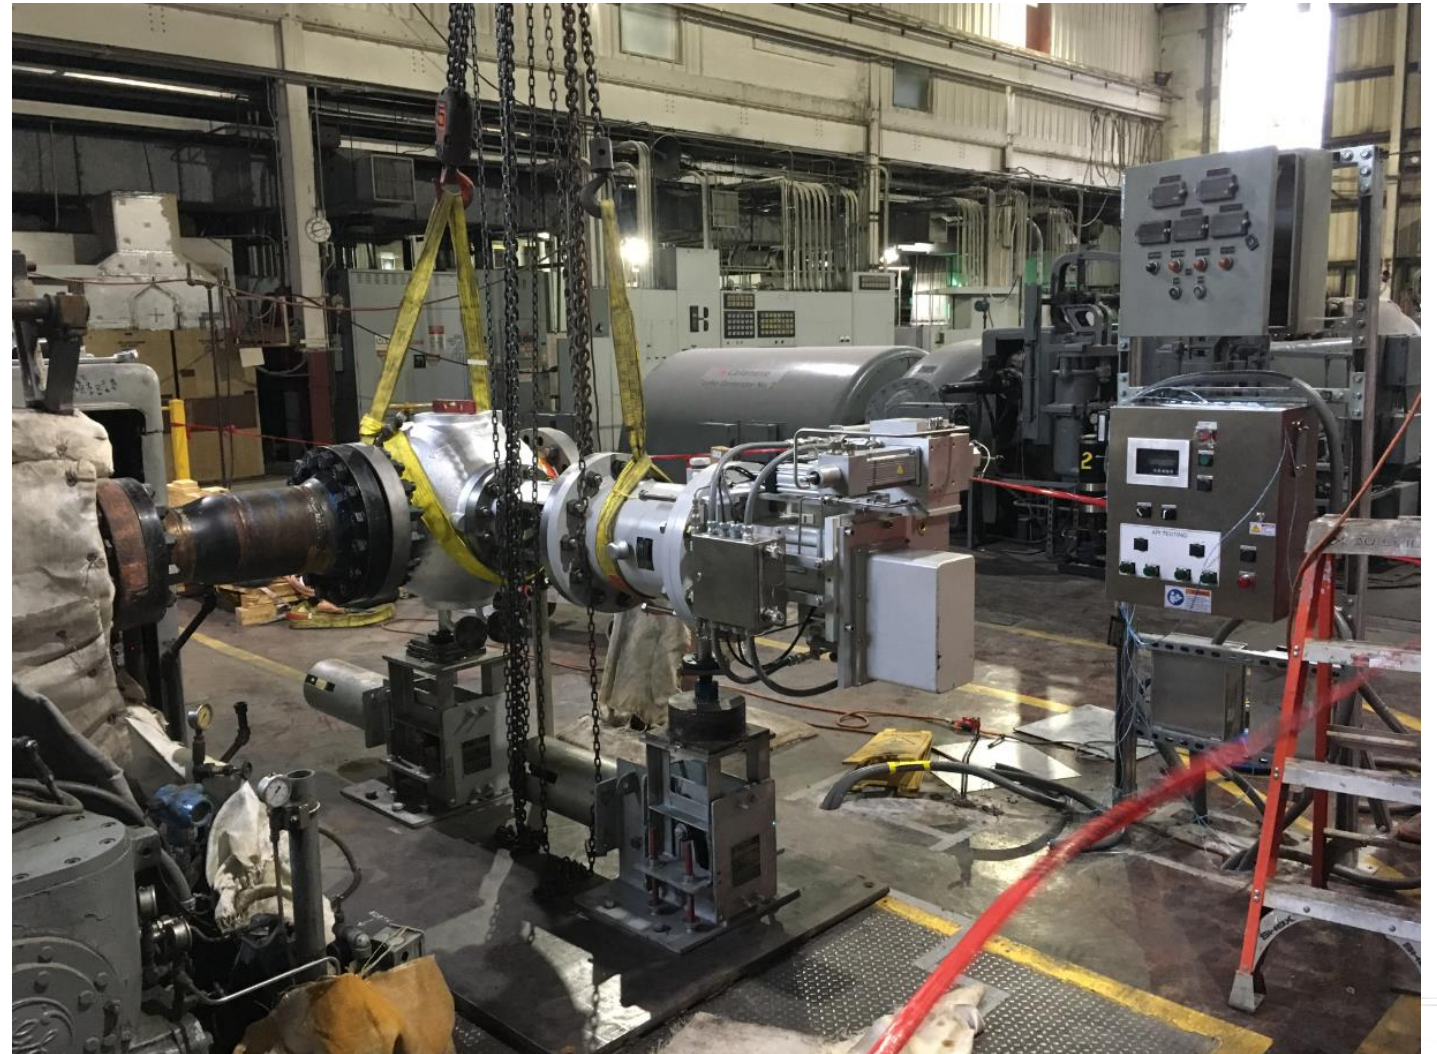
Construction Photographs

- New Trip and Throttle Valve installed on continuous force spring cans
- Control Panel (to the right hand side of Trip and Throttle Valve in photograph)

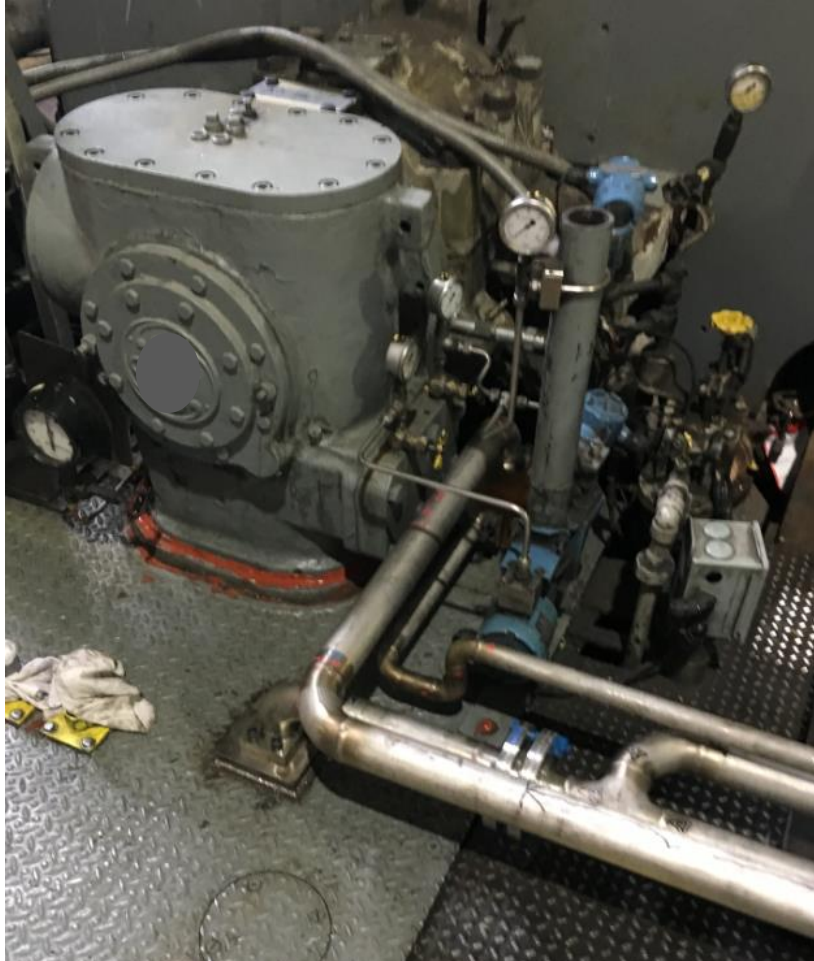
Piping to and from TMA

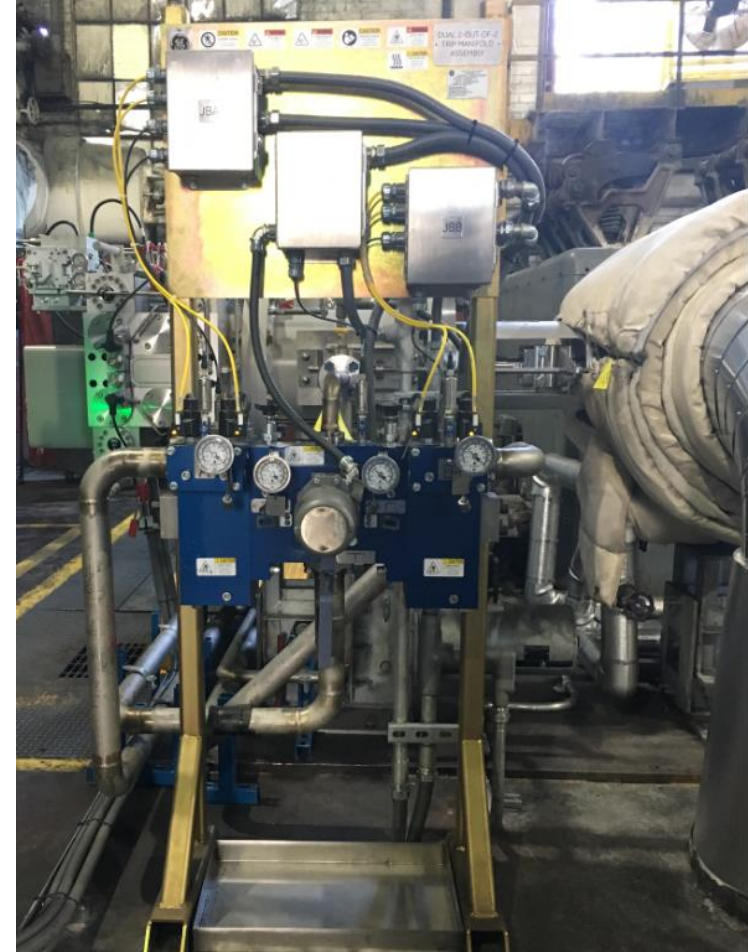
TMA mounted with T&TV in background
