49TH TURBOMACHINERY & 36TH PUMP SYMPOSIA

Detection of Misalignment from Vibration Data

On a boiler feed pump driven by a motor running close to 3600 rpm, a horizontal misalignment issue was suspected by examining orbit plots besides shaft centerline plots. The follow-up inspection did uncover large parallel misalignment of 0.012 inch along the horizontal direction between the pump and the motor. The root-cause of changes in alignment indicates piping strain as evidenced by loose bolts between the pump and the foundation. The unit was then re-aligned to below 0.001 inch in parallel alignment, followed by correct re-assembly of the coupling. Shaft vibration was successfully reduced to below 2 mil pp and with a normal orbit orientation.

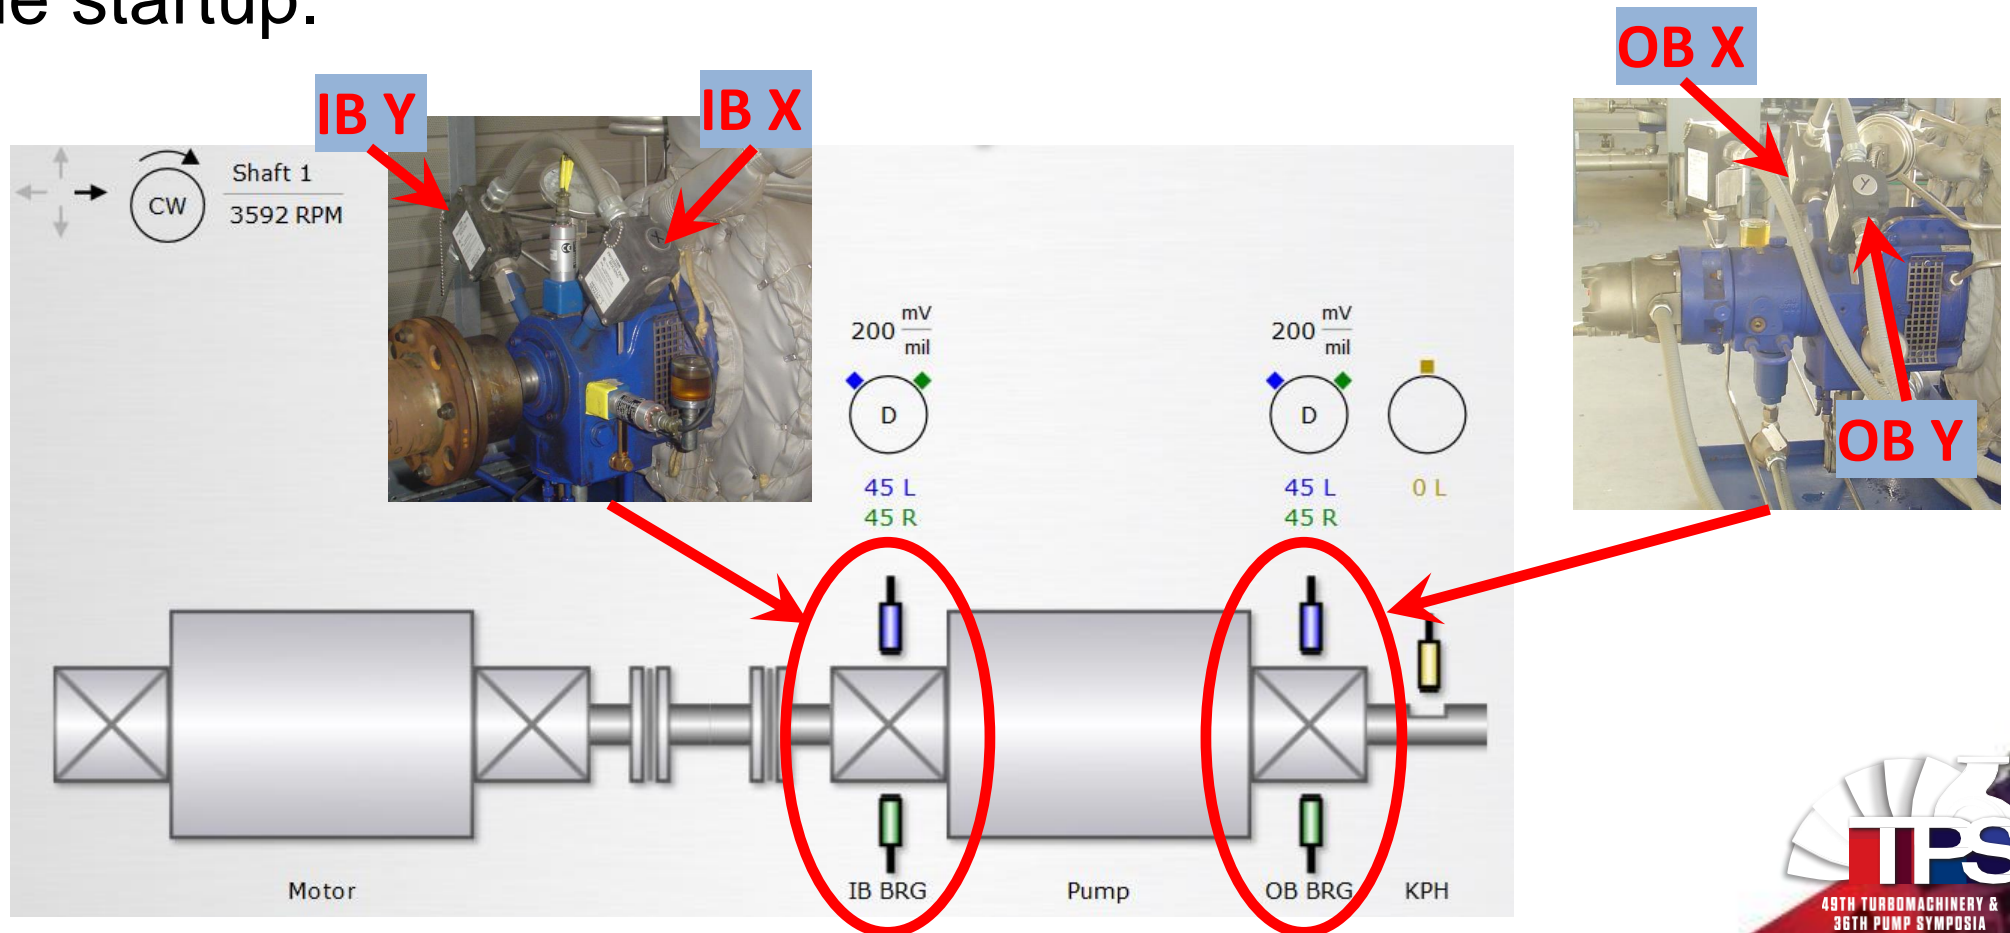
- After startup, shaft vibration gradually increased from 1 mil pp to over 3 mil pp at the pump **inboard** (IB) bearing.
- Root-cause to be determined as soon as possible to avoid any delay in main turbine startup.

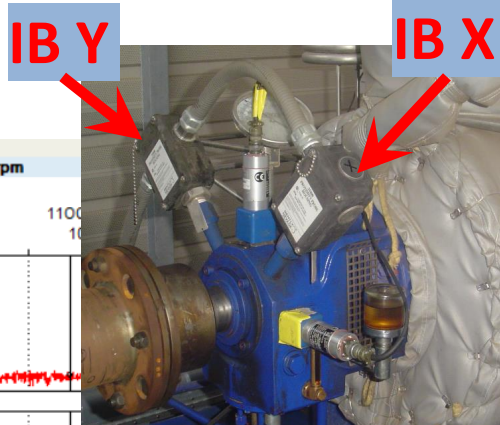
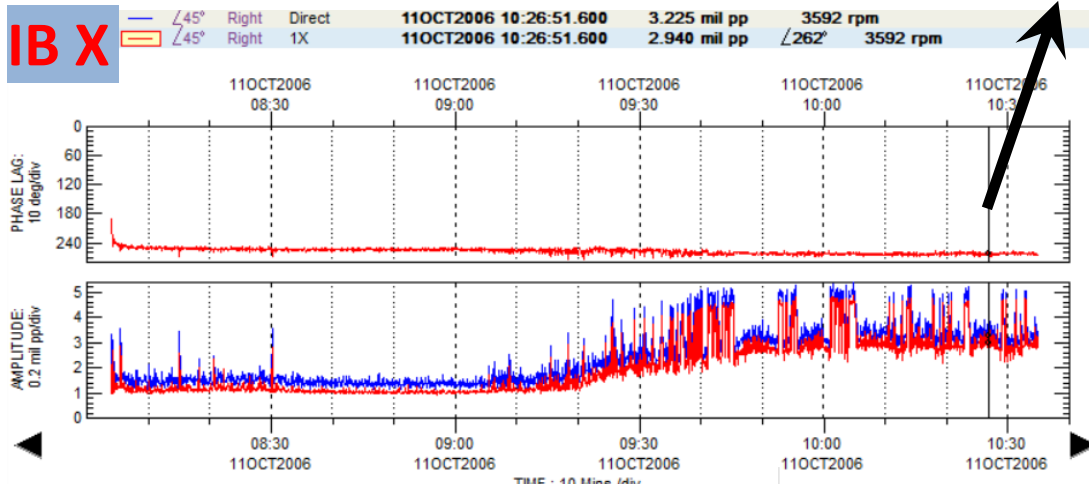
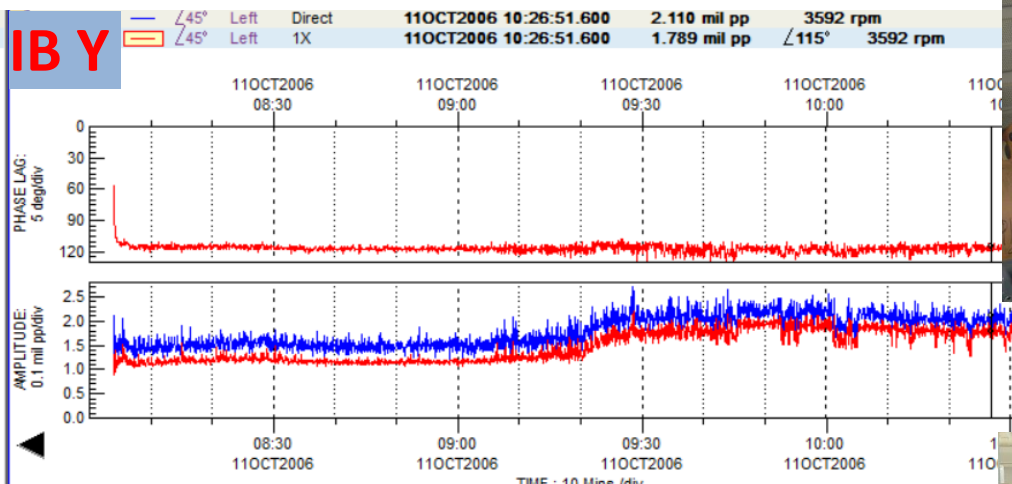
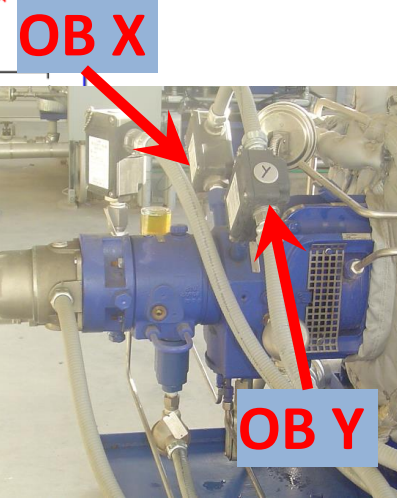
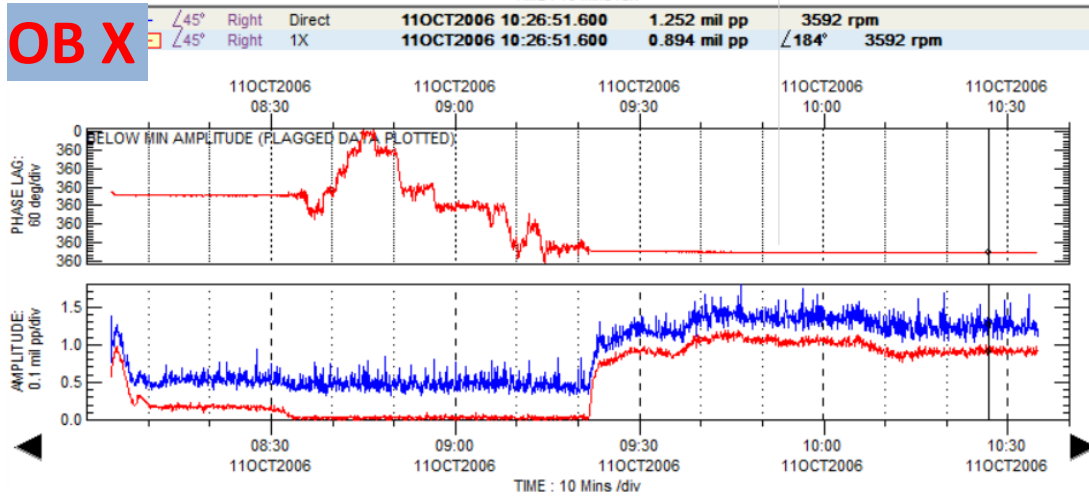
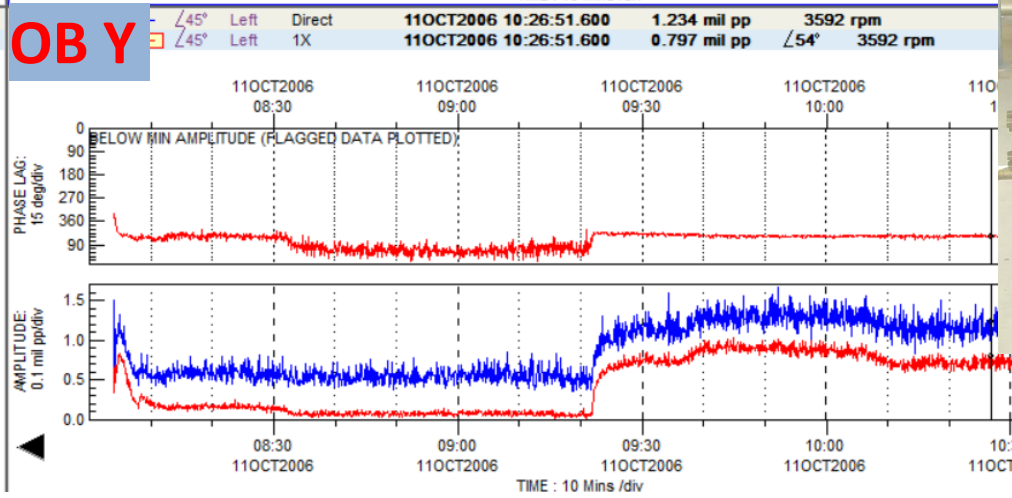
3.1 Data Review – Direct and 1X trend plots

Direct	3.225 mil pp	3592 rpm
1X	2.940 mil pp	262°

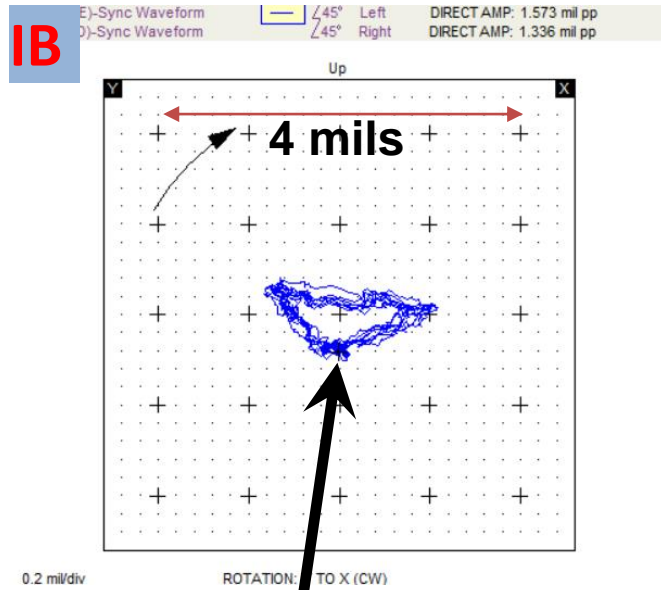
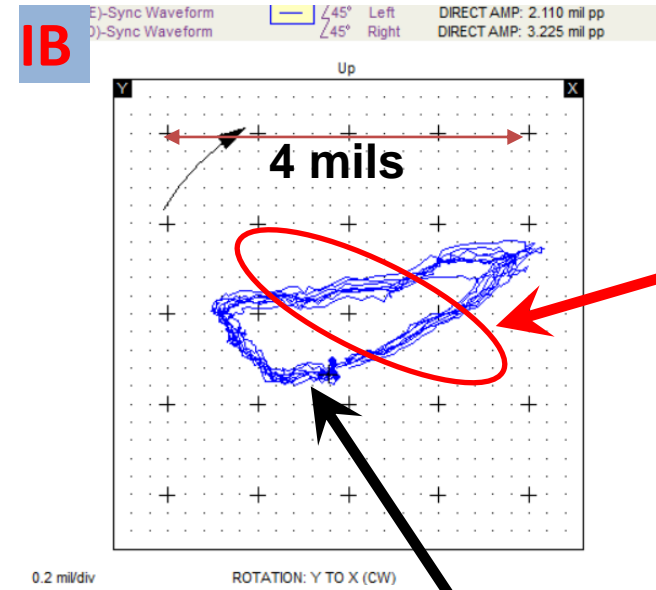
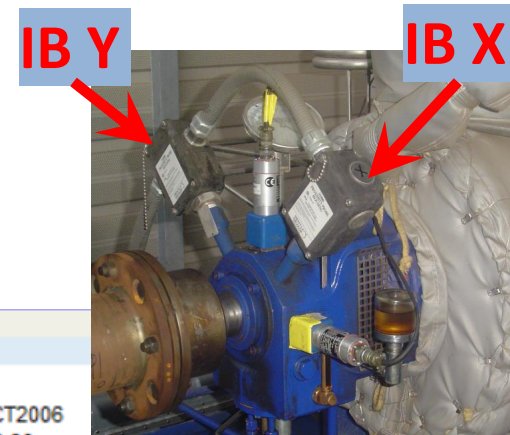
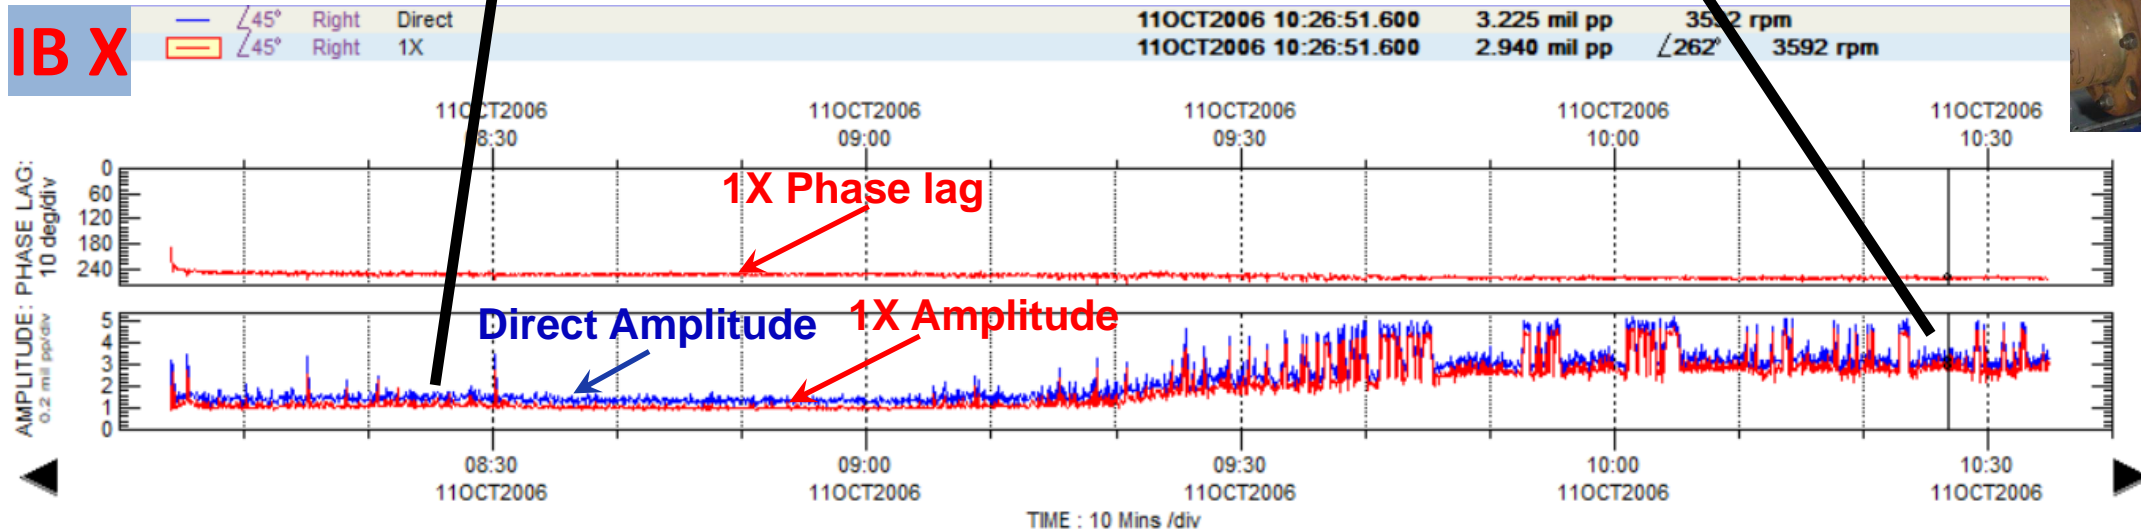
3.2 Data Review –Changes in orbits

Normal orbit orientation for CW shaft rotation

- **Misalignment?** – **Yes, likely in the horizontal direction**
 - Changes in shaft centerline position, mainly in the horizontal direction
 - Vibration level dependent on shaft centerline position
 - Abnormal orbit orientation (amplitude higher at 45 Right probe than at 45 Left probe for clockwise shaft rotation)

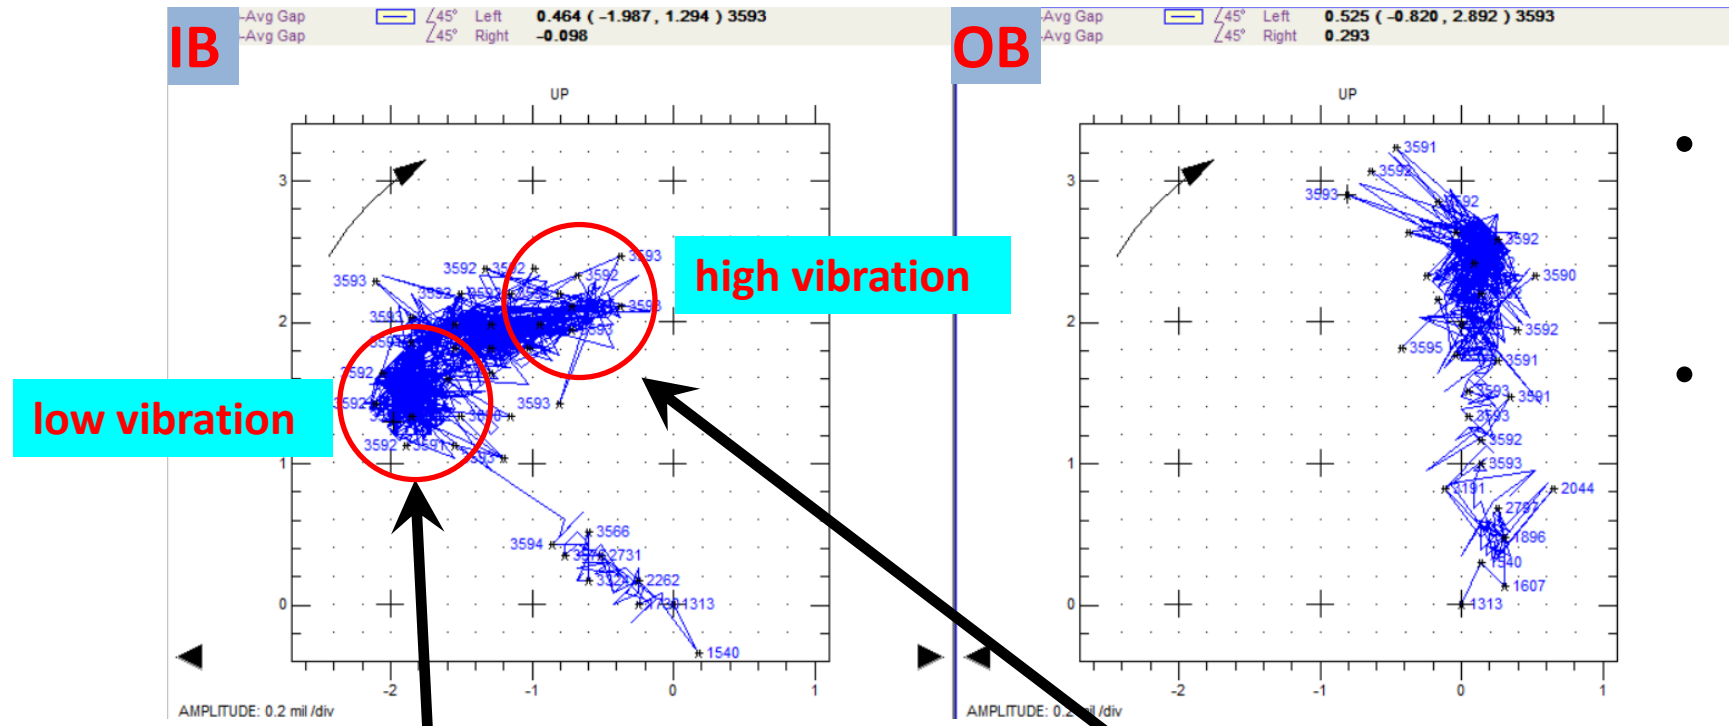
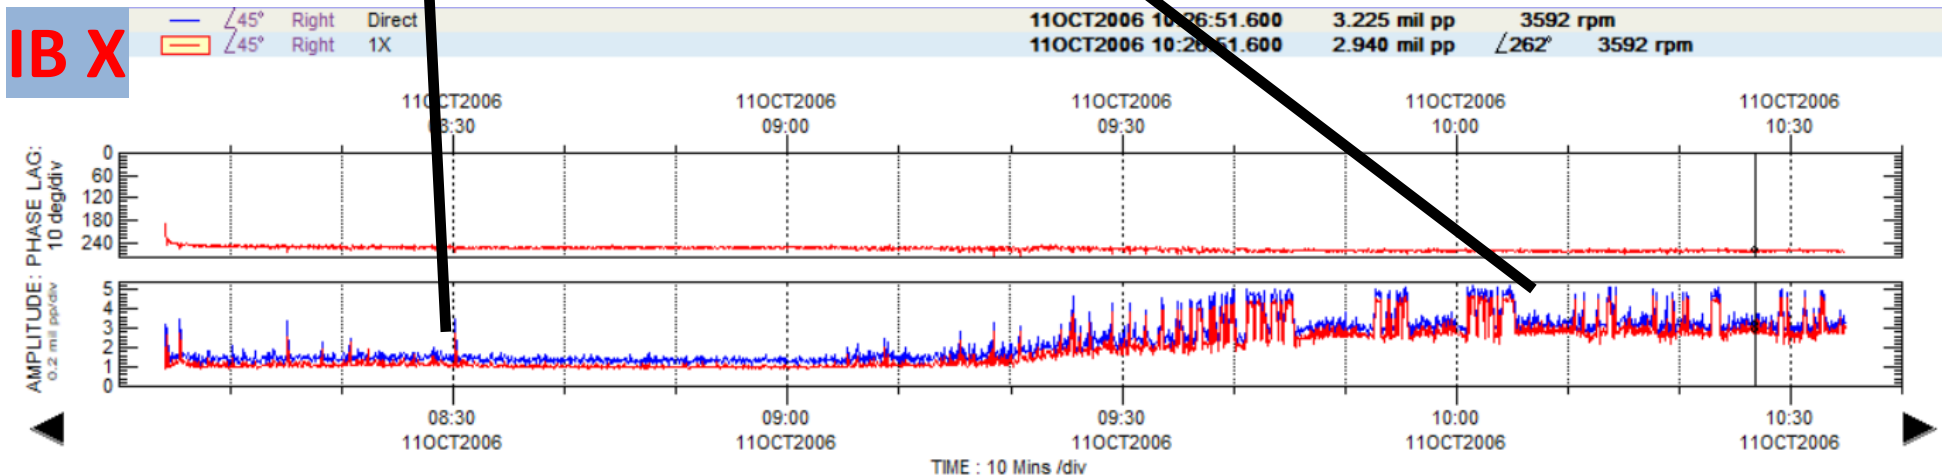
3.3 Data Review – Shaft centerline plots

- Inboard shaft centerline position moved horizontally.
- High vibration occurred when shaft centerline was towards the right.

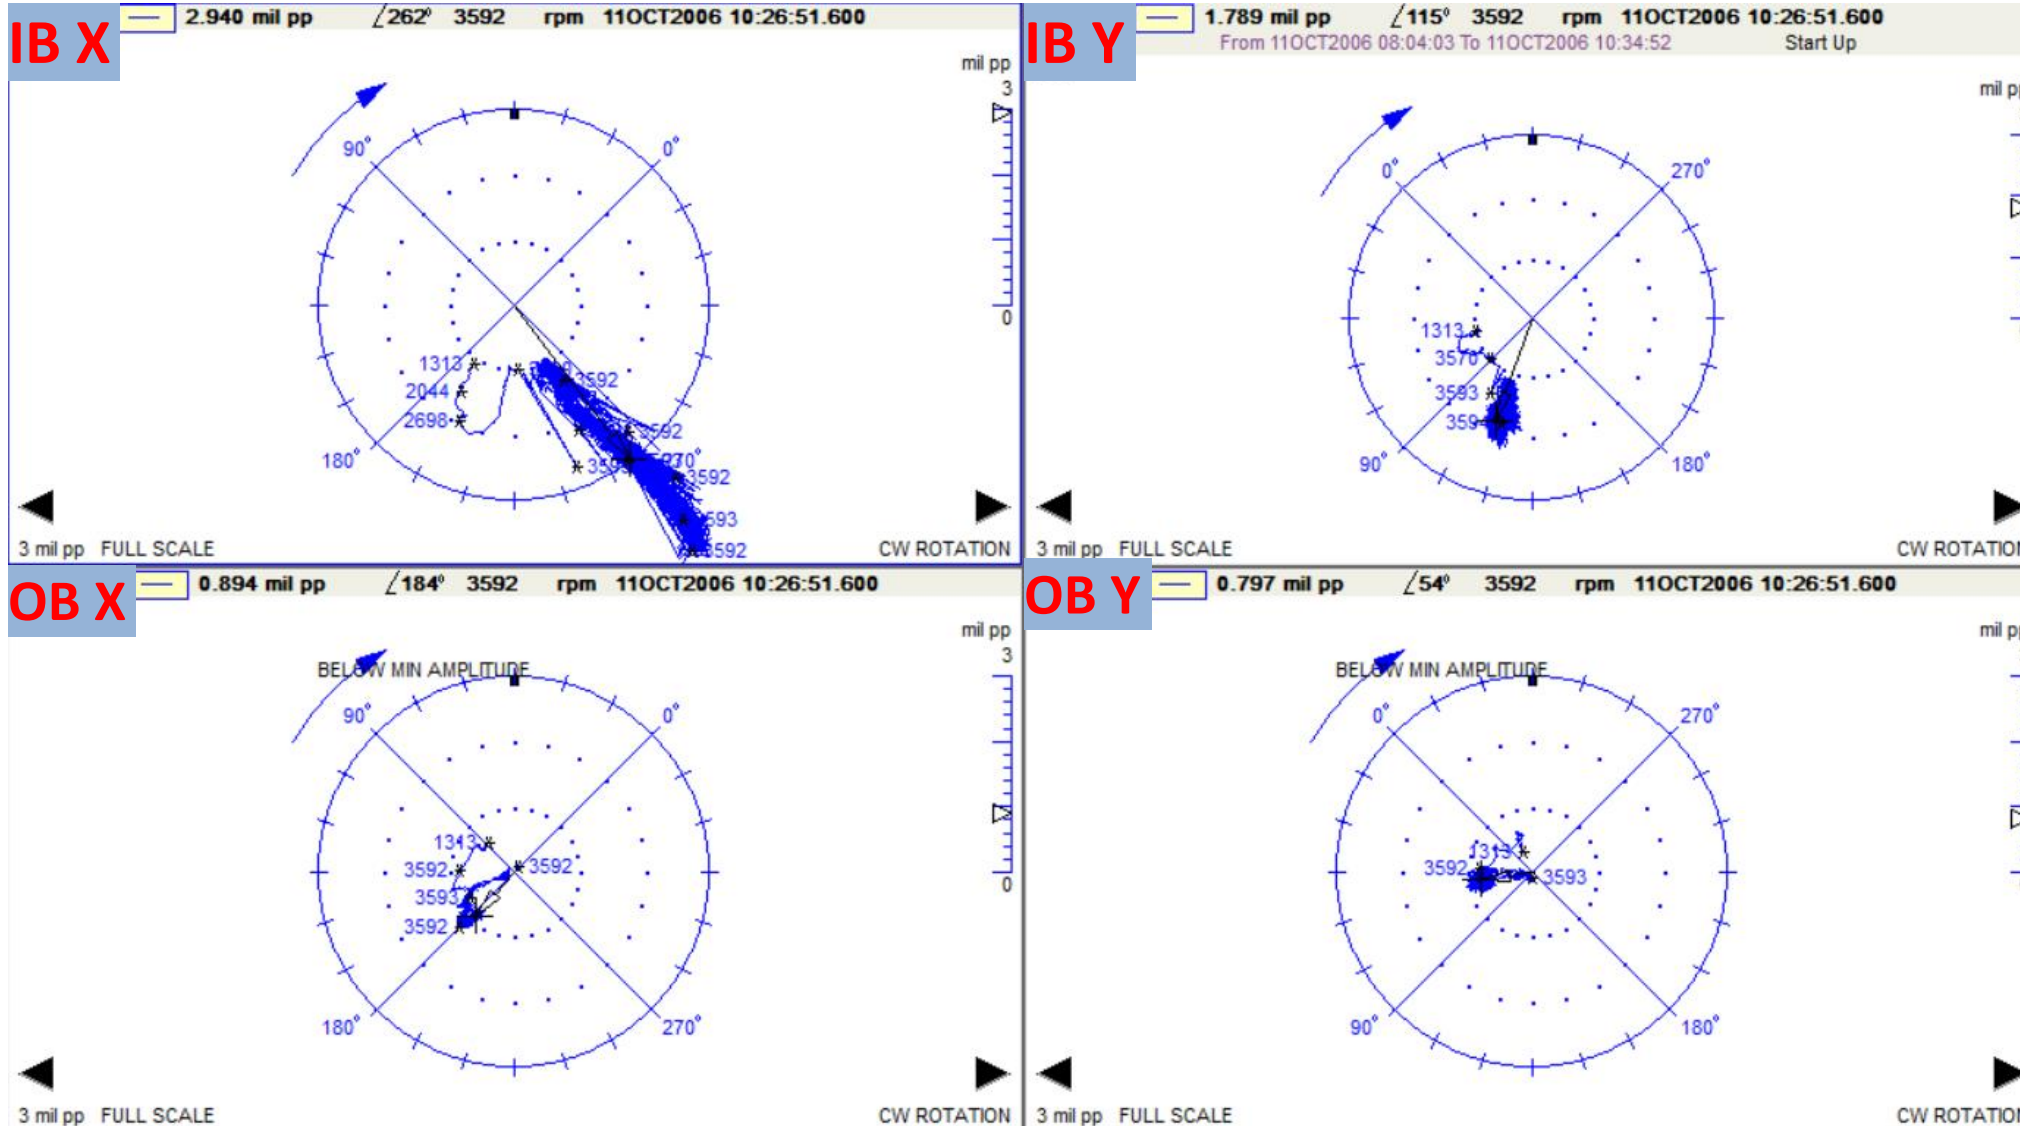
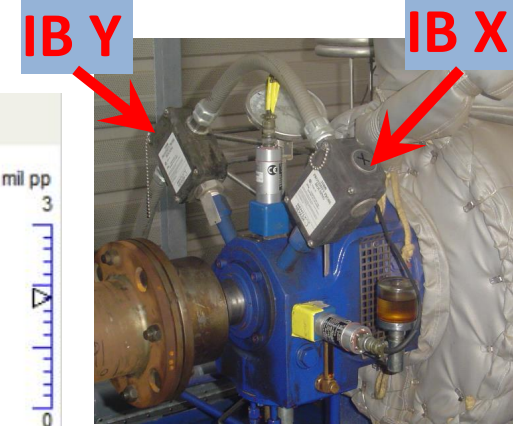
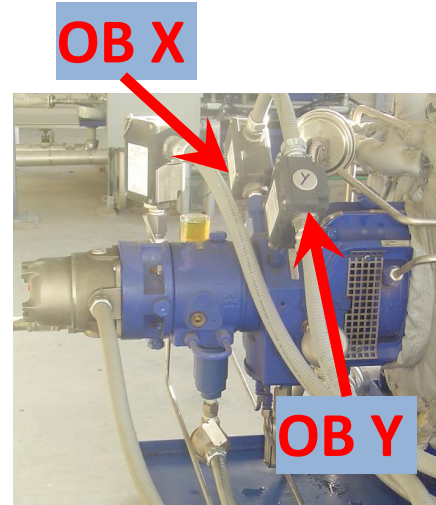
3.4 Data Review – Polar plots from prox. probe

Changes in 1X vibration vector. Is it a rub?

- **1X component ? – Yes**
 - 1X dominant with variation at proximity probes as well as casing-mounted transducer in the horizontal direction.
- **Rub? – No**
 - 1X amplitude increased but the 1X vector not behaving as a rub pattern in polar plots at constant speed
 - Distorted orbits resulting from runout only

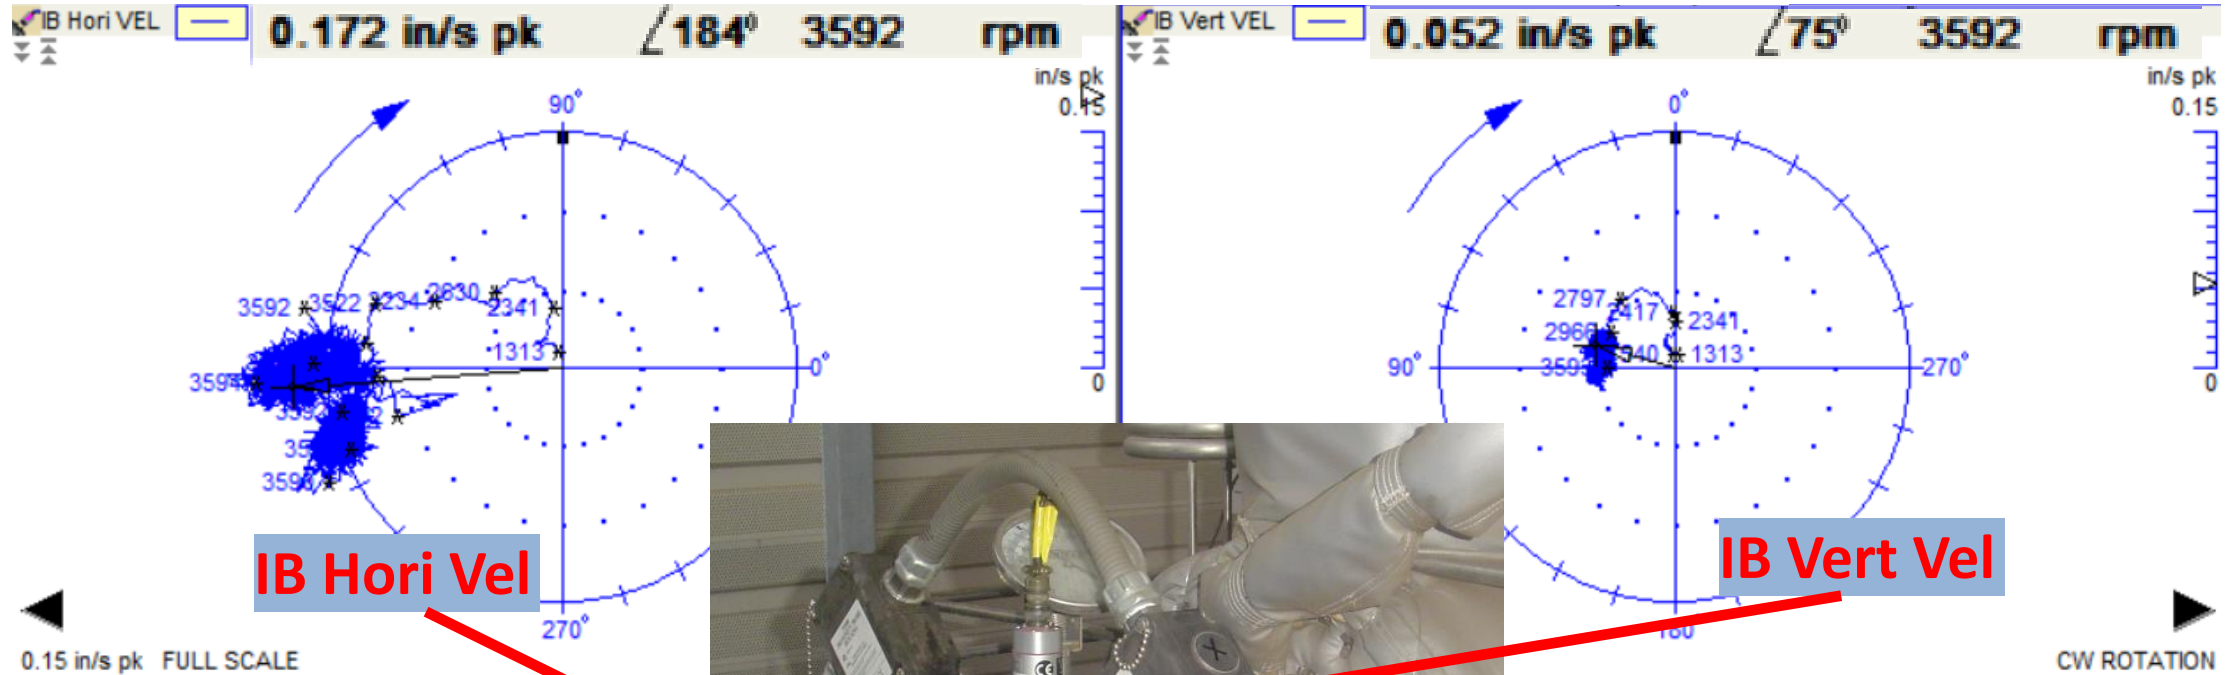
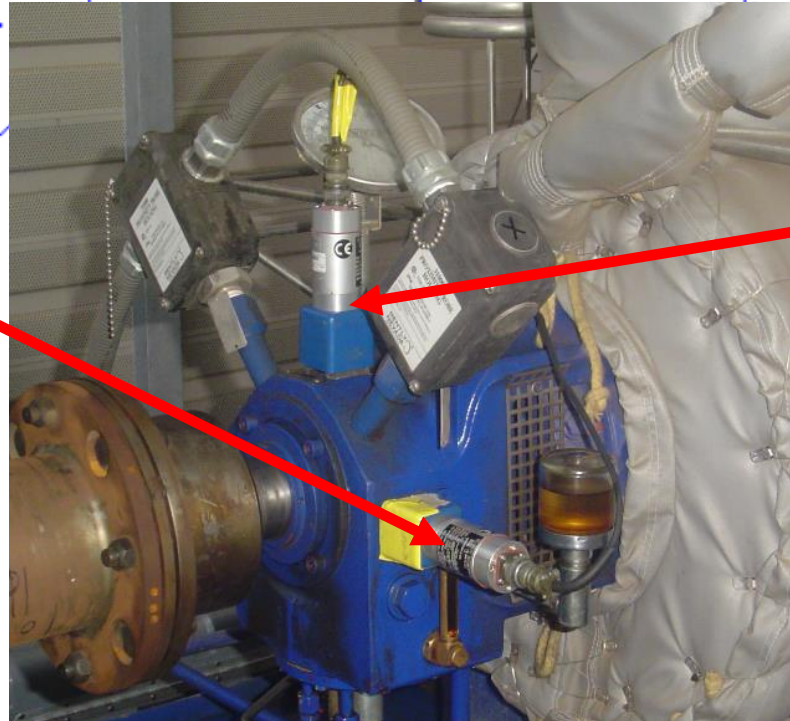
3.5 Data Review – Polar plots from seismics

Changes in 1X vibration vector. Is it a rub?

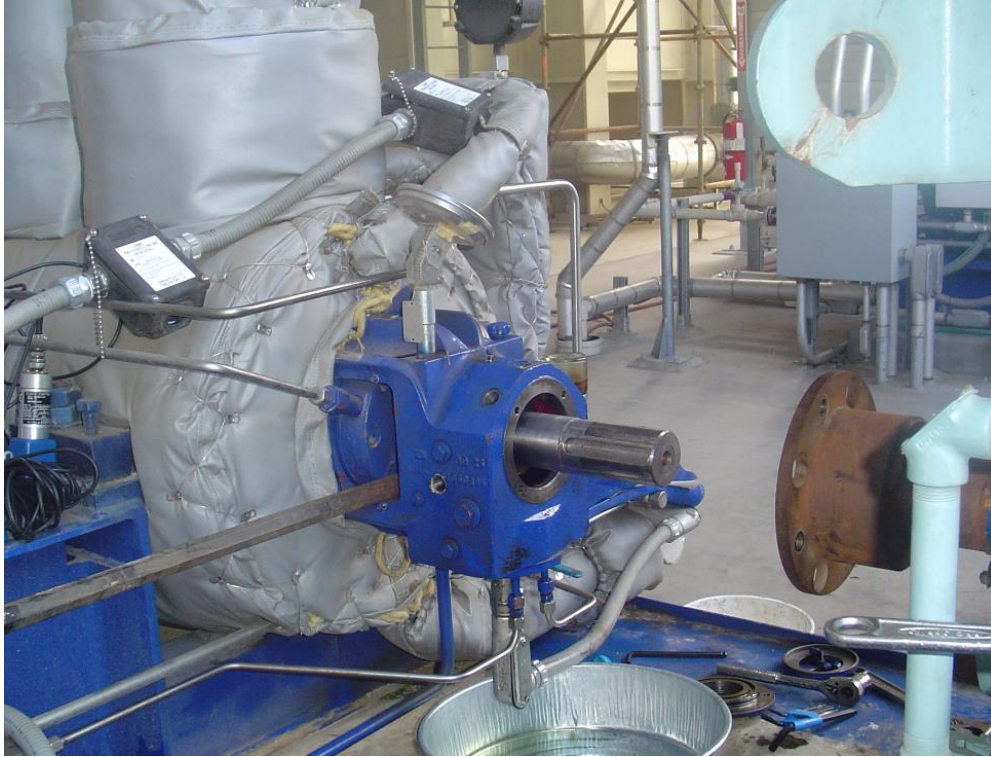
Bearing surface worn in the upper right area, possibly due to high vibration touching bearing wall in X-direction

- Inspect the bearing condition and change it if found worn.
- Check alignment conditions and correct them if found significantly off.

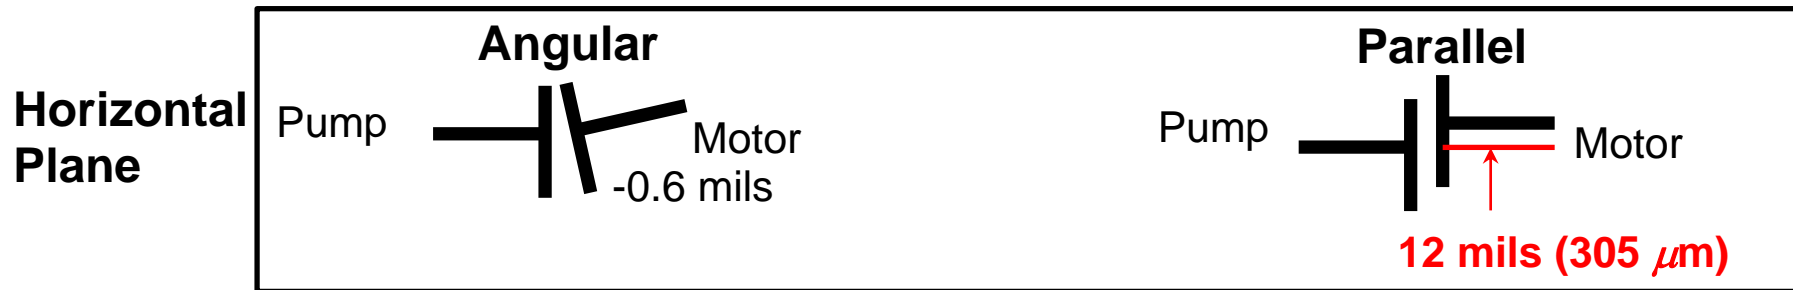
- Large parallel misalignment (offset of 0.012 inch or 305 μm) was found in horizontal plane between the pump and the motor, as shown below:

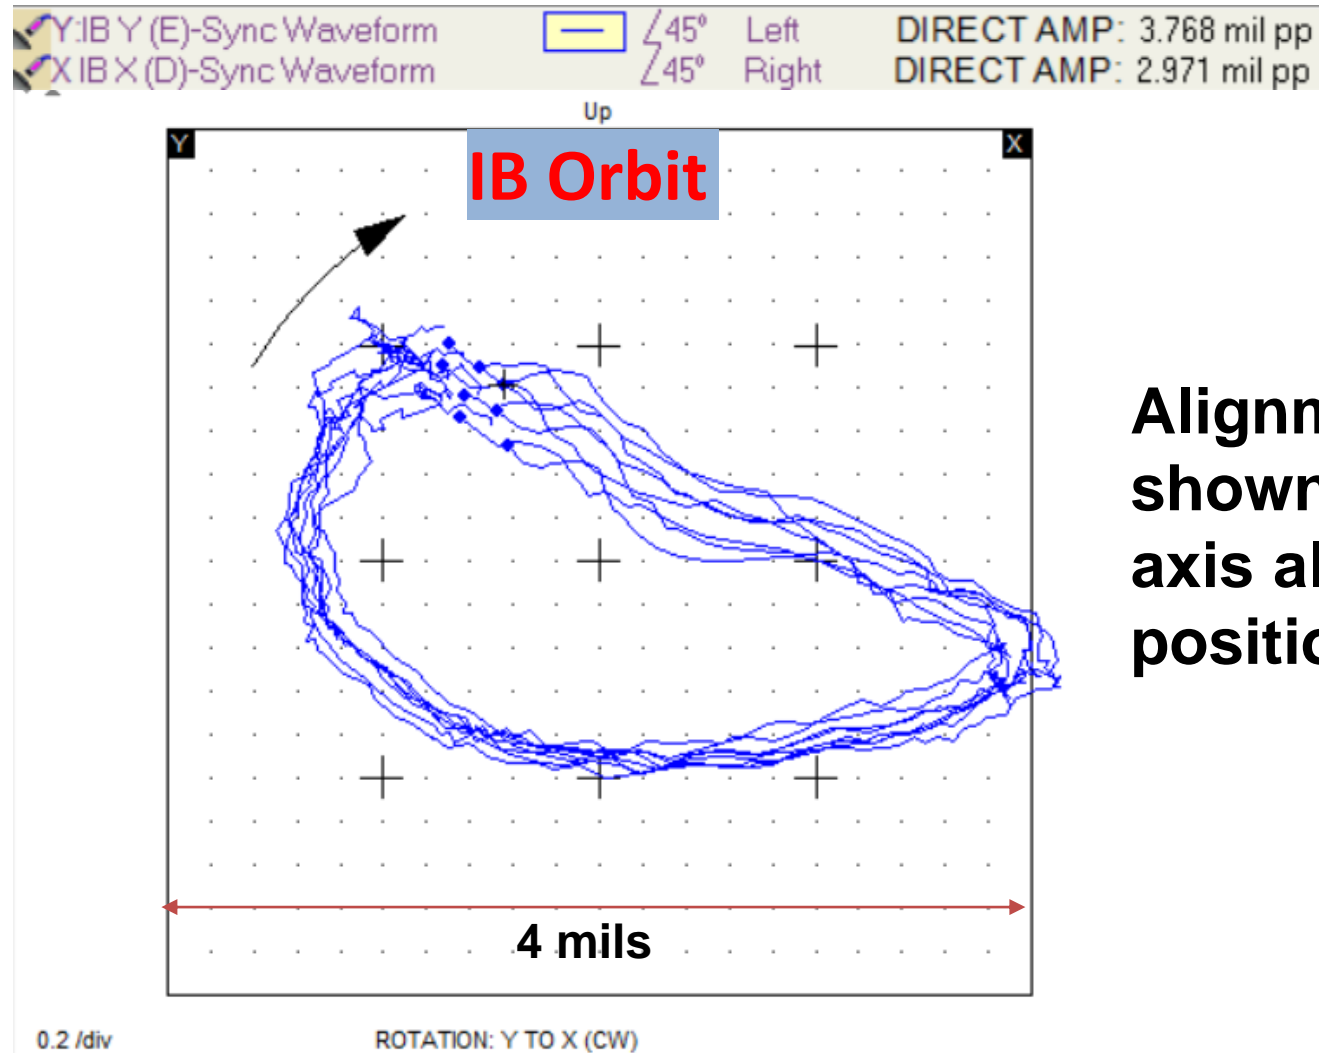
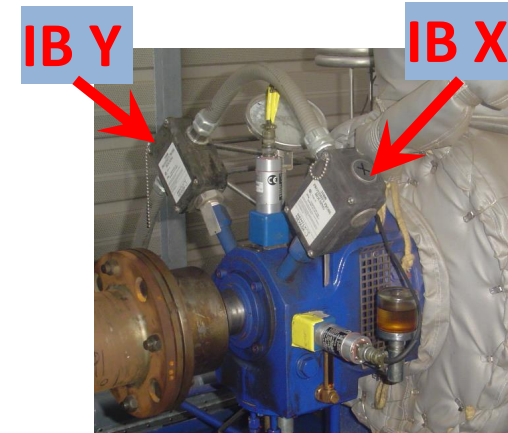
After Re-alignment

Alignment issue resolved as shown by orbit orientation (major axis aligned to 10 o'clock position) after re-alignment.

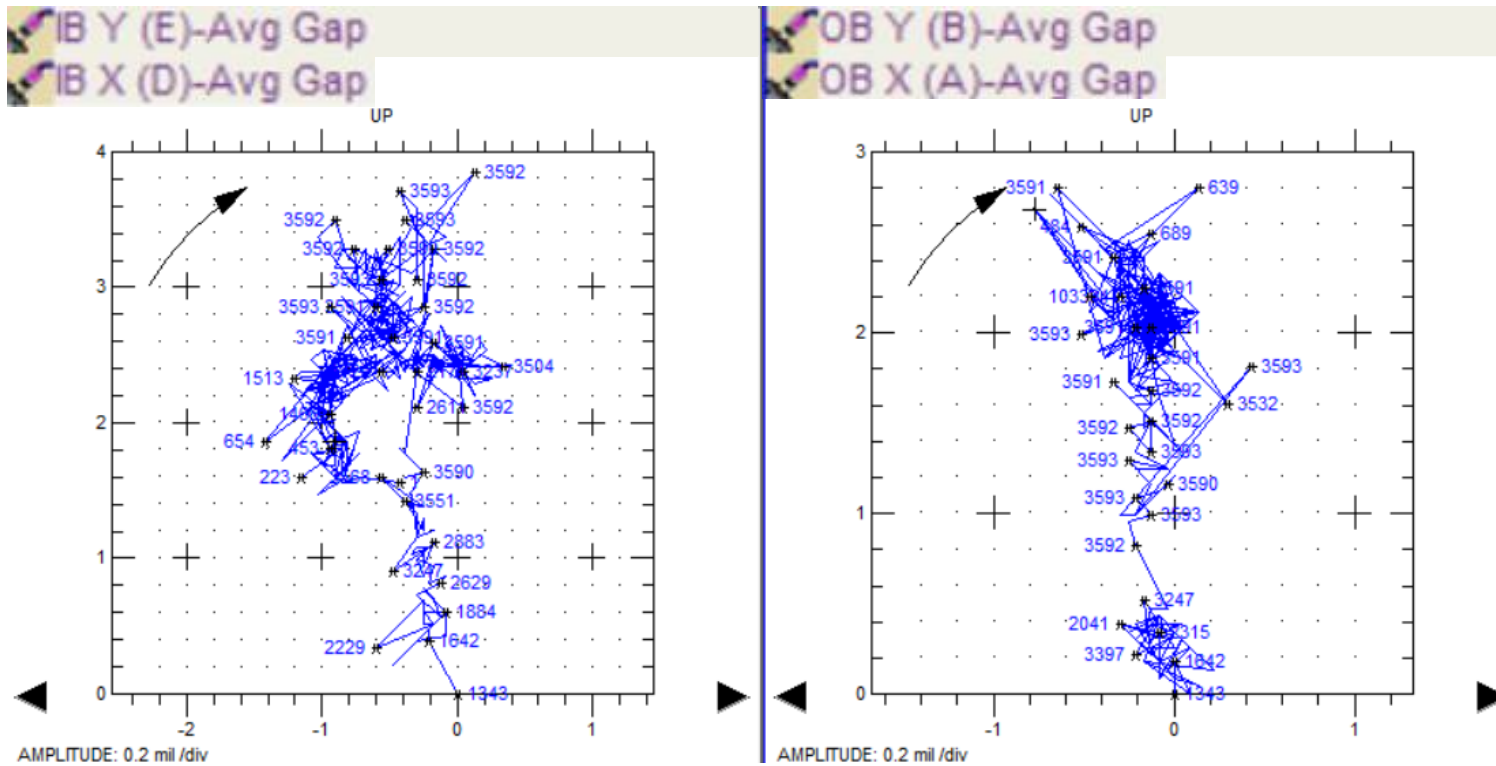
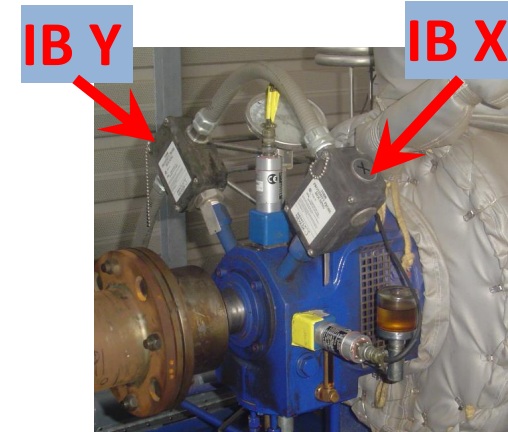
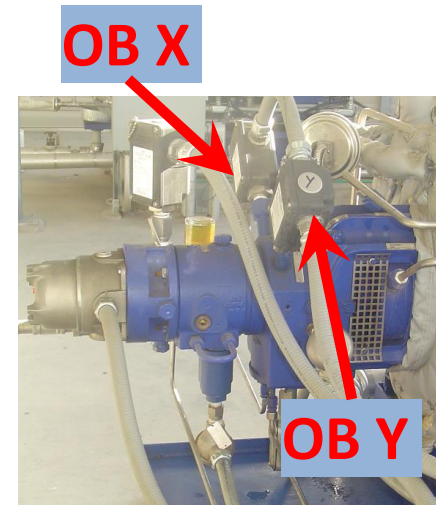
Shaft Centerline Plots After Re-alignment

The horizontal misalignment issue resolved as shown by shaft centerline plots after re-alignment.

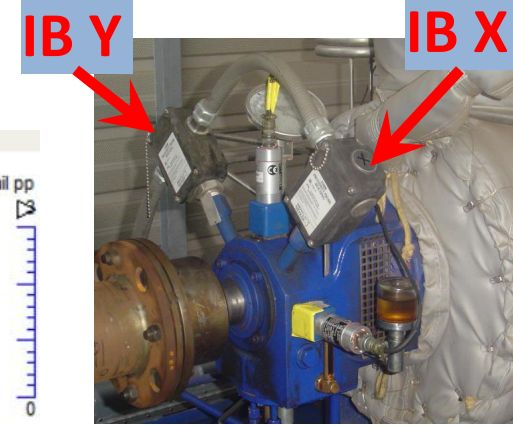
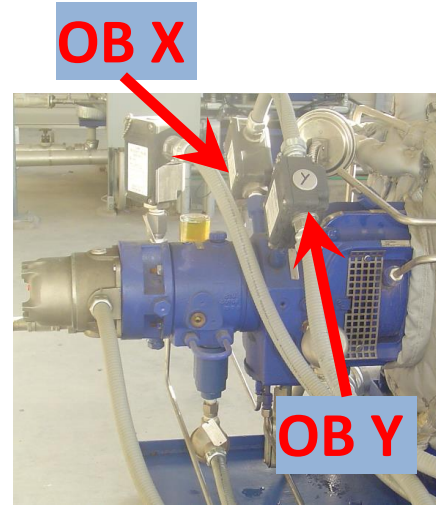
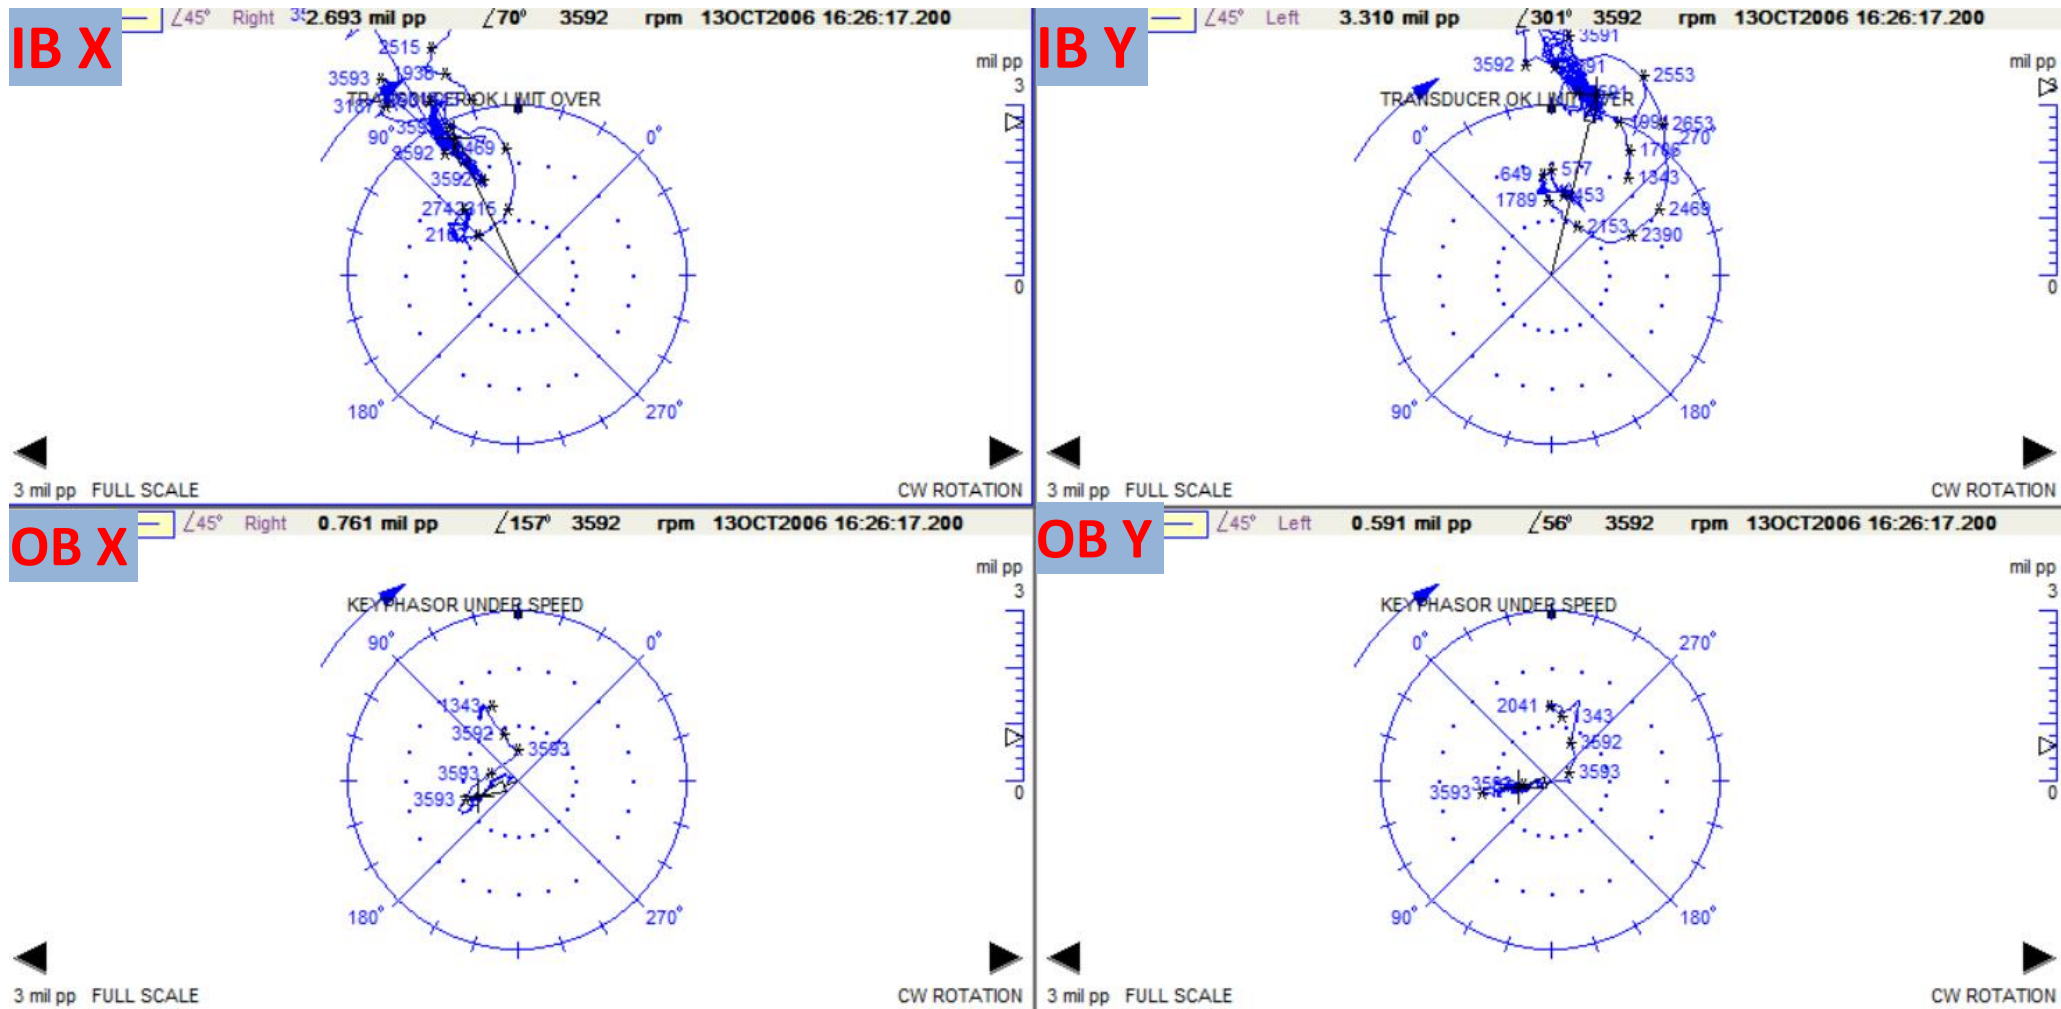
Note that 1X vectors at IB proximity probes became almost 180-degrees-out-of-phase

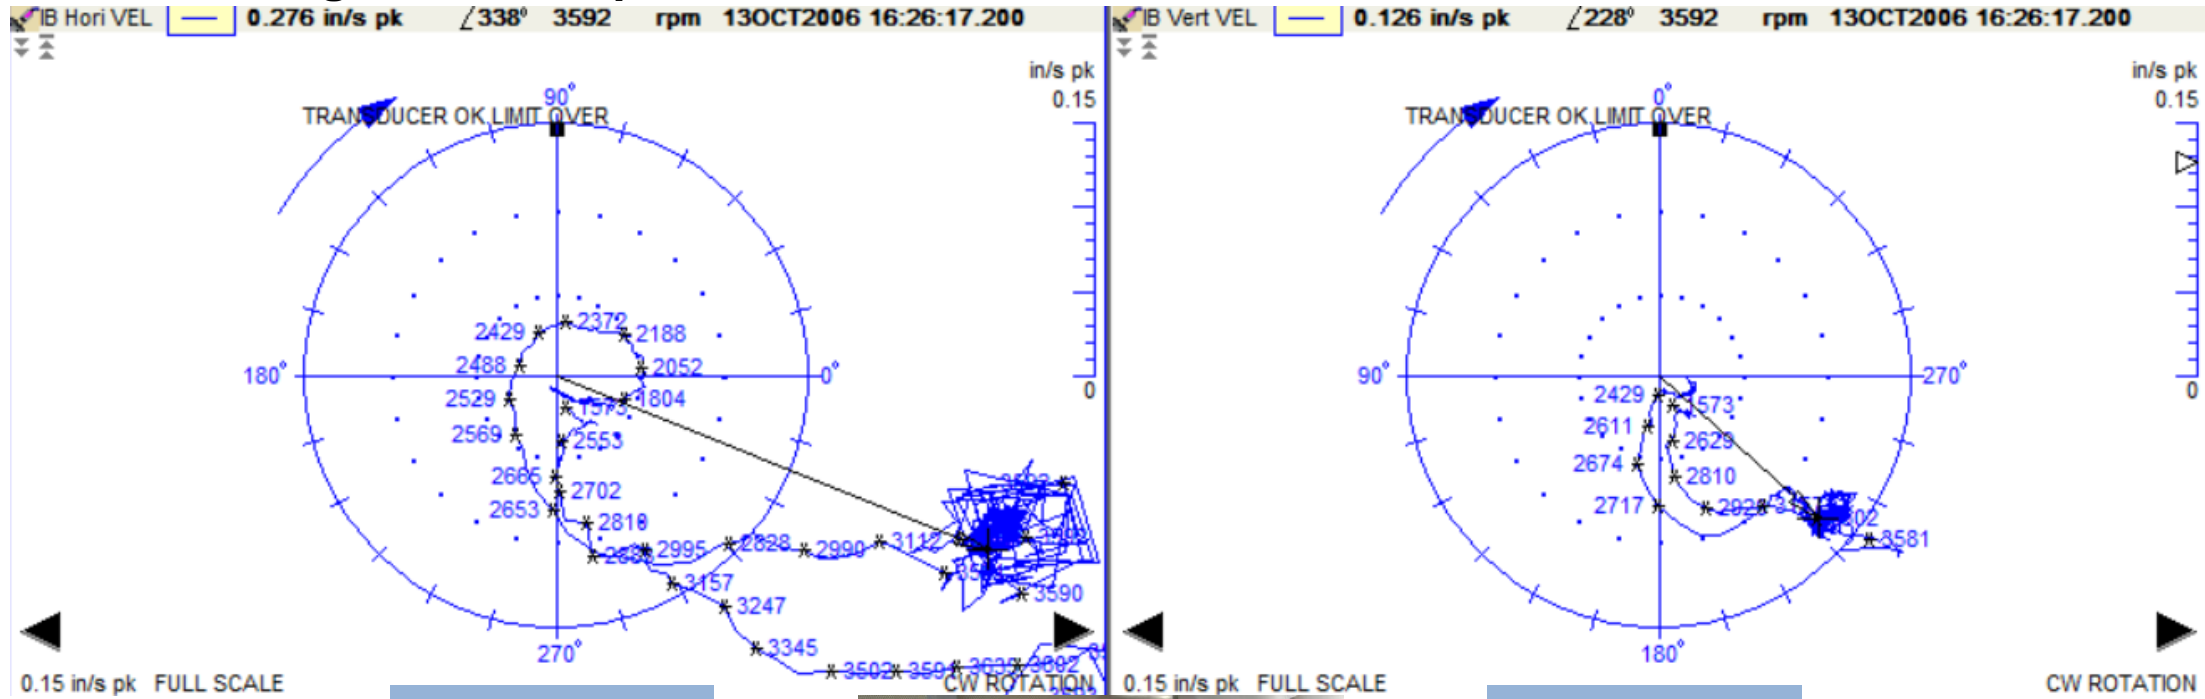
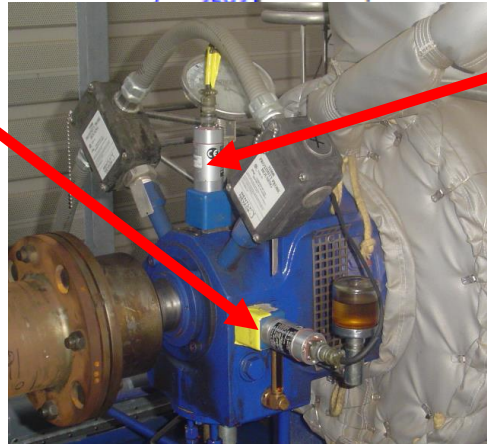
Note that 1X vectors measured by IB casing-mounted transducers became almost 180-degrees-out-of phase as well.
