49TH TURBOMACHINERY & 36TH PUMP SYMPOSIA

Detection of Misalignment from Vibration Data

On a boiler feed pump driven by a motor running close to 3600 rpm, a horizontal misalignment issue was suspected by examining orbit plots besides shaft centerline plots. The follow-up inspection did uncover large parallel misalignment of 0.012 inch along the horizontal direction between the pump and the motor. The root-cause of changes in alignment indicates piping strain as evidenced by loose bolts between the pump and the foundation. The unit was then re-aligned to below 0.001 inch in parallel alignment, followed by correct re-assembly of the coupling. Shaft vibration was successfully reduced to below 2 mil pp and with a normal orbit orientation.

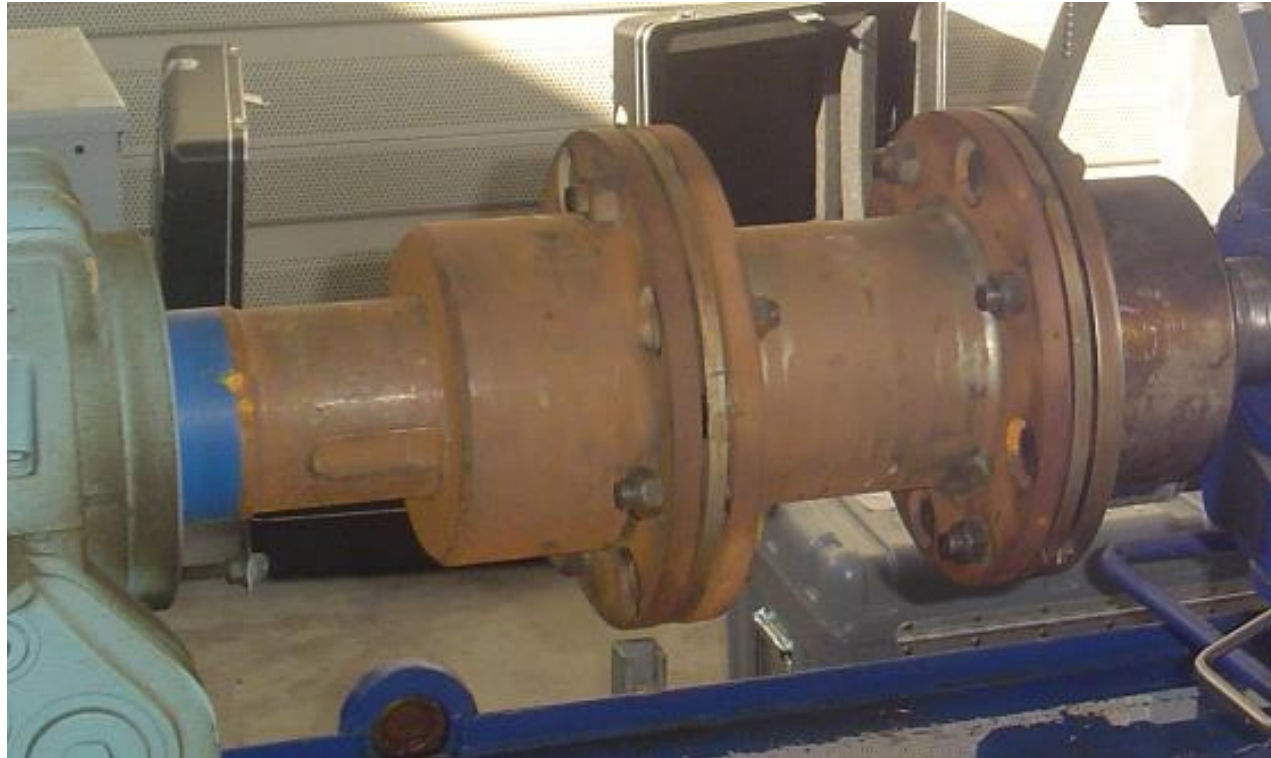
**Vibration level was still higher than normal.
Wrong coupling spool or bolt installation was
suspected.**

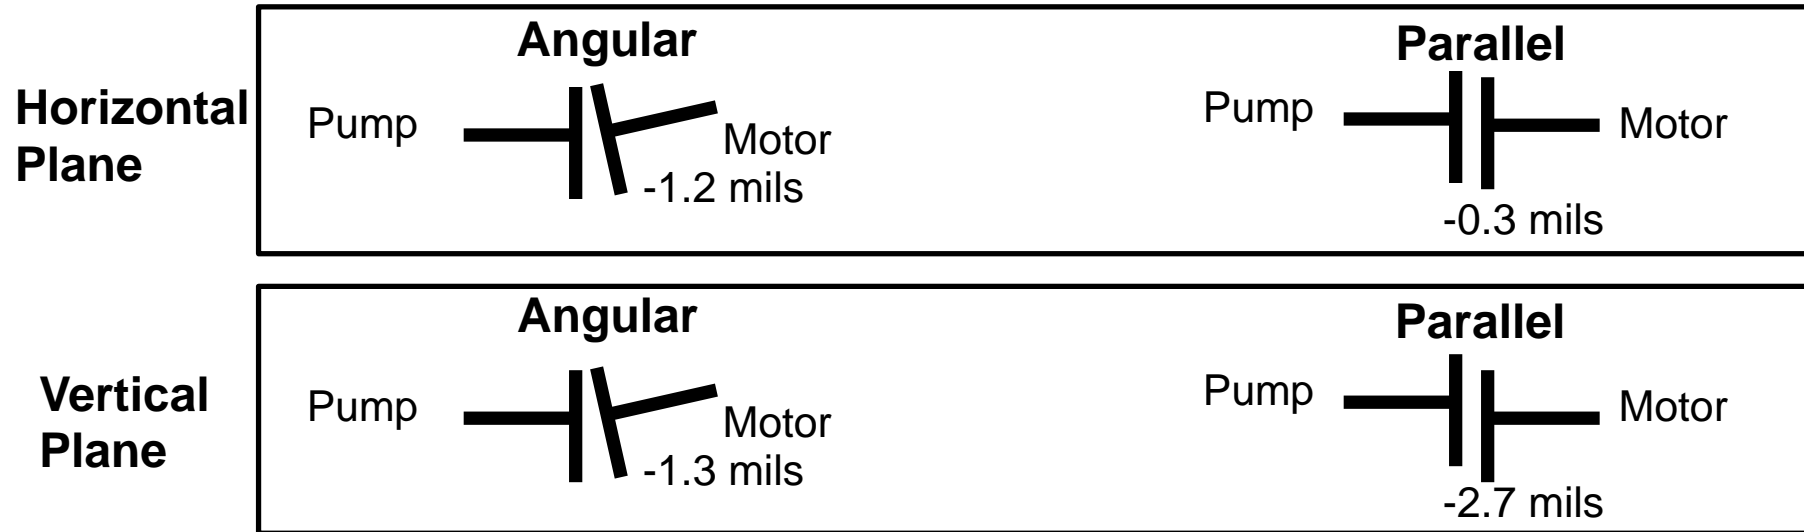
- Mismatch of flanges and spool found, which caused high mass unbalance. The coupling re-assembled. Alignment verified as below:

- Bolts connecting the pump to the foundation found to be loose. All four bolts re-tightened.

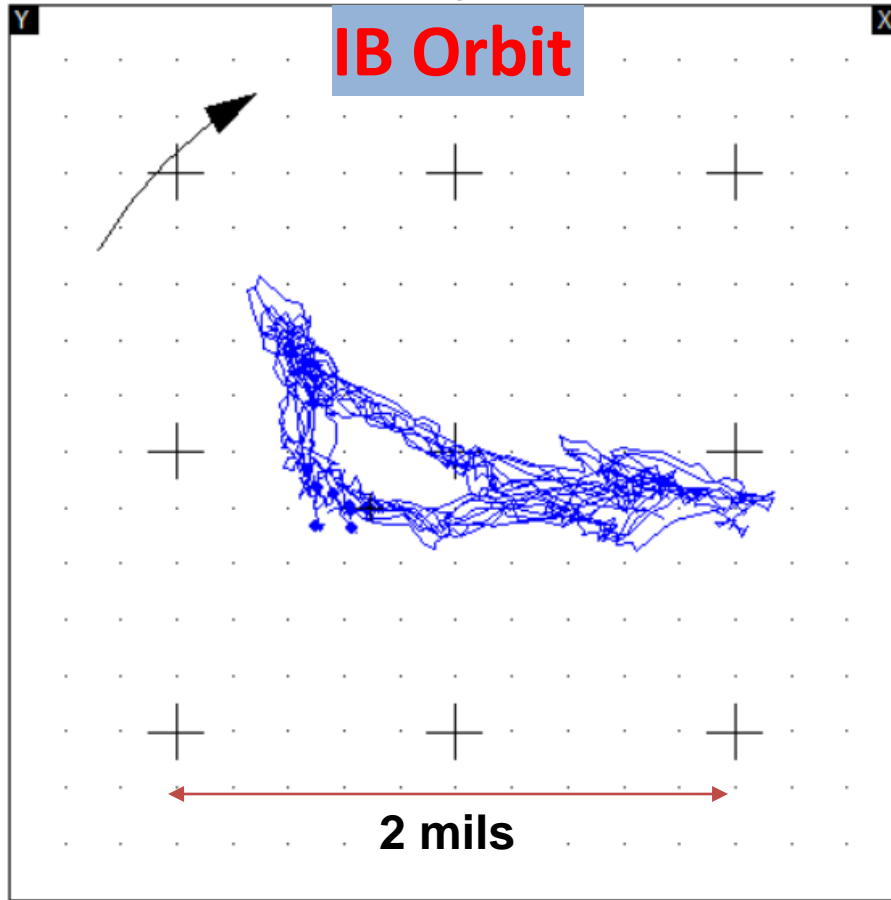
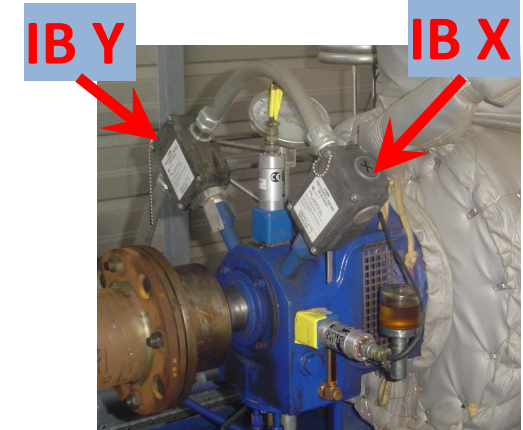
- Normal orbit orientation (major axis aligned to 10 o'clock position)
- Low vibration amplitude (less than 2 mil pp)

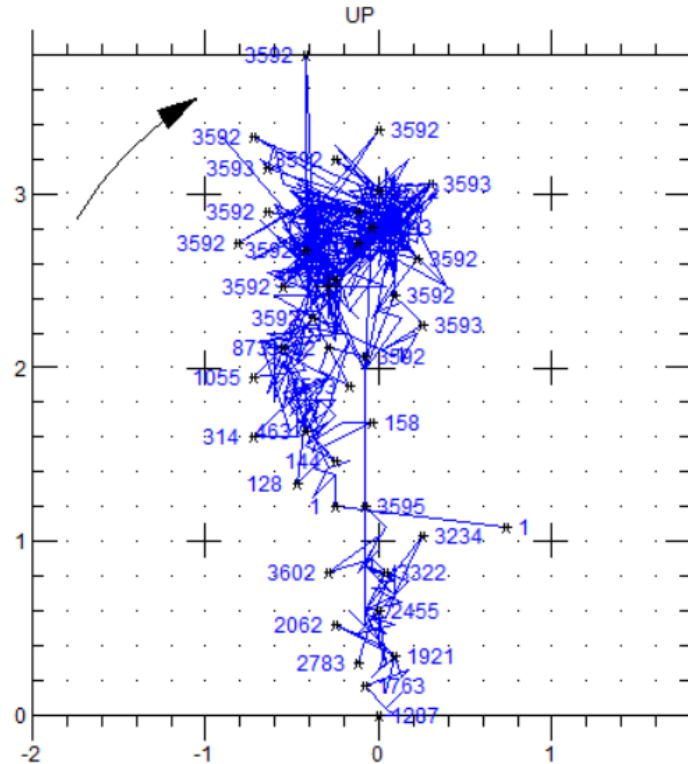
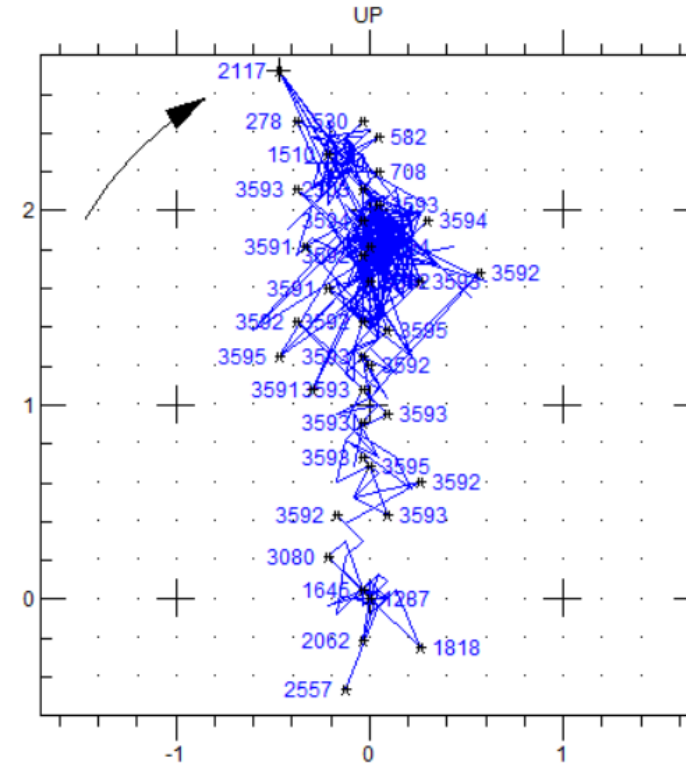
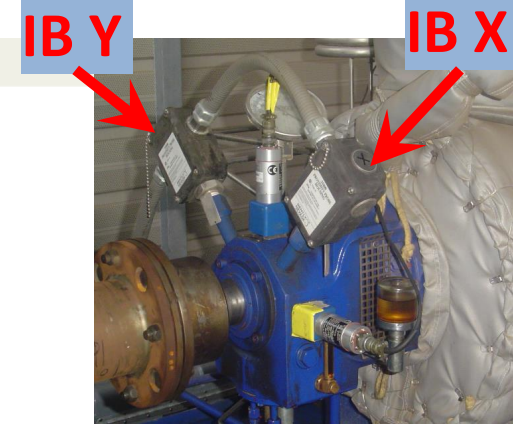
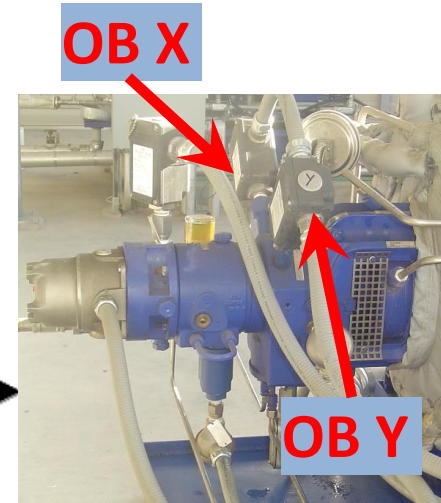
**Normal shaft centerline plots
(no significant horizontal shift)**
