# 49<sup>TH</sup> TURBOMACHINERY & 36<sup>TH</sup> PUMP SYMPOSIA

## Video Based Vibration: A tutorial and case study with a live demonstration and data analysis on real life pump data

Jeff Hay, PhD, CEO RDI Technologies

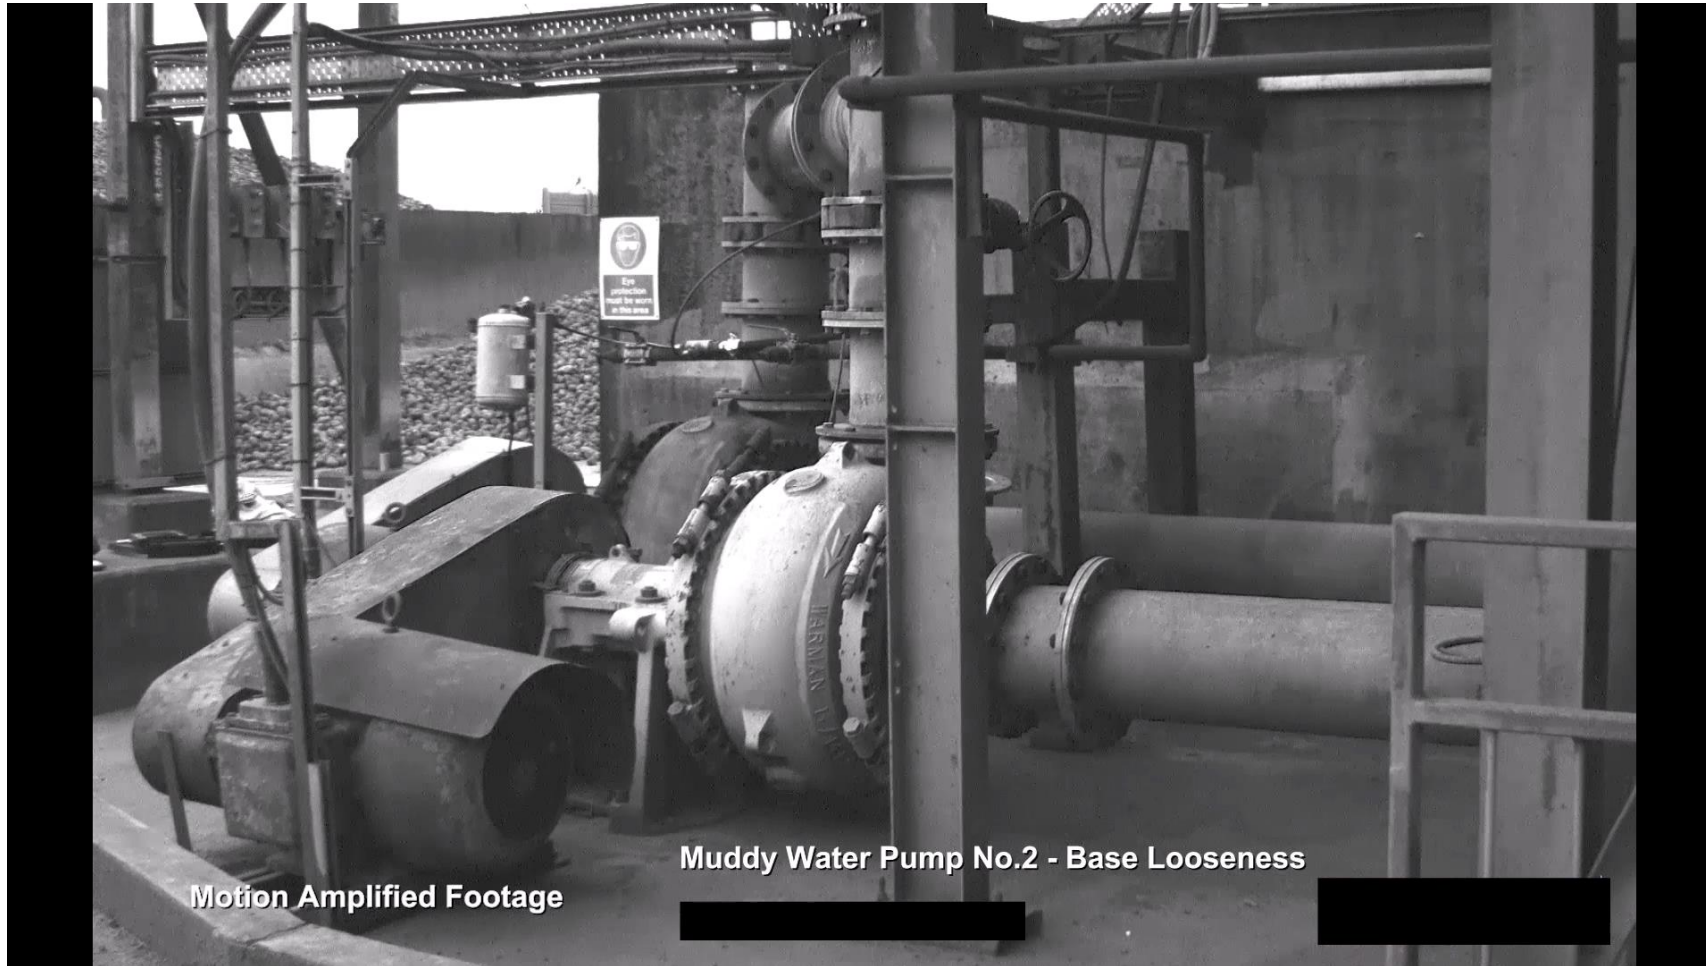
Muddy Water Pump No.2 - Base Looseness

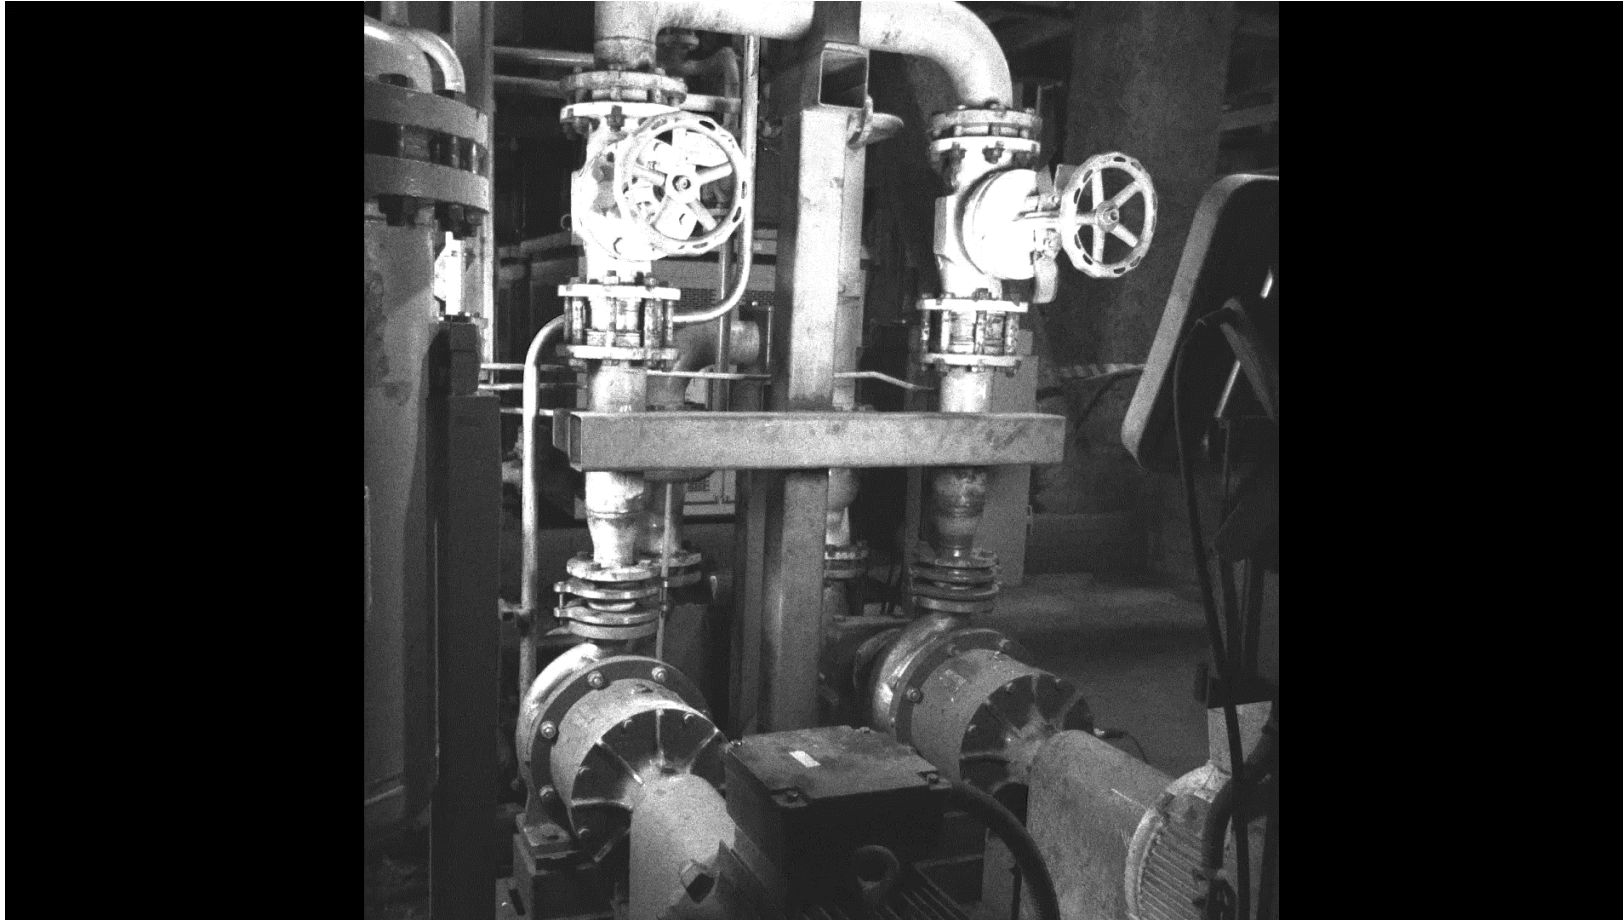
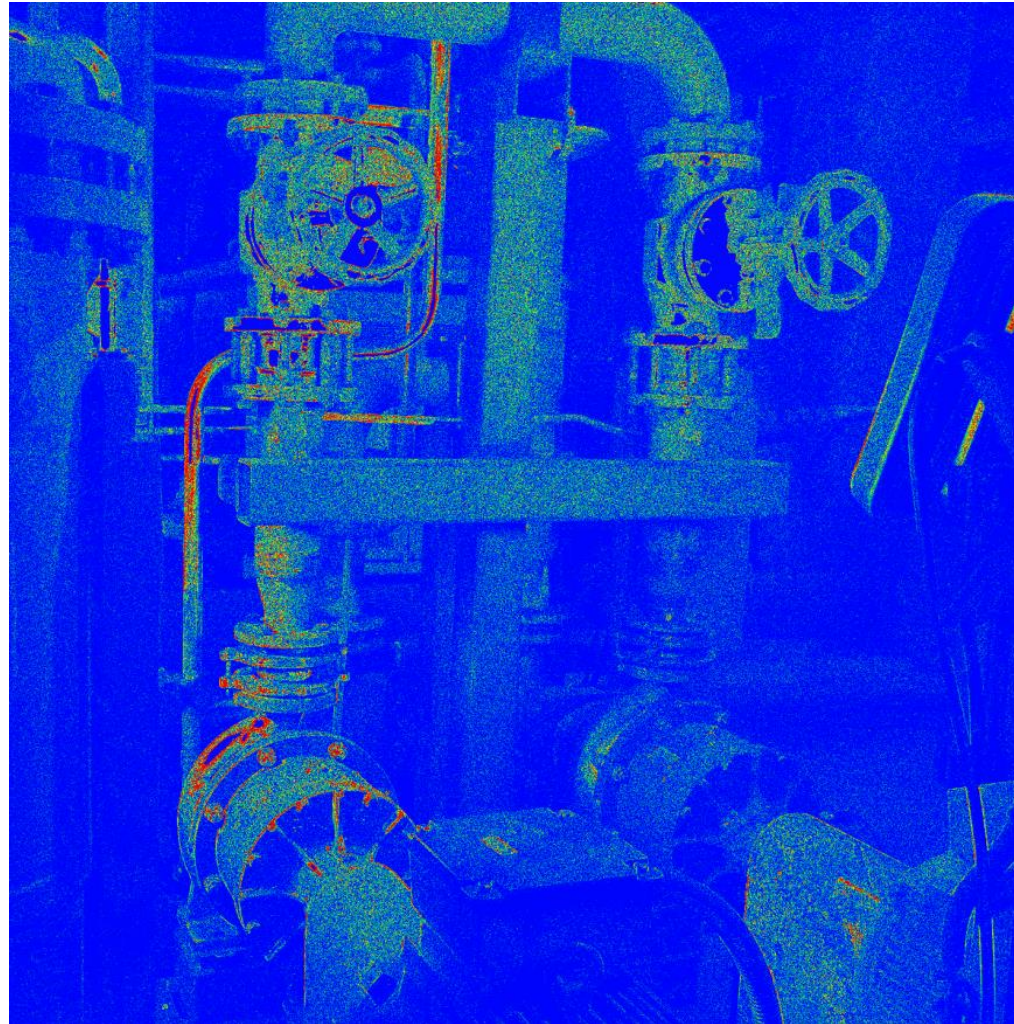
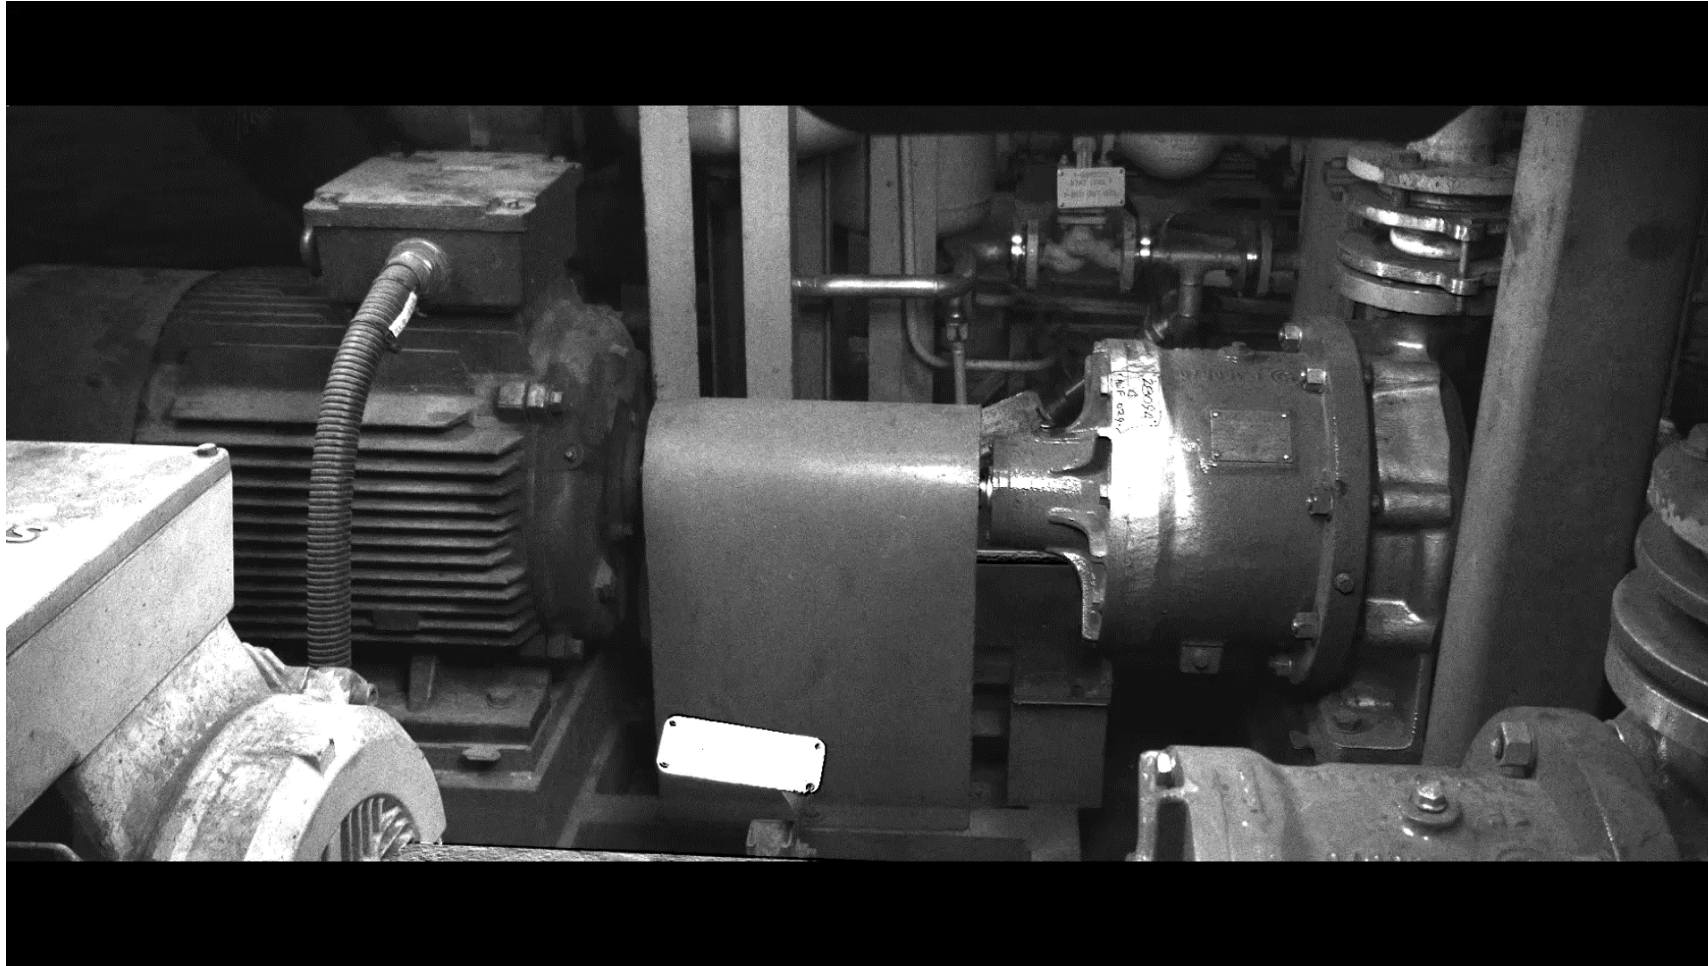
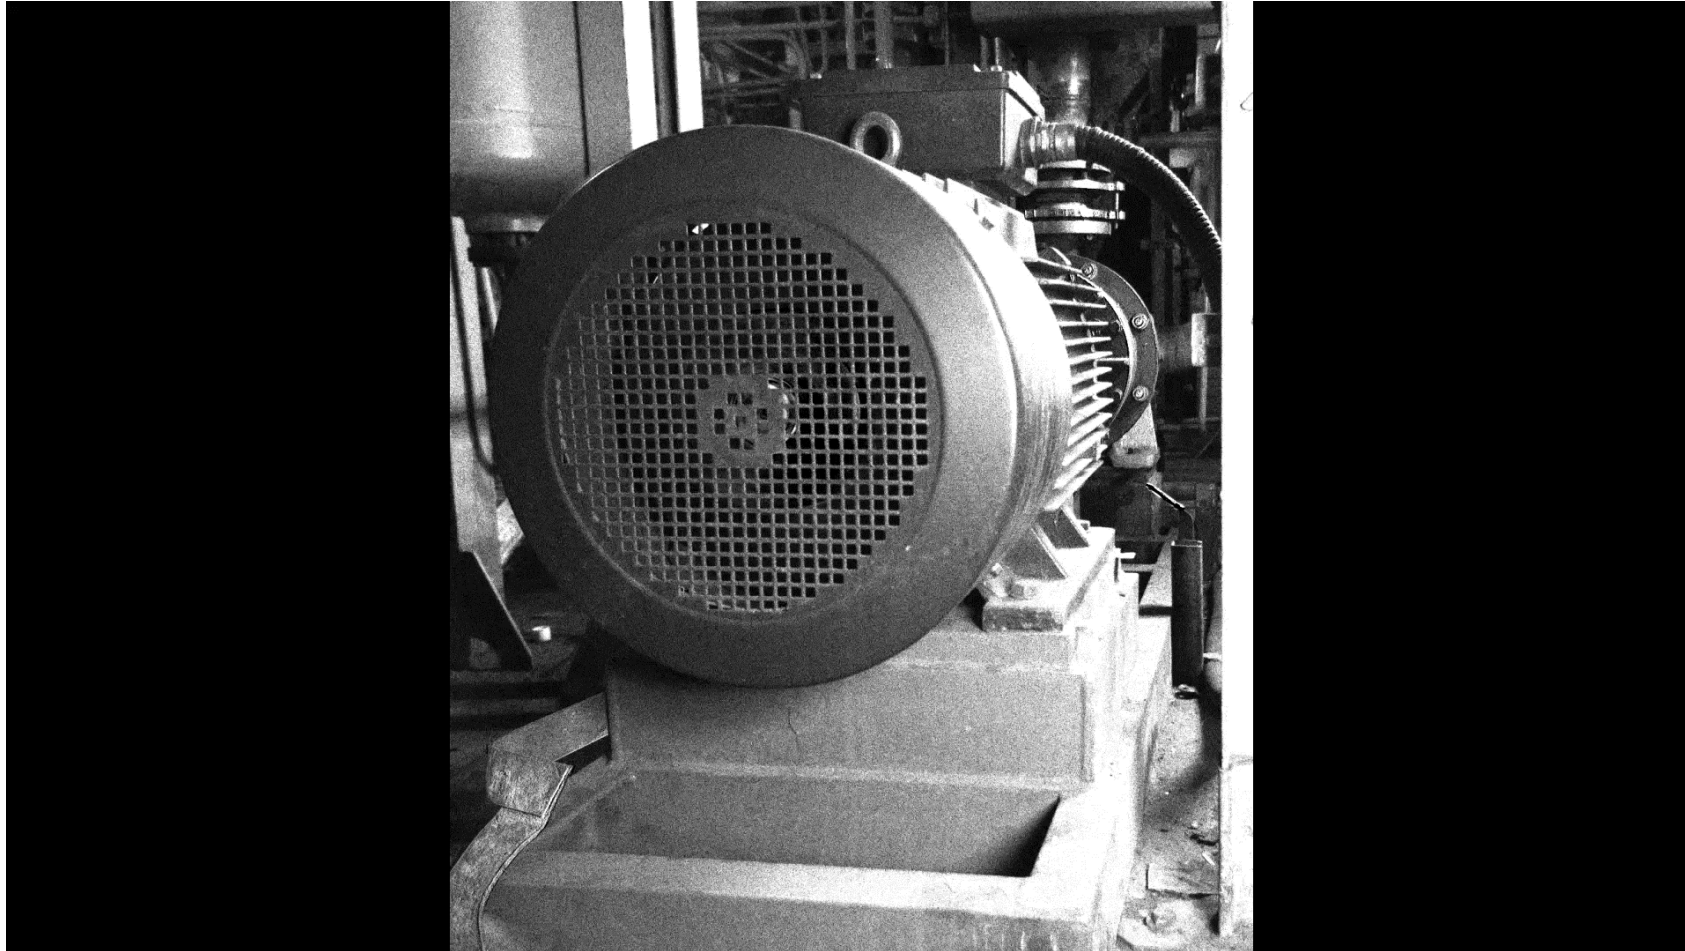
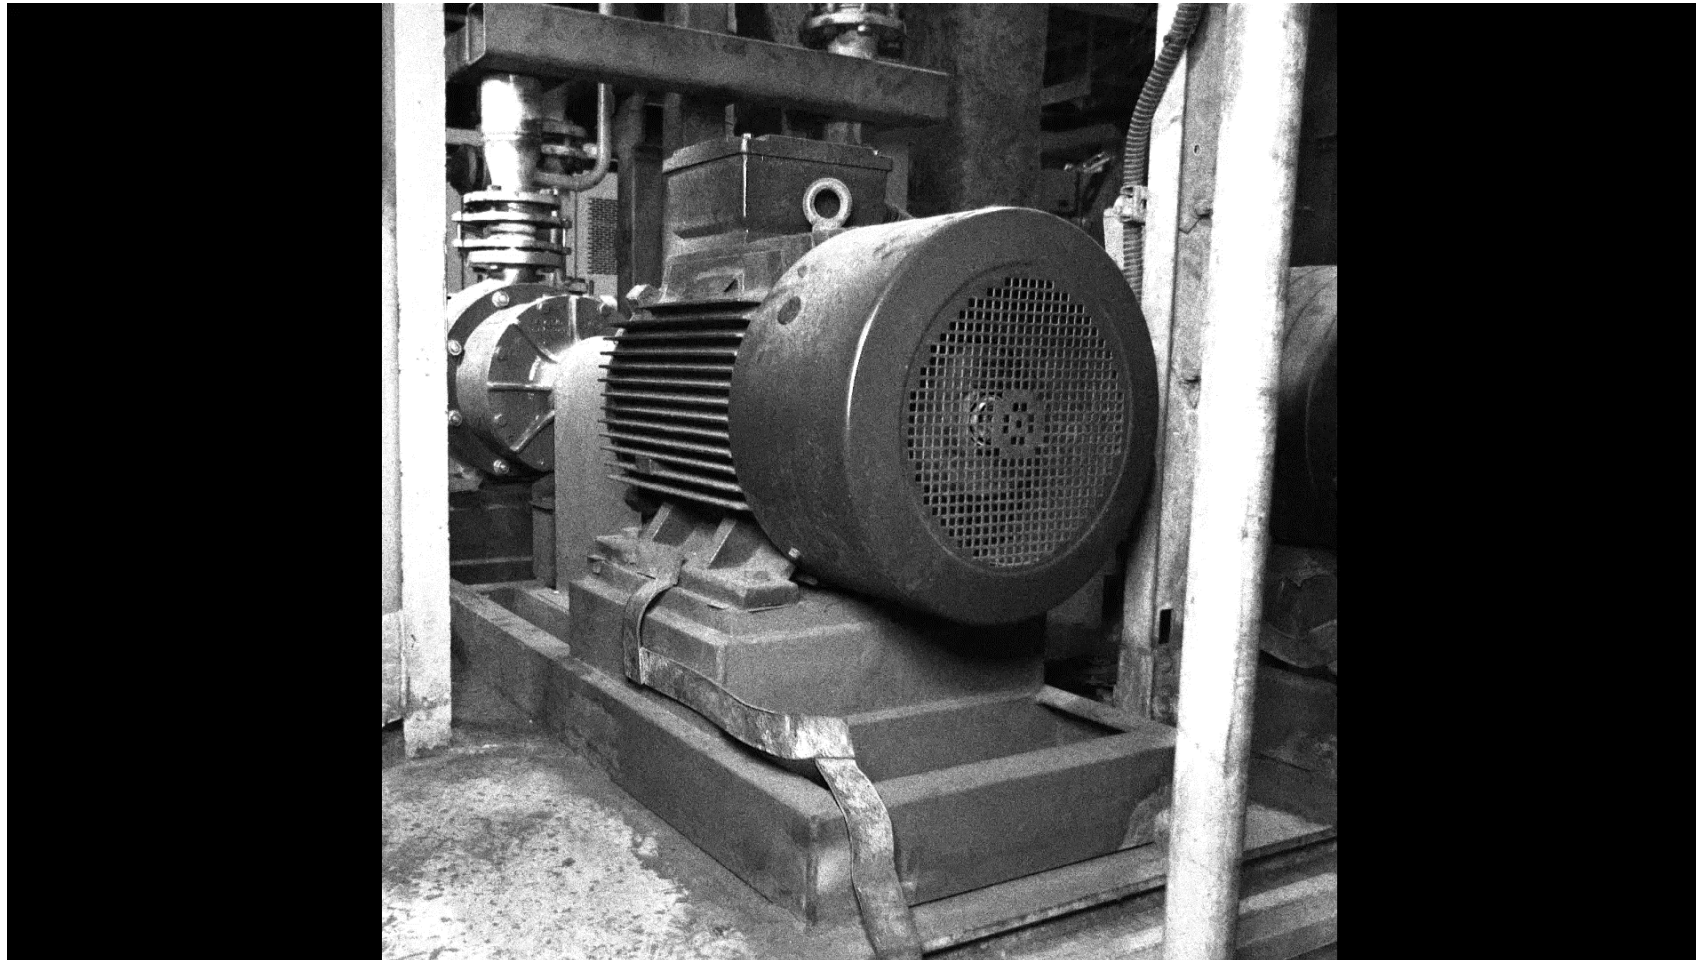
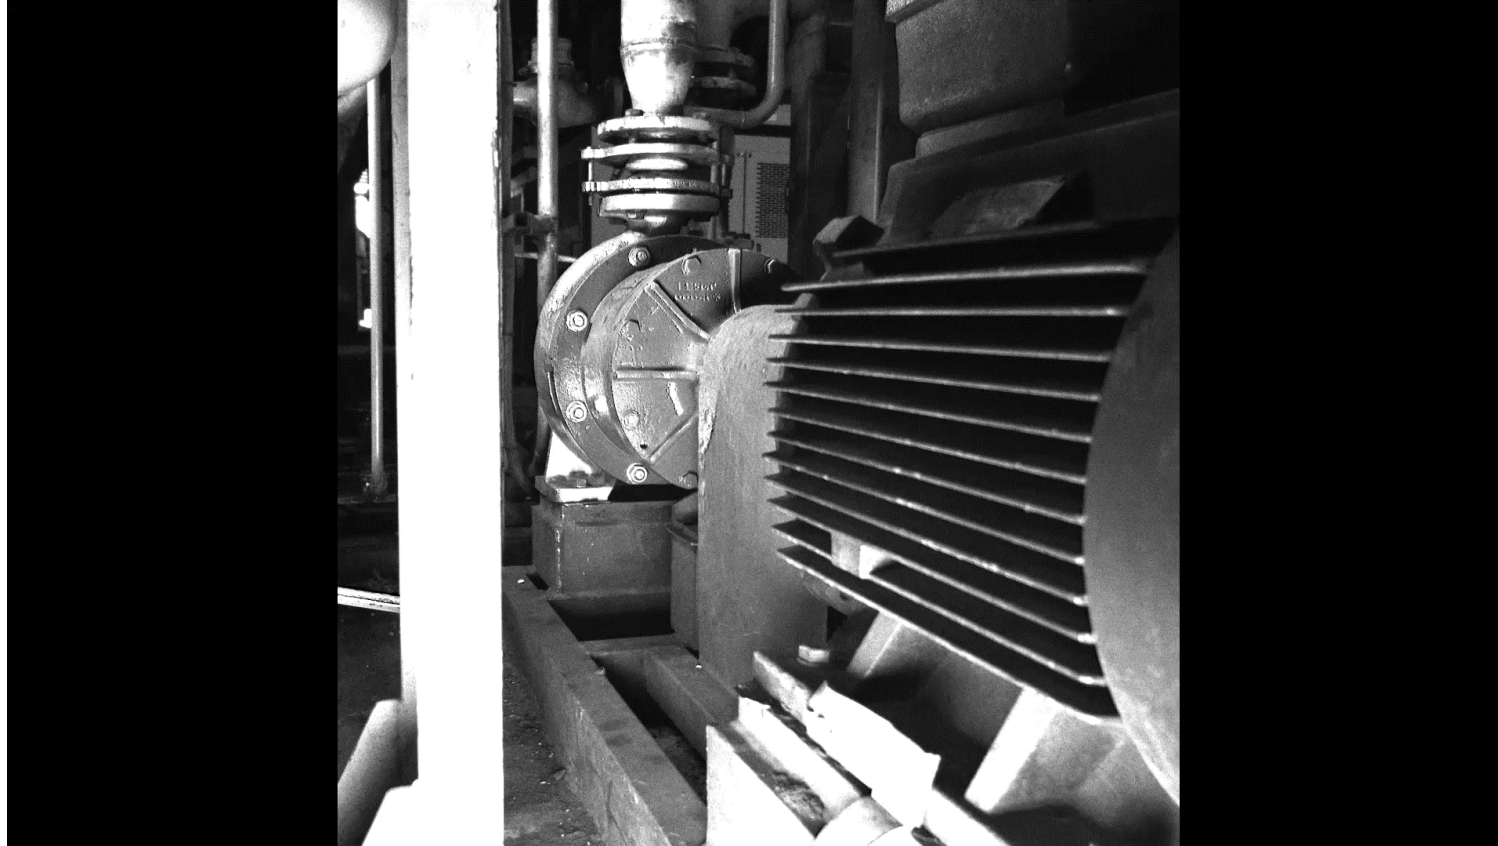
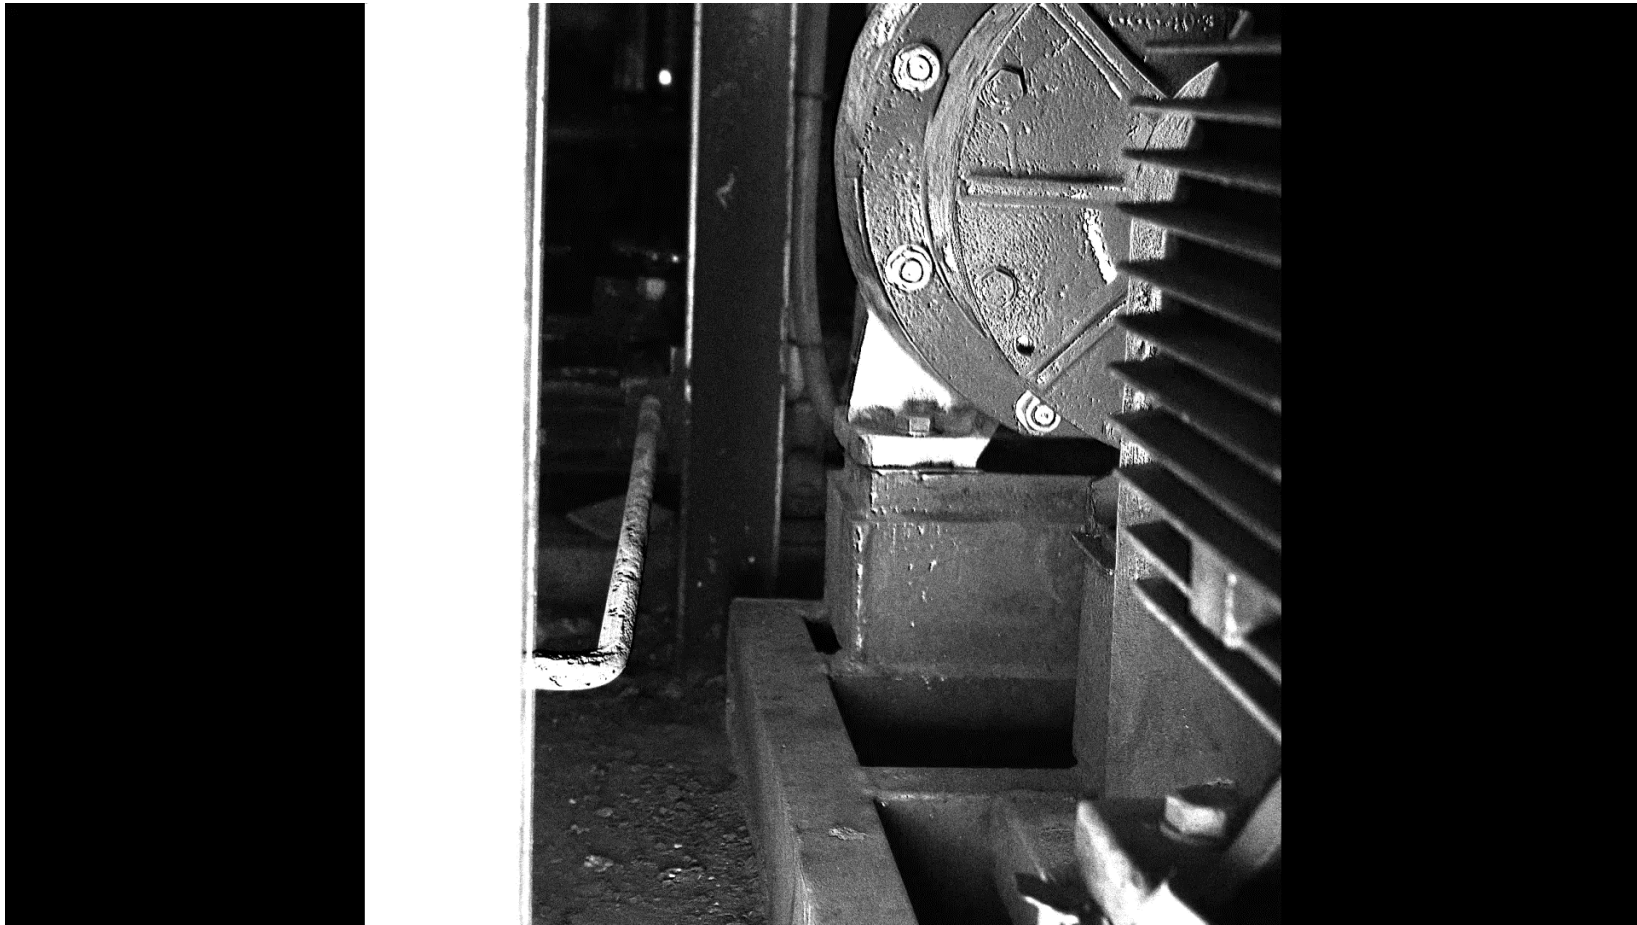
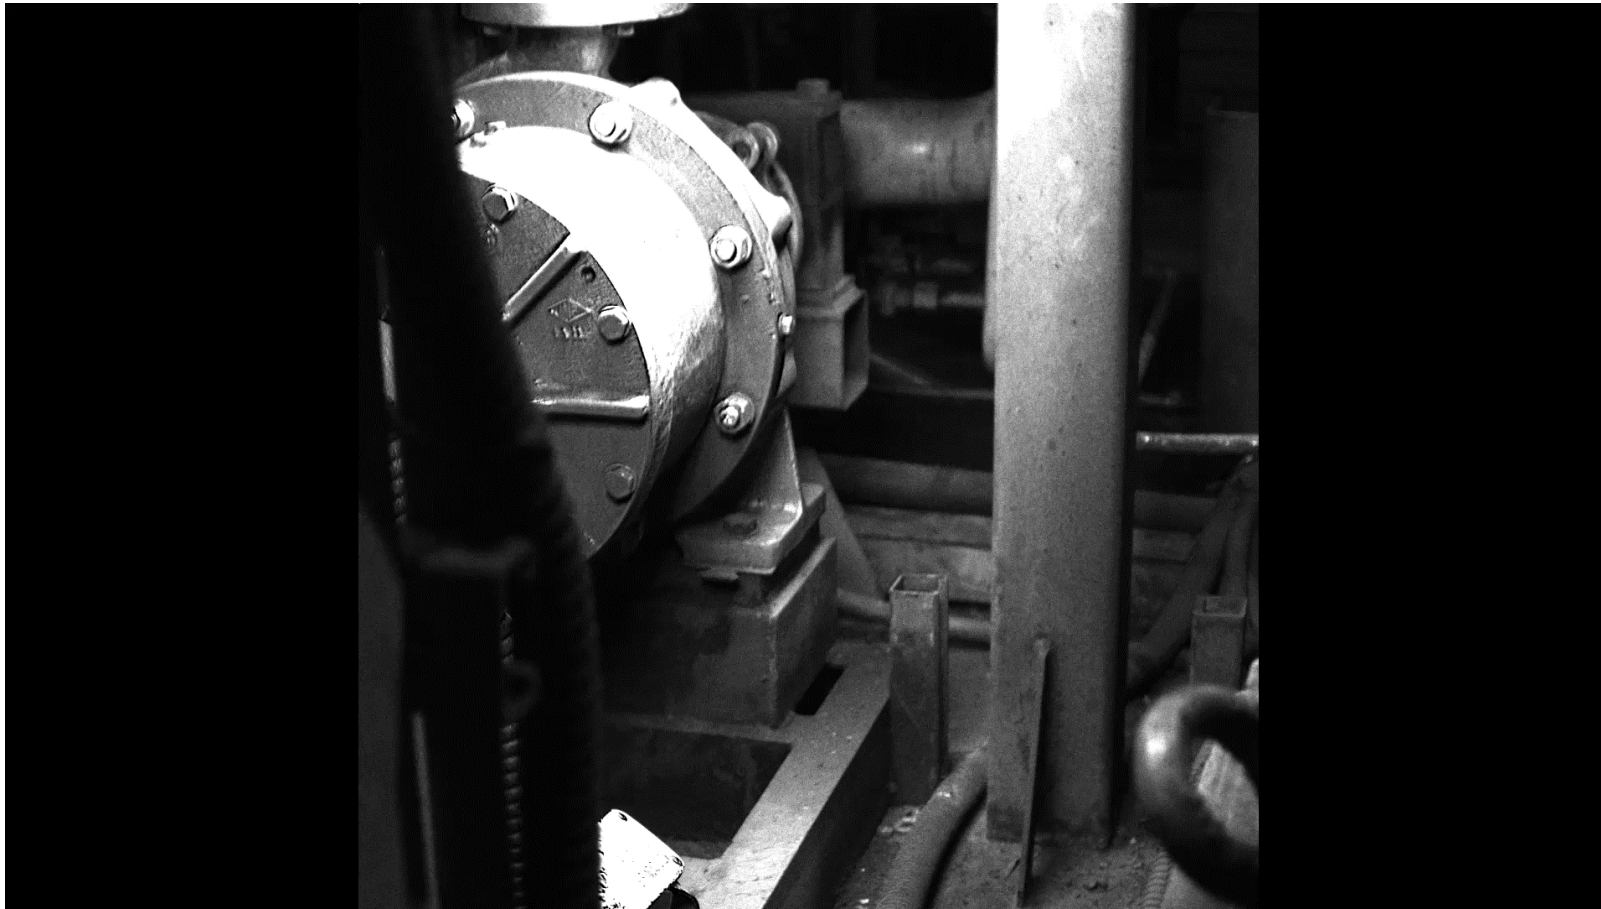
**Problem:** Excessive Vibration Levels

- Camera revealed issues in the structural integrity of pump base frame
- Majority of Repair Complete through fillet welds interior to base – Client confident the problem is now understood
- Prior to this study additional repairs were planned that would not have addressed the problem
- Camera allows for a quick Root Cause look – quickly isolating issues

- Main indicator was that there was relative motion (soft foot) between the steel motor/pump frame and the common skid steel base plate
- “There was simply insufficient weld to secure the motor/pump frame properly to the skid base plate”
- ~2 mils Pk-Pk (Red Box on motor/pump frame) vs ~0.4 mils Pk-Pk (Blue Box on skid base plate)
- Root Cause Issue Identified
- Vibration reduced from 0.55 in/s to 0.15 in/s
- This is before realignment- expected to improve more.

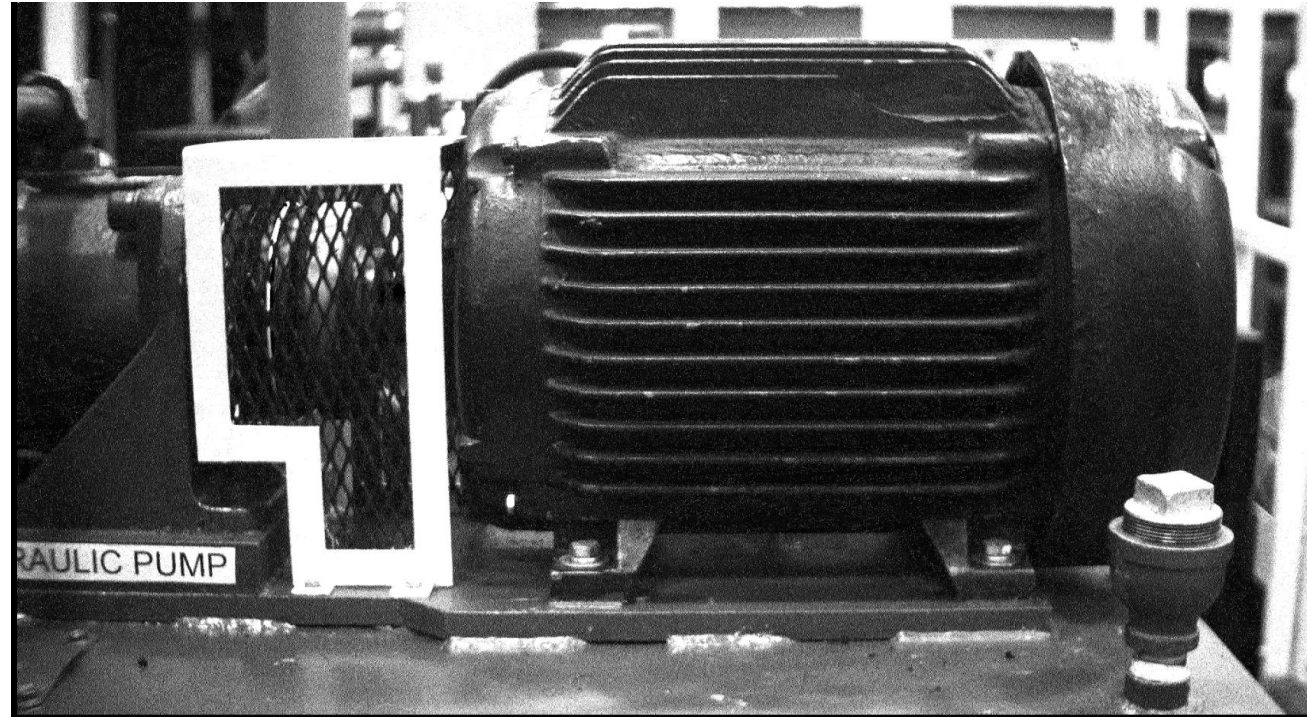
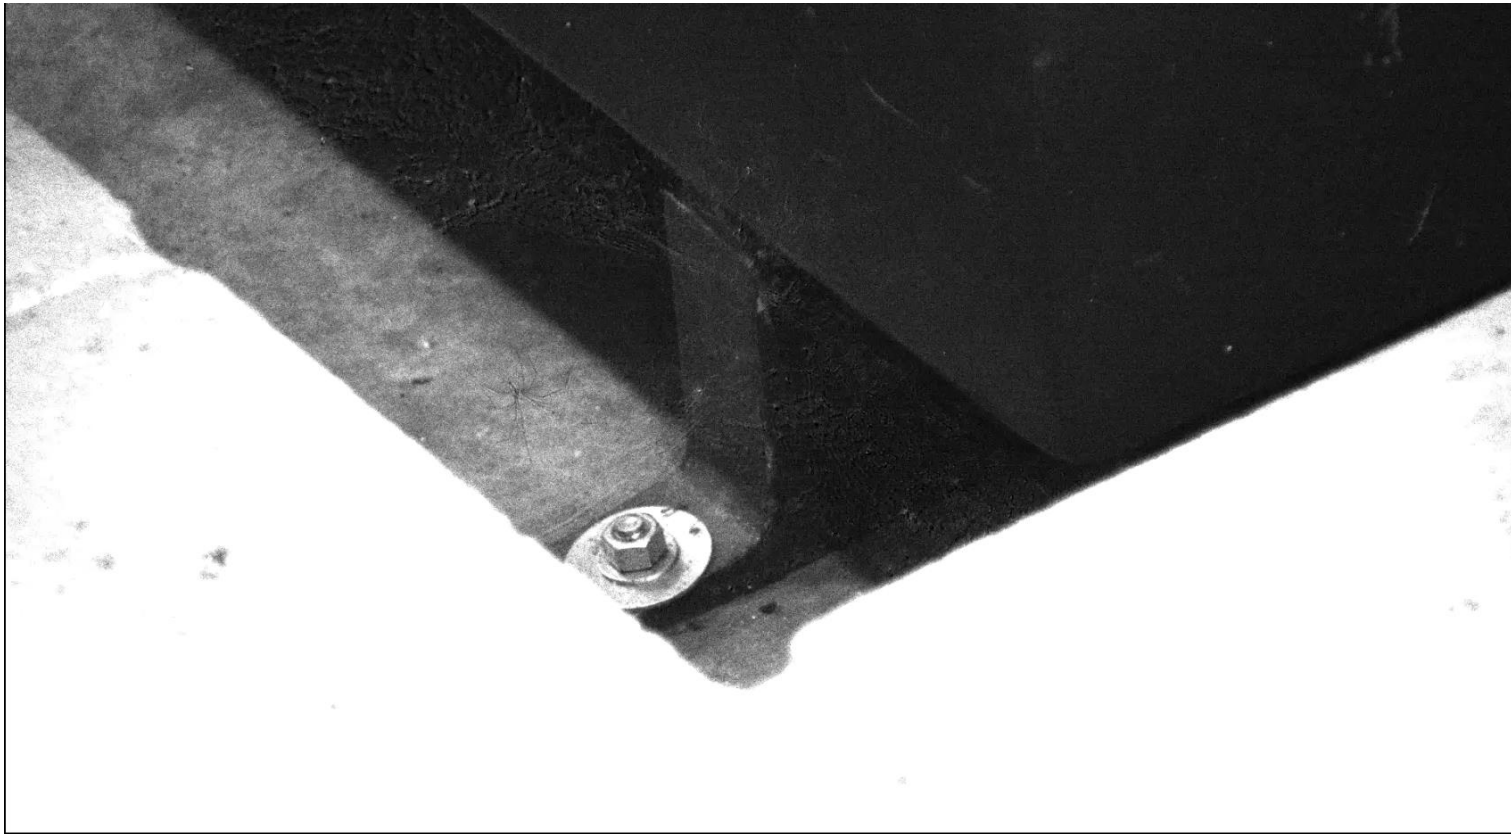
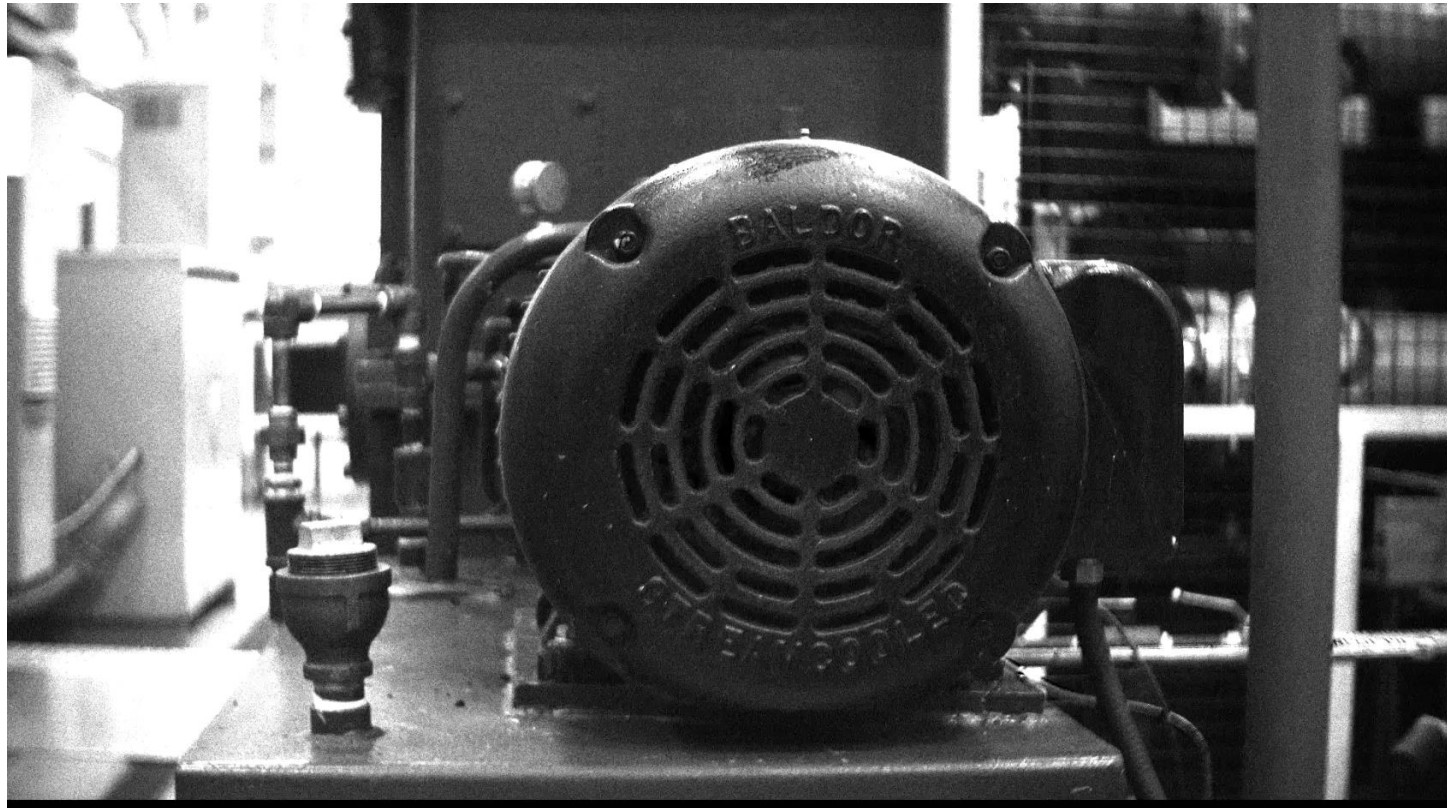
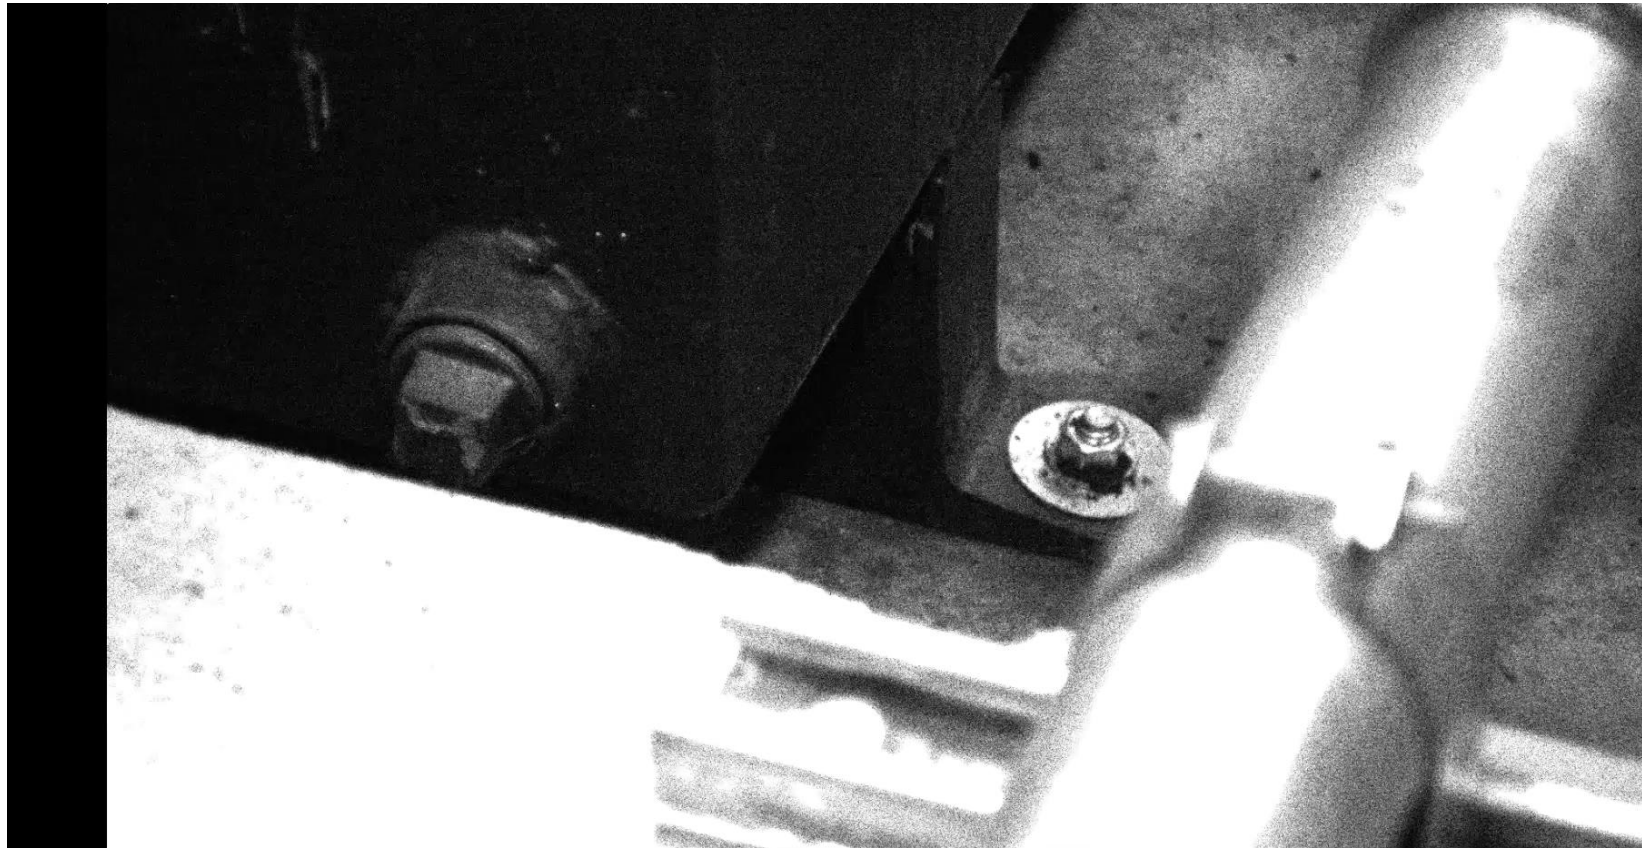
- Operator knew of problem (High Vibration and Change in Audible Noise Levels)
- Could not determine root cause
- Motion Amplification process < 30 minutes.
- Issue identified as bolt drilled at an angle at install

- Client confirmed the bolt was drilled at an angle during installation
- Allowed the bolt to work its way loose
- Client confirmed they intended to remove the bolt and redrill correctly.
