ASIA TURBOMACHINERY & PUMP SYMPOSIUM

High Speed Coupling Failure related to Torsional Vibration

ExxonMobil

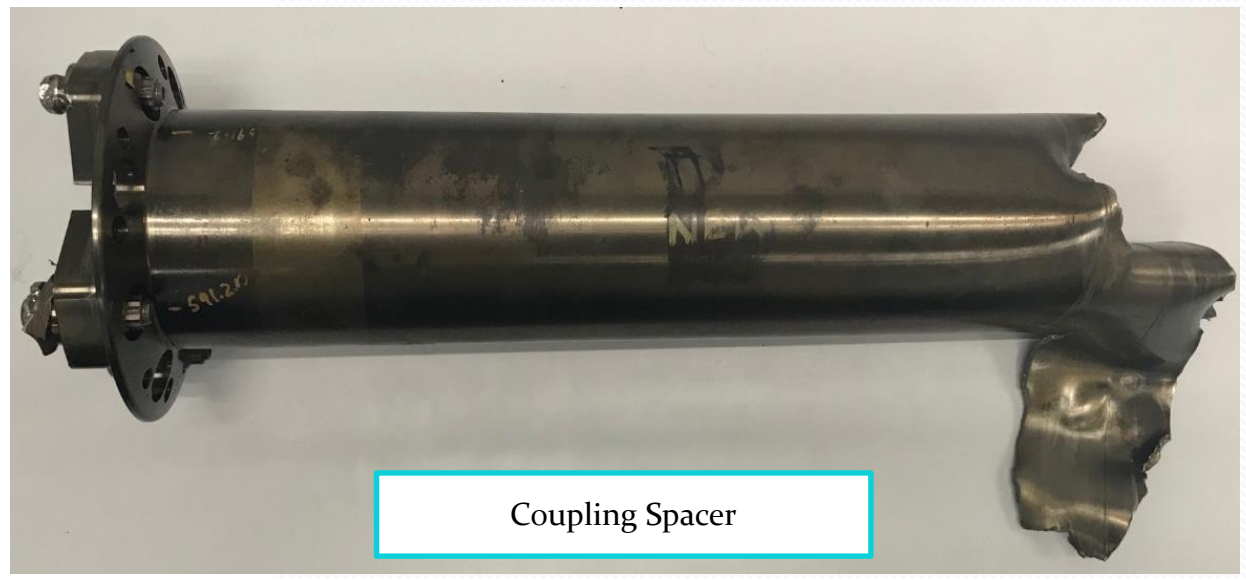
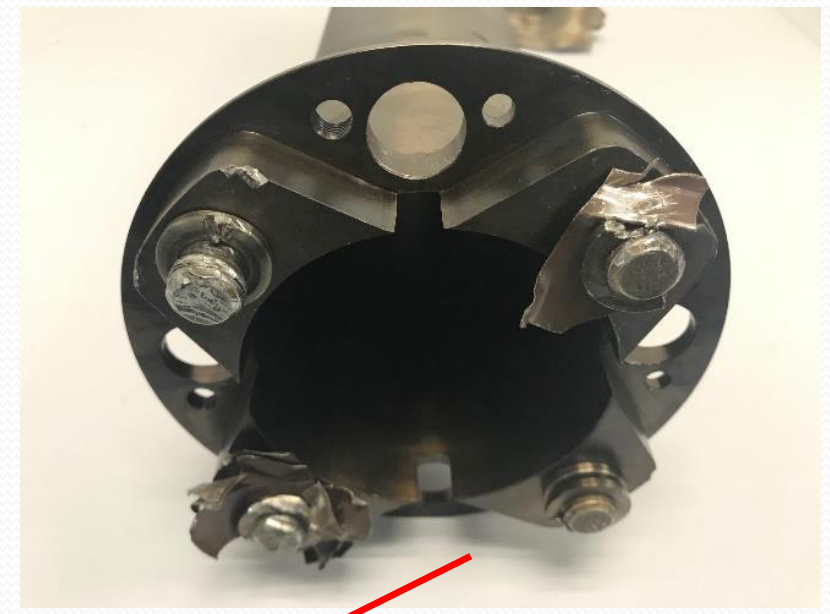
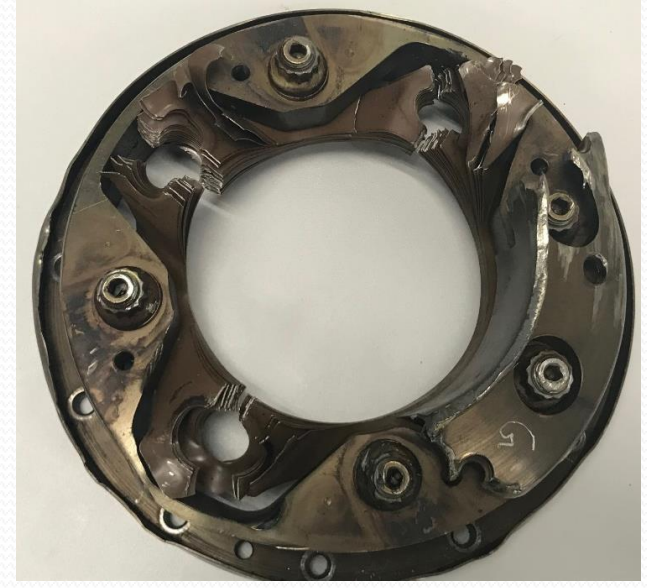
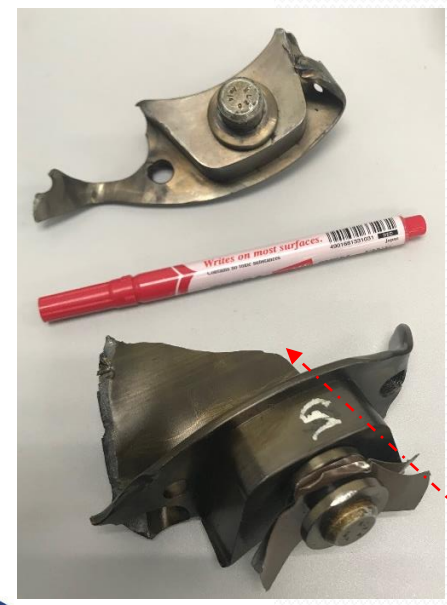
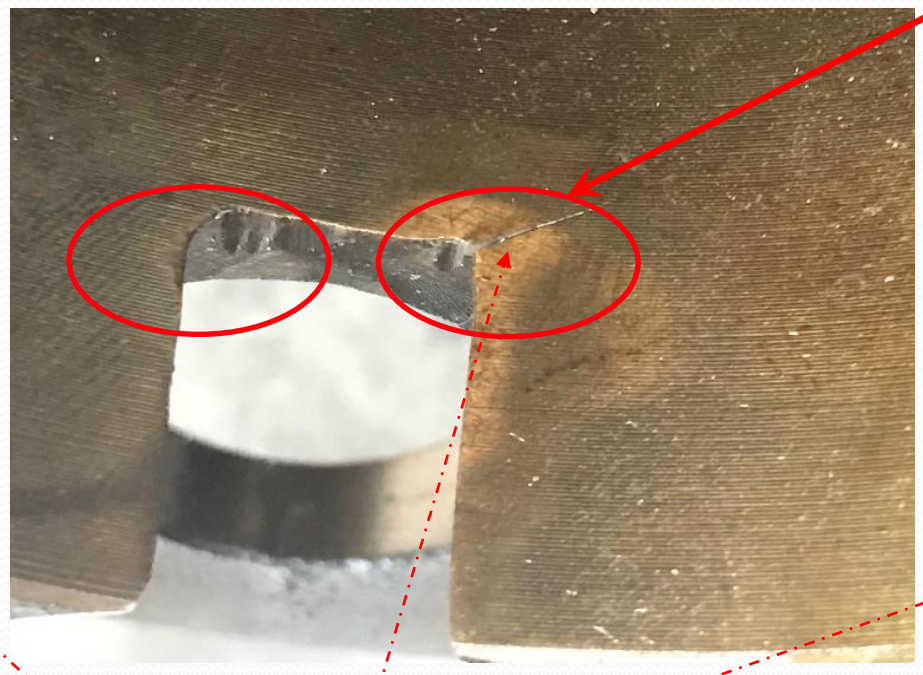
First Failure:

Findings are similar for First failure and Second failure

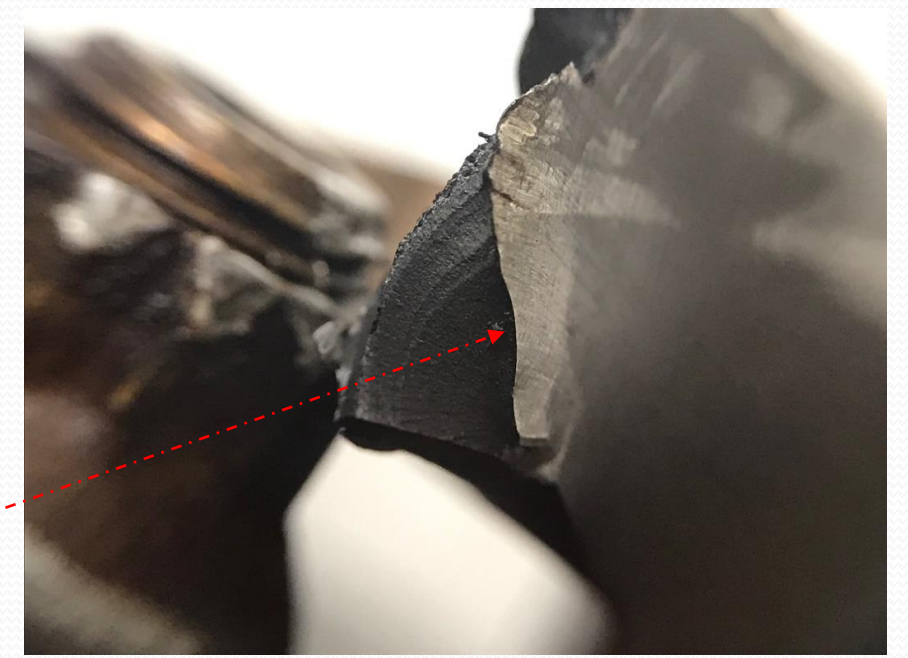
Crack propagated

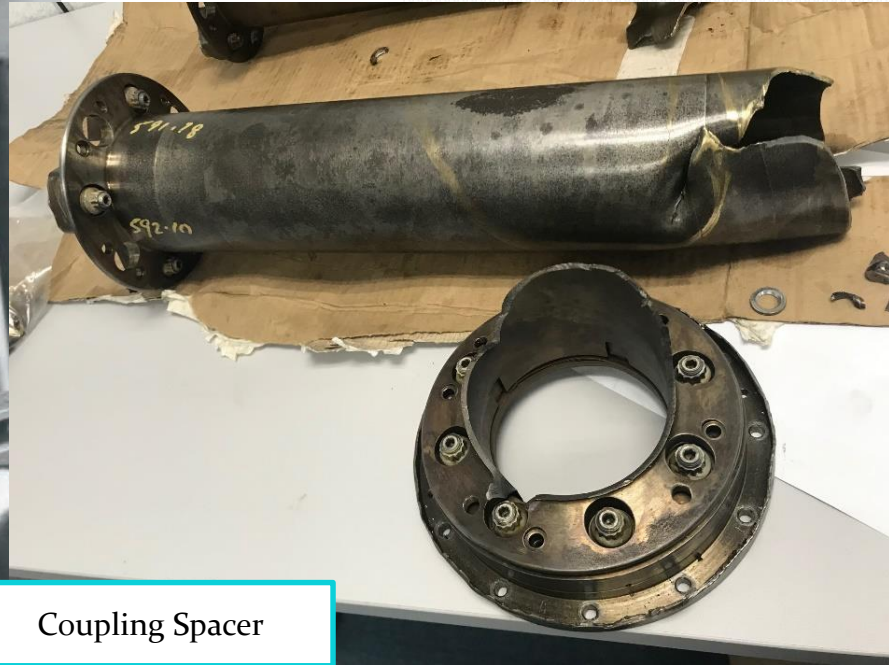
Coupling Spacer

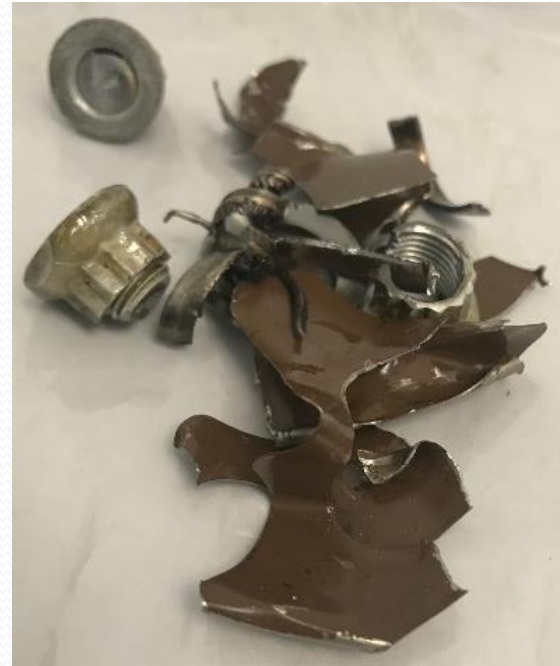
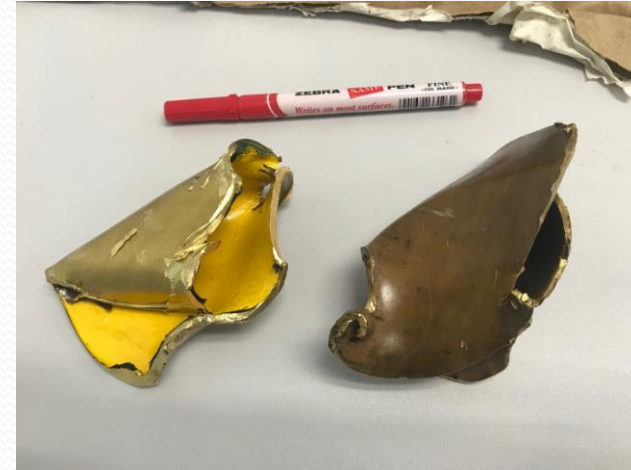
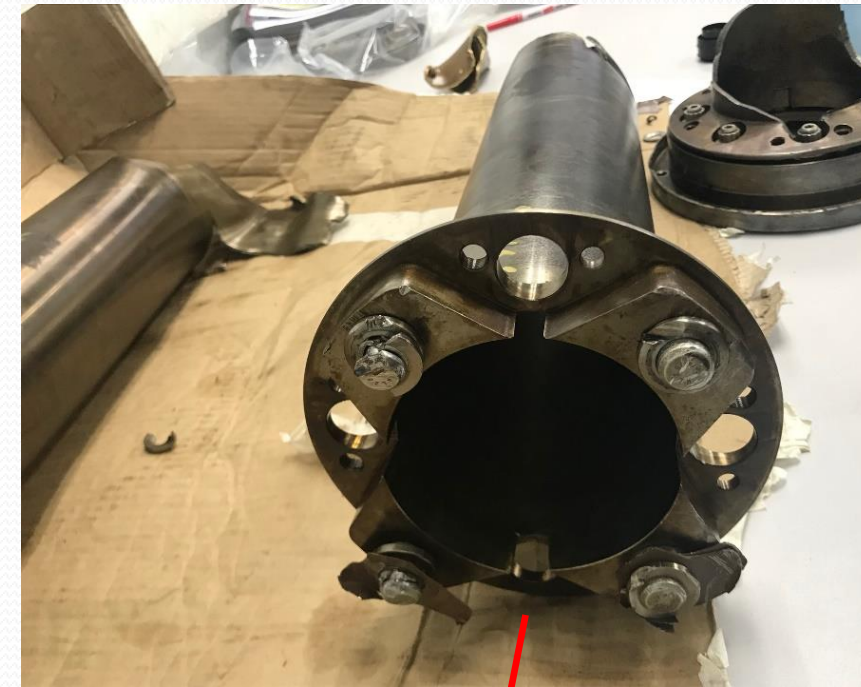
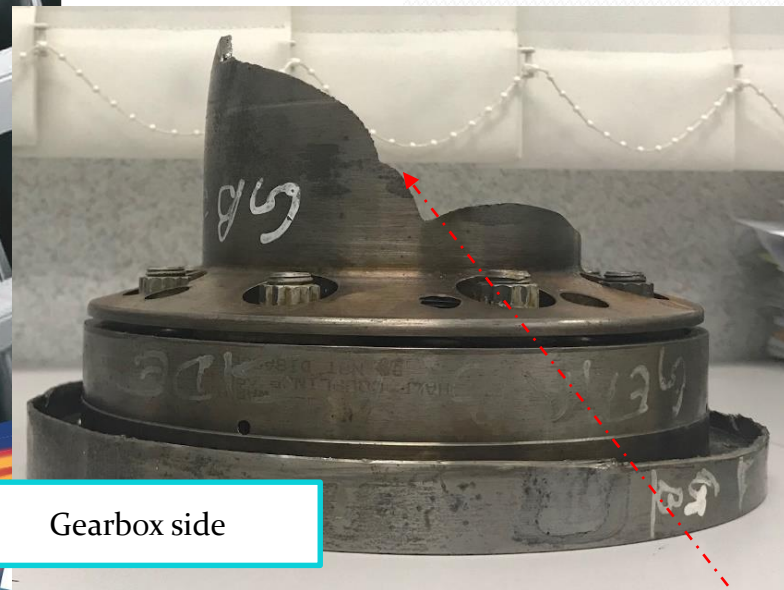
Second Failure:

Gearbox side

Findings are similar for First failure and Second failure

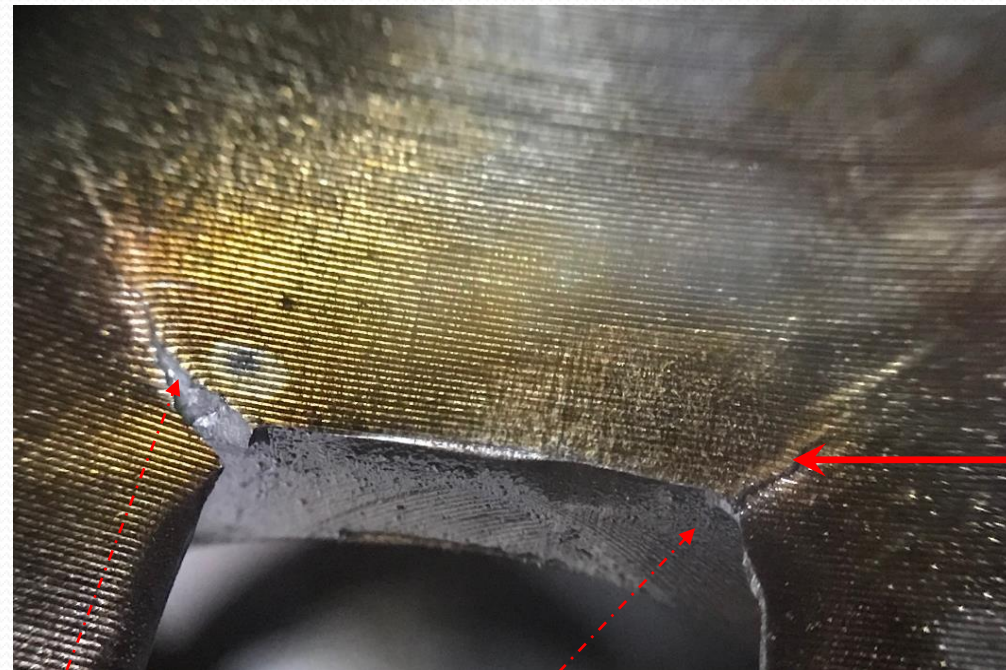
Crack propagated

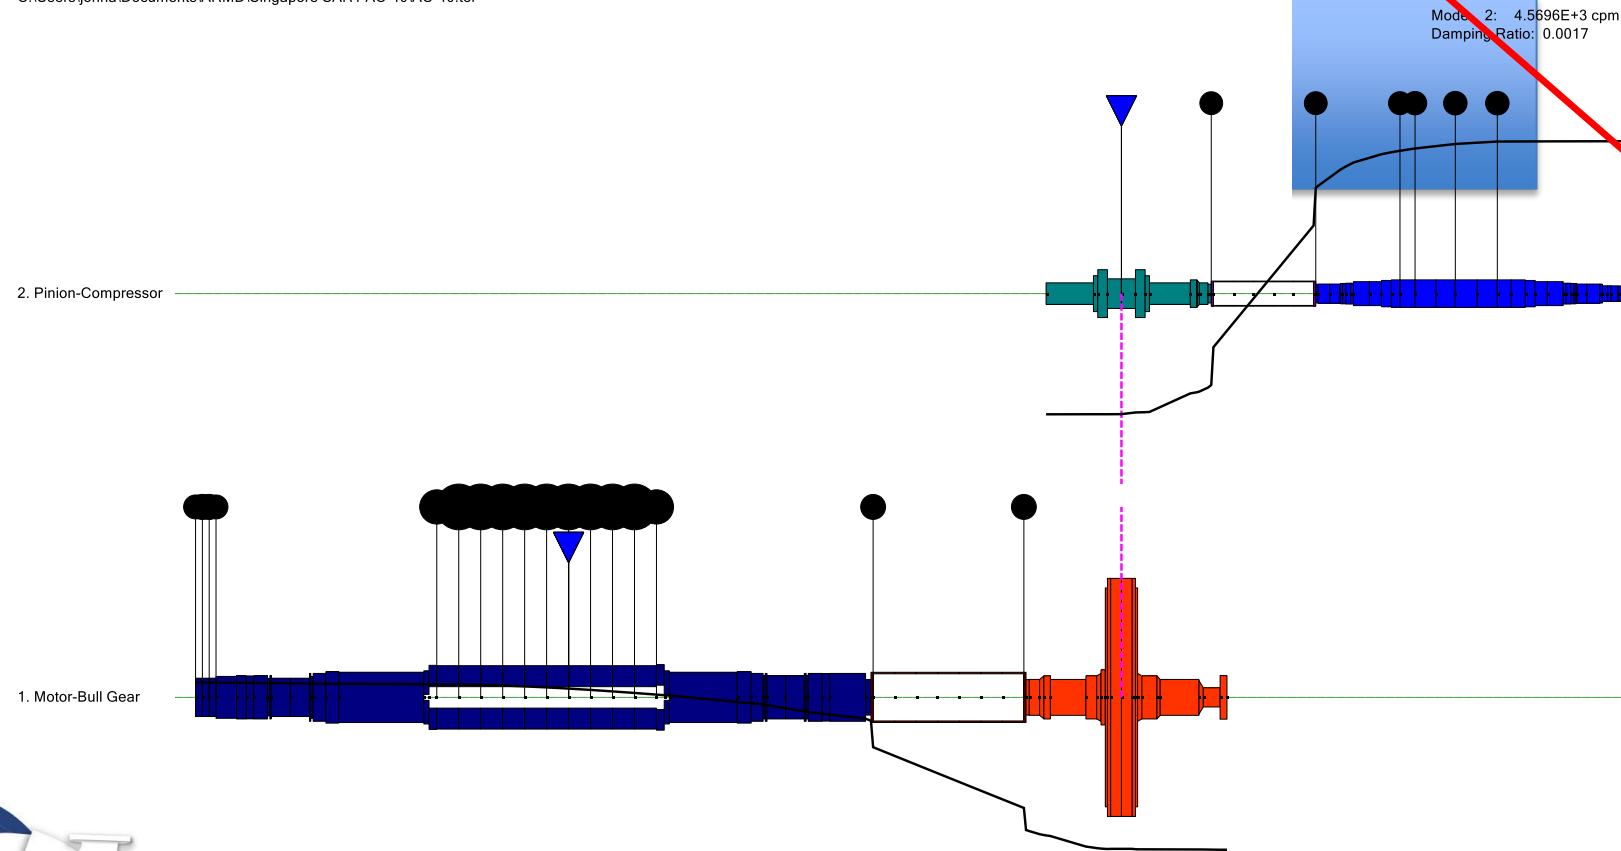
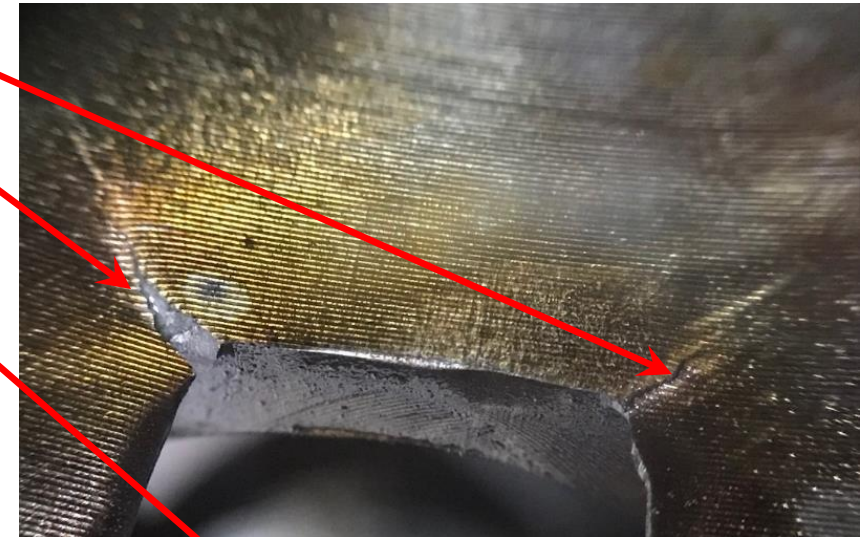
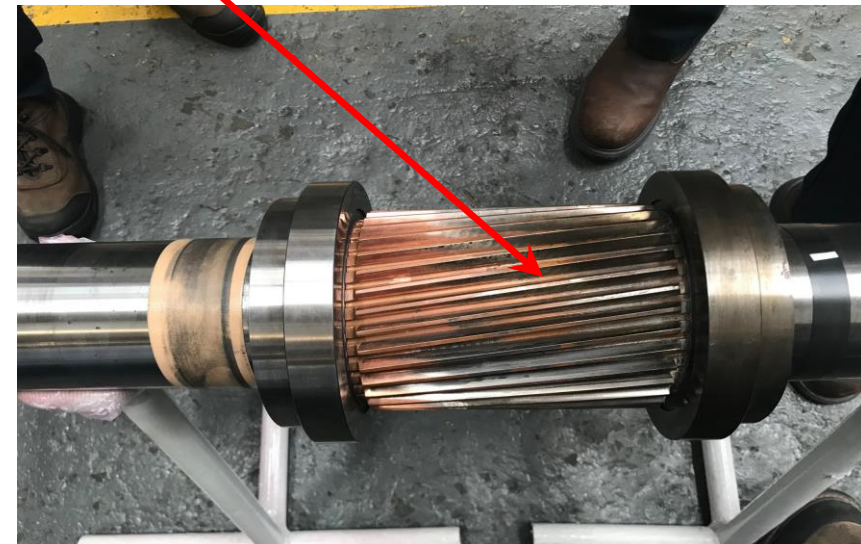
- Experienced coupling failures – observed 9x pinion speed vibration on the pinion shaft
- Torsional analysis was performed to identify modes close to 9x pinion speed
- Likely excitation of 2nd TNF

Torsional Natural Frequency (cpm)	OEM	EM
1 st	1342	1341
2 nd	4566	4570

- Fatigue crack initiation in two principle directions
- Gear tooth wear pattern on both sides

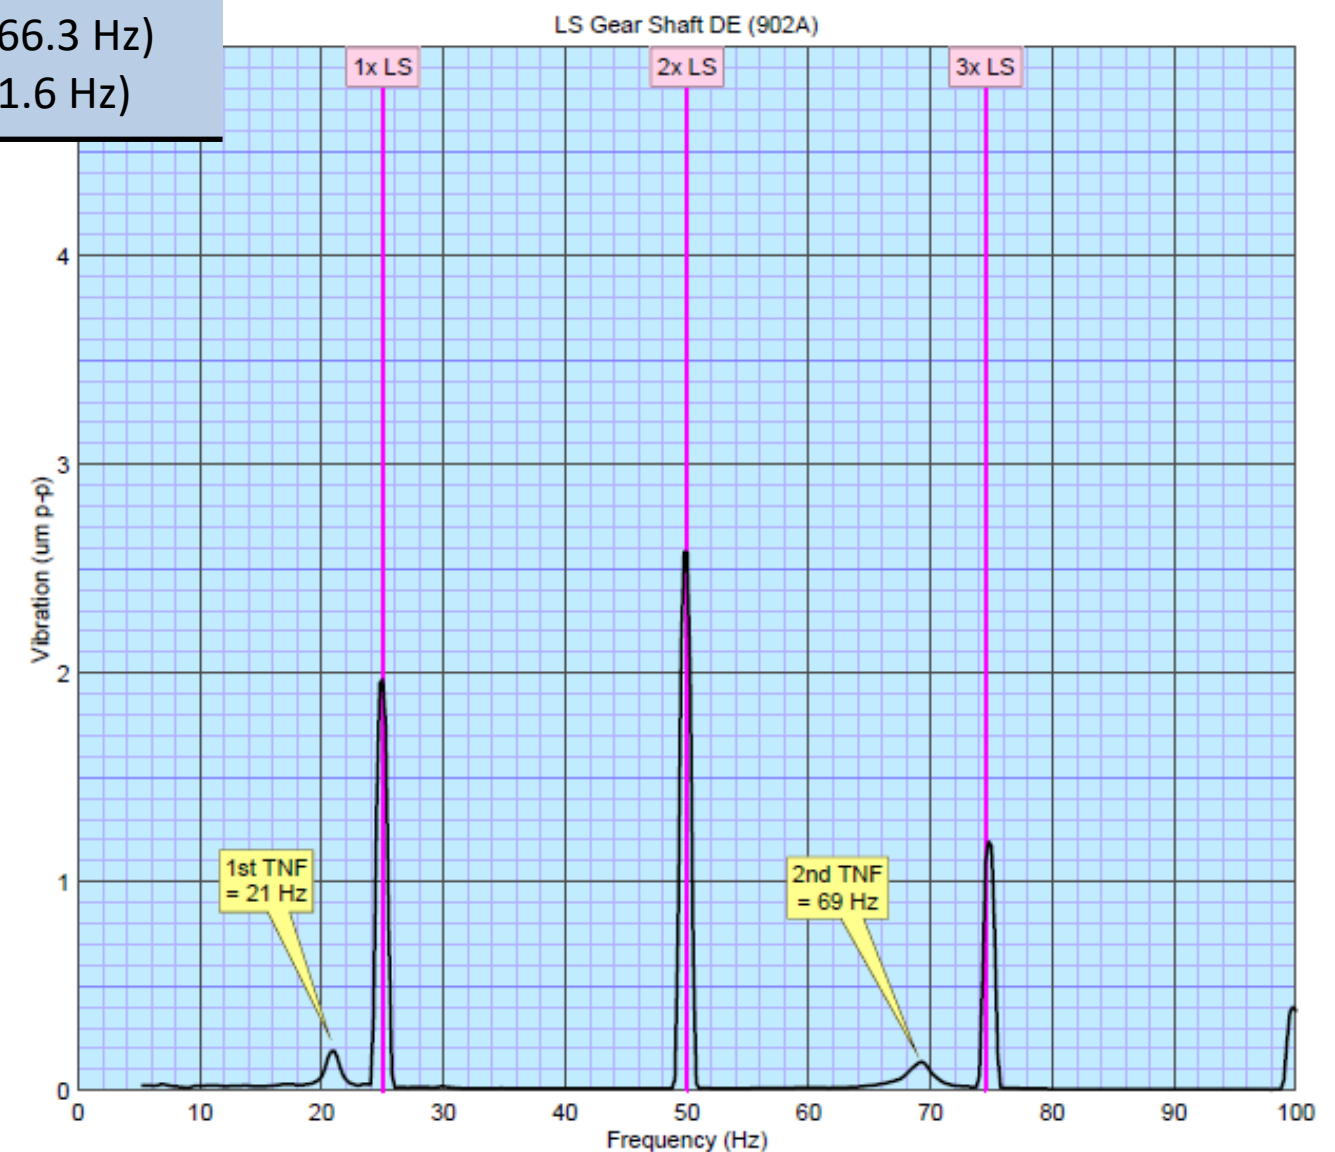
Torsional Natural Frequency	OEM	EM	Vendor A	Vendor B
1 st	1342 cpm (22.4 Hz)	1341 cpm (22.4Hz)	1260 cpm (21 Hz)	1296 cpm (21.6 Hz)
2 nd	4566 cpm (76.1 Hz)	4570 cpm (76.1 Hz)	4140 cpm (69 Hz)	3978 cpm (66.3 Hz) - 4296 (71.6 Hz)

During Unit Start-up, various instruments were setup to measure TNF

- 1st TNF is found ~ 1260 cpm (21Hz)
- 2nd TNF is found ~ 4140 cpm (69Hz)

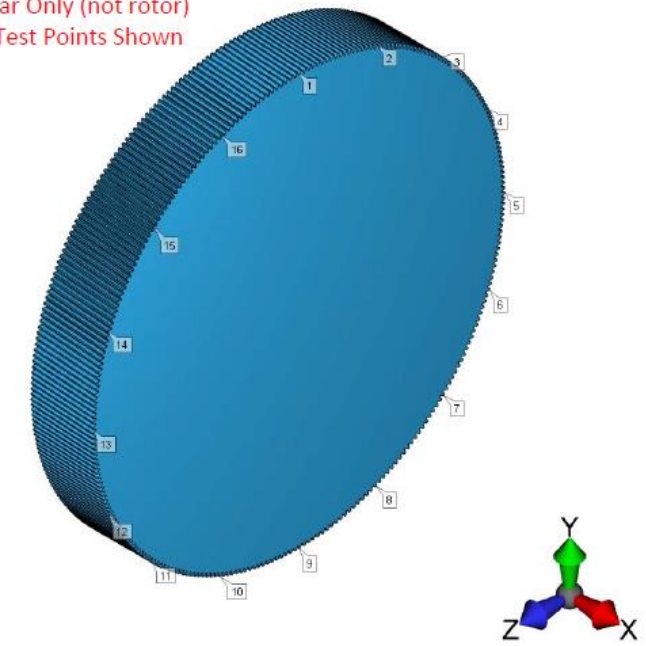
- Impact mode shape (IMS) was performed on Bull Gear.
- The purpose is to identify axial mechanical natural frequencies and mode shapes of the bull gear itself
- Response at 1,688Hz (101,280cpm) corresponds to 8.4x pinion speed.

Impact/Response on Gear Only (not rotor) in Axial (X) Direction at Test Points Shown

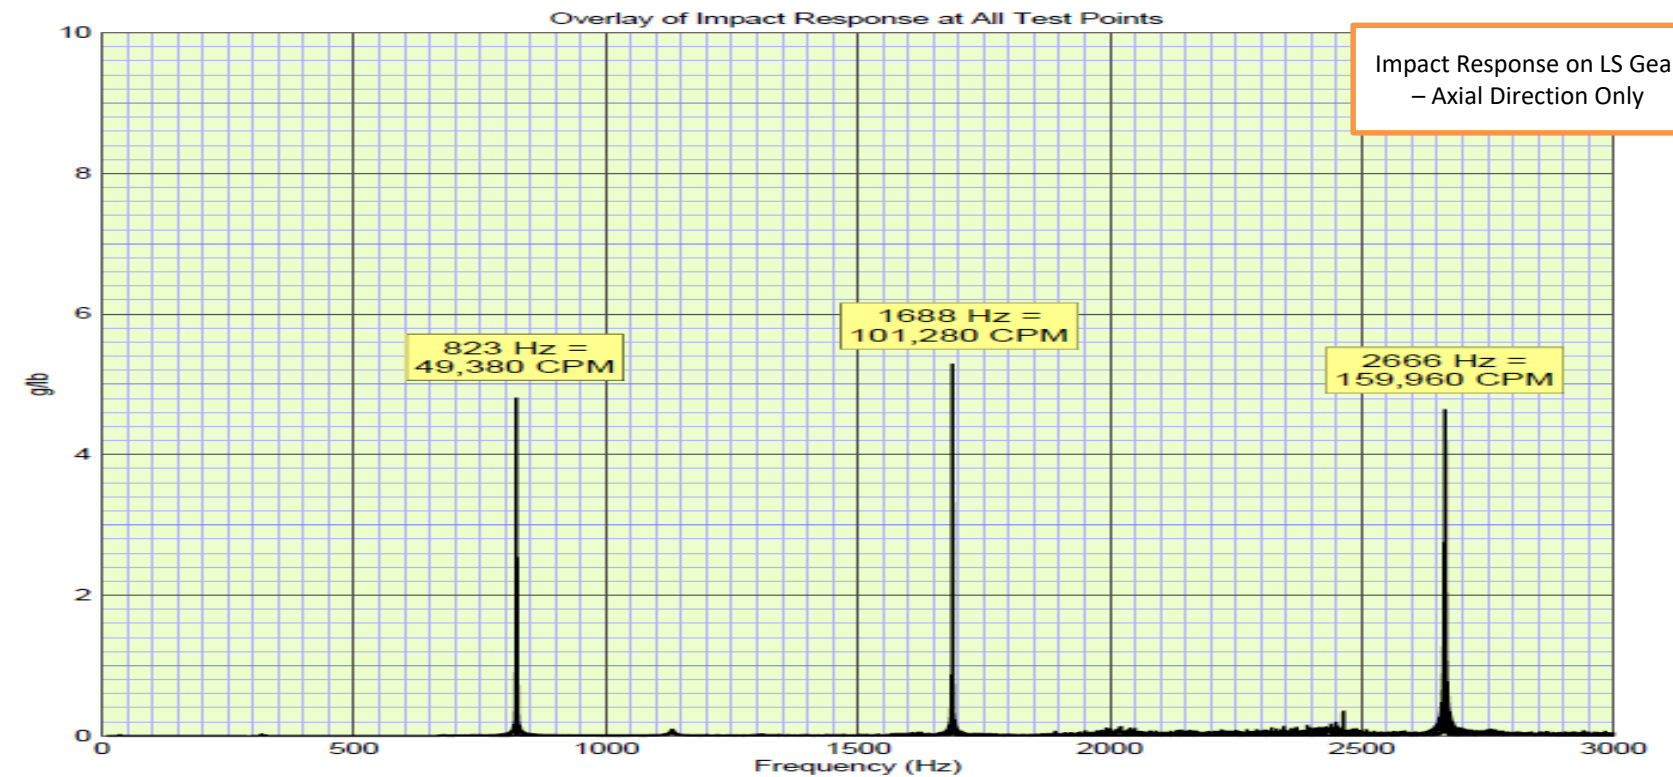
Impact Response Frequency

Response Frequency		Comments
	Hz	CPM	
1	823	49,380	33x bull gear (motor) speed 4.1x pinion speed
2	1,688	101,280	67.8x bull gear speed 8.4x pinion speed
3	2,666	159,960	107x bull gear speed 13.3x pinion speed

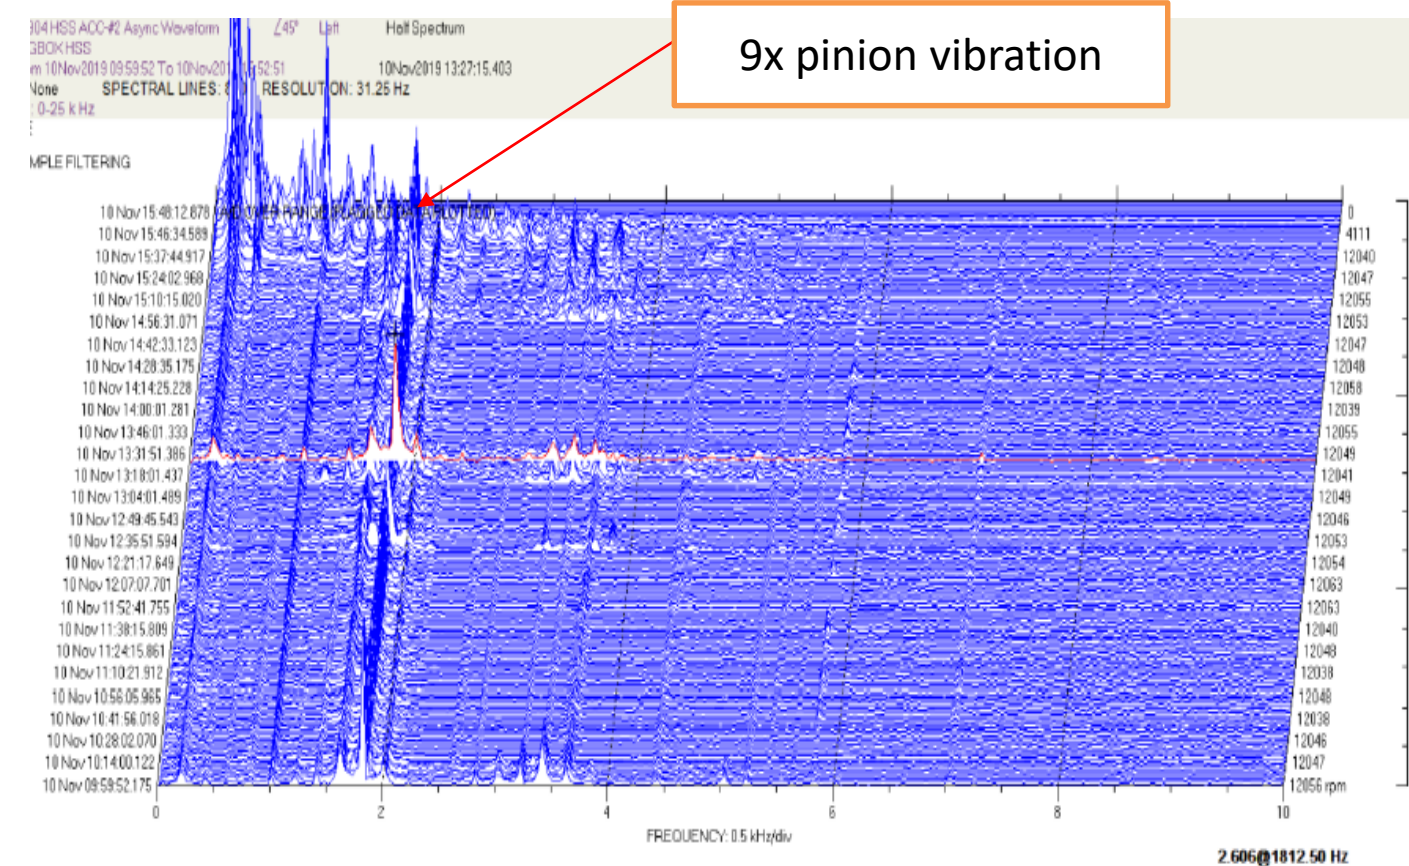
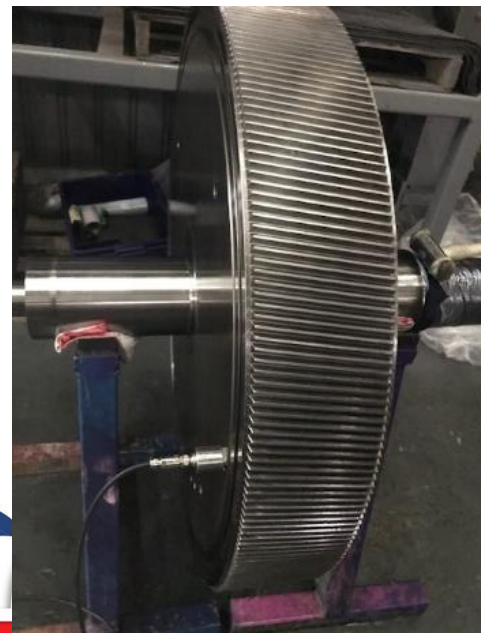
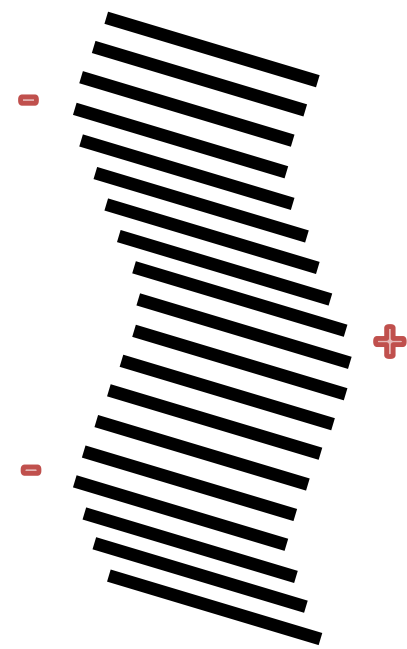
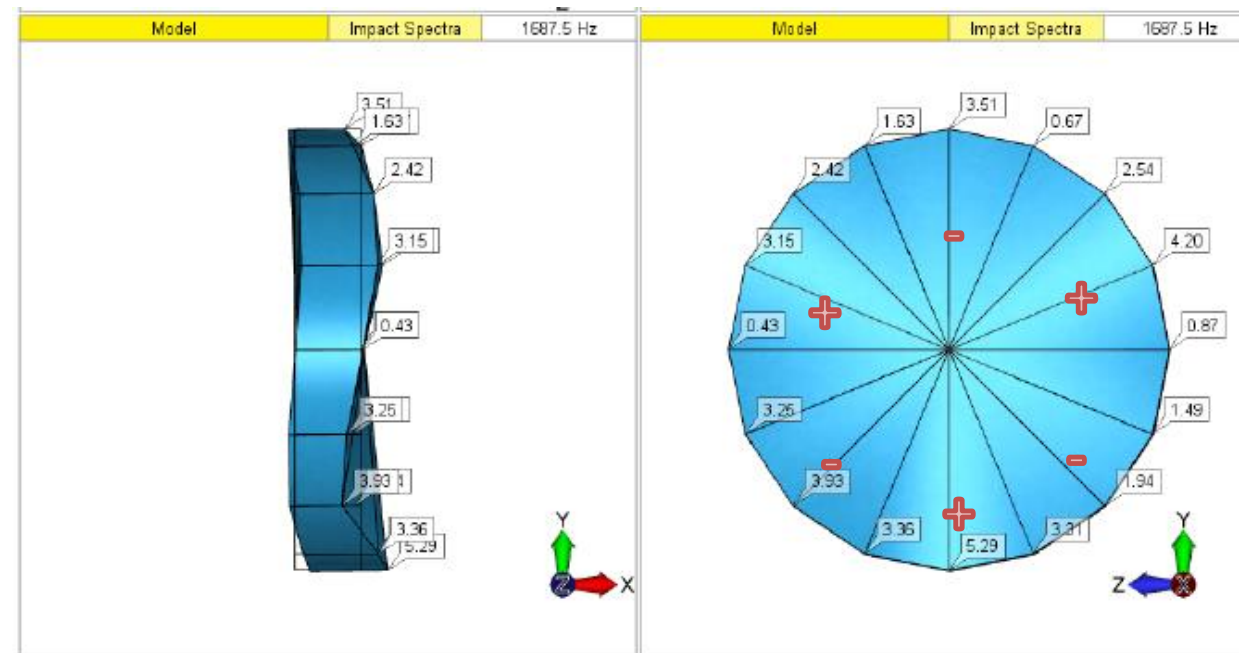
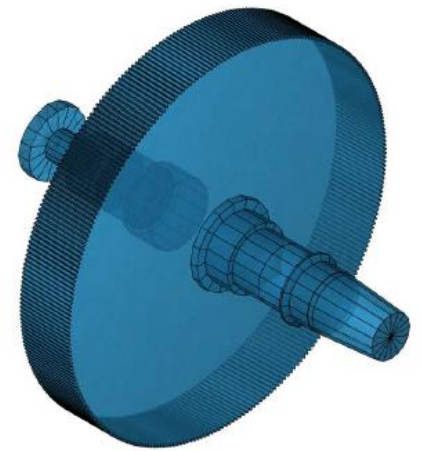
- Oil contamination from cooler leaks
- Significant gear wear results in imperfect teeth contact at the gear mesh.
- Extra friction with scuffing tooth contact, especially during lower viscosity oil period results ring the bull gear like a bell
- Increased 'play' between mating gear teeth possibly leading to excitation of Bull Gear natural frequency at 9x pinion speed
- Measured 9x pinion speed vibration, probably caused by excitation of Bull Gear natural frequency
- Mitigations of bull gear and pinion replacement/repair have been implemented and the failure has not reoccurred
