Catastrophic Mechanical Seal Failure Leading to Loss of Primary Containment (LOPC)

ASIA TURBOMACHINERY & PUMP SYMPOSIUM

Mohd Faizal Mohamed –
PETRONAS
Khairil Ikhwan Abdul Rahman –
PETRONAS

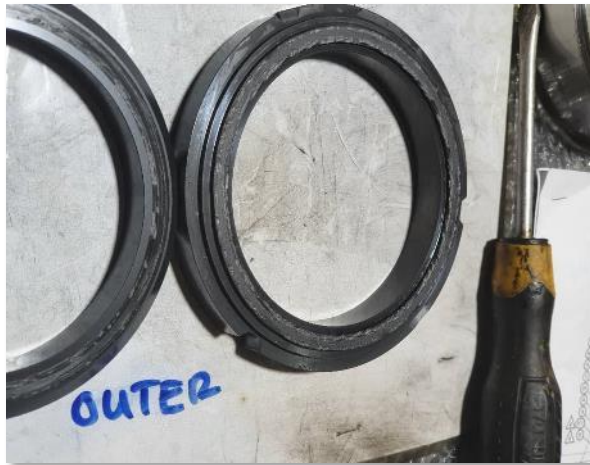
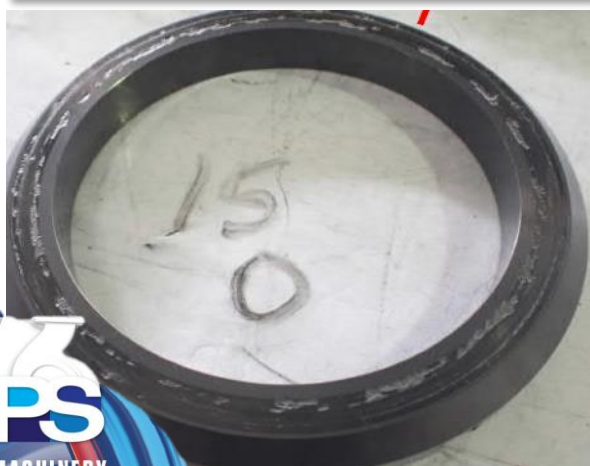
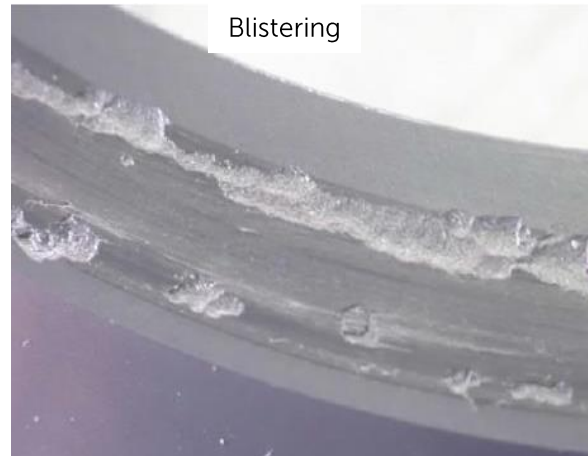
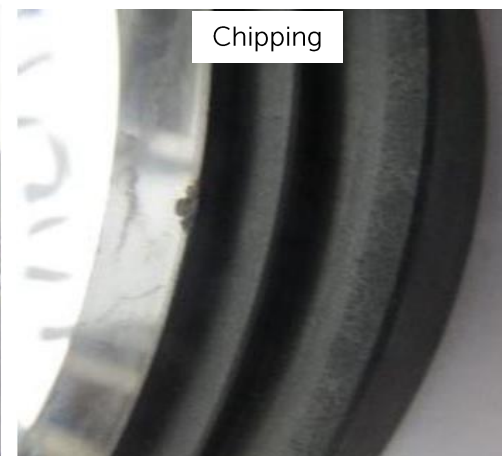
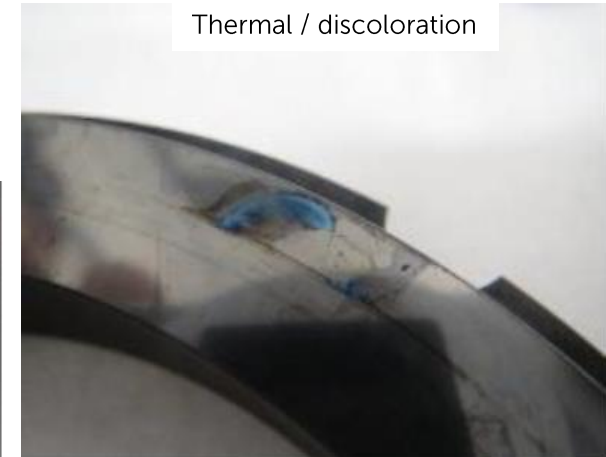
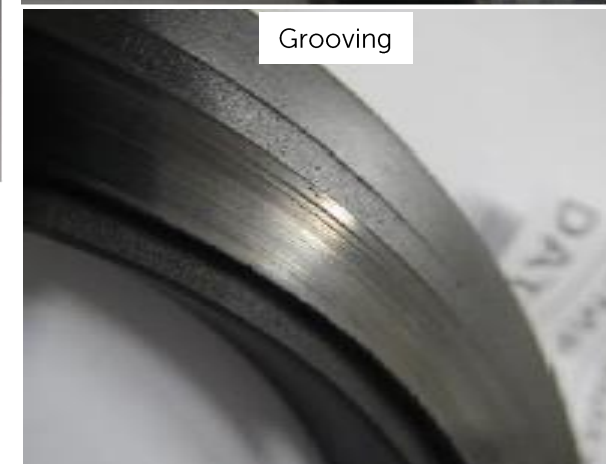
- For case#1, catastrophic seal failure occurred due to presence of free water and sludge in seal barrier fluid which has caused water vaporization due to high heat generation and low boiling point. The thin barrier fluid film between seal faces could not be sustained leading to face-to face contact causing chipping of seal face.

1. Failure occurred within 1-2 month post installation & unit running
2. Internal parts showed seal face chipping/discoloration/blistering in most failure events

Some of photos on seal faces with following observation

- Chipping
- Blistering
- Thermal discoloration
- grooving

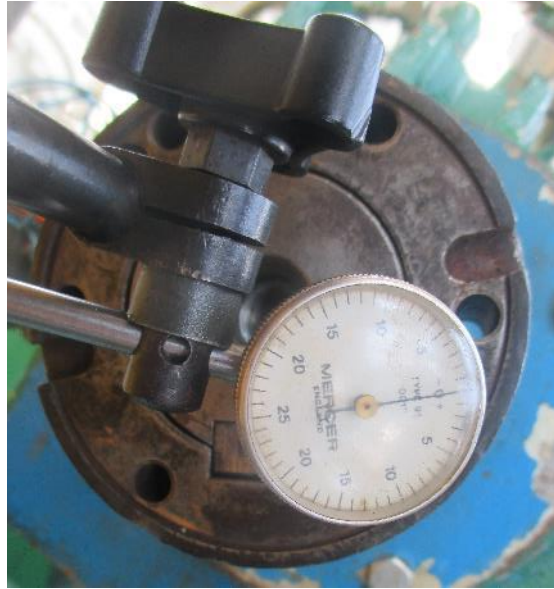
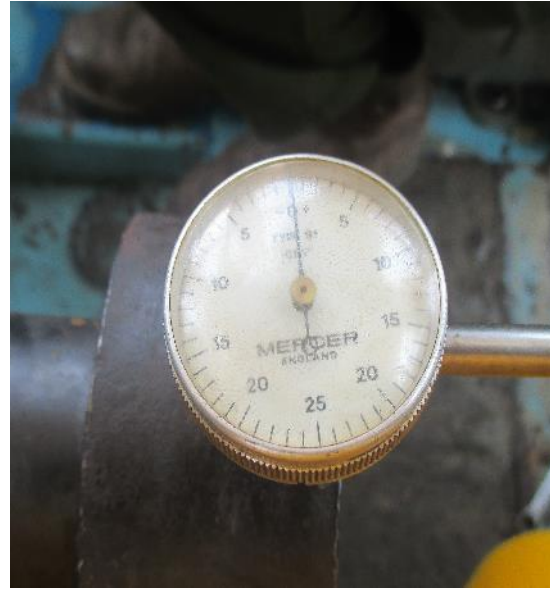
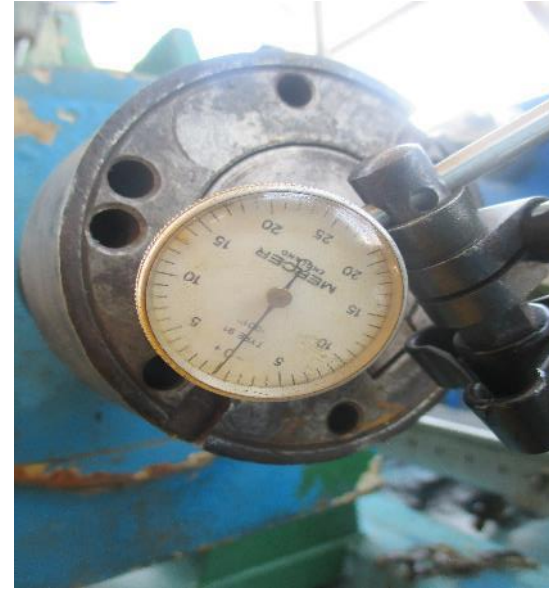
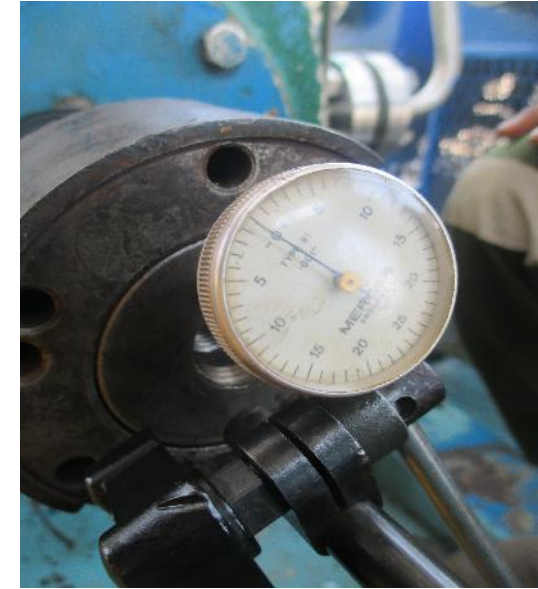
1(b) Verification & Elimination Process – Alignment & Vibration

Vibration & alignment result is within specification – normal

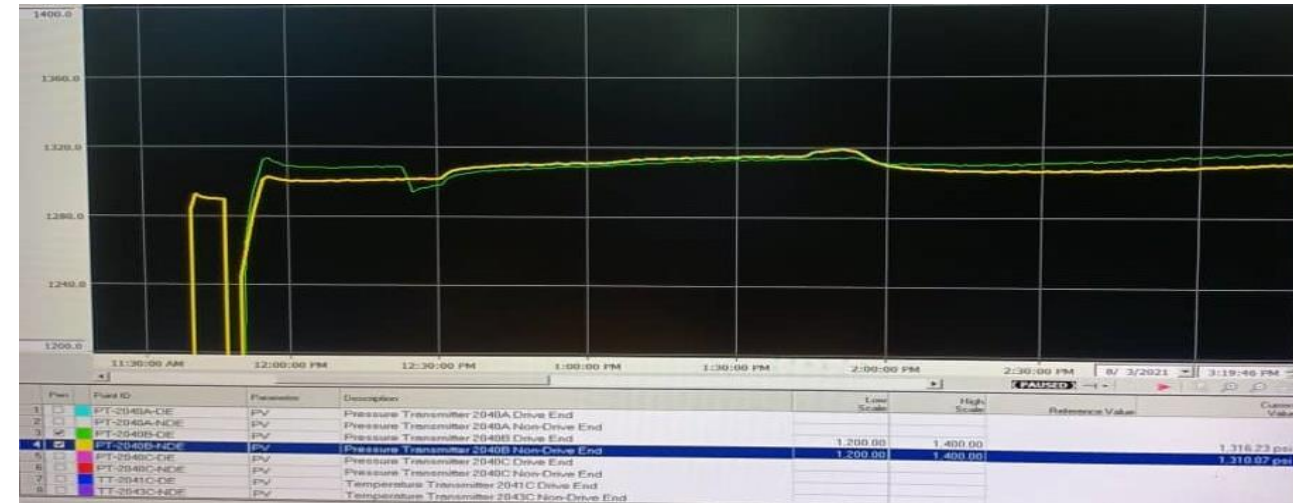
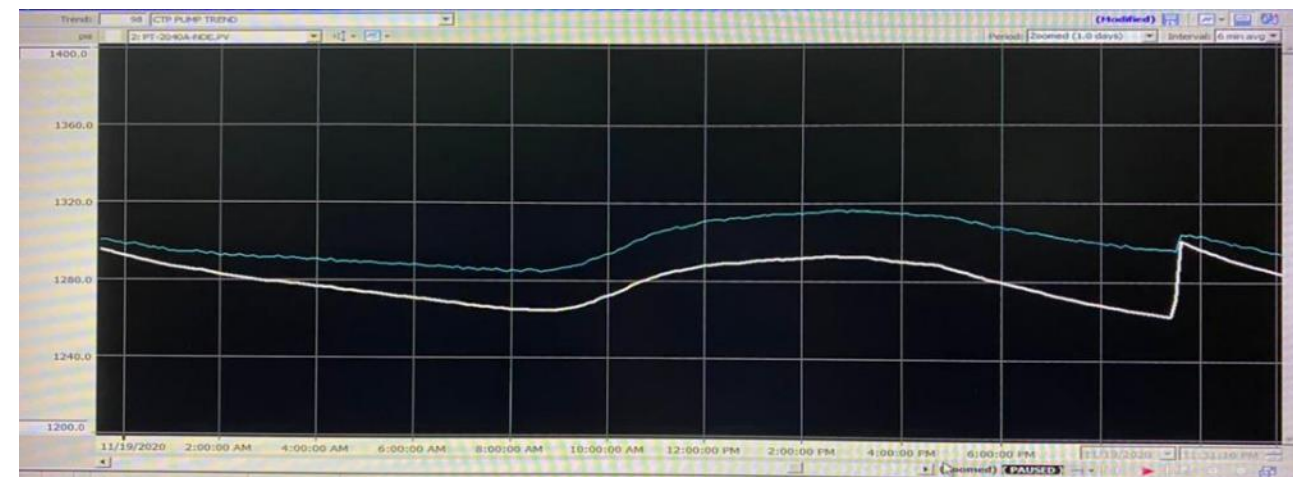
- During this repetitive failure, CTP barrier fluid pressure was maintained at around 1280-1380 psi (as per specification)
- Trend of BF Pressure indicate an expected value of BF pressure.
- Reading of seal temperature were also within allowable range (130 – 160F)
- However, the MTBF for the seal as recorded was less than a month after installation when the unit was put back in service.

Parameters was normal before failure event - normal

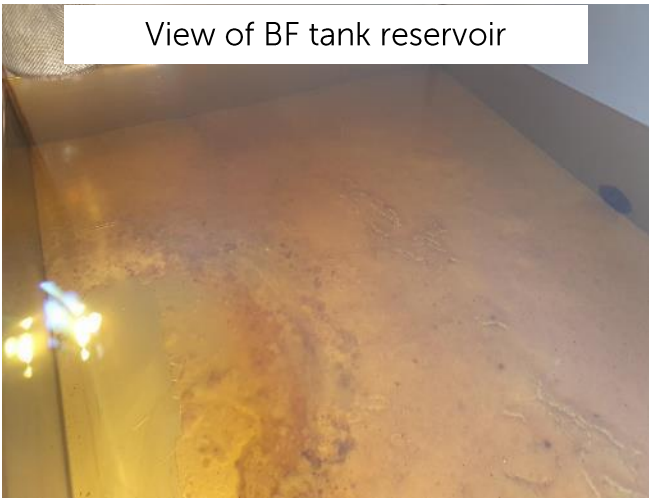
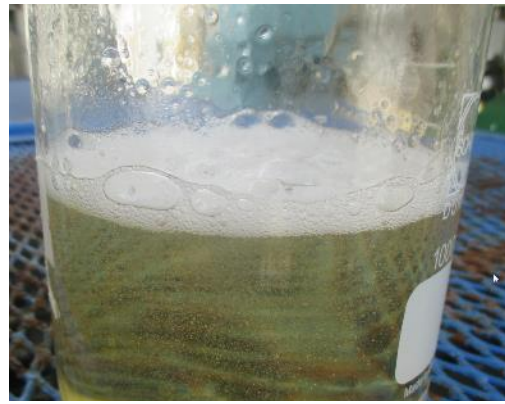
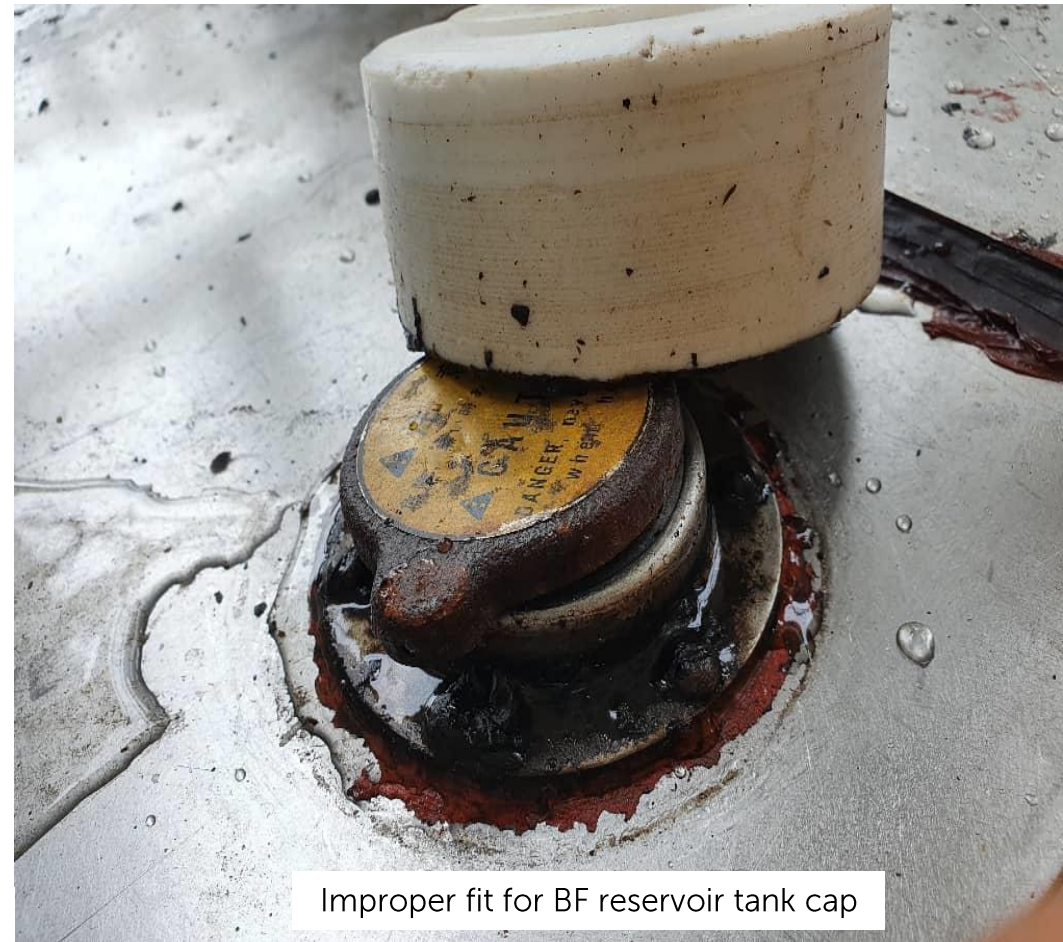
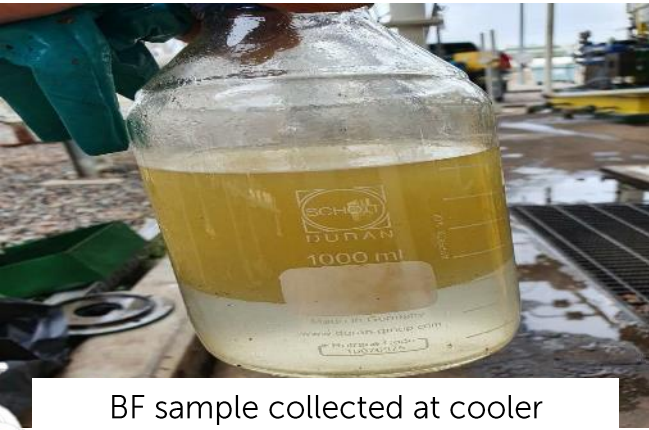
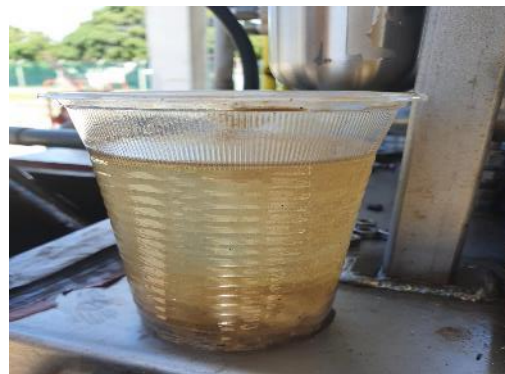
1(d) Findings on Barrier Fluid Tank

Further investigation at site revealed BF tank has been contaminated with water and sludge, and the tank cap used was not fit for the BF tank

No	Recommendation	Status
1	Perform full flushing of BF for CTP during major maintenance activities.	Task already included in Maintenance Plan for Pump Changeout.
2	Replaced & maintain adequate & proper BF tank cover cap.	Defective BF tank cover cap replaced and continuously inspected during operation EBC round.
3	Ensure new sealant is applied after each BF tank cleaning activity.	The task already included in Maintenance Plan for BF tank cleaning.
4	To enhance PM task with BF system component inspection and BF flushing (6M): <ul style="list-style-type: none"> • Open and inspect BF condition at the BF tank • Drain and flush BF reservoir (replace 1 drum of BF). Ensure proper flushing of BF tank • Establish SOP for BF replacement in the PM task 	Included system component inspection and BF flushing in 6M activity.
5	Introduce 3M task for BF inspection and sampling: <ul style="list-style-type: none"> • Inspect BF tank sealant and tank cap condition and ensure no leak point present. • Collect a BF sample from tank drain for visual inspection. If contamination observed (water or sludge) to raise corrective maintenance notification for BF replacement at the earliest opportunity. • CBM to perform BF analysis 	Introduced BF inspection and sampling for 3M task.

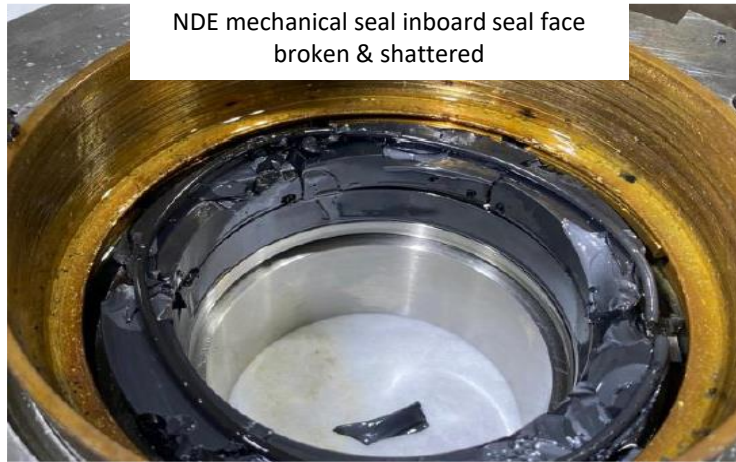
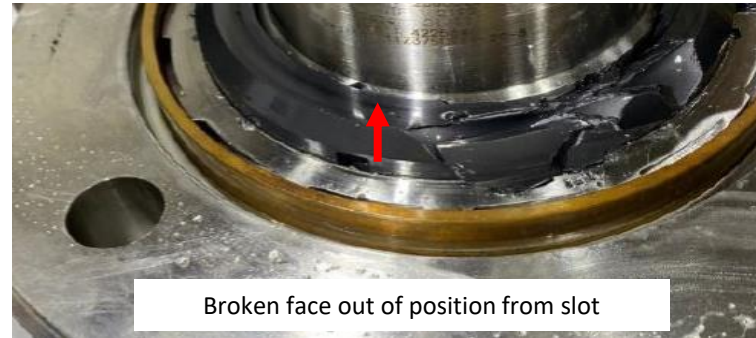
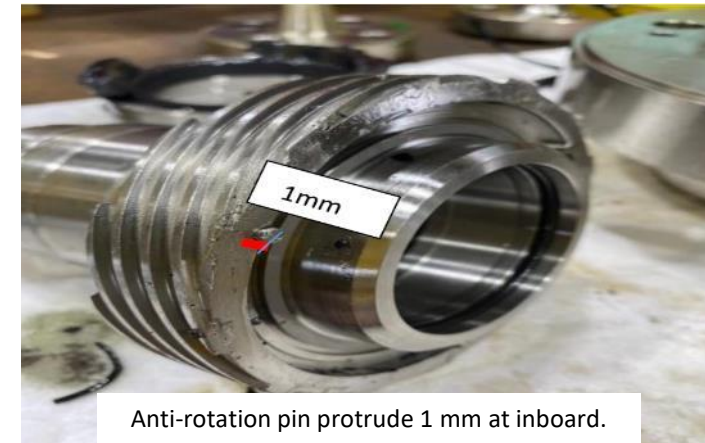
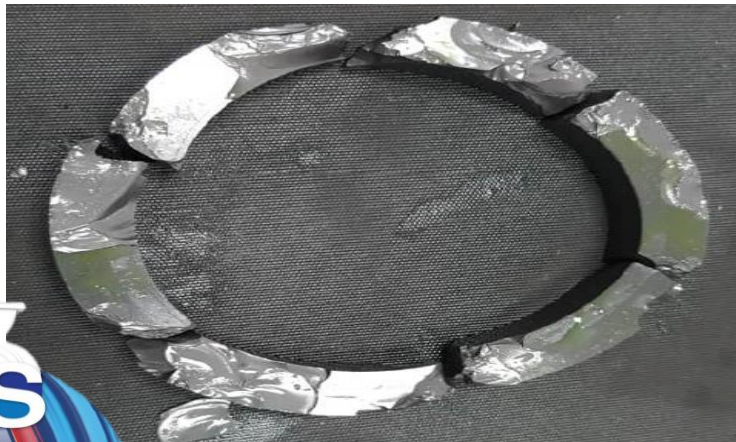
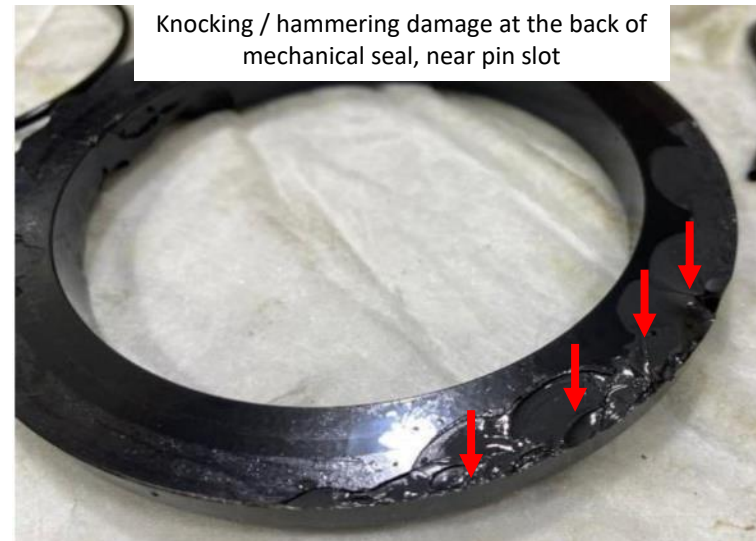
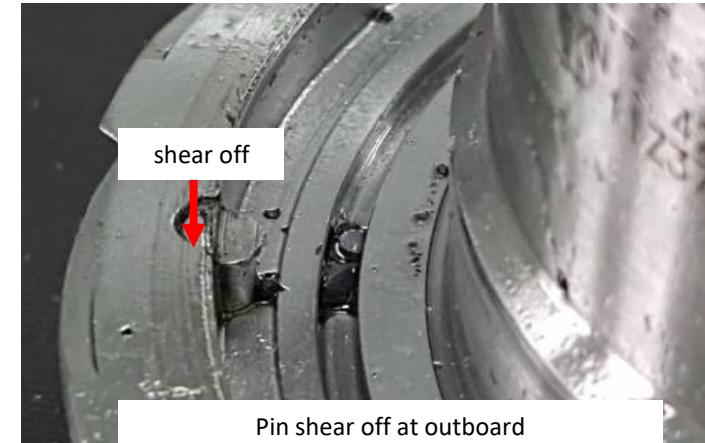
- Meanwhile for case#2, another failure mechanism was due to poor preservation of spare mechanical seal which has caused the moisture from atmosphere to accumulate at the seal face, creating a slip stick condition and initiated a hairline crack on seal face pin slot. Due to the high torque from the pump, the hairline crack propagated through the pin slot at the outboard rotating seal face. The outboard seal cracked, leading to anti-rotating pin dislodged and subsequently hammered the inboard seal face.

1. Failure occurred within minutes after pump running post seal installation
2. Seal faces broken into pieces/shattered. Broken point started around pin slot

Mechanical seal spare preservation conditions & practices are less-than-adequate (Stationary and rotating seal face stuck due to humidity accumulation-long storage item)

No	Recommendation	Status
1	Select the newest spare for installation for CTP-A DE mechanical seal.	Installed CTP-A DE mechanical seal with the newest spare.
2	Manually exercise & adequately rotate seal face to ensure no sticking condition ahead of installation.	This step has been included in mechanical seal installation procedure.
3	Send remaining spare to contractor / OEM for servicing after some period of seal in storage.	All spare mechanical seals with more than 1 year since last test were send to contractor for revalidation. This recommended practice has been included in mechanical seal preservation and storage guideline.
4	Establish a yearly program of inspection & servicing of spare mechanical seal and establish tracking database of spare mechanical seal.	Spare mechanical seal database has been developed. Spare seals are being tracked and any seal which has passed the 1 year mark will be sent to contractor for inspection and servicing.
