Detection of Broken Blade on Compressor

ASIA TURBOMACHINERY & PUMP SYMPOSIUM

SYMPOSIA: 24 – 26 MAY 2022
SHORT COURSES: 23 MAY 2022

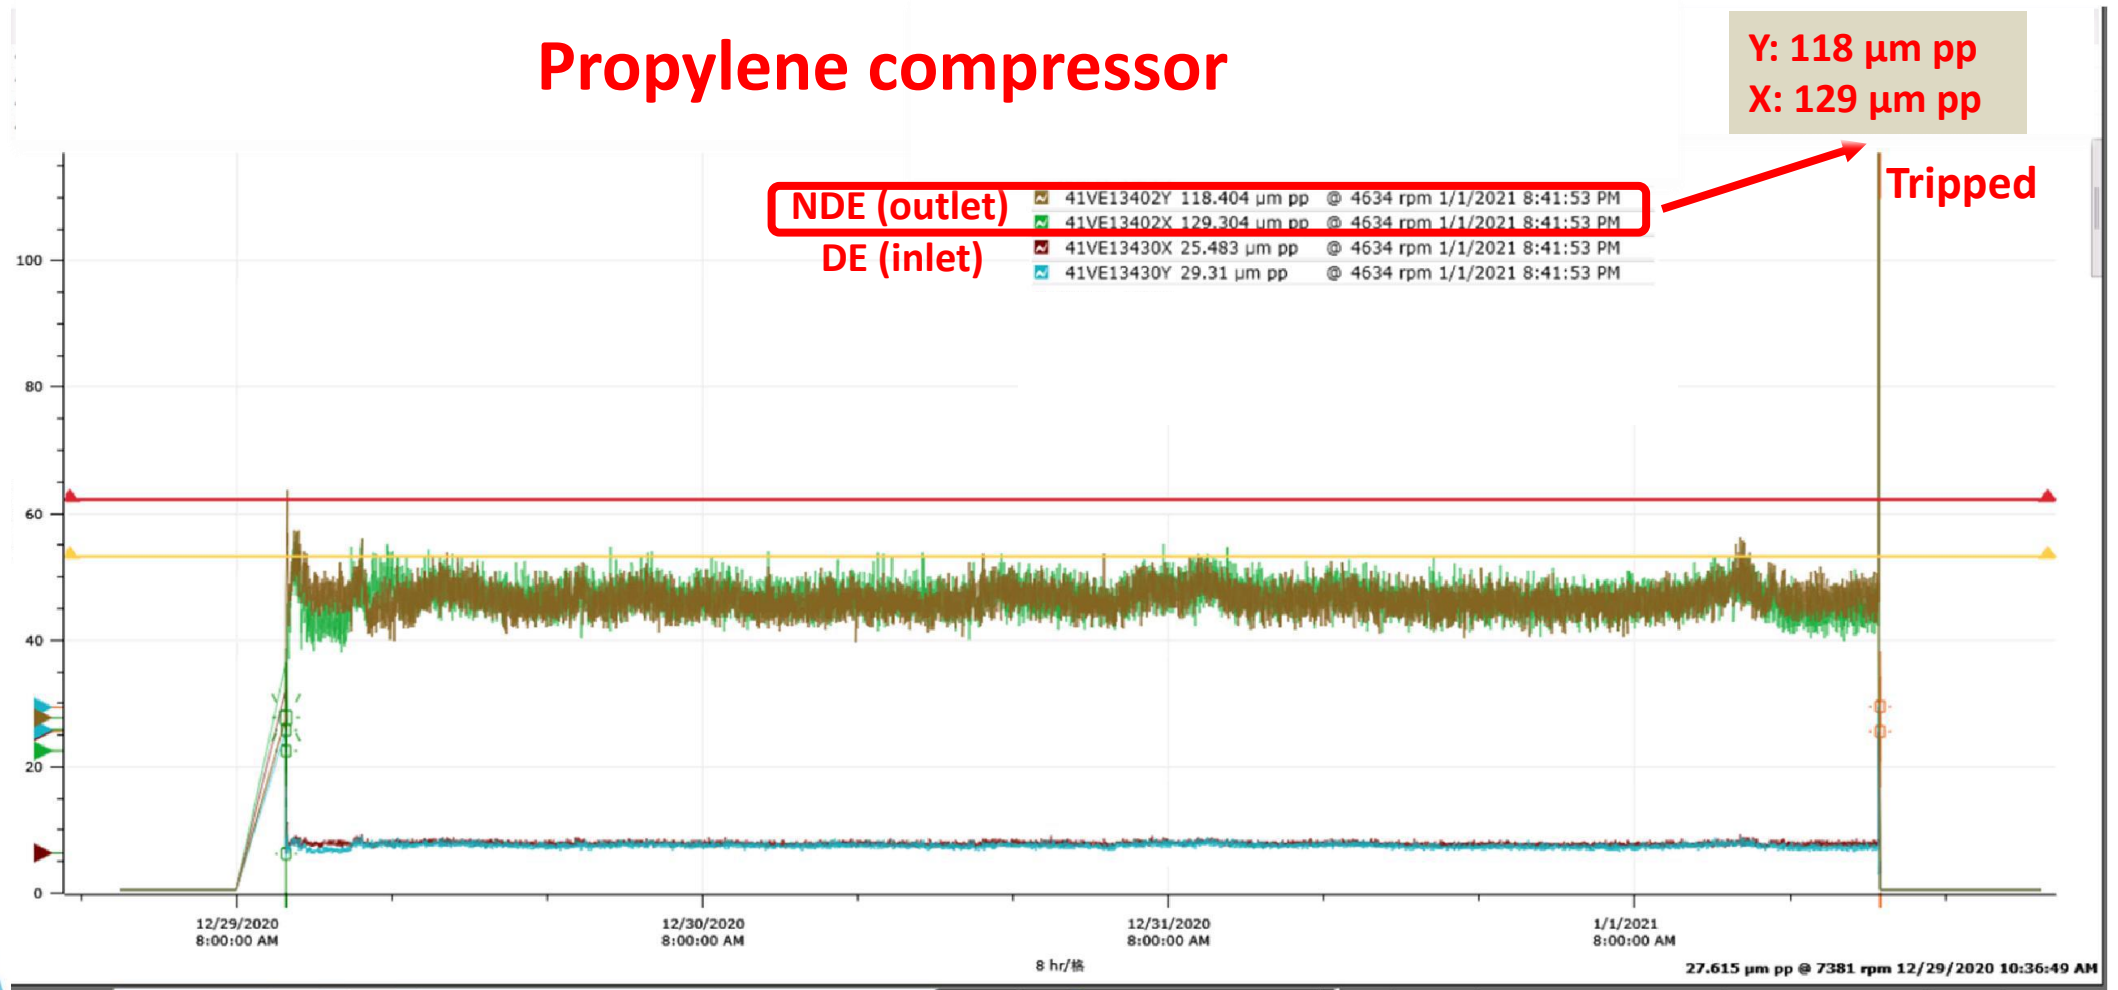
3.1 Data Review – direct vibration trend plots on compressor

- Vibration excursion occurred after normal operation for more than 3 days.
- The level of vibration tripped the unit.

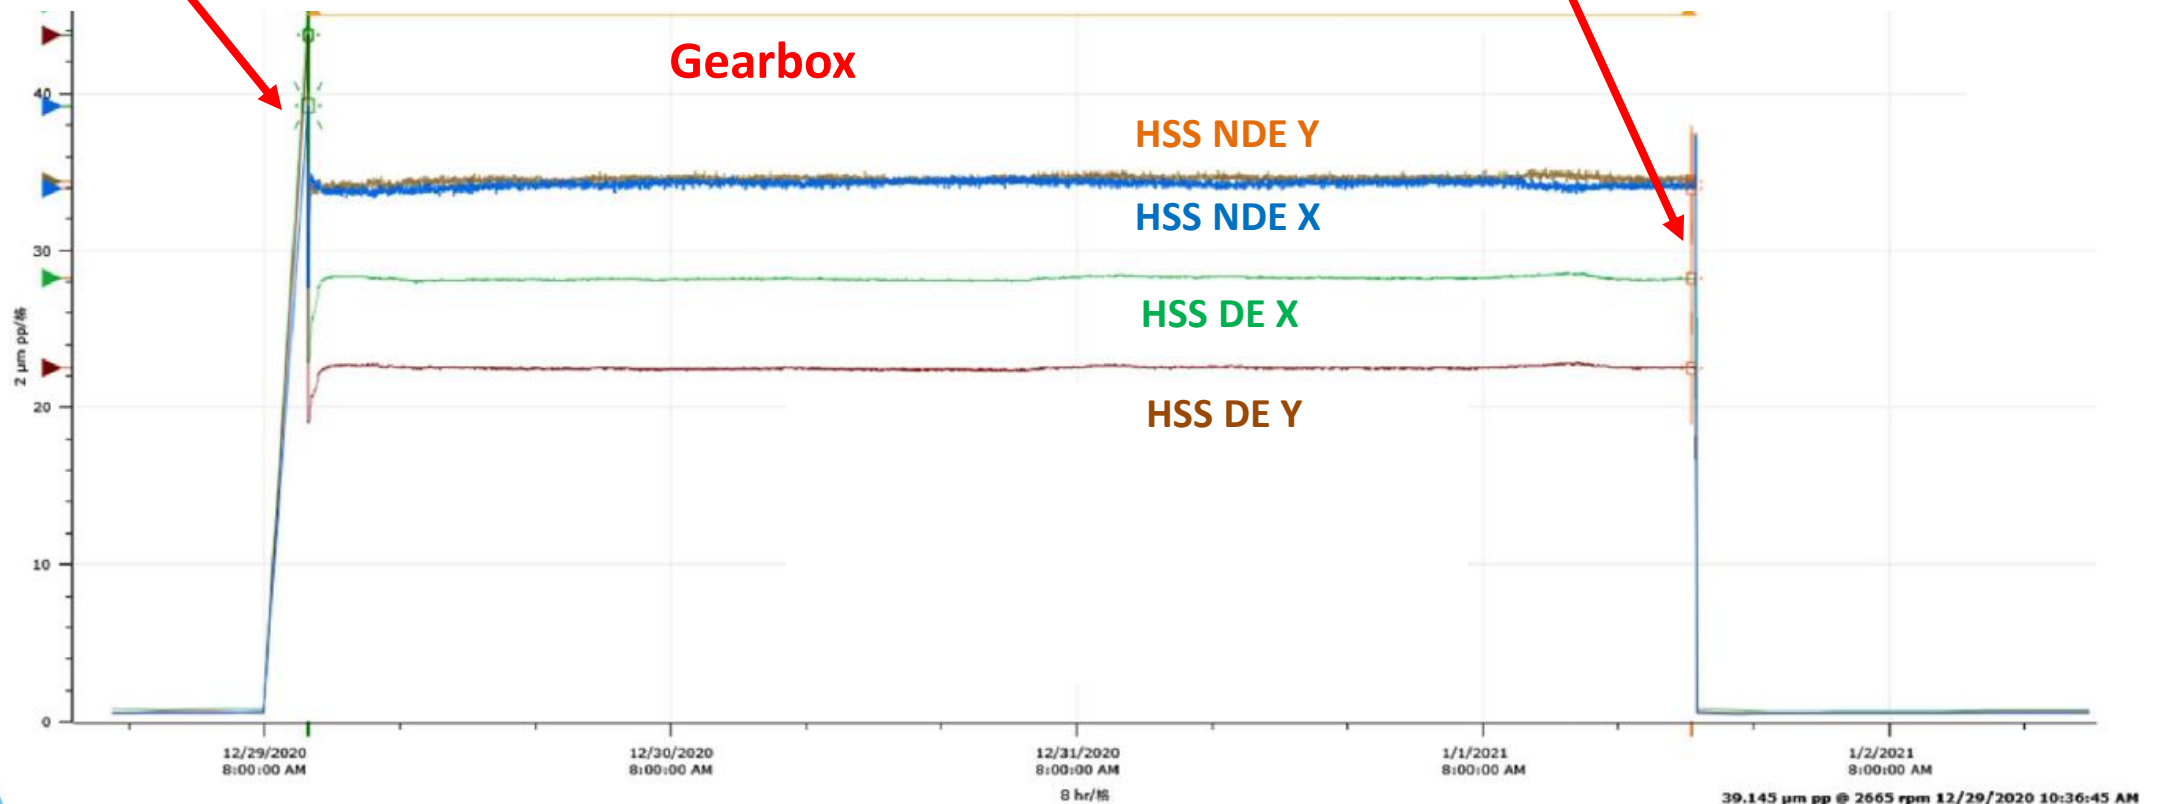
3.2 Data Review – direct vibration trend plots on gearbox

- No significant vibration change at high-speed shaft gearbox bearings
- Vibration level even lower during coast-down than during startup

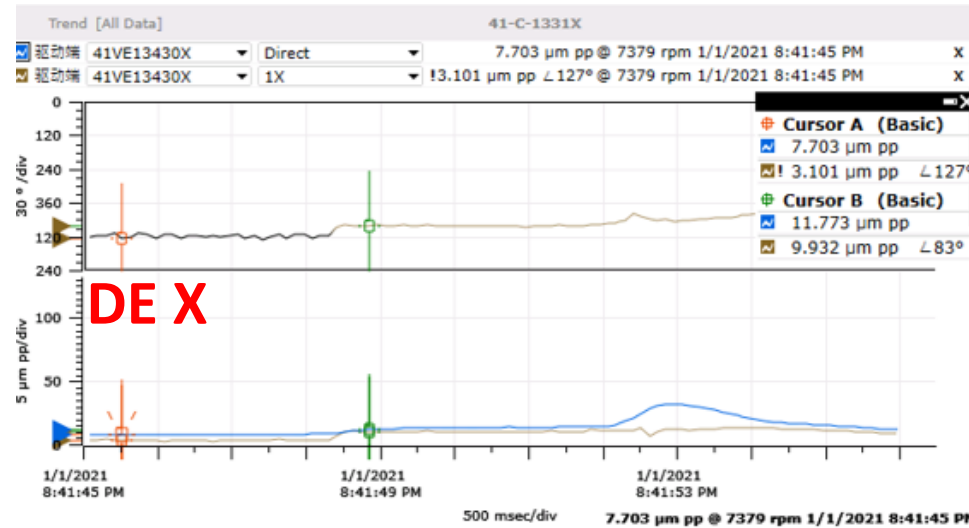
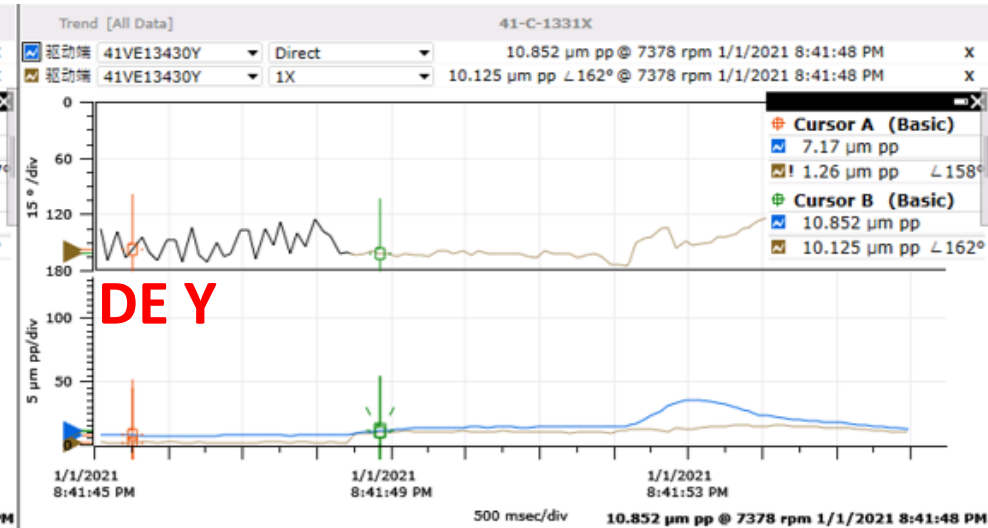
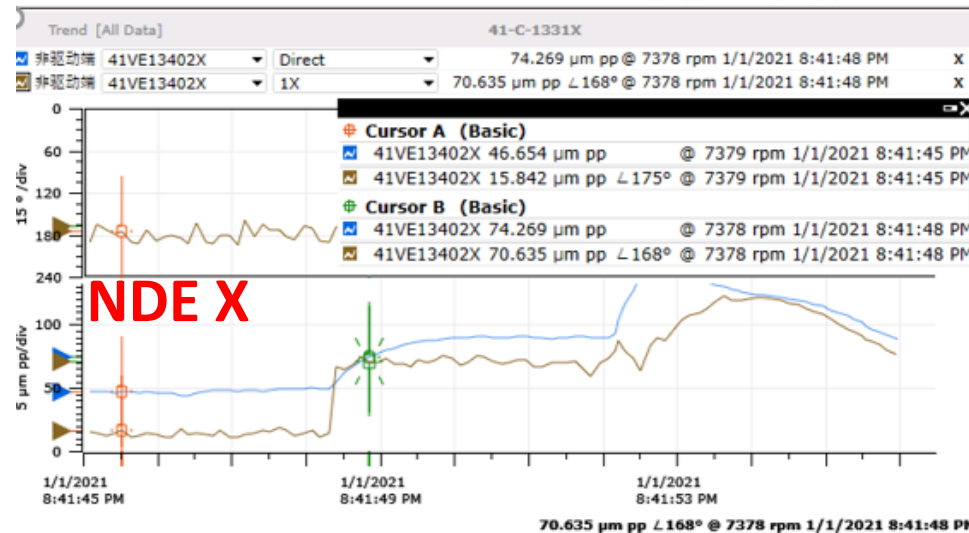
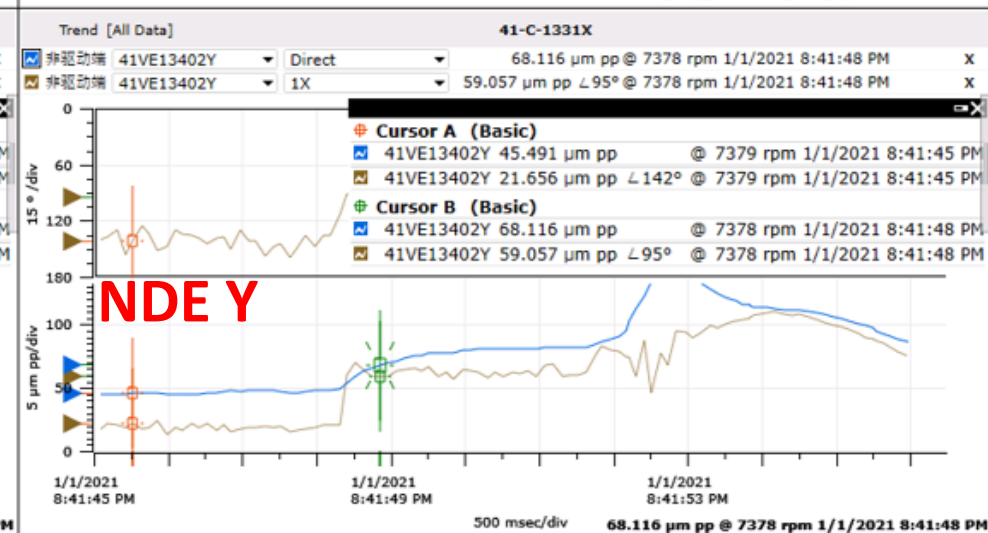
3.3 Data Review – vibration from each probe on compressor

- Vibration excursion occurred simultaneously from all 4 probes.
- Vibration excursion was due to 1X component.

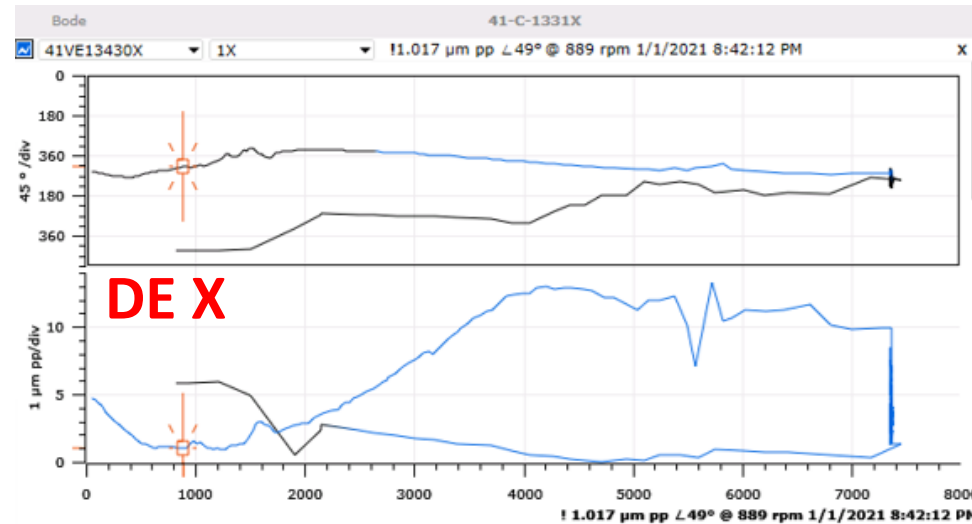
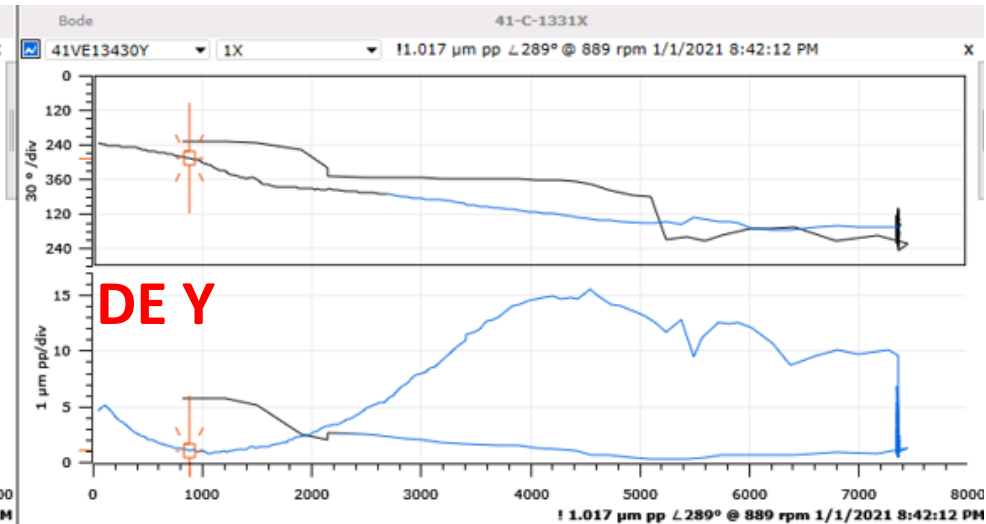
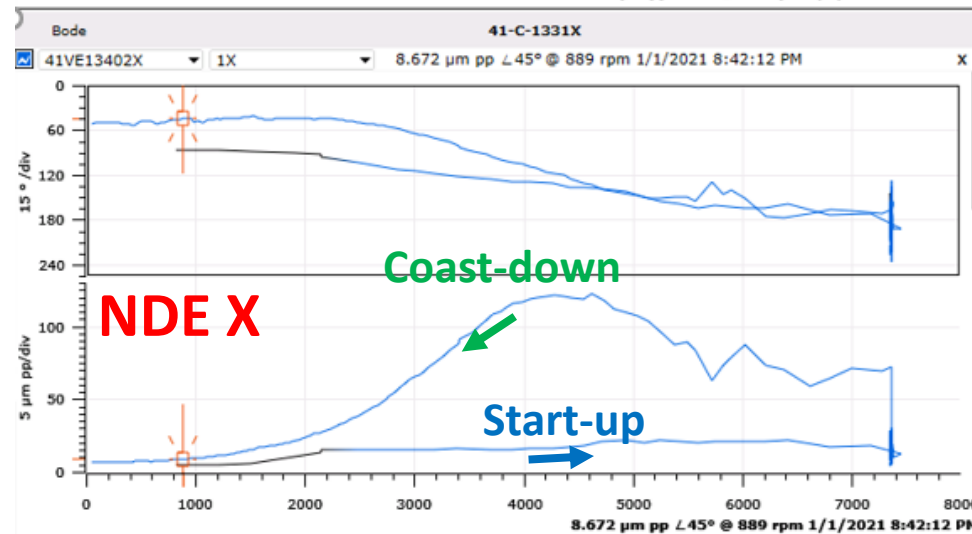
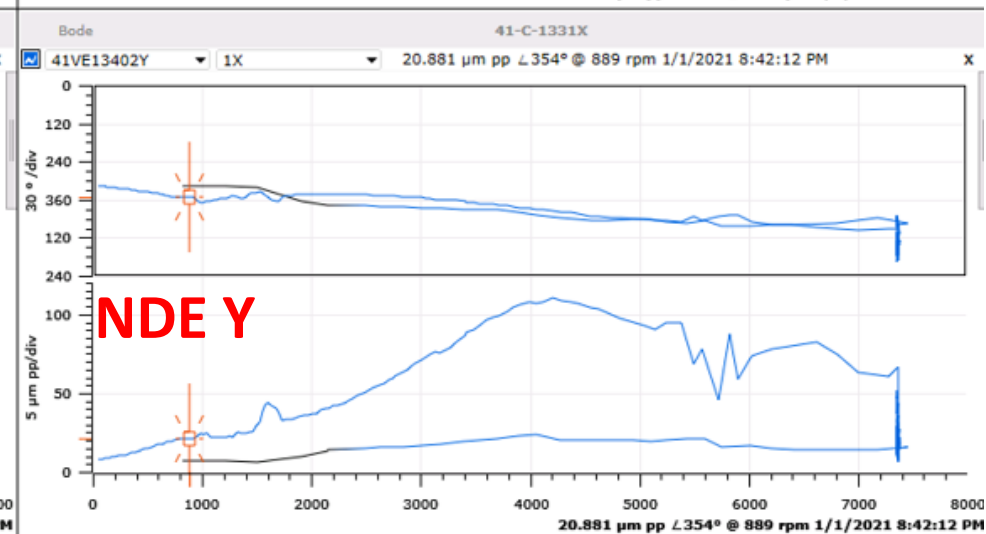
3.4 Data Review – 1X Bode plots from each probe on compressor

- During **coast-down** after trip vibration even became higher. Much higher than **startup**.
- 1X vibration was measured 130 $\mu\text{m pp}$ at ~ 4000 rpm from NDE X.

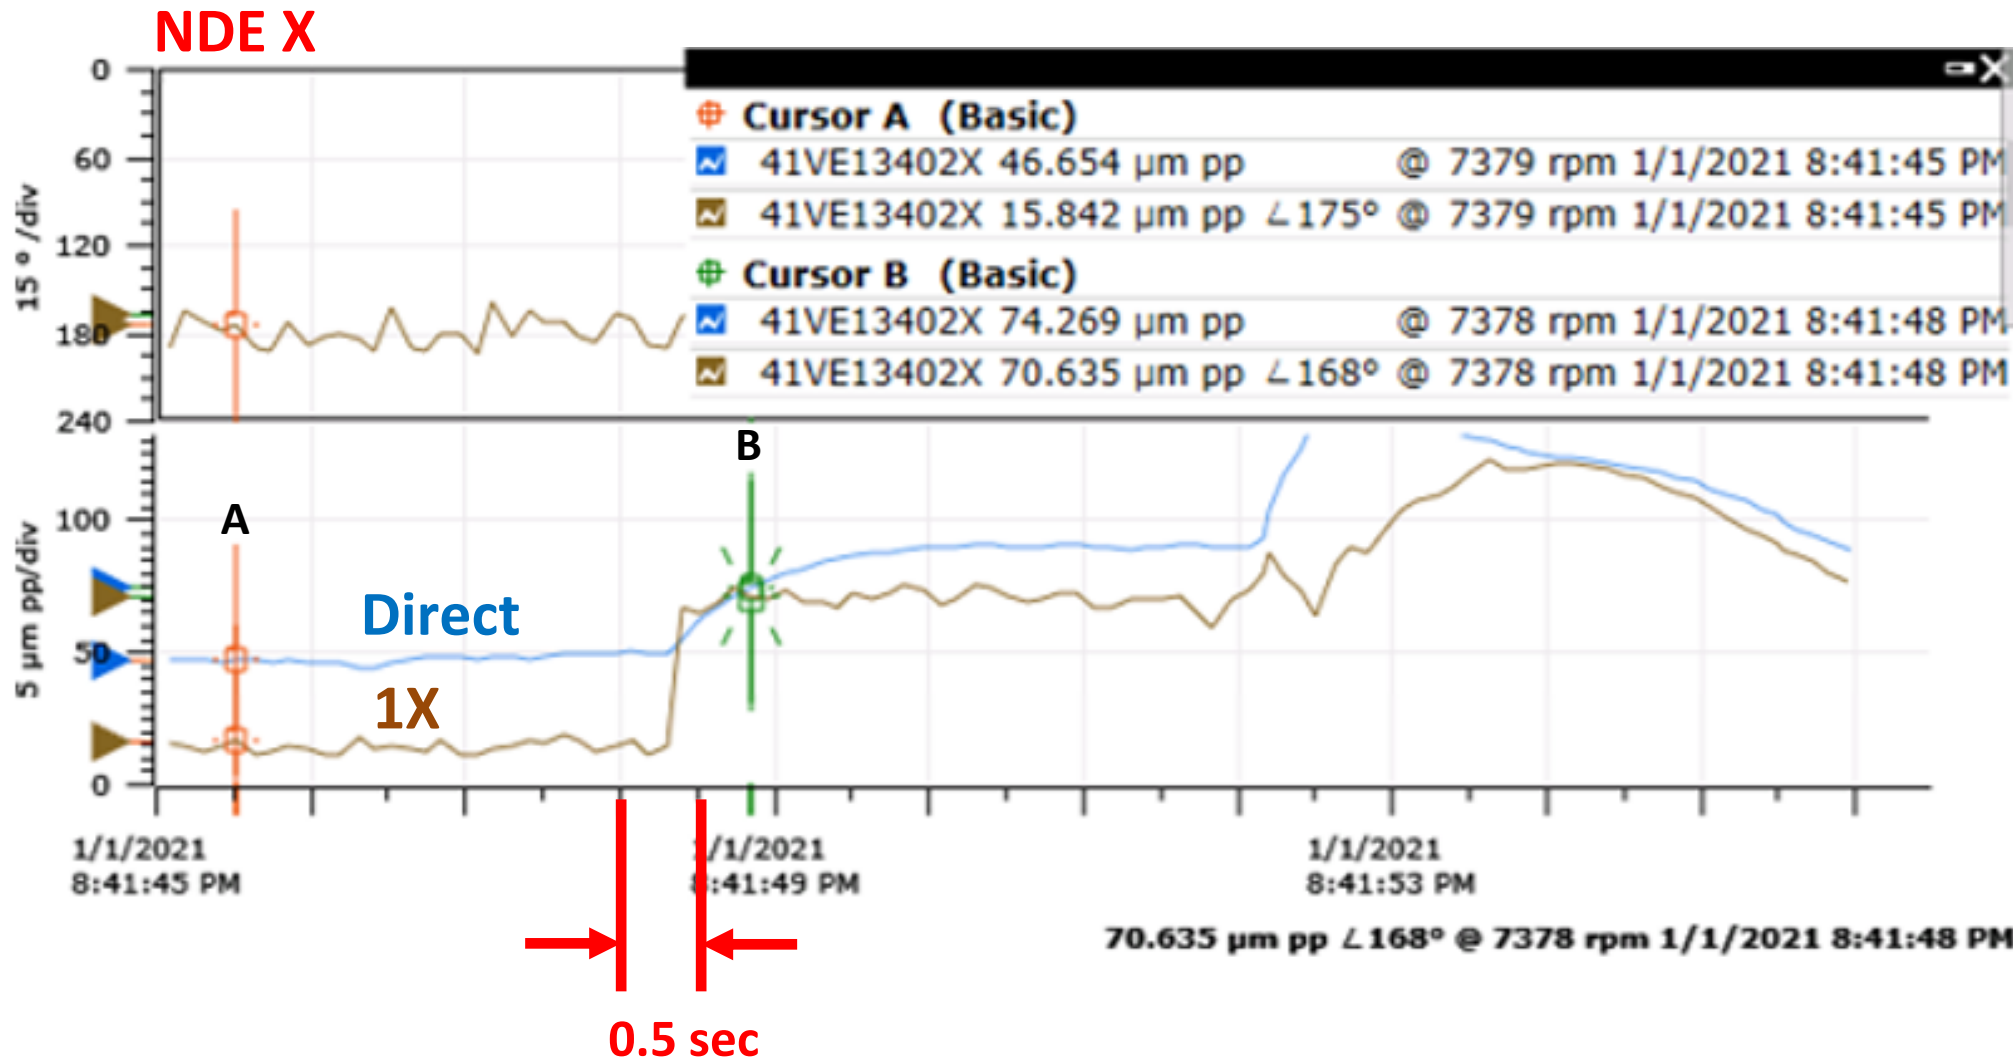
3.5 Data Review –examining the change at NDE X-probe

- The change occurred within <math><0.25</math> second in the plot.
- 1X vector changed from 16 μm pp $\angle 175^\circ$ to 71 μm pp $\angle 168^\circ$

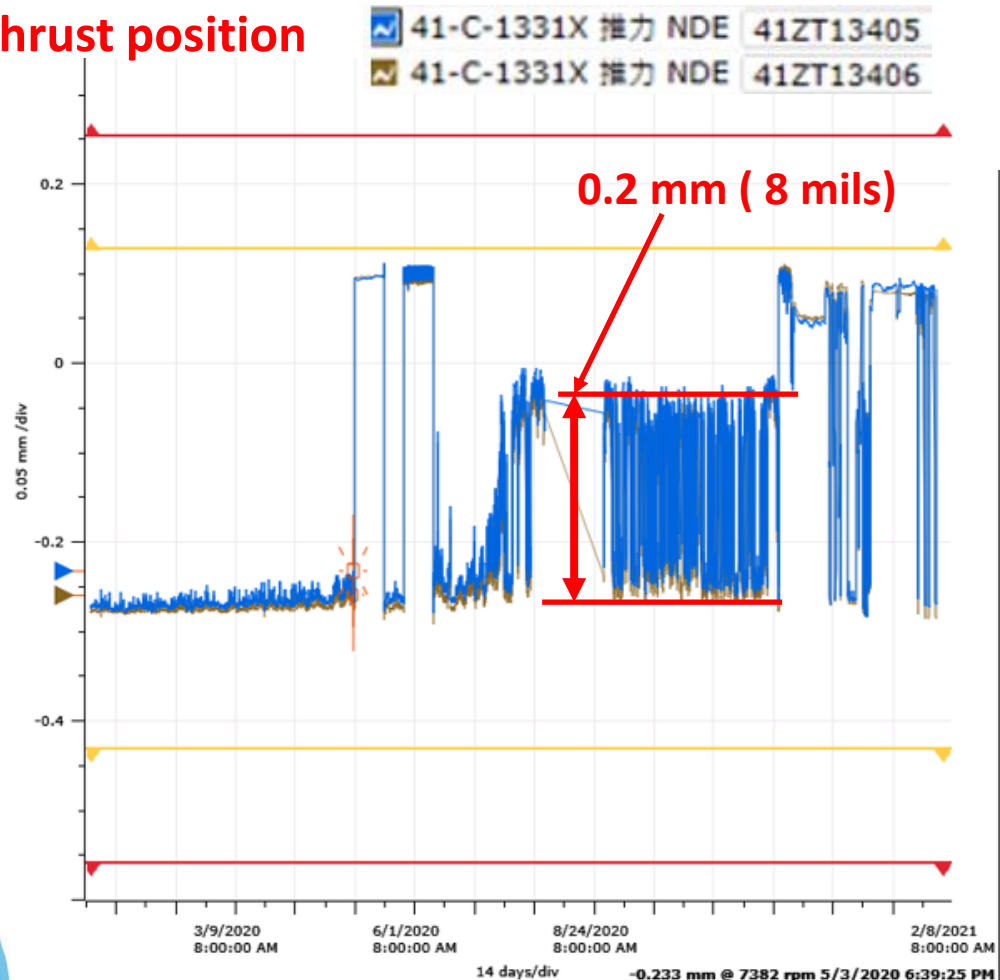
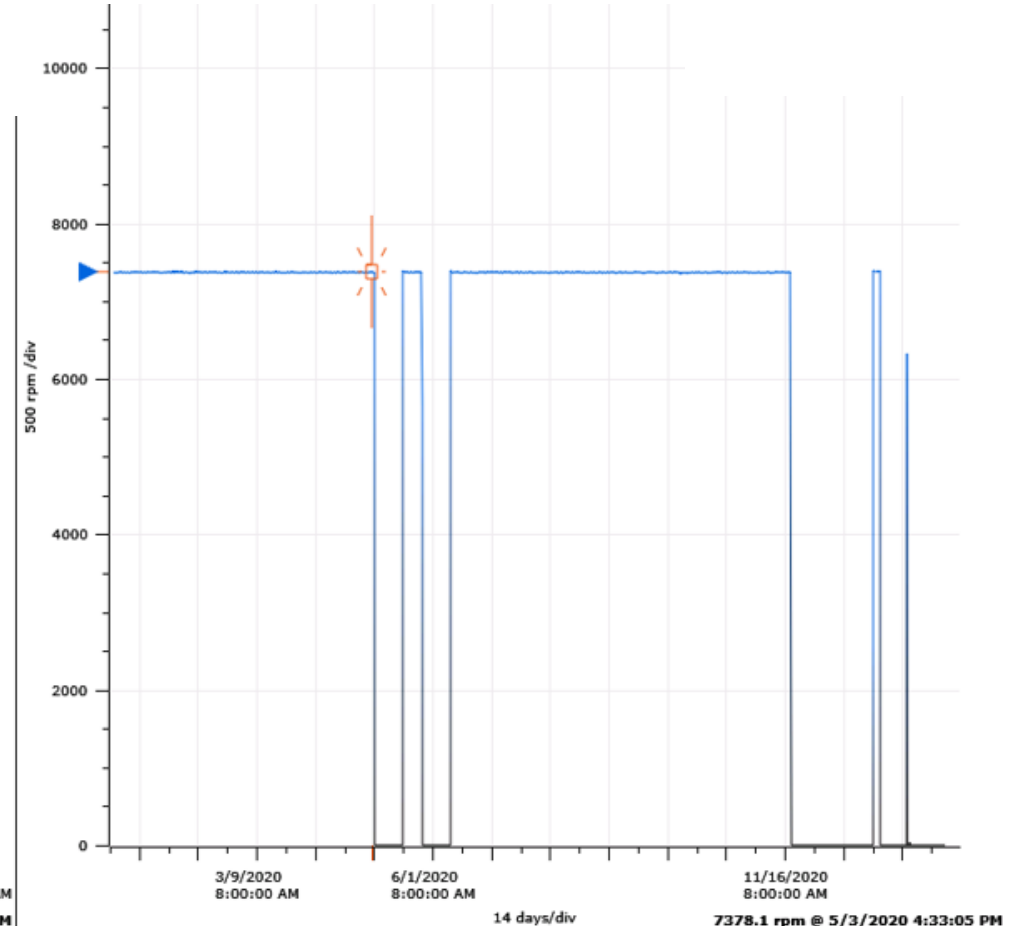
3.6 Data Review –thrust position on compressor

- Thrust position started to fluctuate 6 months prior to the current vibration trip.
- Is this behavior related to the vibration trip?

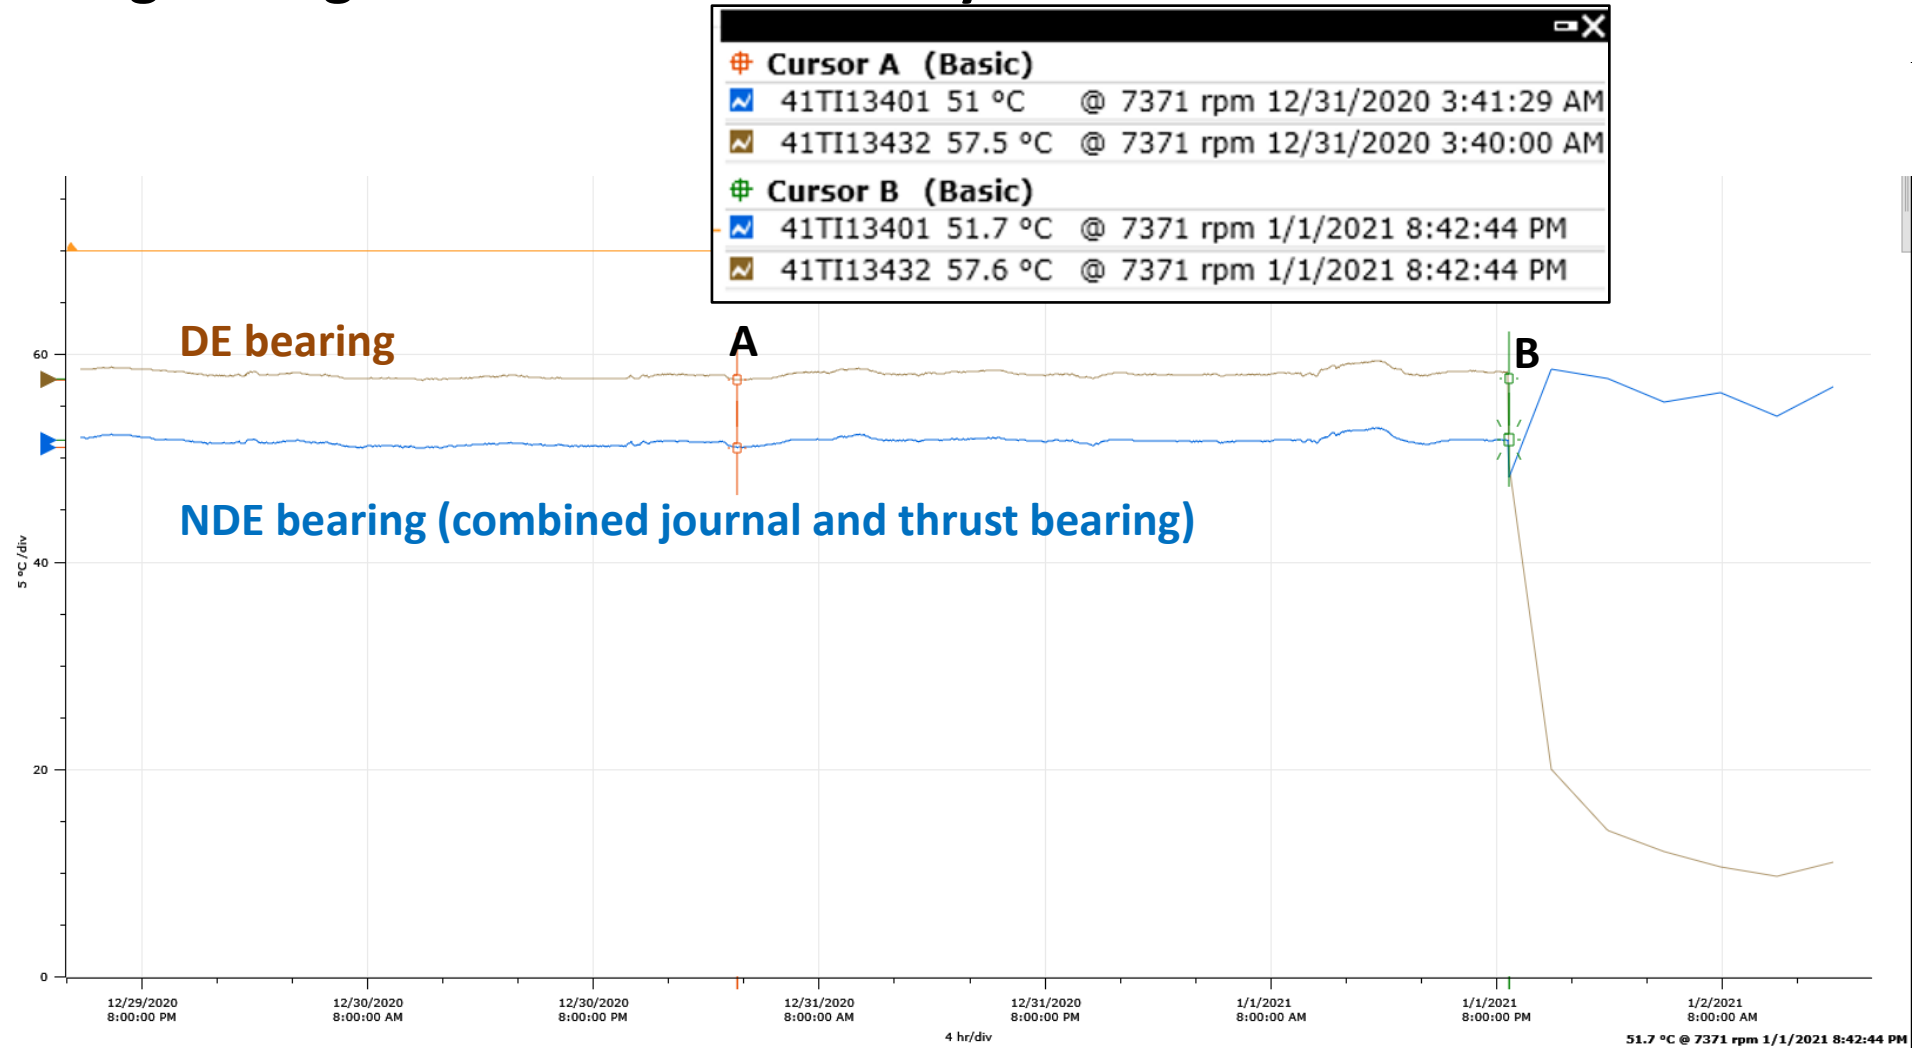
3.7 Data Review –Bearing metal temperature

- Bearing (combined journal and thrust bearing) metal temperature remained normal.
- Thrust bearing damage seemed to be unlikely.

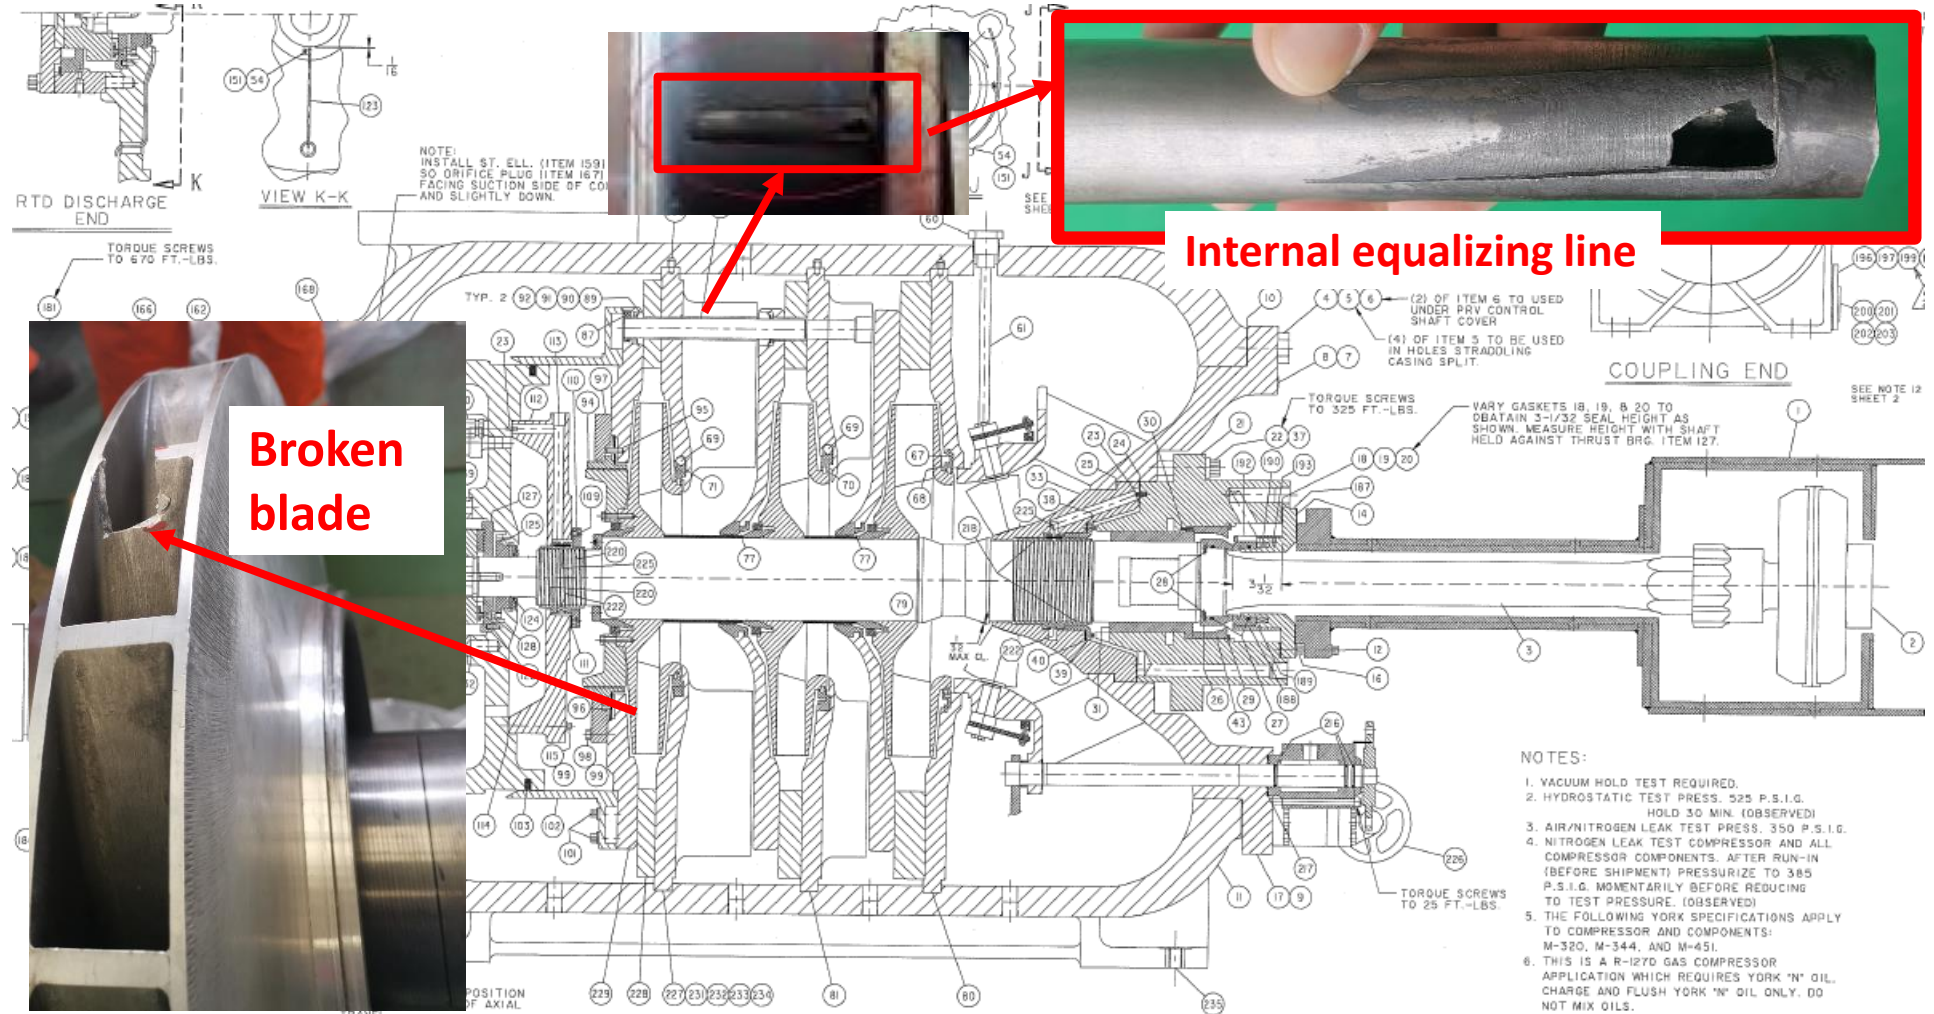
6.1 Inspections and Findings

- The internal equalizing line or balance pipe started to leak, causing the thrust force/position to fluctuate, as indicated by fluctuating thrust gap readings.
- Though not confirmed, it was likely that a damaged piece entered the gas flow and then hit the 3rd stage blade, thus breaking the blade to lead to a sudden change in unbalance.

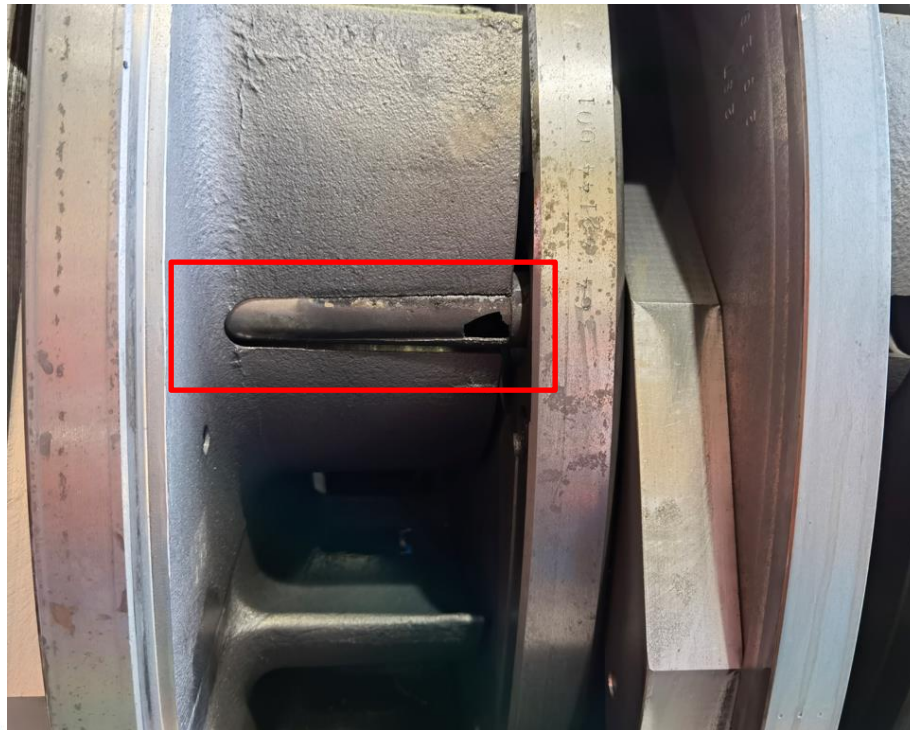
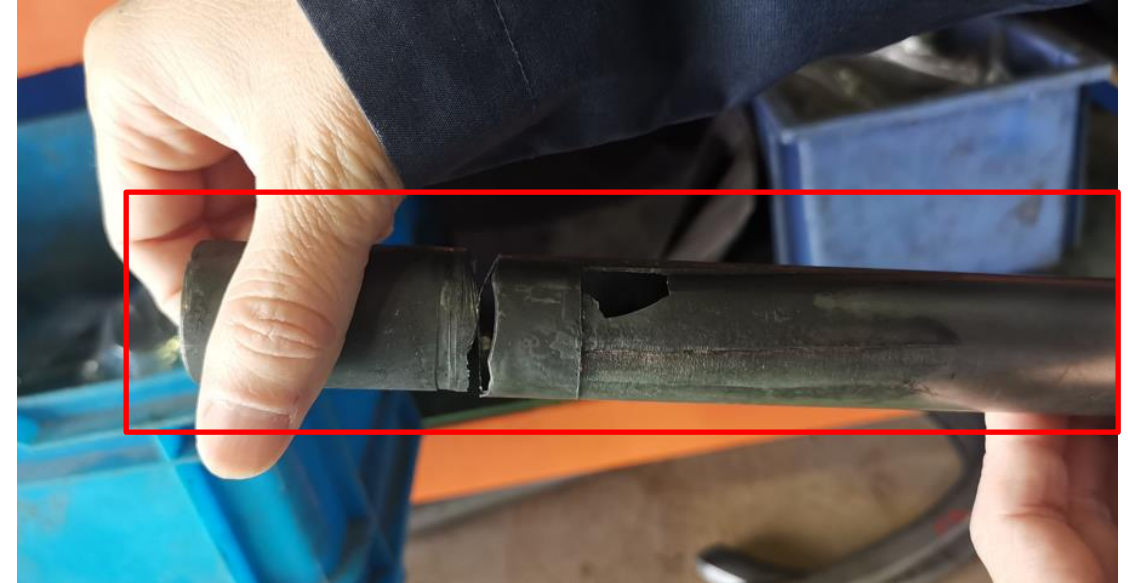
6.2 Inspections and Findings

- The balance pipe had been used for 7 years. It appeared that the corrosion due to flow-impact plus not enough thickness of the pipe itself, caused the pipe failure. It was also possible that its looseness might result in friction, causing the damage.
- The thickness of the newly-designed balance pipe was increased after this incident.
- The compressor then started up successfully after the newly-designed balance pipe was installed.
